Reconstruction Report

Missouri State Highway Patrol Reconstruction Report

Level IV Reconstruction: Sergeant David Leitman, #234 C-SS
Major Crash Investigation Team
Troop C
St. Louis, Missouri

Date of Report: October 27, 2003

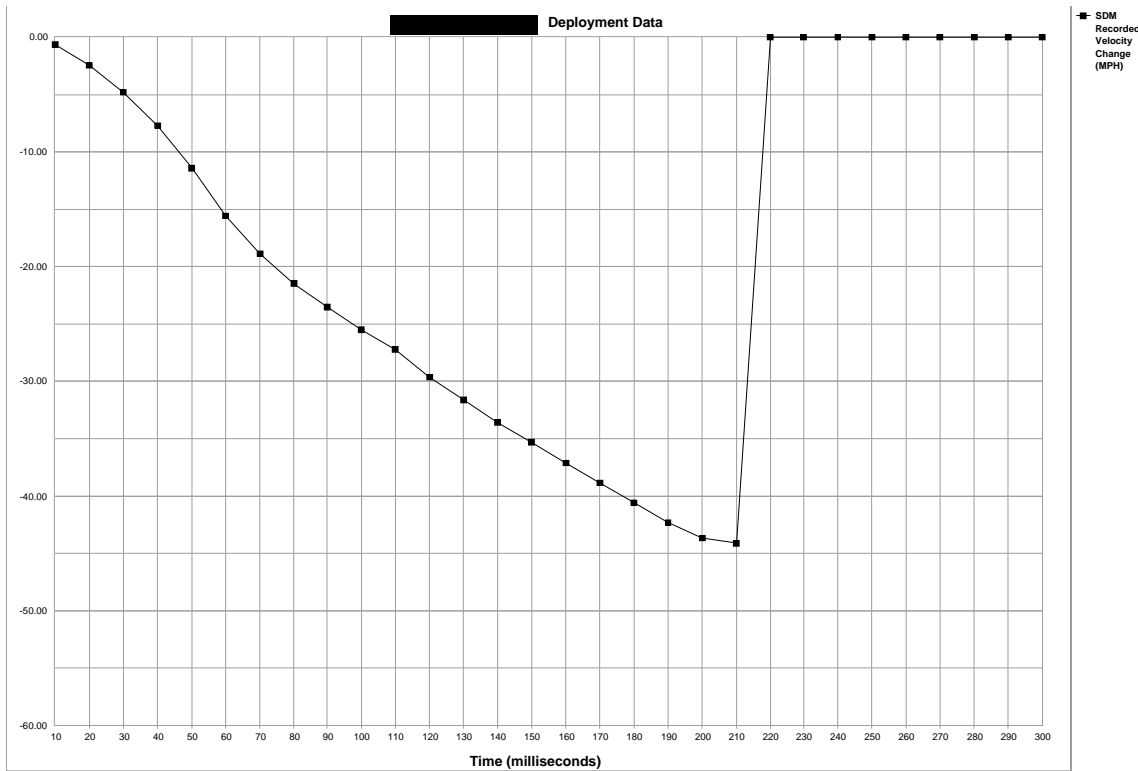
System Status At Deployment

SIR Warning Lamp Status	OFF
Driver's Belt Switch Circuit Status	UNBUCKLED
Passenger Front Air Bag Suppression Switch Circuit Status	Air Bag Not Suppressed
Ignition Cycles At Deployment	0
Ignition Cycles At Investigation	8403
Time From Algorithm Enable To Deployment Command (msec)	13.75
Time Between Non-Deployment And Deployment Events (sec)	N/A

Time (milliseconds)	10	20	30	40	50	60	70	80	90	100	110	120	130	140	150
Recorded Velocity Change (MPH)	-0.66	-2.41	-4.83	-7.68	-11.41	-15.58	-18.87	-21.50	-23.48	-25.45	-27.21	-29.62	-31.59	-33.57	-35.32
Time (milliseconds)	160	170	180	190	200	210	220	230	240	250	260	270	280	290	300
Recorded Velocity Change (MPH)	-37.08	-38.83	-40.59	-42.34	-43.66	-44.10	0.00	0.00	0.00	0.00	0.00	0.00	0.00	0.00	0.00

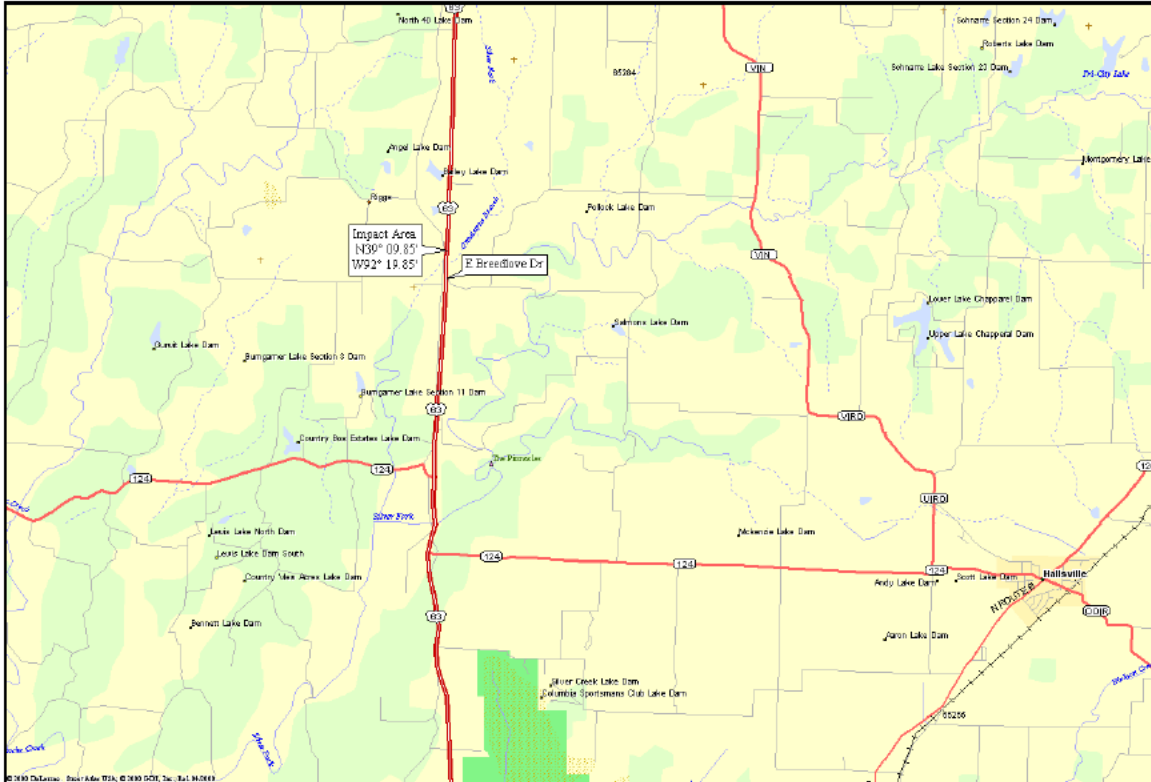
US-63 is part of the Federal Highway System and is maintained by the Missouri Department of Transportation. Below is a graphic depiction of the crash area.

US-63 is a divided highway consisting of two roadways that measured approximately 24 feet in width. Each of the roadways is divided into two lanes of travel by standard segmented lane lines. The roadways are separated by a grassy median. Asphalt shoulders border the driving lanes. The outer shoulders measured approximately ten feet wide and the inner or median shoulders measured approximately 4.5 feet wide.
