Federal Highway Administration
Every Day Counts
Innovation Initiative

Safety Edge_{SM}
Demonstration Project
State Route 182
Columbus, Mississippi

Field Report
June 27, 2011

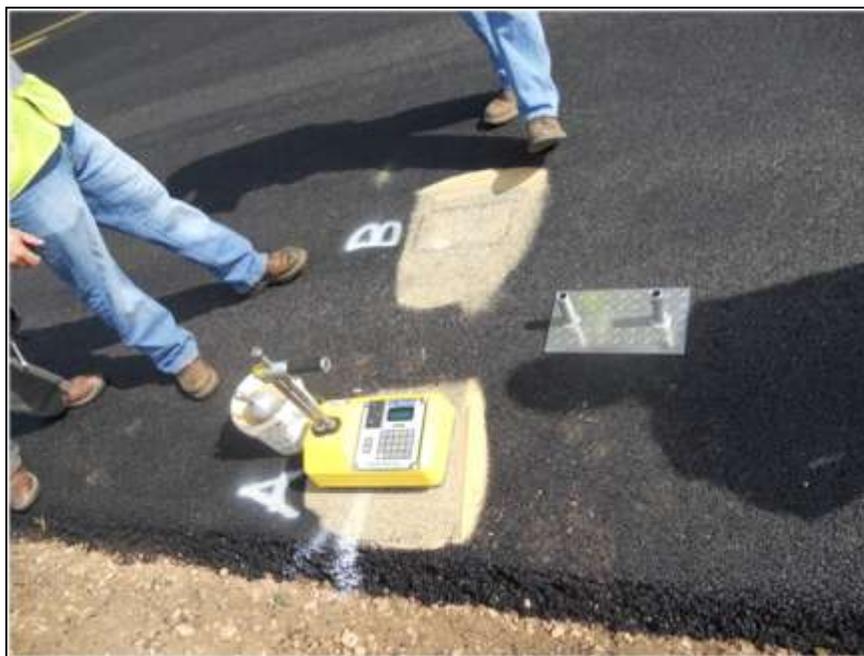
Figure 7. Nuclear gauge used to measure HMA density.

Density measurements were made with a Troxler 3440 gauge (refer to Figure 7). Four readings were recorded at each station or location. Two readings were made at a point adjacent to the Safety Edges_{SM} and two were made near the center of the steel drum roller. At each point, one reading was recorded with the nuclear gauge positioned parallel to the pavement edge and the other positioned perpendicular to the edge. The average nuclear density gauge readings at each point are listed in Table A-5 in Appendix A.

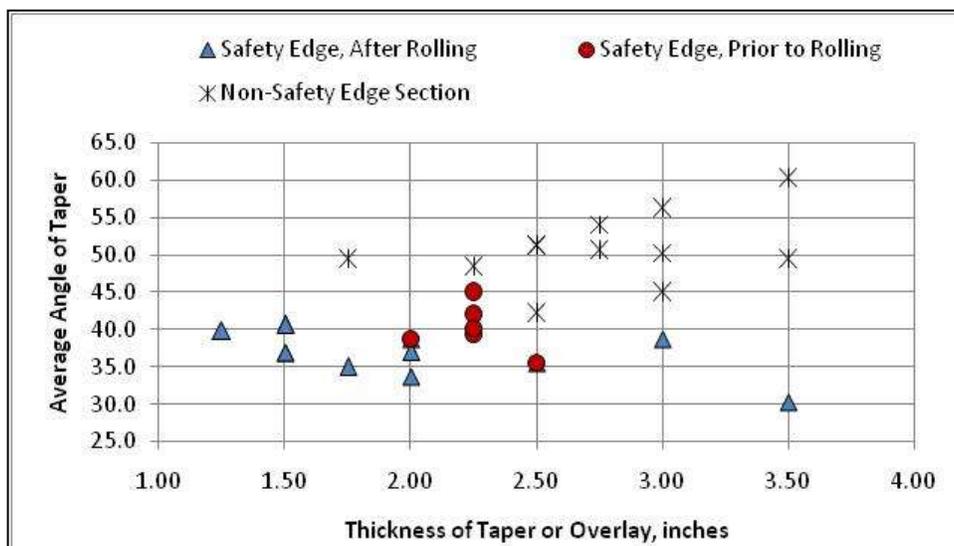
Figure 8. Comparison of the Safety Edge_{SM} slope and thickness of the HMA adjacent to the edge of the HMA overlay.

Slope measurements were taken using a straight-edge to measure the width and thickness of the taper of the Safety Edge_{SM} (refer to Figure 6). The average slope of the Safety Edge_{SM} was found to be 37°. All slope measurements are listed in Tables A-1 through A-3 in Appendix A. Only one of the measurements was about 30°. Figure 8 includes a comparison between the slope of the Safety Edge_{SM} after final rolling and thickness of the Safety Edge_{SM} for the two test sections. As shown, there appears to be no correspondence between thickness and the slope of the Safety Edge_{SM}.

Slope measurements were also made prior to rolling the Safety Edge_{SM}. These measurements are in Table A-2 in Appendix A and were compared to the values after final rolling; refer to Figure 8. As shown, the slopes prior to rolling are slightly steeper than after final rolling. These data sets were measured in different areas, so there is no direct correspondence between the individual point measurements. An observation from this comparison is that rolling did not steepen the slope, and suggests that rolling the Safety Edge_{SM} by overhanging the steel drum about 4 to 6 inches over the edge did not increase the slope. The rolling patterns used along the project are explained in the *Compaction Operations* section.

Slopes were also measured along the non-Safety Edge_{SM} section. These slope measurements are included in Table A-3 in Appendix A and shown in Figure 8. As expected, the slopes without use of the Safety Edge_{SM} are greater than when using the Safety Edge_{SM} device.

Other slope measurements were made at random along the Safety Edge_{SM} in other areas of the project, and the results were the same as for the specific Safety Edge_{SM} sections established for future performance reviews. Thus, the slope of the Safety Edge_{SM} was found to be steeper than what was planned.

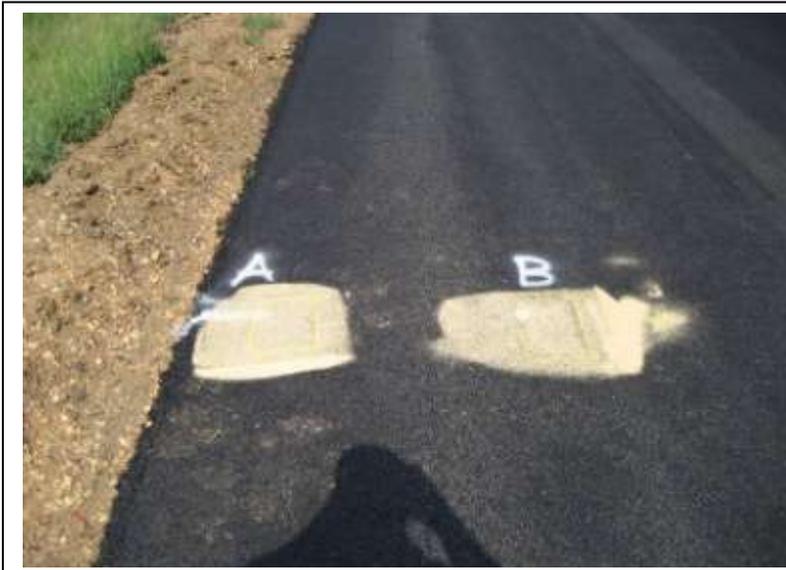
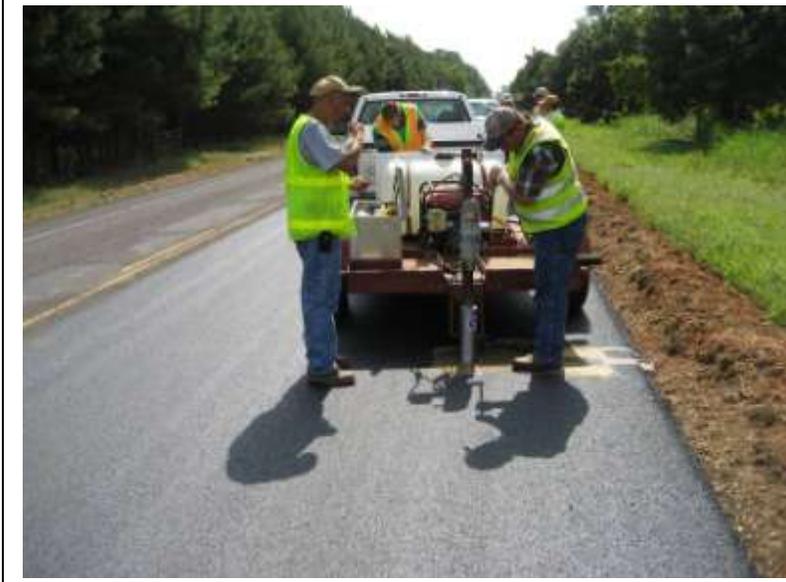
Figure 9. Photos showing location of cores and nuclear density tests made with the Troxler 3440 gauge (nuclear density readings were taken and then the HMA overlay was cored).

Location of nuclear density test; A location is adjacent to the edge; B location is near the center of the steel drum roller (about 3 feet from edge).

Core sets recovered from selected stations; A location is adjacent to the edge; B location is near the center of the steel drum roller (about 3 feet from edge).

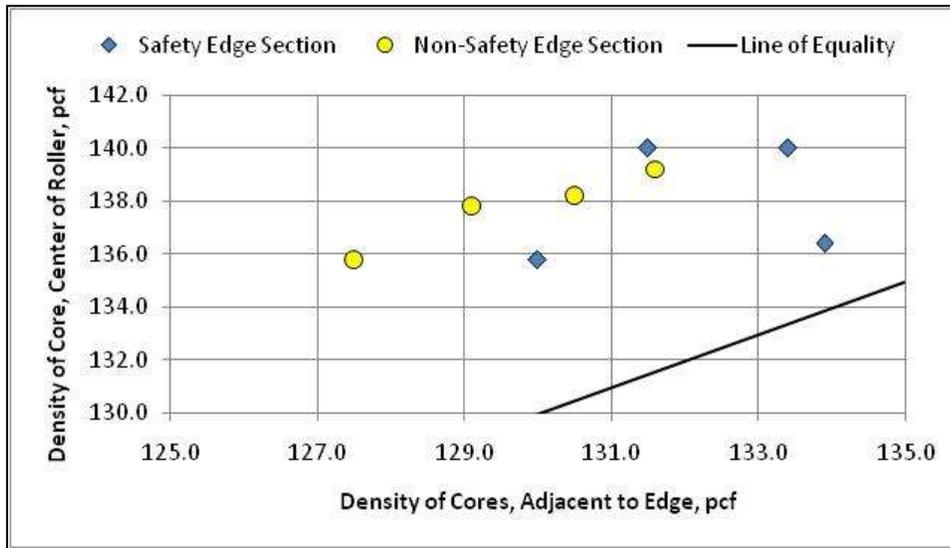
Figure 10. Comparison of core densities adjacent to the edge of pavement and near center of steel drum rollers.

Tables A-4 and A-5 in Appendix A include a summary of these test results; core thickness and bulk specific gravities (saturated surface dry) converted to bulk densities. Figure 10 includes a comparison of the core densities taken along the edge and near the center of the steel drum roller for the Safety Edge_{SM} and non-Safety Edge_{SM} sections. As expected, densities near the center of roller are higher than along the edge of the mat (unconfined edge). More importantly, the core densities taken along the pavement's edge are consistently higher for the Safety Edge_{SM} section than for the non-Safety Edge_{SM}. These results suggest that the Safety Edge_{SM} is providing better confinement for rolling an unconfined edge of the mat.

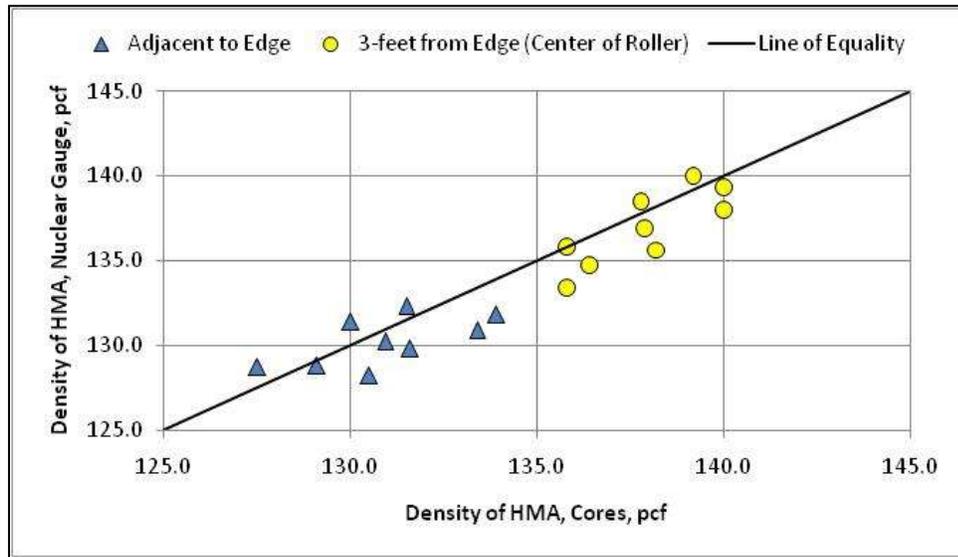
Figure 11. Comparison of the nuclear density readings and densities measured on the cores recovered from the mat.

Nuclear density readings were taken before drilling each core. Figure 11 shows a comparison of the nuclear gauge readings and densities measured on the cores. As shown, there is close correspondence between the nuclear gauge readings and core densities. Adjustment factors were determined for the nuclear gauge readings taken at the Safety Edges_{SM} and near the center of the steel drum roller being used to compact the HMA mat. The adjustment factors are included in Table A-4 in Appendix A. The following lists the average factors determined for this project, which are near unity.

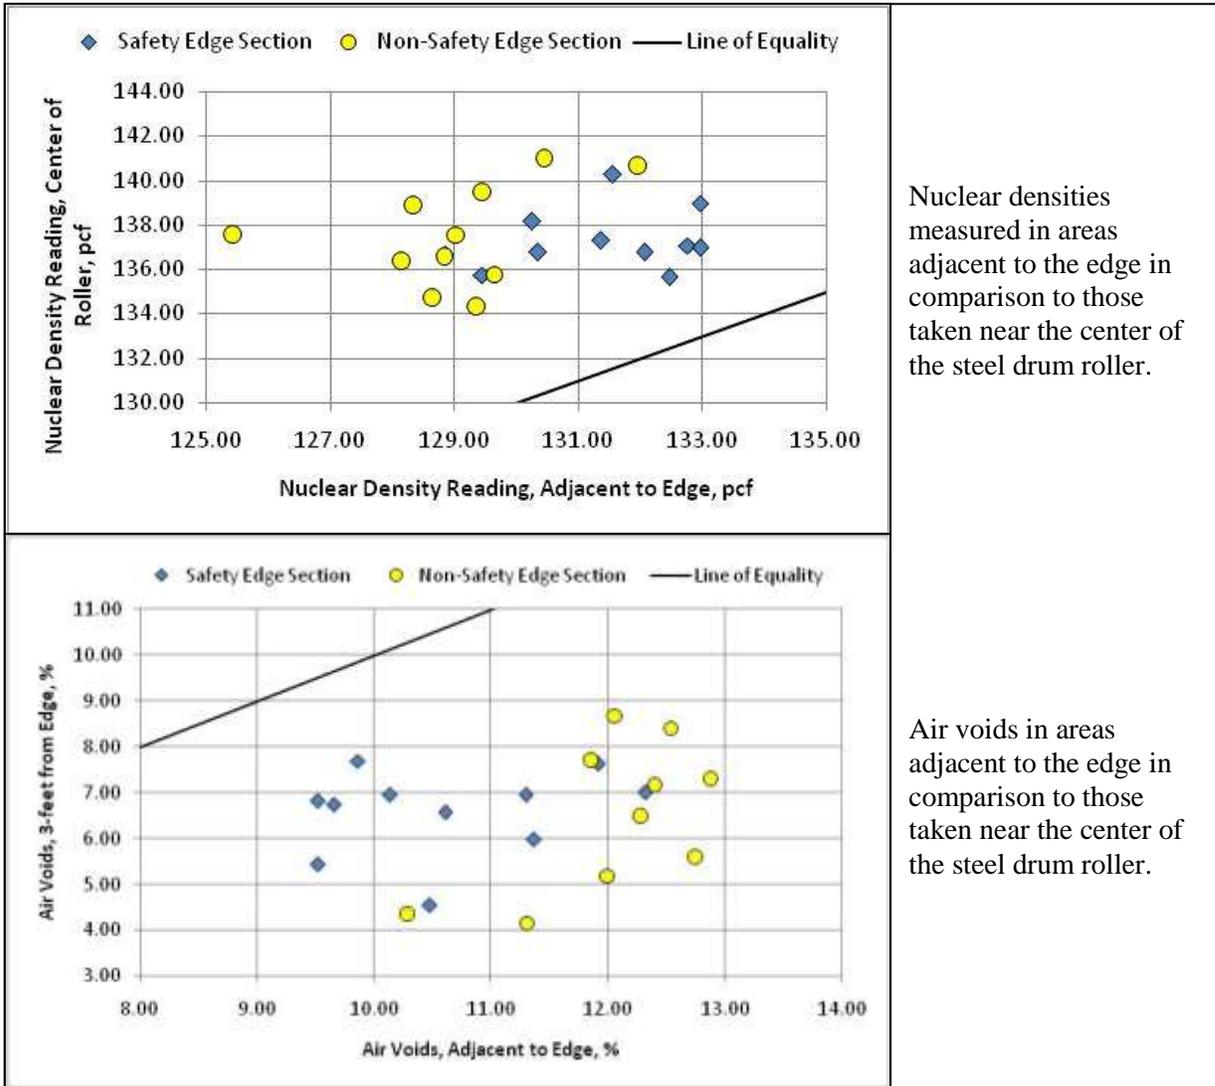
Figure 12. Comparison of the adjusted nuclear density readings and air voids between the areas adjacent to the edge and center of the steel drum roller.

Figure 12 shows a comparison of the adjusted nuclear density gauge readings taken adjacent to the Safety Edge_{SM} and near the center of the vibratory steel wheel roller. Figure 12 also includes a comparison of the HMA air voids between both areas. As shown, the air voids are higher adjacent to the Safety Edge_{SM}, in comparison to 3-feet from the Safety Edge_{SM}. The other important observation from this data is that the densities are higher and air voids consistently lower along the mat’s edge for the Safety Edge_{SM} sections, in comparison to the non-Safety Edge_{SM} section.

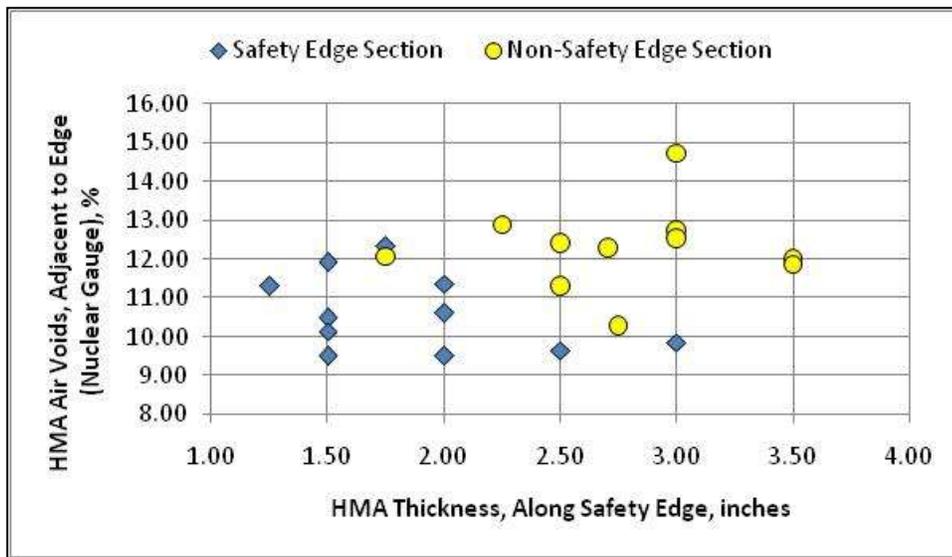
Figure 13. Comparison of HMA thickness at the edge of the mat and HMA air voids.

Figure 8 included a comparison between the HMA thickness (near the Safety Edge_{SM}) and slope of the Safety Edge_{SM}. The thickness of the HMA appears to have no effect or impact on the slope of the Safety Edge_{SM}. Figure 13 shows a comparison of the density and HMA overlay thickness. As shown, there is also little correspondence between the overlay thickness and density or air voids.

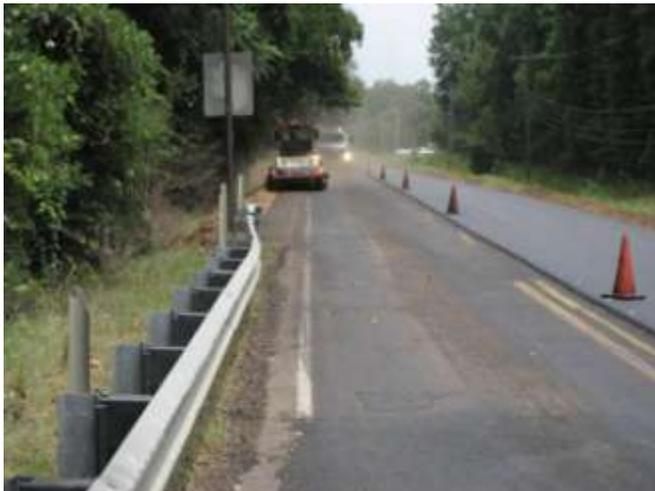
Motor grader was used to move and level the windrowed material along the edge of the pavement. In a few areas, the motor grader was used after the tack coat had already been applied.

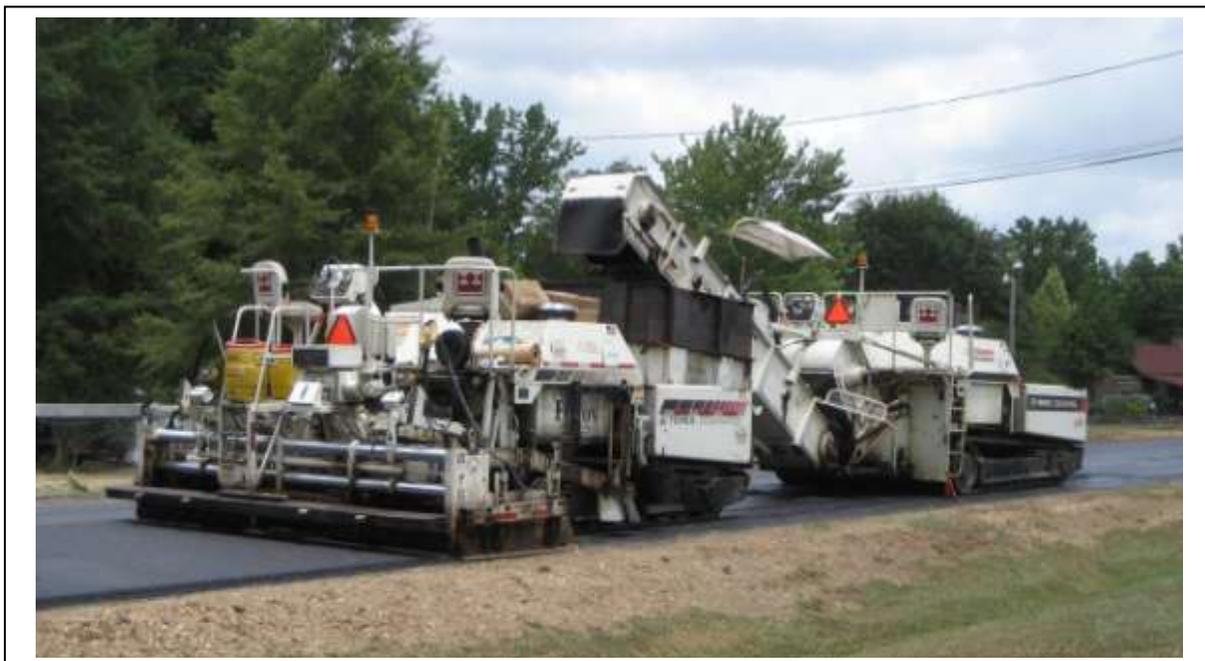
Figure 15. Equipment used to place the HMA overlay.

- The screed operator recommended that the Safety Edge_{SM} device be an automated system rather than manually turning the screw to raise and lower the Safety Edge_{SM} device.
- The shaft of the Safety Edge_{SM} device was bent during use on a previous project, such that when the screed operator turned the screw to raise or lower the device, the device would rotate creating a space between the end plate and Safety Edge_{SM} device. HMA material could then become lodged between the screed end plate and the Safety Edge_{SM} device. The screed operator continued to monitor this condition to prevent it from occurring, but in some cases HMA mix would push the device away from the screed end plate – increasing the slope. This condition may have resulted in some of the steeper slopes that were measured within the Safety Edge_{SM} Area #3 (refer to Table A-1 in Appendix A).

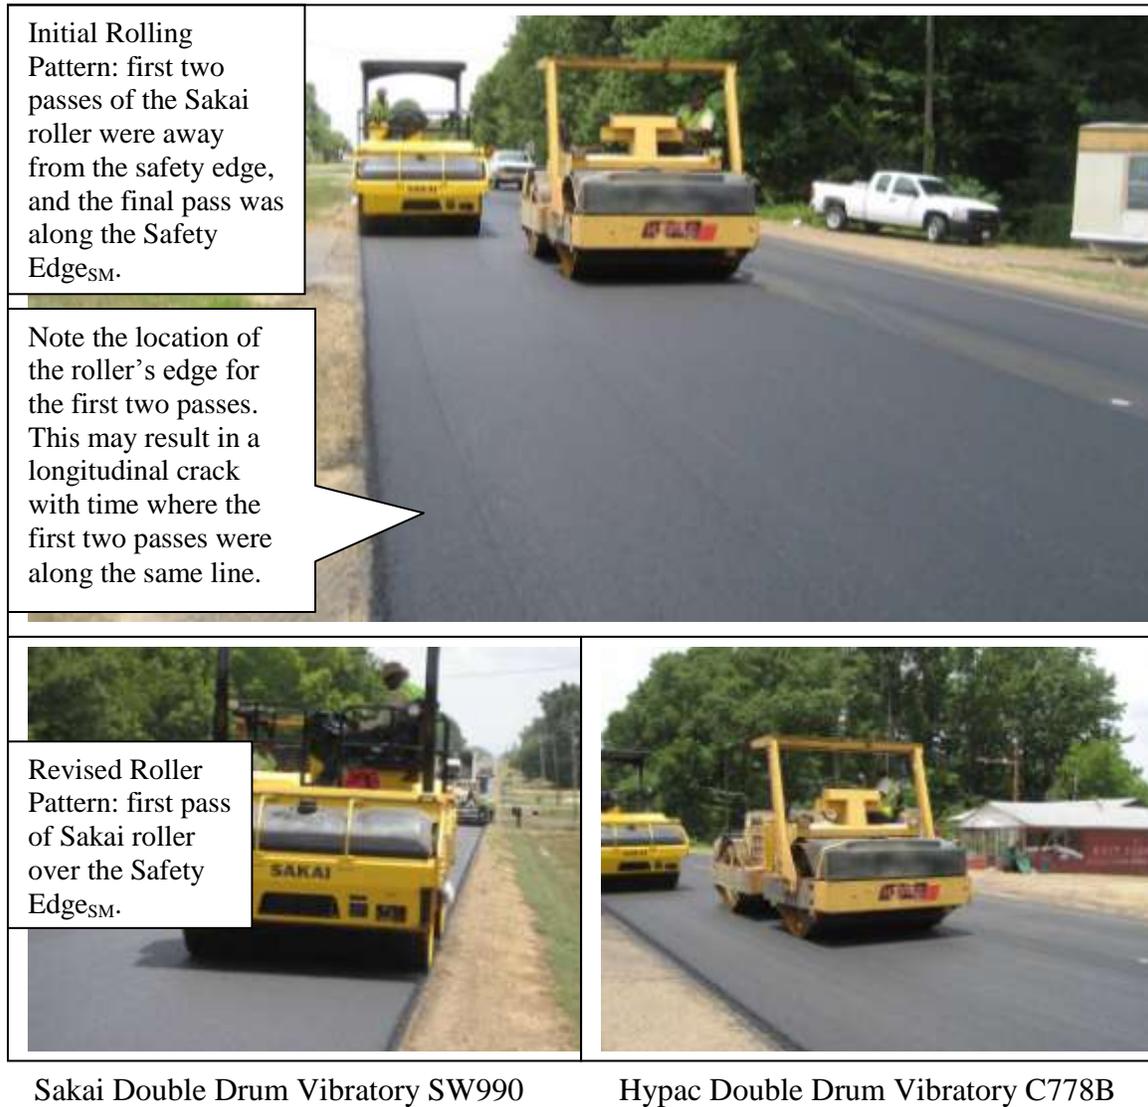
Figure 18. Two double drum vibratory steel wheel rollers were used in parallel in the breakdown position to compact the 9.5 mm HMA mix.

Figures 18 and 19 show the rollers that were used to compact the 9.5 mm HMA mixture. Two breakdown rollers were used in parallel for most of the project (refer to Figure 18). One of the primary or breakdown rollers was a Sakai double drum vibratory steel wheel (SW990), and the other breakdown roller was a Hypac double drum vibratory steel wheel (C778B). Both rollers were operated in the vibratory mode (low amplitude, high frequency). The third roller used on the project was an Ingram pneumatic, rubber tired roller (5x6 tires) and used in the intermediate position (refer to Figure 19). The finish roller was a Hypac static steel wheel roller (C784 [refer to Figure 19]).

The Safety Edge_{SM} was rolled inconsistently along the project. The rolling pattern used along most of the project, however, was that the first pass of the Sakai breakdown roller was along the Safety Edge_{SM} with the roller extended over the edge of the HMA mat by about 4 to 6 inches (refer to Figures 18 and 20). As noted above, the Sakai roller operator did divert back to initially rolling the mat away from the edge and delayed rolling the edge until the last pass in different locations (refer to Figures 18 and 20). For the initial rolling pattern, the edge of the mat along the Safety Edge_{SM} received only one pass of the breakdown roller. The exact locations of the different rolling patterns were not identified along the project.

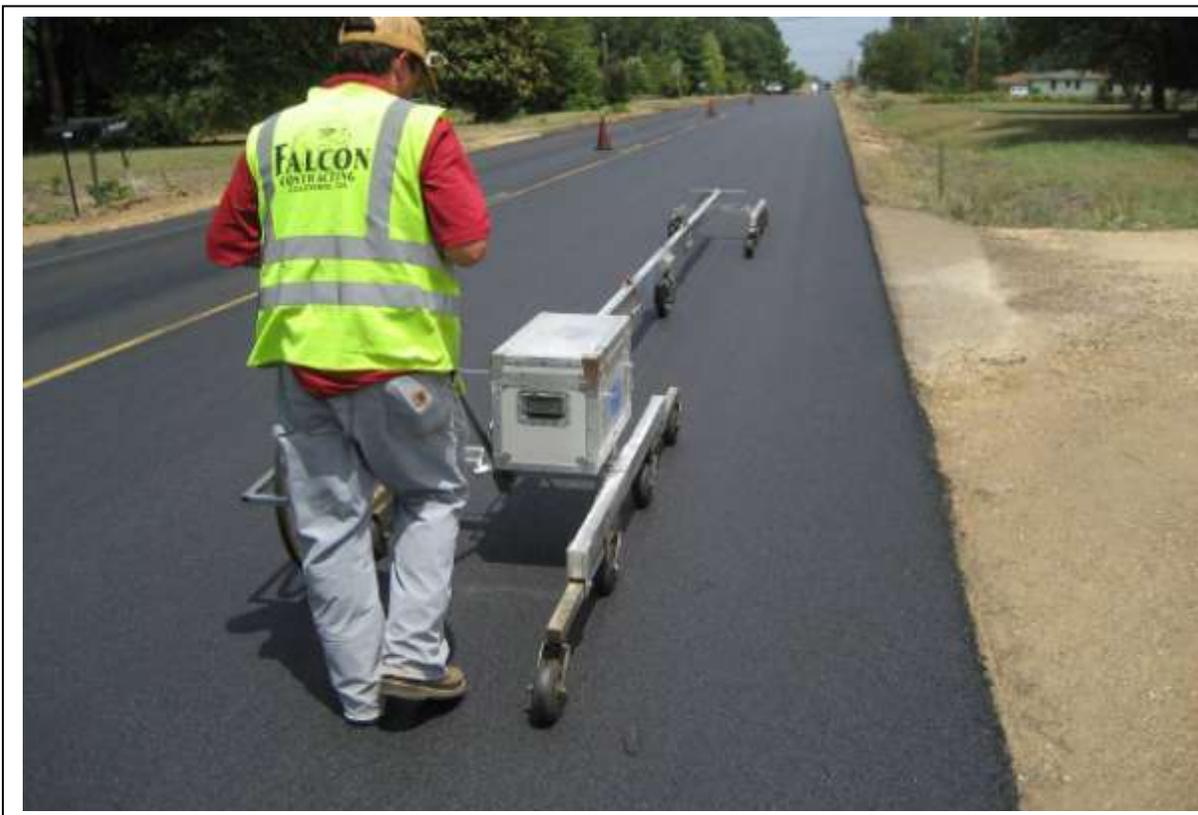
Figure 24. Longitudinal Profile Testing of Final Surface of Overlay

The other concern of the contractor was that the smoothness of the mat would decrease in those areas, and smoothness was a pay item (refer to Figure 24). The contractor requested that the Mississippi DOT permit the Safety Edge_{SM} device to be removed in those areas. It is unknown whether the Mississippi DOT permitted the contractor to remove the Safety Edge_{SM} device in those areas.
