Federal Highway Administration
Every Day Counts
Innovation Initiative

Safety Edge_{SM}
Demonstration Project
Kearney, Nebraska

Field Report
May 24, 2011

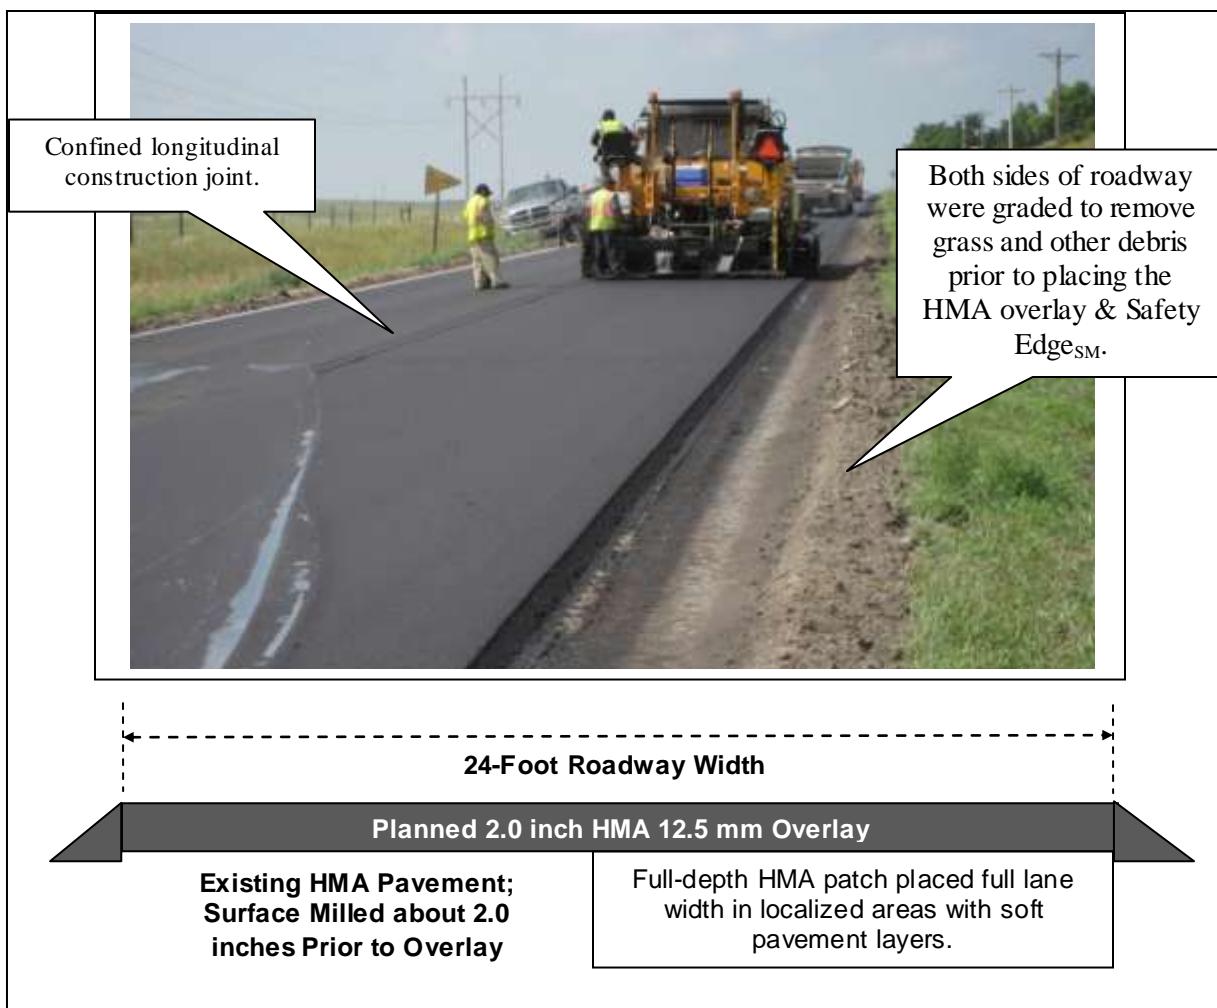
The project consisted of milling the existing surface to a depth of about 2 inches (basically removing the existing wearing surface and some of the underlying layer) and placing a 2 inch lift of a 12.5 mm HMA mix over the existing HMA pavement. Figure 2 provides a general view of the 2 inch HMA overlay and typical cross section of the pavement. Figure 3 provides a general view of the roadway for this project. In preparation for the HMA overlay, the following activities and repairs were made.

- The existing shoulder was graded to remove grass and other debris; no other surface preparation along the shoulder was completed. Figures 2 and 4 show the shoulder that was graded prior to placement of the HMA overlay and Safety Edge_{SM}.
- Full depth patches were placed in selected areas of the roadway where the subgrade or subsurface layer was found to be soft. Figure 5 shows a full-depth HMA patch that was used to repair the roadway prior to overlay placement, and shows depressions caused by the paver and belly-dump trucks delivering the 12.5 mm HMA mixture to the project site. The full-depth HMA patch was placed across the entire lane width.
- An emulsion tack coat was placed on the milled surface and patched areas.

Figure 2. 12.5 mm HMA overlay being placed in one direction where the overlay in the opposite lane has already been placed.

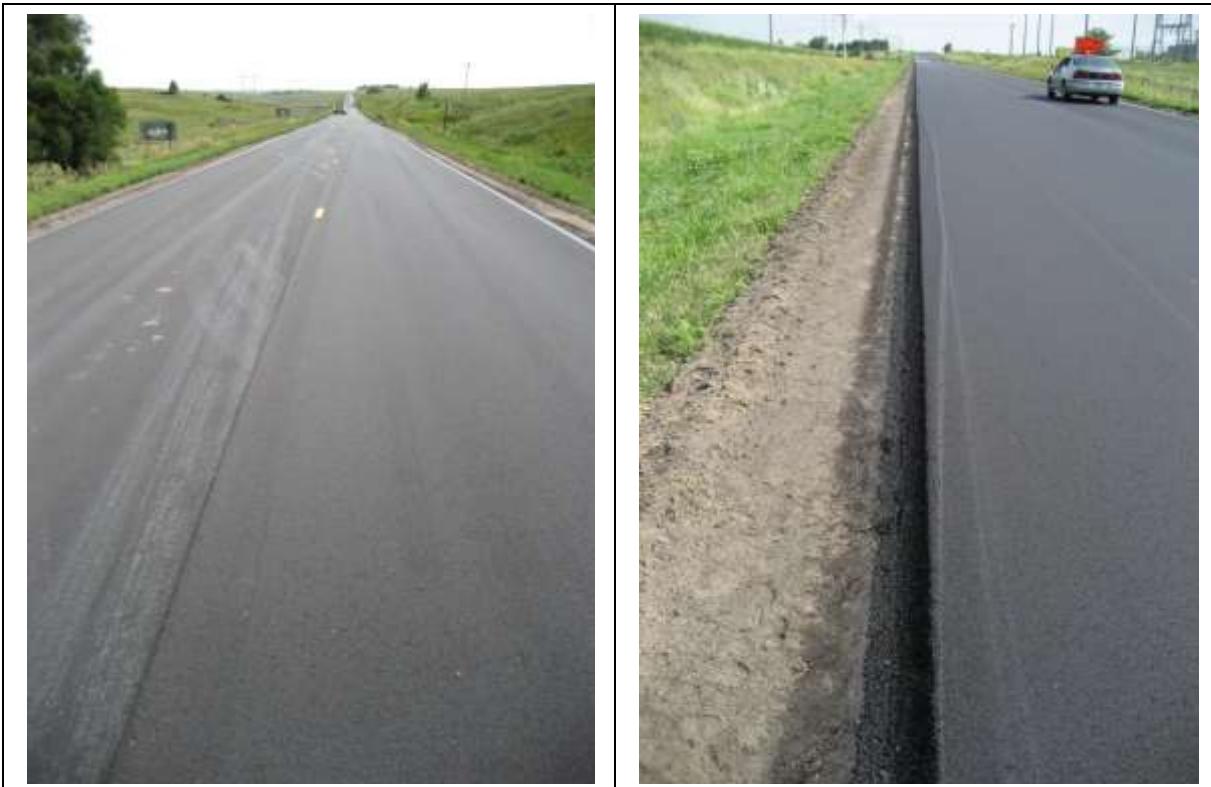
Figure 3. General overview of project location; view is towards the north.

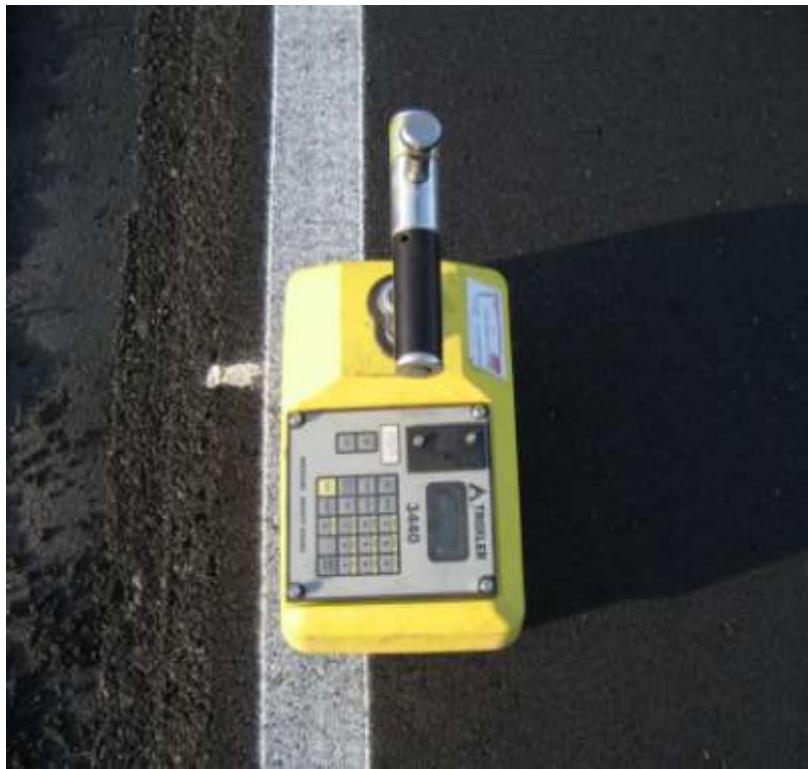
Field tests were conducted within each test section for measuring slope and HMA density. Slope measurements were taken using a 4-foot aluminum straight-edge and six inch ruler (refer to Figure 6), while density readings were taken adjacent to and 3-feet from the mat's edge using a Troxler 3440 nuclear density gauge (refer to Figure 7).

Figure 7. Troxler nuclear density gauge used to measure HMA density.

Density measurements were made with a Troxler 3440 gauge (refer to Figure 7). Two readings were recorded at each station or location; one reading was taken at a point adjacent to the Safety Edge_{SM} and one near the center of the steel drum roller. The nuclear gauge was positioned parallel to the pavement edge (refer to Figure 7). The nuclear gauge readings at each point are listed in Table A-3 in Appendix A.

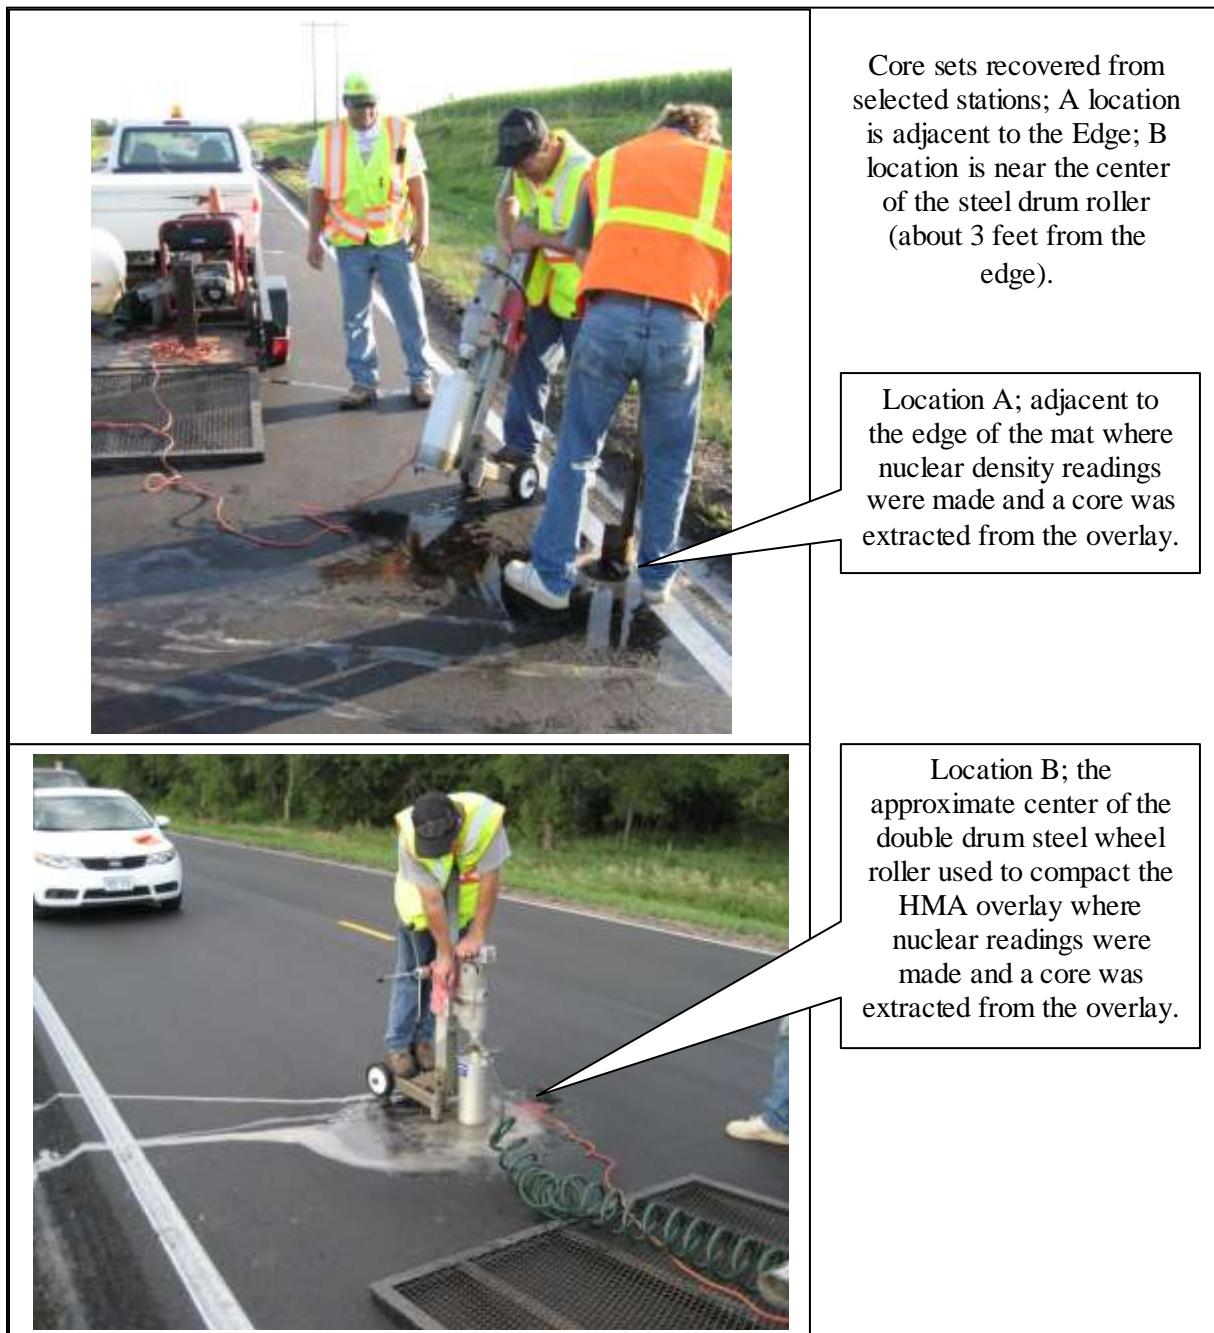
Figure 9. Photos show location of cores and nuclear density tests made with the Troxler gauge (nuclear density readings were taken and then the overlay was cored).

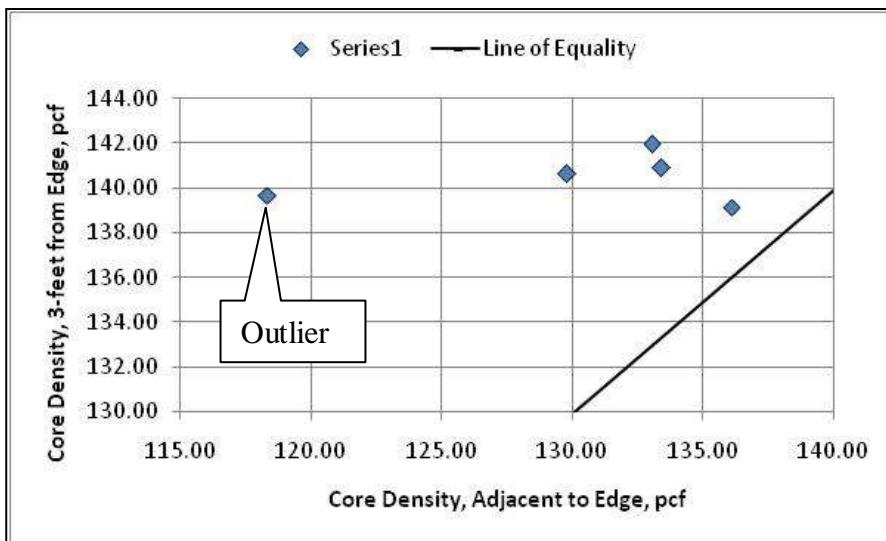
Figure 10 includes a comparison of the core densities taken along the edge and near the center of the steel drum roller for the Safety Edge_{SM} and non-Safety Edge_{SM} sections. As expected, densities near the center of roller are higher than along the edge of the mat (unconfined edge). As shown, one of the densities of the cores taken along the edge is extremely low and considered an outlier. The core densities taken along the pavement's edge are approximately equal for the Safety Edge_{SM} and non-Safety Edge_{SM} sections.

Figure 10. Comparison of core densities adjacent to the edge of pavement and near center of the steel drum rollers.

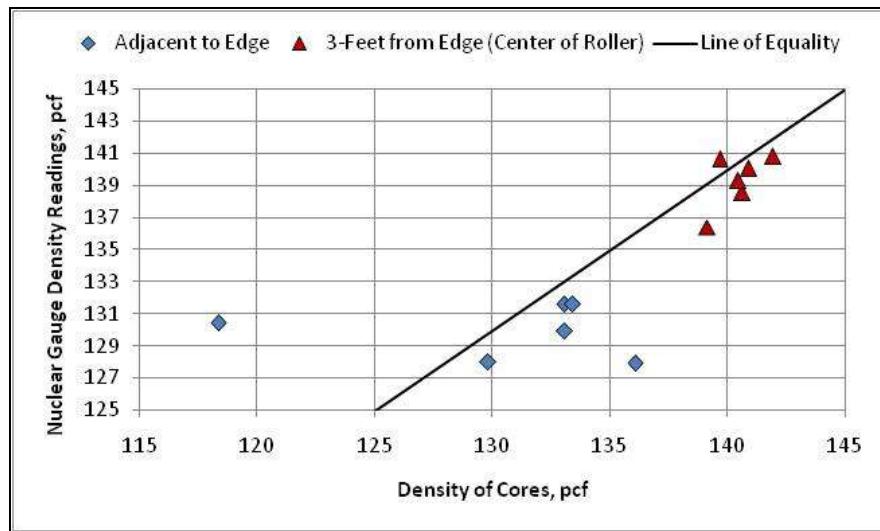
Nuclear gauge readings were taken before drilling each core. Figure 11 shows a comparison of the nuclear gauge readings and densities measured on the cores. As shown, there is a positive bias for the readings taken adjacent to the edge of the mat. Adjustment factors were determined for the nuclear gauge readings taken at the edge of the HMA mat and near the center of the steel drum roller being used to compact the HMA mat. The following lists the average adjustment factors determined for this project:

Figure 11. Comparison of the nuclear gauge readings and densities measured from cores.

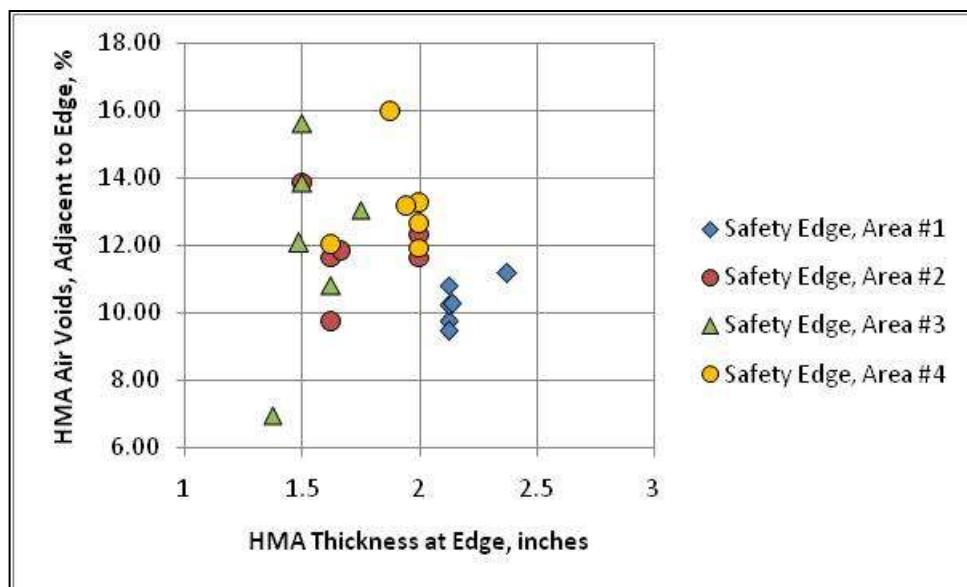
Figure 8 included a comparison between the HMA thickness (near the Safety Edge_{SM}) and slope of the Safety Edge_{SM}. The thickness of the HMA appears to have no effect or impact on the slope of the Safety Edge_{SM}. Figure 13 shows a comparison of the density and HMA overlay thickness. As shown, there is also little correspondence between the overlay thickness and air voids or densities.

Figure 13. Comparison of HMA thickness at the edge of the mat and HMA air voids.

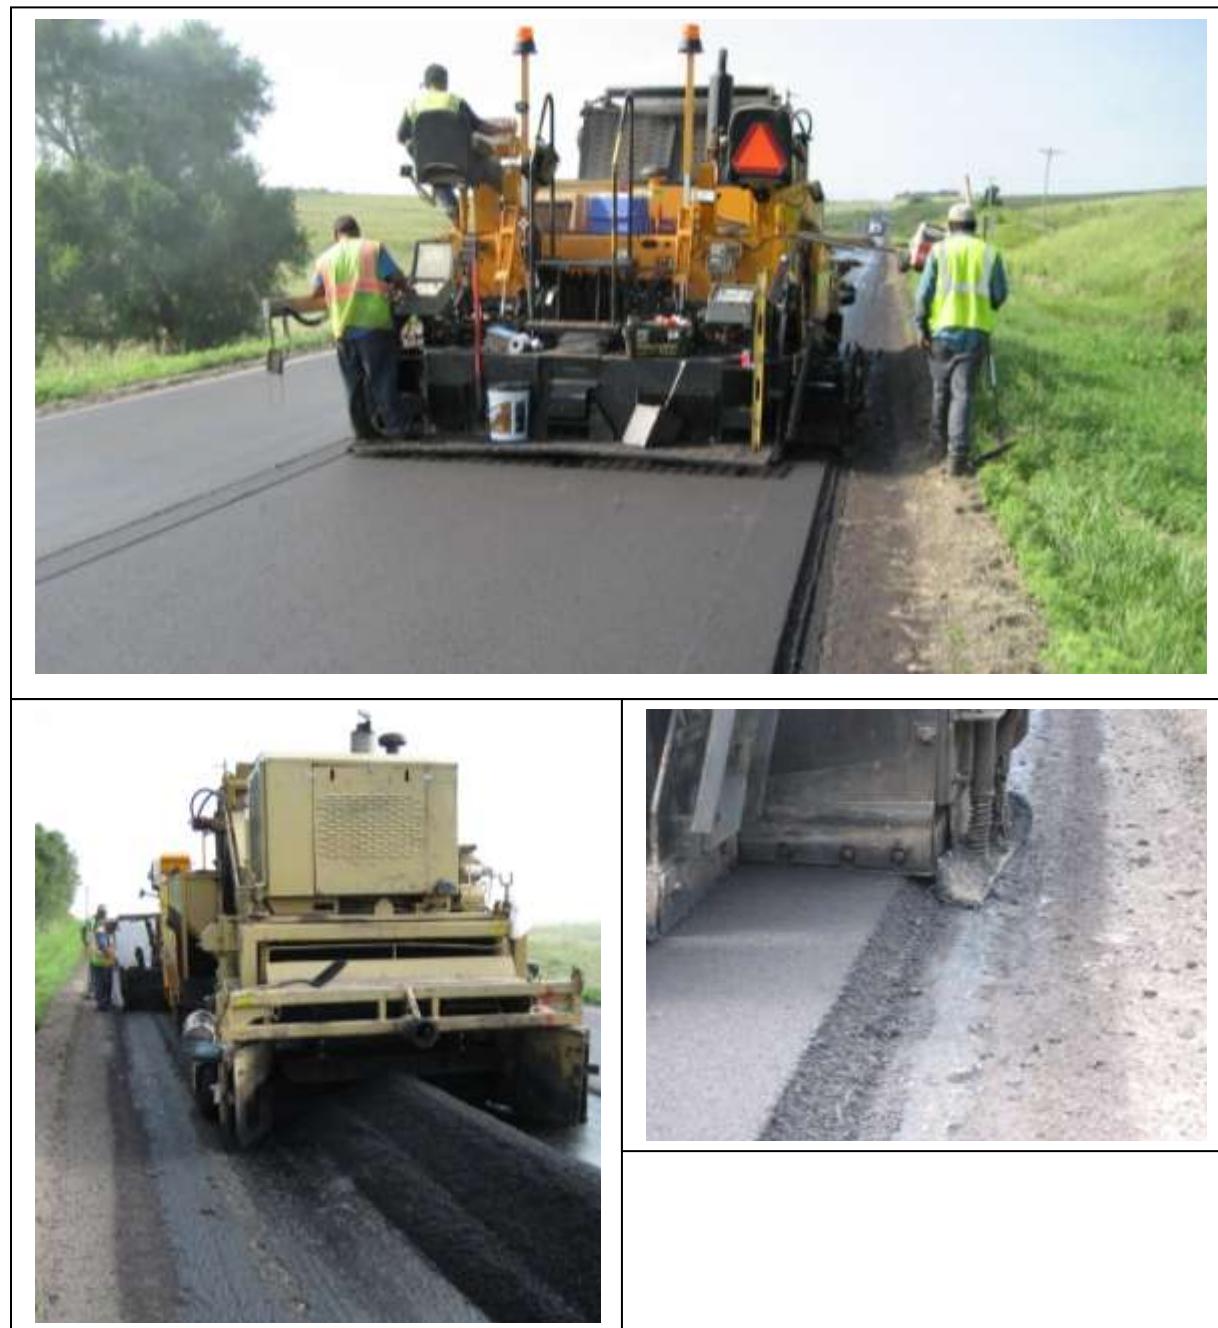
Figure 14 shows the equipment used to place the HMA overlay. The paving contractor operated the paver in the automatic longitudinal grade control mode and used non-contact sonic sensors for controlling the grade. Figure 15 shows the TransTech Shoulder Wedge

Figure 14. Equipment used to place the HMA overlay.

Figure 14 showed the HMA behind the screed and the Safety Edge_{SM} slope prior to rolling. The slope of the Safety Edge_{SM} prior to rolling was equal to or slightly steeper than the planned 30°. The distance between the end of the auger and screed end plate was about 18 inches (refer to Figure 15). This distance should be less than 18 inches. The temperature of the HMA being delivered to the project site was reported to be 310 to 318 °F. Mix temperature and the distance between the end of the auger and screed end plate are not believed to be contributing factors to the steeper slopes.

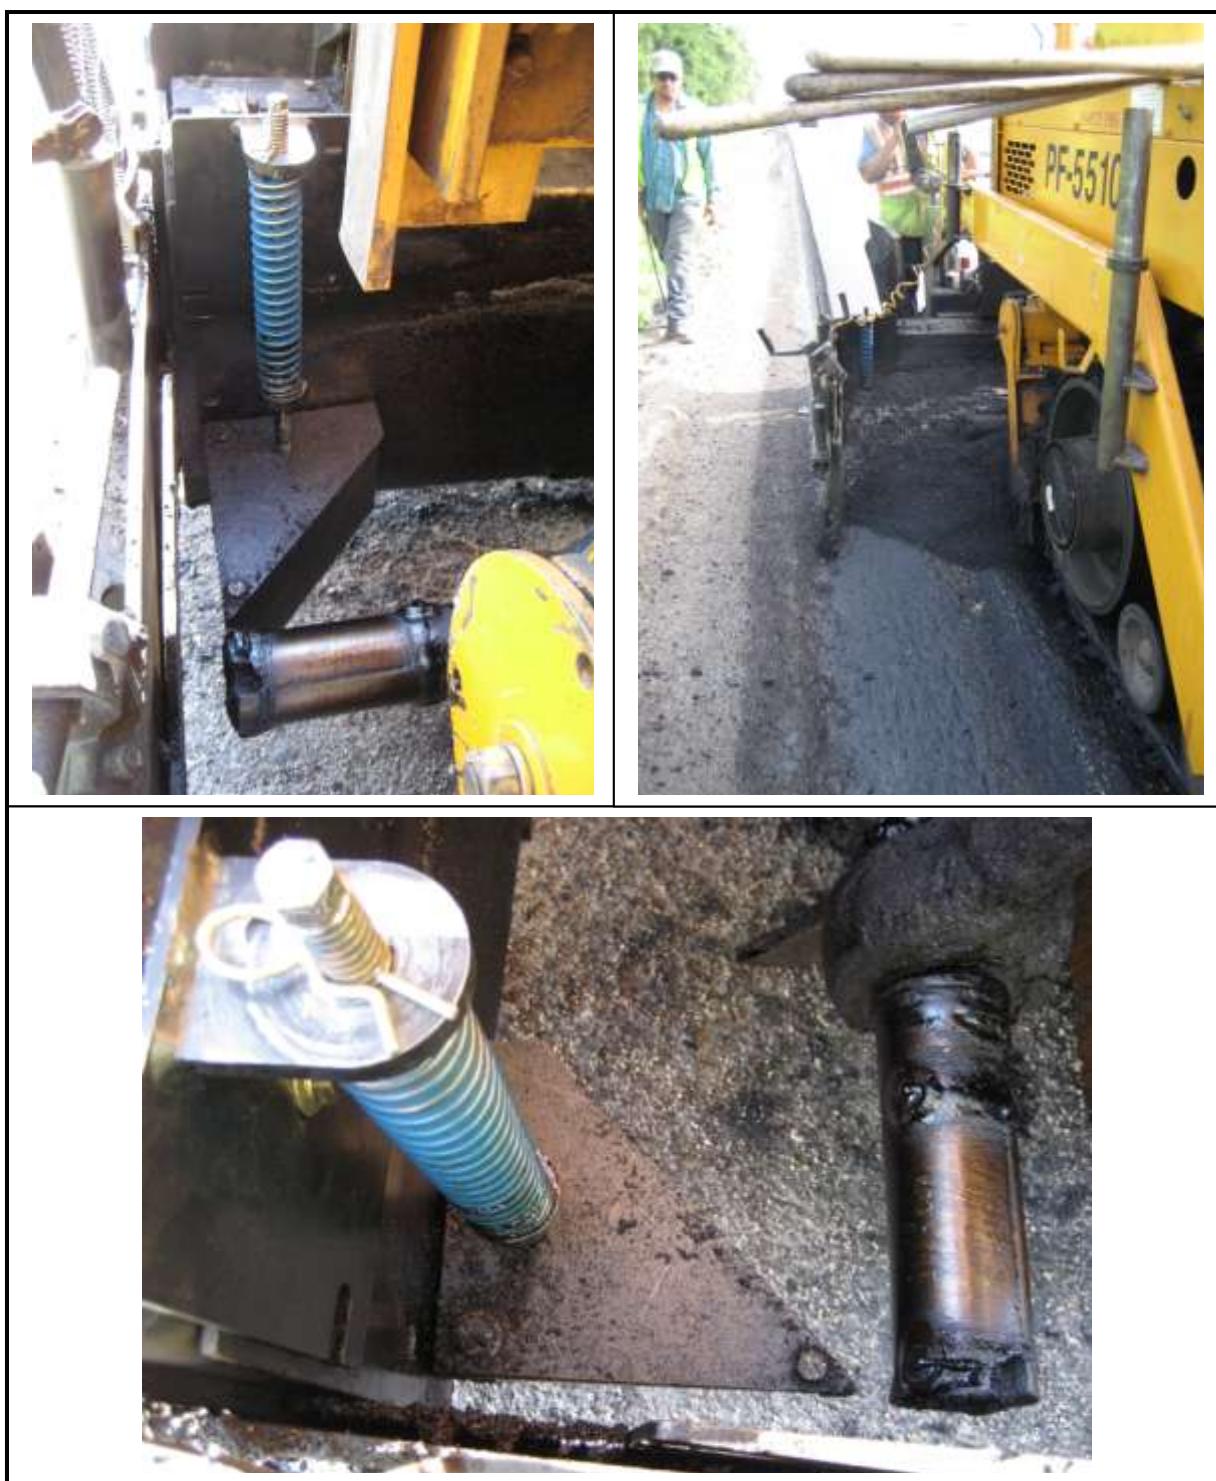
Marker device attached to the screed. The HMA overlay was placed in windrows using belly-dump trucks. The use of windrows and associated paving equipment allowed the paver to place the HMA at a constant and uniform rate with few stops of the paver.

Figure 15. TransTech Shoulder Wedge Maker device attached to the screed.

- The Safety Edge_{SM} was formed using the TransTech Shoulder Wedge Maker device, which was properly bolted to the screed. Construction personnel recommended that the Safety Edge_{SM} device include an automated system for raising and lowering the device.
- Both contractor and agency personnel voiced a concern that the spring stiffness is too high and the travel length too short. In paving across intersections or in areas with higher longitudinal profile, the Safety Edge_{SM} device may raise the screed relative to the profile set by the longitudinal ski.

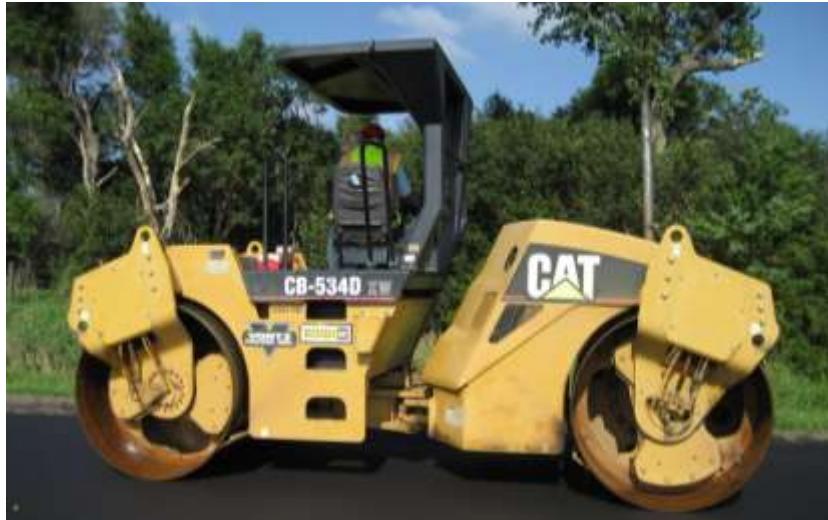
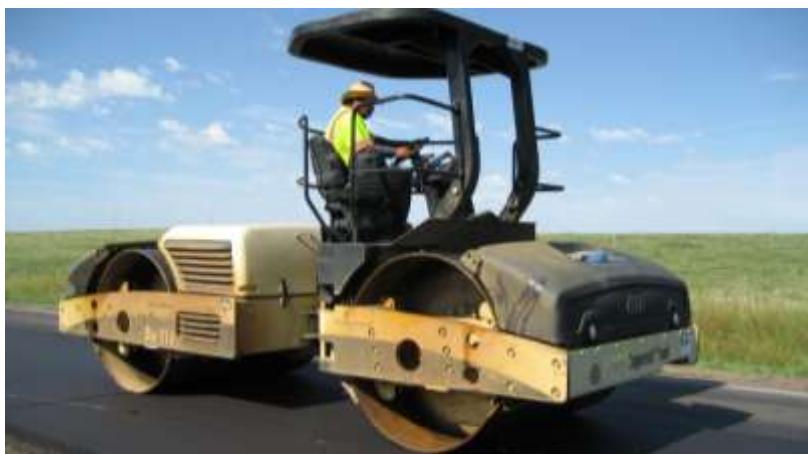
Figure 17. Rollers used for compacting the 12.5 mm HMA overlay mixture.

Figure 17 shows the two rollers that were used to compact the 12.5 mm HMA mixture. The primary or breakdown roller was a Caterpillar double drum vibratory (CB 534D), while the finish roller was an Ingersoll-Rand double drum vibratory (DD118 420HFA). The field evaluation forms identify the number of passes and coverage used by all rollers (a pass is defined as one movement of the roller in one direction, while coverage is defined as each point on the mat receiving a pass of the roller). In summary, each roller had 5 passes with 2 coverages, except for the area adjacent to (within 6 inches) and along the Safety Edge_{SM}, which only received one pass of the breakdown roller.

A control strip was not used to confirm that the roller pattern being used was achieving an adequate density of the mix. The nuclear density gauge readings and the densities of the cores suggest that adequate density was obtained for this mixture away from the edge, but the density was low near the edge.

Caterpillar double drum vibratory steel wheel roller used in breakdown or primary position for compacting the HMA overlay.

Ingersoll-Rand double drum vibratory steel wheel roller used in the vibratory and static mode that was used in the finish position for compacting the HMA overlay.

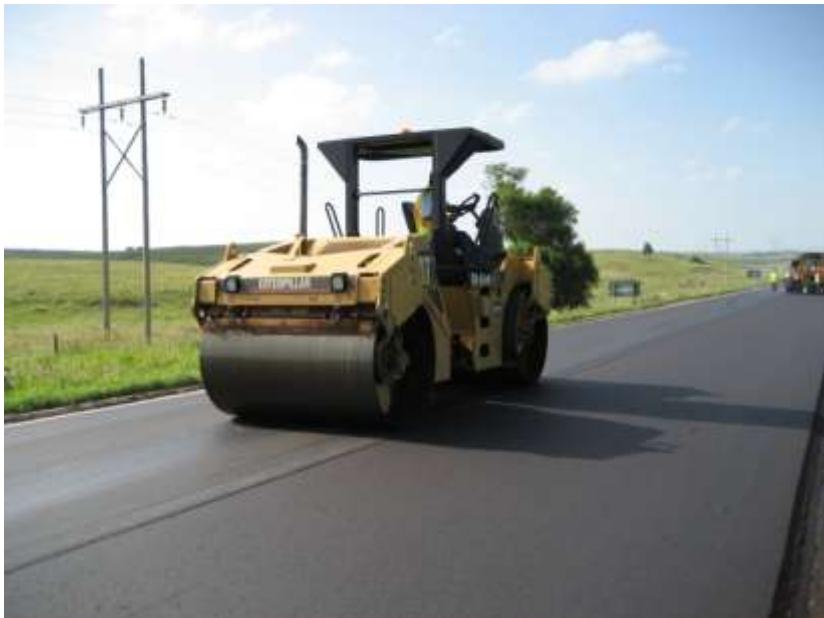
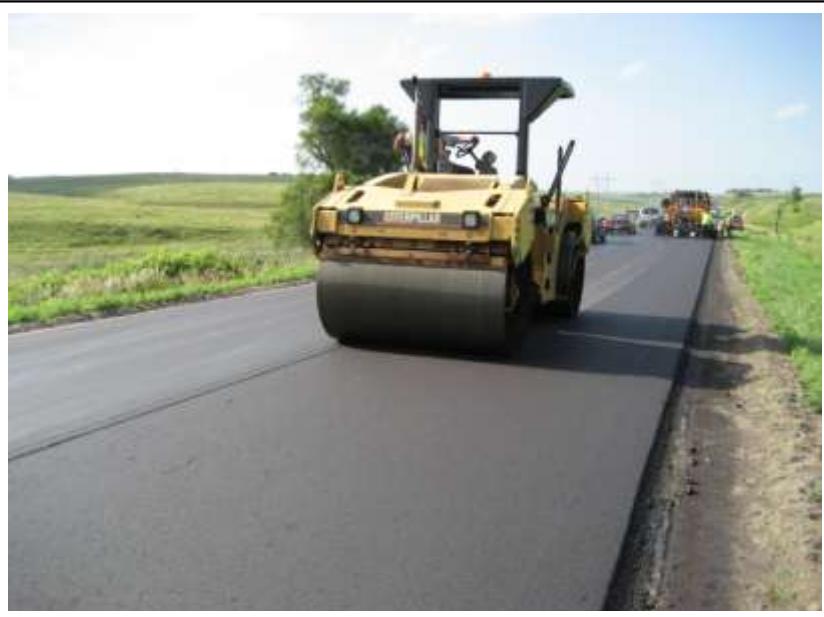
Figure 19. Initial rolling pattern; cold-side-pinch was used to compact the confined longitudinal construction joint.

- First pass was along the longitudinal centerline joint in the static position along the cold side of the joint (refer to Figure 19.a; cold-side-pinch).

- Second pass was along the longitudinal centerline joint but on the hot side of the joint in the vibratory mode (low frequency, low amplitude [refer to Figure 19.b]).

(a) First pass of Caterpillar breakdown roller in static mode along the cold-side of the longitudinal joint.

(b) Second pass of Caterpillar breakdown roller in vibratory mode along the hot-side of the longitudinal

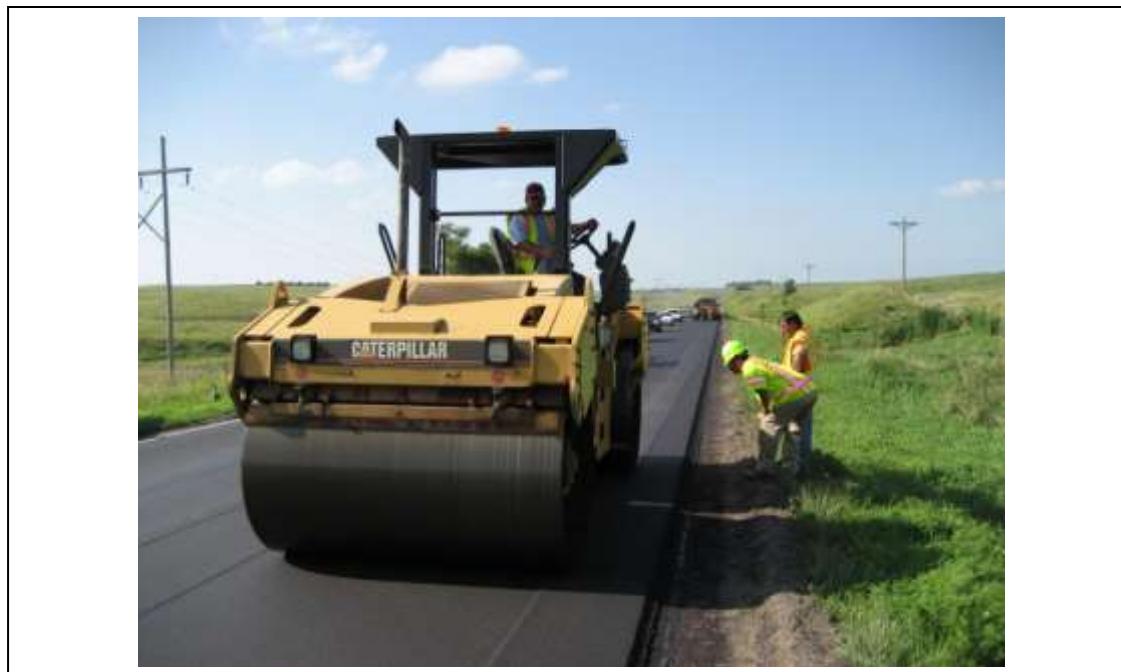
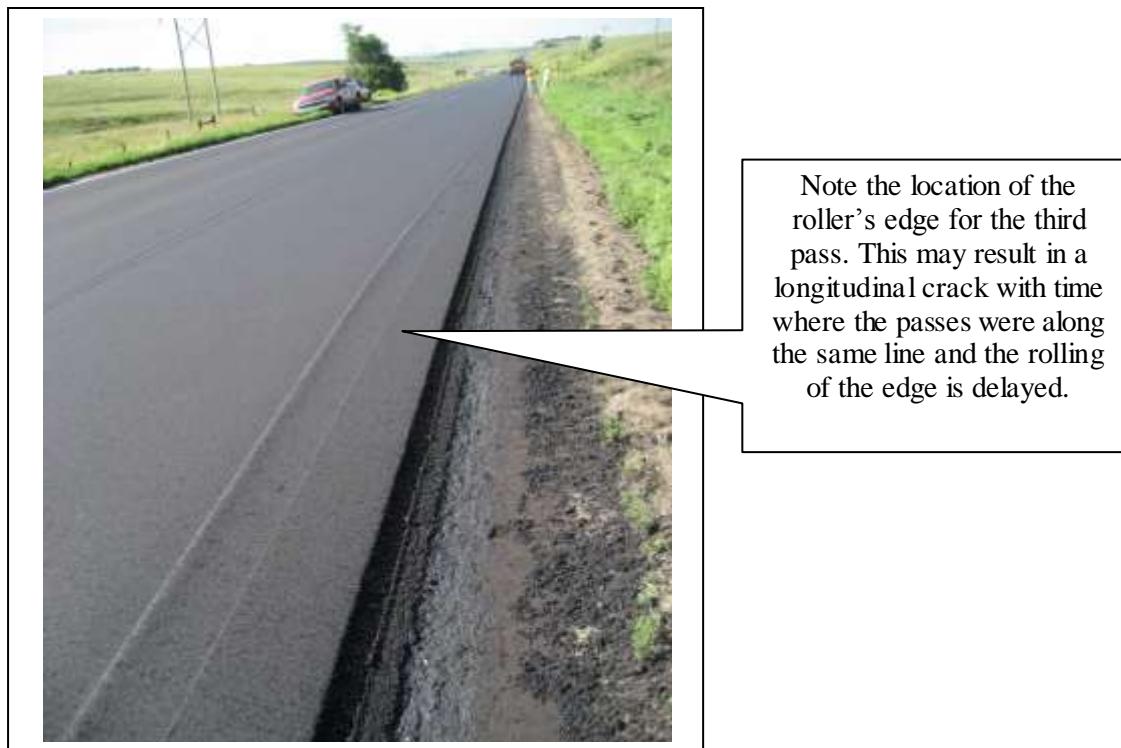
- Third pass was near the center of the mat but about 6 to 12 inches from the Safety Edge_{SM}; also in the vibratory mode (refer to Figure 20).
- Fourth pass was over the same location as for the third pass but in the reverse direction and in vibratory mode.

Pass #3 of Caterpillar roller is 6 to 12 inches from the edge of the mat.

Figure 20. Rolling the unconfined edge with the vibratory steel wheel roller.
