Evaluation of Bibb Graves Bridge Arch in Wetumpka, Alabama

Petrographic Evaluation and Recommendations

ASR Development and Deployment Program
Field Application and Demonstration Projects

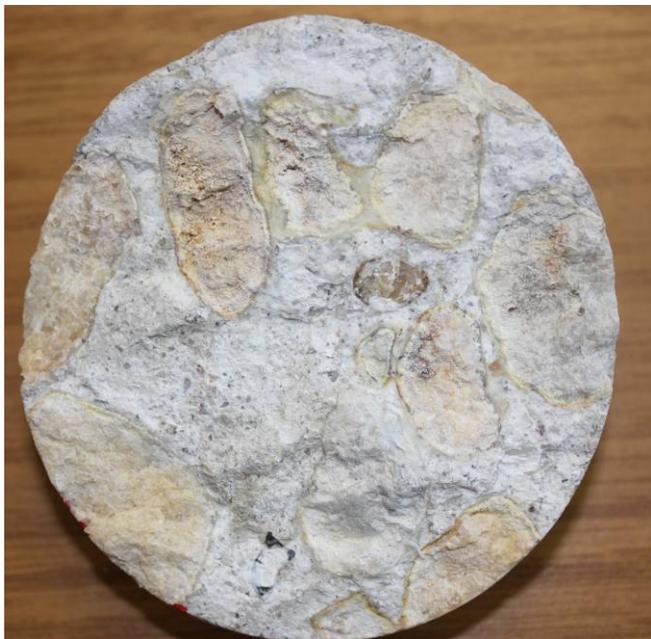
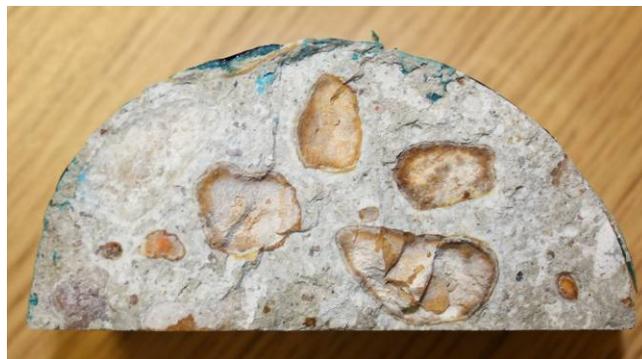
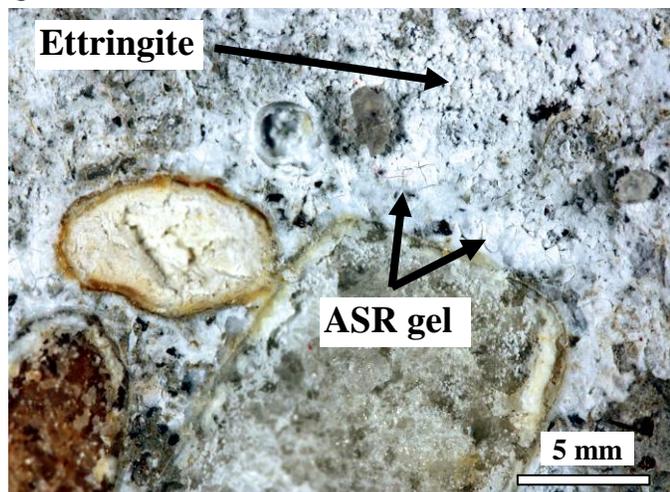
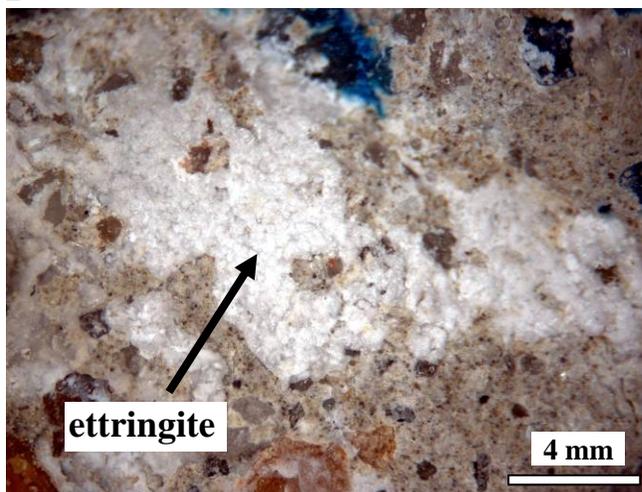
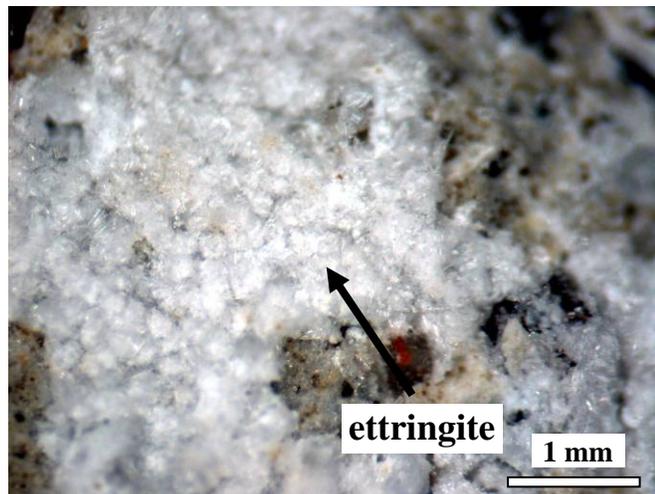
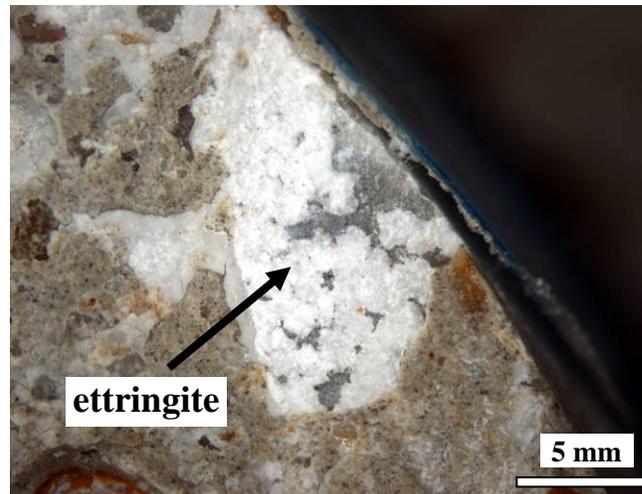
Figure B2: Micrographs of the polished core section 2A-South (distance between vertical lines = 1 cm)
 The micrographs show extensive cracking in the coarse aggregate particles and in the cement paste. The coarse aggregates mainly consist of chert (Ch) (sometimes partially leached/weathered) and quartzite particles (Qtz). Dark reaction rims (RR) are observed around some coarse aggregate particles. Concrete is not air entrained but some air voids are filled with ettringite (ett) (e.g. D). Cracks in the cement paste are often filled by ettringite (whitish and powdery deposits; also clear and waxy in luster) and alkali-silica reaction products, as illustrated in more details in Figure B3.
