Evaluation of Six Bridge Structures along Interstate 395 in Bangor, Maine

Field Site and Petrographic Evaluation

U.S. Department of Transportation
Federal Highway Administration

1. Report No. FHWA-HIF-13-066		2. Government Accession No.		3. Recipient's Catalog No.	
4. Title and Subtitle Evaluation of Six Bridge Structures along Interstate 395 in Bangor, Maine: Field Site and Petrographic Evaluation				5. Report Date September 2009

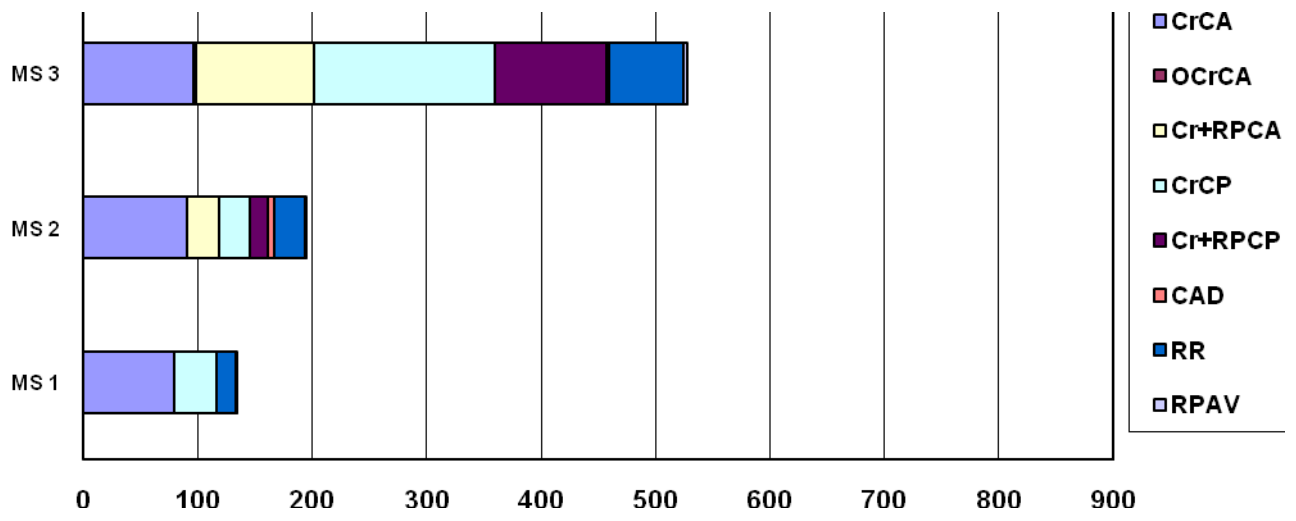
Figure 1: DRI values for the cores extracted from I395 over Main Street

4.2.1 I395 over Main Street (3 cores) (Figure 1)

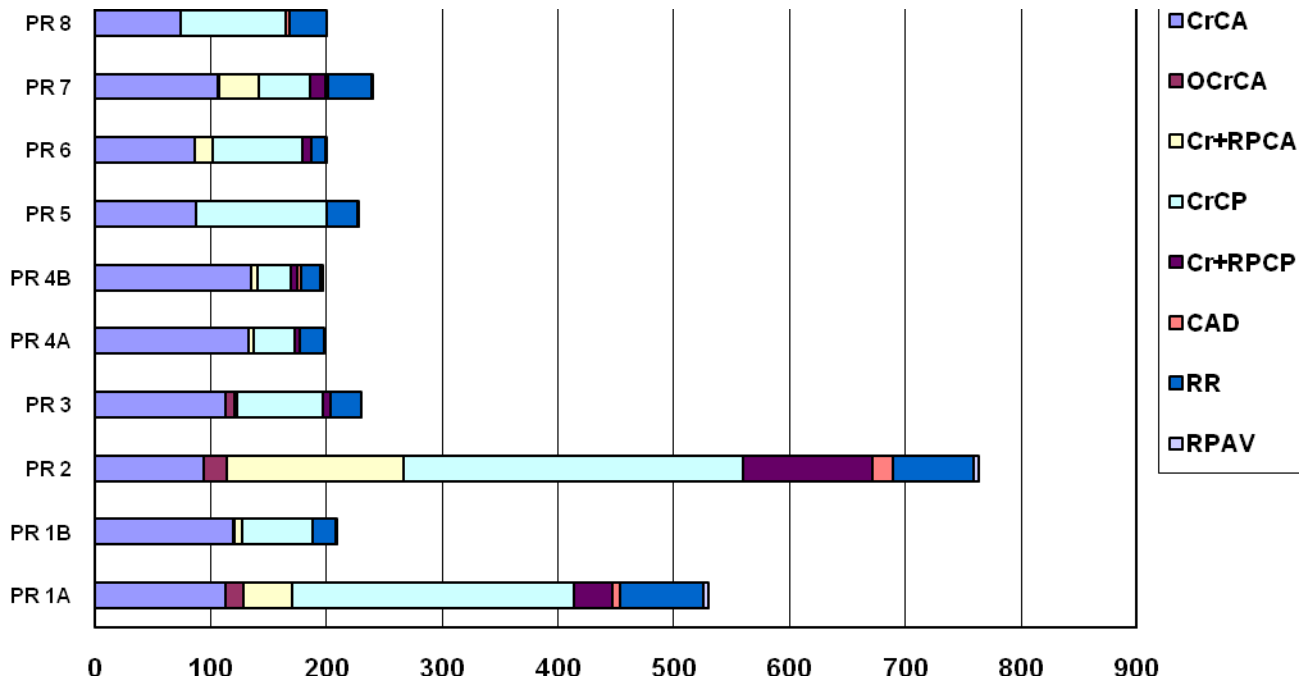
Figure 2: DRI values for the cores extracted from I395 over Penobscot River

4.2.2 I395 over Penobscot River (10 cores) (Figure 2)

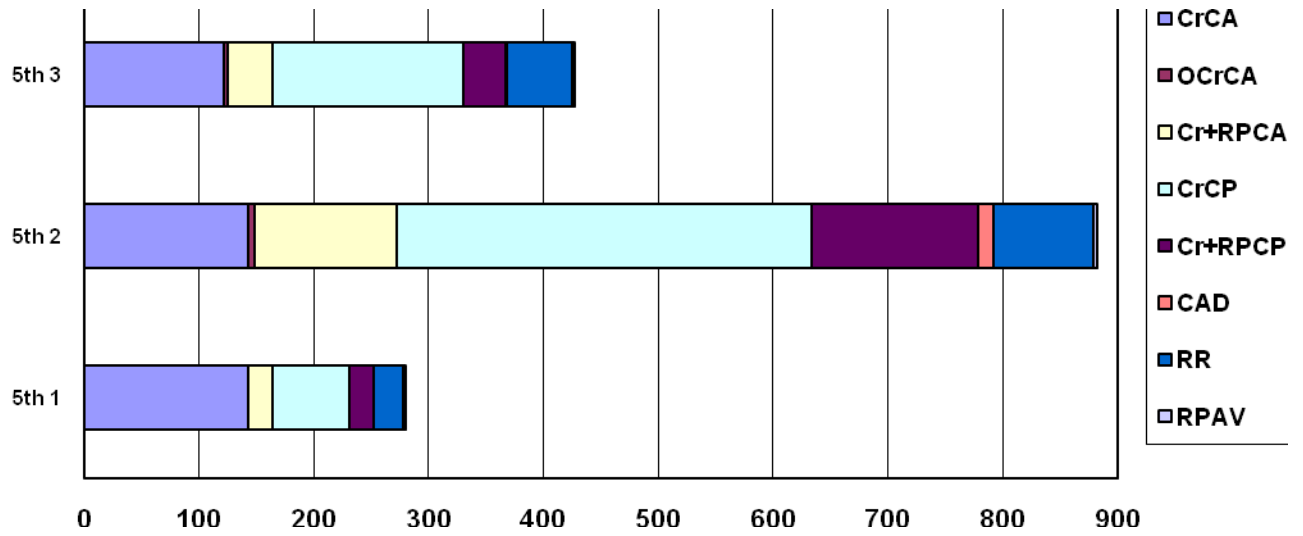
Figure 3: DRI values for the cores extracted from 5th Parkway over I395

4.2.3 5th Parkway over I395 (3 cores) (Figure 3)

The DRI values for this set of cores range from 279 (I395 5th-1) to 882 (I395 5th-2). Signs of ASR are observed in all cores; however, the extent of ASR ranges from fair (DRI=279), for

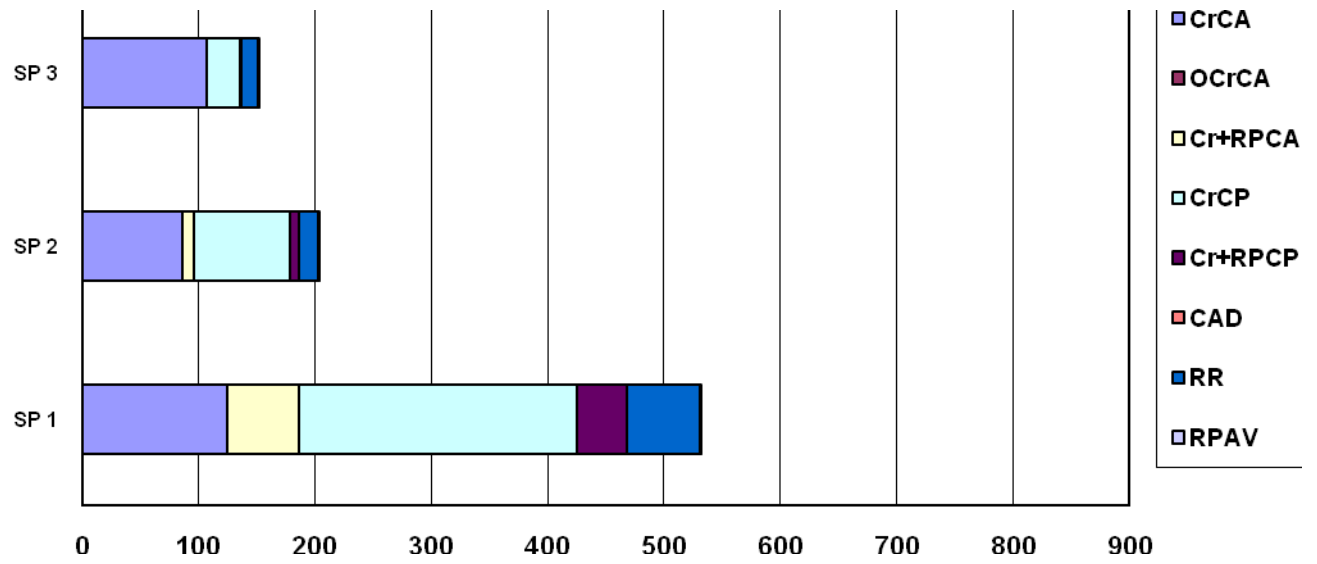
Figure 4: DRI values for the cores extracted from South Parkway over I395

4.2.4 South Parkway over I395 (3 cores) (Figure 4)

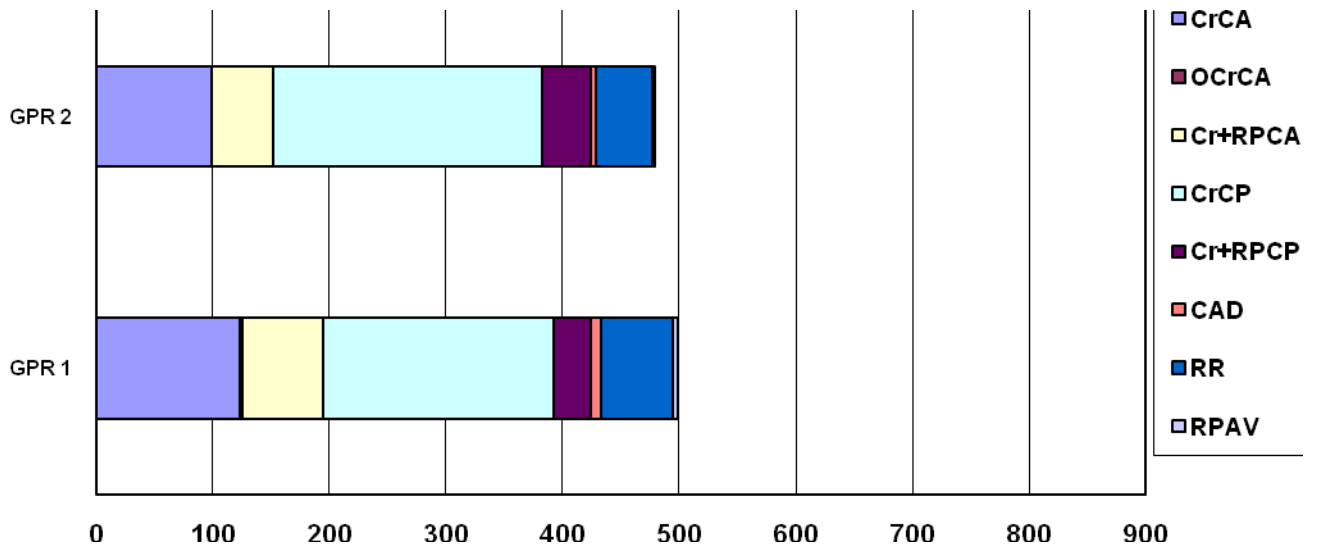
Figure 5: DRI values for the cores extracted from Green Point Road over I395

4.2.5 Green Point Road over I395 (2 cores) (Figure 5)

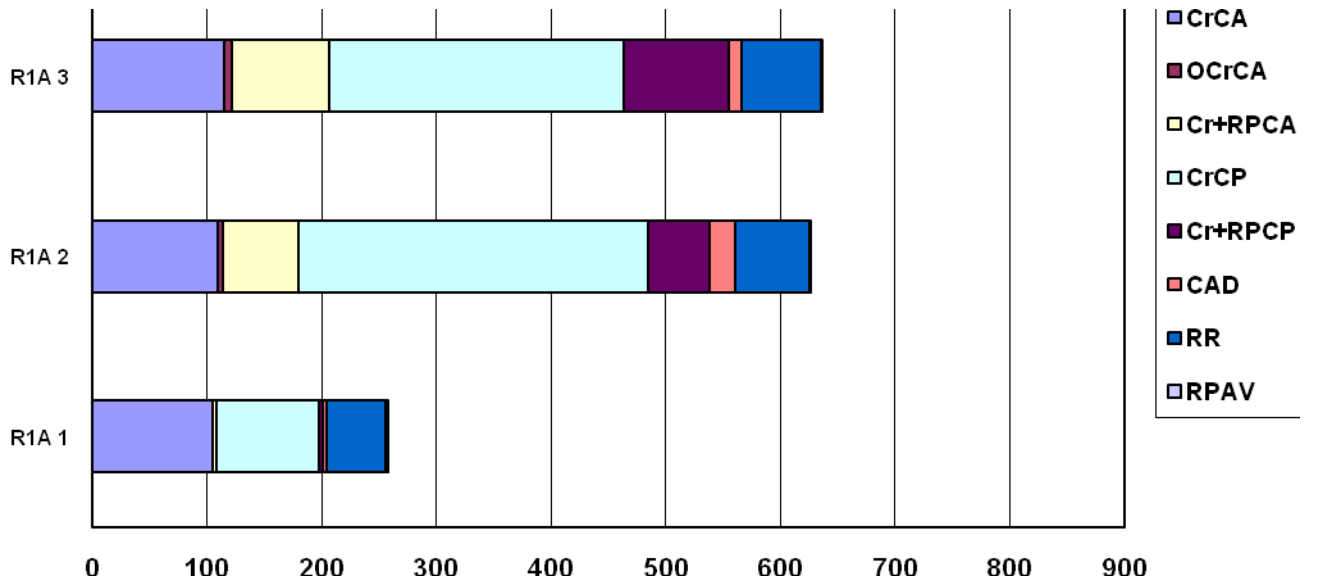
Figure 6: DRI values for the cores extracted from Route 1A over I395

4.2.6 Route 1A over I395 (3 cores) (Figure 6)

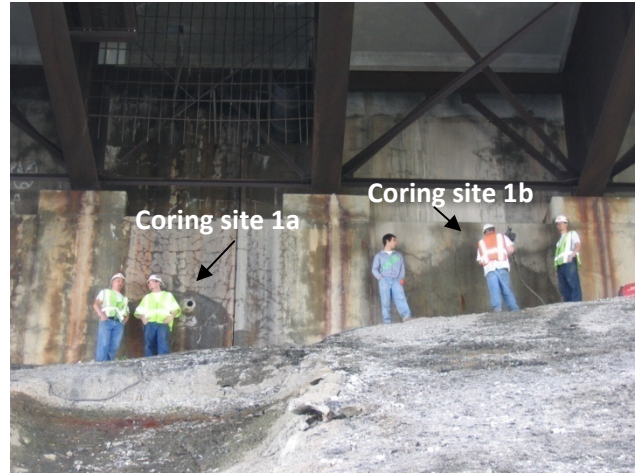
B

Bridge structure	Notes on the coring sites and the structural elements	Photo (Appendix B)	Core identification	Length, inch (all cores are 4-in diameter)
I395 over Main Street	General view of the coring sites – north side of the bridge; west side of the street.	B1-A		
	<u>Coring site 1</u> : in the abutment under the bridge deck, sheltered. No cracking was observed in the section from where the core was extracted.	B1-B	I395 MS-1	9.5
	<u>Coring site 2</u> : in the abutment, exposed. The section sampled shows a fairly severe network of vertical and horizontal cracks.	B1-C B1-D	I395 MS-2	8
	<u>Coring site 3</u> : in the wing wall, exposed. Coring was performed in a section of the wall showing moderate map cracking.	B1-E	I395 MS-3	7
I395 over Penobscot River (Brewer side)	General view of the sites (east side of the river) where cores 1 and 2 were collected.	B2-A		
	<u>Coring site 1a</u> : in the abutment under the bridge deck, sheltered. Coring was performed in a section showing map/pattern cracking due to leaking joint in the deck.	B2-B B2-C	I395 PR-1a	9.5

A: General view of the abutment on the east shore of the river (coring sites no. 1 and 2). B: Coring sites no. 1a and 1b. C: Coring site no. 1a. D: Coring site no. 1b. E: Coring site no. 2.

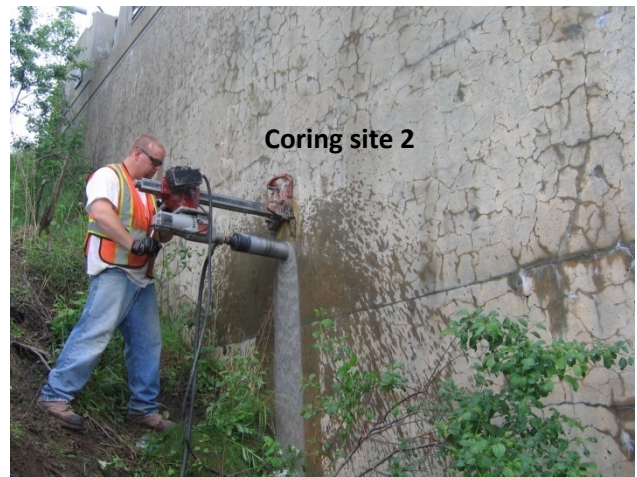
E

<u>Coring site 1b</u> : in the same abutment under the bridge deck, about 25 feet south of site 1a, sheltered. Coring was performed in a section with no visible cracking.	B2-B B2-D	I395 PR-1b	9
	<u>Coring site 2</u> : in the wing wall, exposed. Coring was performed in a section showing fairly severe map cracking.	B2-E	I395 PR-2	7.5

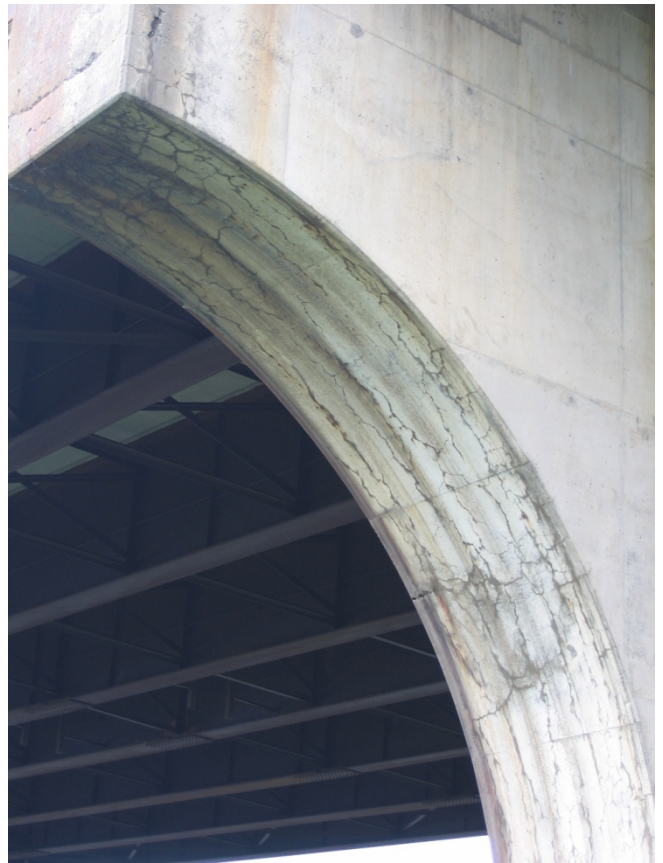
E

A: General view of the bridge from the west shore of the river. B: Coring site no. 3 and 4 (first row of piers). C: Coring site no.4. D: Coring sites no. 5 to 8 (2nd row of piers). E: Closer view of cracking in the arch of the north pier, 2nd row of piers (coring sites 7 and 8).

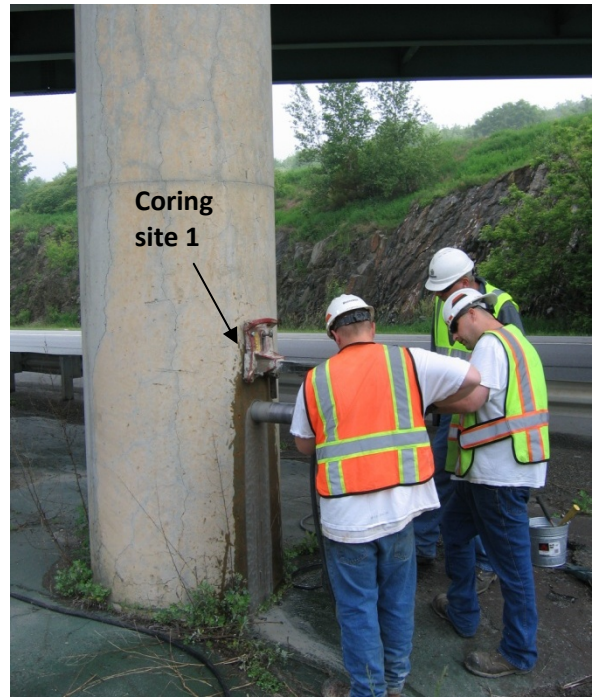
B

Bridge structure	Notes on the coring sites and the structural elements	Photo (Appendix B)	Core identification	Length, inch (all cores are 4-in diameter)
5 th Parkway over I395	General view of south part of the structure.	B4-A		
	<u>Coring site 1</u> : in the abutment, sheltered. Coring was performed in a section with no visible cracking.	B4-B B4-C	I395 5 th -1	10
	<u>Coring site 2</u> : in the abutment, exposed. Coring was performed in a section showing fairly severe vertical and horizontal cracking.	B4-B B4-D	I395 5 th -2	7.5
	<u>Coring site 3</u> : in the wing wall, exposed. Coring was performed in a section of the wall showing moderate map cracking.	B4-E	I395 5 th -3	11
South Parkway over I395	General view of the middle part of the bridge. There are six circular columns supporting the structure at that location.	B5-A		
	<u>Coring site 1</u> : in the first column on the east side of the bridge, exposed. Coring was performed in the exposed part (eastern side) of the column showing regularly-spaced vertical cracks connected by map cracking.	B5-B	I395 SP-1	9

A: General view of the middle (supported) part of the bridge. B. External pier (east side - coring site no. 1. C: Second pier from the east side (coring site no. 2). D: Third pier from the east side (coring site no. 3).

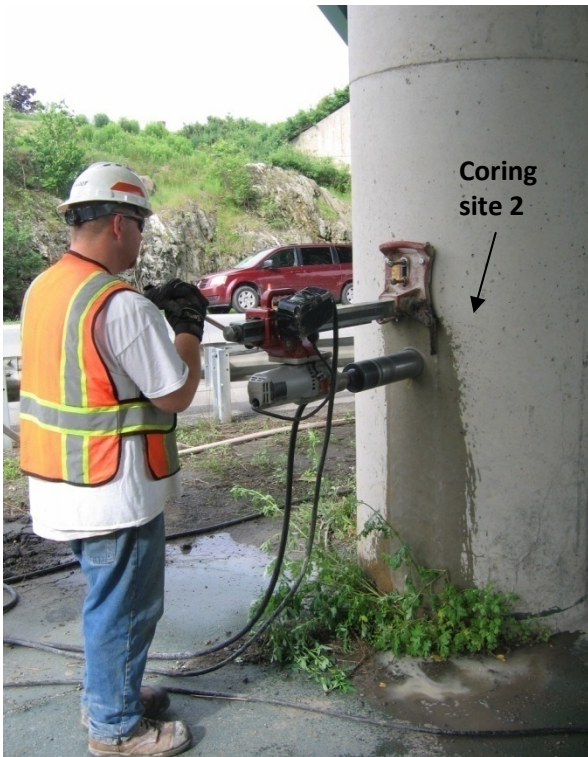
C

<u>Coring site 2</u> : in the second column (from the east side of the bridge), sheltered. Coring was performed in the eastern part of the column showing light vertical cracking.	B5-C	I395 SP-2	10
	<u>Coring site 3</u> : in the third column (from the east side of the bridge), sheltered. Coring was performed in the eastern part of the column showing light vertical cracking.	B5-D	I395 SP-3	11

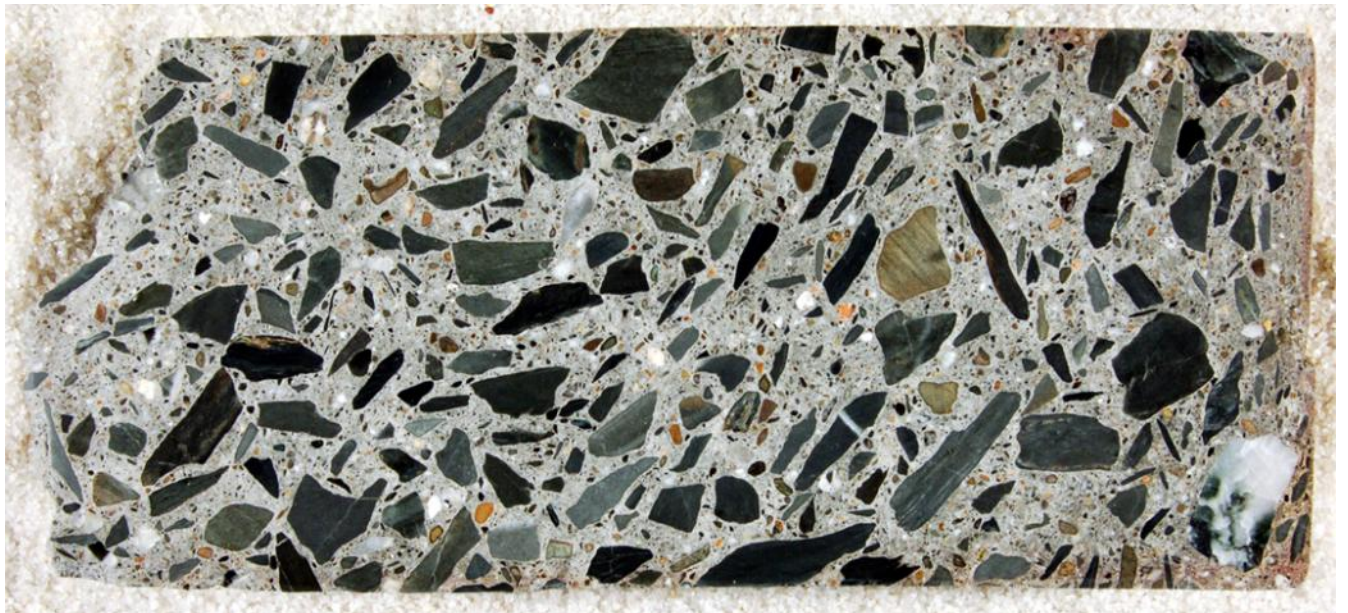
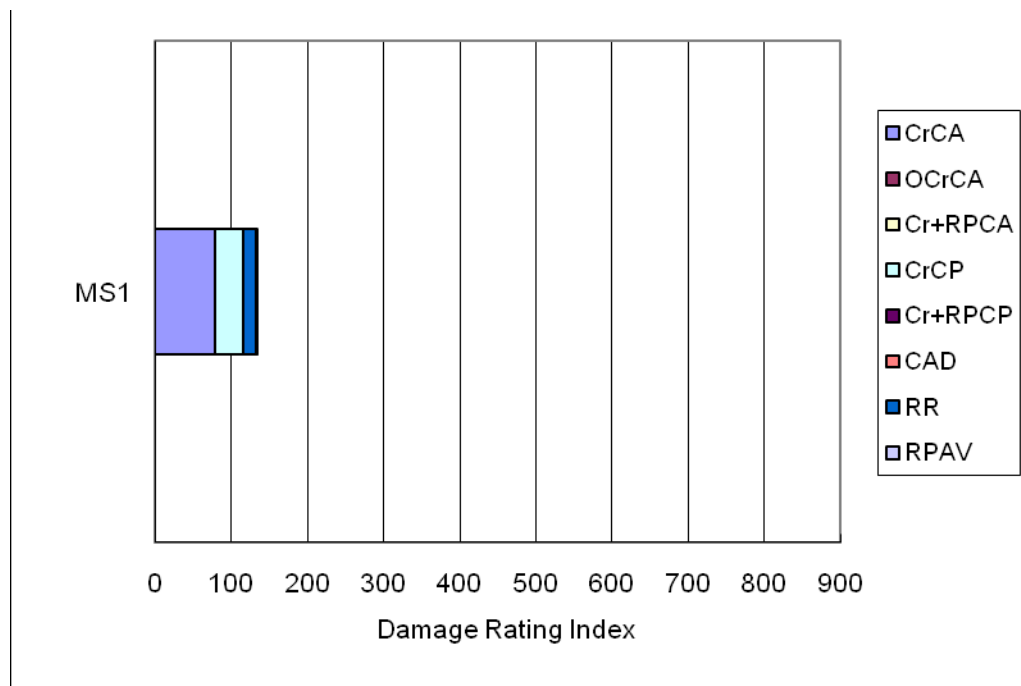
Figure C1: DRI results for Core I395 MS1

Sample	CrCA	OCrCA	Cr+RPCA	CrCP	Cr+RPCP	CAD	RR	RPAV	DRI
MS1	80	0	0	37	0	0	17	0	133

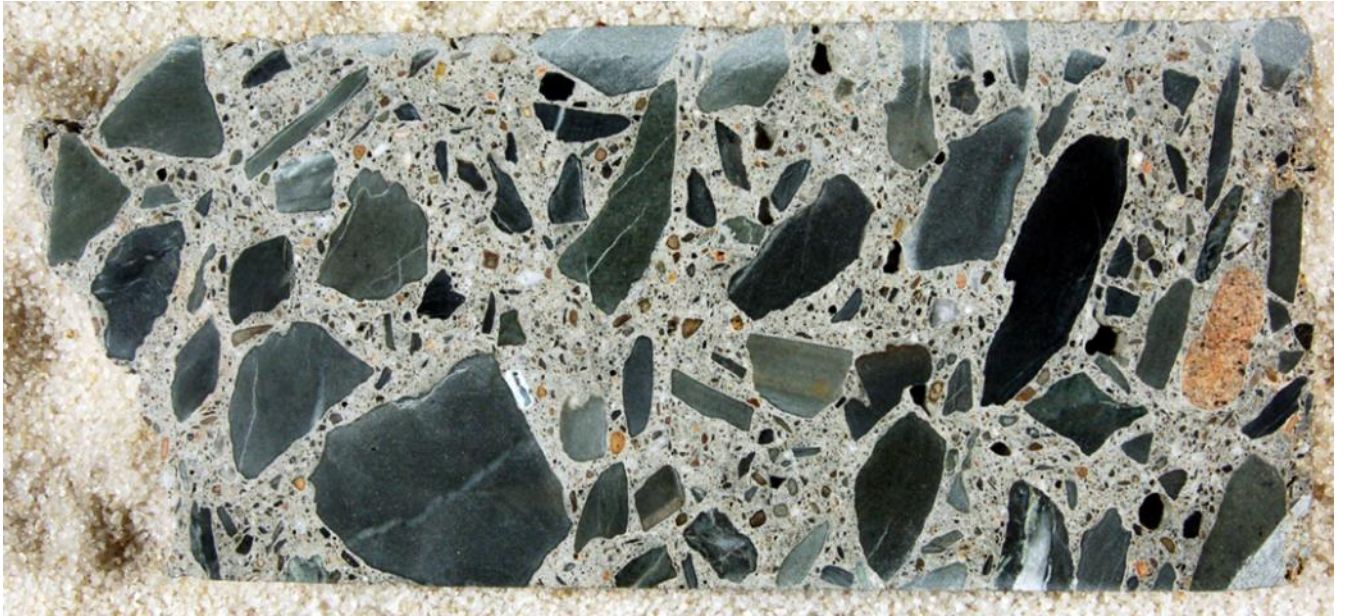
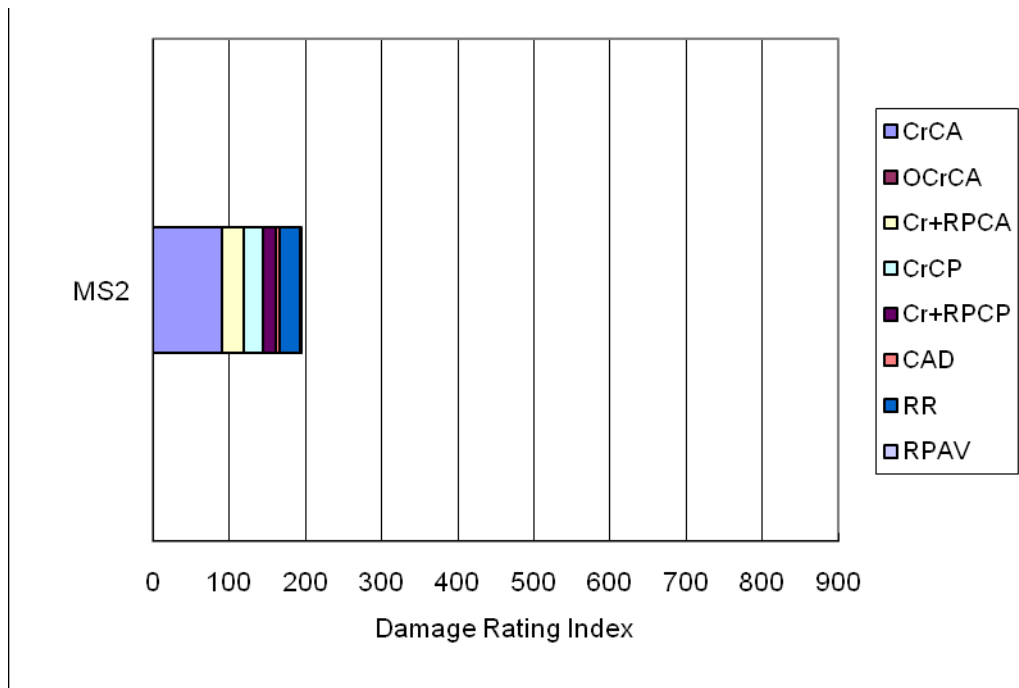
I395 over Main Street - CORE I395 MS2

Sample	CrCA	OCrCA	Cr+RPCA	CrCP	Cr+RPCP	CAD	RR	RPAV	DRI
MS2	91	0	28	27	16	5	27	0	195

Figure C2: DRI results for Core I395 MS2

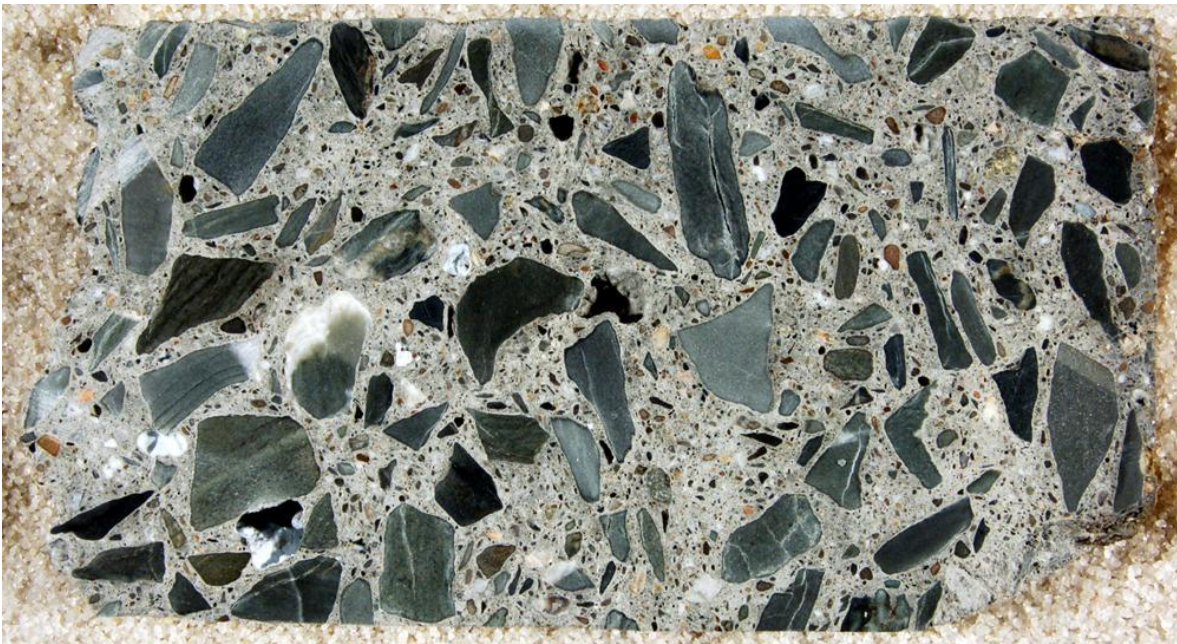
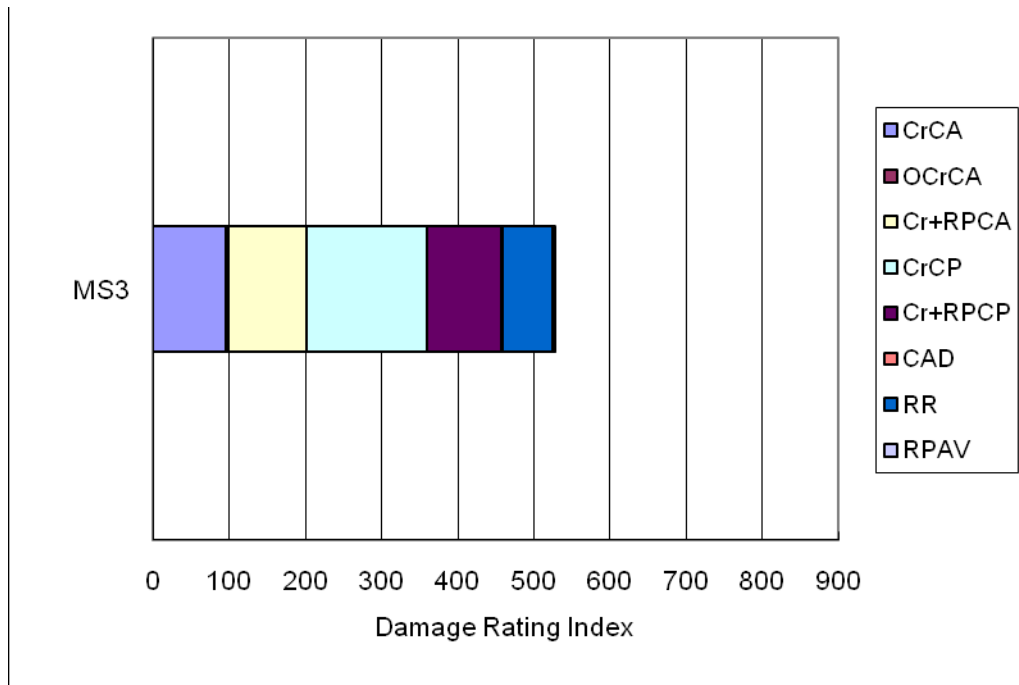
I395 over Main Street - CORE I395 MS3

Sample	CrCA	OCrCA	Cr+RPCA	CrCP	Cr+RPCP	CAD	RR	RPAV	DRI
MS3	96	2	103	159	97	2	65	4	528

Figure C3: DRI results for Core I395 MS3

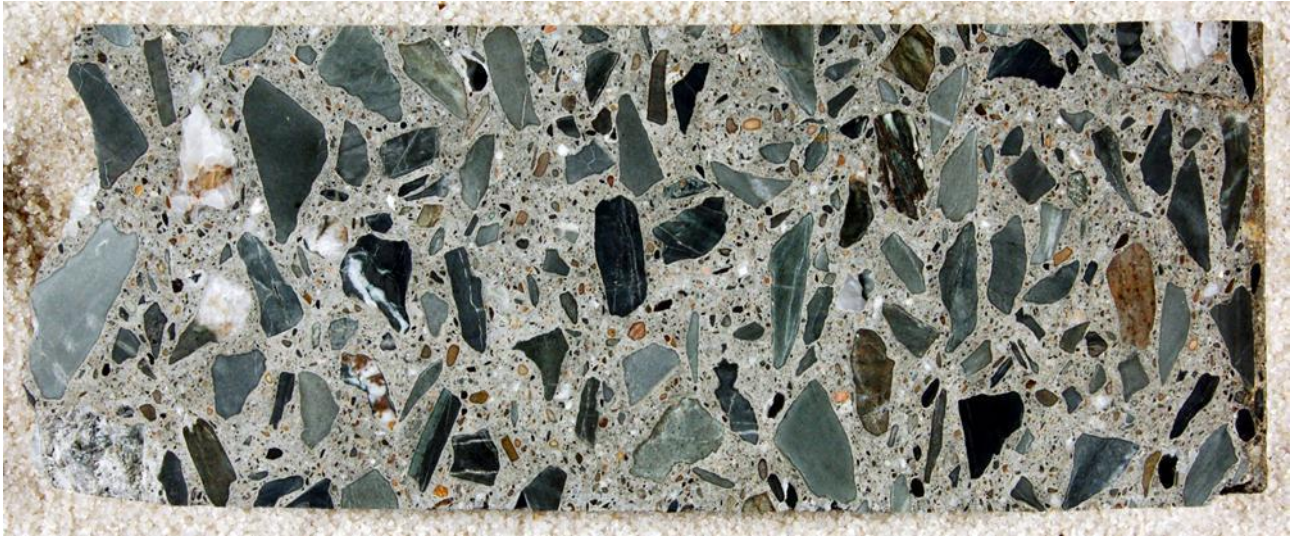
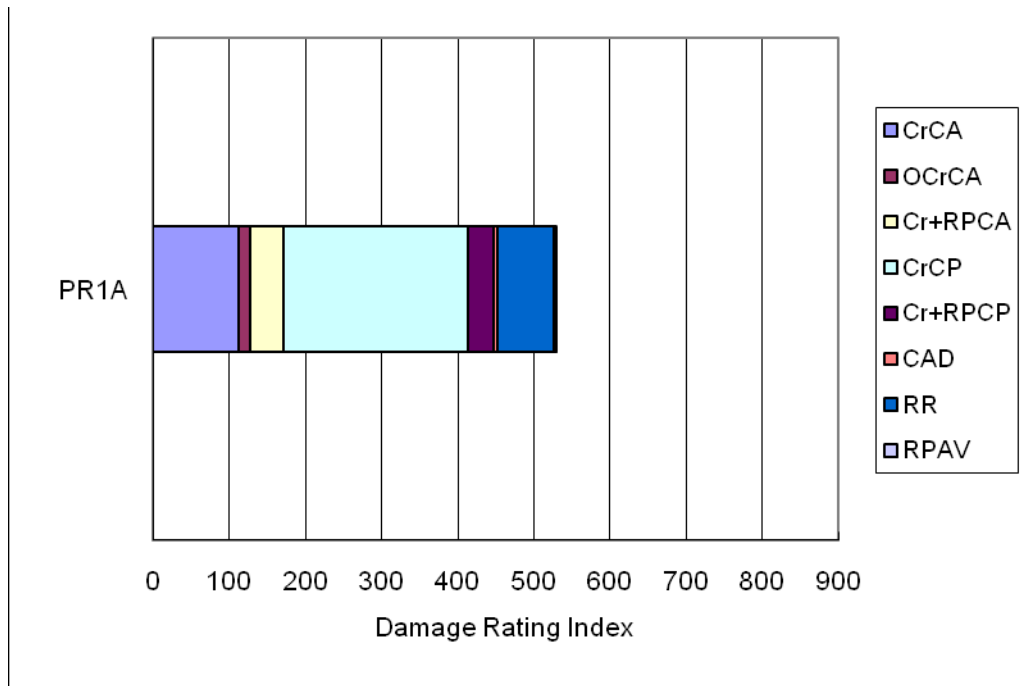
I395 over Penobscot River - CORE I395 PR1a

Sample	CrCA	OCrCA	Cr+RPCA	CrCP	Cr+RPCP	CAD	RR	RPAV	DRI
PR1a	113	15	43	243	34	6	73	5	530

Figure C5: DRI results for Core I395 PR1a

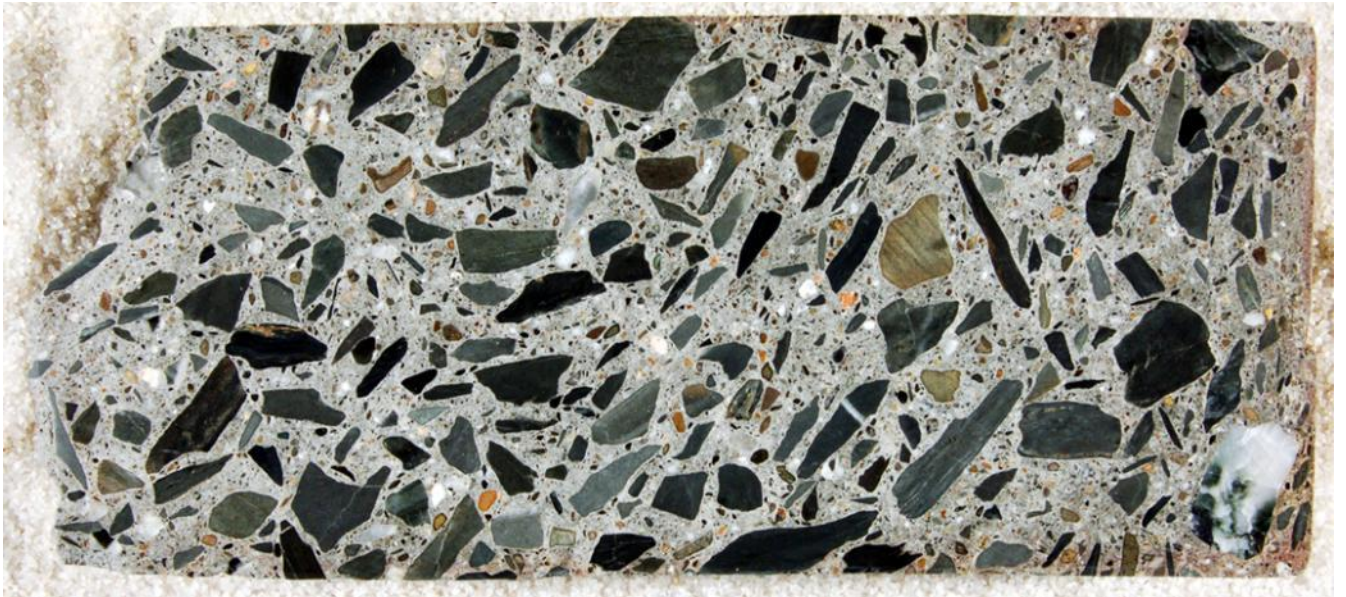
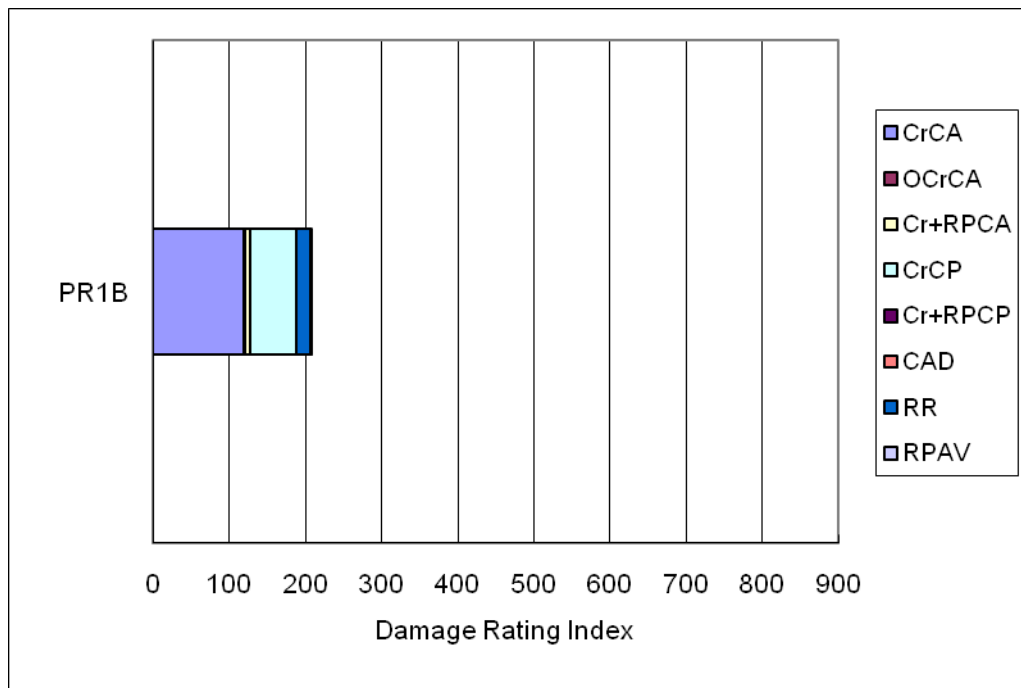
I395 over Penobscot River - CORE I395 PR1b

Sample	CrCA	OCrCA	Cr+RPCA	CrCP	Cr+RPCP	CAD	RR	RPAV	DRI
PR1b	119	2	7	61	0	0	19	0	208

Figure C6: DRI results for Core I395 PR1b

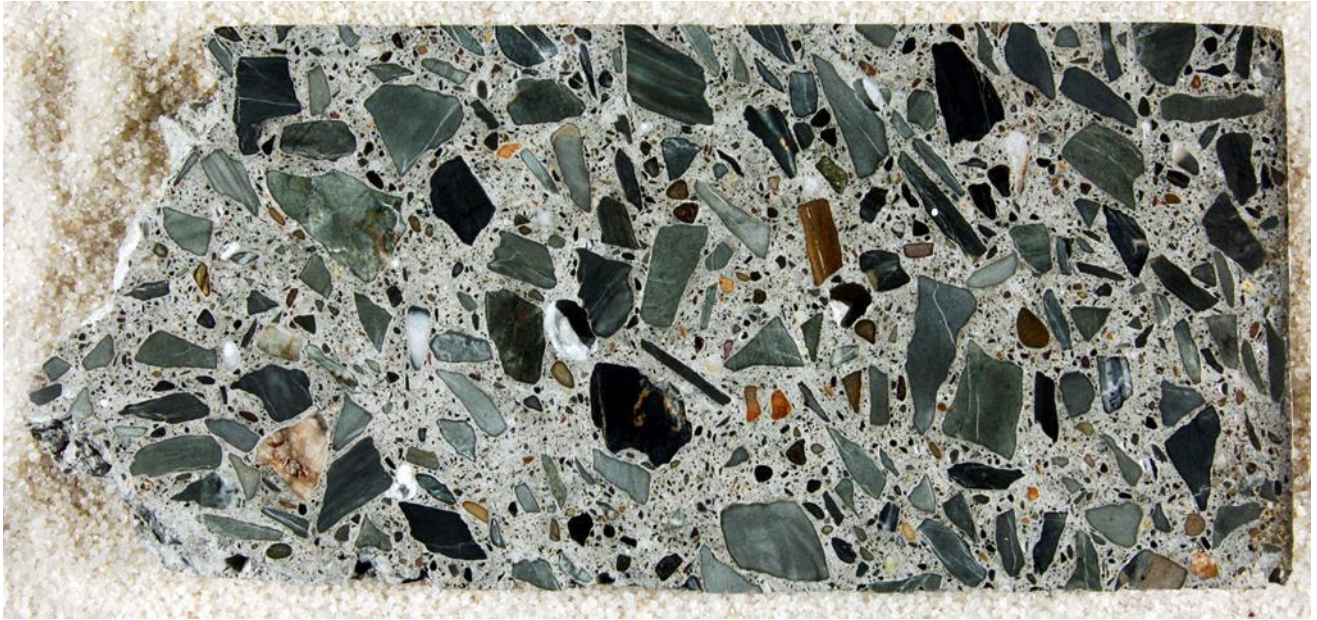
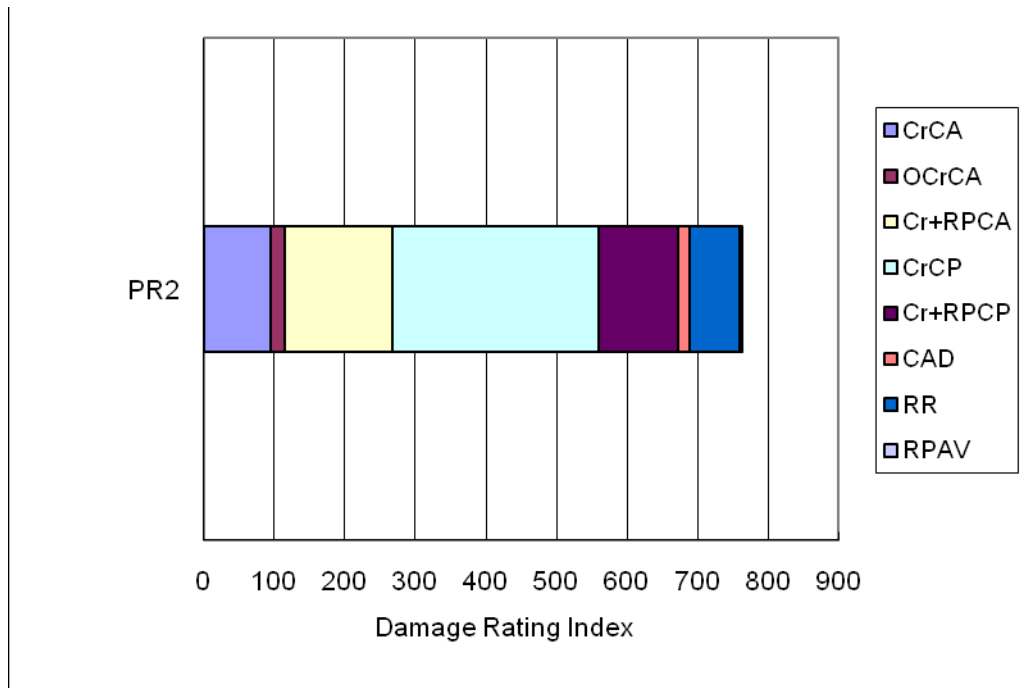
I395 over Penobscot River - CORE I395 PR2

Sample	CrCA	OCrCA	Cr+RPCA	CrCP	Cr+RPCP	CAD	RR	RPAV	DRI
PR2	95	20	153	293	111	18	70	5	764

Figure C7: DRI results for Core I395 PR2

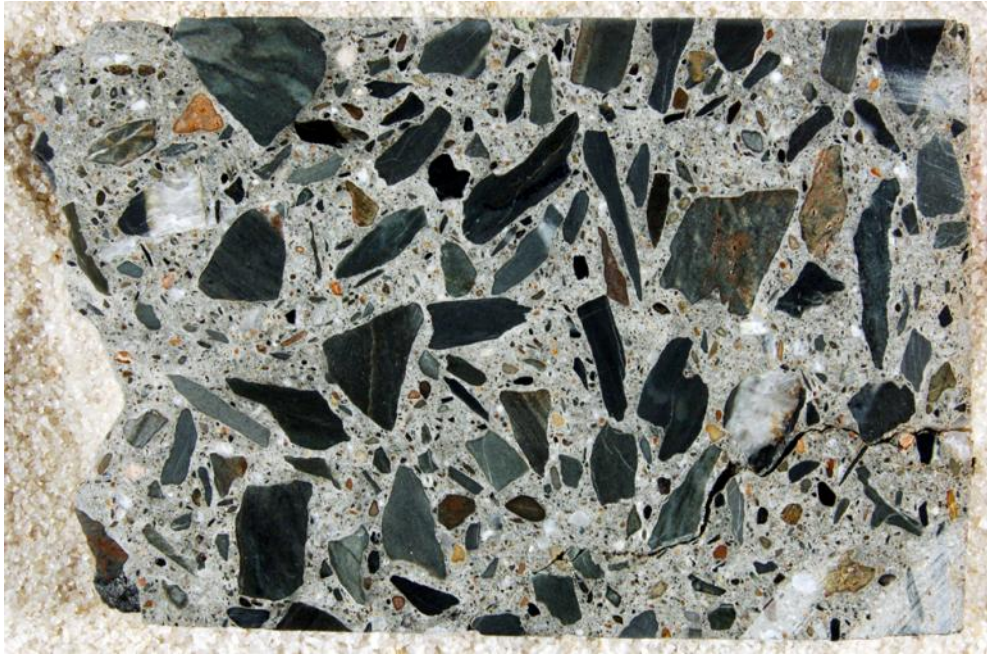
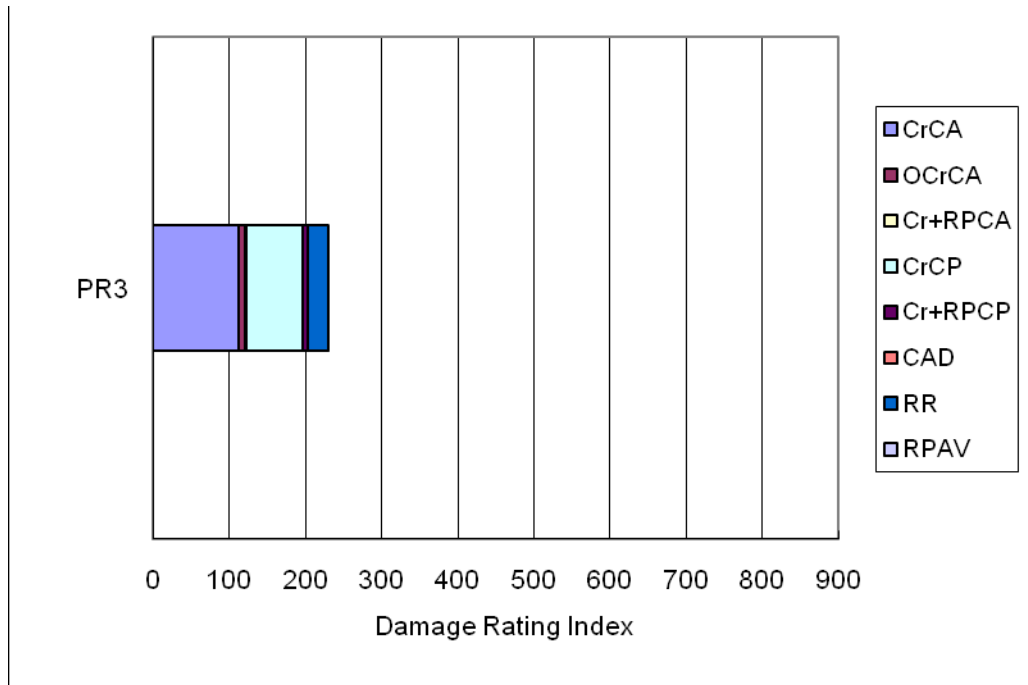
I395 over Penobscot River - CORE I395 PR3

Sample	CrCA	OCrCA	Cr+RPCA	CrCP	Cr+RPCP	CAD	RR	RPAV	DRI
PR3	113	8	2	74	7	0	27	0	230

Figure C8: DRI results for Core I395 PR3

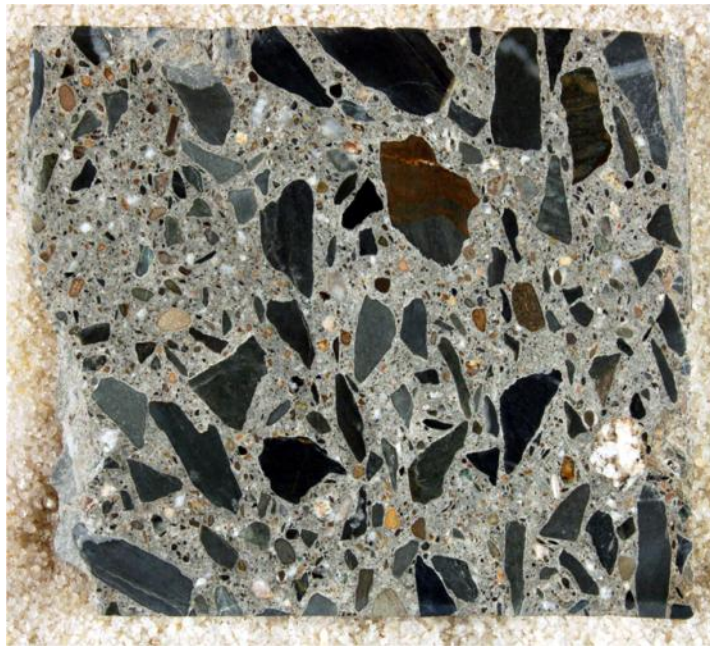
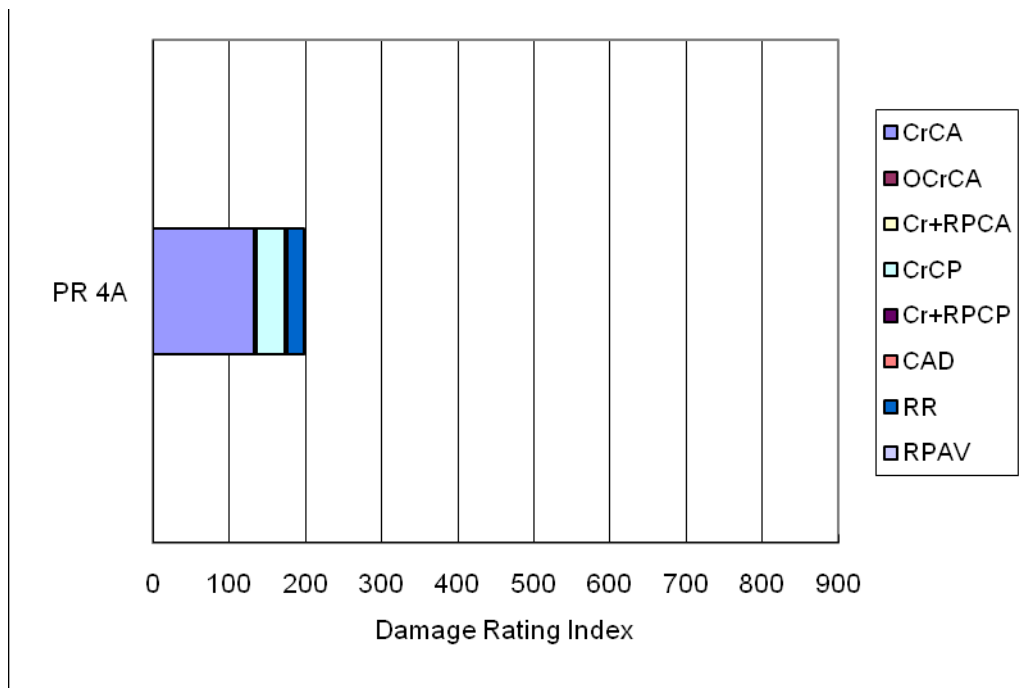
I395 over Penobscot River - CORE I395 PR4a

Sample	CrCA	OCrCA	Cr+RPCA	CrCP	Cr+RPCP	CAD	RR	RPAV	DRI
PR 4A	132	0	4	36	4	0	21	0	198

Figure C9: DRI results for Core I395 PR4a

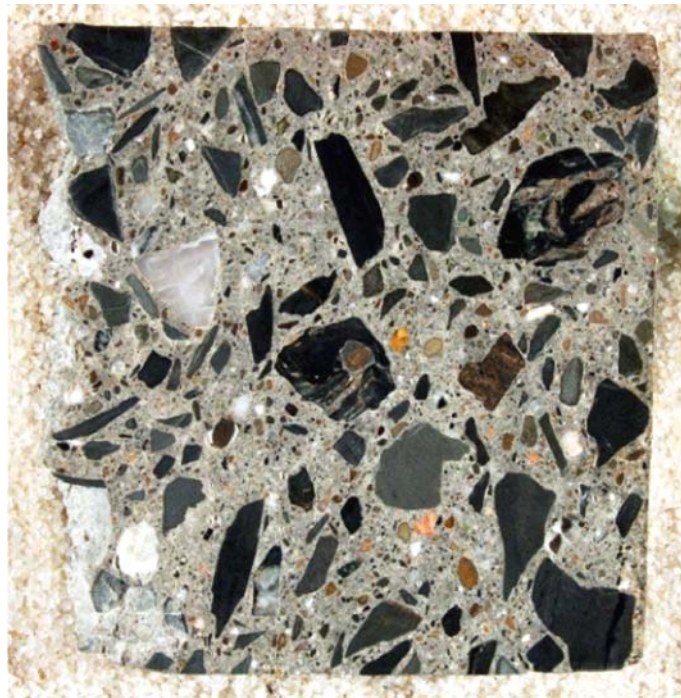
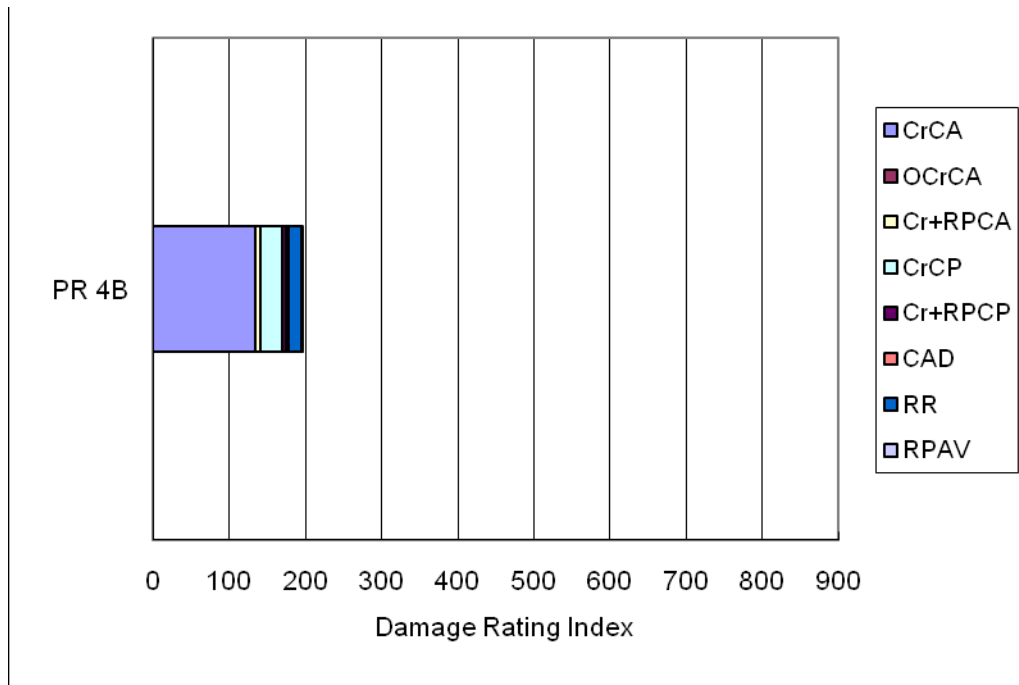
I395 over Penobscot River - CORE I395 PR4b

Sample	CrCA	OCrCA	Cr+RPCA	CrCP	Cr+RPCP	CAD	RR	RPAV	DRI
PR 4B	135	0	5	29	5	4	17	1	196

Figure C10: DRI results for Core I395 PR4b

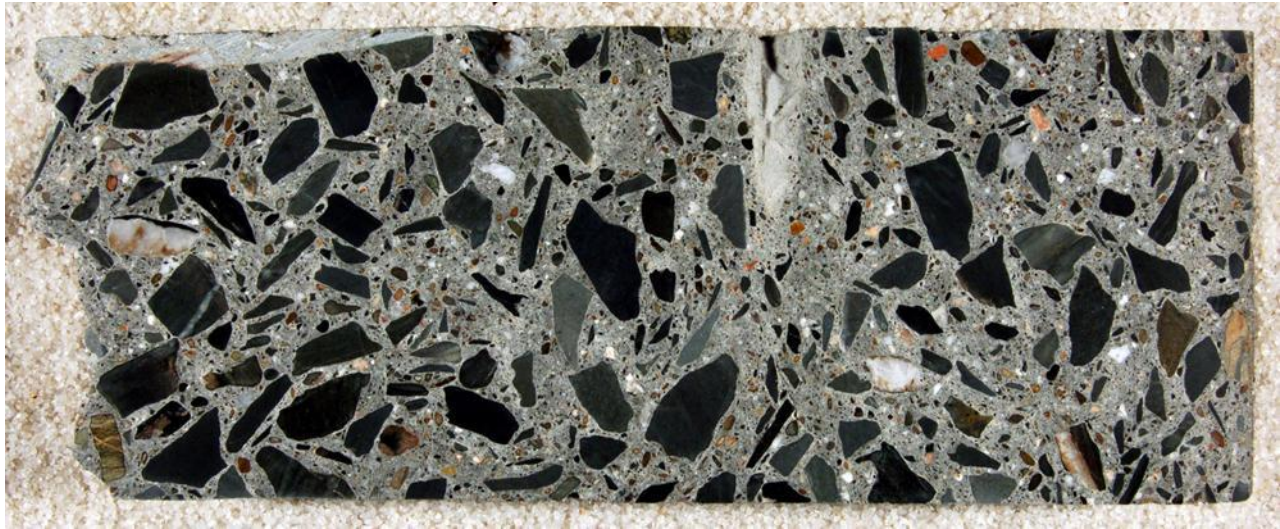
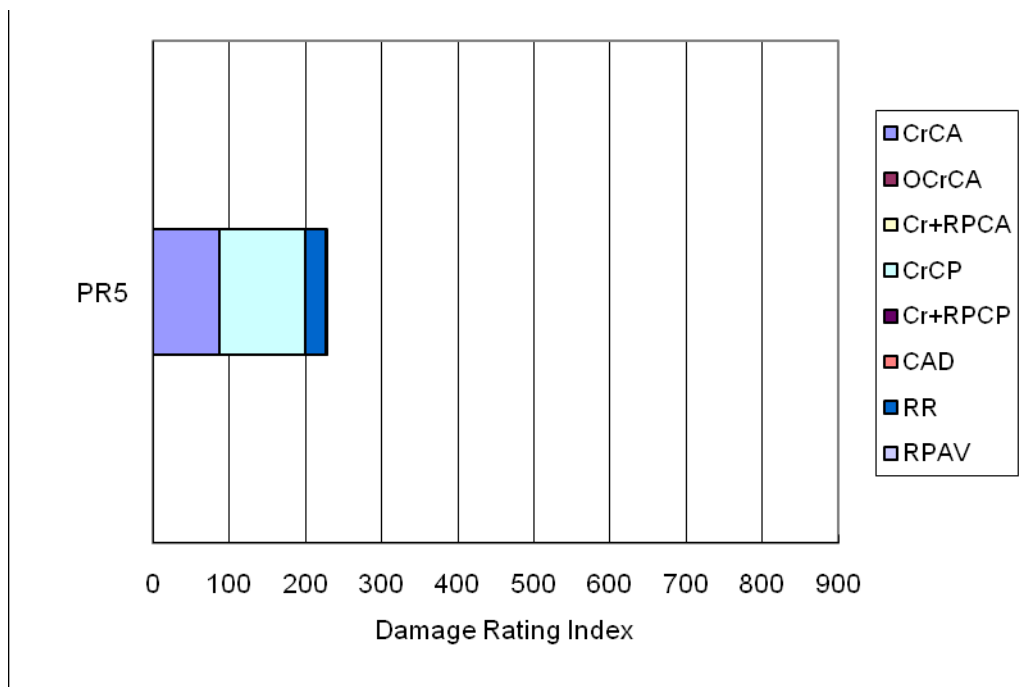
I395 over Penobscot River - CORE I395 PR5

Sample	CrCA	OCrCA	Cr+RPCA	CrCP	Cr+RPCP	CAD	RR	RPAV	DRI
PR5	88	0	0	112	0	0	27	0	228

Figure C11: DRI results for Core I395 PR5
