Evaluation of Six Bridge Structures along Interstate 395 in Bangor, Maine

Field Site and Petrographic Evaluation

U.S. Department of Transportation
Federal Highway Administration

1. Report No. FHWA-HIF-13-066		2. Government Accession No.		3. Recipient's Catalog No.	
4. Title and Subtitle Evaluation of Six Bridge Structures along Interstate 395 in Bangor, Maine: Field Site and Petrographic Evaluation				5. Report Date September 2009

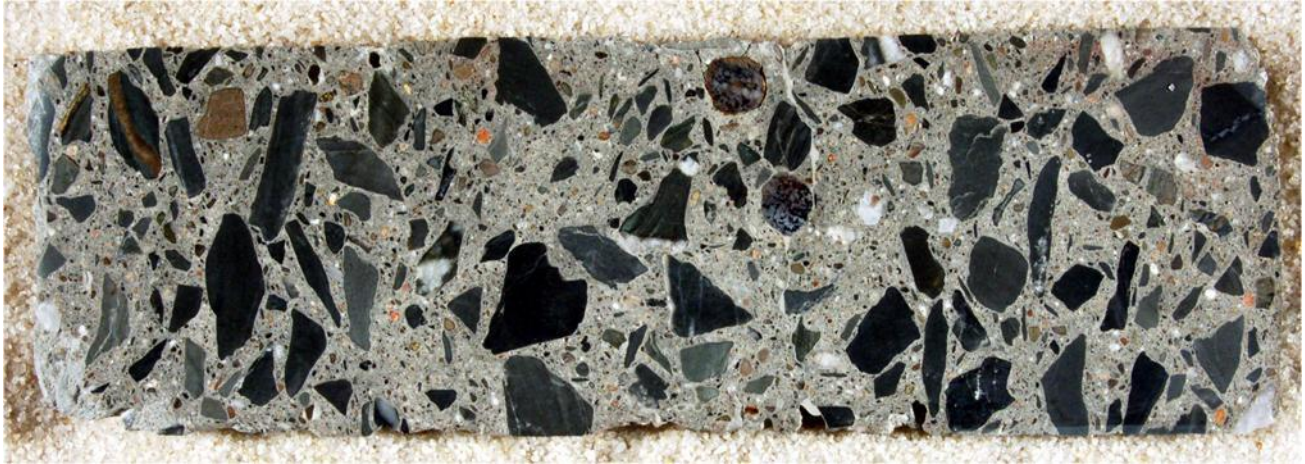
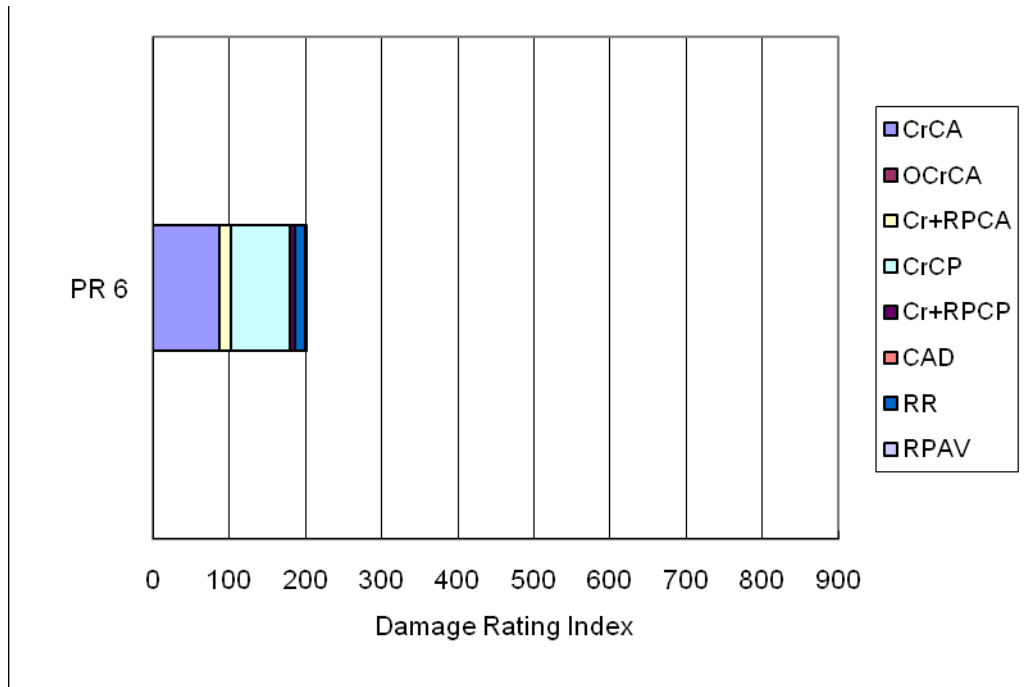
I395 over Penobscot River - CORE I395 PR6

Sample	CrCA	OCrCA	Cr+RPCA	CrCP	Cr+RPCP	CAD	RR	RPAV	DRI
PR 6	87	0	16	78	7	0	12	0	200

Figure C12: DRI results for Core I395 PR6

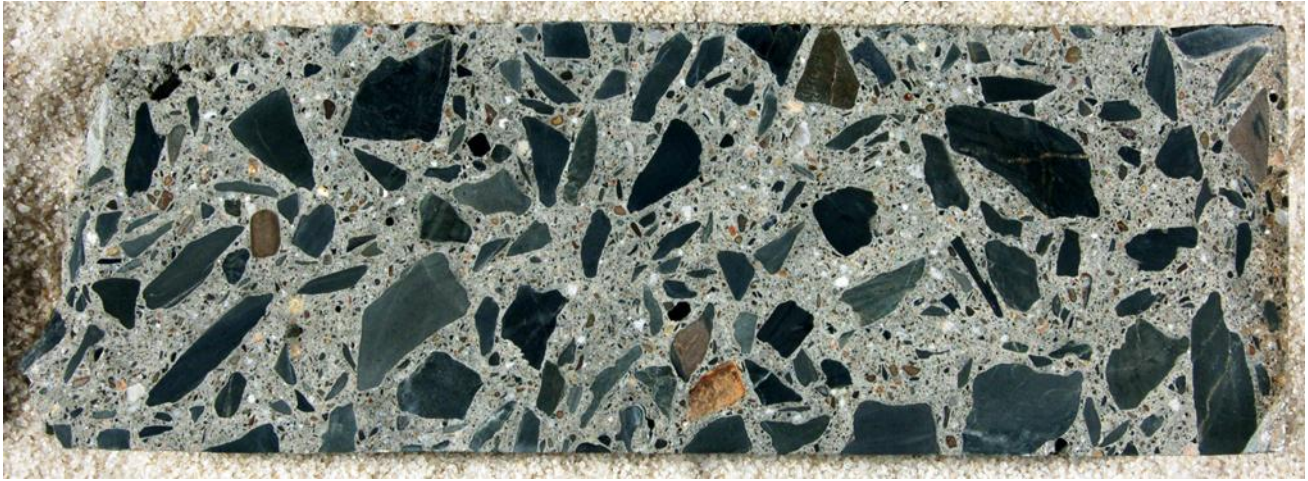
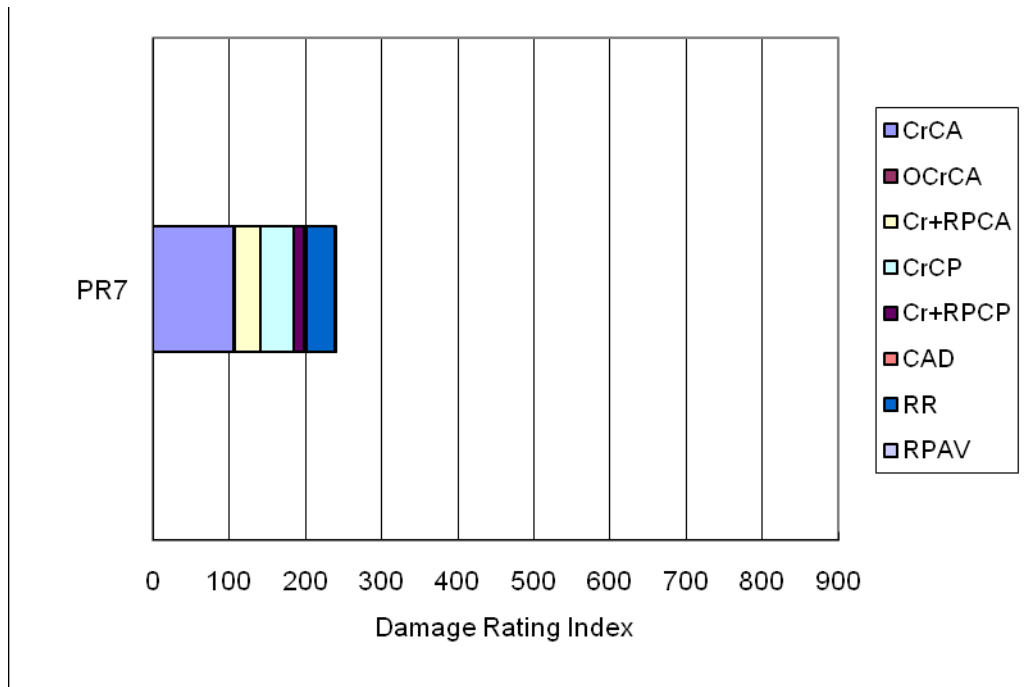
I395 over Penobscot River - CORE I395 PR7

Sample	CrCA	OCrCA	Cr+RPCA	CrCP	Cr+RPCP	CAD	RR	RPAV	DRI
PR7	106	1	34	44	13	3	38	0	240

Figure C13: DRI results for Core I395 PR7

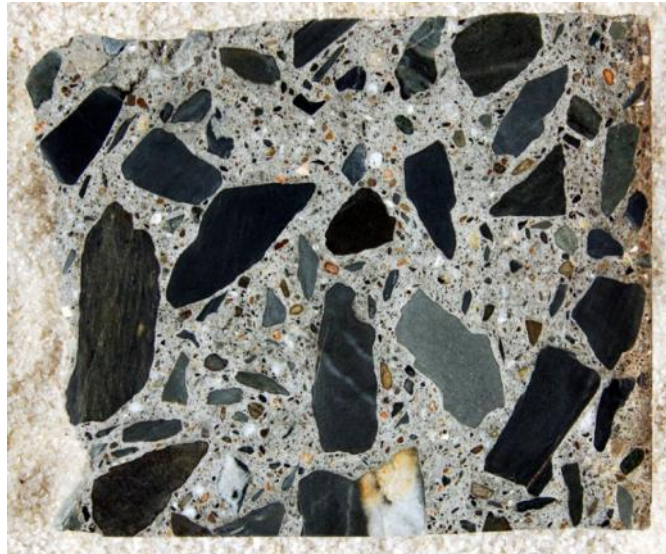
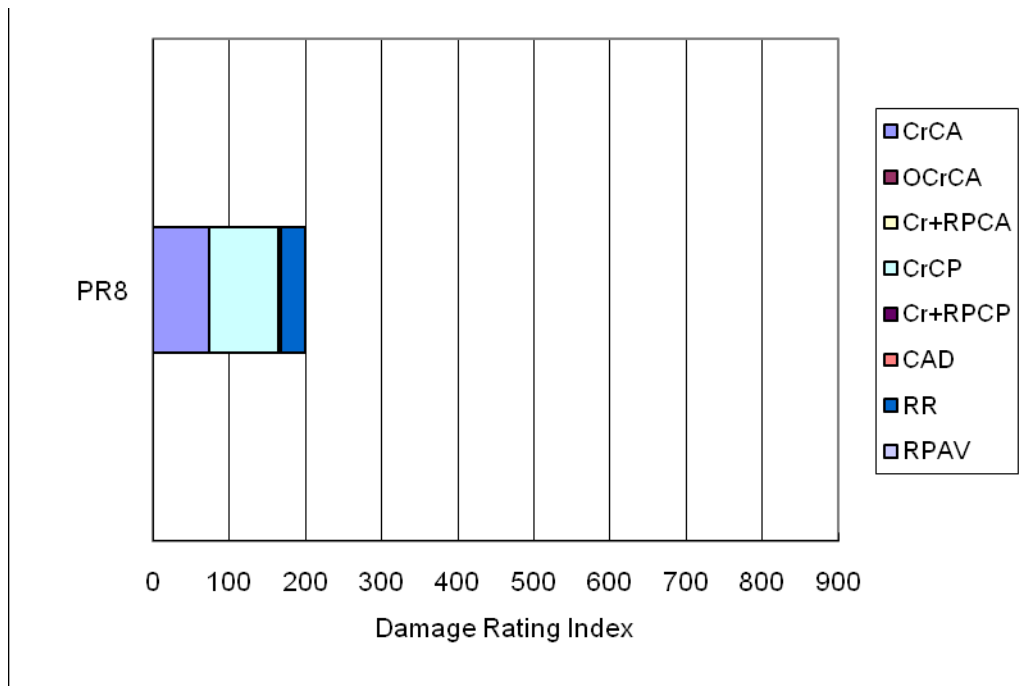
I395 over Penobscot River - CORE I395 PR8

Sample	CrCA	OCrCA	Cr+RPCA	CrCP	Cr+RPCP	CAD	RR	RPAV	DRI
PR8	74	0	0	91	0	3	32	0	201

Figure C14: DRI results for Core I395 PR8

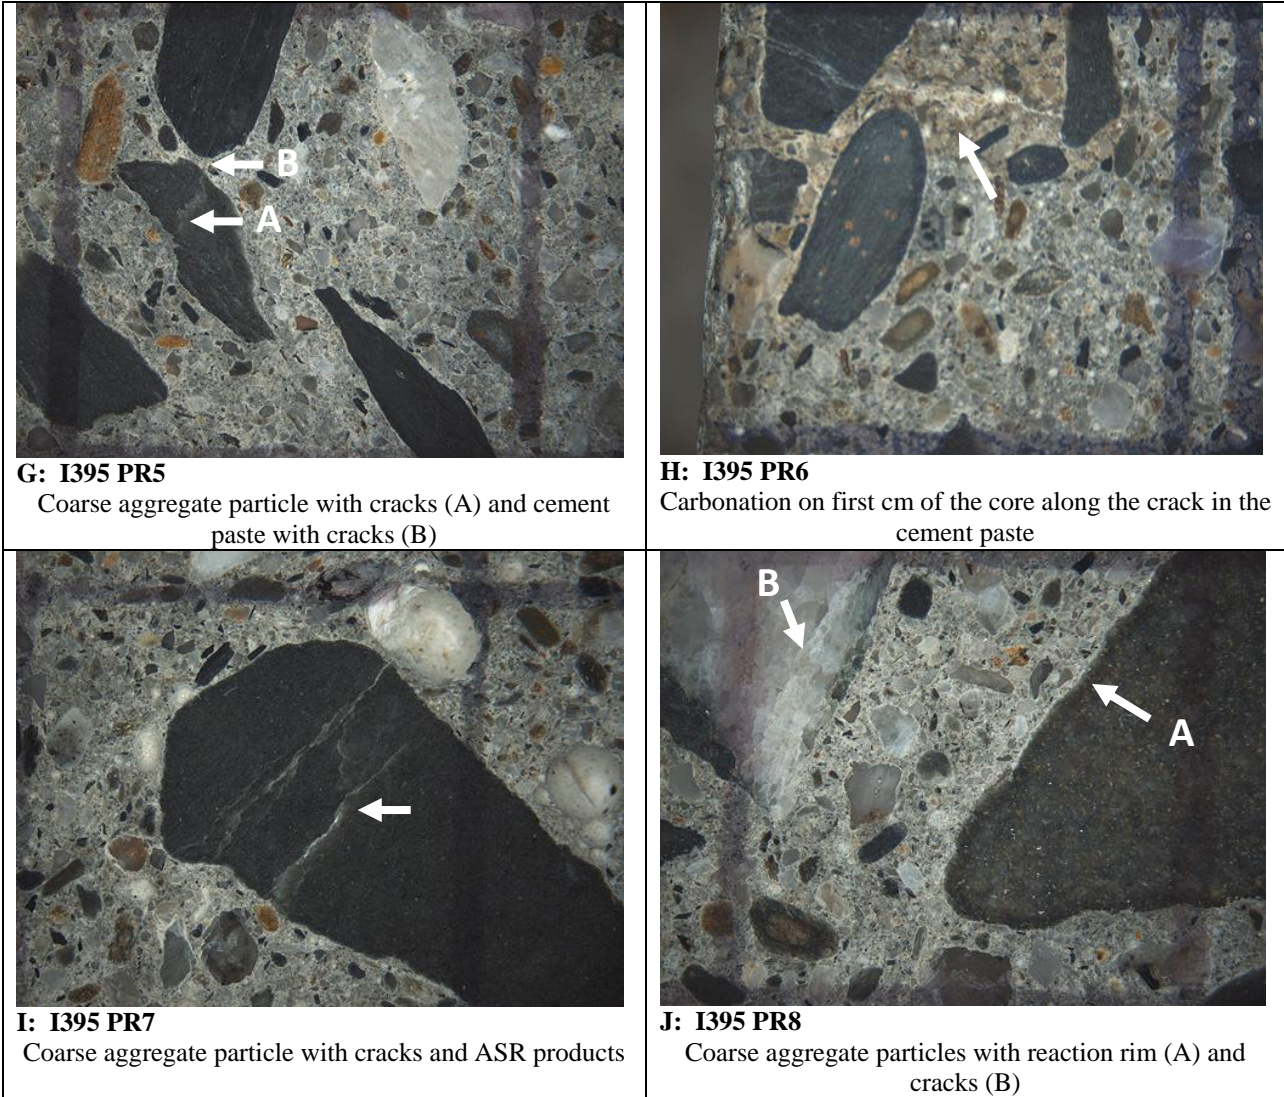
Figure C15 (cont'd): Micrographs illustrating petrographic features of deterioration in cores from the structure I395 over Penobscot River.

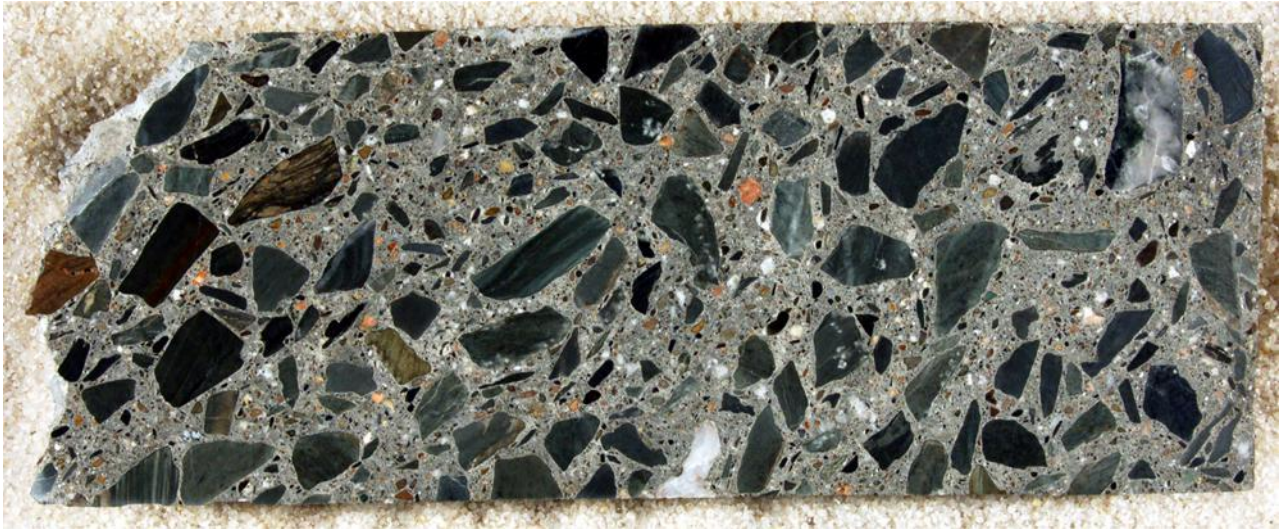
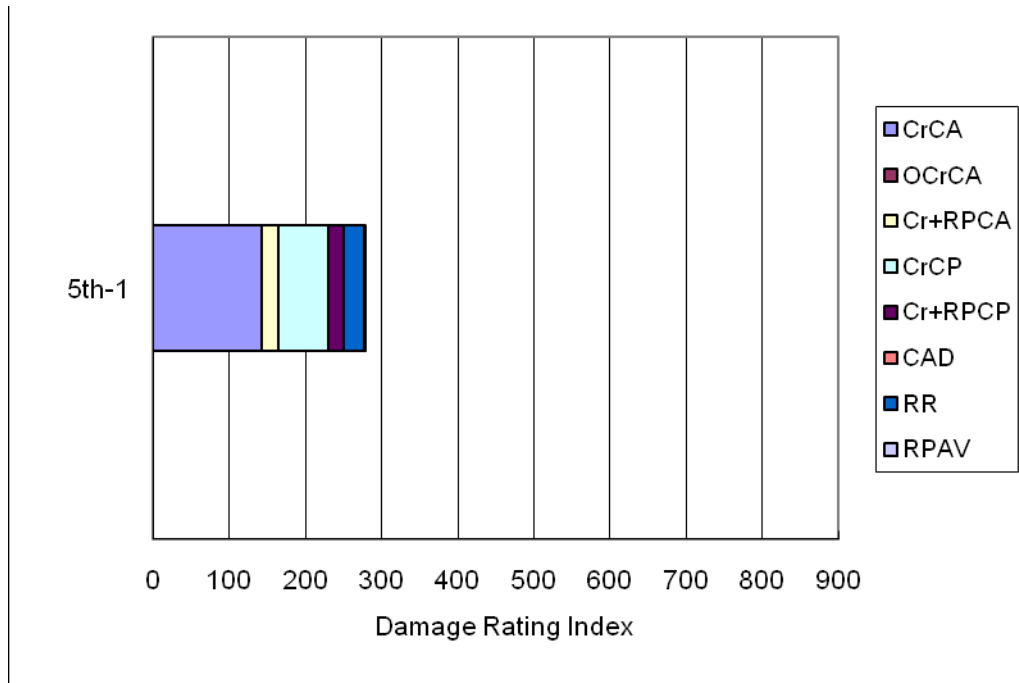
5th Parkway over I395 - CORE I395 5th-1

Sample	CrCA	OCrCA	Cr+RPCA	CrCP	Cr+RPCP	CAD	RR	RPAV	DRI
5th-1	143	0	21	67	20	0	26	2	279

Figure C16: DRI results for Core I395 5th-1

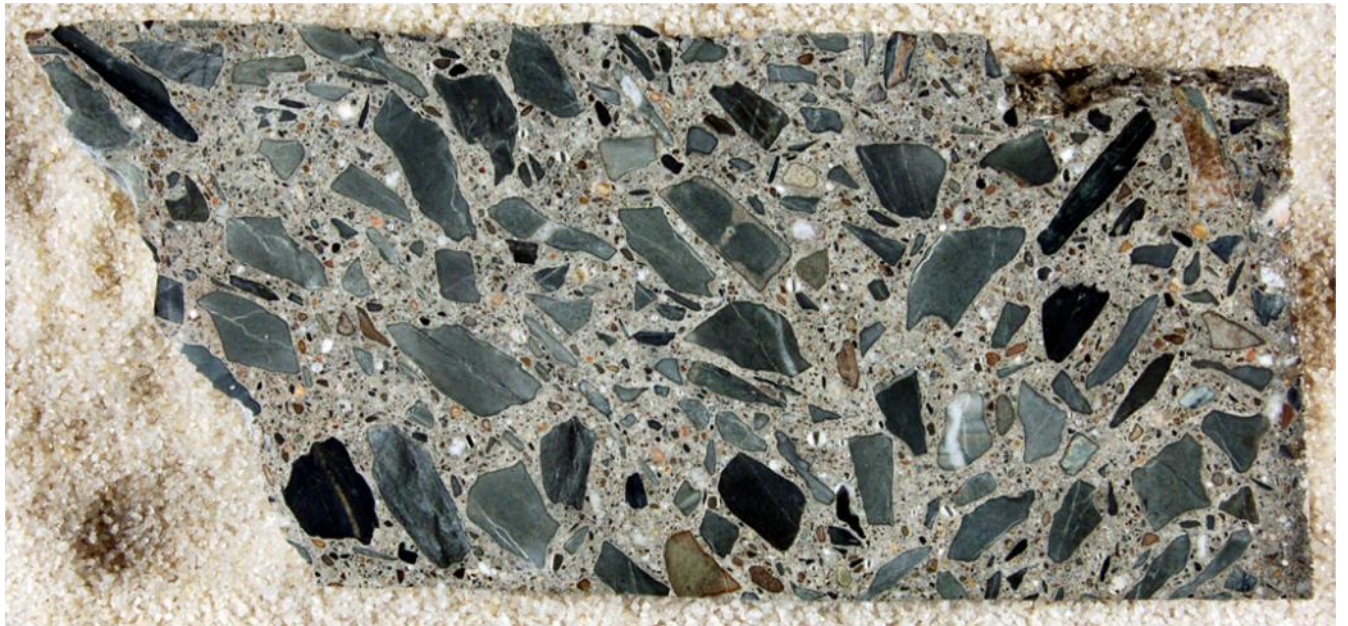
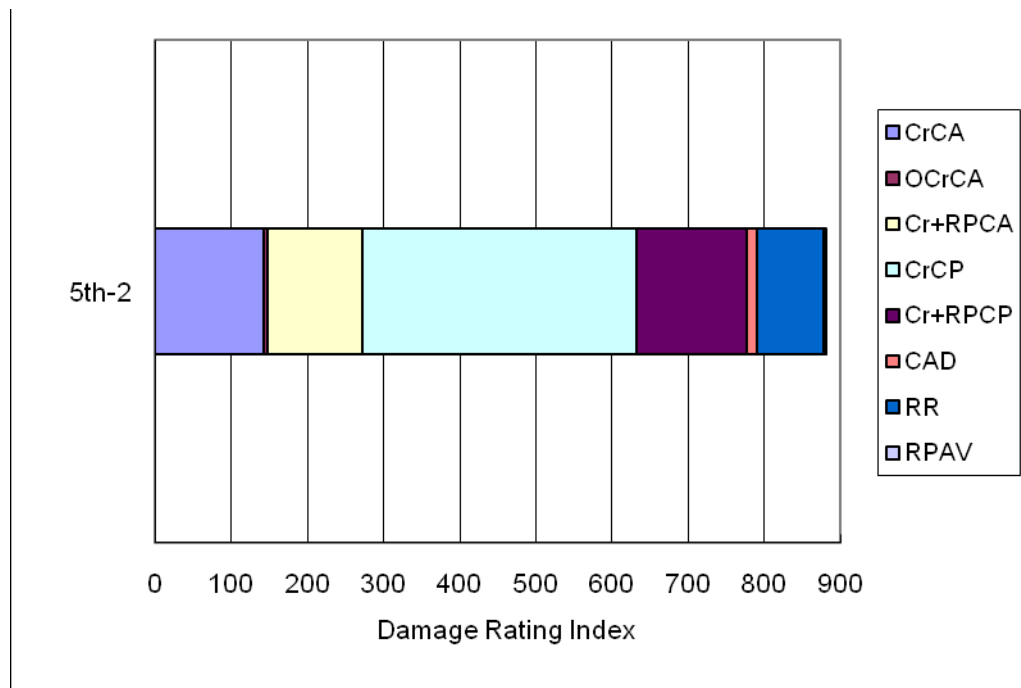
5th Parkway over I395 - CORE I395 5th-2

Sample	CrCA	OCrCA	Cr+RPCA	CrCP	Cr+RPCP	CAD	RR	RPAV	DRI
5th-2	143	6	124	361	145	13	87	3	882

Figure C17: DRI results for Core I395 5th-2

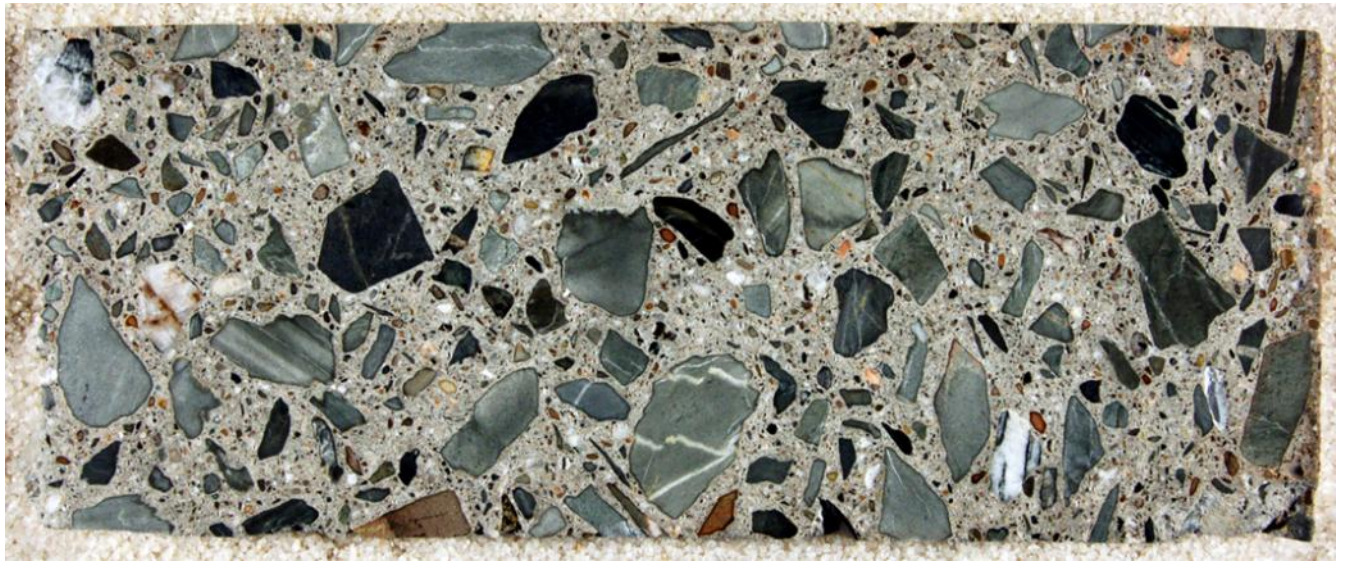
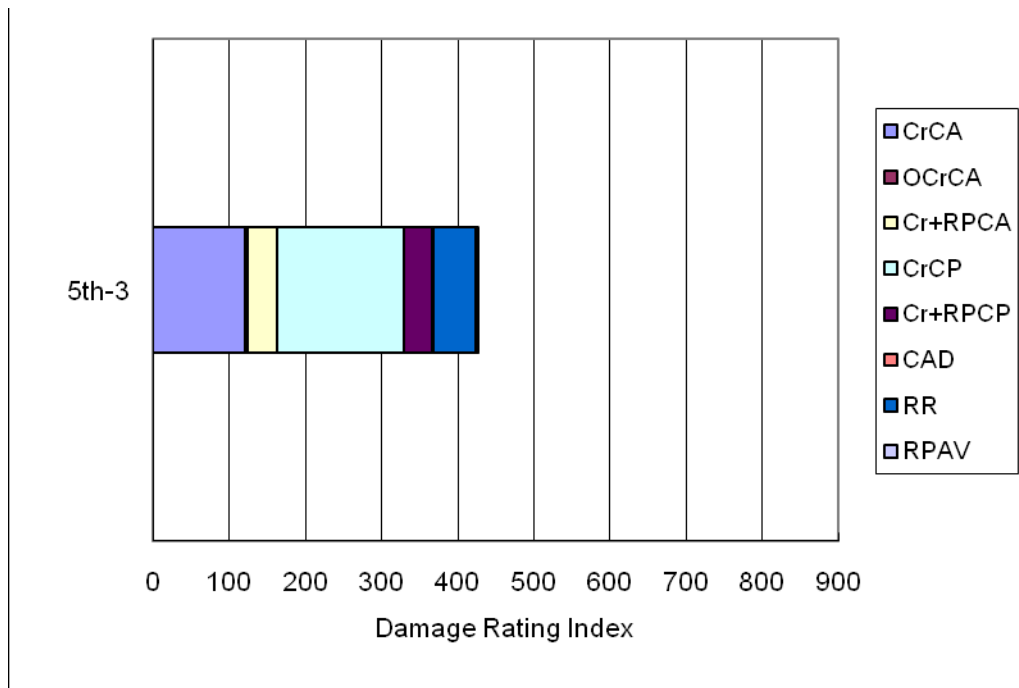
5th Parkway over I395 - CORE I395 5th-3

Sample	CrCA	OCrCA	Cr+RPCA	CrCP	Cr+RPCP	CAD	RR	RPAV	DRI
5th-3	122	3	39	167	36	1	57	2	427

Figure C18: DRI results for Core I395 5th-3

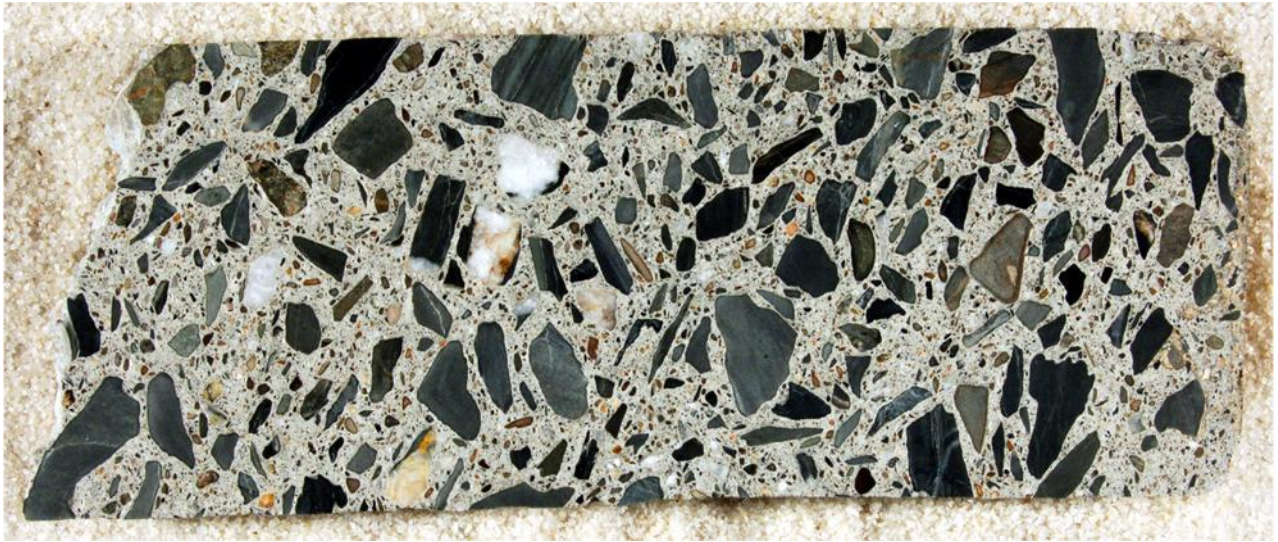
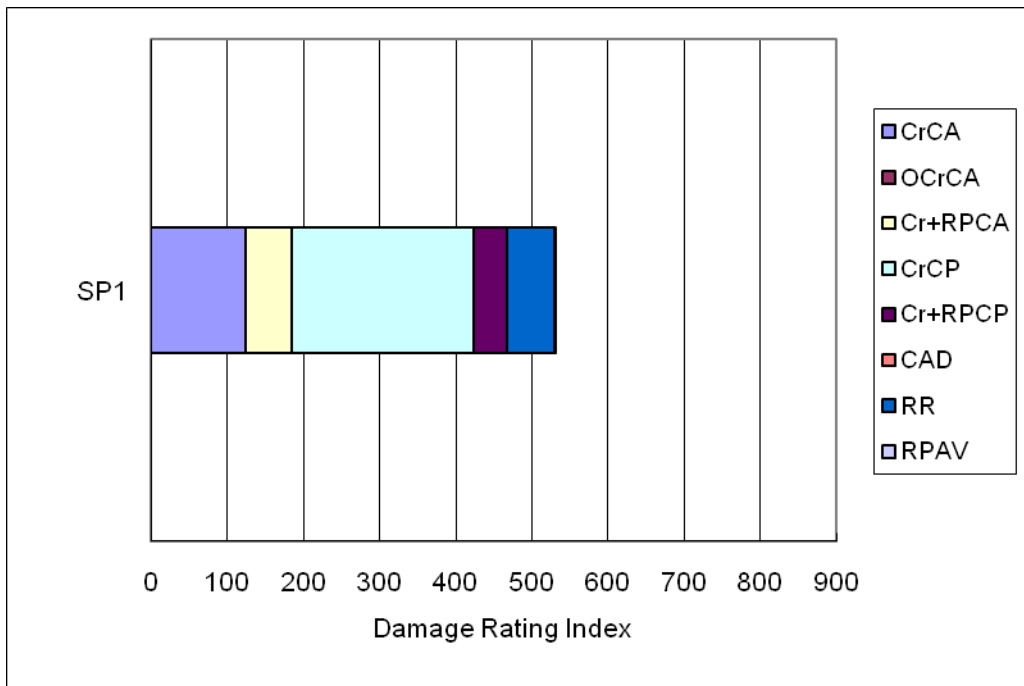
South Parkway over I395 - CORE I395 SP-1

Sample	CrCA	OCrCA	Cr+RPCA	CrCP	Cr+RPCP	CAD	RR	RPAV	DRI
SP1	125	0	61	239	44	0	62	1	531

Figure C20: DRI results for Core I395 SP-1

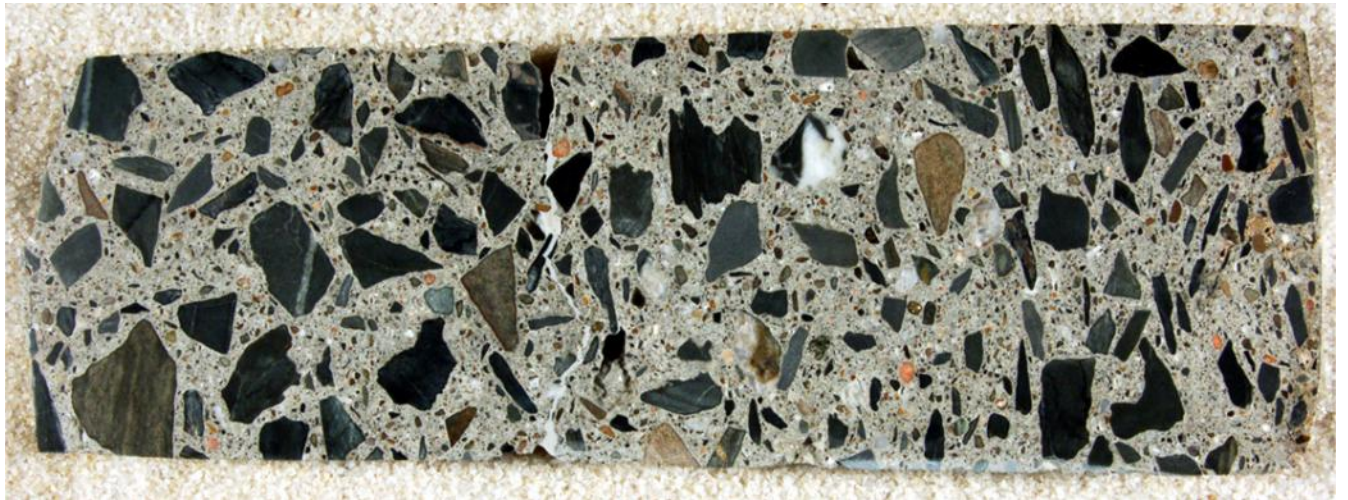
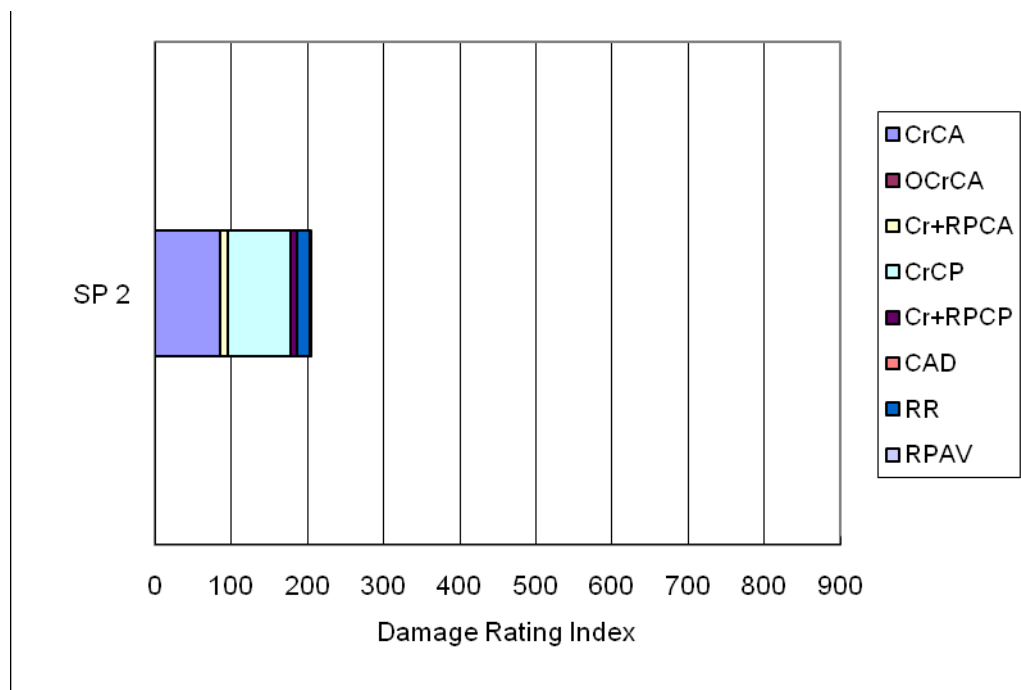
South Parkway over I395 - CORE I395 SP-2

Sample	CrCA	OCrCA	Cr+RPCA	CrCP	Cr+RPCP	CAD	RR	RPAV	DRI
SP 2	86	0	10	82	8	0	17	1	203

Figure C21: DRI results for Core I395 SP-2

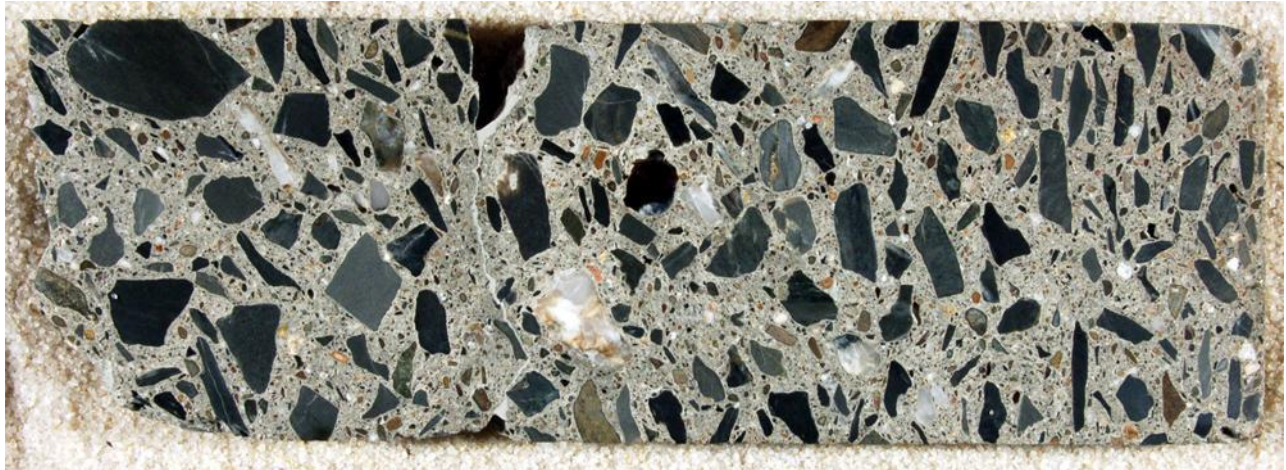
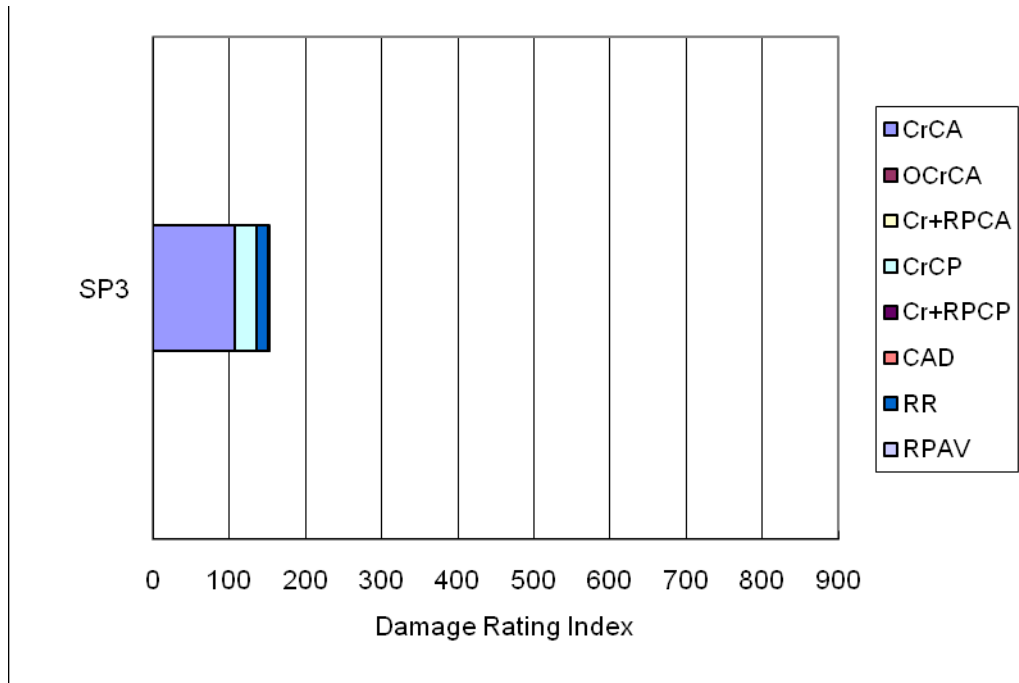
South Parkway over I395 - CORE I395 SP-3

Sample	CrCA	OCrCA	Cr+RPCA	CrCP	Cr+RPCP	CAD	RR	RPAV	DRI
SP3	107	0	0	28	0	1	14	1	152

Figure C22: DRI results for Core I395 SP-3

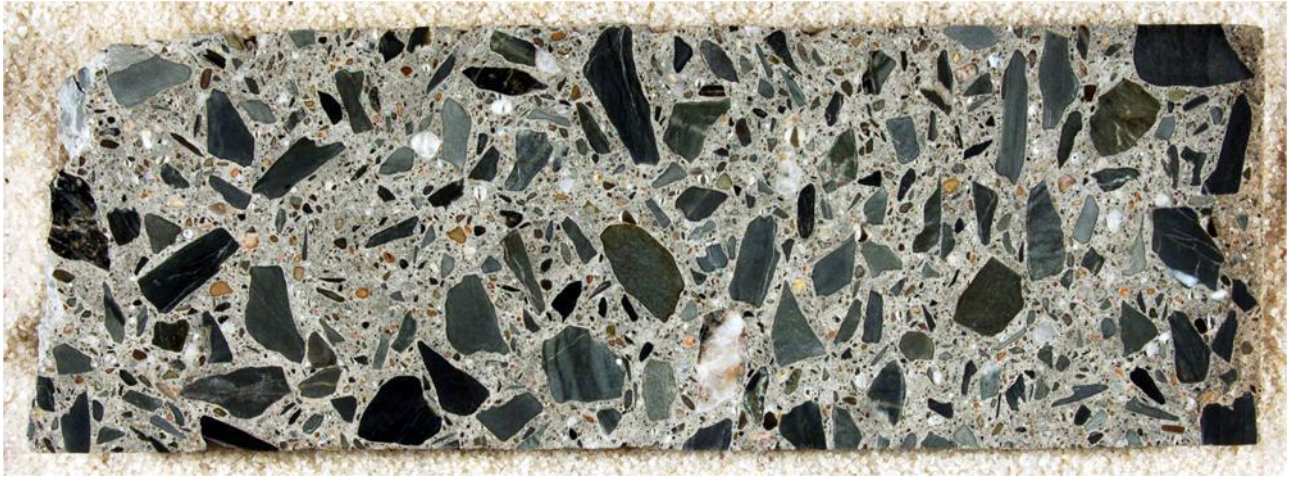
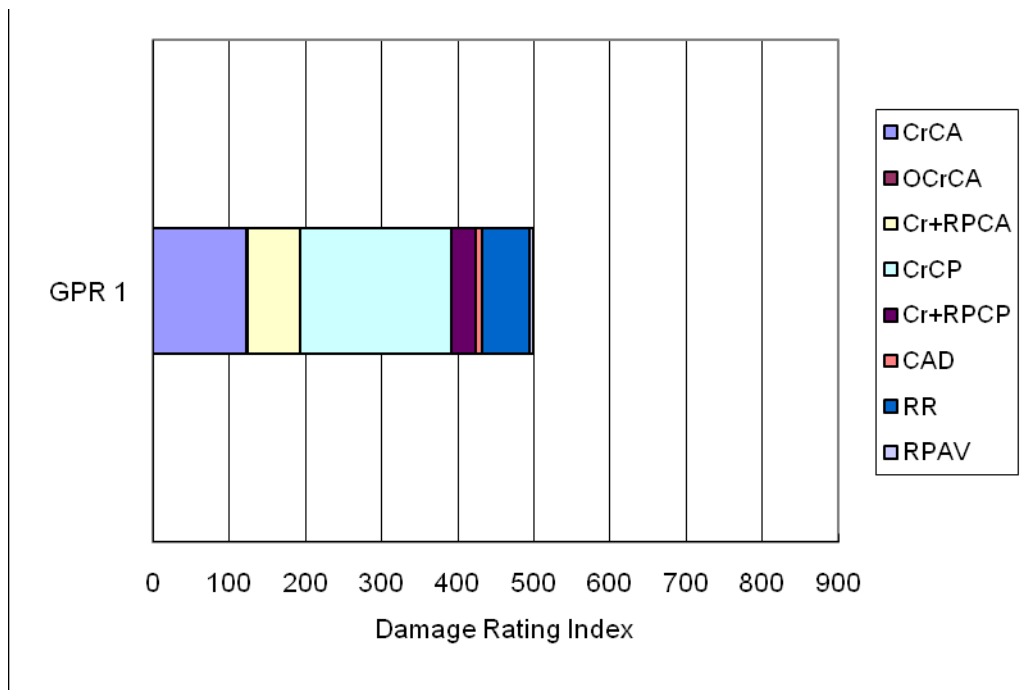
Greenpoint Road over I395 - CORE I395 GPR-1

Sample	CrCA	OCrCA	Cr+RPCA	CrCP	Cr+RPCP	CAD	RR	RPAV	DRI
GPR1	123	2	69	198	31	9	62	5	499

Figure C24: DRI results for Core I395 GPR-1

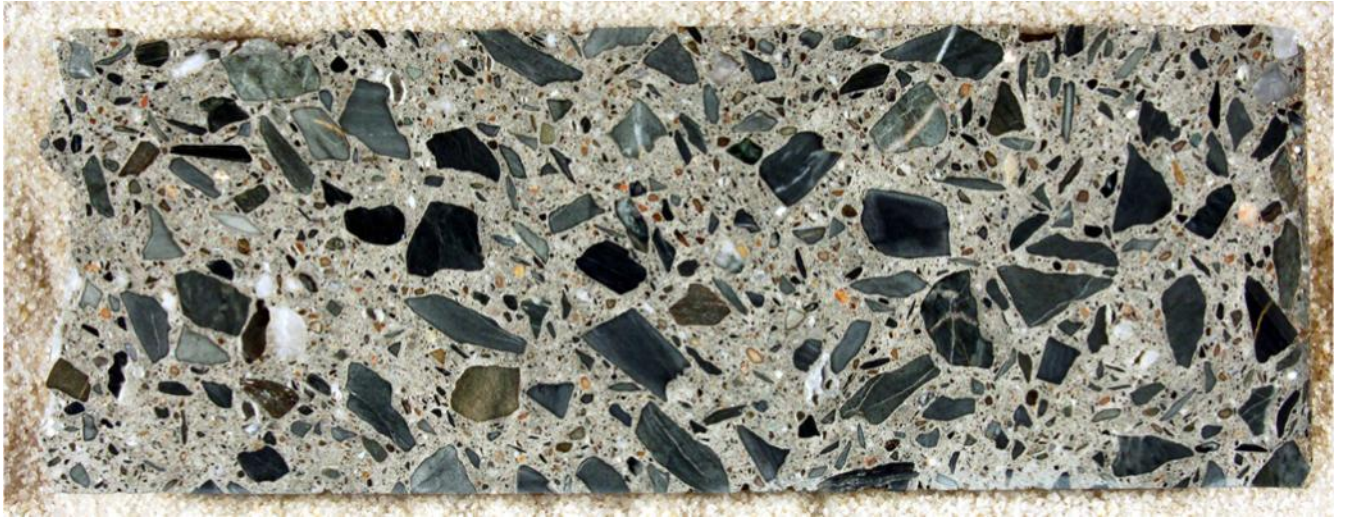
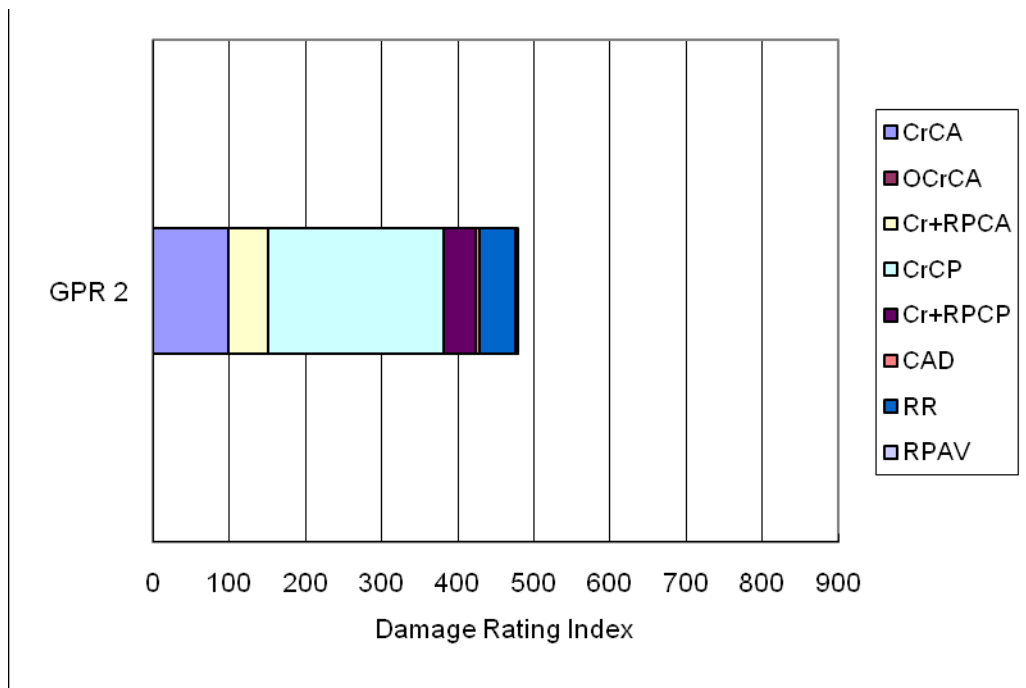
Figure C25: DRI results for Core I395 GPR-2

Greenpoint Road over I395 - CORE I395 GPR-2

Sample	CrCA	OCrCA	Cr+RPCA	CrCP	Cr+RPCP	CAD	RR	RPAV	DRI
GPR2	99	0	53	231	41	5	48	2	479

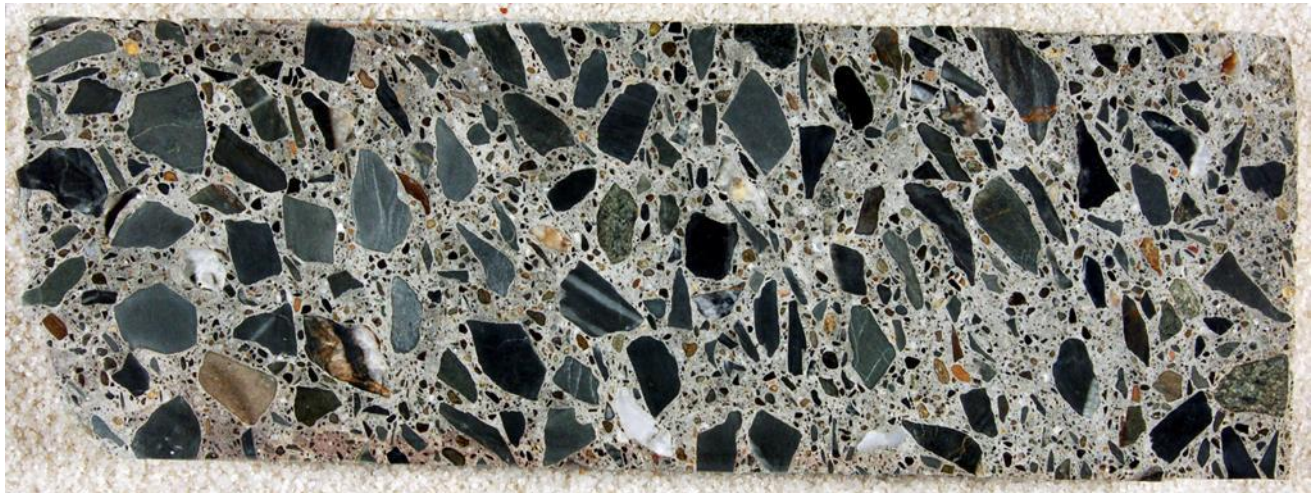
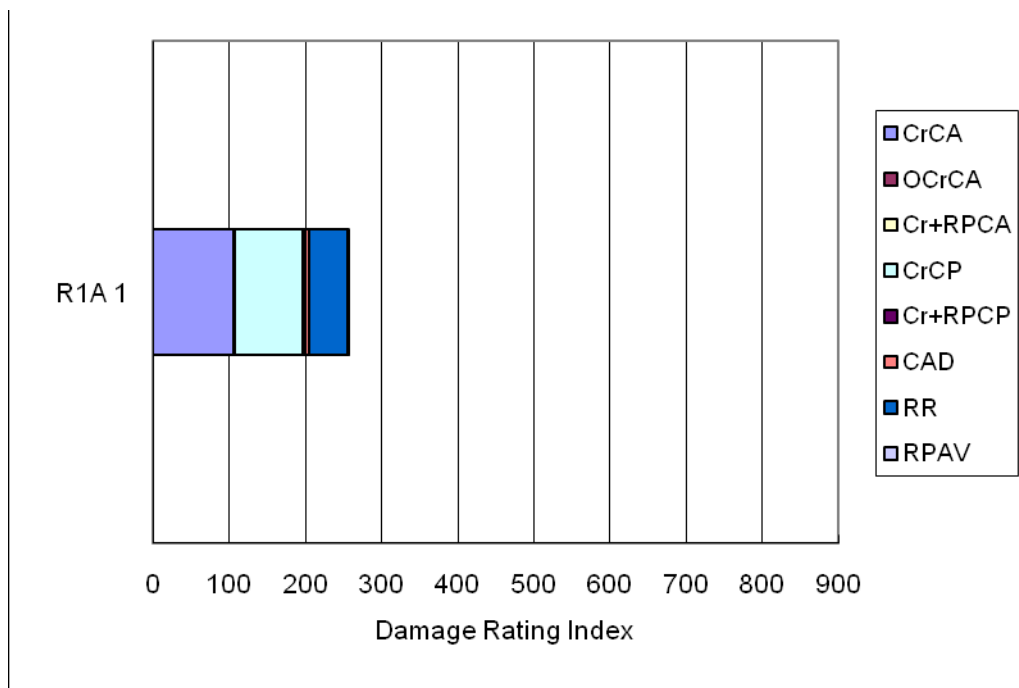
Figure C27: DRI results for Core I395 R1A-1

Road 1A over I395 - CORE I395 R1A-1

Sample	CrCA	OCrCA	Cr+RPCA	CrCP	Cr+RPCP	CAD	RR	RPAV	DRI
R1A 1	105	0	3	90	3	4	51	3	258

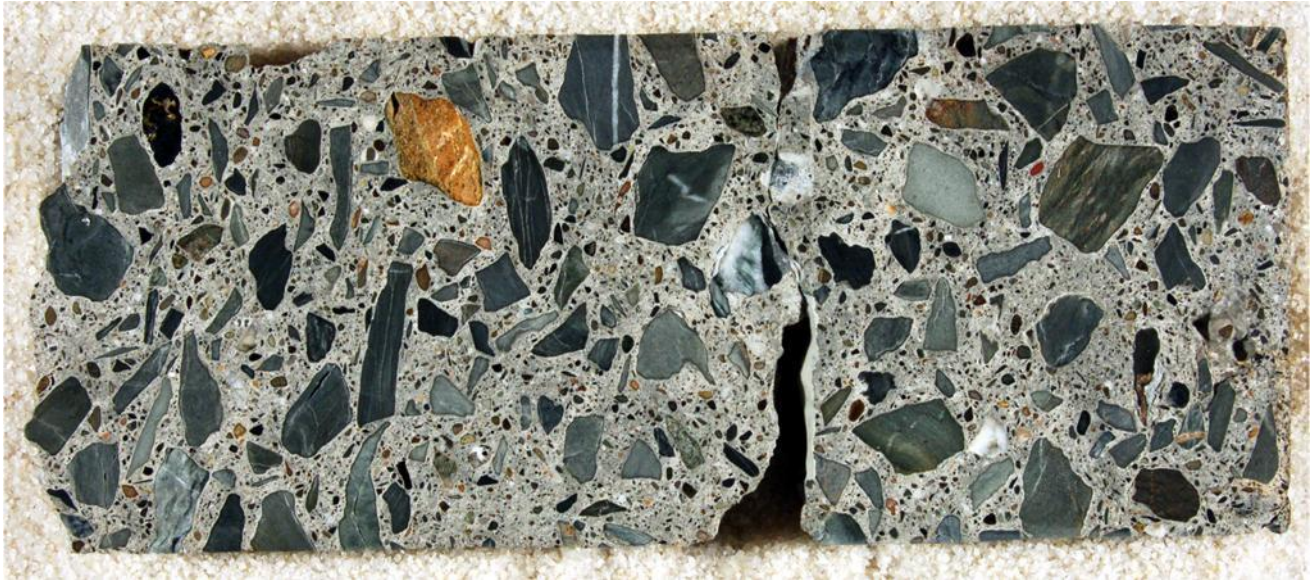
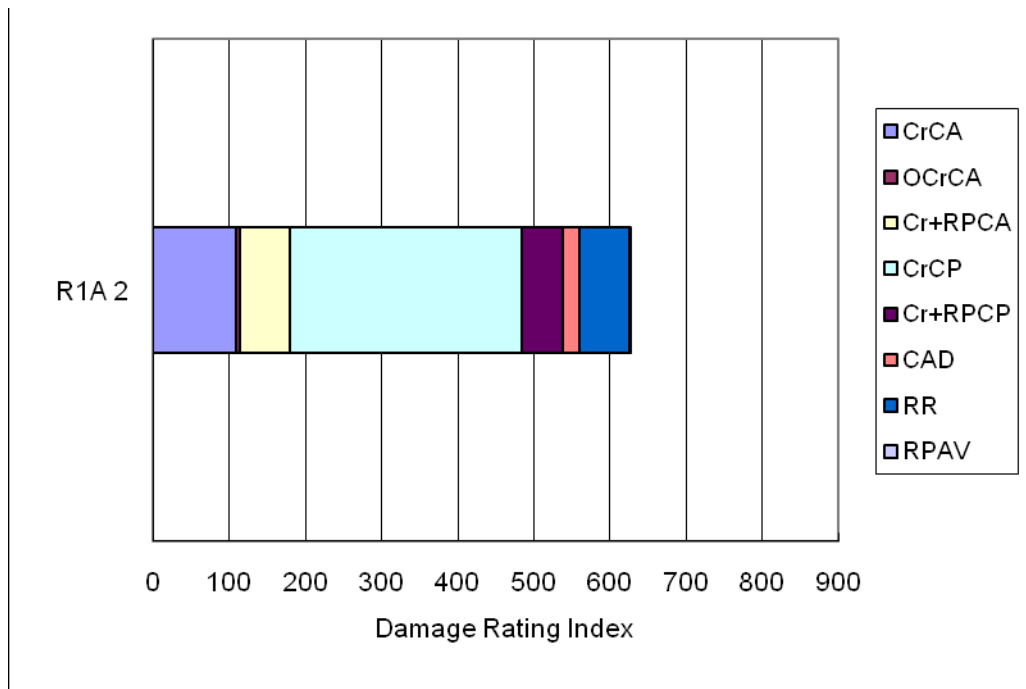
Figure C28: DRI results for Core I395 R1A-2

Road 1A over I395 - CORE I395 R1A-2

Sample	CrCA	OCrCA	Cr+RPCA	CrCP	Cr+RPCP	CAD	RR	RPAV	DRI
R1A 2	109	5	66	305	54	22	65	2	627

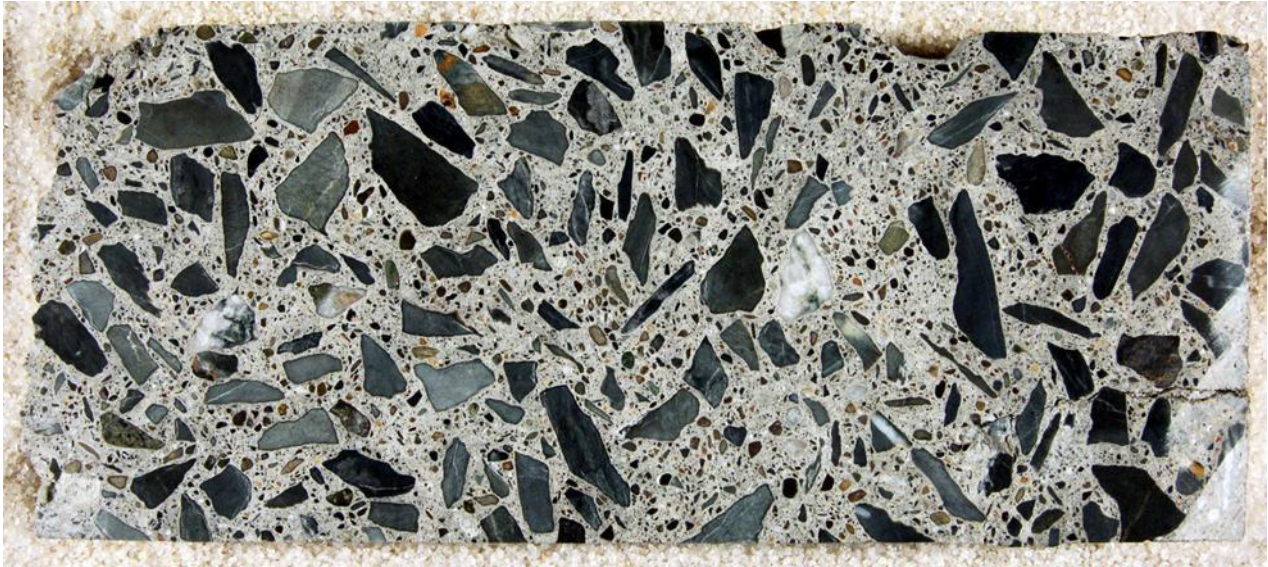
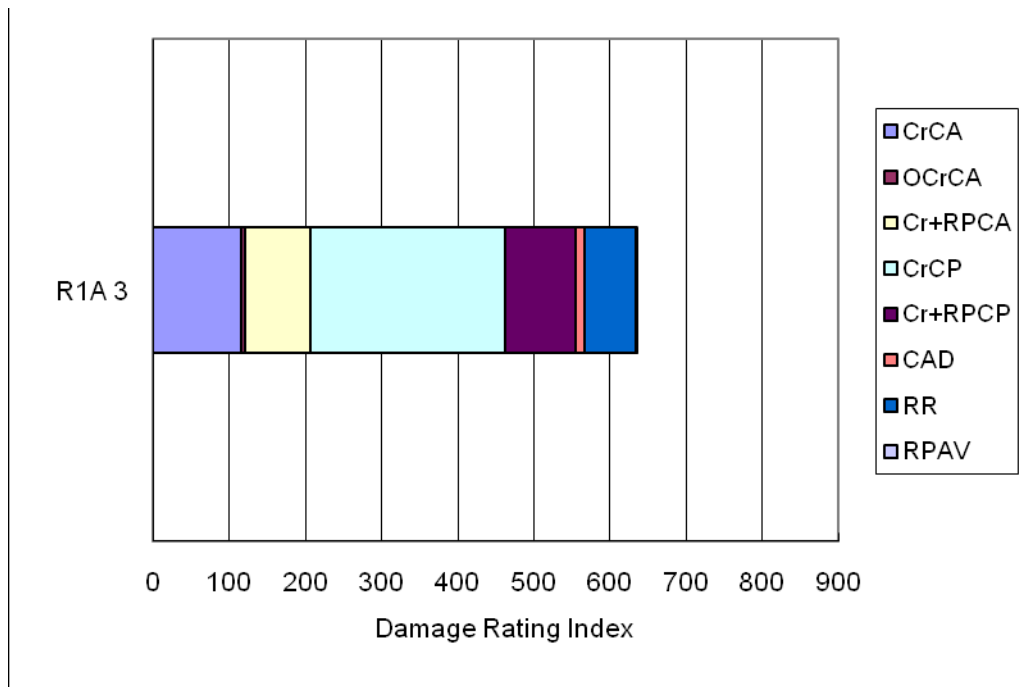
Figure C29: DRI results for Core I395 R1A-2

Road 1A over I395 - CORE I395 R1A-3

Sample	CrCA	OCrCA	Cr+RPCA	CrCP	Cr+RPCP	CAD	RR	RPAV	DRI
R1A 3	116	6	84	257	92	11	69	1	636
