Ohio Route 50 Joint Sealant Experiment

State Job No.: 14668(0)

FINAL REPORT

April 2002

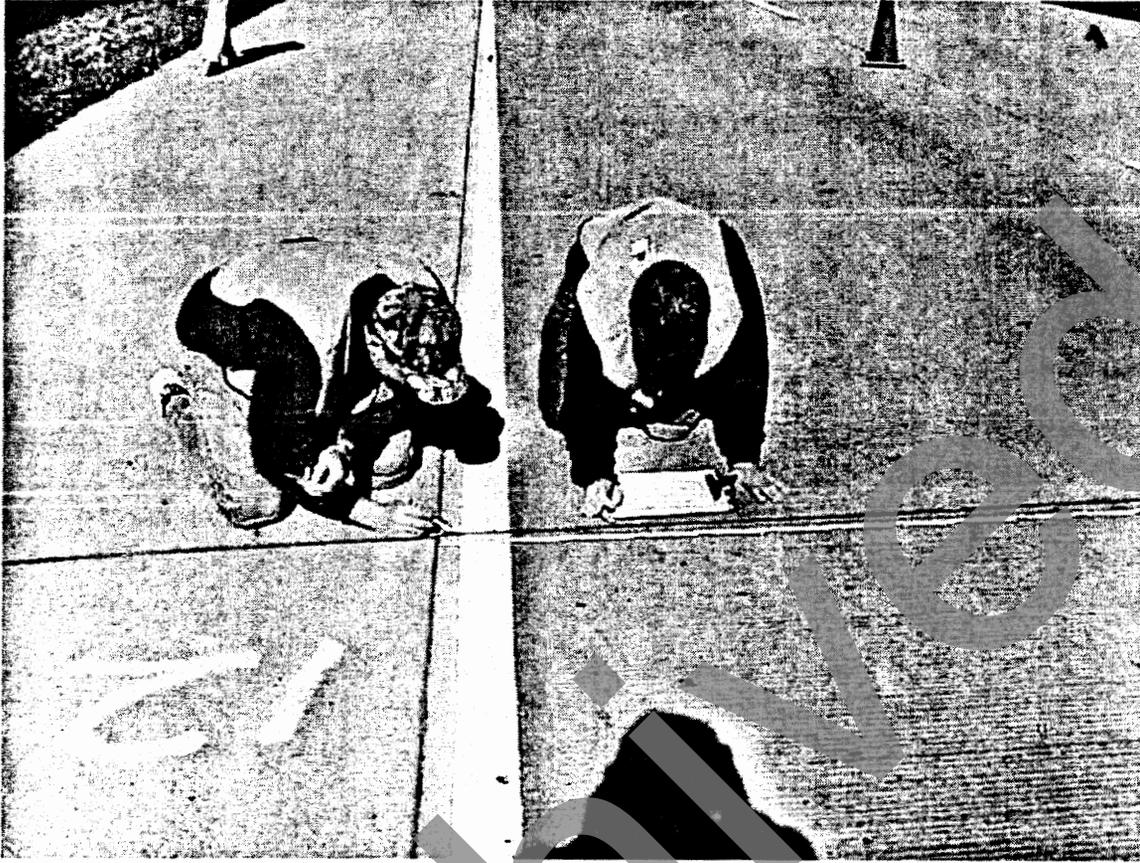
Figure 4.1 Members of the UC research team examining a joint

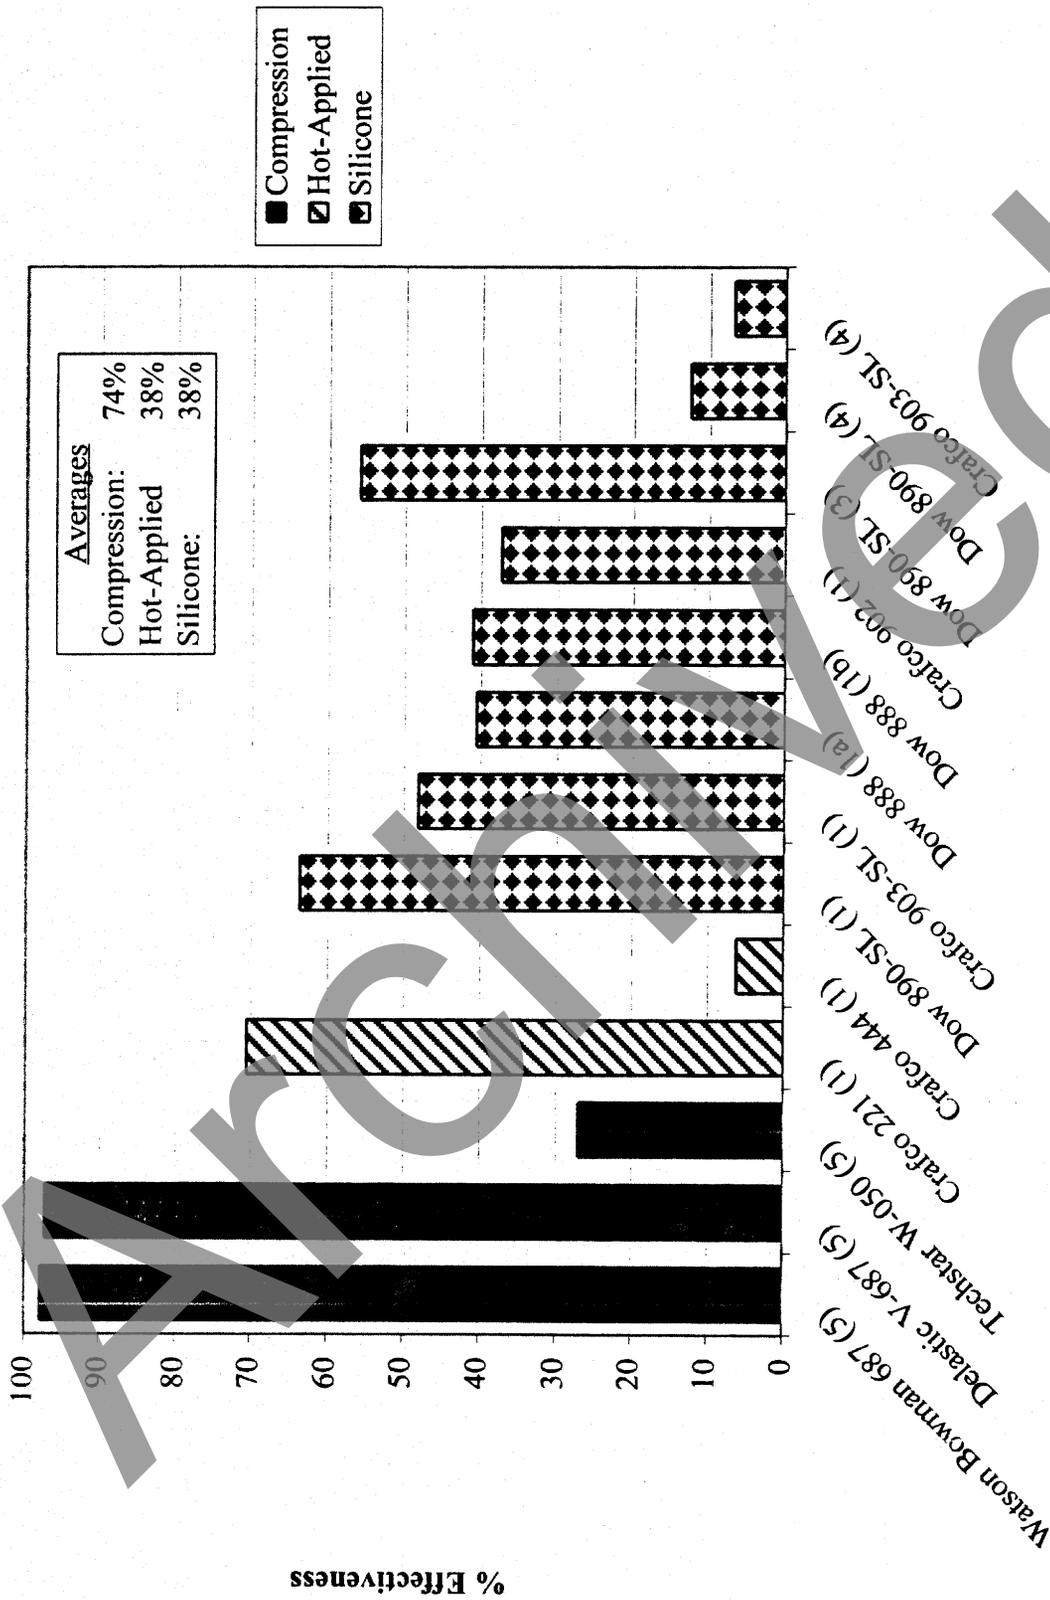
the manner described previously by Sander (2002). The effectiveness of the sealants is shown in the bar graph of Figure. 5.1. The sealants are categorized by sealant type, (silicone, hot-applied, or pre-formed compression), for which average effectiveness values are listed. The joint configuration for each sealant is denoted by the number in parentheses.

The silicone sealants are in very poor condition, averaging only 38% effectiveness. Figure 5.1 suggests that their value is influenced greatly by the joint configuration. In general, silicone sealants with the wider joint configuration No. 1 seem to perform significantly better than those with the narrower joint configuration No. 4. The former are averaging 46% effectiveness, compared to only 10% for the latter. Moreover, self-leveling silicones appear superior to non-sag ones, even when the somewhat narrower joint configuration No. 3 is used: the Dow 890-SL (3) section has an effectiveness value of 56%. Joint configurations 1, 3, and 4 have nominal widths of 10 ± 2 mm ($3/8 \pm 1/16$ in.), 6 ± 2 mm ($1/4 \pm 1/16$ in.), and 3 ± 2 mm ($1/8 \pm 1/16$ in.), respectively.

Figure 5.1 Comparison between silicone, hot-applied, and compression sealants during EBOC00

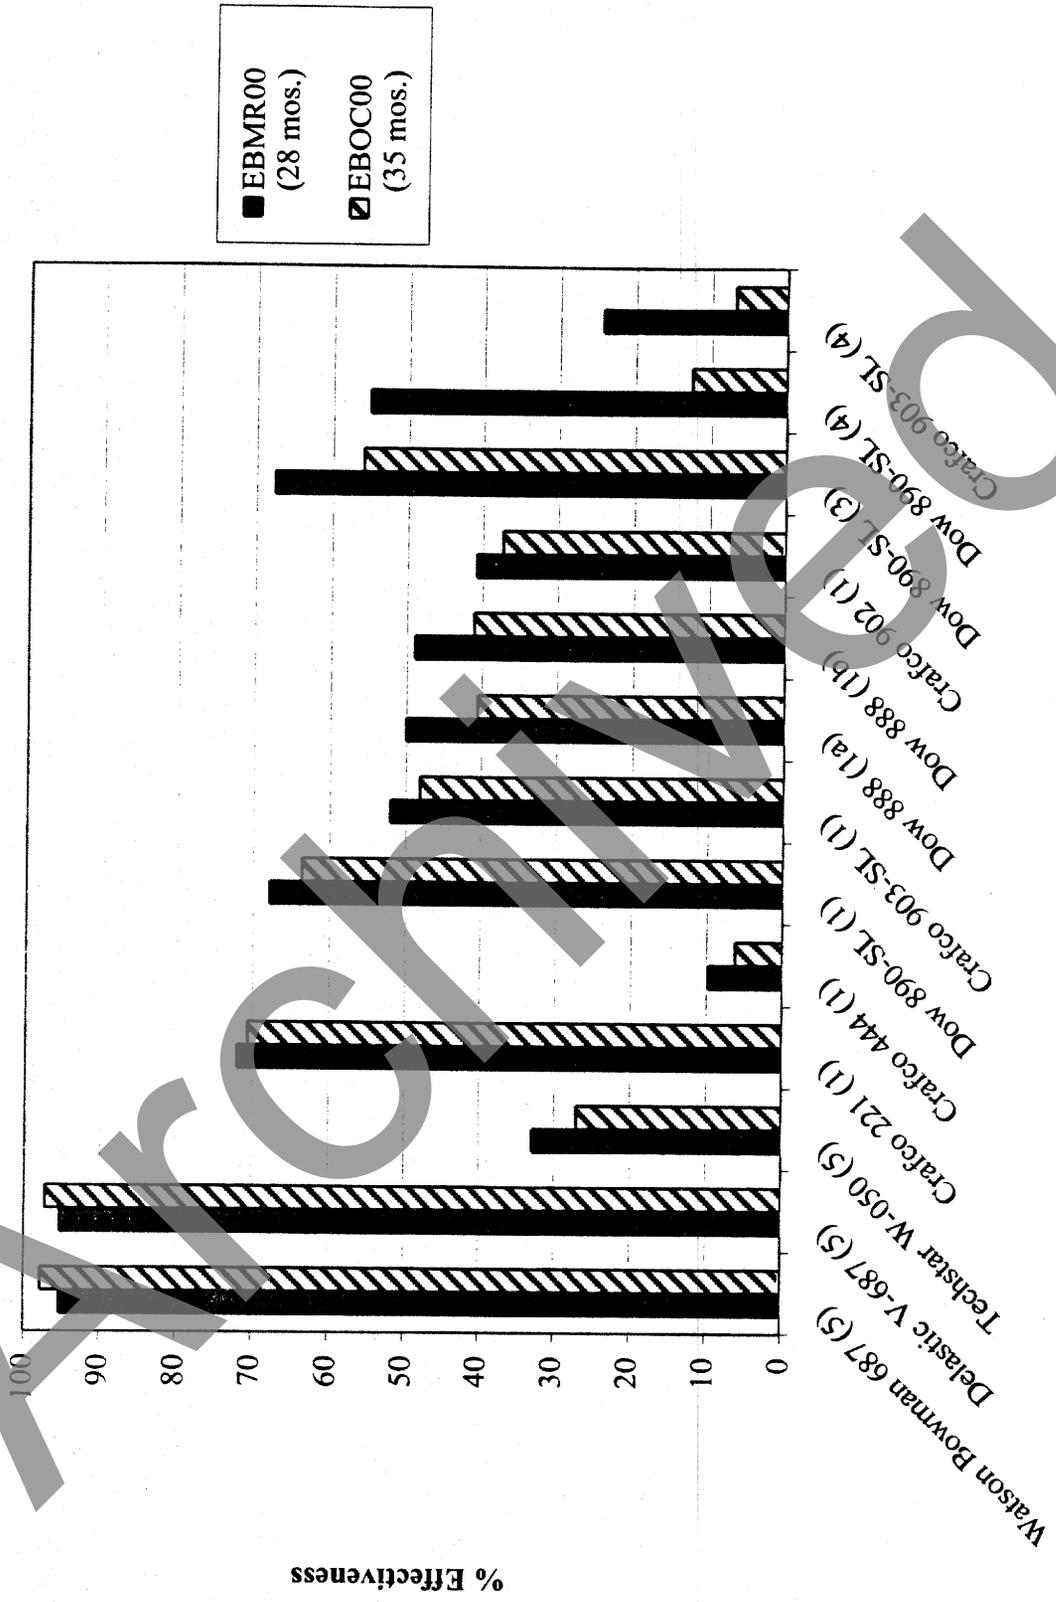
Figure 5.2 presents a comparison between results obtained during the EBOC00 survey and those collected in the previous one, conducted in Spring 2000 (code-named

Figure 5.2 Deterioration of sealants from EBMR00 to EBOC00

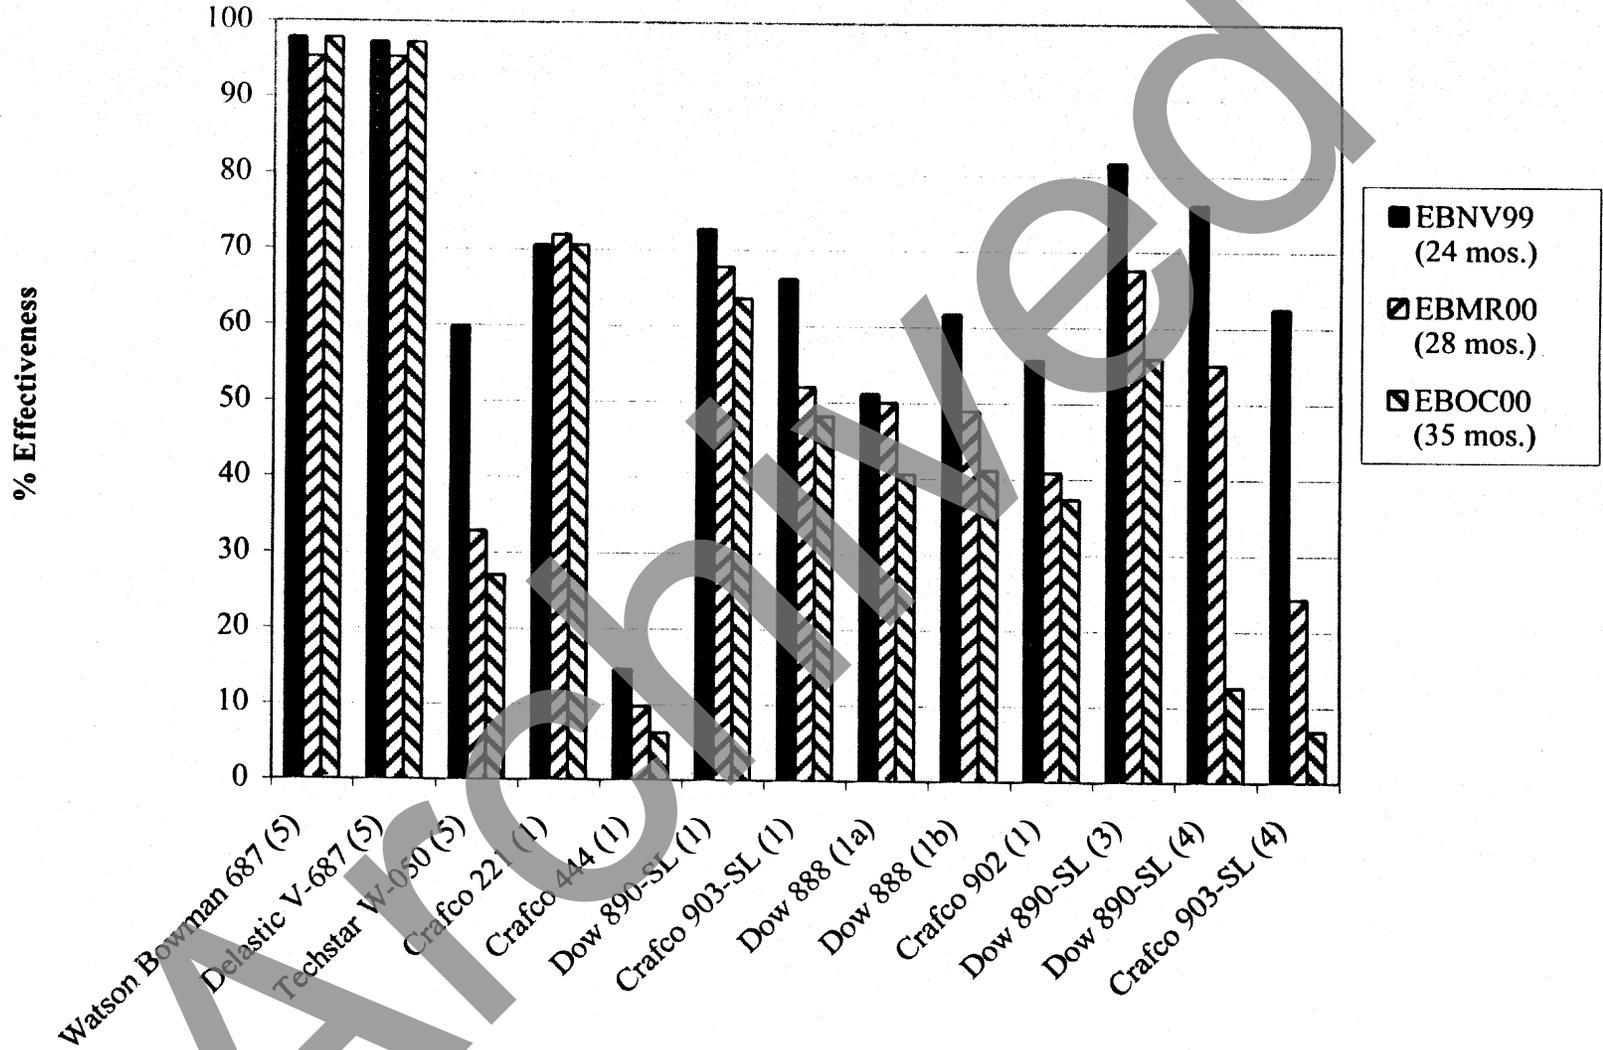
In order to reach sound conclusions regarding the effectiveness of each sealant, monitoring must continue for a substantial period of time. Figure 5.3 shows the effectiveness trends for all sealant sections emerging from the three surveys conducted as of EBOC00. Separate Figures for each sealant type, i.e. compression, hot-applied, and silicone, are provided as well (Figures 5.4 to 5.6).

Figure 5.3 Deterioration of sealants from EBNV99 to EBOC00

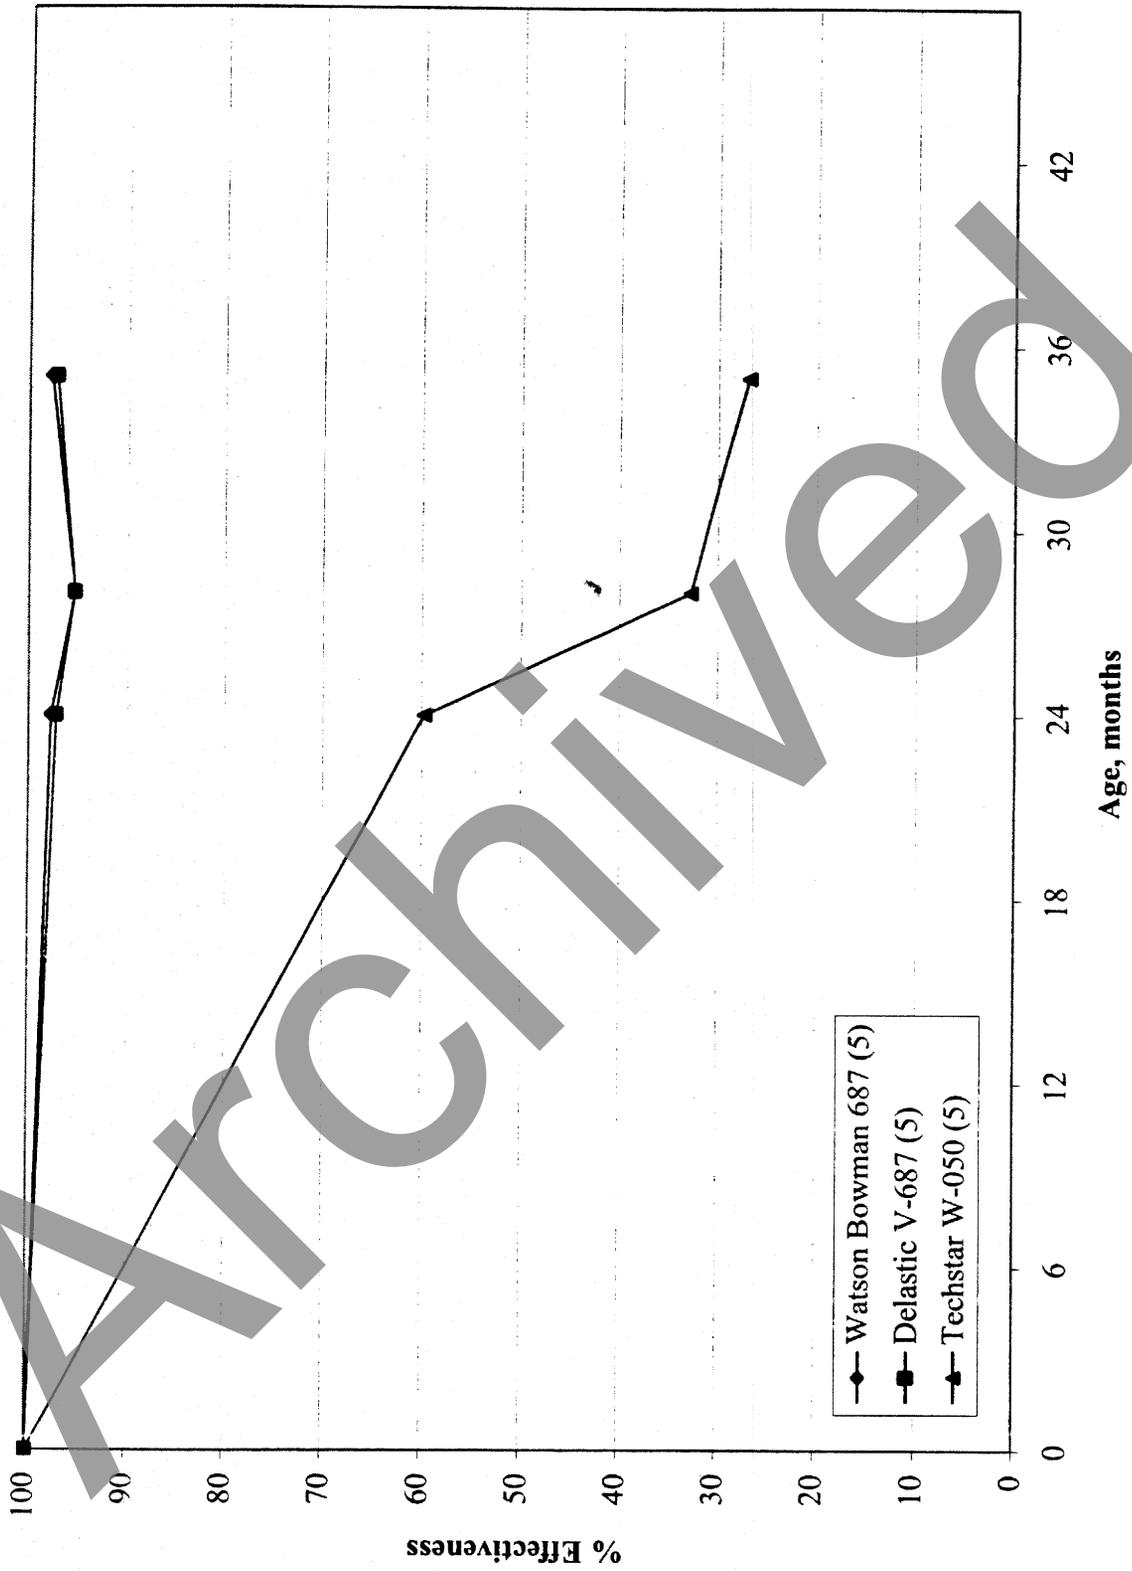
As noted earlier, the compression seals are exhibiting the smallest degree of deterioration. Two of the compression seal sections, Delastic V-687 (5) and Watson Bowman WB-687 (5), have had essentially no deterioration since the first survey in November 1999 as shown in Figure 5.4. The reliance of the compression seals on mechanical rather than chemical bonding appears to be the major attribute that makes these seals withstand the toll of time.

Figure 5.4 Deterioration of compression seals in the eastbound lanes as of EBOC00

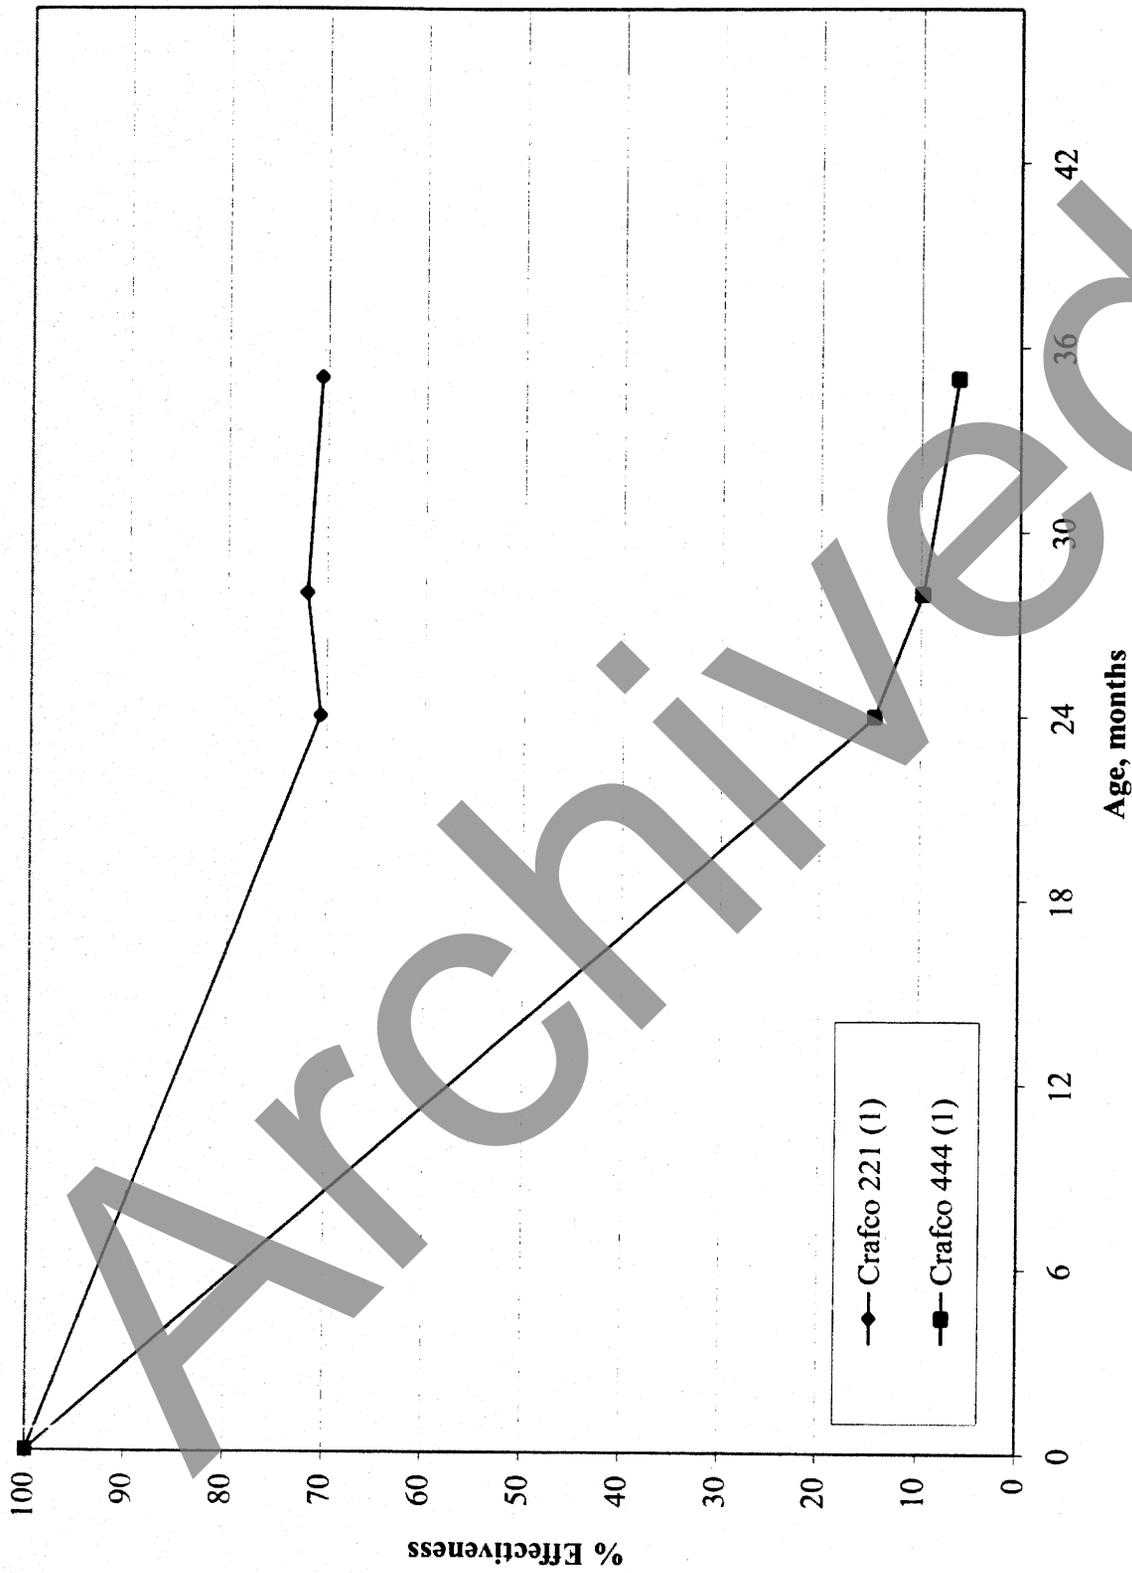
Figure 5.5 indicates that the Crafcoc 221 (1) section has experienced no loss of effectiveness since November 1999, yet its current effectiveness is only 71%. This gives rise to a concern that poor workmanship during installation may have resulted in a rather low initial effectiveness. A visual inspection conducted from the pavement shoulder in October 1998, however, indicated an initial effectiveness of this sealant in excess of 95%; by May 1999, this value had decreased significantly (Hawkins, 1999). Evidently, there was a very rapid, if brief, deterioration in the earliest stages of this sealant's service life, but it is not possible to ascertain whether poor workmanship was exclusively responsible for this behavior.

Figure 5.5 Deterioration of hot-applied sealants in the eastbound lanes of EB00C00

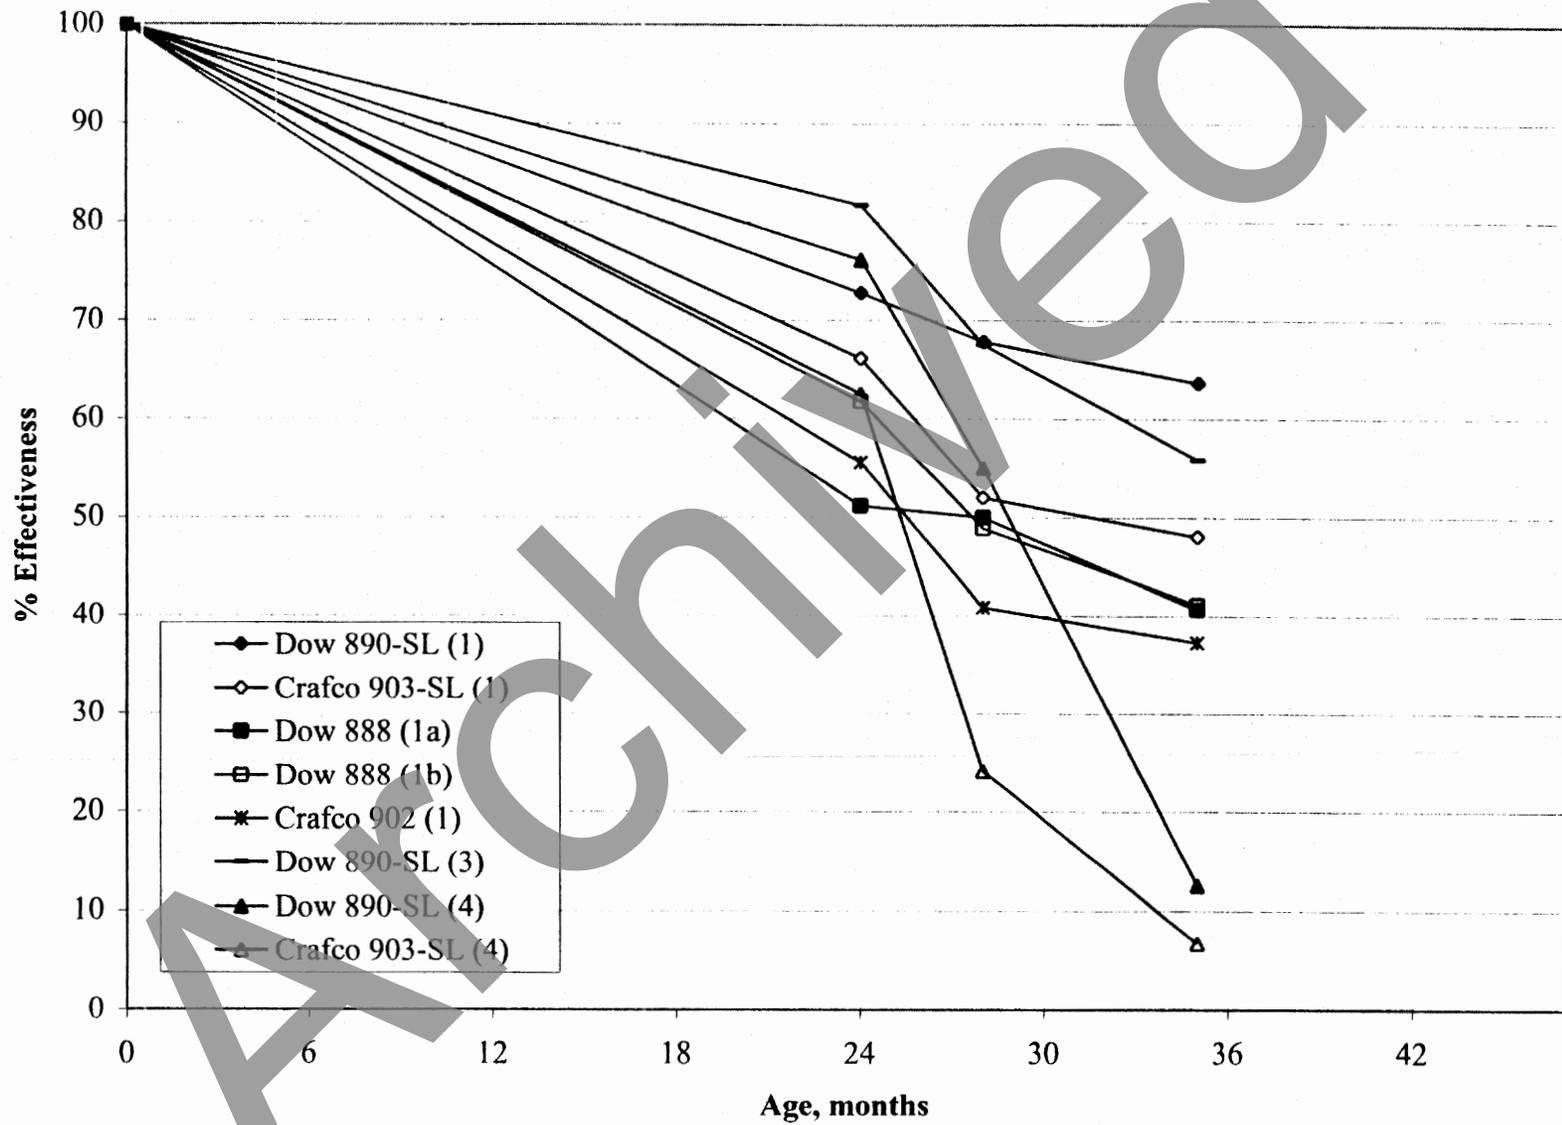
Silicone sealant sections with the joint configuration No. 1 appear to be undergoing a slow deterioration over time (Figure 5.6). The effectiveness loss of these sealants over the preceding twelve months is only about 10%. Their current mediocre effectiveness seems primarily to be due to the rapid deterioration that occurred prior to the first survey under this Project (Fall 1999). Deficiencies in installation workmanship, reported by Hawkins (1999), appear to be largely responsible for these observations. In

Figure 5.6 Deterioration of silicone sealants in the eastbound lanes as of EBOC00

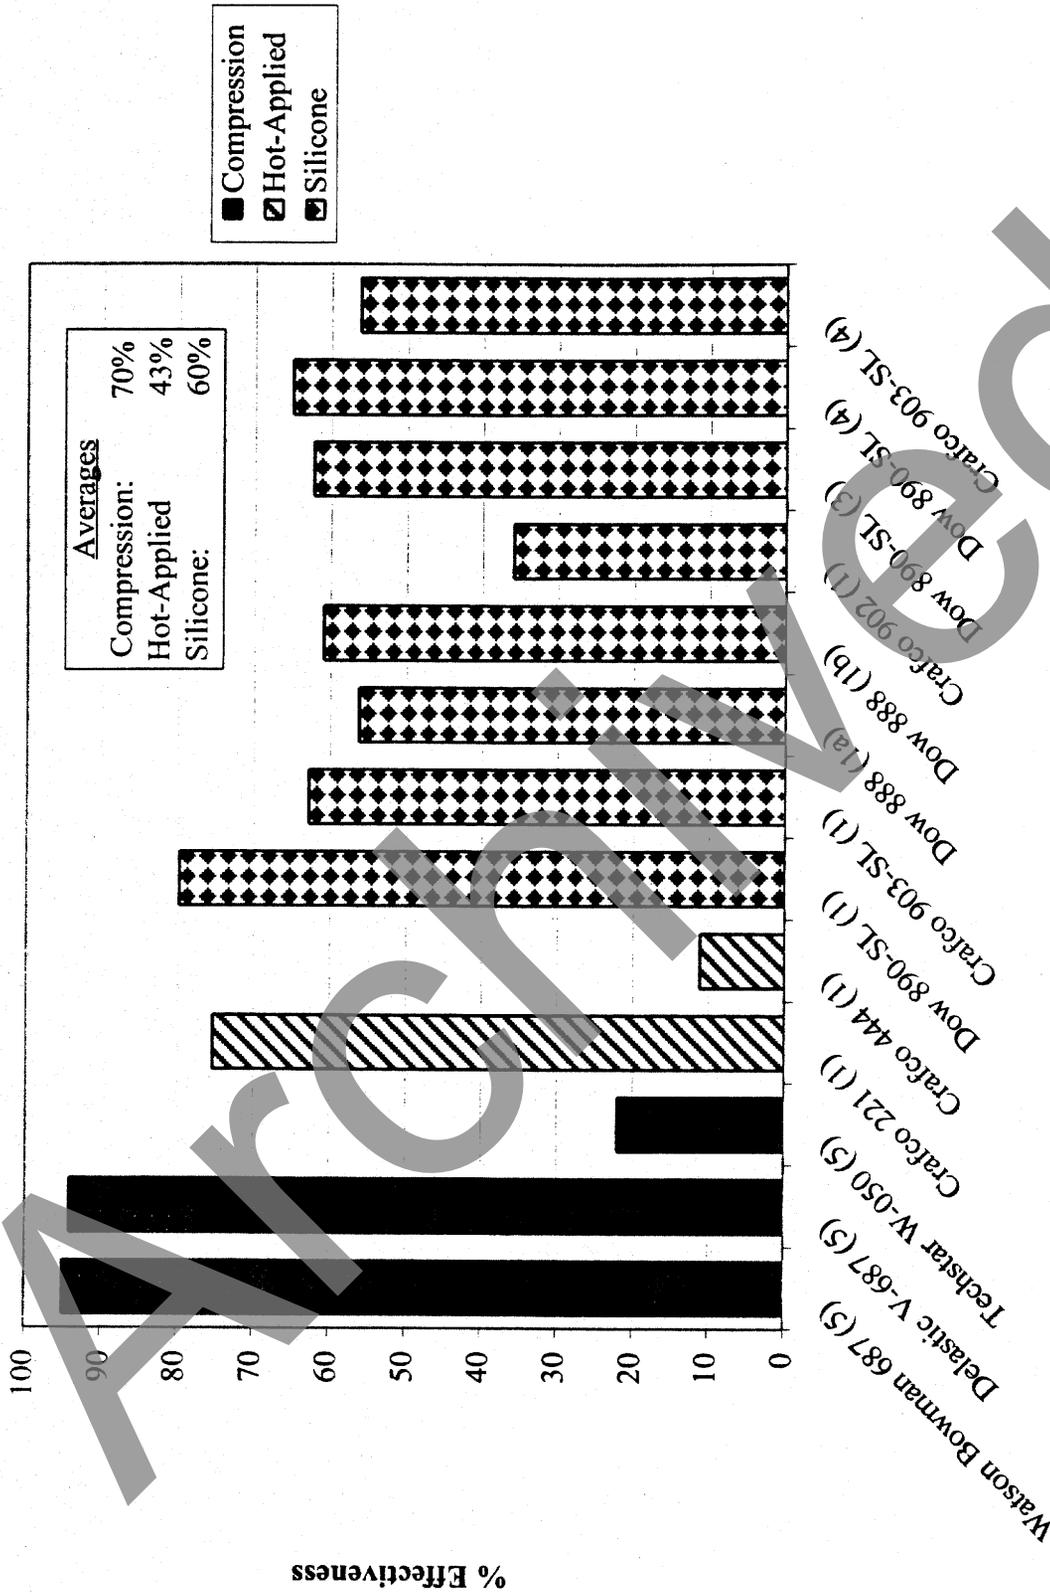
On Monday, June 4, 2001, the University of Cincinnati research team performed the fourth survey of the joint sealants condition in the eastbound driving lane. The data set collected is code-named EBJN01. The evaluation was conducted in the manner described previously by Sander (2002). The effectiveness of the sealants is shown in the bar graph of Figure 5.7. The sealants are categorized by sealant type, (silicone, hot-applied, or pre-formed compression), for which average effectiveness values are listed. The joint configuration for each sealant is denoted by the number in parentheses.

Figure 5.7 Comparison between silicone, hot-applied, and compression sealants during EBJN01

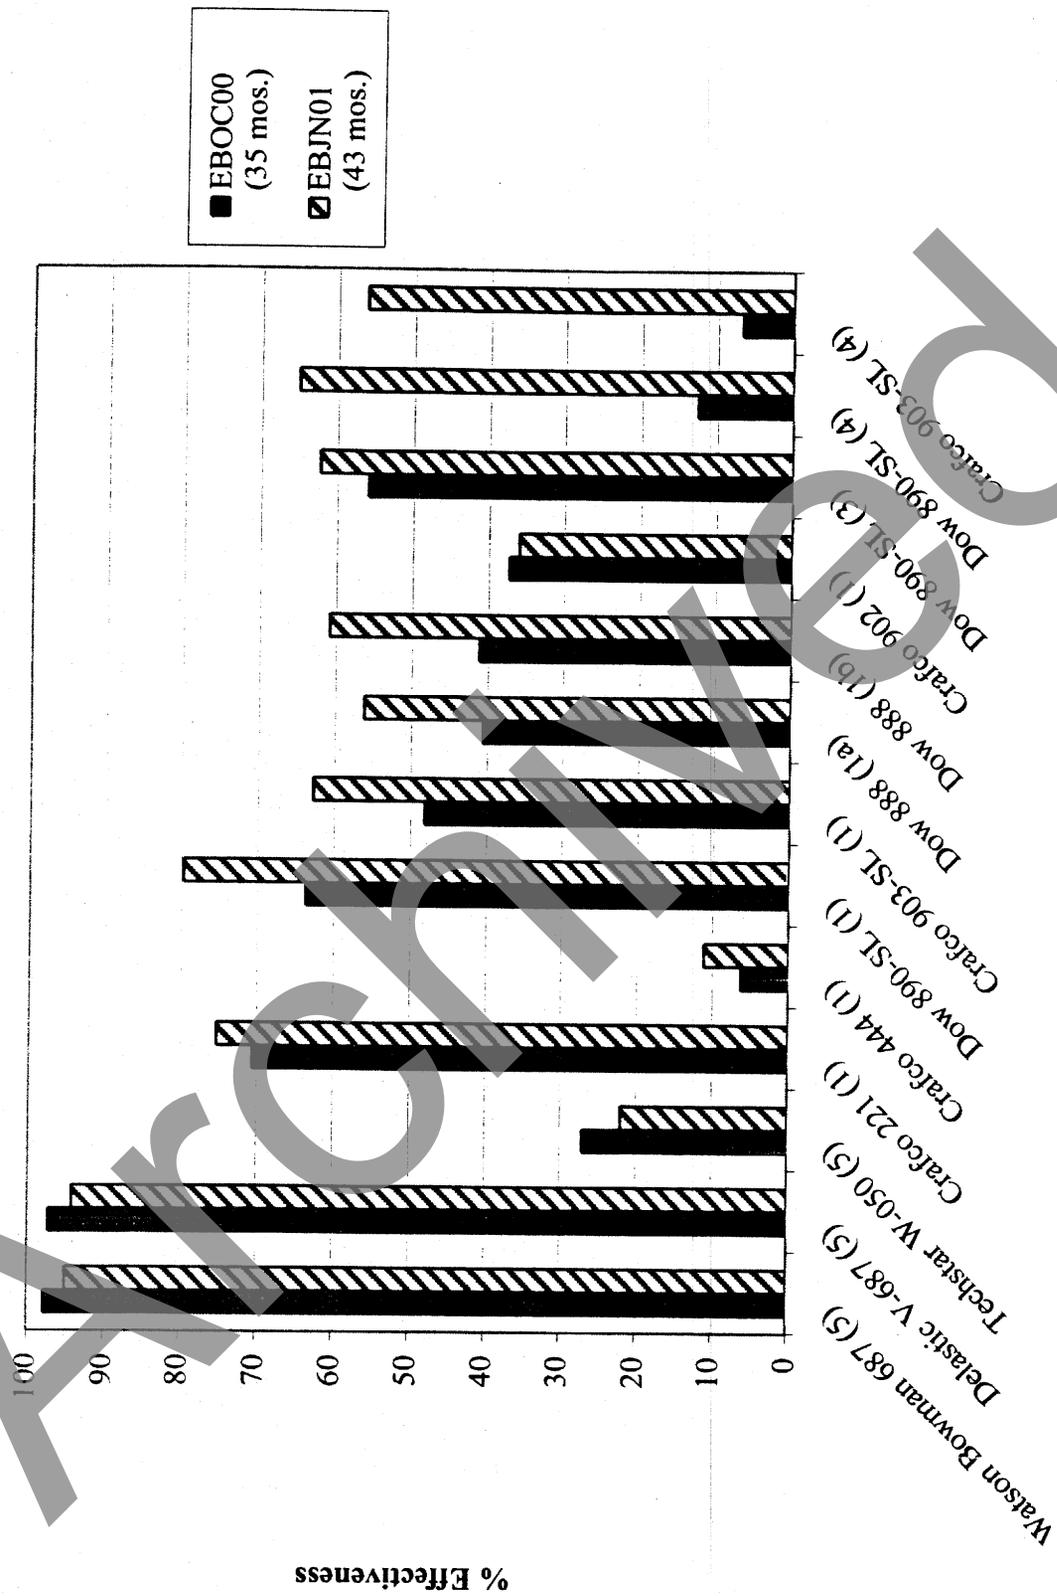
The results of the previous two surveys are shown in Figure 5.8. Table 5.2 lists the effectiveness values for the past two surveys and ranks them accordingly. Differences between the two surveys are also tabulated and ranked; a rank of 1 indicates the greatest loss of effectiveness and a rank of 13 means the least. The most striking observation is that nine of the thirteen sections exhibit increases in effectiveness. The increase is mainly in the silicone and hot-applied sections. The compression seals show a decrease of effectiveness of less than 5%.

Figure 5.8 Deterioration of sealants from EBOC00 to EBJN01

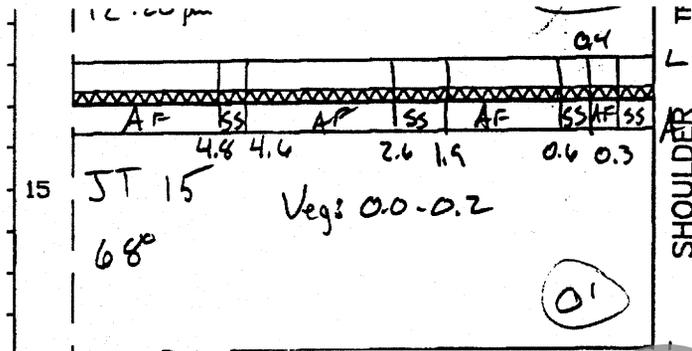
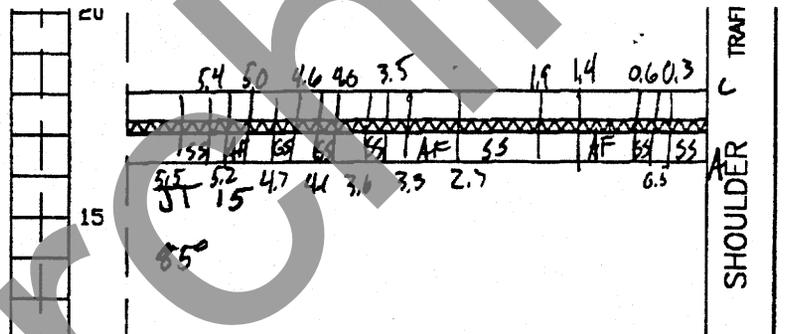
A possible explanation for the apparent improvements in effectiveness is offered in Figure 5.9, which shows the field logs for Joint 15 in the Crafc0 903-SL (4) section, recorded during the EBOC00 and EBJN01 evaluations. The latter appears to be more detailed, revealing a series of increments of sunken seal or adhesion failures, interspersed with short intact segments. In contrast, the earlier log shows longer increments of failure

Figure 5.9 Comparison between field logs from EBOC00 and EBJN01 for Joint 15 in the Crafc0 903-SL (4) section.

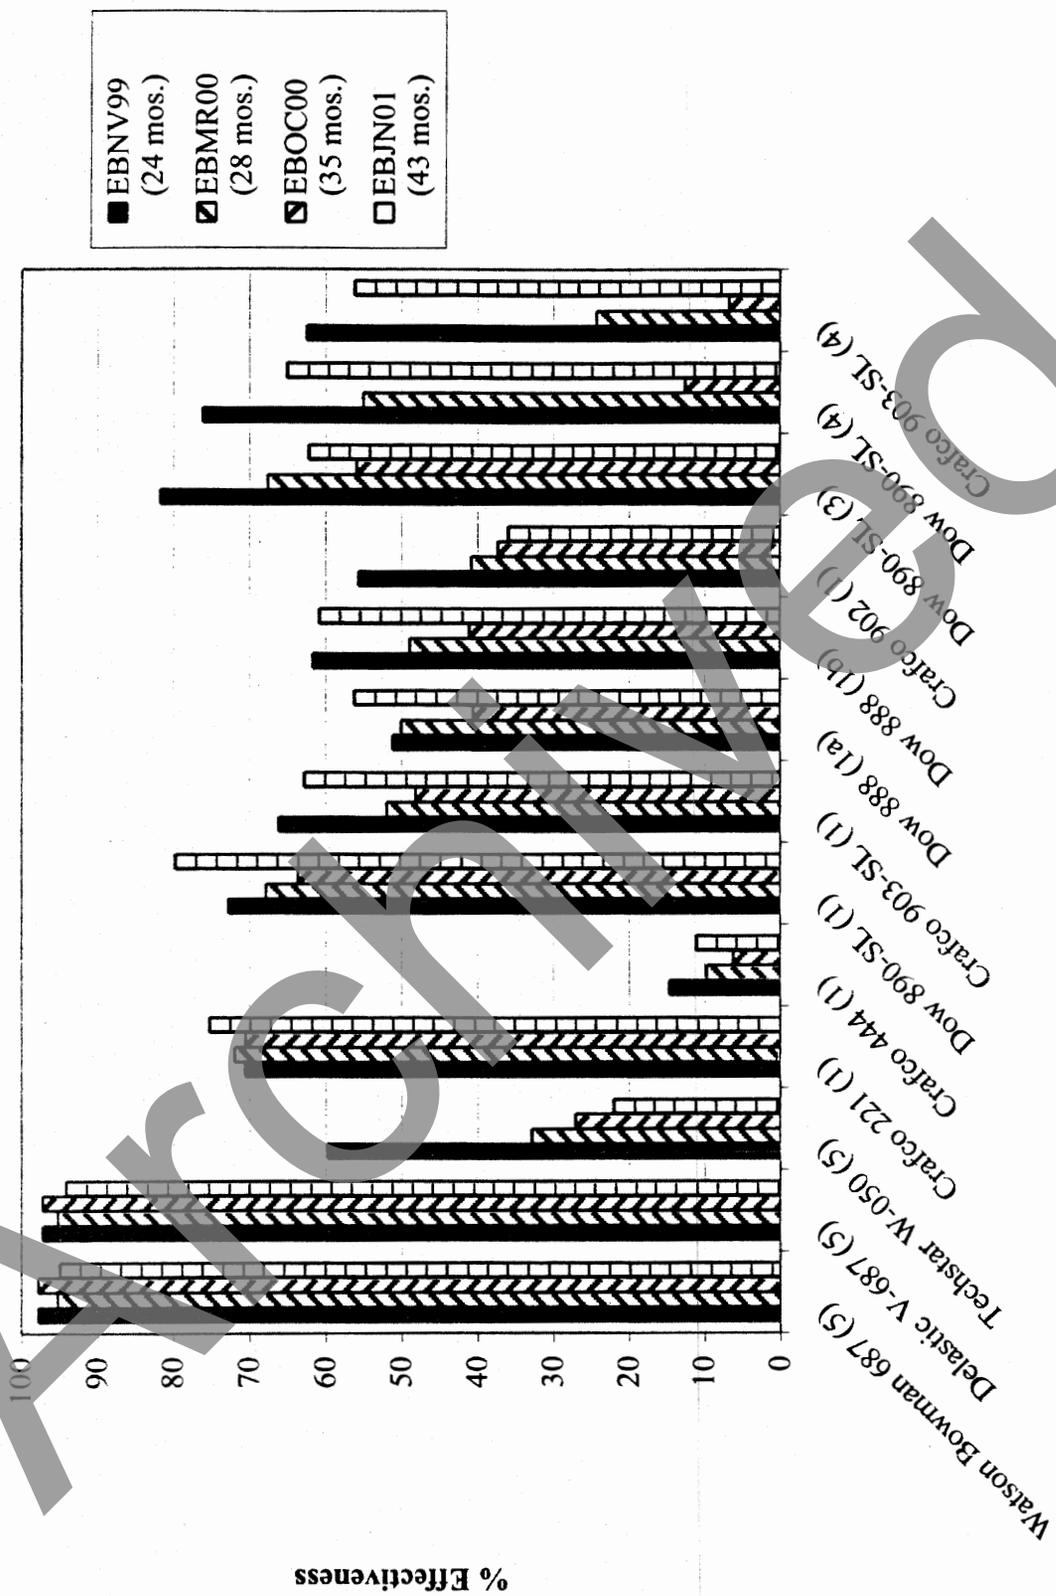
Figure 5.10 graphs the results of all sealant sections and all surveys to date. Figure 5.11 shows the deterioration of the preformed compression seals since their installation. As expected, the two superior seals (Watson Bowman 687 and Delastic V-687) continue to maintain most of their original effectiveness. Techstar W-050, on the other hand, continues to deteriorate, albeit more slowly after each survey.

Figure 5.10 Deterioration of sealants from EBNV99 to EBJN01

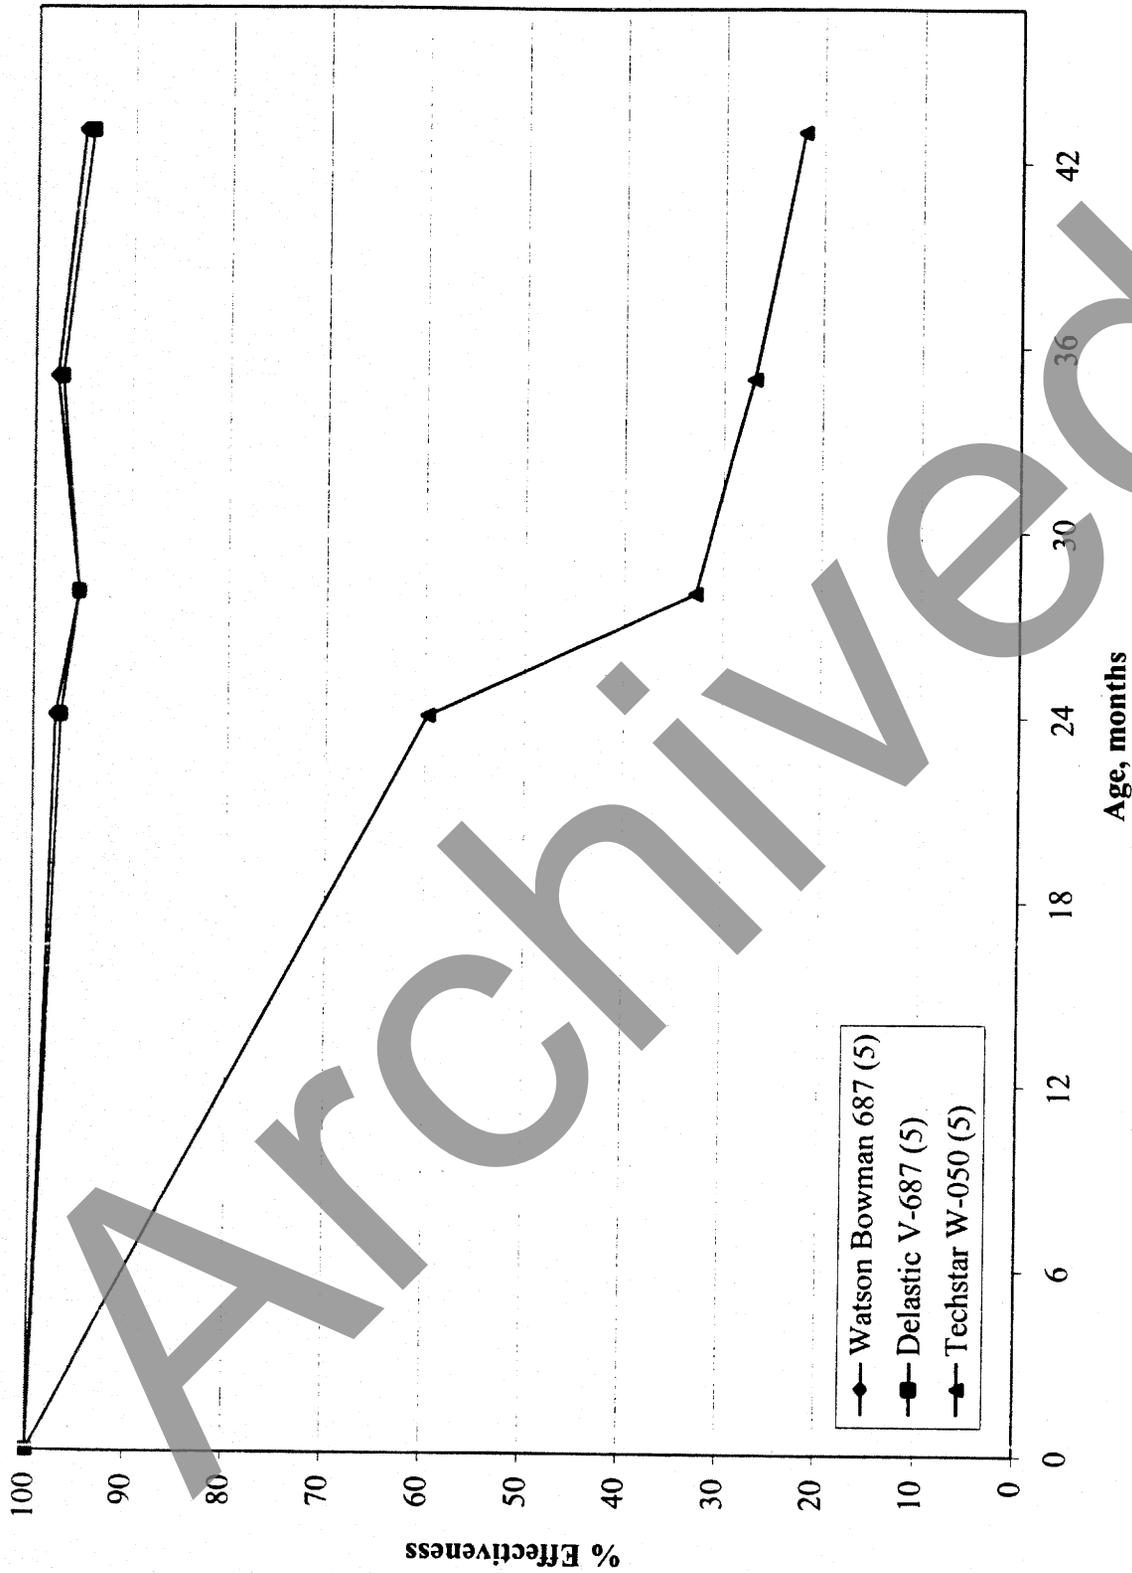
Figure 5.11 Deterioration of compression seals in the eastbound lanes as of EBJN01

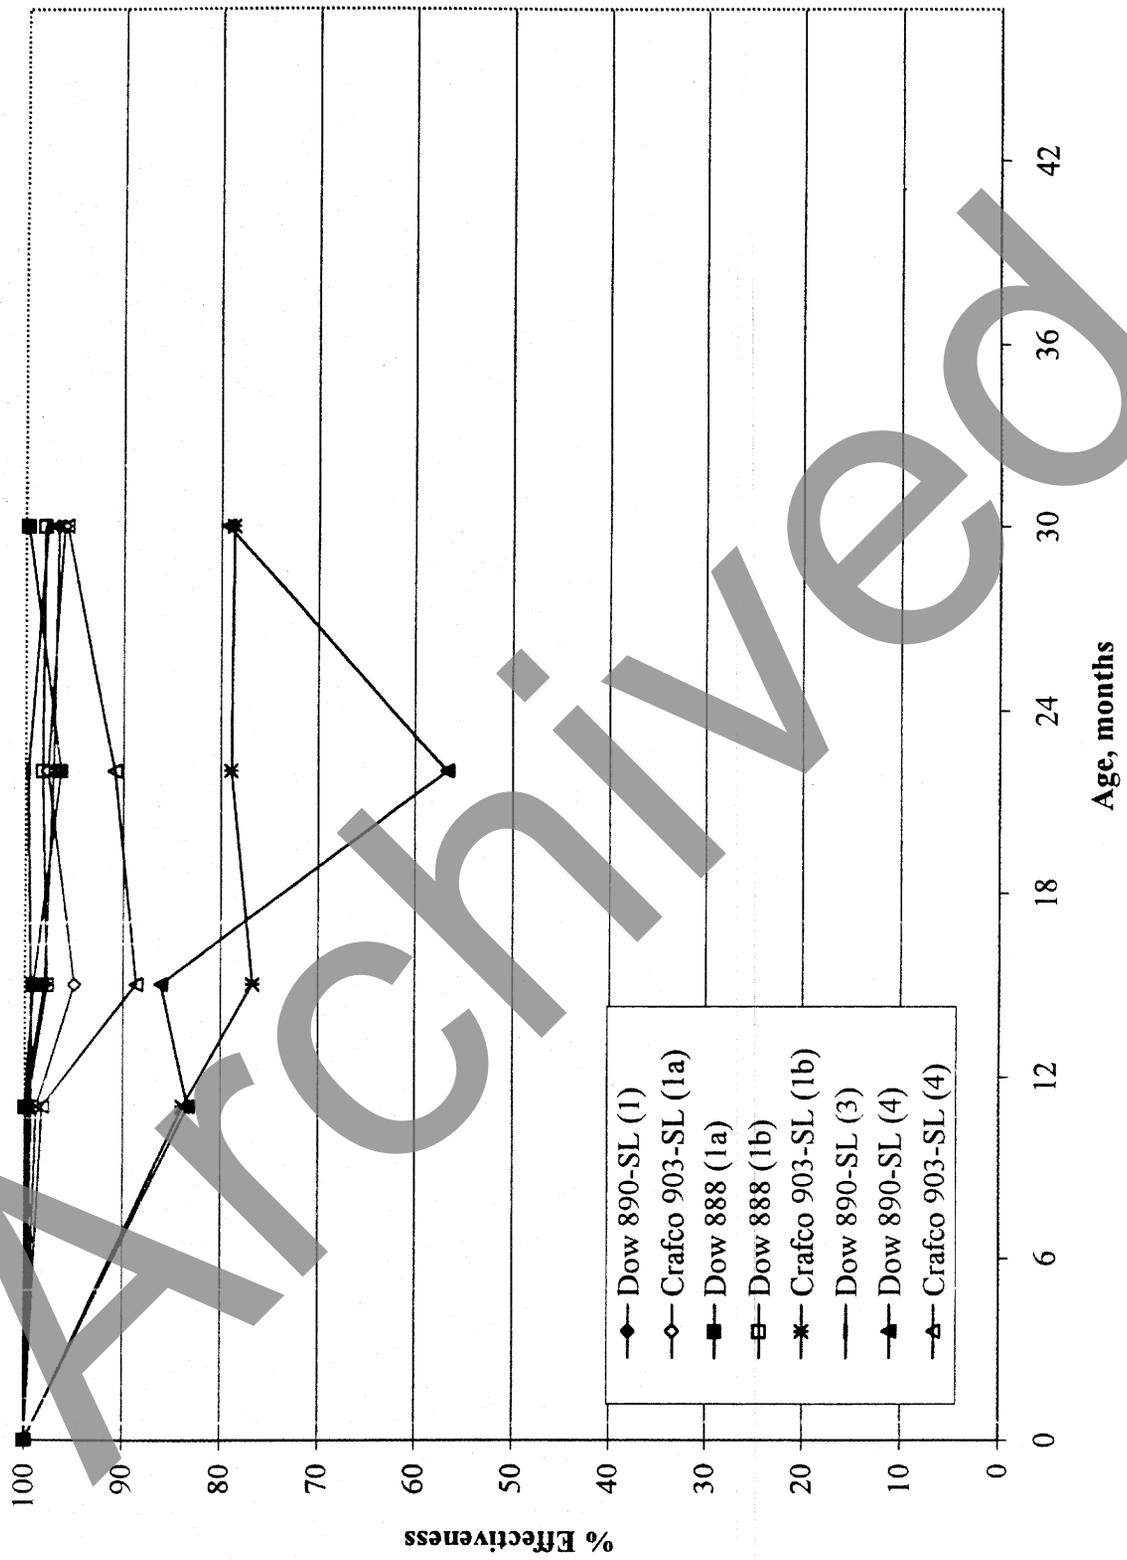
Figure 5.32 Deterioration of silicone sealants in the westbound lanes as of WBJN01
