Ohio Route 50 Joint Sealant Experiment

State Job No.: 14668(0)

FINAL REPORT

April 2002

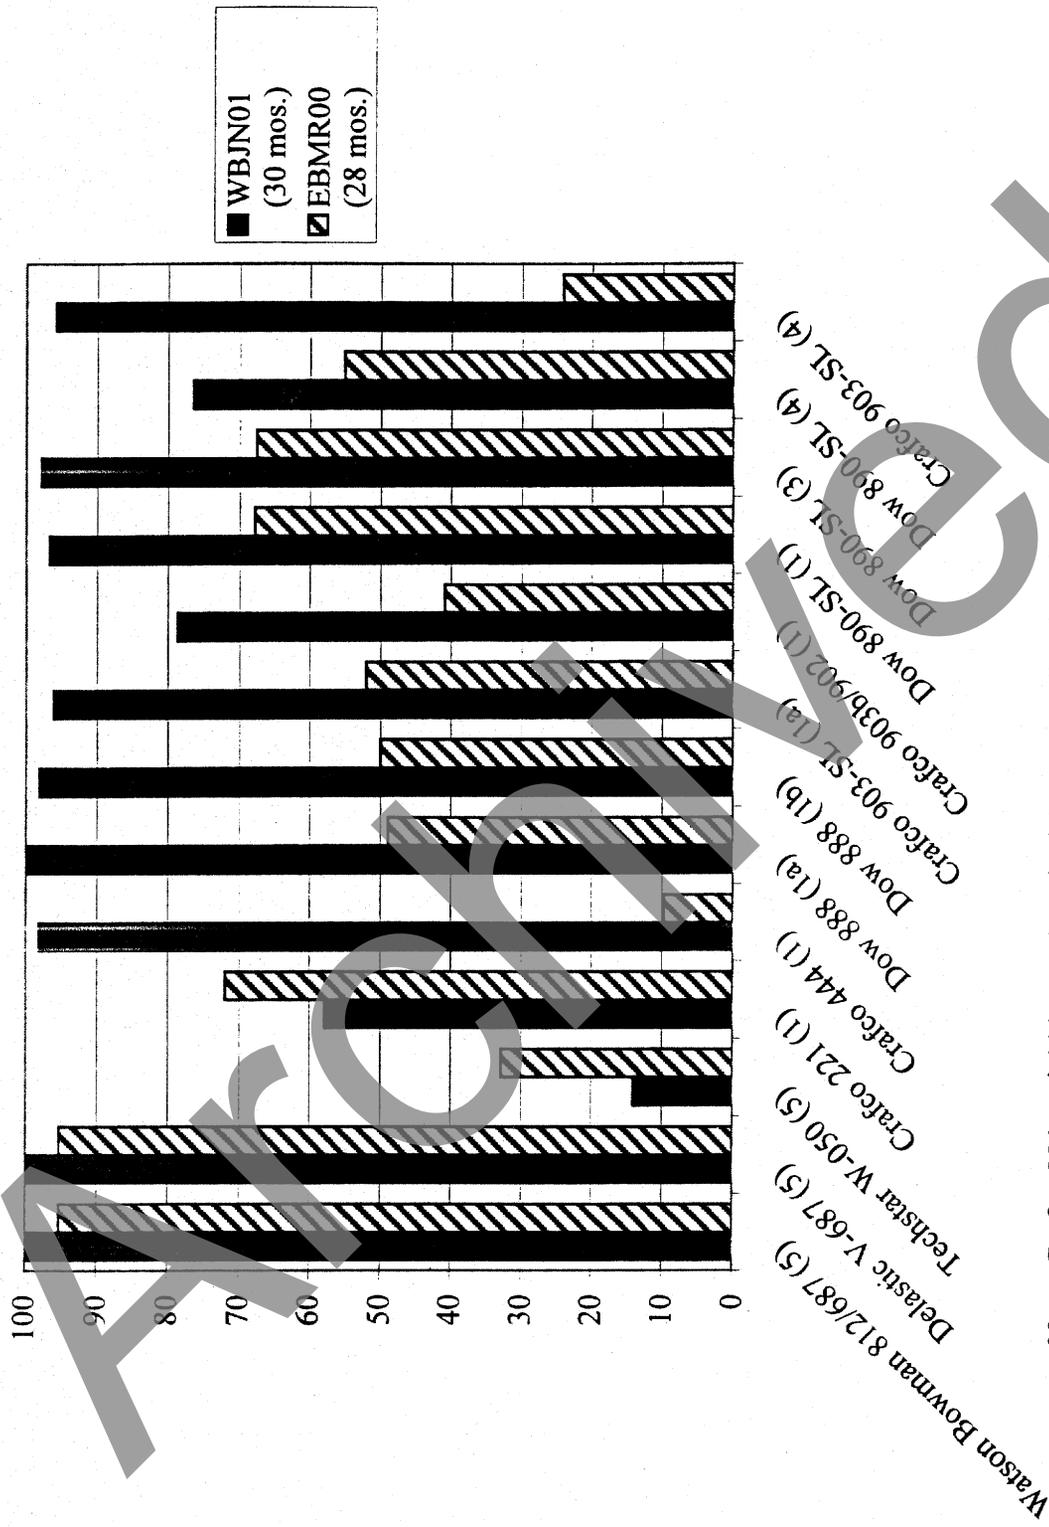
Note: Crafo 221 and 444 were installed 4 months after the other westbound sealants

Figure 5.33 Comparison of eastbound and westbound lane sealants after 2 1/2 years in service

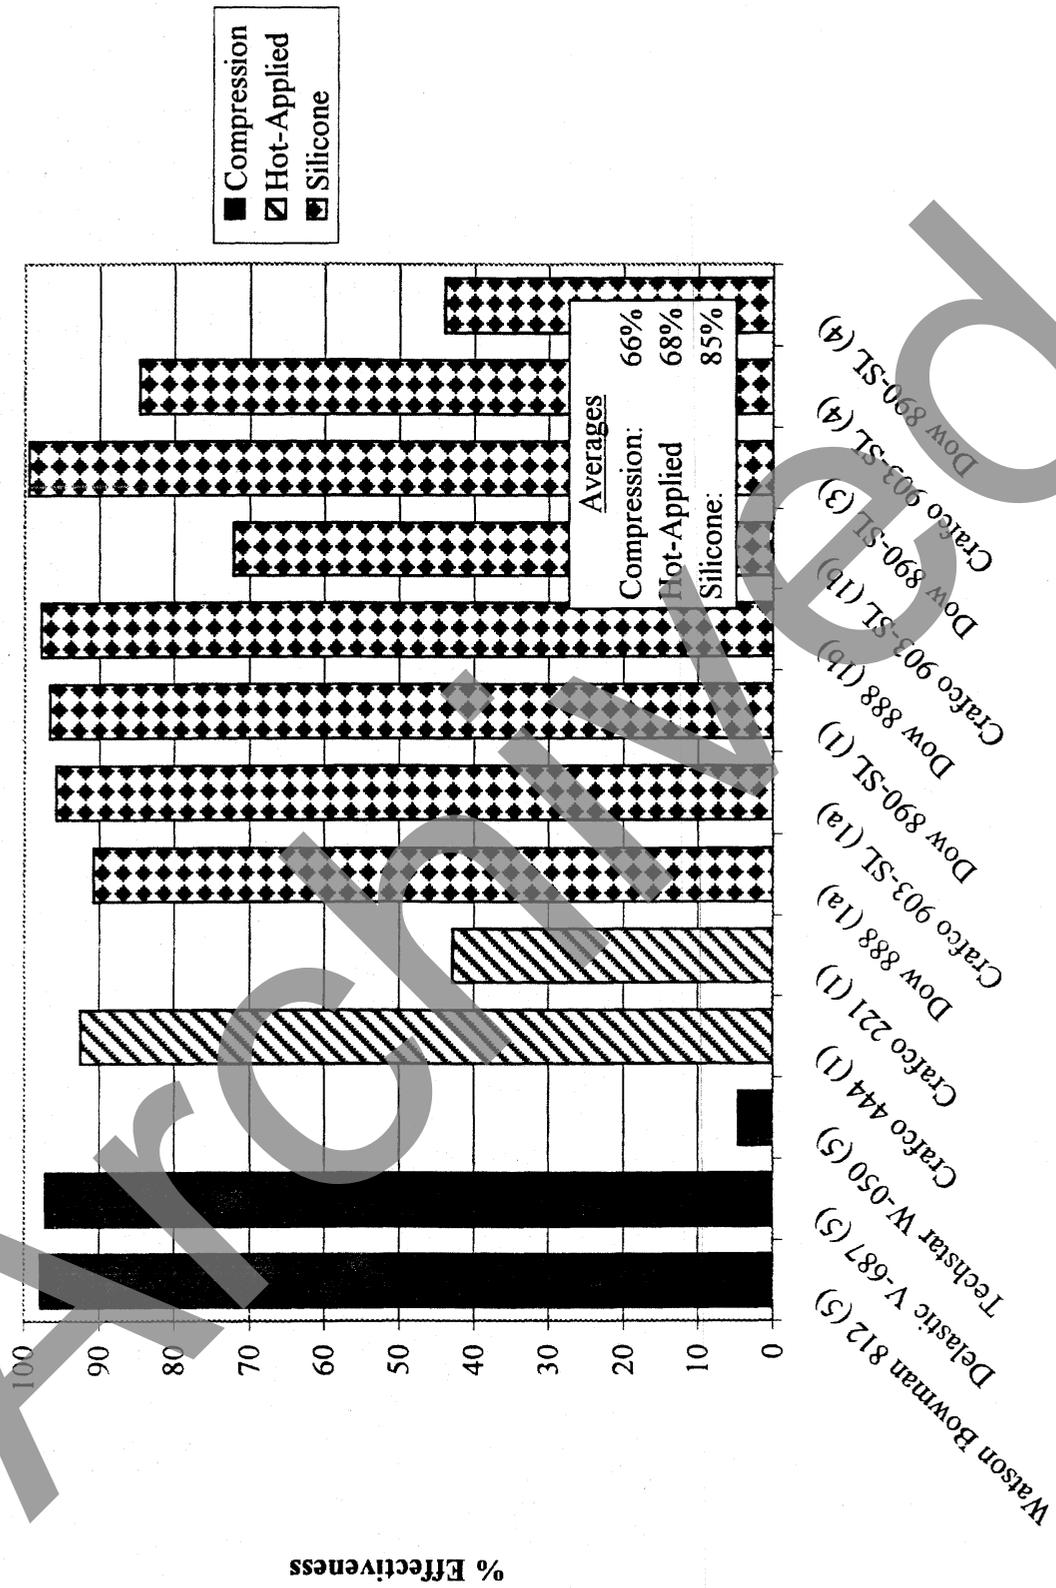
Figure 5.34 Comparison between silicone, hot-applied and compression sealants during WBOC01

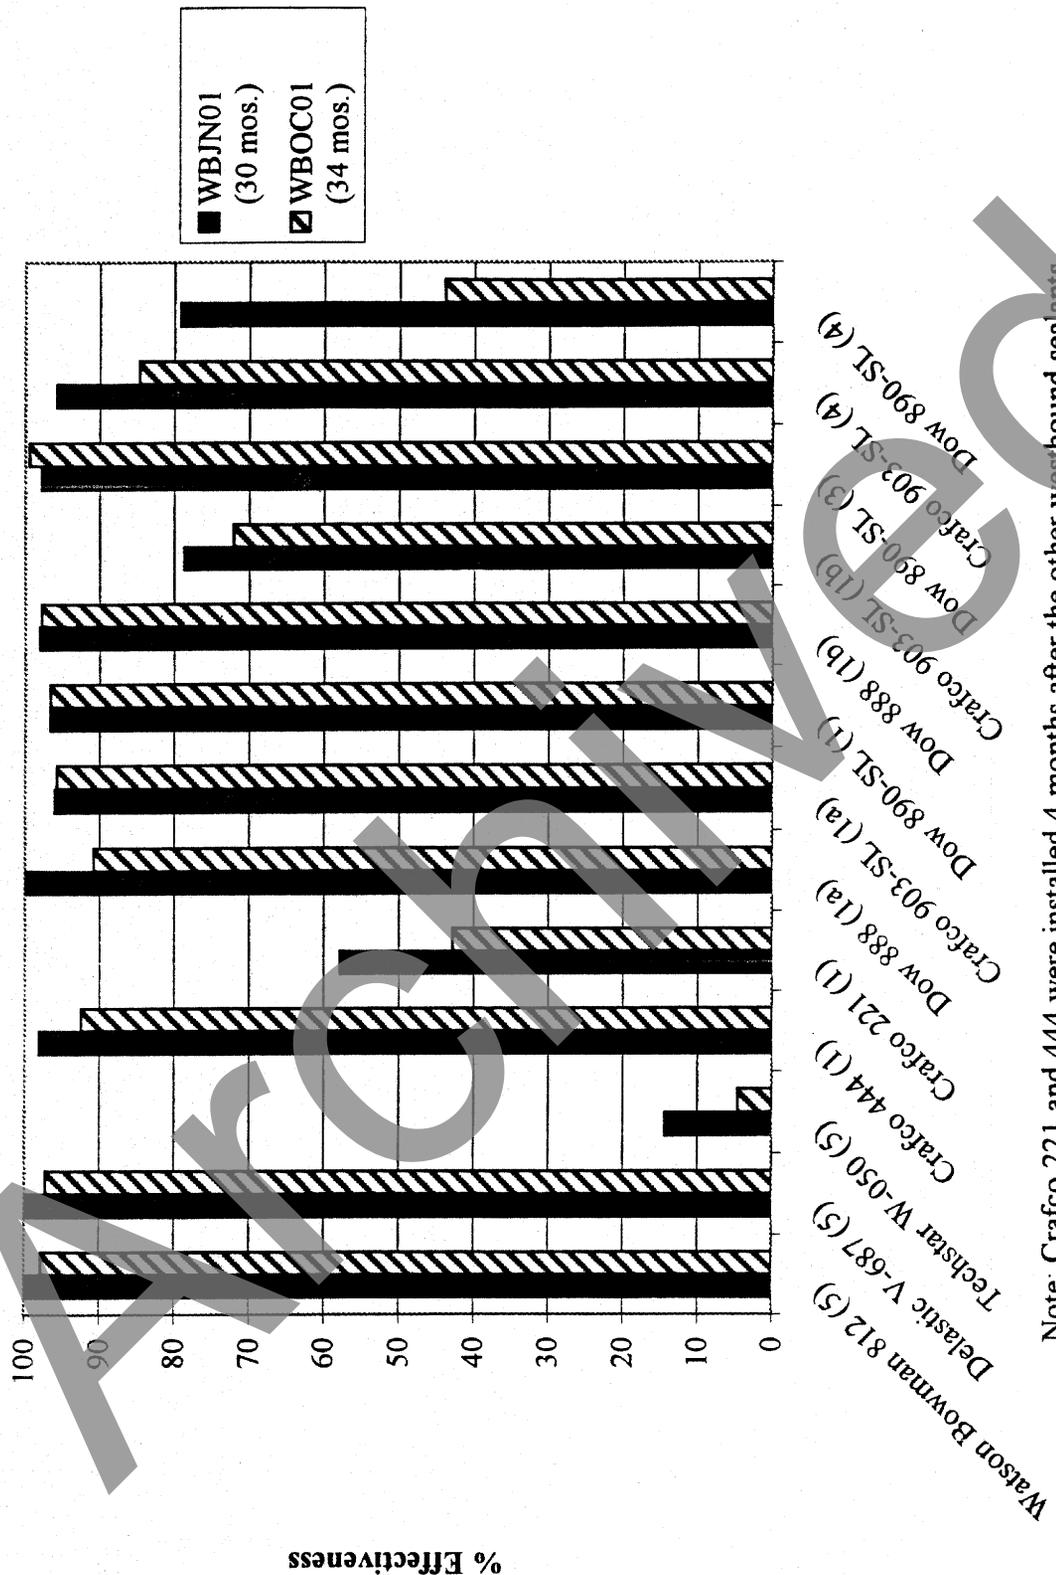
Note: Crafco 221 and 444 were installed 4 months after the other westbound sealants

Figure 5.35 Deterioration of sealants from WBJN01 to WBOC01

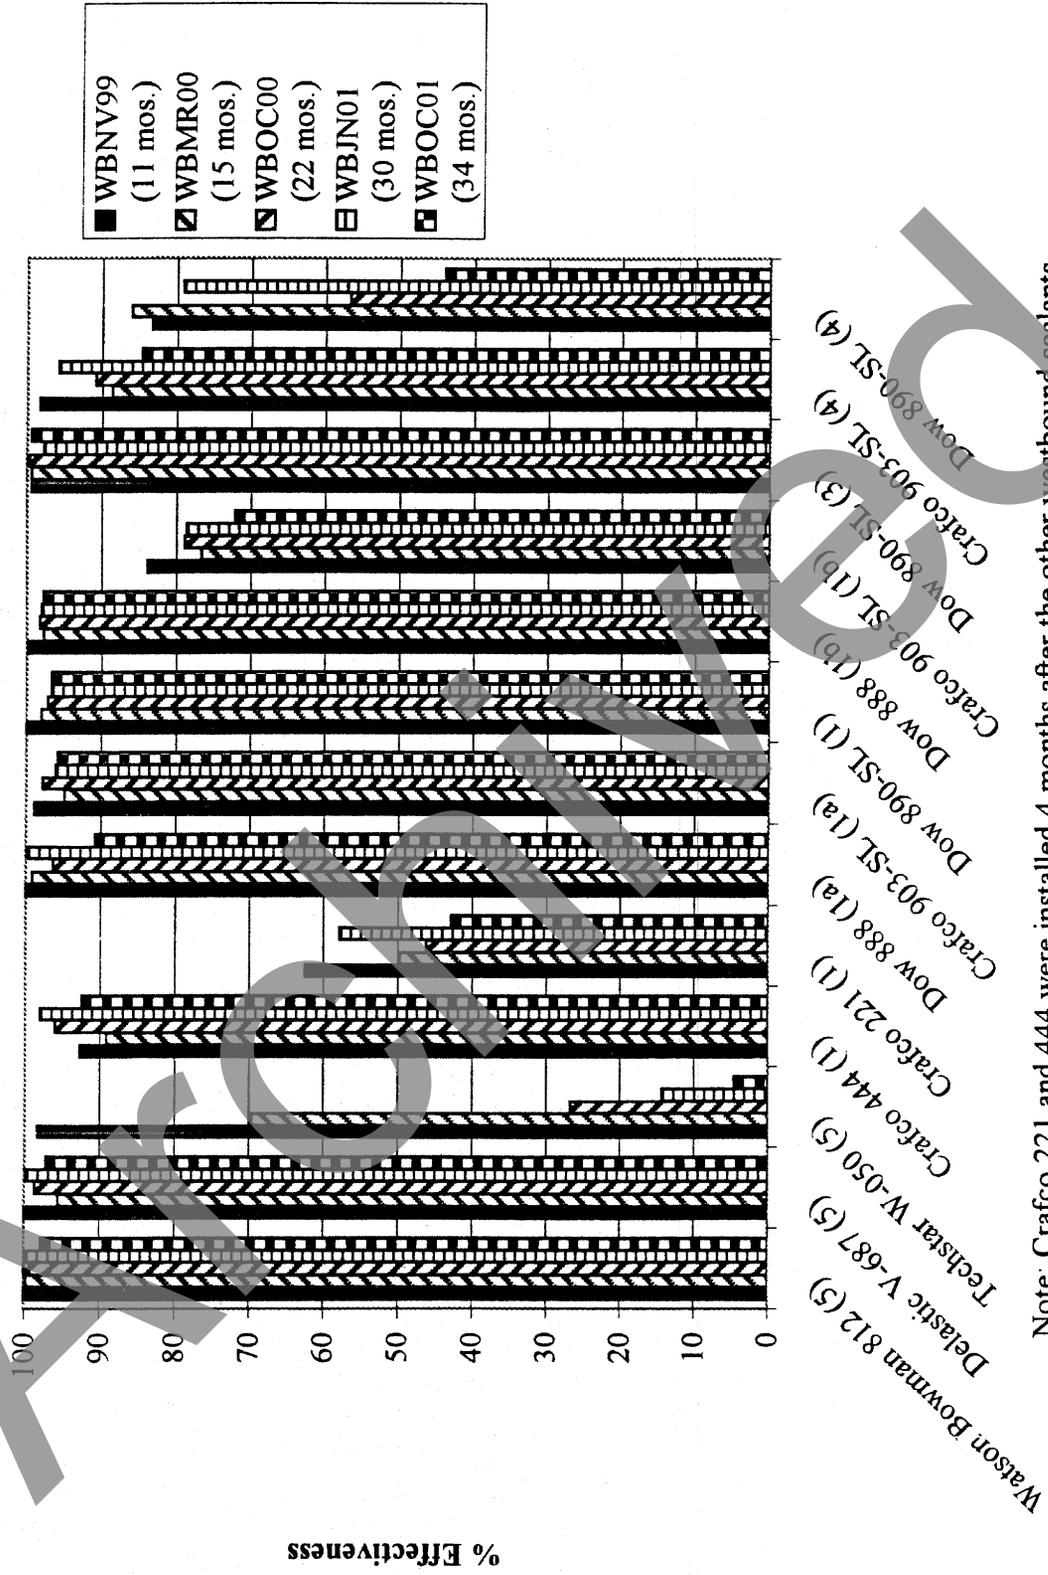
Note: Crafco 221 and 444 were installed 4 months after the other westbound sealants

Figure 5.36 Deterioration of sealants from WBNV99 to WBOC01

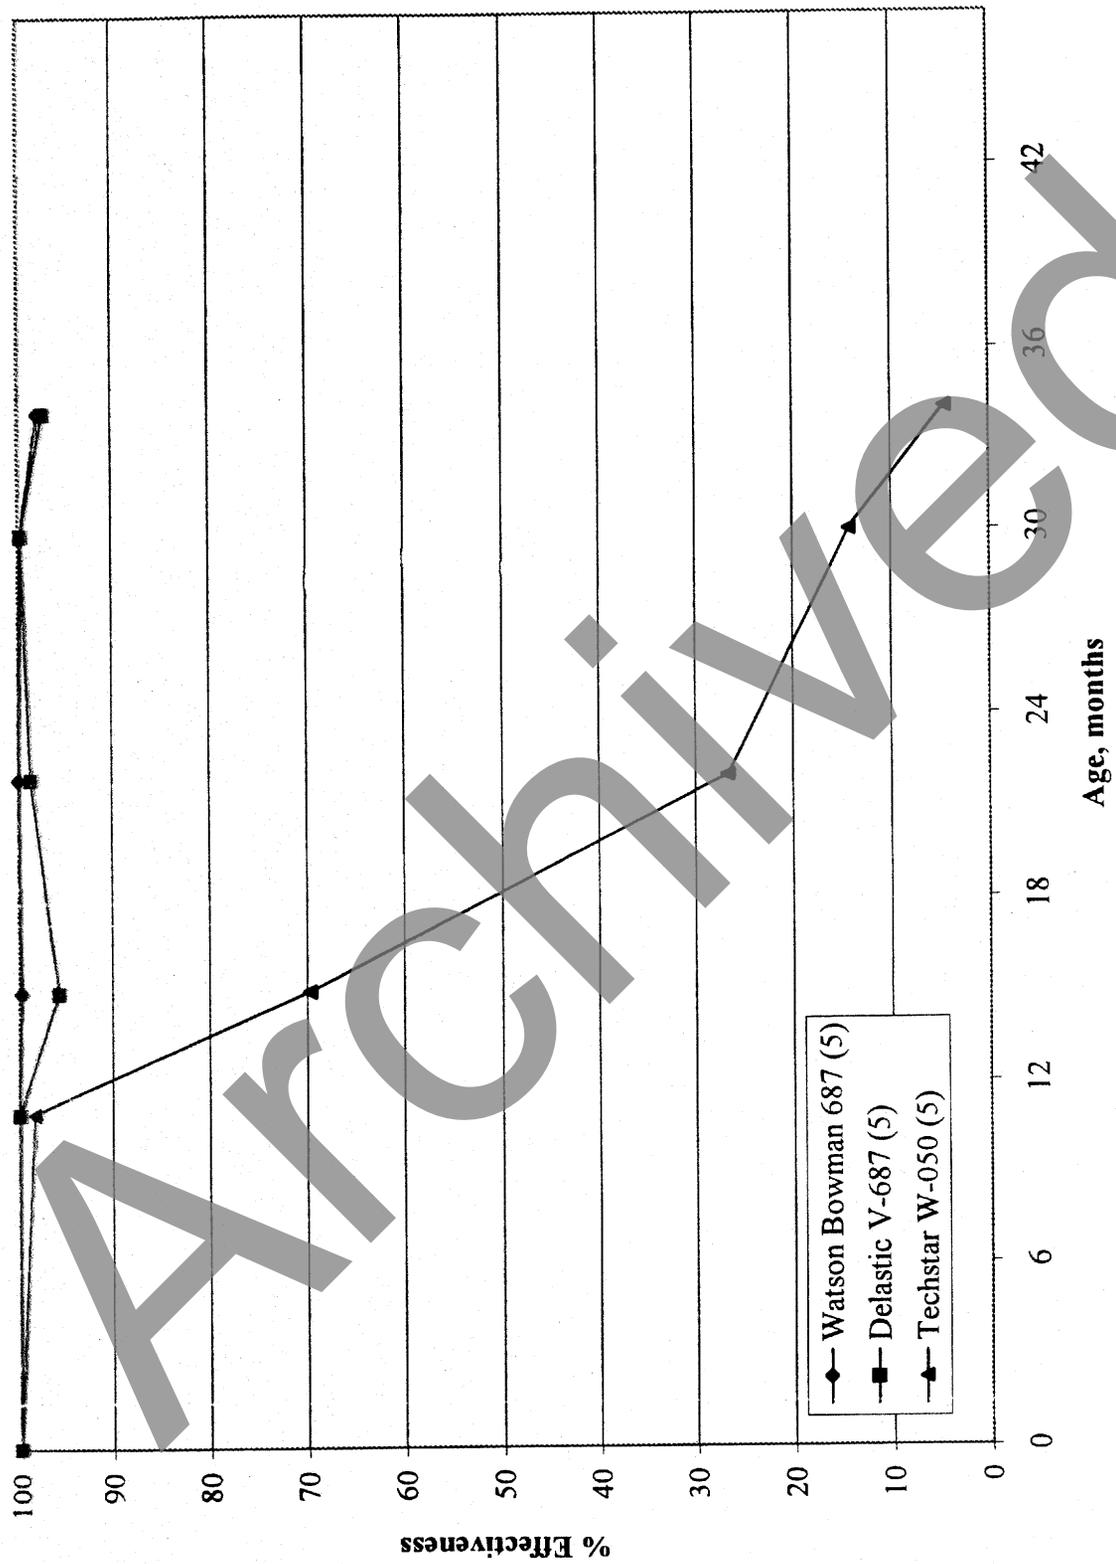
Figure 5.37 Deterioration of compression seals in the westbound lanes as of WBOC01

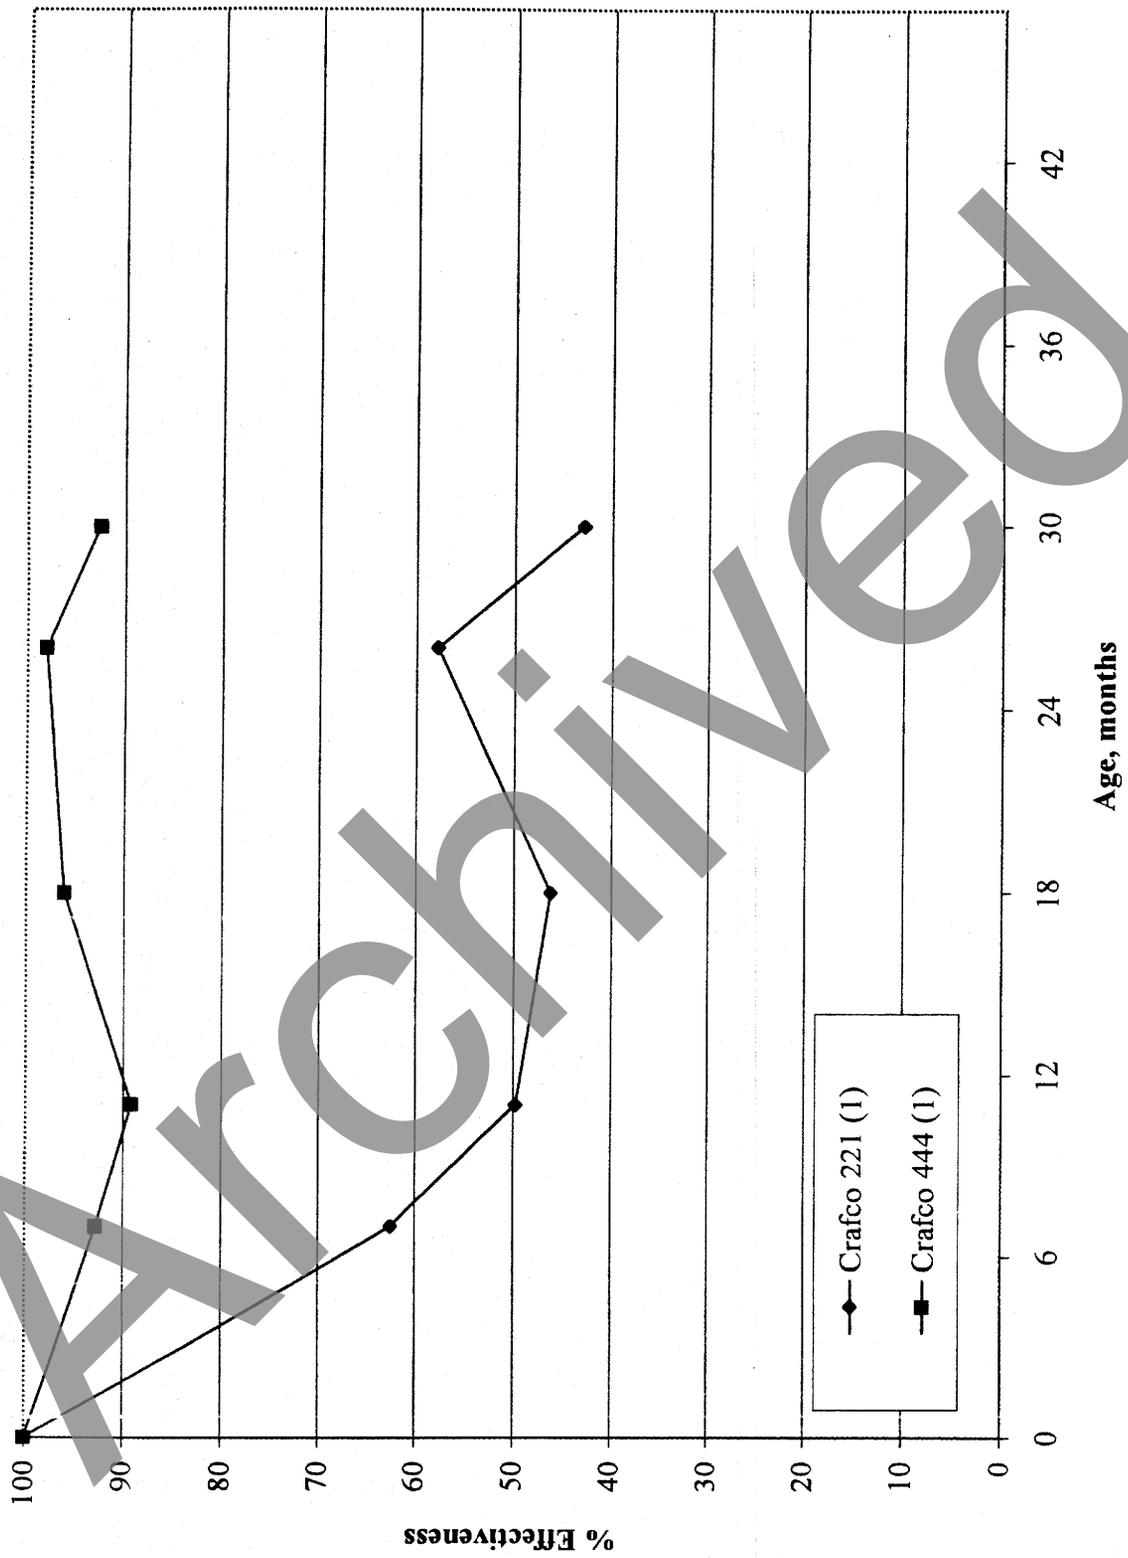
Figure 5.38 Deterioration of hot-applied sealants in the westbound lanes as of WBOC01

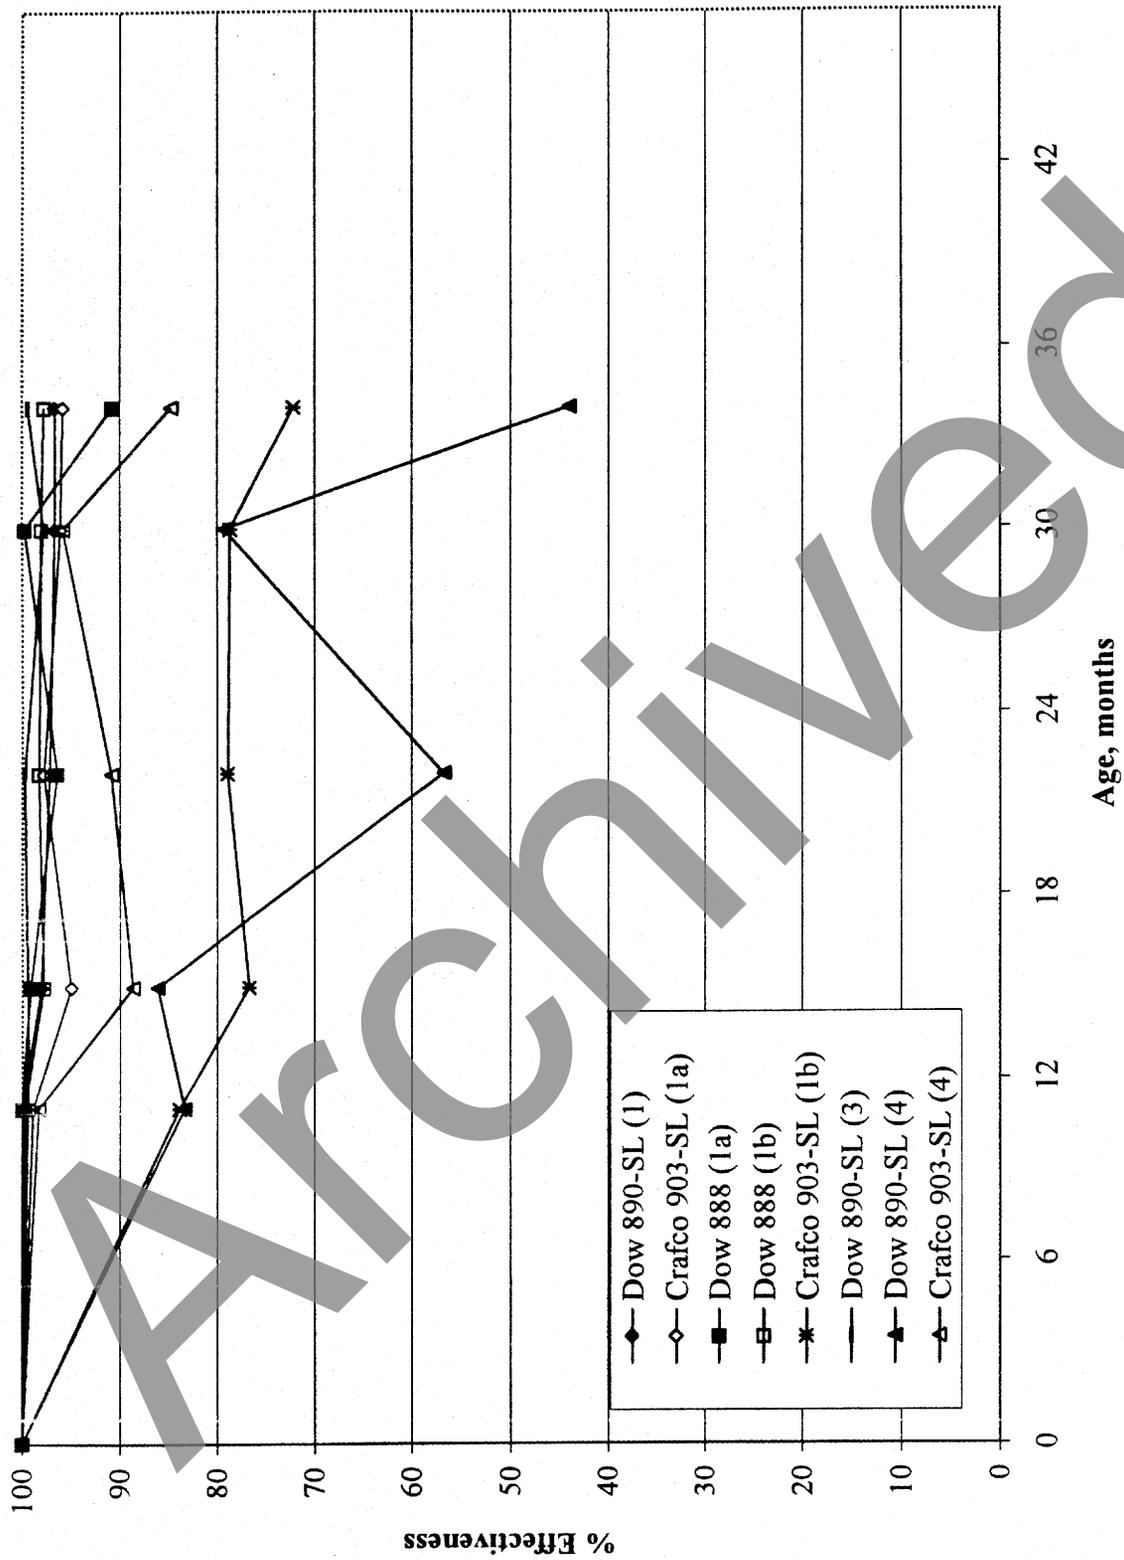
Figure 5.39 Deterioration of silicone sealants in the westbound lanes as of WB0C01

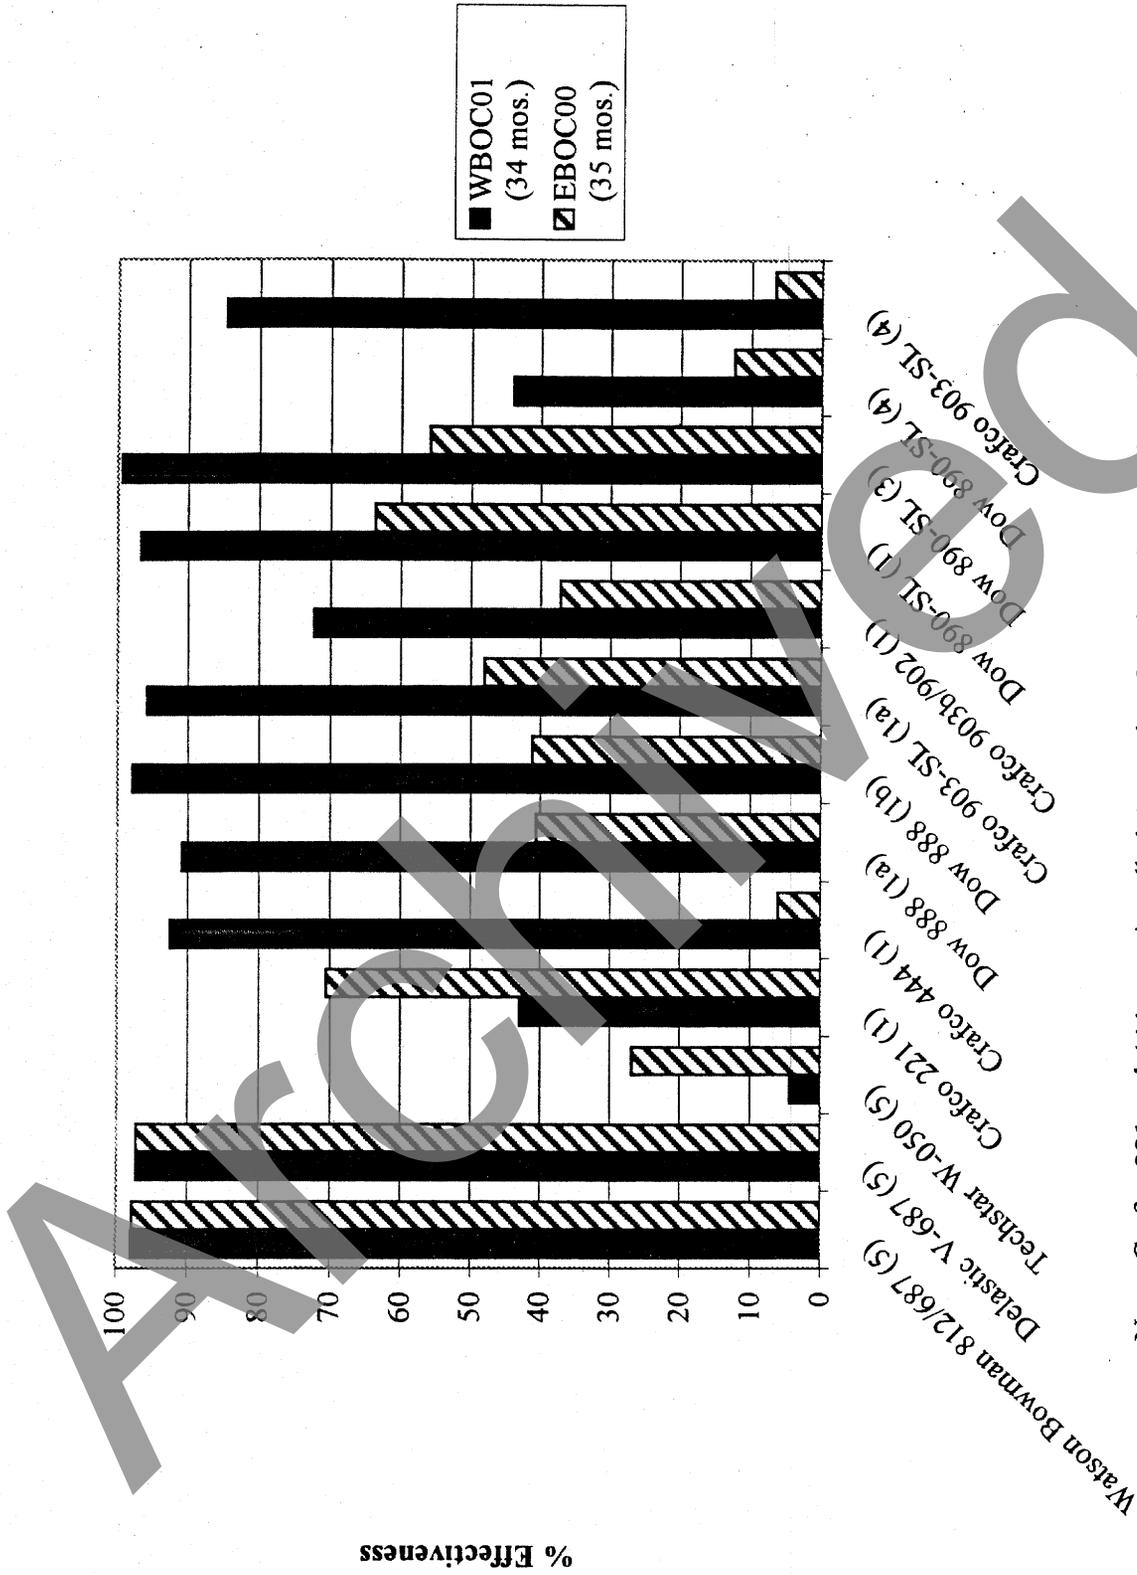
Note: Crafco 221 and 444 were installed 4 months after the other westbound sealants

Figure 5.40 Comparison of eastbound and westbound lane sealants after 3 years in service

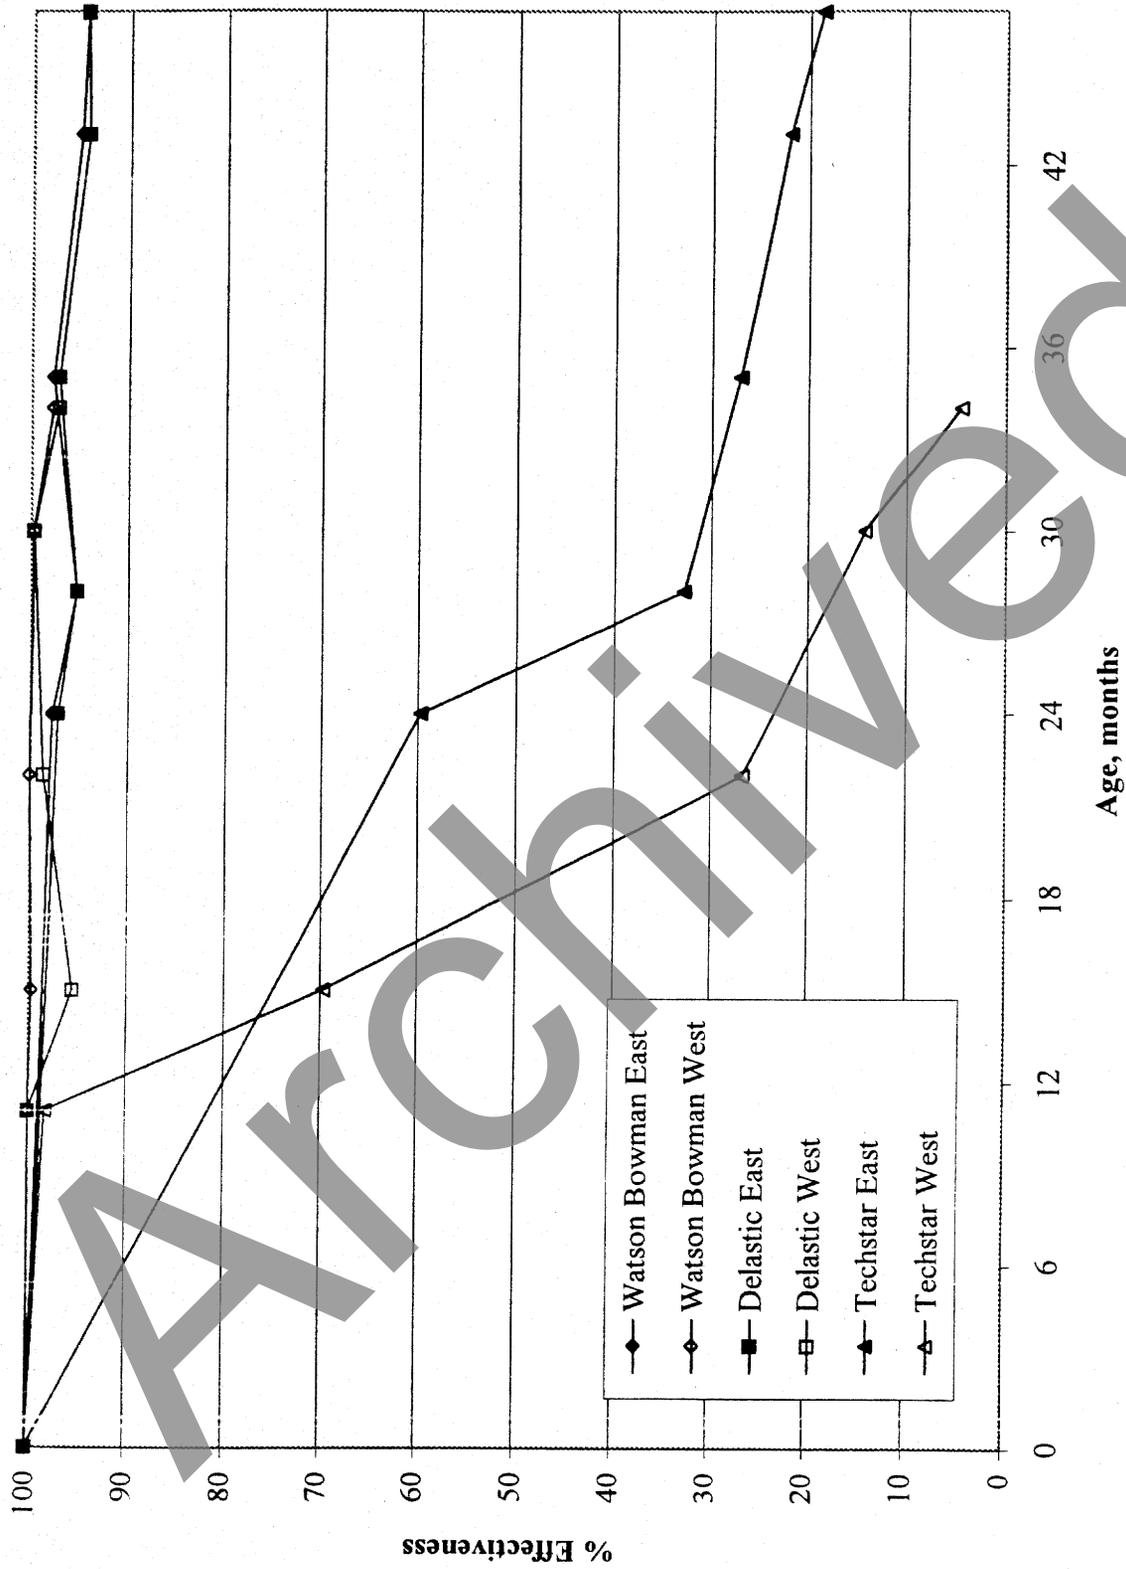
Figure 5.41 Deterioration of compression seals in the eastbound and westbound lanes

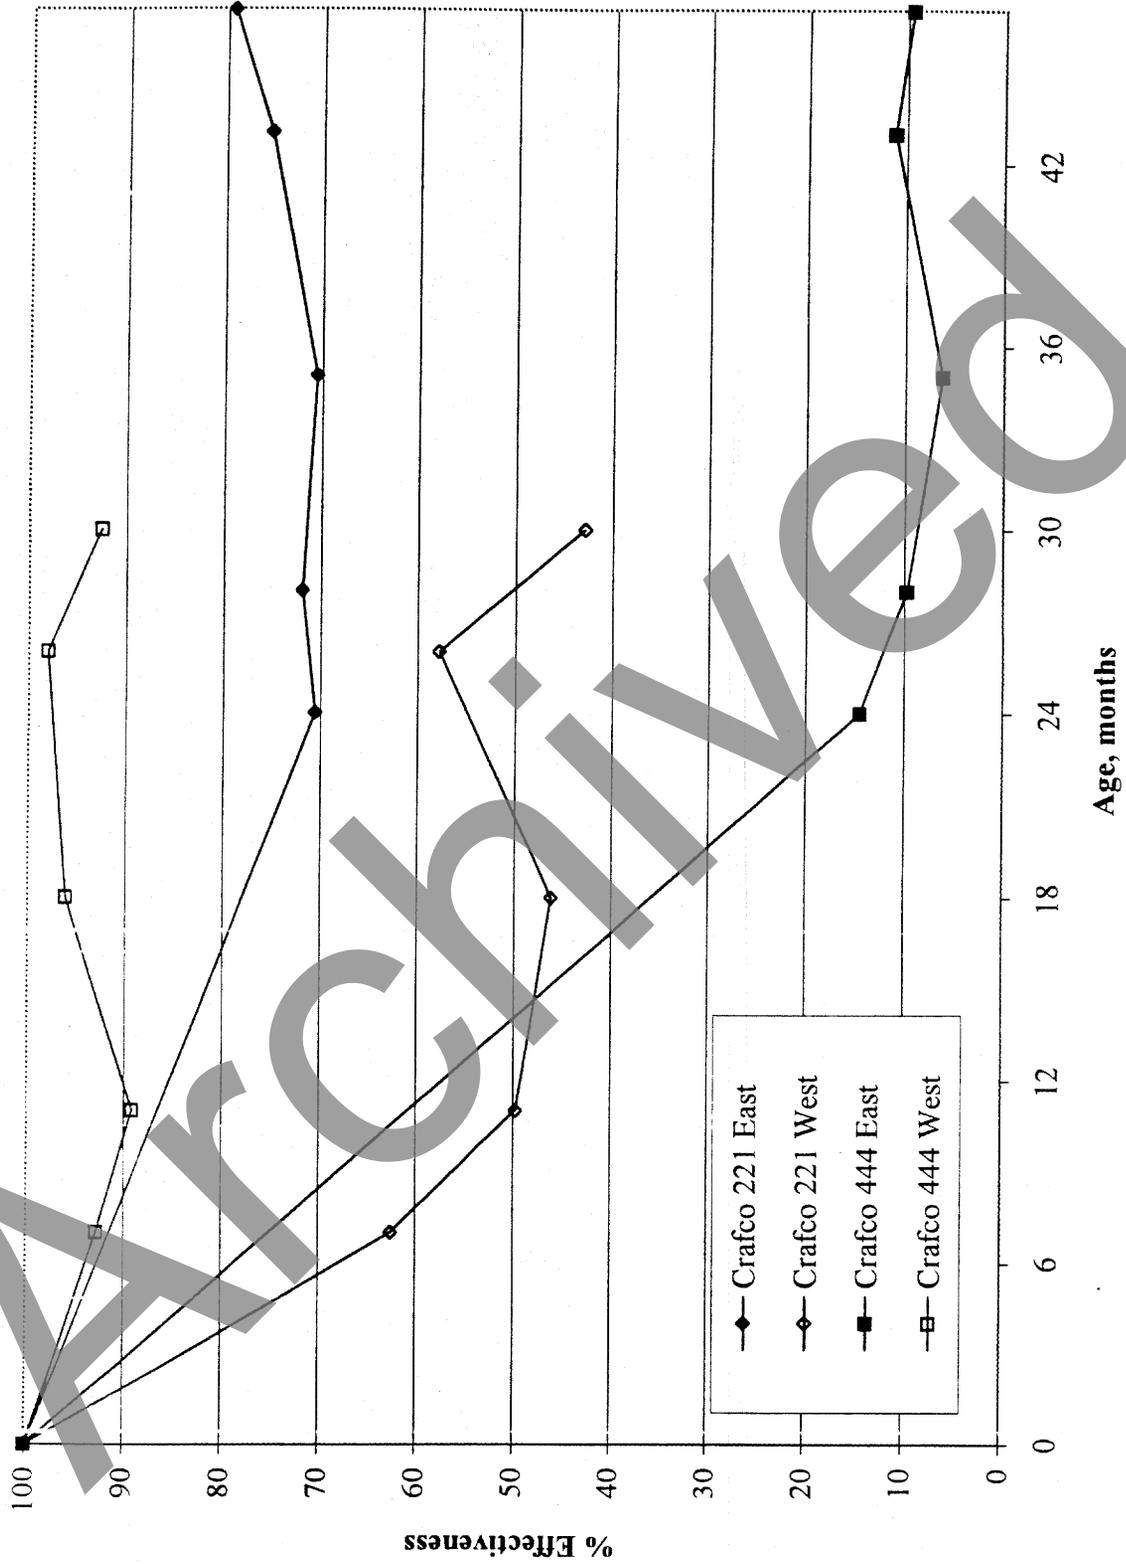
Figure 5.42 Deterioration of hot-applied sealants in the eastbound and westbound lanes

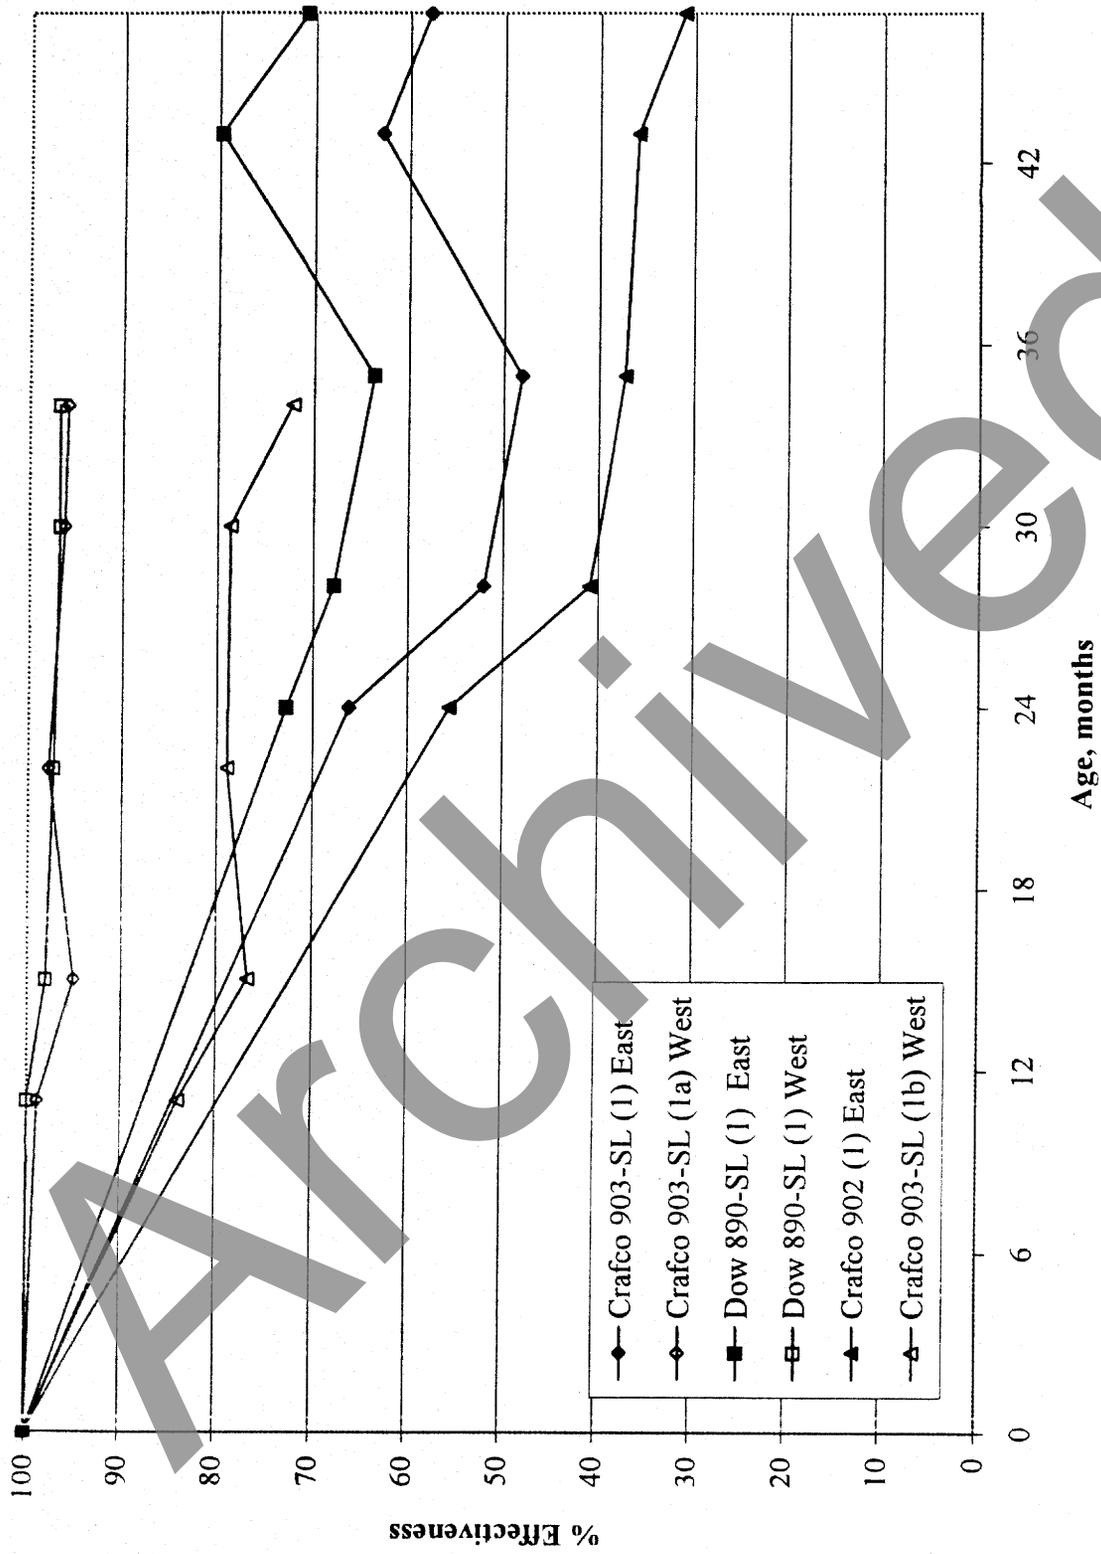
Figure 5.43 Deterioration of self-leveling silicone sealants with Joint Configuration 1 in the eastbound and westbound lanes

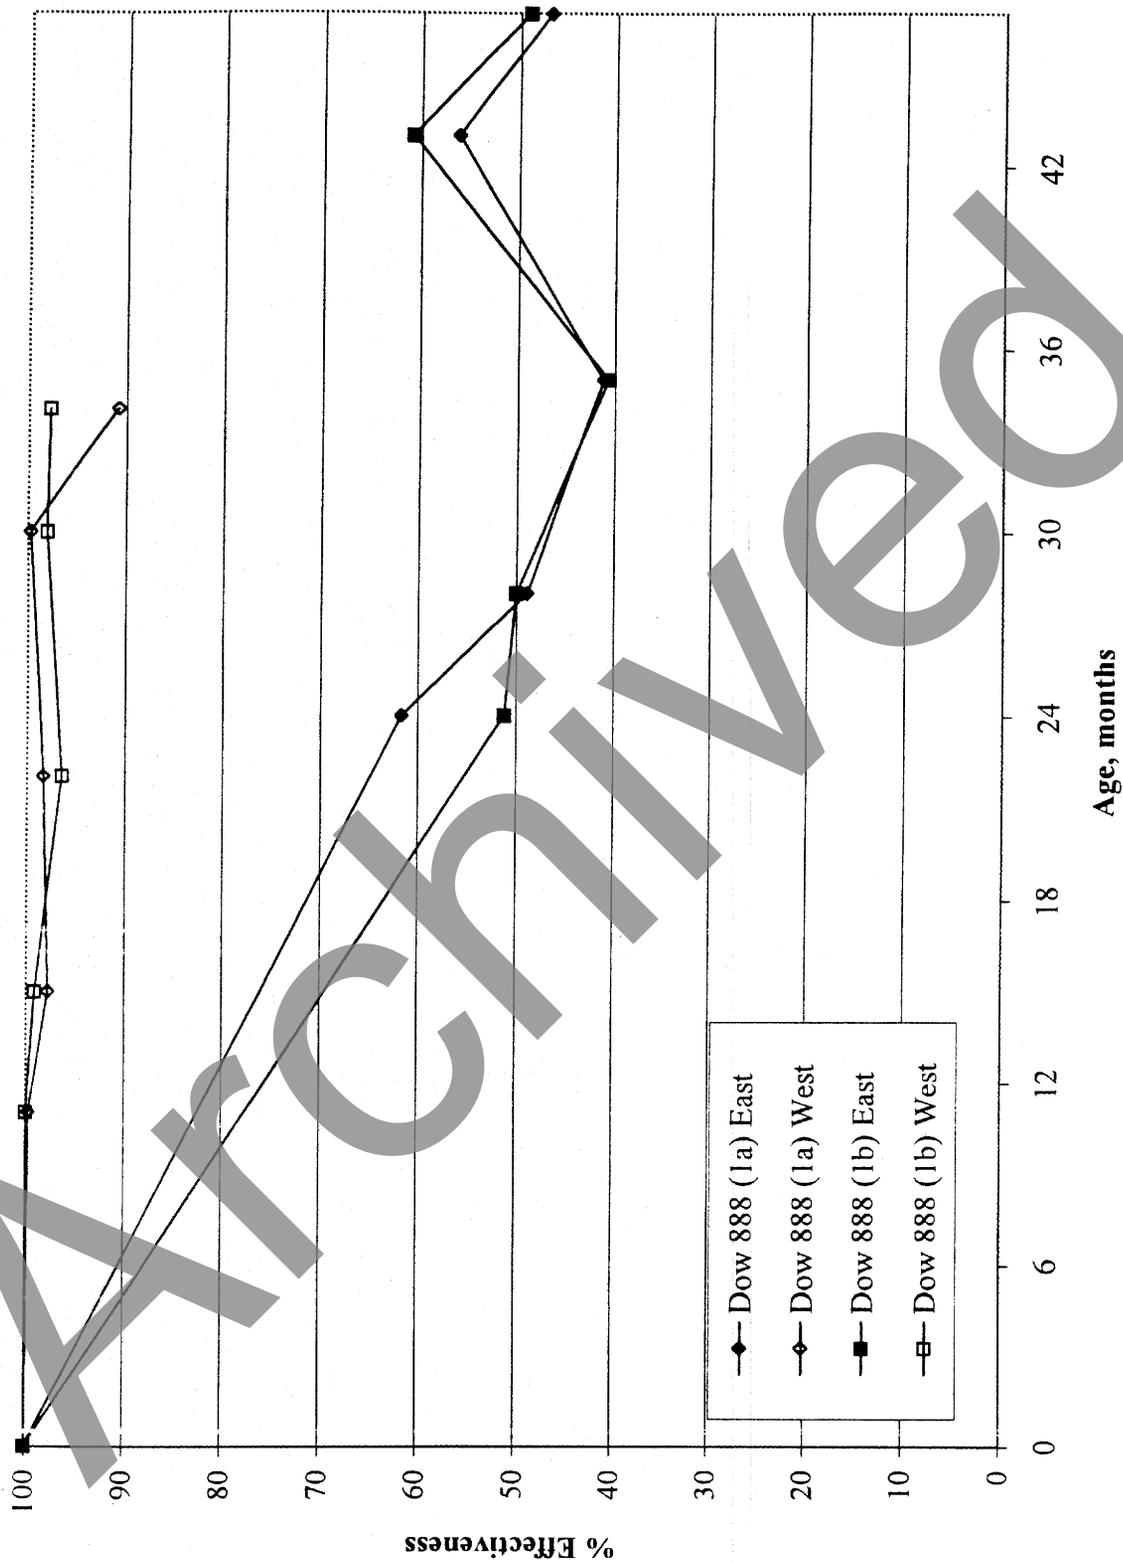
Figure 5.44 Deterioration of non-sag silicone sealants in the eastbound and westbound lanes

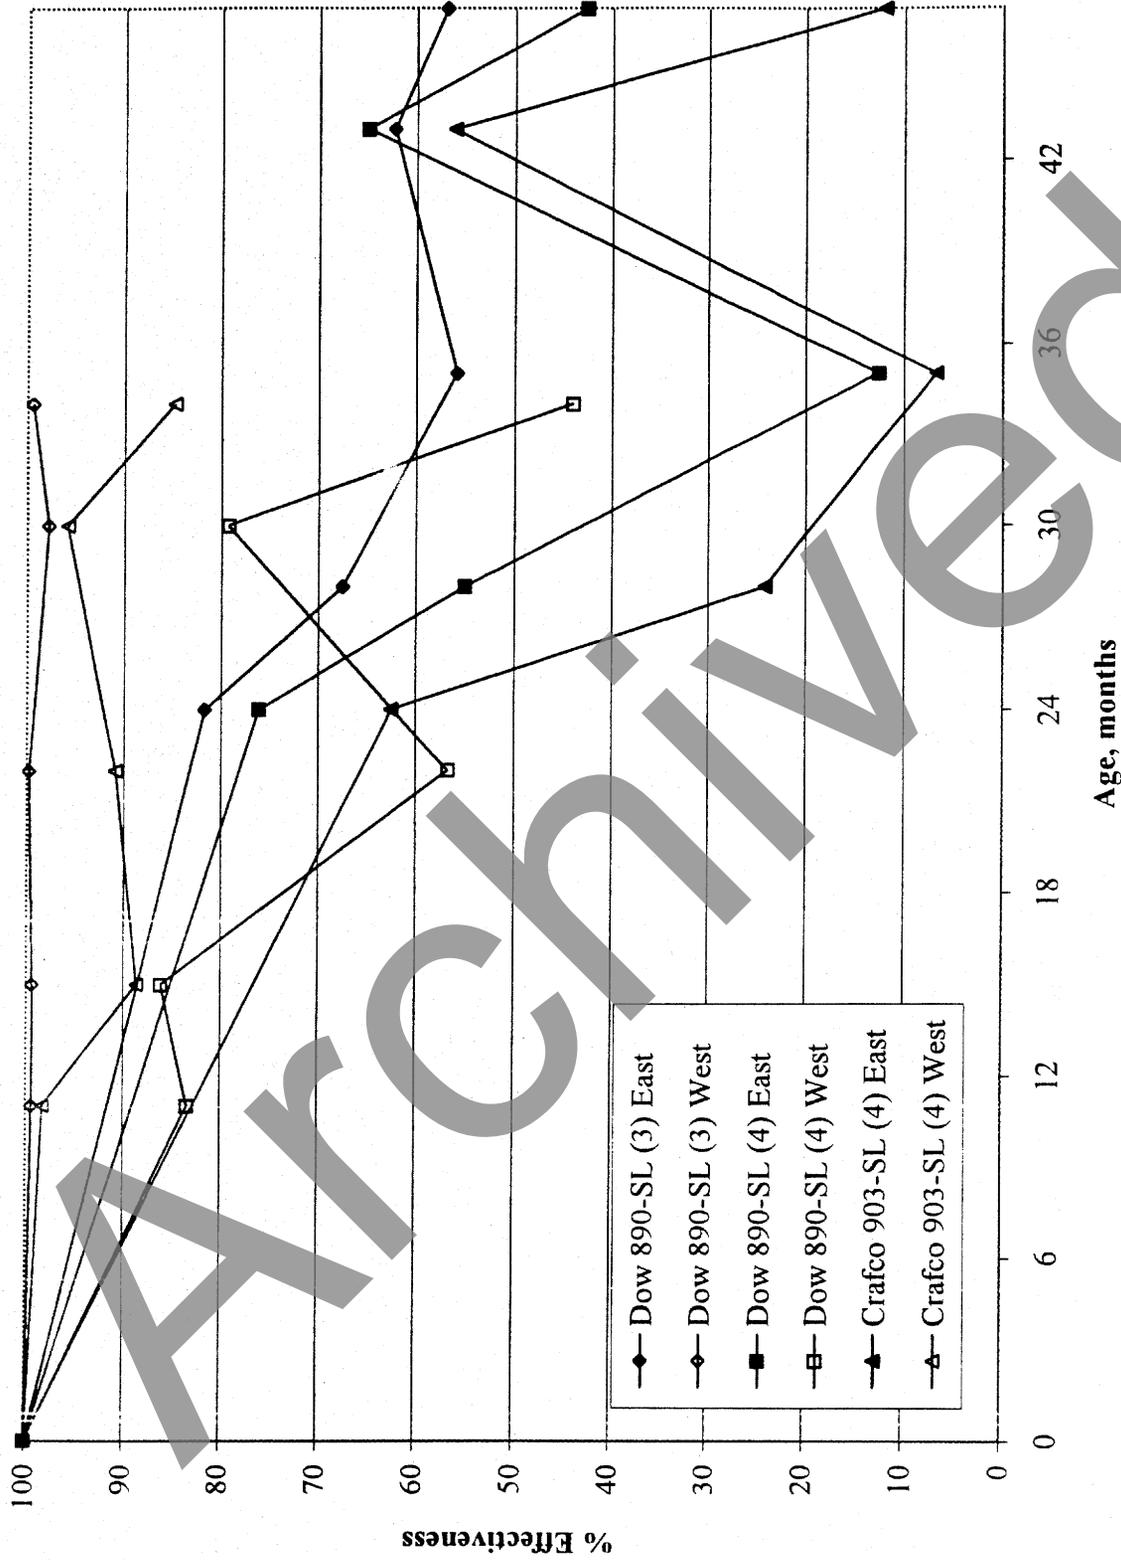
Figure 5.45 Deterioration of self-leveling silicone sealants with Joint Configurations 3 and 4 in the eastbound and westbound lanes
