Ohio Route 50 Joint Sealant Experiment

State Job No.: 14668(0)

FINAL REPORT

April 2002

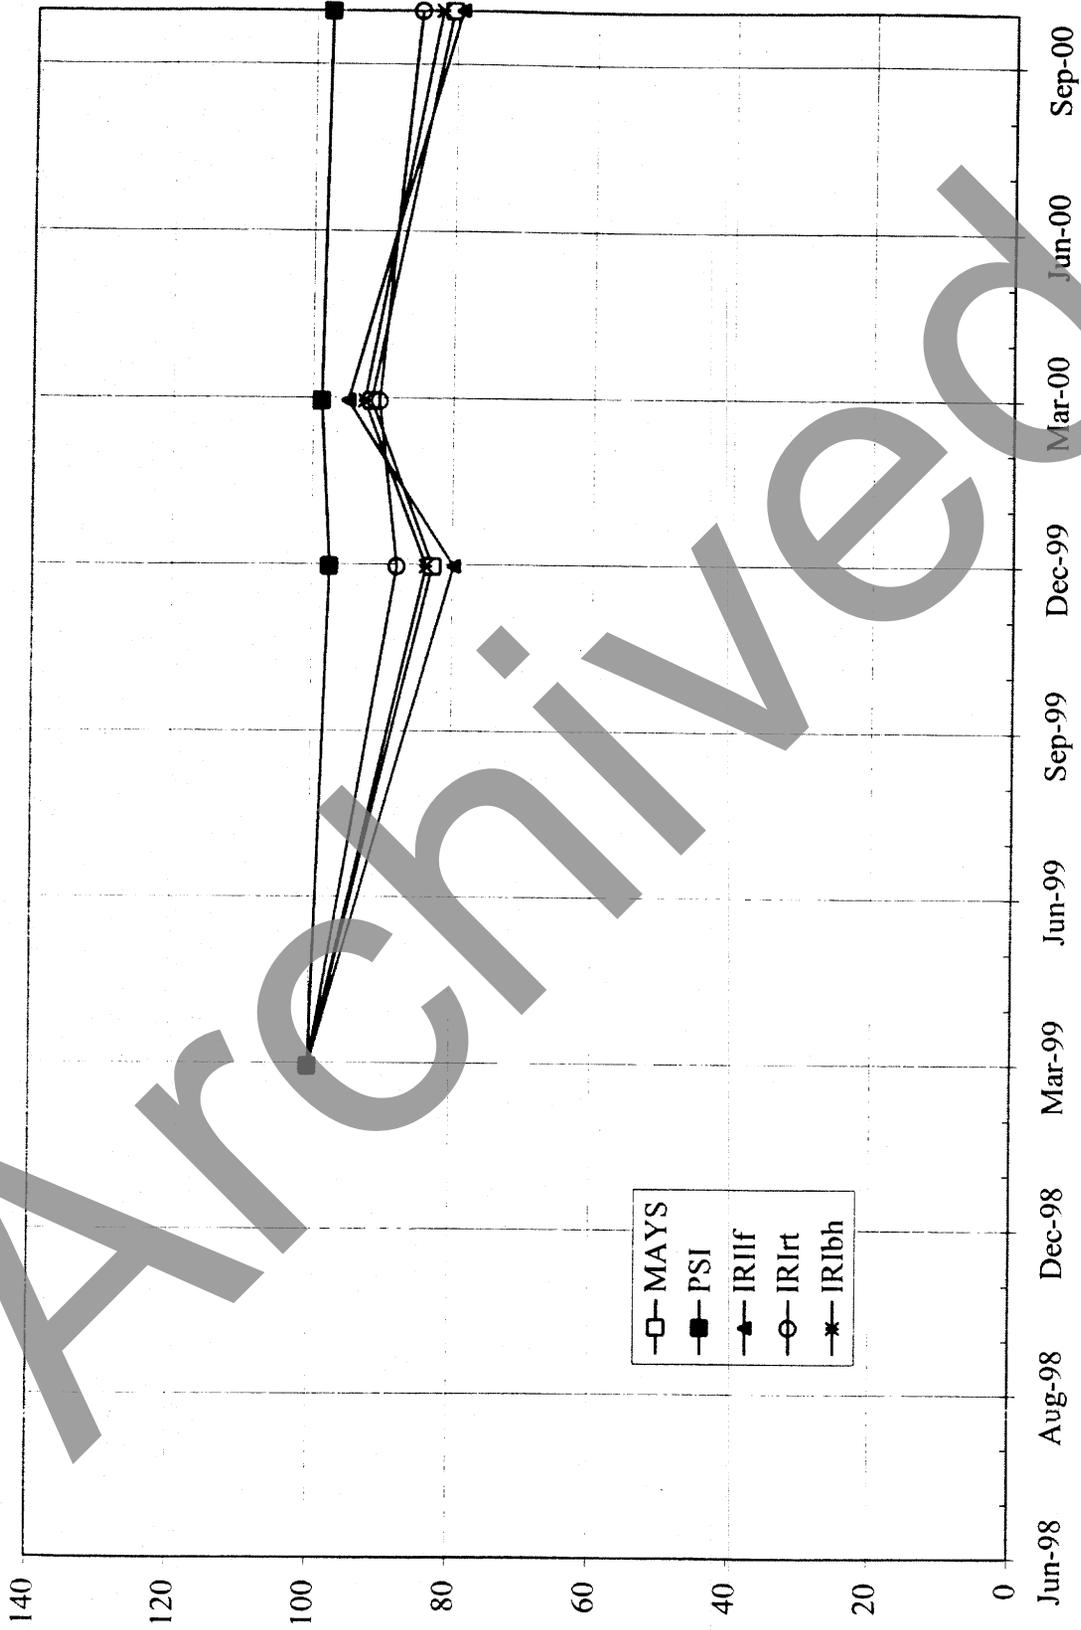
The trendlines for the four profilometer surveys to date are presented in Figure 5.56. All measurements, except for the PSI scale, follow the same pattern and are remarkably close to each other. The PSI scale, however, does not fluctuate very much. All sections decline in smoothness after March 1999, increase after December 1999, and then decline again after March 2000. The PSI is currently at 98% of its original value and the remaining indices range from 79% to 85%.

Figure 5.56 Trendlines for the Westbound Driving Lane through October 2000

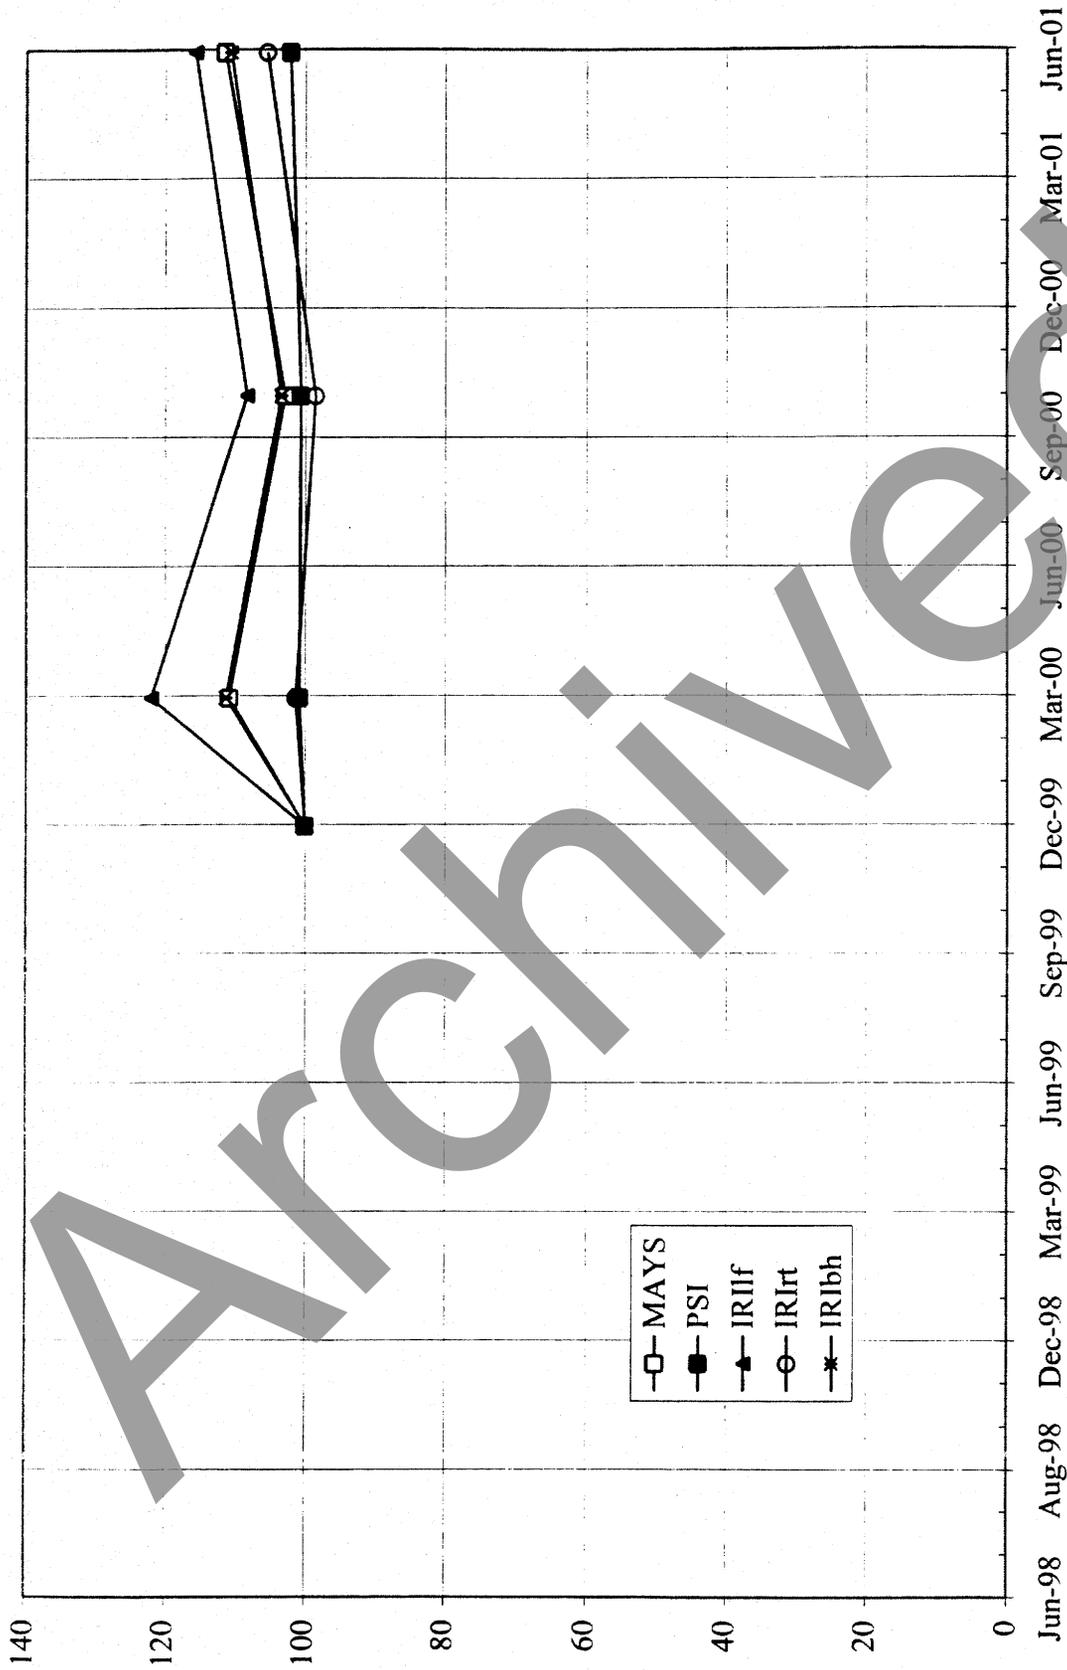
The westbound passing lane has the fewest number of profilometer surveys conducted on it due to various construction related reasons (Hawkins, 1999). It is difficult to evaluate the long-term performance of this lane because only 1.5 years have passed since its original survey. Figure 5.57 shows the results of the four surveys conducted to date.

Figure 5.57 Trendlines for the Westbound Passing Lane through June 2001

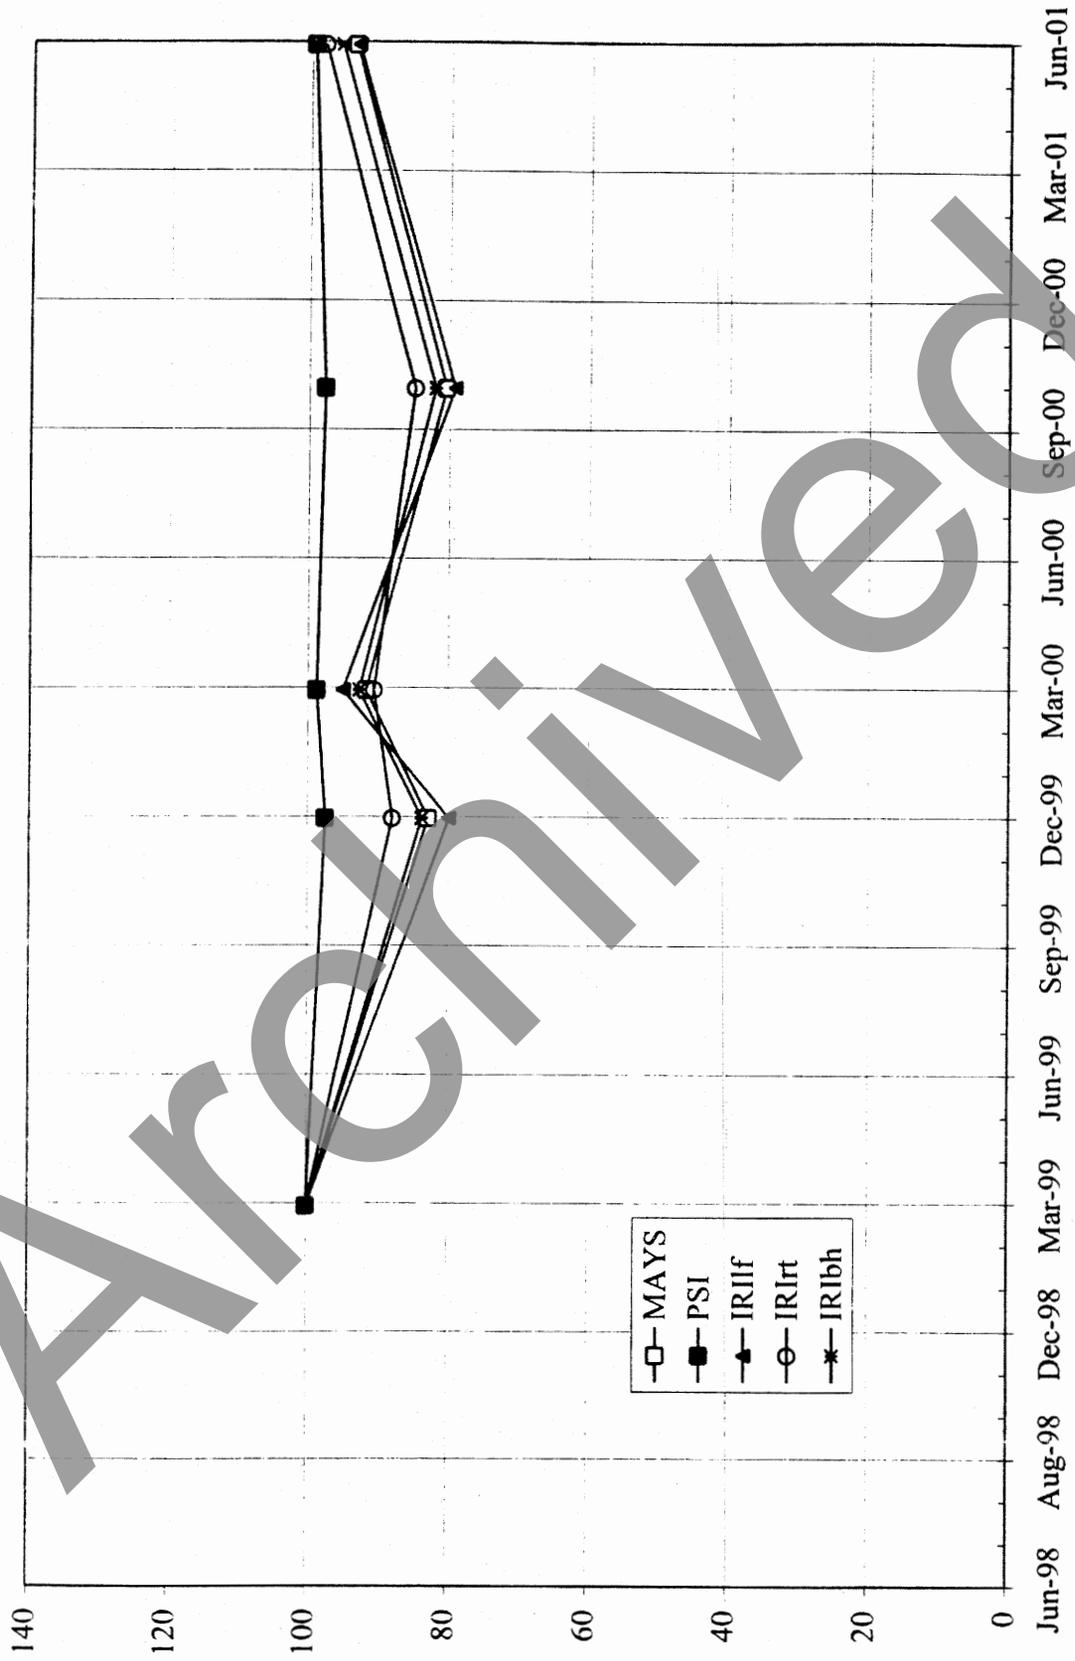
The results of the past five profilometer surveys are presented in Figure 5.58. The wavy nature of these surveys is very apparent. Each large decline in smoothness is followed by a nearly equal increase in smoothness. The PSI scale increases and decreases as well, although not to the degree of the other scales. It is uncertain if these fluctuations are attributable to seasonal temperature changes. Pavement temperatures can vary widely during a day. Recall that during the WBOC00 survey, pavement temperatures ranged from 1.1 to 21.7° C (34 to 71° F).

Figure 5.58 Trendlines for the Westbound Driving Lane through June 2001

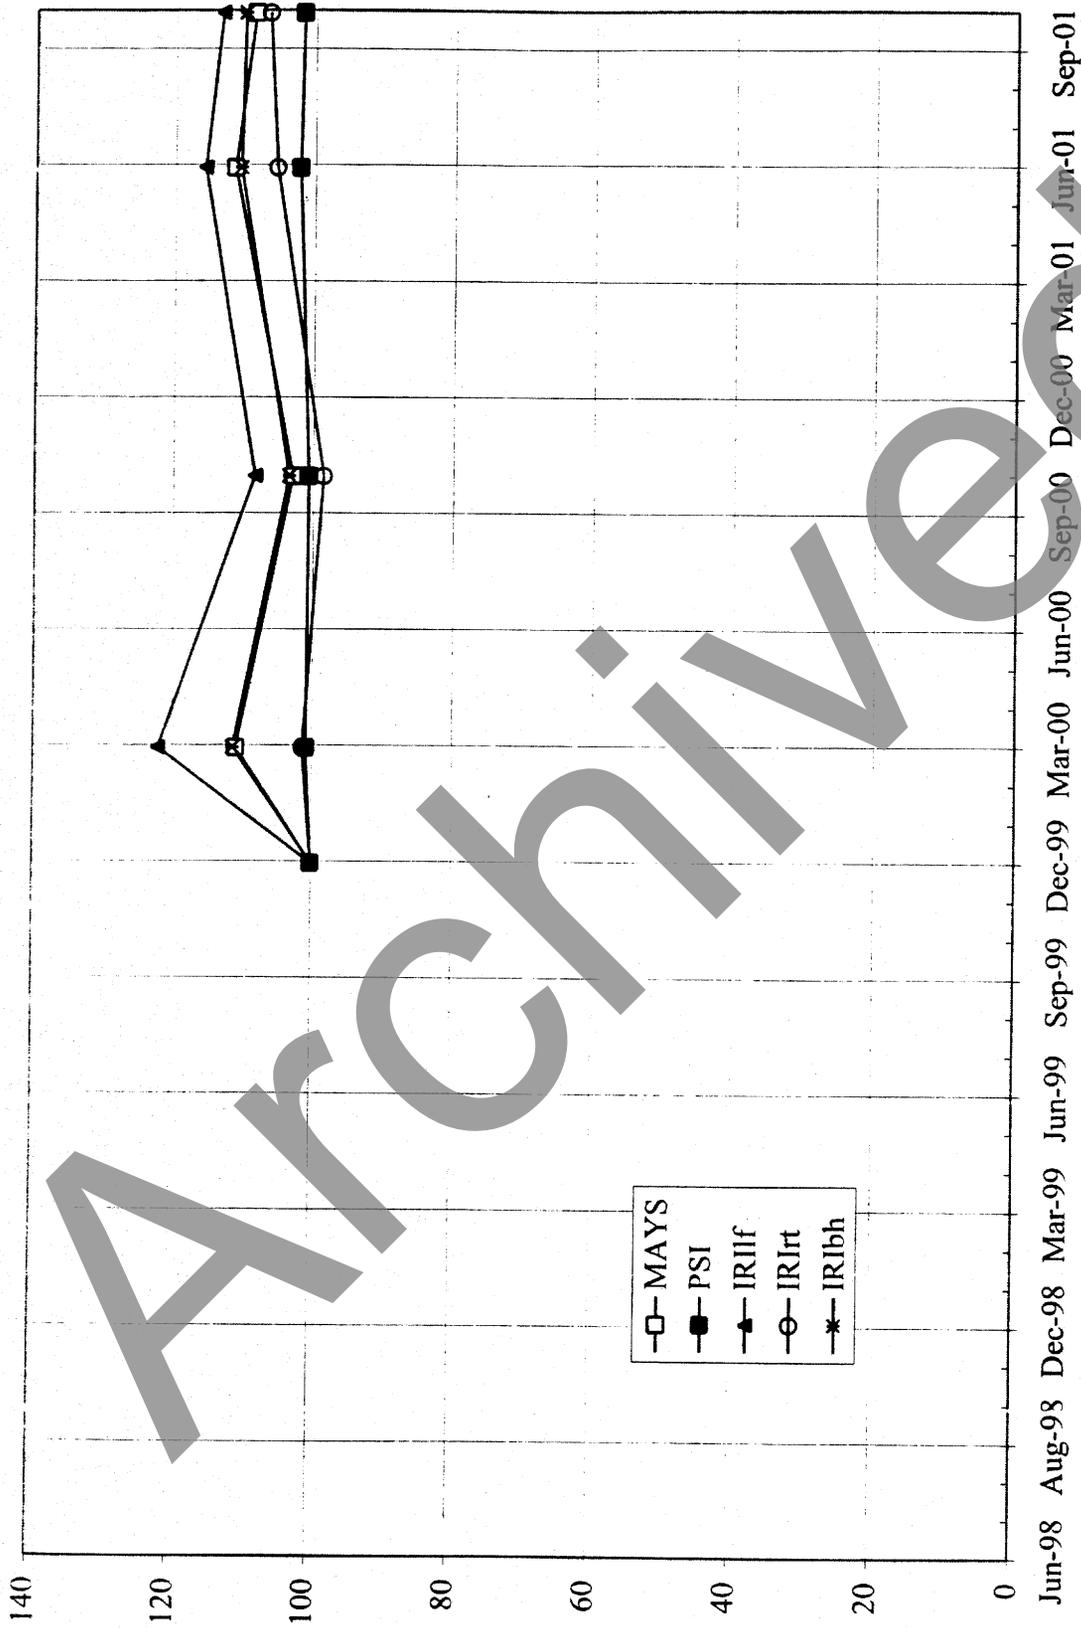
The five profilometer surveys to date are shown in Figure 5.59. All five indices remain above their original value and all but one declined during this current survey, which follows the up-and-down pattern that has been observed to date.

Figure 5.59 Trendlines for the Westbound Passing Lane through October 2001

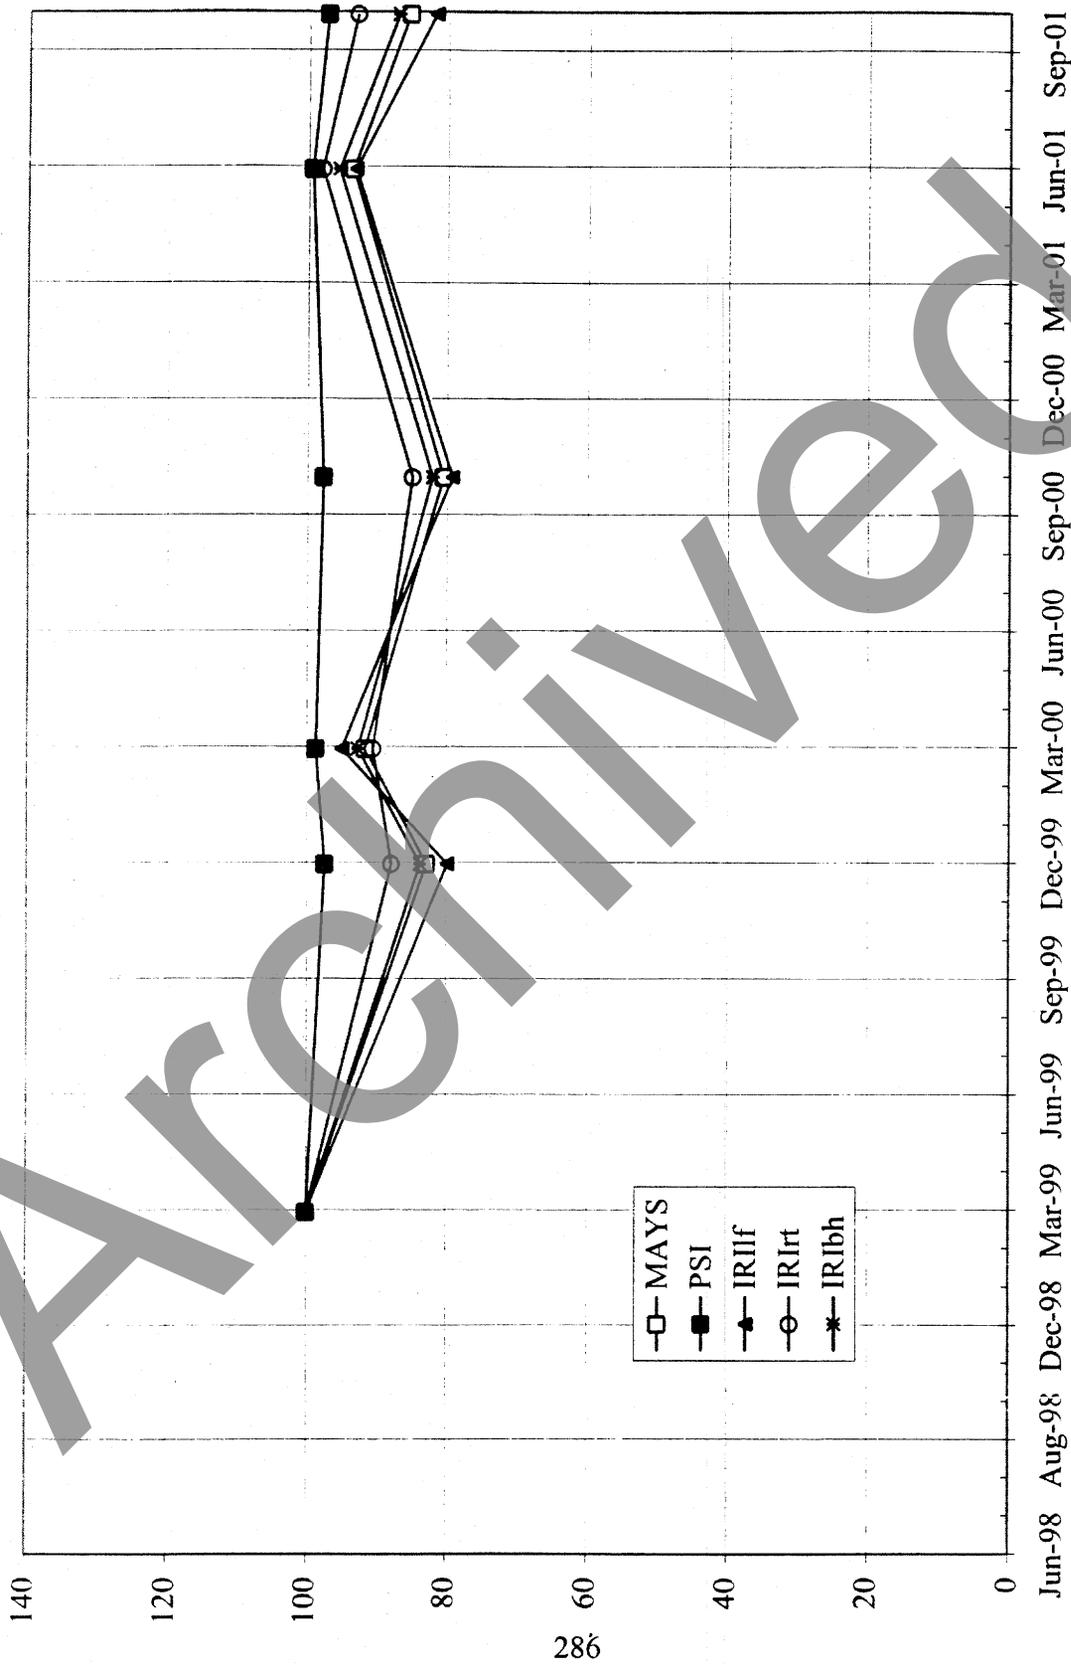
The results of the past six profilometer surveys are shown in Figure 5.60. As in the passing lane, the wavy nature of the surveys are apparent but to a larger degree. All five indices decreased in smoothness during this survey, yet during the previous survey all five increased. This pattern is repeated throughout the life of the pavement, which would suggest cyclic warping and curling effects as postulated for the passing lane.

Figure 5.60 Trendlines for the Westbound Driving Lane through October 2001

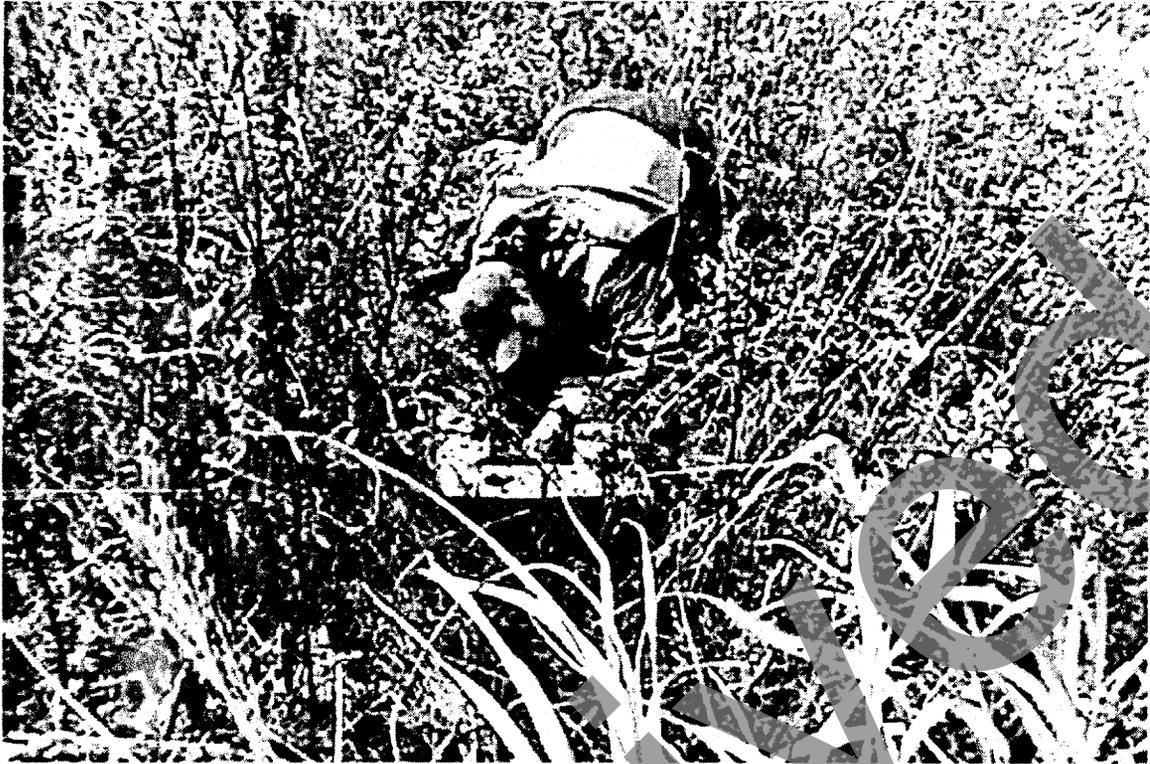
Consequently, collector pipes could be viewed only near the outlet, with the help of a flashlight (Figure 6.1). At one of the outlets, a video camera was placed near the end of the collector pipe and using the infrared feature, a picture of the inside of the pipe was obtained (Figure 6.2). Large amounts of silt and debris, which impede the flow of water, are observed. If the collector pipes cannot discharge the infiltrating water quickly, the base may become saturated and significantly weaker, which may explain some of the observed transverse cracking.

Figure 6.1 Inspecting the inside of a drain

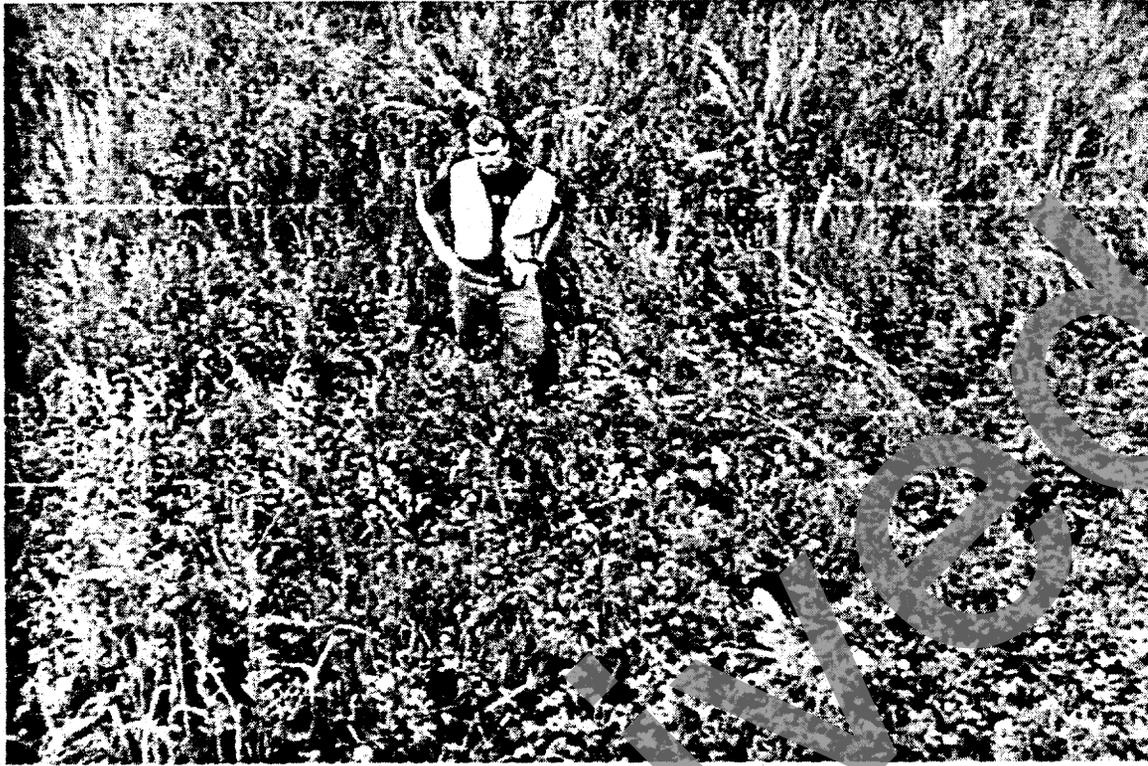
Some of the outlets that listed on the Ohio Department of Transportation (ODOT) specifications and plans (ODOT, 1995) were not found. Of the 26 outlets listed in the project span, 19 were found (73%). Many of the outlets were engulfed by tall vegetation growth (Figure 6.3), which had to be cleared before they could be examined (Figure 6.4). The area adjacent to the shoulder had been mowed, but the region further back, where the outlets are located, had not been (Figure 6.5). Such regions are intentionally left unmowed for environmental conservation reasons (Bob McQuiston, 2001: personal communication). It is believed that some of the outlets were not found because of the thick vegetation, even after the area had been thoroughly searched. Other locations, however, did not have large amounts of vegetation, yet some outlets were not found there either. These outlets were probably never constructed in accordance with the ODOT (1995) plans. The experience of the UC research team is not untypical. Baldwin and Long (1987) conducted a similar evaluation in the mid-1980s, inspecting drain outlets once a year for three years. During their inspections, they never found more than 60% of the total 533 possible outlets. Compared to their efforts, the number of outlets discovered at the Athens project site may be considered remarkable.

Figure 6.3 Tall vegetation made finding the outlets difficult

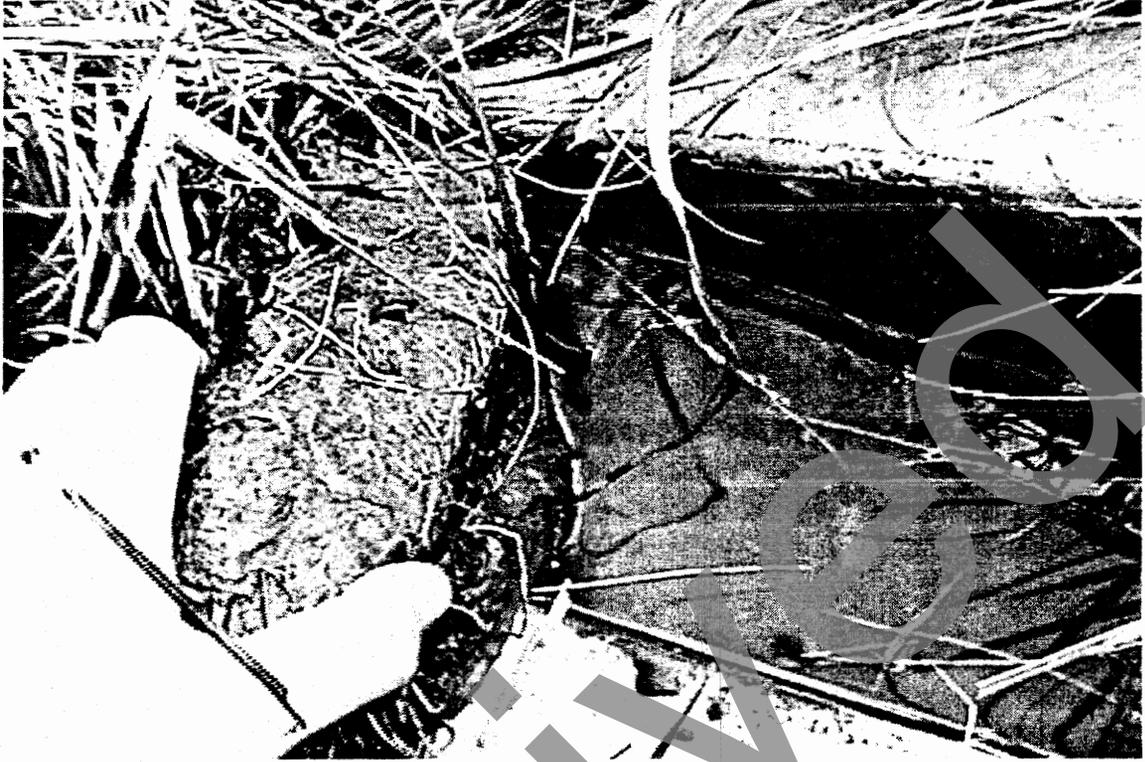
Most of the outlets that were found had large amounts of silt, moss, and weeds in them, and at times this combination was several inches thick (Figure 6.6). One outlet even had a large weed growing out of its rodent screen (Figure 6.7). All outlets were checked for standing or flowing water, which is a telltale sign as to whether the collector pipes are functioning properly. If water is found flowing out of the outlet, the drain is obviously

Figure 6.6 Combination of silt, moss and weeds that has collected in the outlet

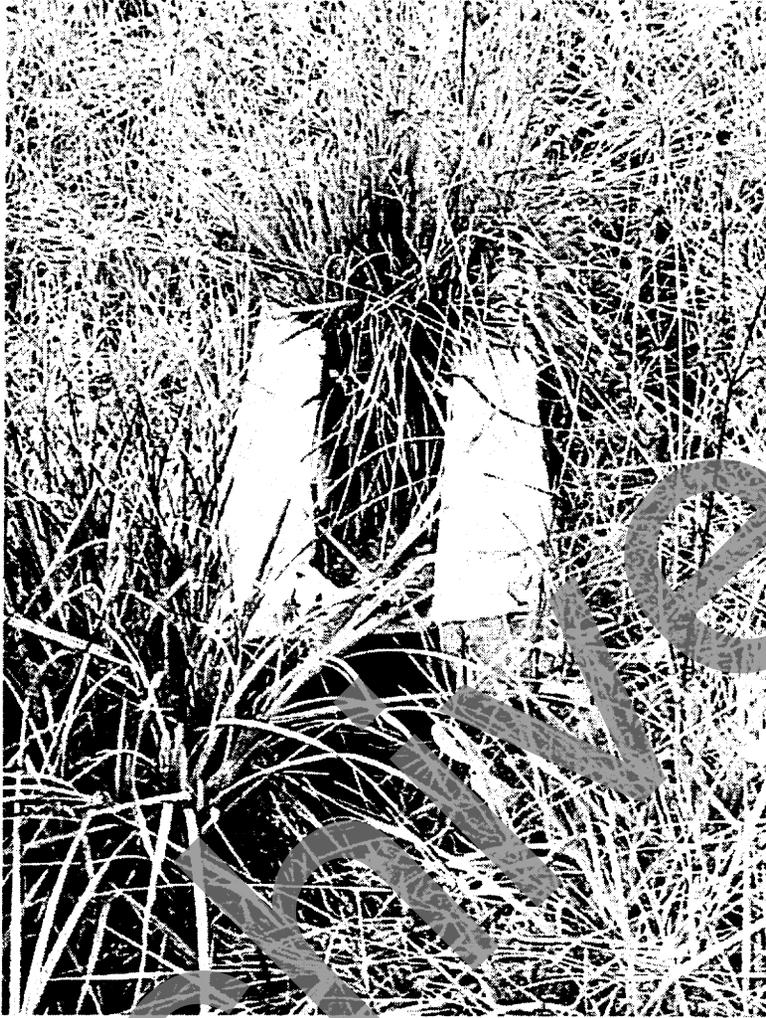
Figure 6.7 A large weed growing out of one of the outlets

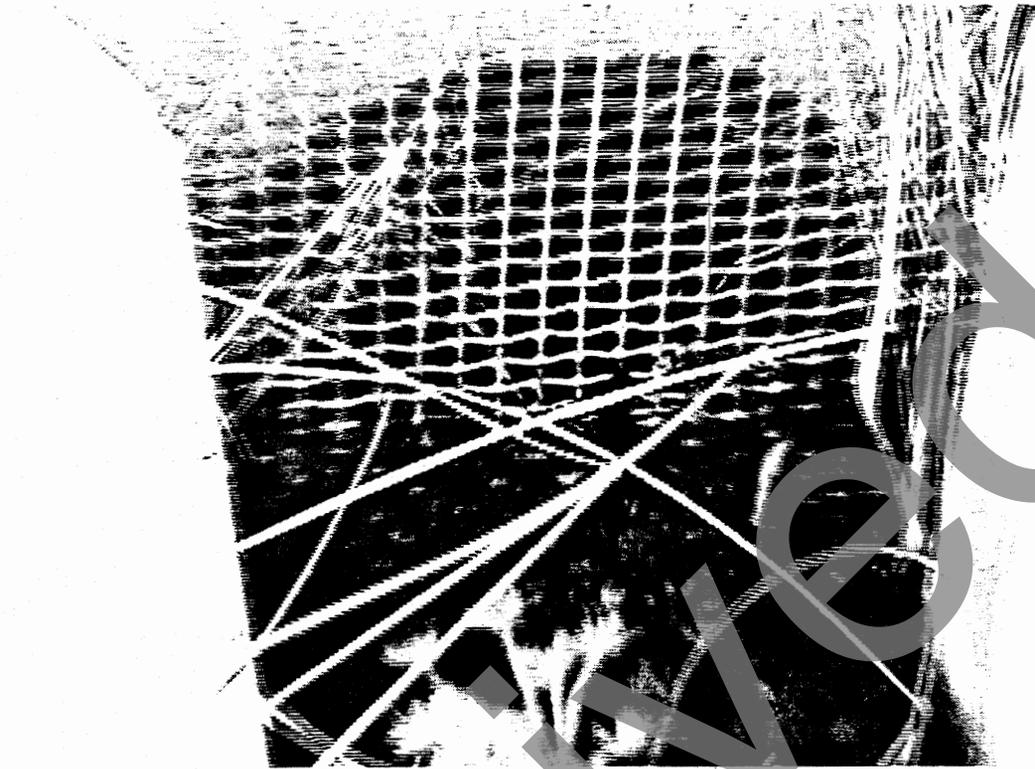
None of the outlets in the eastbound lanes have rodent screens, whereas all but one of the outlets in the westbound lanes have them. The investigators found that the absence of a screen may actually be beneficial. At the outlets with the rodent screens, moss, weeds, and eventually silt is allowed to gather on them (Figure 6.10), transforming them in some cases into small dams that prevent any drainage water from flowing out. When the screen was temporarily removed during the survey, water was able to flow out. The rodent screen did not appear capable of serving its intended purpose: several of the screens had been bent, creating a gap large enough for small rodents to fit through (Figure 6.11). It is unclear why these screens had been bent, but two hypotheses emerge: (a) The screens had been bent on purpose during construction, possibly to provide a snugger fit with the concrete outlet, even though this is not a method endorsed by ODOT; and (b) they had been bent accidentally during construction or subsequent periodic mowing

Figure 6.10 Moss and silt that has gathered on the rodent screen
