Highway Concrete Pavement Technology Development and Testing: Volume IV— Field Evaluation of Strategic Highway Research Program (SHRP) C-206 Test Sites (Early Opening of Full-Depth Pavement Repairs)

PUBLICATION NO. FHWA-RD-02-085

AUGUST 2006

U.S. Department of Transportation
Federal Highway Administration

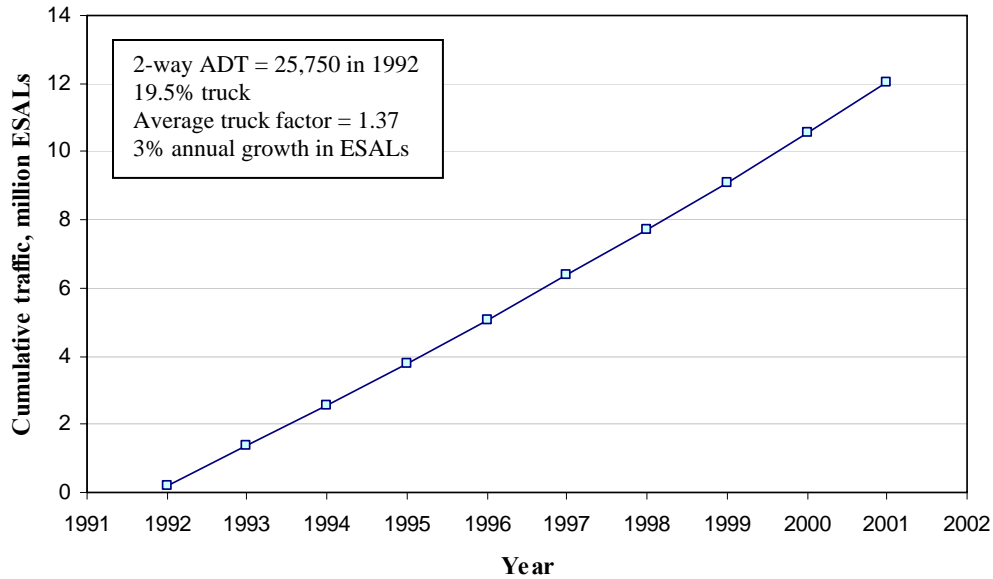
Figure 1. Estimated traffic on Georgia site.

The cracking problem was analyzed using the fatigue calculation procedure and model developed by Yu and colleagues (1998). The traffic data needed for the fatigue analysis are shown in figure 1. The traffic on I-20 through the project site is relatively high. The annual traffic is about 1.1 million equivalent single axles (ESALs) in the design lane.

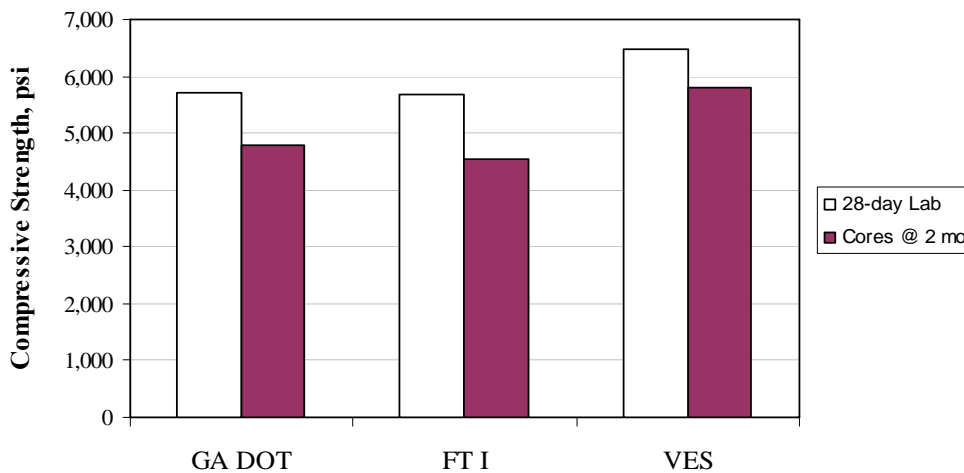
Figure 2. Available material strength data for the Georgia sections.

Figure 2 shows lower strength for cores retrieved at 2 months, but this is likely caused by damage during coring or shipping of the cores and testing variability. Extensive material testing was conducted under task C of this project for VES and HES mixes, and the results of those tests showed that the long-term (5-yr) strength of those mixes is up to 18 percent greater than the 28-day strength. A comparison of early-age (up to 90 days) strength-gain characteristics of these mixes suggests that the long-term strength-gain characteristics of the GADOT mix should be similar to those of VES and HES. Based on this assumption, figure 3 was developed to show the long-term strength development of the GADOT mix.

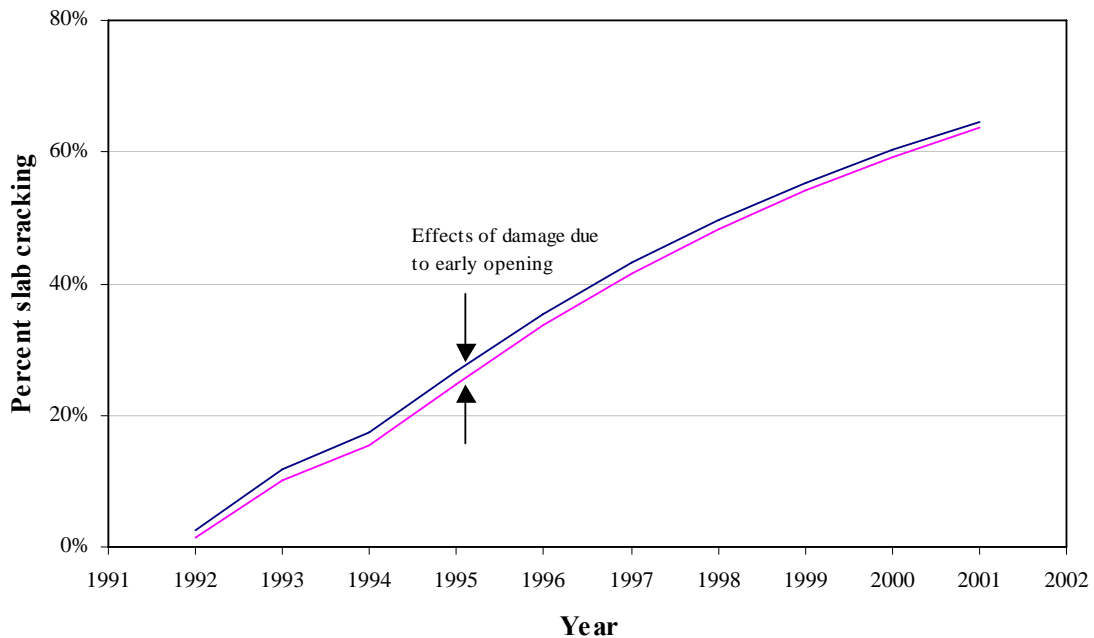
Figure 5. Illustration of the effects of damage due to early opening.

The results of fatigue analysis are shown in figure 4, along with the observed slab cracking. The model was run with built-in curling of $-2.2\text{ }^{\circ}\text{C}$ ($28.04\text{ }^{\circ}\text{F}$), which accounts for differential shrinkage. The effects of damage due to early opening are illustrated in figure 5. As shown in table B1 in appendix B, the amount of fatigue damage attributable to early opening was minimal (Miner's damage of 0 to 0.07, except for 0.10 for the last patch). The damage due to early opening has the effect of shifting the time (or traffic) versus cracking curve upward, as illustrated in figure 5. However, for the Georgia sections, early opening to traffic had a negligible effect on the fatigue life of the repairs, even for the 4.6-m repairs. In fact, the last three 4.6-m repairs placed in the GADOT section (i.e., the repairs that were opened to traffic at the lowest strength) did not crack. For shorter repairs, the effects of early opening (and fatigue damage in general) are inconsequential.

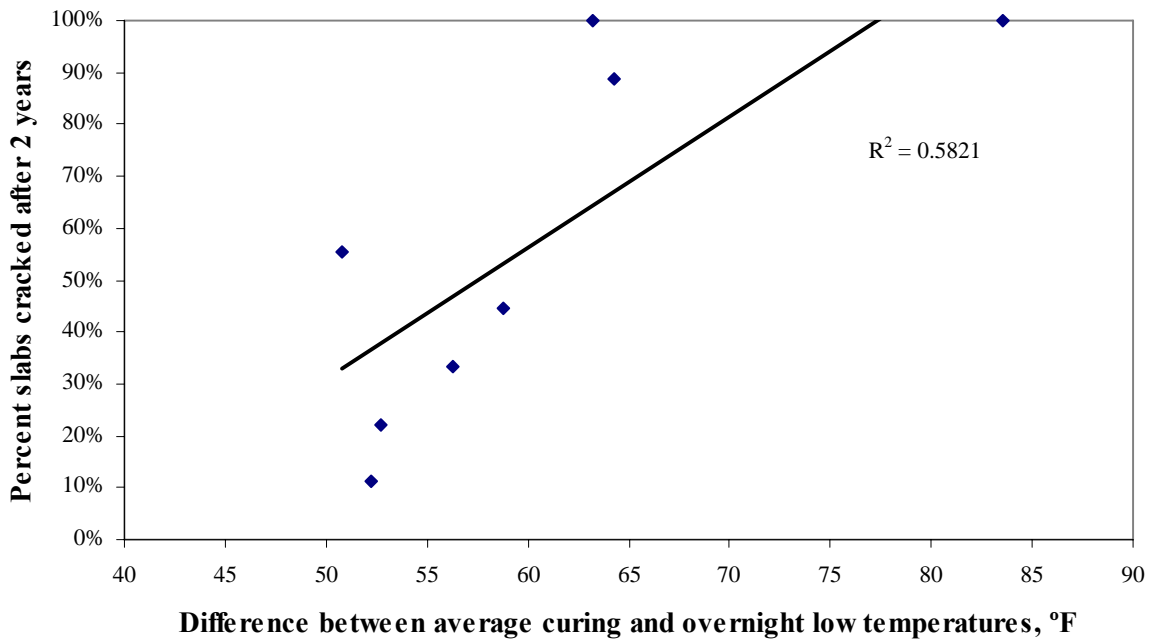
Figure 11. Correlation between the difference of average curing and overnight low temperatures and longitudinal cracking in Ohio sections at 2 years.

correlation between this parameter and longitudinal cracking in Ohio sections is shown in figures 10, 11, and 12 for the correlation at 2 months, 2 years, and 6 years of age. Figure 10 shows excellent correlation between this parameter and longitudinal cracking. If the cracking is caused by dowel restraint (of the horizontal movement in the transverse direction), this should be an effect that mostly influences the early-life behavior. Various factors would alleviate this effect at later ages, including creep and higher material strength. This is consistent with the trends shown in figures 10, 11, and 12. The best correlation is exhibited in figure 10 at 2 months of age, and the correlation becomes progressively worse for later ages.

The results shown in table 9 and figures 10 through 12 strongly suggest that the climatic conditions during construction played a major role in early development of longitudinal cracking in the Ohio sections. Figure 10 shows that if the difference between average curing temperature and overnight low temperature is less than about 10 °C (50 °F), the risk of developing longitudinal cracking due to dowel restraint is relatively low. That difference was less than 5 °C (41 °F) for all the Georgia sections, and none of the Georgia sections developed longitudinal cracking.
