# RECYCLING ASPHALT PAVEMENTS

Elkhart County, Indiane

FINAL REPORT

EVALUATION OF RECYCLED BITUMINOUS PAVEMENTS.

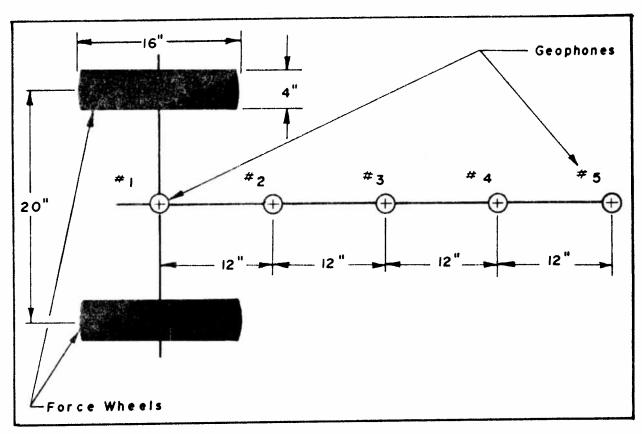
FIGURE 2 : DYNAFLECT CONFIGURATION (After Utah)

deflection and define the deflection basin due to the loading transmitted by the force wheels as shown in Figures 2 and 3. Sensor 1 is located closest to the force wheels and is used to determine the maximum deflection (DMD). The numerical difference between Sensor 1 and Sensor 2 gives the Surface Curvature Index known as the SCI. The SCI is an indication of the load carrying capability of the surface course. A greater difference between these values indicates a weaker surface or one that is not adequately transferring the load down through the pavement system. The difference between the pavement deflections at Sensor 4 and Sensor 5 is defined as the Base Curvature Index (BCI). The BCI is an indication of the relative strength of the subbase or lower level of the pavement structure. The strength or suitability of the base course is inversely proportional to the BCI. The deflections are recorded in mils or one-thousandths of an inch.

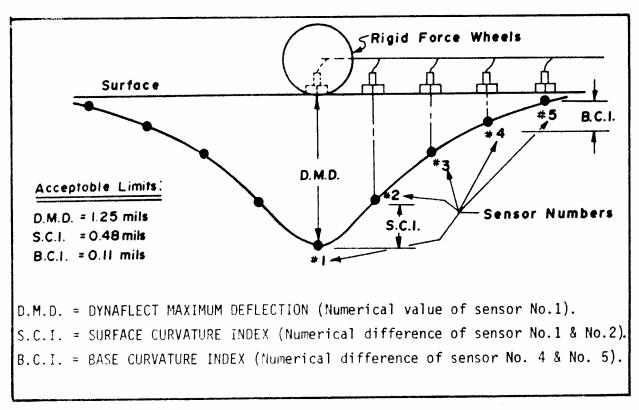
FIGURE 3: DEFLECTION BASIN PARAMETERS (After Utah)

the Dynaflect which is summarized in Figure 3, the tests performed on CR-28A before recycling indicate without doubt that both the pavement and the subgrade are weak. In Figure 6 the DMD's for all eleven Dynaflect sites in both lanes were much greater than the suggested 1.25 mil maximum. The SCI's were very high and very erratic. The BCI's were also high but relatively uniform.

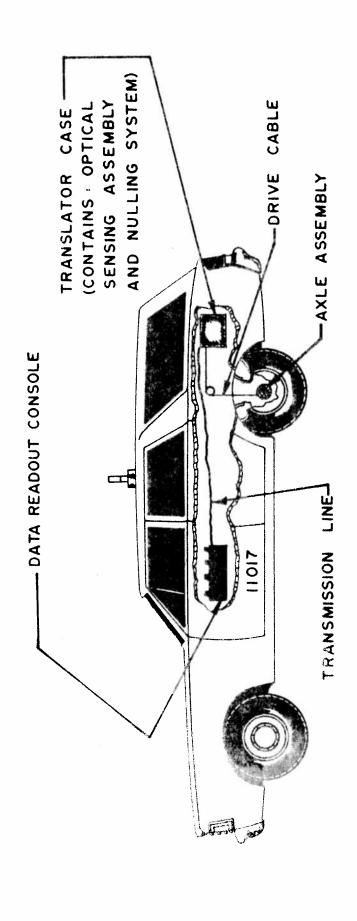
FIGURE 16: PCA ROADMETER IN 1973 AMC STATION WAGON

Pavement smoothness tests were performed on the two recycled pavements using a PCA Roadmeter mounted in a 1973 AMC Stationwagon as shown in Figure 16. The roadmeter records vertical movement of the rear axle in both directions in one-eighth increments and distance travelled so that pavement roughness can be indexed as counts per mile and averaged with respect to the length of runs in each direction to produce a weighted counts per mile value for the project. The weighted mean value represents the relative response of the vehicle to the roughness of the pavement surface.
