The November 1999 Duzce Earthquake: Post-Earthquake Investigation of the Structures on the TEM

Publication No. FHWA-RD-00-146

Hamid Ghasemi, James D. Cooper, Roy Imbsen,
Hasan Piskin, Fulya Inal, and Azmi Tiras

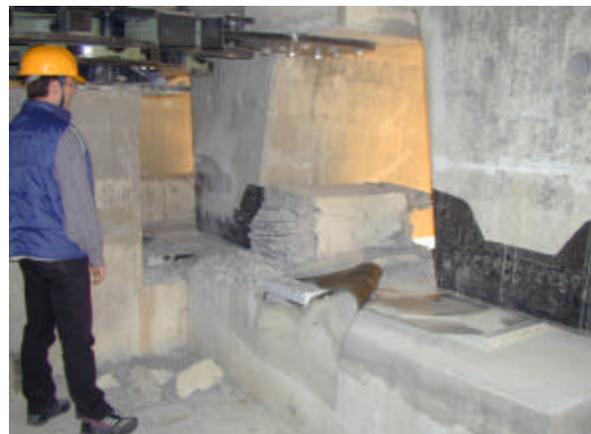
3. Shear keys or blocks used to control transverse girder movement, although severely damaged, have functioned as intended appear to (Figure 19).

Figure 19. Shear block damage (translational restraint).

- Shear keys or blocks used to control transverse girder movement of Bolu Viaduct #1, although severely damaged, appear to have functioned as intended.

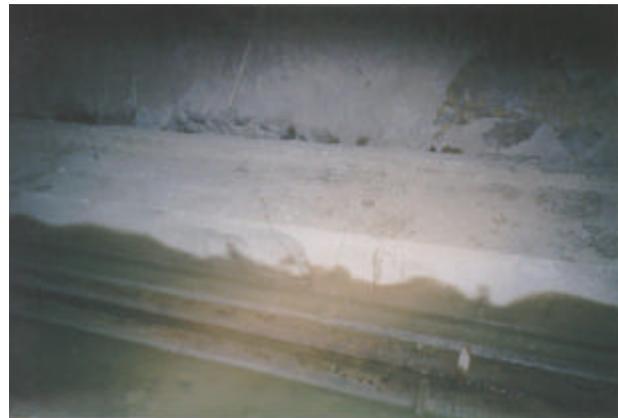
5. One-millimeter-wide longitudinal and radial cracks were observed in the structurally complete reinforced-concrete liner (Figures 35 and 36).
6. Cracking of the reinforced-concrete utility box beams was also noted (Figures 37 and 38).

Figure 38. Completed concrete liner showing utility box beam.
