# Field Testing of an Ultra-High Performance Concrete Overlay

PUBLICATION NO. FHWA-HRT-17-096

SEPTEMBER 2017

Constructed in 1960s, the Laporte Road (County Road L) bridge over Mud Creek is a three-span reinforced concrete slab bridge located in Brandon, IA, approximately 35 mi (56.3 km) northwest of Cedar Rapids. A photo of the bridge is shown in figure 14. The bridge was originally designed using H20-44 loading, and although it has low average daily traffic (ADT), it carries large trucks with agricultural loads. The bridge is supported at the ends by reinforced concrete abutments that were cast over steel H-piles. The abutment-to-abutment length of the bridge is 100 ft (30.5 m). The width of the bridge is 28 ft (8.53 m) and services two lanes of traffic.

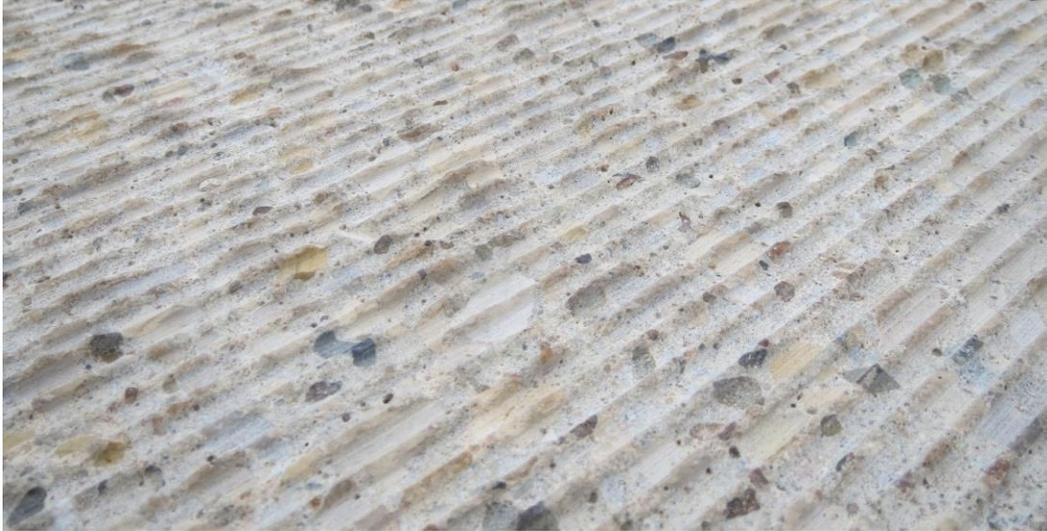
As noted above, the existing surface of the deck was ground to remove poor concrete and provide a roughened surface to promote bond between the concrete substrate and the UHPC overlay material. A photo of the deck surface after scarification is shown in figure 18. On completion of the grinding, all fines and debris were to be removed from the surface of the deck, and deck surface was premoistened a few hours prior to installing the overlay.

**Figure 18. Photo. Deck surface after scarification.**

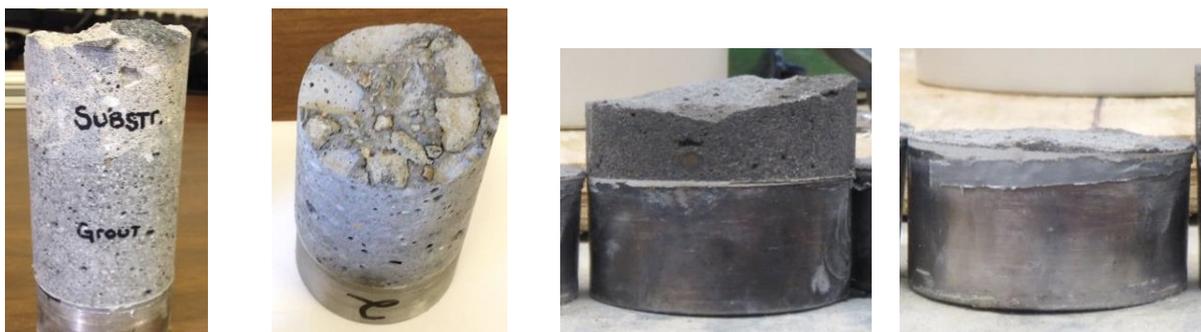
Typically, failure occurred by one of four modes, which are shown in Figure 25. These photos were taken from previous projects where this test was employed. If Mode 2 failure occurred (Figure 25-B) the true bond strength between the two materials could be assessed. If Mode 1 (Figure 25-A) or 3 (Figure 25-C) occurred, the tensile strength of the failing material could be assessed and the interface bond strength recognized to be higher than the tensile stress achieved. Finally, if Mode 4 failure occurred (Figure 25-D), the interface bond strength could be recognized to be higher than the tensile stress achieved.

A. Mode 1: Substrate failure.

B. Mode 2: Bond failure at the interface.

C. Mode 3: Failure in the bonded material.

**Figure 25. Photos. Failure modes associated with the direct tension pull-off bond test; photos taken from previous projects.**

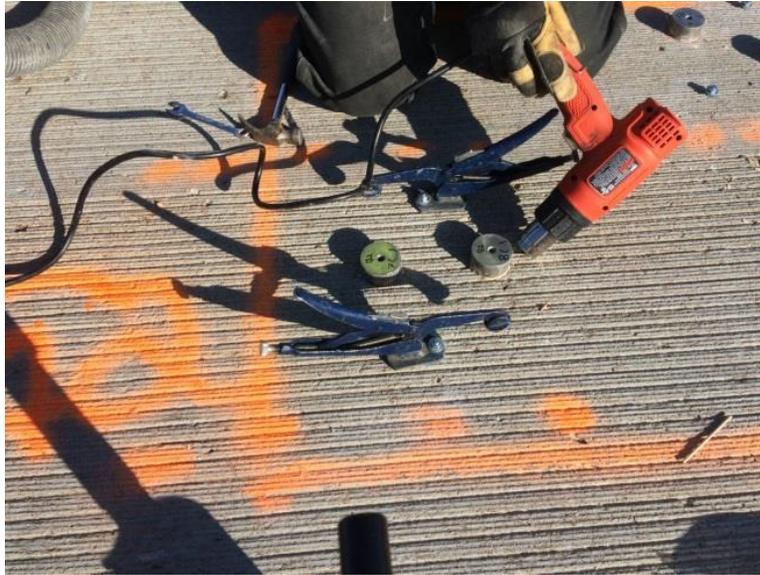
These tests were completed over the course of two days in November 2016. On day one, air temperature was between 40°F (4.5°C) and 50°F (10°C), and the bridge deck surface was damp. On day two, air temperature was also the between 40 °F (4.5°C) and 50°F (10°C), but the deck surface was dry. A specially formulated two-part adhesive was used to secure the pull-off disc to the UHPC overlay. A heat gun was used to dry the deck surface prior to pull-off disc installation and was also used to accelerate adhesive curing (shown in figure 26). Figure 26 and Figure 27 show photos from test preparation and the bond testing, and figure 28 shows a set of samples after testing.

**Figure 26. Photo. In-situ bond testing on the Laporte Road bridge.**

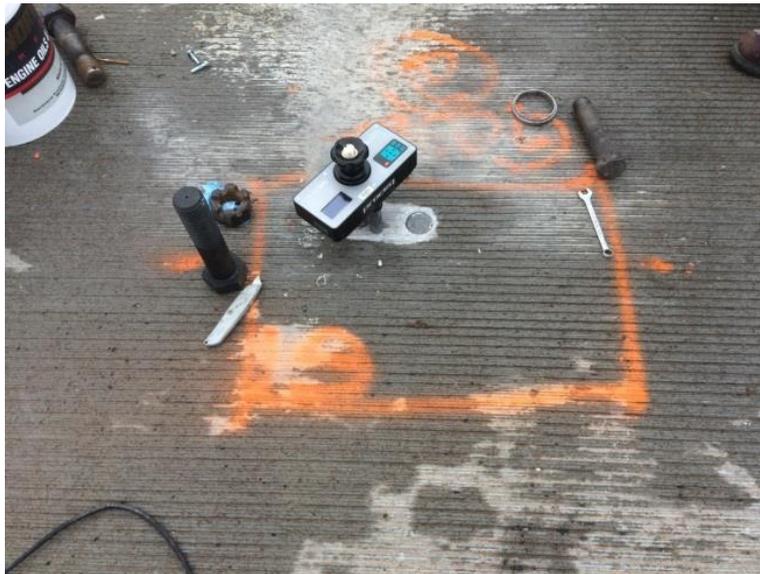
**Figure 27. Photo. Preparation of the bond test location on the Laporte Road bridge.**

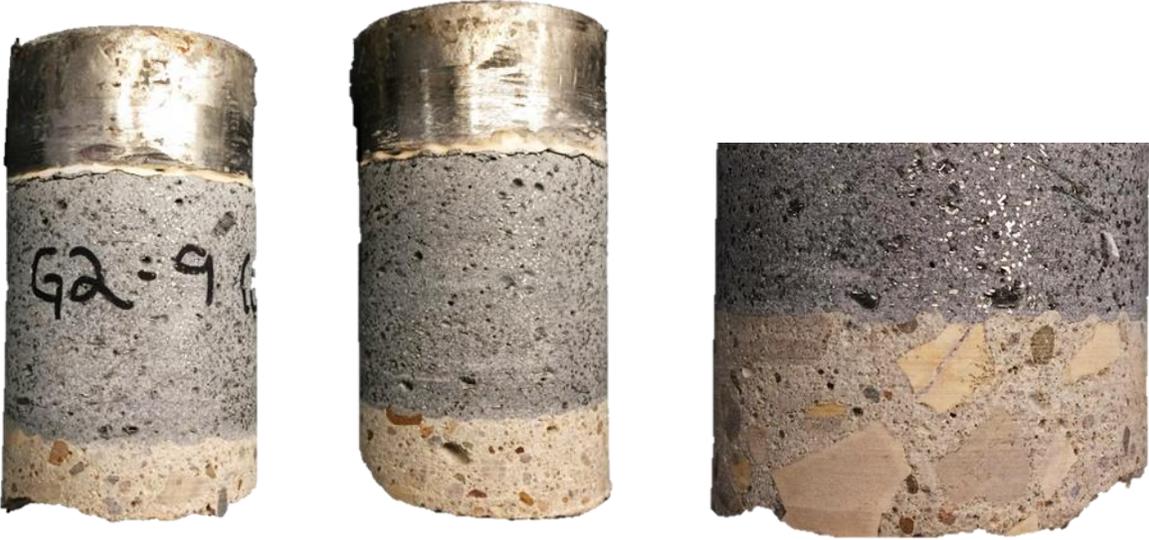
Specimens tested from region G1 and G2, which represented a test location with no indication of delamination and scarification prior to placement of the UHPC overlay, all failed in the adhesive between the test disc and the UHPC overlay (Mode 4). Peak stresses recorded prior to failure were between 182.9 psi (1.26 MPa) and 420.3 psi (2.90 MPa). Figure 30 shows a set of test discs removed from G1 and G2 samples. The figure shows the face of the disc that was bonded to the UHPC overlay. Portions of the failure are seen in the UHPC and at the interface between the adhesive and the UHPC.

Specimens failing in Mode 4 were subsequently removed from the test location by applying a prying action to the sample using a hand tool. In each case, the prying action resulted in fracture of the substrate concrete. Figure 30 and Figure 31 show a representative sample (G2-9) from the G1 and G2 test locations. The bond between the UHPC overlay and the substrate concrete appears intact.

A. Front of G2-9 specimen after testing.

B. Back of G2-9 specimen after testing.

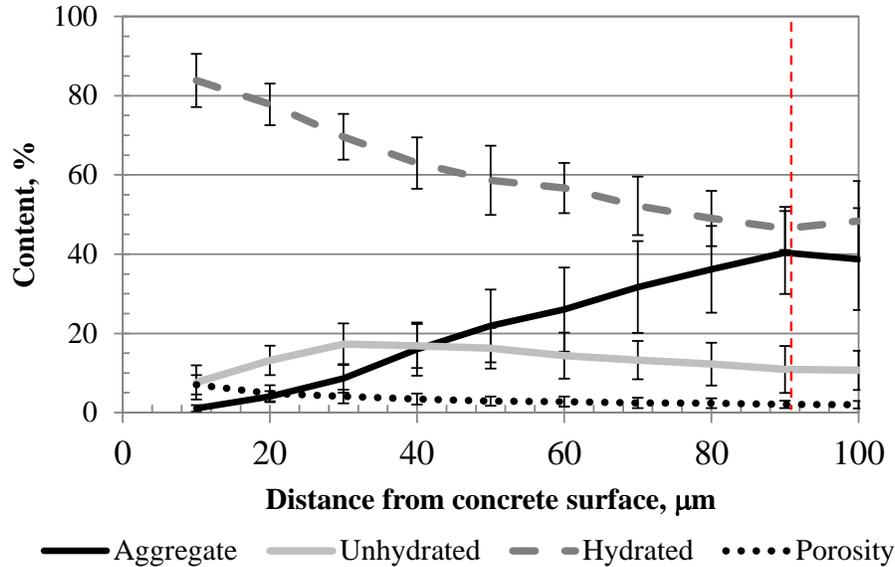
Distribution of the porosity, aggregate, unhydrated, and hydrated cement particles on the UHPC overlay as a function of the distance from the concrete surface is presented in figure 36. This graph shows a high content of hydrated products, above 80 percent, at the interface (from 0- to 10- $\mu\text{m}$  distance). The percentage of hydrated products was reduced as the distance from the interface increased. This diminishing percent of hydrated products was caused by an increase of the aggregate content in the UHPC paste. At approximately 90- $\mu\text{m}$  distance from the interface, the content of both hydrated and aggregate stabilized at from 46 and 40 percent, respectively. This effect has been observed in other types of overlays, and it is associated with reduction in the packing efficiency of the UHPC paste in the vicinity of the concrete surface, also known as “wall-effect.” (Garboczi and Bentz 1991; Ollivier, Maso, and Bourdette 1995; Scrivener, Crumbie, and Laugesen 2004; H Beushausen and Gillmer 2014) The inflexion point on the content of phases, hydrated product, and aggregates at 90- $\mu\text{m}$  distance from the surface is depicted in figure 36 with a vertical dashed red line that marks the extent of wall effect on the UHPC paste.

**Figure 36. Graph. Overall distribution at the interface as a function of distance from the concrete surface of specimen G2-8 phases.**

The content of unhydrated cement was below 8 percent in the 10- $\mu\text{m}$  gap close to the surface. The value reached a maximum of approximately 17 percent at 30  $\mu\text{m}$  away of the surface and progressively decreased to 10 percent at 100- $\mu\text{m}$  distance. The porosity also showed a maximum of 7 percent close to the interface in the 10- $\mu\text{m}$ -wide gap close to the surface. The high packing efficiency of the UHPC and low water-to-cement ratios explained the comparative low values of porosity relative to other overlay configurations where ordinary portland cement or grout materials were used. These systems typically showed porosity values on the interface on the order of from 30 to 20 percent. (De La Varga et al. 2017; Hans Beushausen, Höhlig, and Talotti 2017)

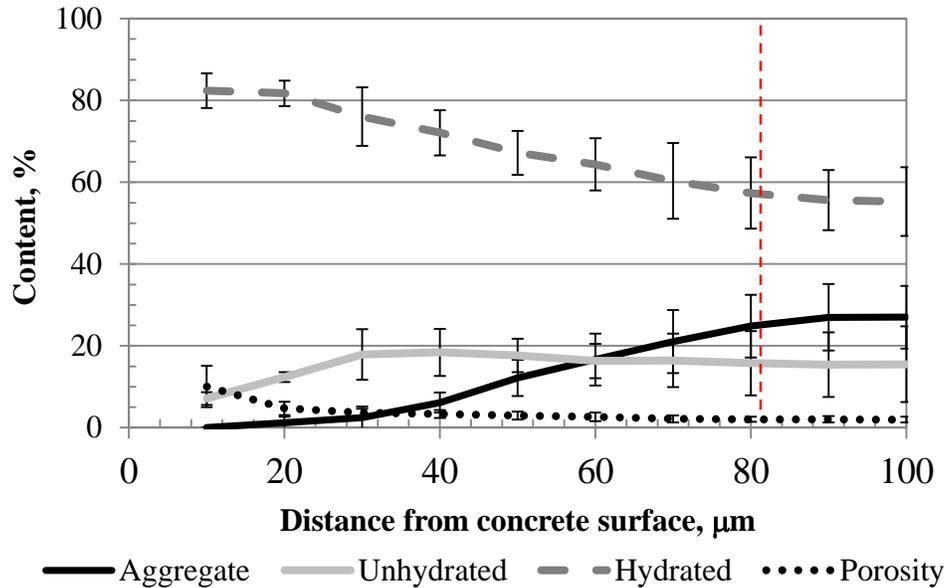
The main difference of this specimen relative to the two analyzed under the SEM is the absence of scarification on the concrete surface. This can be observed in the General map shown in figure 40, which shows that the interface line is relatively flat and lacks the “valley-hill” topography observed in the G2-8 sample shown in figure 33. This flat configuration contributed to improving the packing efficiency of the overlay material in direct contact with the substrate. (De La Varga et al. 2017) The direct consequence was a reduction in the wall effect on this interface compared with those having a valley-hill topography (surfaces previously subjected to scarification).

The trends in the distribution of phases on the interface for the G3-14 specimen, displayed in figure 40, were similar to those in the previous specimen, G2-8. Hydrated products of the UHPC paste were the principal phase in the first 100  $\mu\text{m}$  of the interface microstructure. Its value progressively decreased from 80 percent in the first 0 to 10  $\mu\text{m}$  to approximately 55 percent at 80  $\mu\text{m}$  away from the concrete surface. In parallel to the decrease in hydrated products, the aggregate content increased from 0 percent right at the interface to a value of approximately 25 percent at 80  $\mu\text{m}$ . The content of both unhydrated particles and porosity evolved following the same trend as the one observed in specimen G2-8. In the case of the unhydrated particles, the initial 8 percent content right at the surface increased to approximately 20 percent at 30  $\mu\text{m}$  away of the surface and progressively decreased to 10 percent at 100- $\mu\text{m}$  distance. While at initial 10 percent value of porosity, the interface constantly diminished to below 2 percent at 100- $\mu\text{m}$  distance from the surface.

Finally, the distribution graph in figure 40 also confirms a reduction in the extent of the UHPC paste affected by the wall effect induced by the “plateau” configuration of the concrete surface. The inflexion point in this G3-14 specimen was observed at 80- $\mu\text{m}$  distance from the surface instead of the 90- $\mu\text{m}$  mark registered in the previous specimen (G2-8).

**Figure 40. Graph. Overall distribution at the interface as a function of distance from the concrete surface of specimen G3-14 phases.**

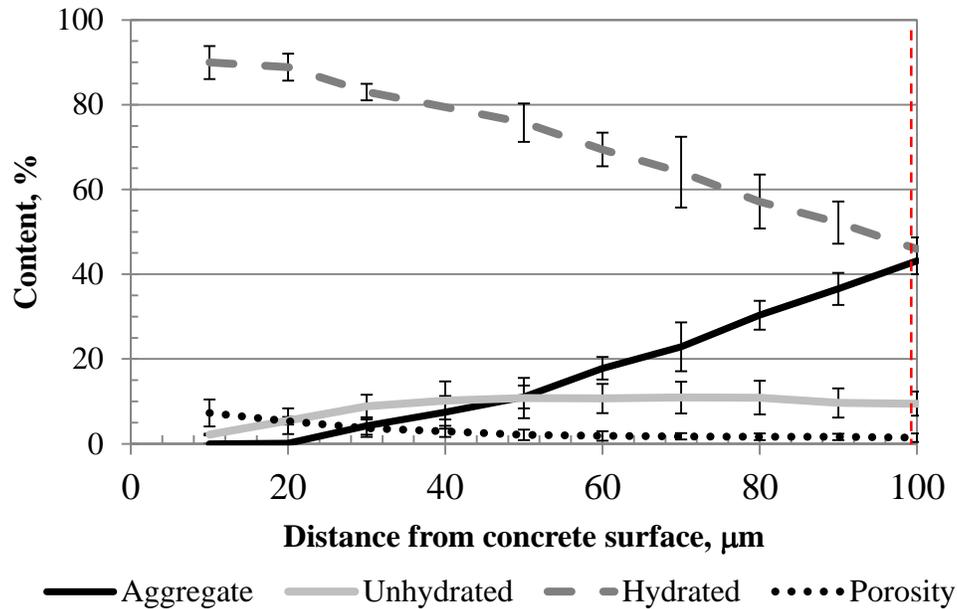
As shown in figure 44, the results of quantitative analysis for this specimen are similar to those measured in G2-8. At the interface, the hydrated products were above 80 percent, and porosity was around 7 percent. The aggregate content showed a similar evolution, reaching 40 percent at 100- $\mu\text{m}$  distance from the interface. This similarity with the G2-8 specimens also extended to the distance where the inflexion point in the trend of hydrated particles and aggregate was located. Based on the data shown in figure 44, it was inferred that this limit was located close to 100- $\mu\text{m}$  distance from the surface. Significantly, this sample came from a location where the concrete surface was subjected to scarification. Thus, as in specimen G2-8, the distance from where the inflexion point occurred was significantly higher than the distance observed for the nonscarified sample (G3-12).

**Figure 44. Graph. Overall distribution at the interface as a function of distance from the concrete surface of the specimen B7-12 phases.**
