Cable-Stay Strand Residual Strength Related to Security Threats

PUBLICATION NO. FHWA-HRT-17-109

JANUARY 2018

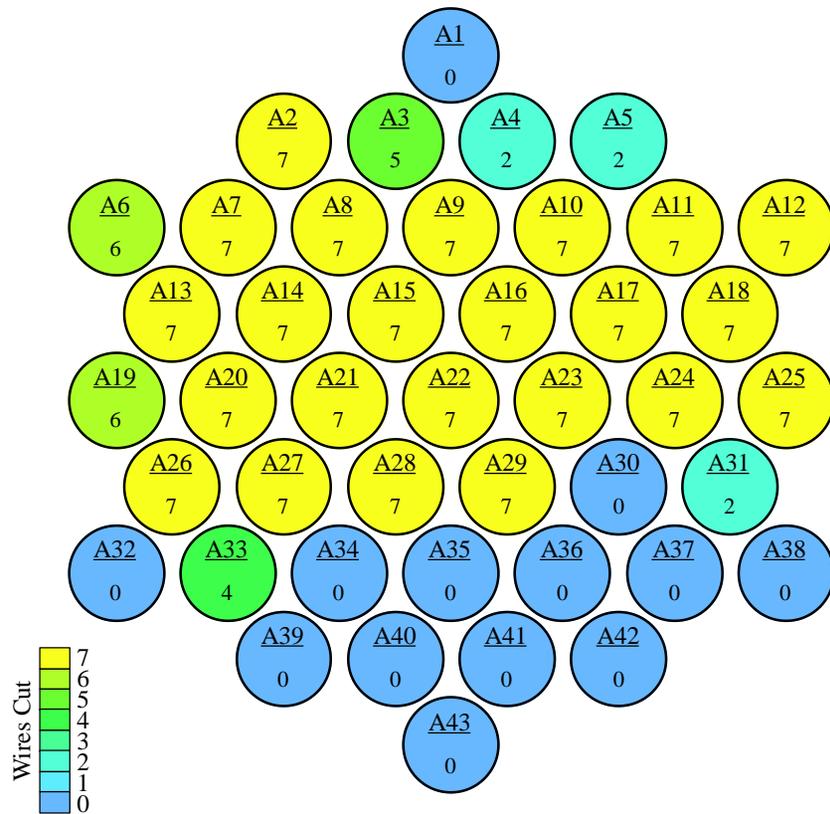
Figure 3. Bubble plot. Map of the number of cut wires in the cross section of thermal lance cut A.

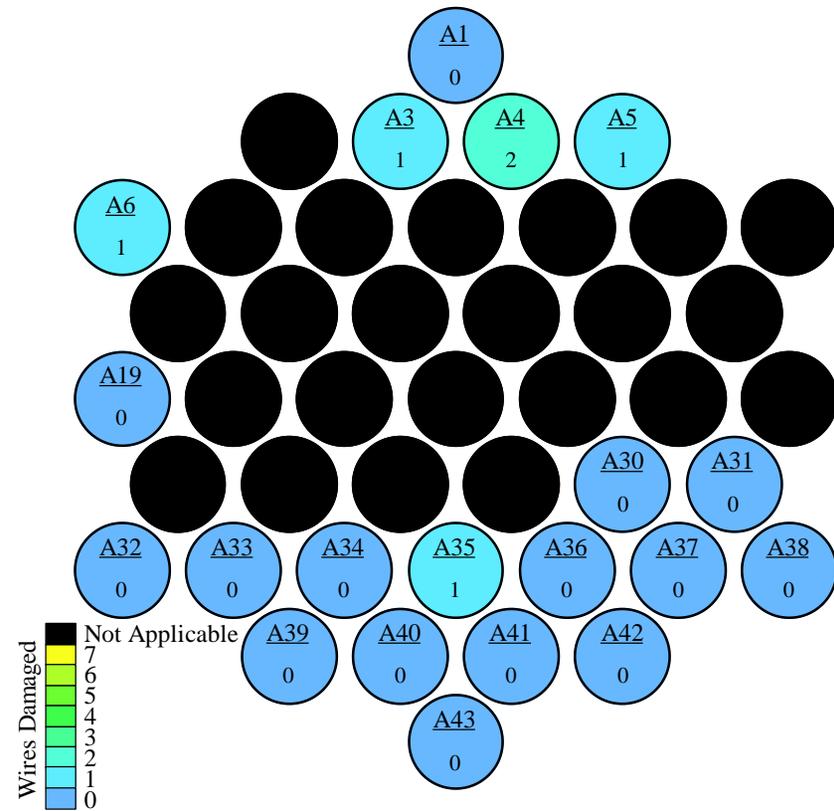
Figure 4. Bubble plot. Map of the number of damaged wires in the cross section of thermal lance cut A.

Table 4 footnotes add important commentary to explain posttest observations not known a priori. First, according to the map of damaged wires presented in figure 4, the only strand with seven wires intact with damage was A35; this strand was originally documented as having one wire damaged. Visual examination of the fractured strand after testing (shown in figure 28) clearly shows that fractures on two wires initiated from nicks on each wire from the thermal lance. This indicates that the damage mapping presented in figure 3 through figure 6 is subject to some error, as melted HDPE and/or burned grease may have masked damage to wires, though this damage became more apparent after pressure washing to remove grease before testing. Similarly, strand A34 had no reportable damage, but posttest inspection did reveal one nick on a wire. Note, also, that during the dismantling of the bundle, wires in strands A32 and A43 received nicks from the reciprocating saw blade during the cutting operation to remove the melted HDPE cover. The nicks on wires in strand A32 did not appear to affect the residual capacity test results. However, the nicks on wires in strand A43 did appear to affect the residual capacity test results. A posttest view after the tension test on strand B12 is shown in figure 29, and no obvious nicks are visible around the fracture. However, a slag ball fused to one wire coincided with a fracture in one wire, but since two other wires simultaneously fractured, the low strength was likely the result of microstructural changes due to excessive heat, not necessarily the fused slag ball.

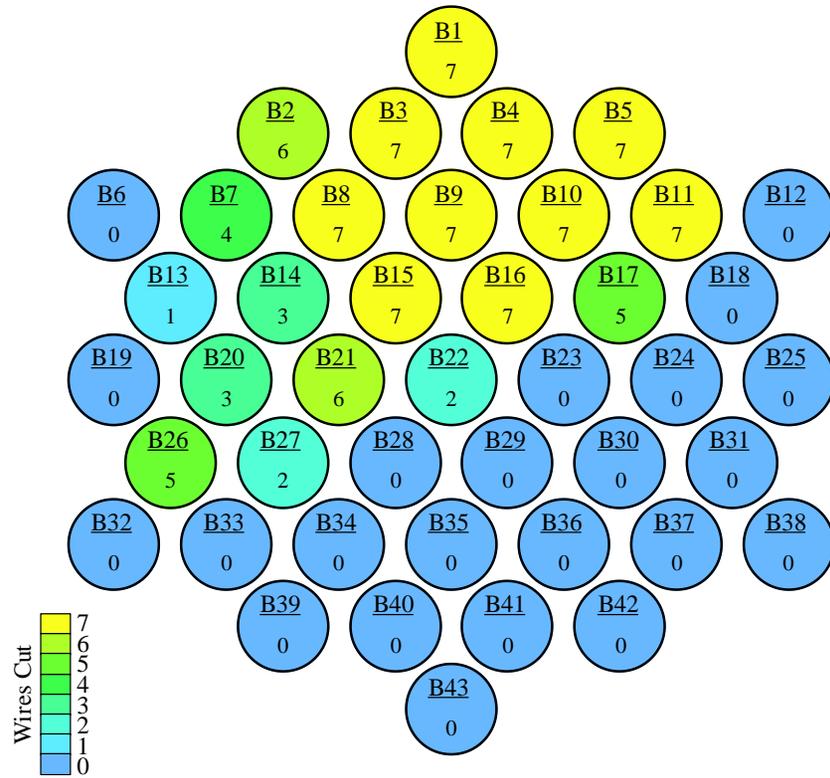
Figure 5 and figure 6 present similar maps of severed and damaged wires for cut B. The extents of cut and damaged wires were much less for this cut, particularly as evident in figure 6. As shown in figure 2, cut B happened to coincide with the location of a bundle retaining plate, and this greatly impeded the thermal lance operator's ability to compromise the bundle. The same data on cut and damaged wires are replicated with histograms in figure 7 and figure 8, respectively, for cut A and cut B.

Figure 5. Bubble plot. Map of the number of cut wires in the cross section of thermal lance cut B.

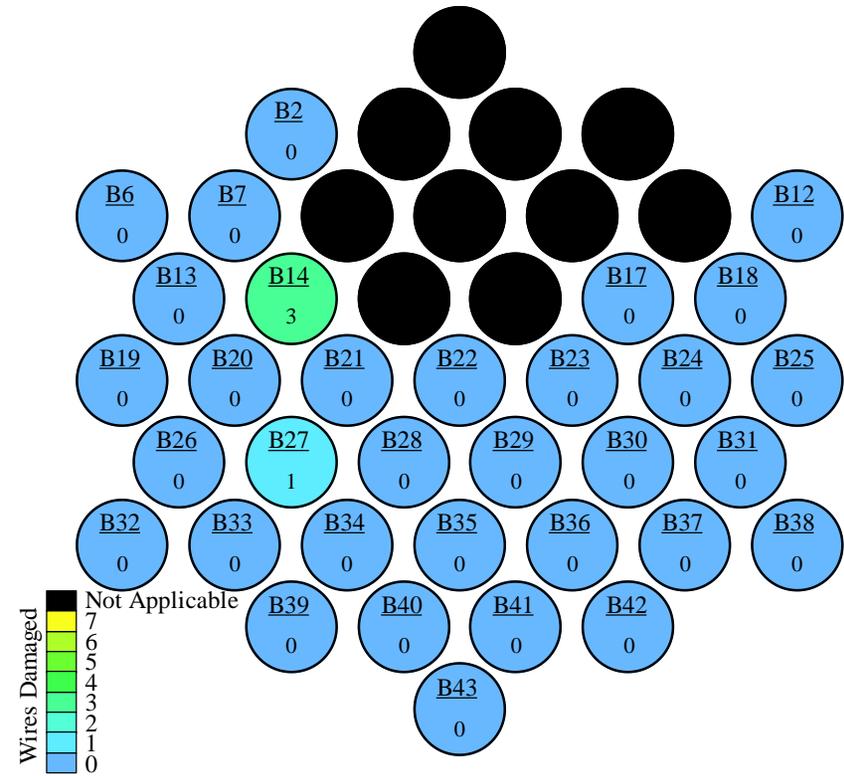
Figure 6. Bubble plot. Map of the number of damaged wires in the cross section of thermal lance cut B.

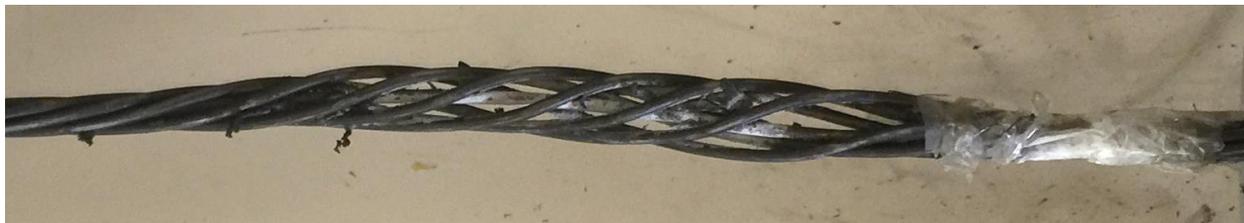
Figure 10. Photo. Strand G2 showing FBC.

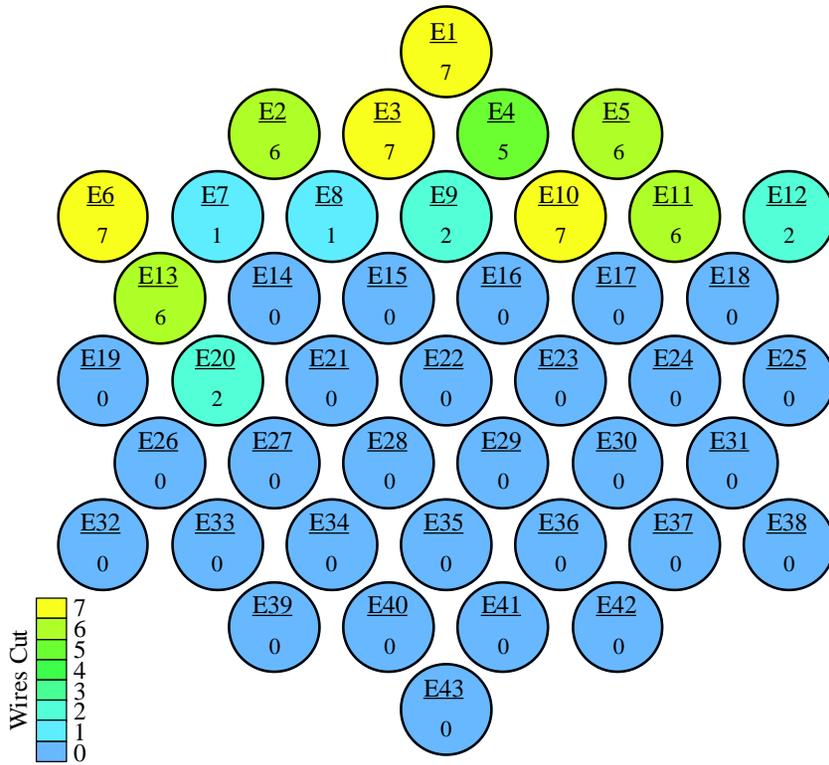
Bundle E remained intact after the blast event such that cut wires and strand damage could be mapped through the bundle cross section. Figure 15 and figure 16 show the maps of cut and damaged wires from bundle E; the maps were formed in the same manner as described in the “Thermal Lance Cut Bundle” section. Based on the cut wire map, it appears the explosive was centered above strand E1, since all cut wires were isolated within the top half of the bundle. The damaged strand map in figure 16 shades all strands that had cut wires with black, as further damage evaluation was not of concern. However, there was no clear trend on birdcage damage, as full and incipient strands seemed to occur throughout the remaining bundle cross section.

Figure 15. Bubble plot. Map of the number of cut wires near the center of the bundle from blast test E.

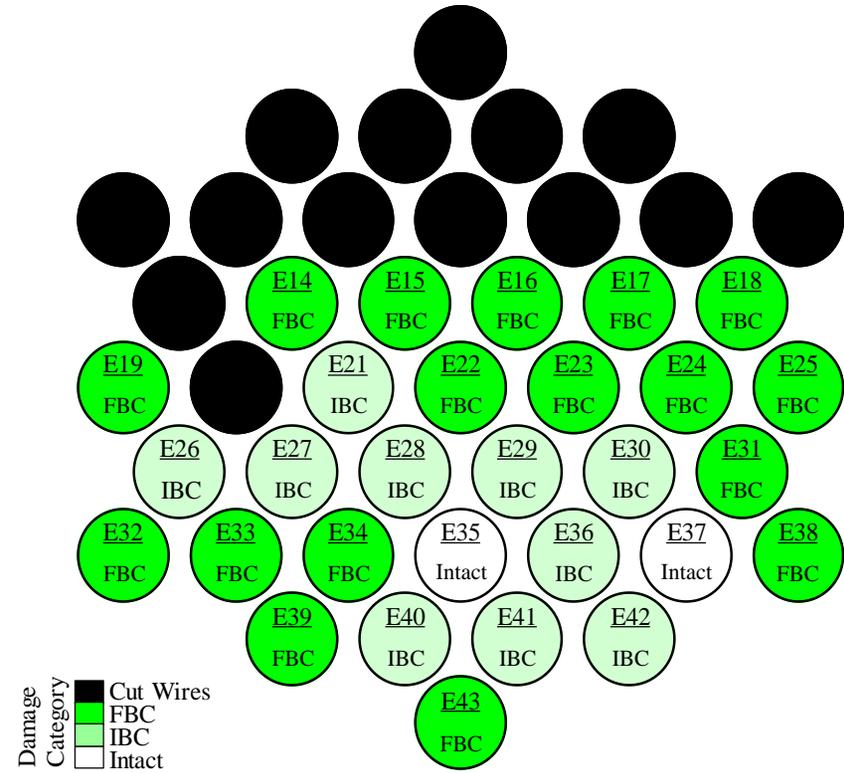
Figure 16. Bubble plot. Map of the number of damaged strands near the center of the bundle from blast test E.

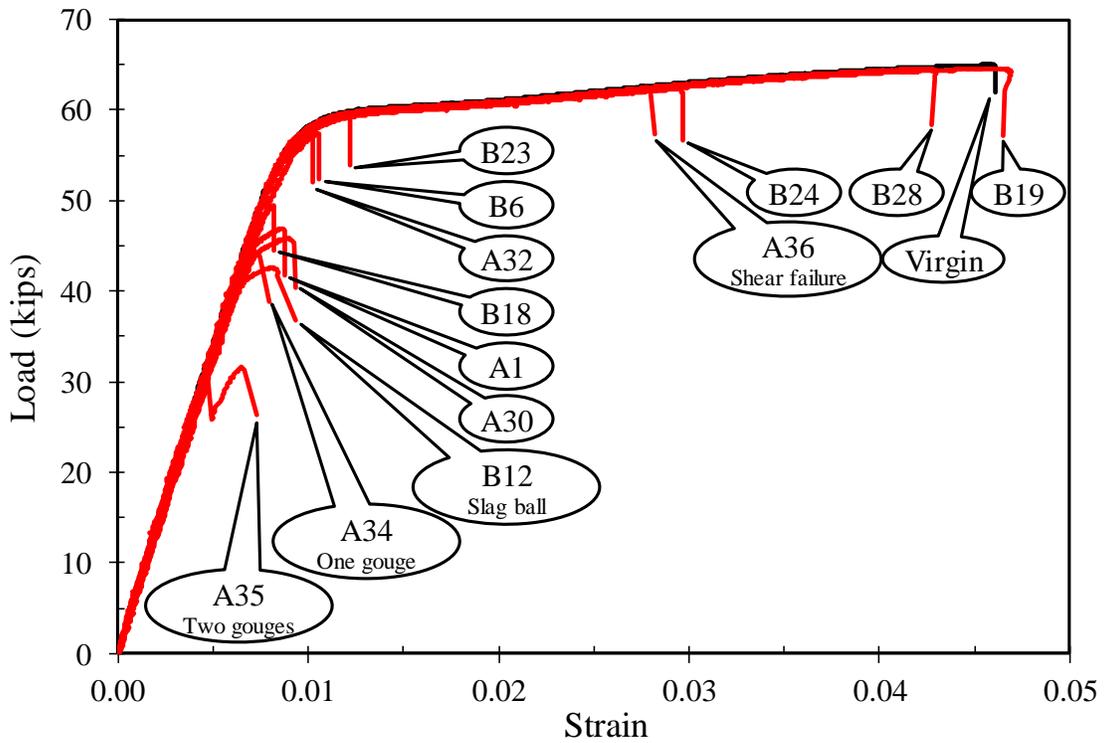
Figure 31. Graph. Load versus strain of thermal lance strands closest to heat.

The results of load versus strain for 13 strands closest to the heat source (i.e., adjacent to strands that were cut or damaged) are presented in figure 31. The results for 4 of 11 strands (A36, B19, B24, and B28) align with load versus strain curves for a virgin strand. Therefore, the proximity of a strand to the thermal cut is not a direct indicator of strength reduction. The HDPE cover of all four of these strands was melted, but the grease was intact around the king wire. The lowest residual capacities were observed after the tension tests of strands exhibiting a form of obvious heat-affected zone (HAZ) within one of the wires, like a gouge or slag ball (e.g., strands A34, A35, and B12). Despite the HAZ defects, these affected strands had residual capacities at least half the maximum load reported for the virgin strand. But the fracture was observed to occur on the elastic portion of the virgin strand reference curve. The residual capacities of remaining strands closest to the heat (A1, A30, A32, B6, B18, and B23) were between half and full capacity of the virgin strand. Similarly, the fracture was observed to occur on the elastic portion of the virgin reference curve. Of these six strands, the grease was completely burned away on four.

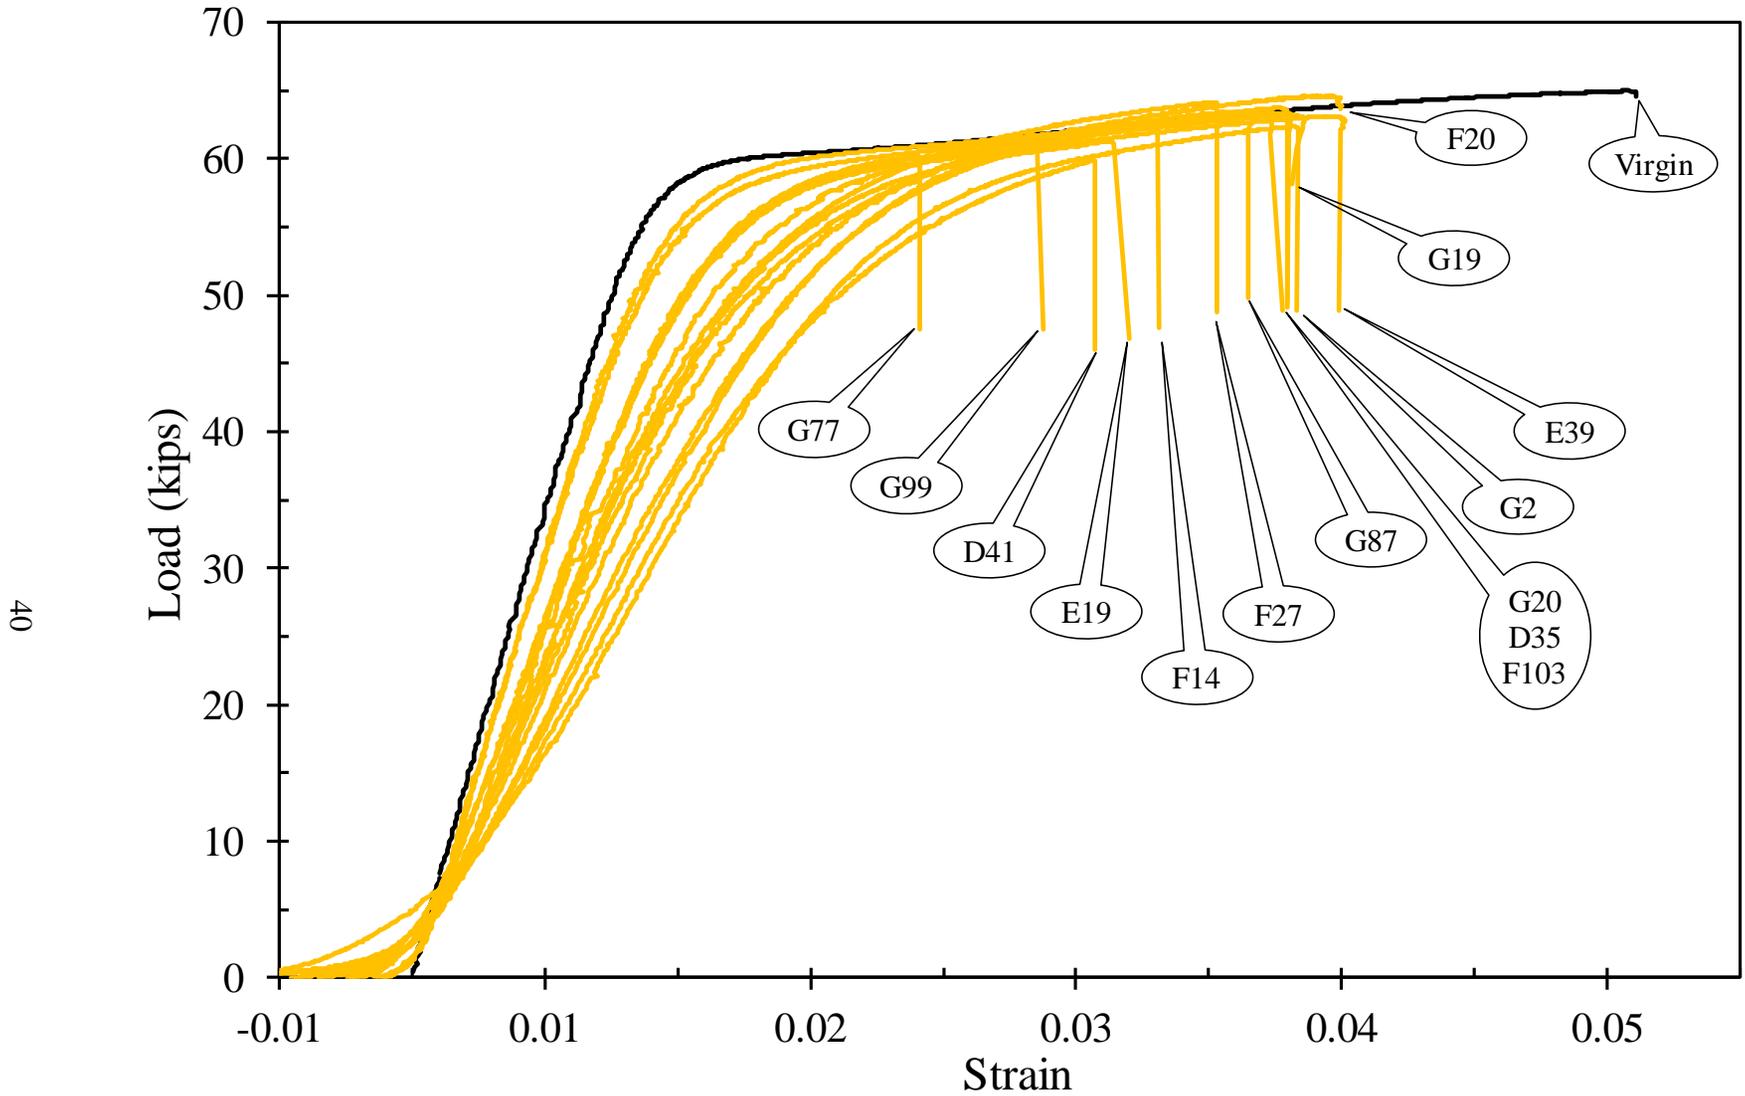
Figure 34. Graph. Load versus strain of blast FBC strands.

Figure 34 shows all the load–strain results from tension tests on FBC strands, and the soft loading response is pronounced. Generally, the load–strain behavior of these strands does not follow the reference curve of the virgin strand. The values of elastic moduli vary and show a much more gradual transition from elastic to strain hardening behavior when compared to the virgin strand curve. From the data listed in table 5 for FBC strands, all those without shear failures had AUTS ratios in excess of 92 percent; the average AUTS ratio was 98 percent. This implies, on average, the residual strength decreases about 2 percent for FBC strands. What also stands out from this batch of specimens is 8 of the 15 tested strands fractured within the gauge length of the specimen, and this did not happen in any virgin strand tests. The table footnotes indicate that for these eight strands, five of them had fractures initiated from impact damage to the strand. Impact damage is demonstrated in figure 37 from the fractured D41 strand. The arrows in the figure point to four areas where wires have impact impressions from other wires. During the blast event, strands are propelled into adjacent strands leading to these localized areas of cold work from impact. Since fractures did initiate out of these areas of impact damage, they obviously have an effect, but, on average, it is a small decrease in strength. As for the other three strands that fractured in the gauge without visual impact damage, it is possible there may have been impact damage present, but it was masked by necking of the wires near the fracture location.

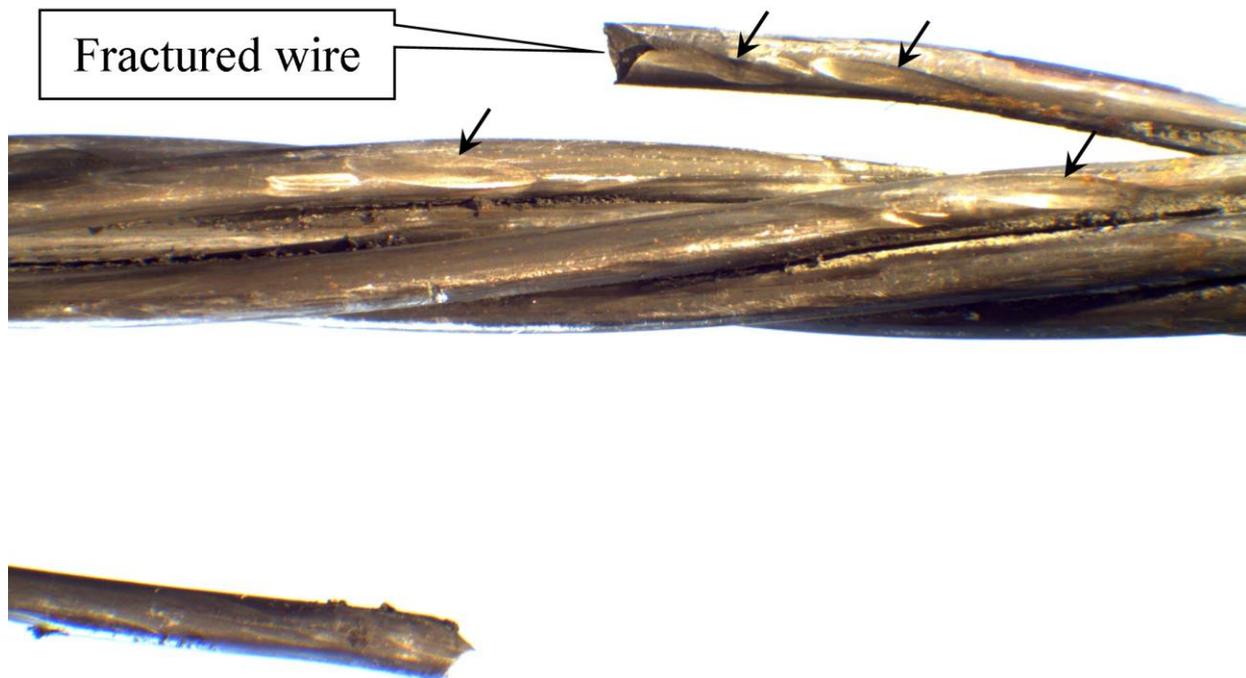
Figure 37. Photo. Fracture D41 strand showing impact marks.

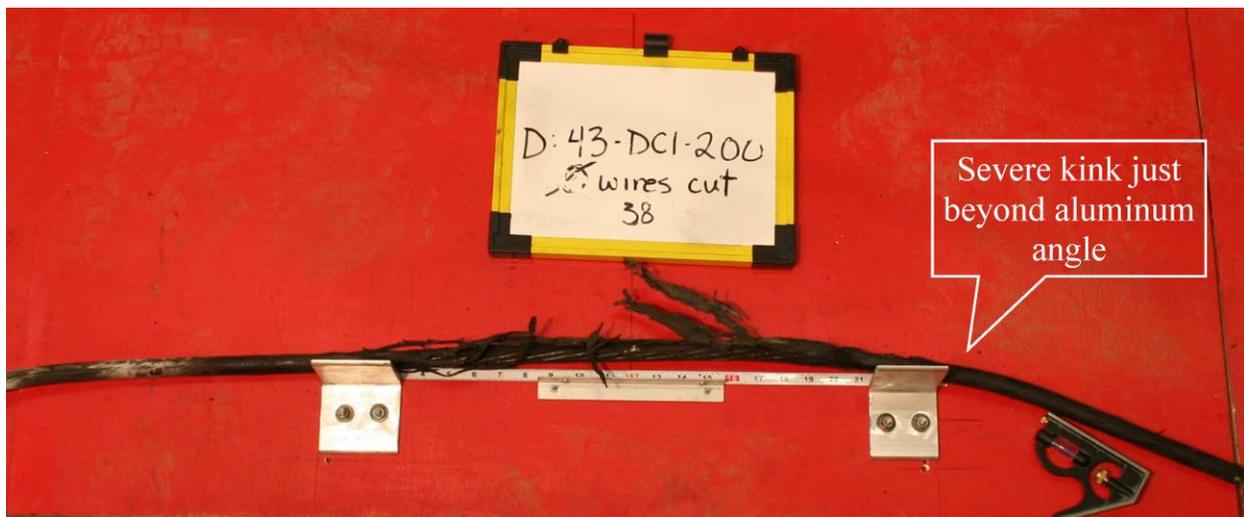
the virgin strand reference curve closely, with little initial soft behavior or deviation from the elastic slope. The notable exceptions in these two plots were the load–strain curves of tests on strand D38 (in figure 36) and D42 (in figure 35). Strand D42 had the largest lateral deformations of any strand tested. The soft behavior observed during the test of stand D42 corresponds to the straightening of the strand as observed in the majority of FBC strand tests. Strand D38 had one of the smallest lateral deformations but displayed soft behavior similar to strand D42. However, after reviewing the documentation photos, it was determined that strand D38 was fairly straight over the measured 24-inch-chord length. But, just beyond the chord measurement jig strand, D38 was very bent (see figure 38). Therefore, installing strand D38 in the testing machine would have caused another kink, which accounts for its soft behavior.

Figure 38. Photo. Strand D38 documentation.

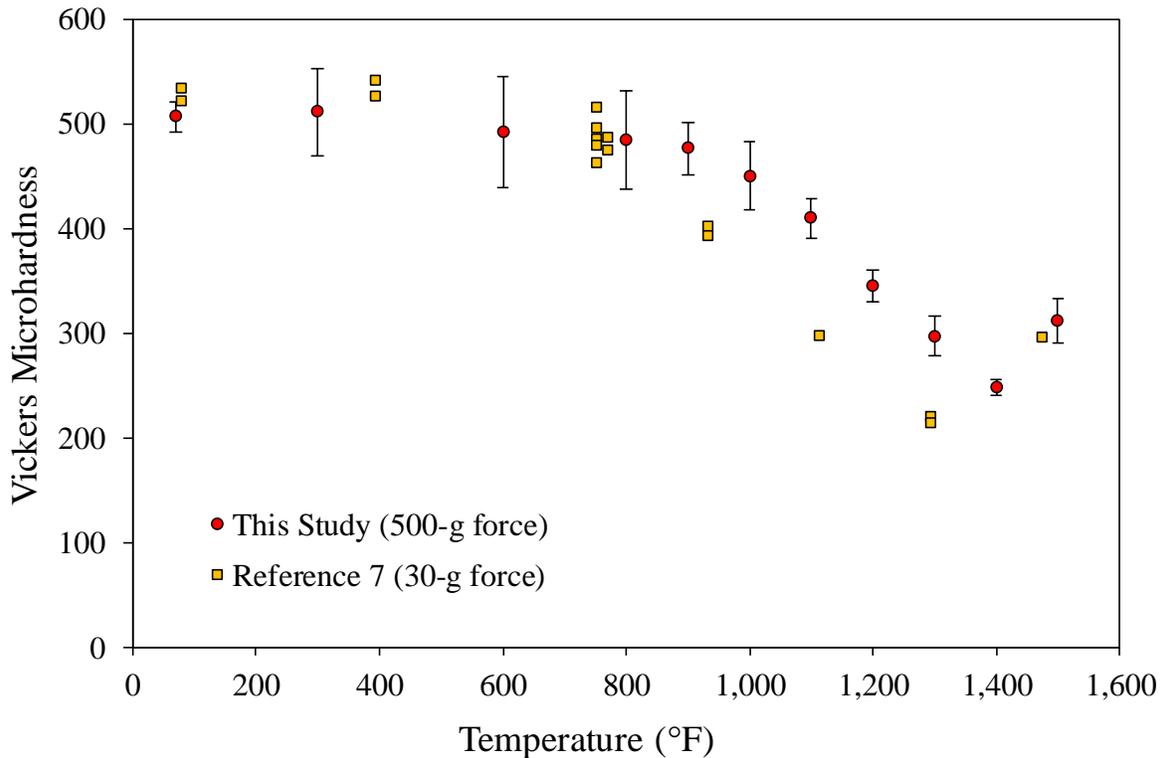
Figure 71. Scatterplot. Variation in hardness with temperature exposure.

The microstructural evaluation showed that changes in hardness started after approximately 1,000 °F. Thus, hardness test values were recorded first on 1,500 °F specimens and hardness values measured on consecutively lower temperature specimens until they remained constant. The raw data collected from each specimen are in appendix C. No variation in hardness was observed from one wire to the next in each sample, and only the bulk statistical results are discussed. Table 12 shows a summary of the average, standard deviation, and COV for each sample. The data in table 12 are graphed and shown in figure 71 with round data points. Error bars are shown for each data point representing 2 standard deviations to each side of the data point. The average data show the hardness remains constant through 900 °F and then begins to decrease until 1,400 °F. At 1,500 °F, the hardness then increases over the value at 1,400 °F. This same behavior was also reported by Robertson et al., and their data are also shown in figure 71 but plotted against the right-hand vertical axis, as they used a different hardness scale.⁽⁷⁾ The Robertson data were attained with a 90-min soak, though replicates were performed at 752 °F at 4- and 8-h soaks. The differences between the data are likely due to a strand lot and the hardness scale selected.

The other characteristic found in figure 71 is that hardness measurements are more scattered at lower temperatures but are the tightest between 1,100 and 1,400 °F. The scatter in measurements shows that hardness would only be good to assess if strands were subjected to temperatures between 1,100 and 1,400 °F, since the scatter bands in this range do not overlap with the lower temperatures. This assumption was based on an average of the 63 measurements per strand, and the graph shown in figure 72 shows the difference in scatter bands if only the center measurements in each of the seven wires are considered (shown as blue squares offset 25 °F to contrast with the red circles). This indicates that the number of measurement points could be reduced to just one within each wire, and the peak temperature between 1,100 and 1,400 °F can be uniquely identified.

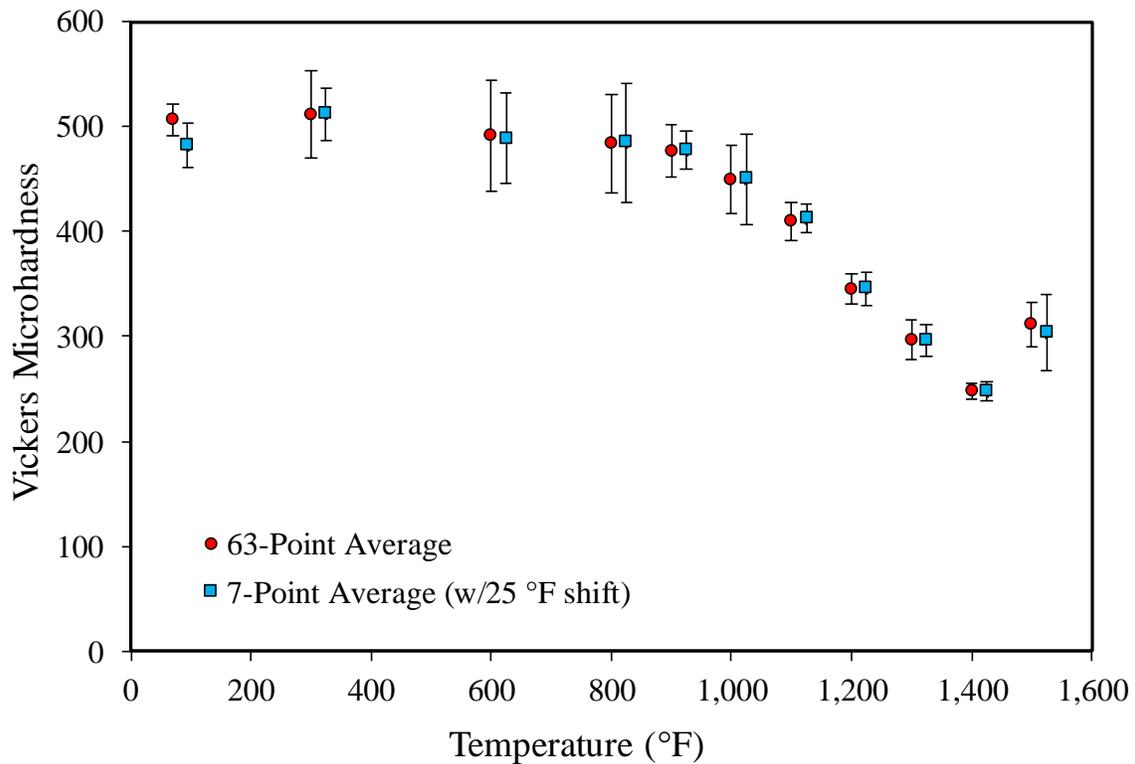
Figure 72. Scatterplot. Variation in hardness with temperature and number of measurement points.

Using the 63-point average line in figure 72, hardness measurements were used to estimate the temperature to which the individual wires were exposed from select thermal lanced strands. Due to the shape of the correlation in figure 72, no estimate of temperature exposure was made if the hardness exceeded approximately 490 HV. For values exceeding 490 HV, the maximum temperature reached was assumed less than 600 °F. Hardness less than approximately 300 HV would indicate temperature exposure exceeded 1,300 °F, and microstructure evaluations were required to determine if 1,400 °F was reached or exceeded. Using this approach, the data were assembled to create table 14, which reports the estimated temperature for each wire in the strand and the AUTS for the specimen. The AUTS is plotted versus the peak temperature in figure 73.

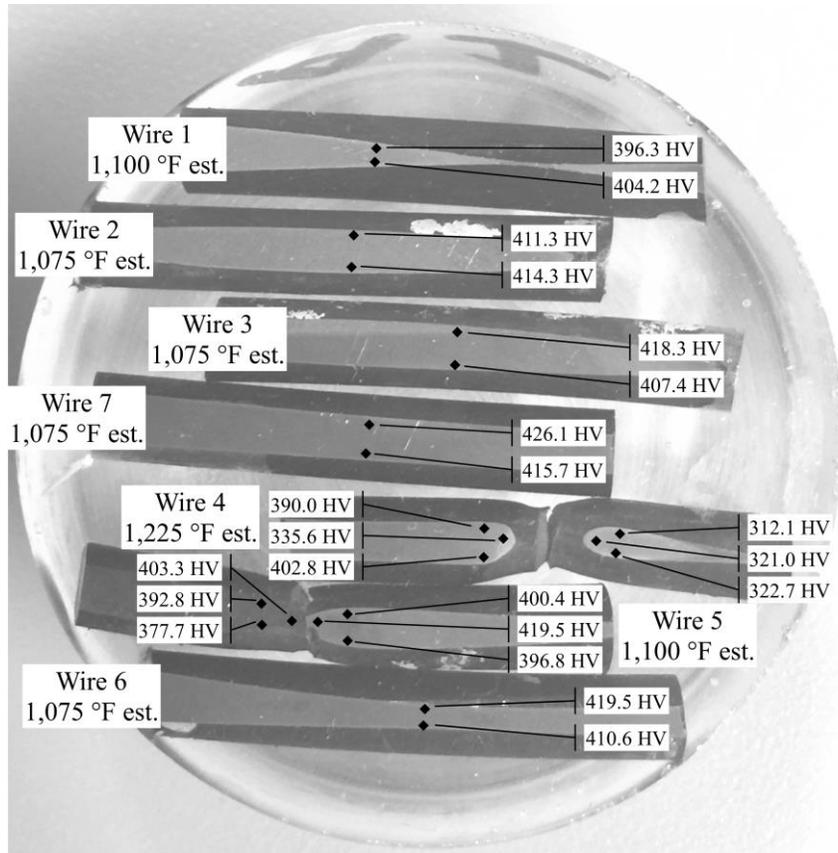
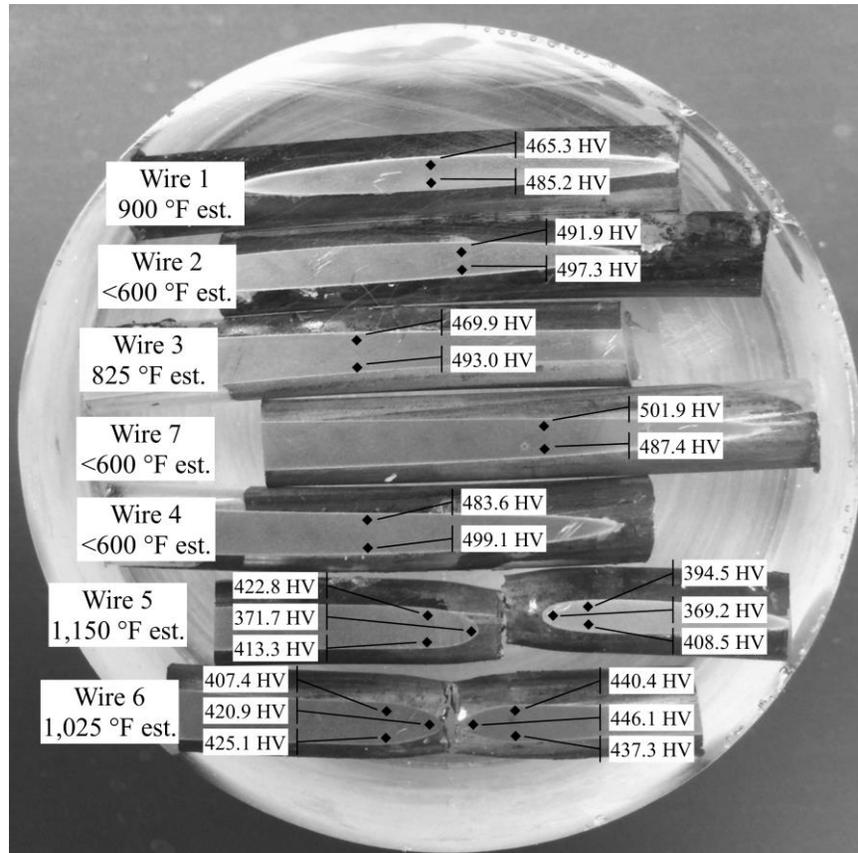
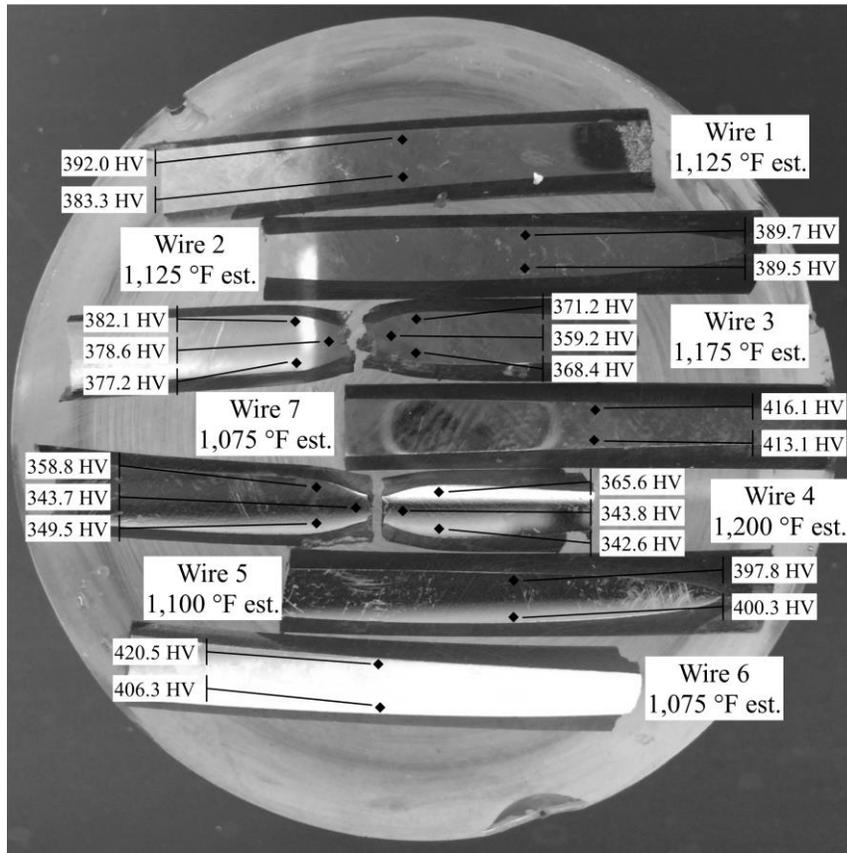
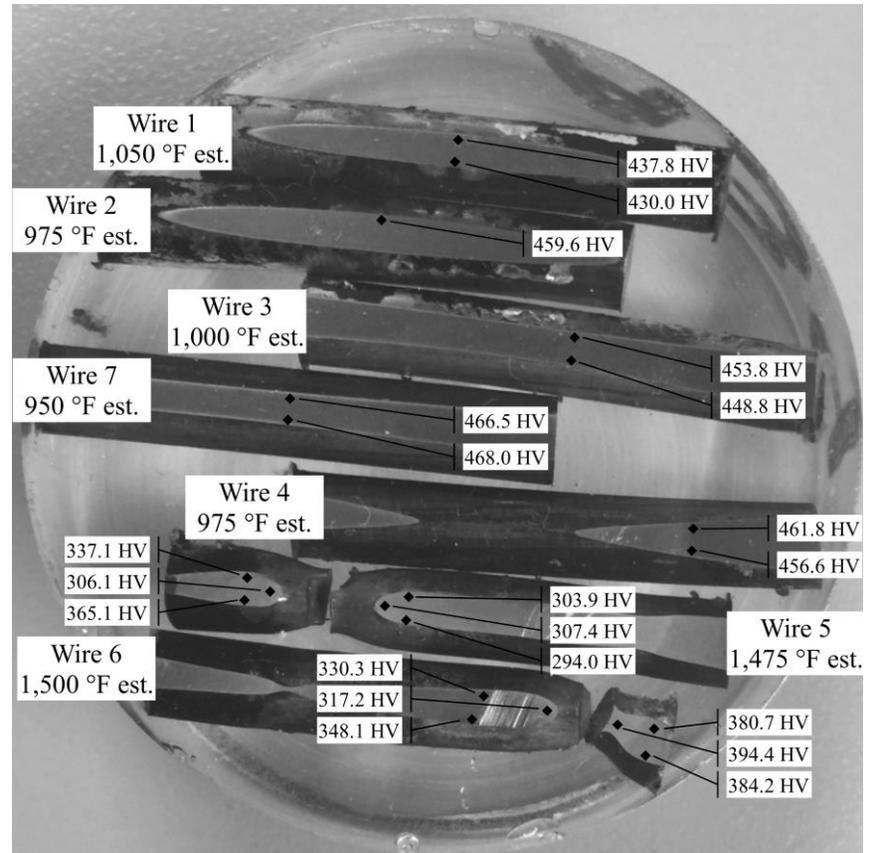
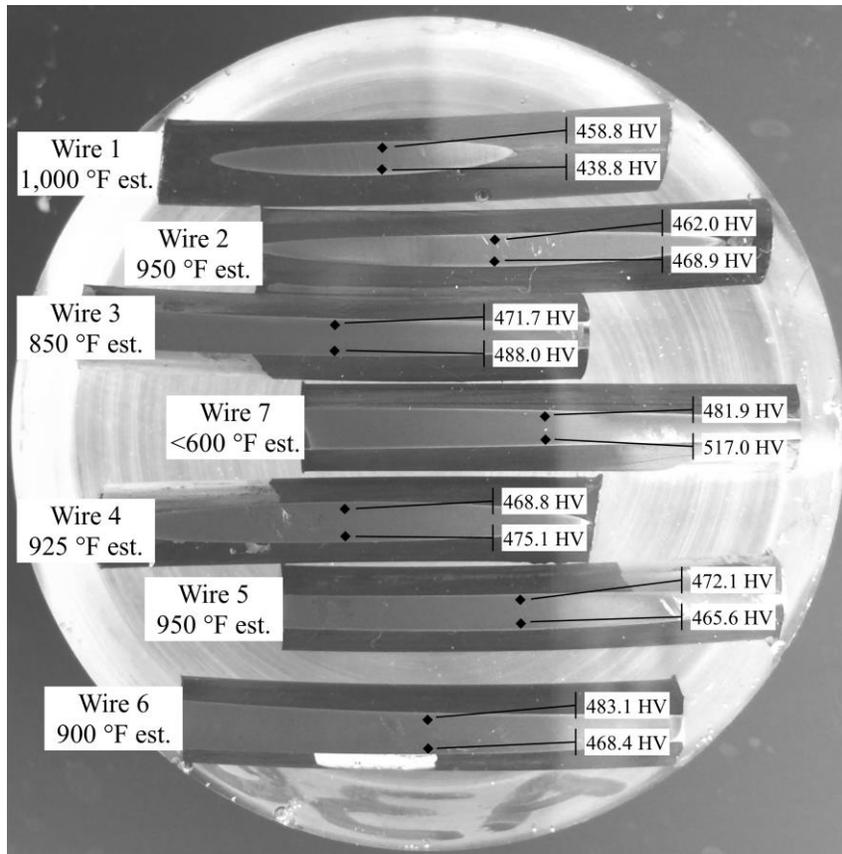
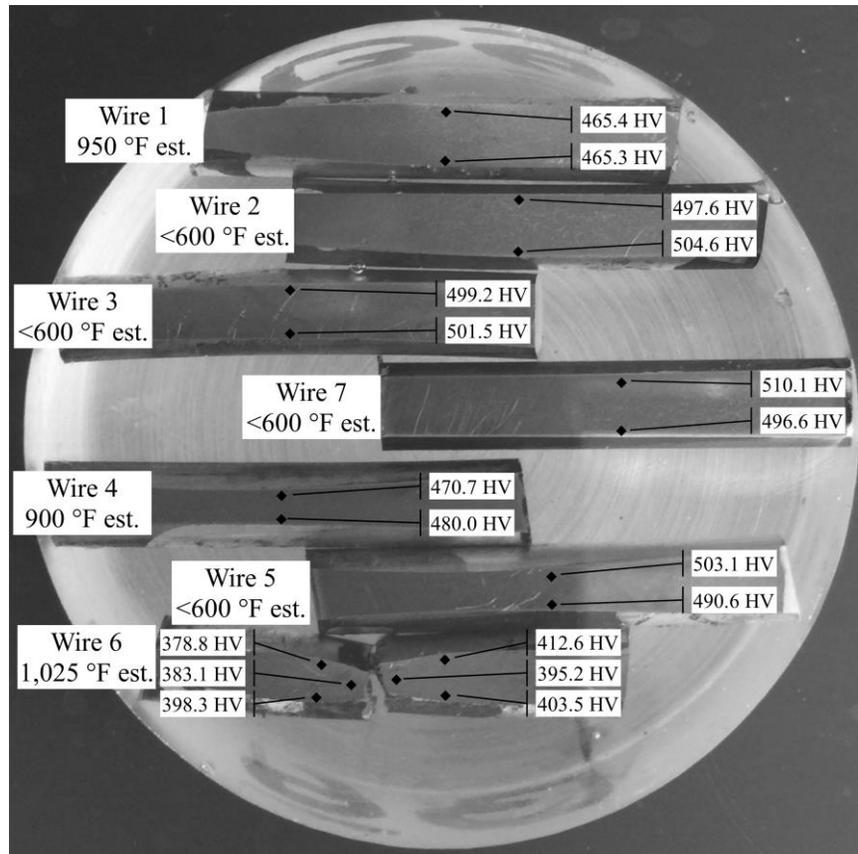
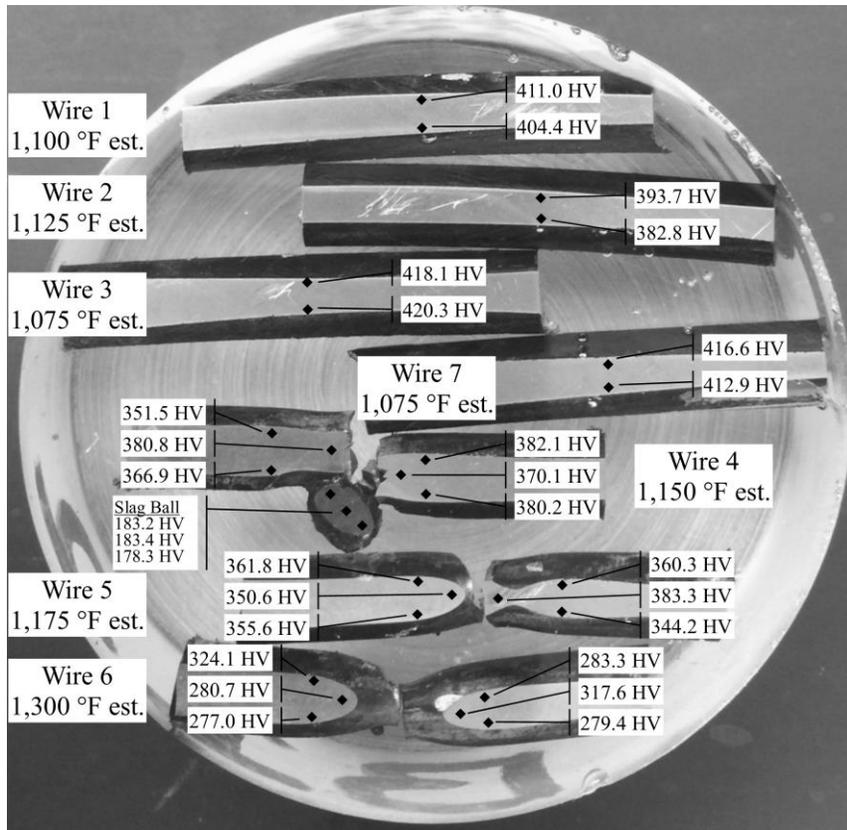
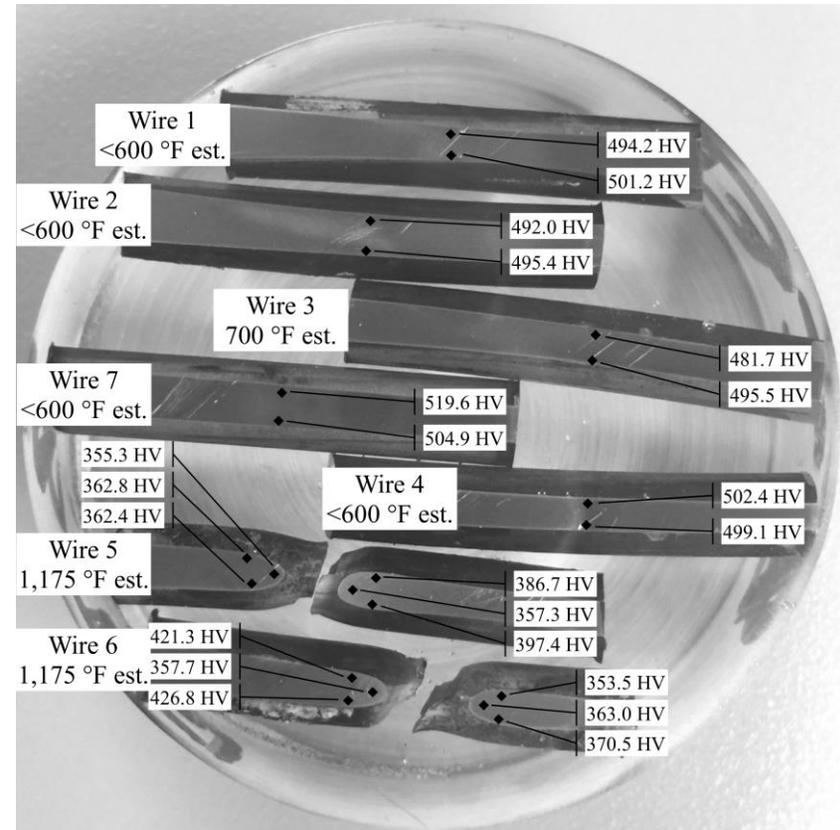
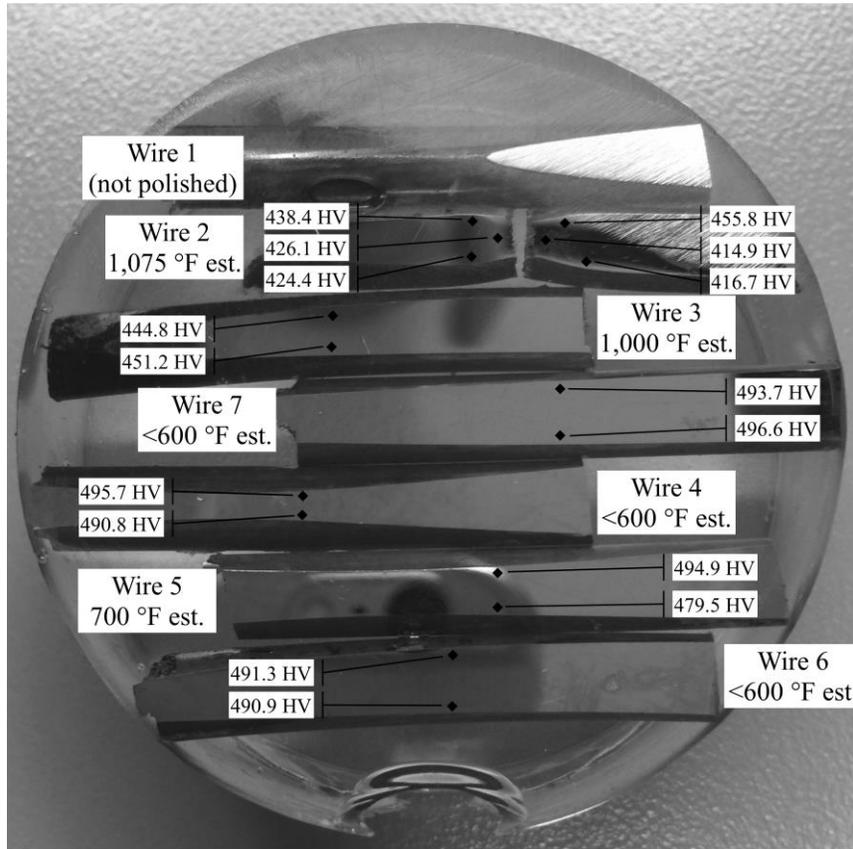
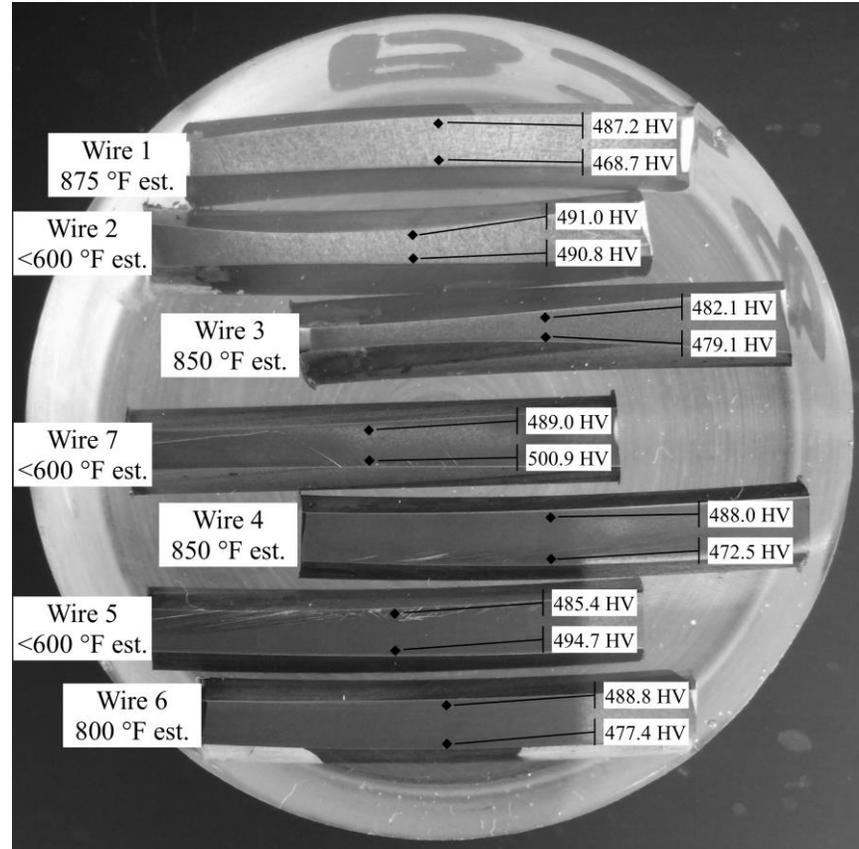
Figure 74 through figure 83 show pictures of transverse mounts of wires removed from strands A1, A32, A30, A34, A36, B6, B12, B18, B23, and B28, respectively. Each figure depicts various hardness measurements that were taken and an estimate of the temperature exposure based on the correlation presented in figure 71.
