# NCHRP Report 350 Test 3-11 of the Strong Wood Post Thrie Beam Guardrail

PUBLICATION NO. FHWA-RD-99-061

DECEMBER 1999

6. Performing Organization Code	
7. Author(s) C. Eugene Buth and Wanda L. Menges		8. Performing Organization Report No. 404211-11	
9. Performing Organization Name and Address Texas Transportation Institute The Texas A&M University System College Station, Texas 77843-3135		10. Work Unit No. (TRAIS)

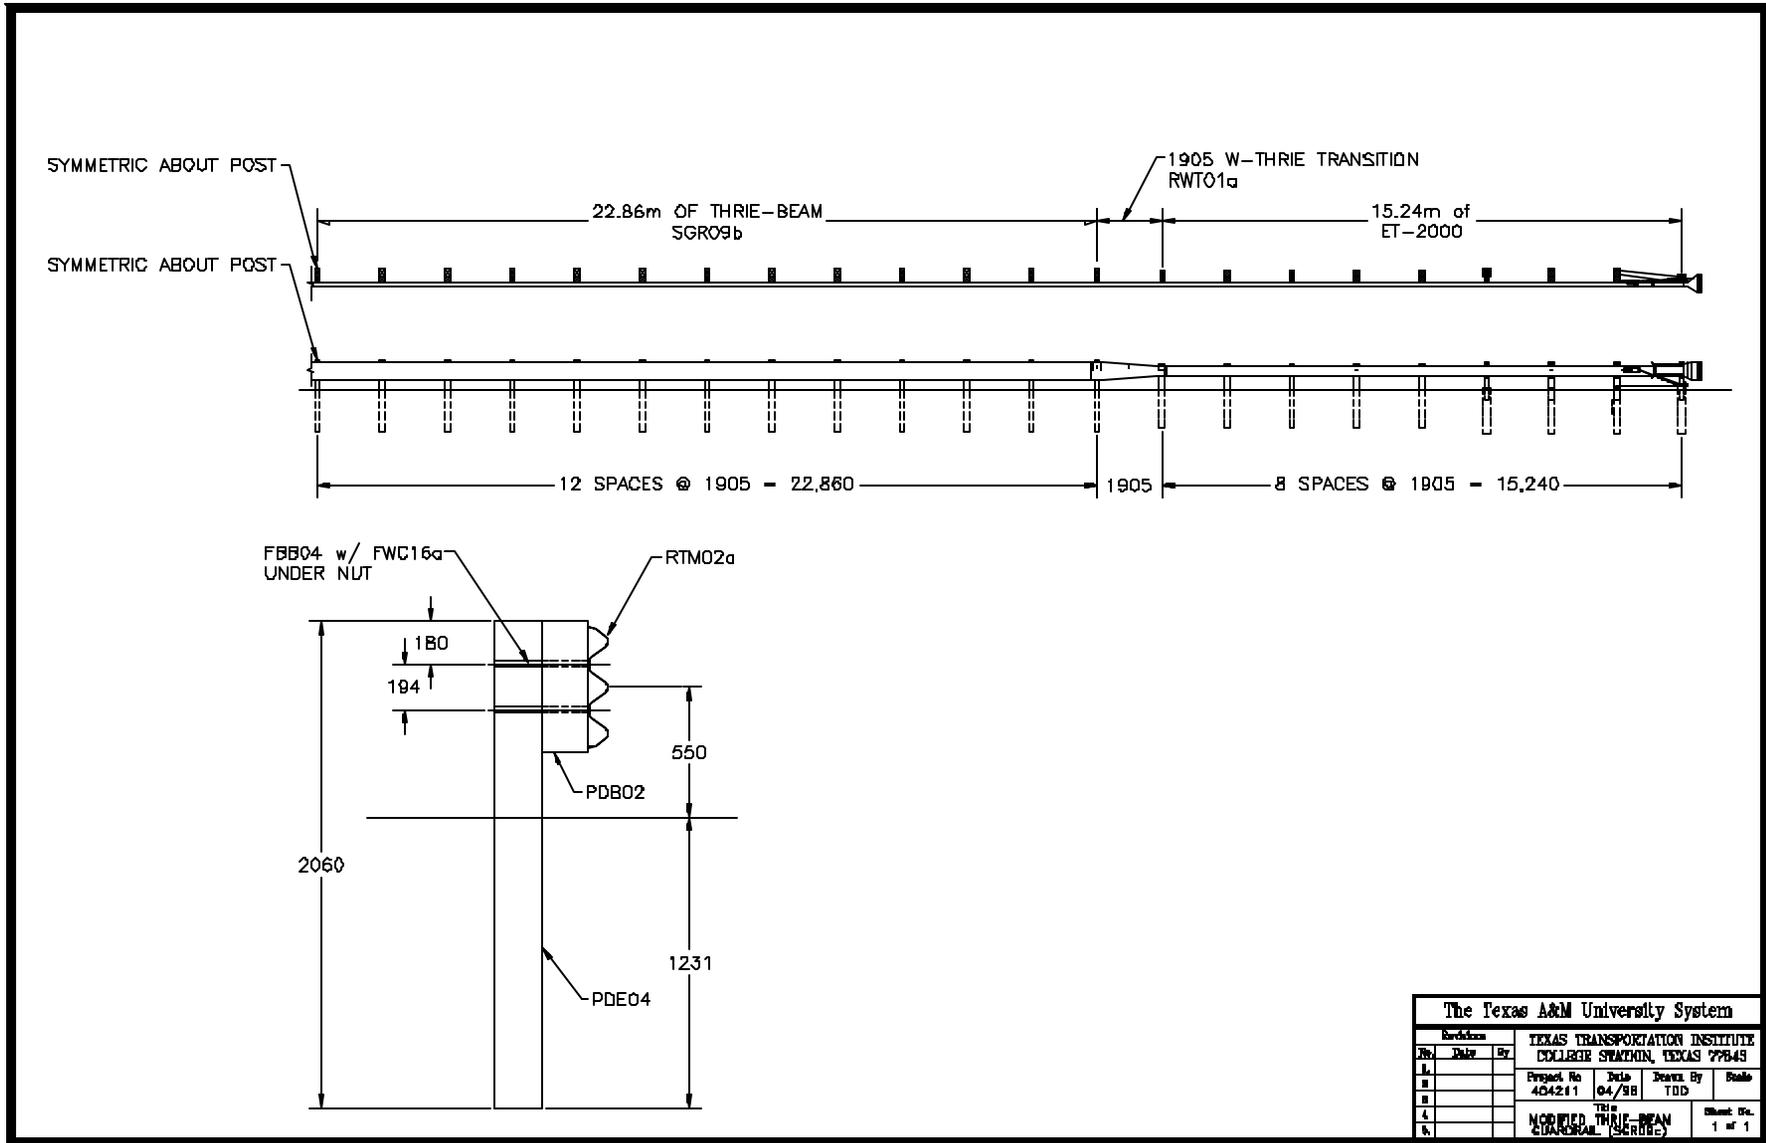
Figure 1. Details of the Strong Wood Post Thrie Beam guardrail installation.

The strong wood post thrie beam guardrail system consisted of 1.98-m-long, 150-mm by 200-mm wood posts spaced 1.9 m apart with 150-mm by 200-mm by 554-mm blockouts. A cross-section of the strong wood post thrie beam guardrail system is shown in figure 1. The blockout and rail element were attached to each post with two 16-mm-diameter button head bolts without a washer under the head. One flat washer was used under the nut. The mounting height of the thrie beam rail was 550 mm to the center and 804 mm to the top of the thrie beam rail element.

The test installation consisted of a 45.7-m-long length-of-need section of strong wood post thrie-beam guardrail with a 1.9-m-long transition section from the thrie beam to the W-beam rail element, and a 15.2-m-long ET-2000 at each end, for a total installation length of 80.0 m. The details and layout of the test installation are shown in figure 1. Photographs of the completed test installation are shown in figure 2.
