# NCHRP Report 350 Test 4-11 of the New York Two-Rail Curbless Bridge Railing

PUBLICATION NO. FHWA-RD-99-076

DECEMBER 1999

6. Performing Organization Code	
7. Author(s) C. Eugene Buth, William F. Williams, Wanda L. Menges, and Sandra K. Schoeneman				8. Performing Organization Report No. Report No. 404531-2

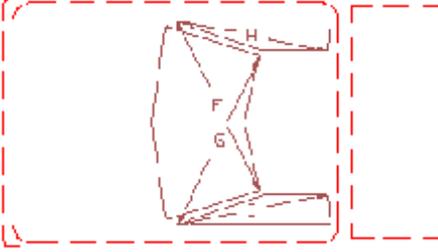
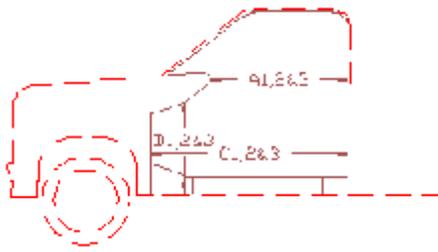
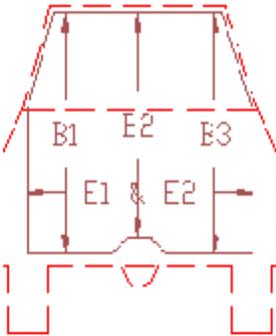
## Occupant Compartment Deformation

The vehicle sustained structural damage on the front right and the right side. The sway bar, tie rod, right front upper and lower A-arms, upper ball joint, right A-post, drive shaft, and transmission housing were all severely damaged. The front right portion of the bumper, hood, grill, fan, radiator, right front tire, and rim were damaged as shown in figure 10. The windshield was shattered and the right door was deformed outward 150 mm. The right front quarter panel and rear bed were dented. The front end of the vehicle shifted 150 mm to the left. At the rear of the vehicle on the right side, the rear tire and rim sustained damage, the rear axle was pushed back, and the rear U-bolts at the leaf springs were broken. The maximum exterior crush to the front bumper was 470 mm on the front and 340 mm on the right side. The floor pan was separated at the seam just above the upward curve (where the occupant's feet normally rest). The opening in the floor pan at the separation was judged to be wide enough to allow an occupant's foot to become jammed into the opening or go through (see lower photo in figure 11). This result was judged to have a potential for causing serious injury to the occupant. Maximum deformation of the occupant compartment was 199 mm (17.6-percent reduction in space) in the floor pan area and maximum reduction of space was 38.8 percent in the center floor pan to instrument panel area. The interior of the vehicle is shown in figure 11. Exterior vehicle crush and occupant compartment measurements are shown in appendix B, tables 3 and 4.

A1 <hr/> 1030	1045
	A2 <hr/> 1082	1070
	A3 <hr/> 1045	1025
	B1 <hr/> 1075	1075
	B2 <hr/> 1054	935
	B3 <hr/> 1090	1131

C1 <hr/> 1374	1374
	C2 <hr/> 1262	1230
	C3 <hr/> 1372	1325
	D1 <hr/> 306	312
	D2 <hr/> 98	60
	D3 <hr/> 310	420

E1 <hr/> 1591	1575
	E2 <hr/> 1589	1595
	F <hr/> 1475	1450
	G <hr/> 1475	1465
	H <hr/> 900	870
	I <hr/> 900	900
	Maximum floor pan to roof. . . . . 1129 . . . . . 930	
	Maximum lateral deformation near occupants feet . . . . . 1520 . . . . . 1390
