# NCHRP Report 350 Test 4-10 of the New York Two-Rail Curbless Bridge Railing

PUBLICATION NO. FHWA-RD-99-077

DECEMBER 1999

**Federal Highway Administration**

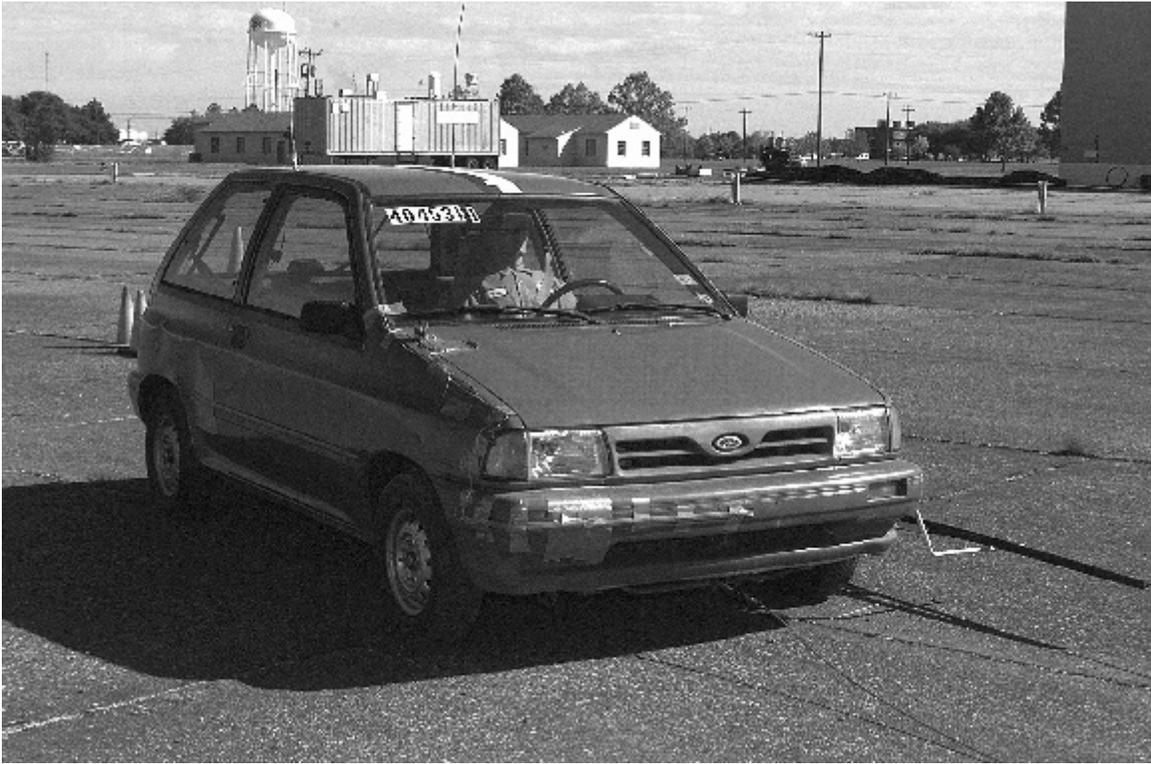
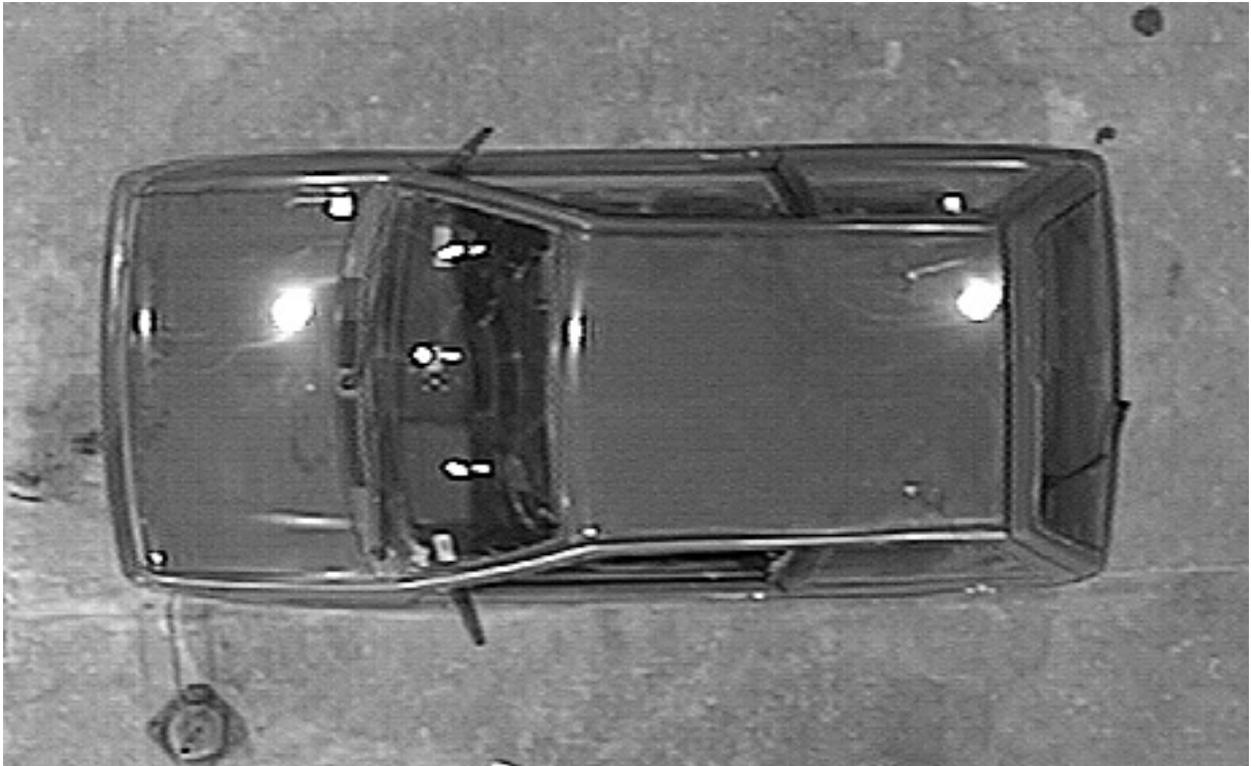
Figure 5. Vehicle before test 404531-1.

The vehicle sustained structural damage on the front right and right side. The sway bar, A-arm, motor support, and right strut and axle were all severely damaged. The front right portion of the bumper, fan, radiator, hood, tire, and wheel were damaged as shown in figure 8. The right front and rear quarter panels and right door were dented. The left front tire also sustained damage. The roof had a slight buckle on the passenger side. The maximum exterior crush was 190 mm, measured near bumper height on the right side. Maximum deformation of the occupant compartment was 15 mm (2-percent reduction in space) in the right firewall area. The door and the floor pan were deformed. The interior of the vehicle is shown in figure 9. Exterior vehicle crush and occupant compartment measurements are shown in appendix B, tables 3 and 4.

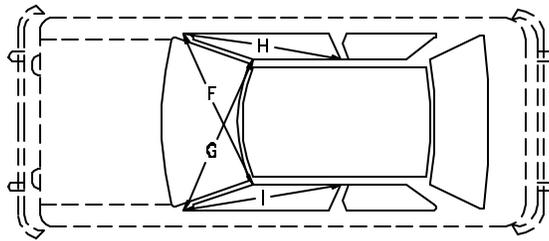
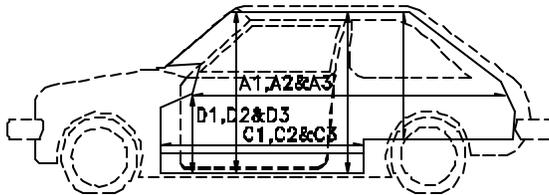
### Occupant Compartment Deformation

BEFORE	AFTER
A1	1548	1548
A2	2032	2032
A3	1550	1550
B1	995	995
B2	934	934
B3	1058	1053
B4	970	970
B5	973	973
B6	970	970
B7	860	860
B8	847	847
B9	838	838
C1	629	629
C2	625	625
C3	635	620
D1	327	327
D2	225	225
D3	330	337
E1	1252	1257
E2	1245	1260
F	1190	1190
G	1190	1185
H	900	895
I	900	900

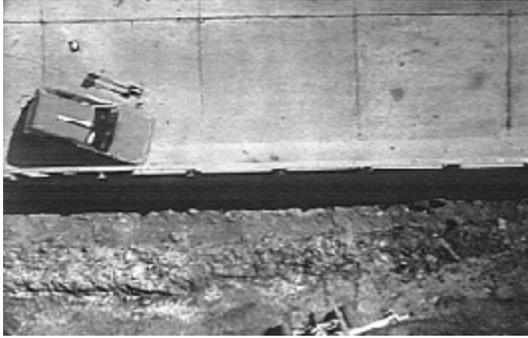
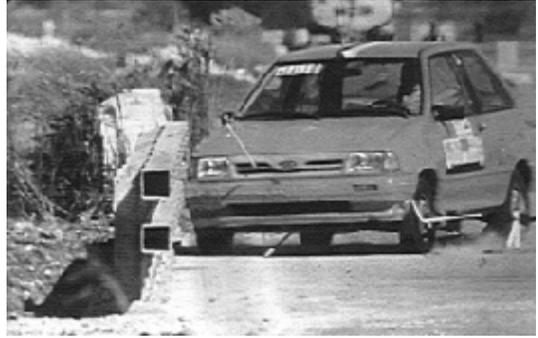
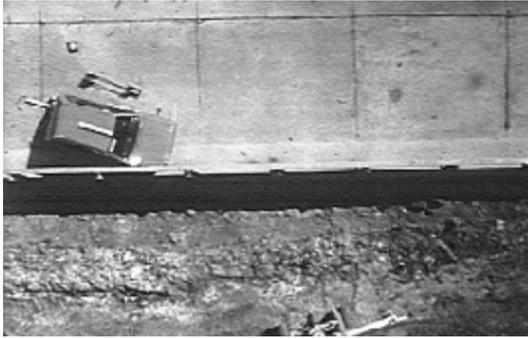
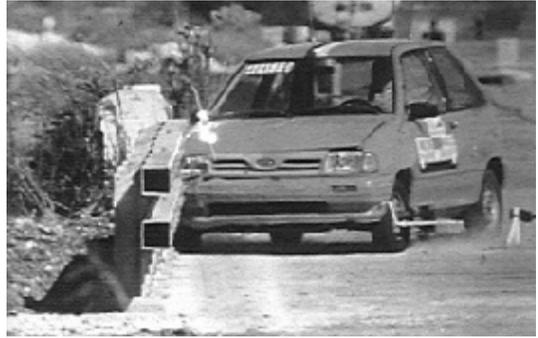
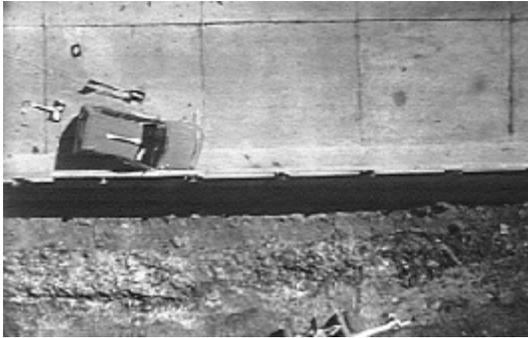
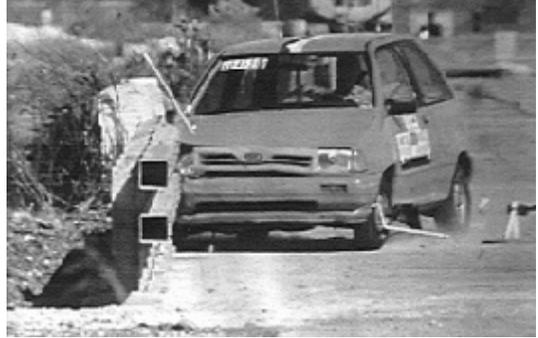
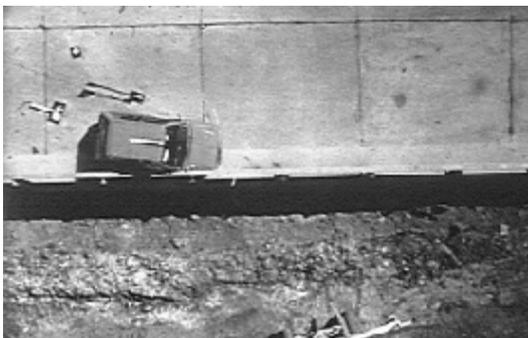
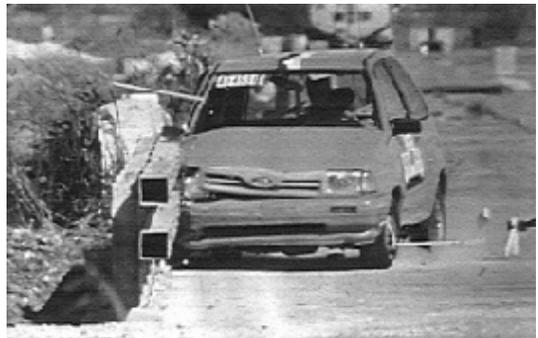
Figure 12. Sequential photographs for test 404531-1 (overhead and frontal views).

The vehicle, traveling at 100 km/h, impacted the two-rail bridge railing 1.2 m upstream from post 4, at a 19.1-degree angle. Shortly after impact, the bottom rail showed movement. At 0.010 s, the right front wheel steered left then traveled parallel with the rail. The upper rail moved at 0.012 s. At 0.017 s, the vehicle's right front wheel continued to steer left. Post 4 deformed at 0.019 s. At 0.024 s, the right front wheel canted as the upper part of the tire was pushed down from the lower bridge railing. The vehicle began to redirect at 0.038 s. The right front tire contacted the concrete and metal base of post 4 at 0.056 s, and at 0.066 s, the right front tire contacted post 4. At 0.068 s, the right-side passenger door window shattered, and at 0.097 s, the rear of the vehicle impacted the bridge railing. Traveling at 89.1 km/h, the vehicle was moving parallel to the rail element at 0.113 s. At 0.165 s, the left front tire steered right. At 0.224 s, traveling at 85.3 km/h, the vehicle lost contact with the bridge railing at a 0.8-degree angle. Brakes on the vehicle were applied at 1.4 s, bringing the vehicle to rest 52.7 m downstream from impact and 9.1 m behind the installation. Sequential photographs of the test period are shown in appendix C, figures 12 and 13.
