Evaluation of Steel Bridge Details for Susceptibility to Constraint-Induced Fracture

FINAL REPORT

Publication No. FHWA-HIF-21-046
Office of Bridges and Structures

September 2021

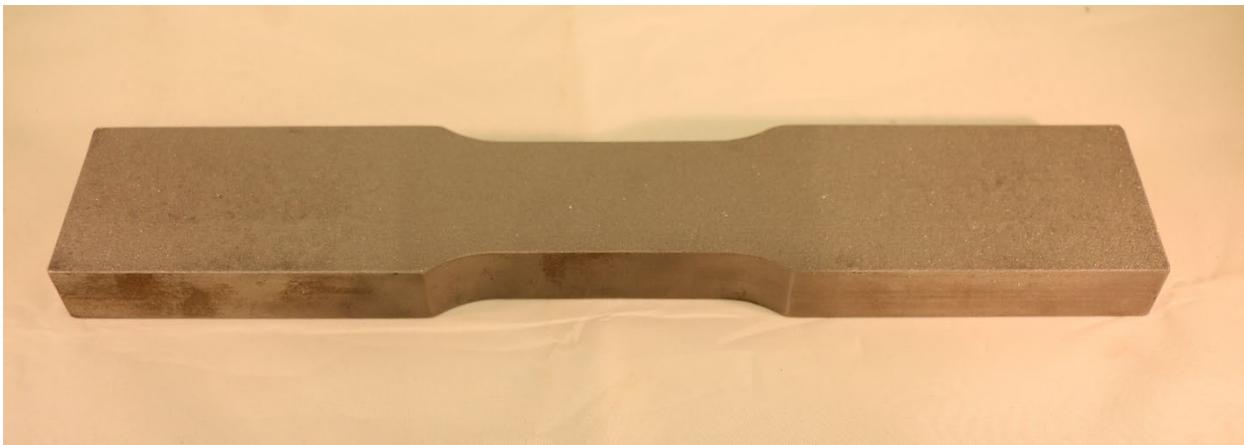
Figure 4. Photo. Typical steel tensile test coupon.

Consider a typical steel tension test coupon, as shown in Figure 4.

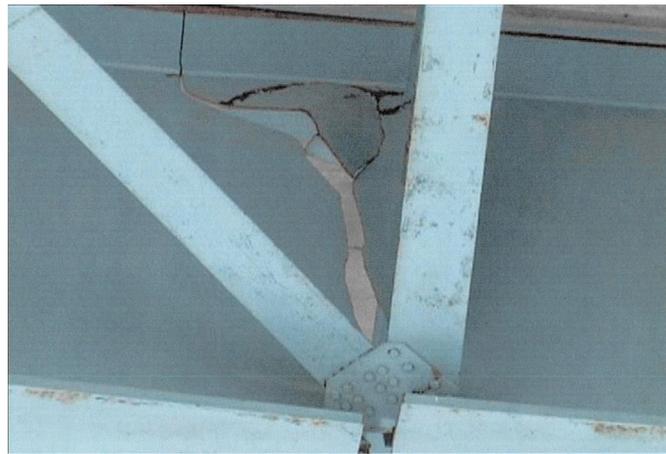
Figure 20. Photo. Hoan Bridge fracture initiation site.

Attachment A in the Cooper memorandum states that the cause of the fractures was excessive triaxial constraint with very small (1/8 inch) “web gaps” (see Section 2.4.2 for this report’s usage of the terms “web gap” and “constraint-relief gap”). The apparent point of initiation of the fracture was a small gap between a welded lower lateral bracing system connection (gusset) plate and a welded cross-frame connection plate where these various elements framed into the girder web (see Figure 19, Figure 20, and Figure 21). Attachment A also noted that low temperatures at the time did not cause the initiation of fracture, but reduced the ability of the structure to arrest dynamic crack growth. One of the “significant findings” (in the words of the memorandum) highlighted in Attachment A is particularly instructive:

A narrow gap between the gusset plate and the transverse connection/stiffener plate created a local triaxial constraint condition and increased the stiffness in the web gap region at the fracture initiation site. This constraint prevented yielding and redistribution of the local stress concentrations occurring in this region. As a result, the local stress state in the web gap was forced well beyond the yield strength of the material. Under triaxial constraint, the apparent fracture toughness of the material is reduced and brittle fracture can occur under service conditions where ductile behavior is normally expected.

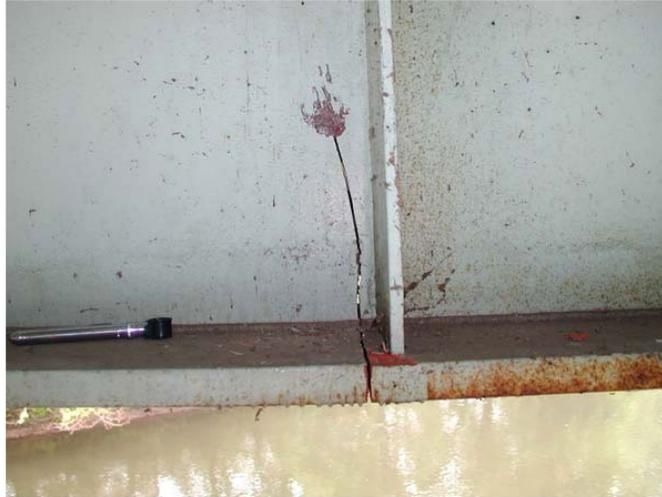
Figure 22. Photo. Fractured bottom flange of girder and arrested web fracture in the US 422 bridge. View of web on opposite side of lateral gusset connection.

On May 20, 2003, a fracture was identified during a routine inspection of a bridge carrying US 422 over the Schuylkill River in Pottstown, PA, while the bridge was undergoing retrofits to lateral gusset plate connections. The bridge was designed and built in 1965. The fracture occurred in one of the two main girders in the bridge cross-section and initiated at the intersection of the web with a welded lateral bracing connection plate and a welded cross-frame connection plate, approximately 3 inches above the bottom (tension) flange (see Figure 22 and Figure 23). The fracture extended 6 inches above the lateral bracing connection plate. The fracture was discussed by Connor et al. (2007), who concluded that the cause of the fracture was excessive triaxial constraint and poor weld quality. Fracture occurred at two separate locations at the lateral connection plate nearly simultaneously. Fracture occurred even though the material met AASHTO Zone 2 fracture-critical toughness criteria for Grade 36 steel (Connor et al., 2007). There was no evidence of an initiating welding discontinuity or fatigue crack extension prior to the fracture.

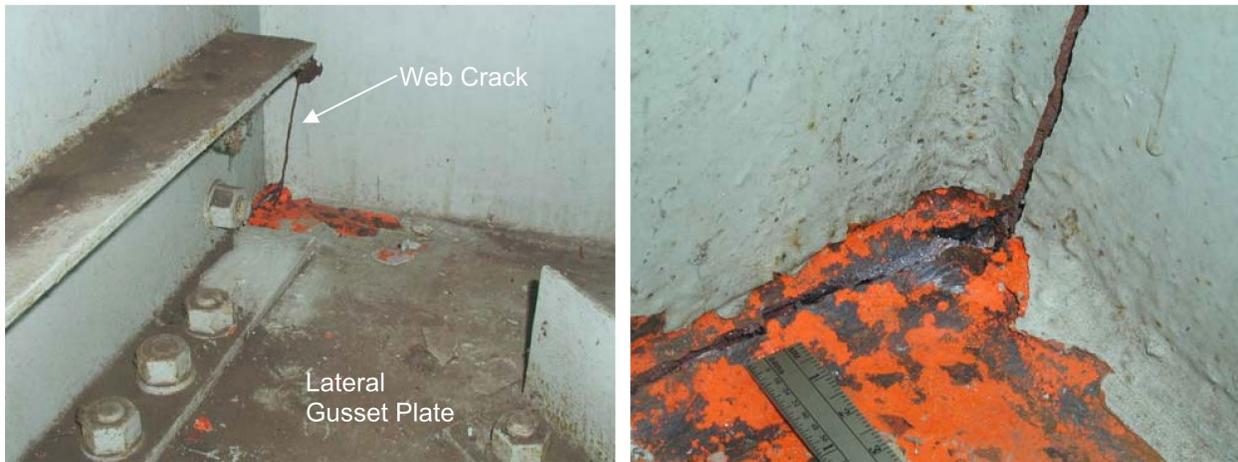
Figure 23. Photo. View of lateral gusset plate connection and fracture at the weld intersection of the gusset and vertical stiffener plates to the web in the US 422 bridge

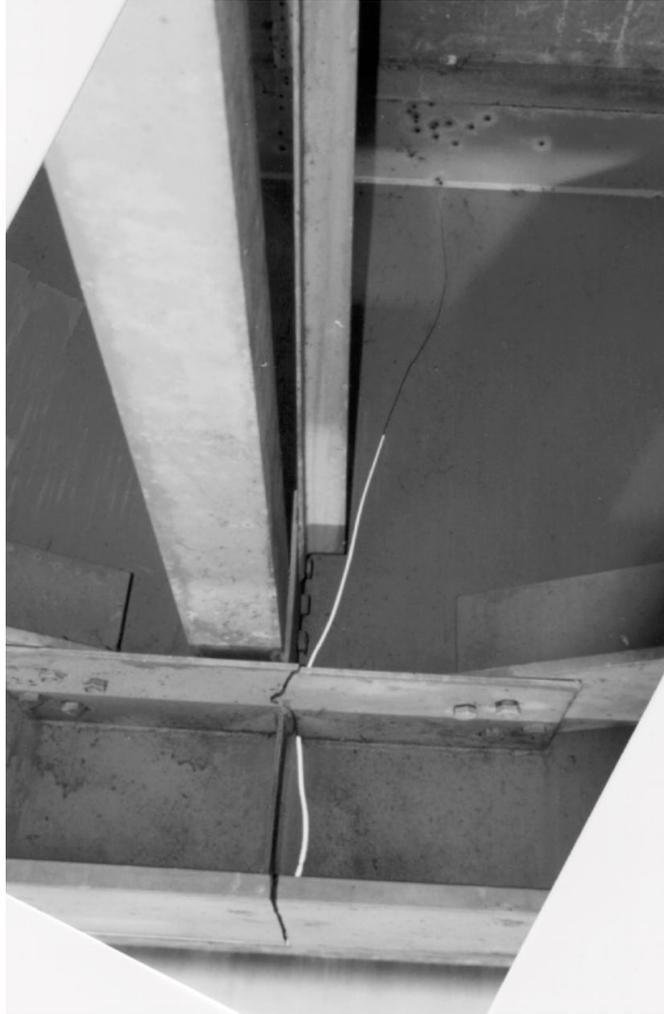
Figure 25. Photo. View of fracture in the outside plate girder of the I-64 Blue River Bridge.

As illustrated in Figure 25, Figure 26, and Figure 27, the details in the Blue River Bridge were similar to the Hoan Bridge details, with small but significant differences. Notably, the Blue River Bridge’s lateral bracing connection plates were welded to the cross-frame connection plates, but the welds do not intersect the welds connecting the lateral bracing connection plates to the web, resulting in a discontinuity in the longitudinal attachment (the lateral bracing connection plate). Furthermore, the cross-frame connection plates were not welded to the tension flange of the girder as is now specified in the AASHTO BDS (AASHTO, 2017a) (23 CFR 625.4(d)(1)(v)), and the lateral gusset plate was not attached to the cross-frames (referred to as the “vertical diaphragms” in the Bowman report). Both conditions contributed to distortion-induced fatigue and out-of-plane bending of the web in the vicinity of the intersection of the lateral gusset and cross-frame connection plates with the web.

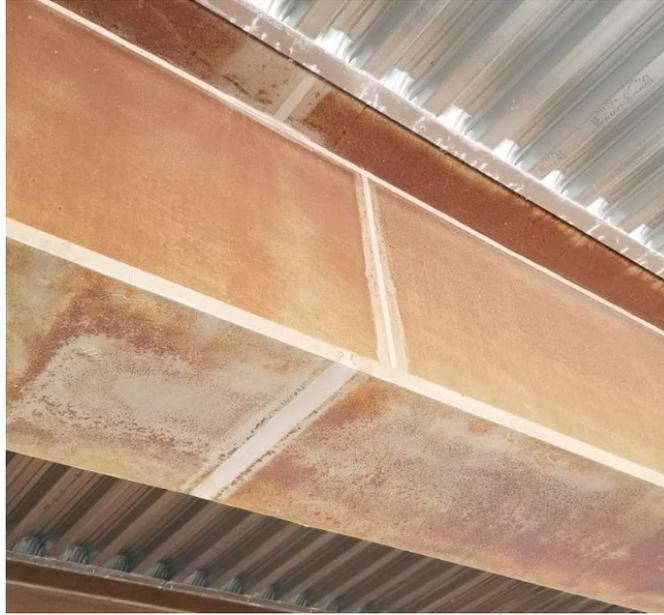
Figure 38. Photo. Steel plate girder with flange-to-web welds intersecting CJP groove welds in butt joints used to accomplish flange and web shop splices.

One of the most common bridge details featuring intersecting welds is the intersection of flange-to-web fillet welds with flange shop splices accomplished using CJP groove welds in butt joints. This situation is unavoidable in many bridge designs. The flange shop splice is generally accomplished prior to attaching the flange to the web. While there are clearly intersecting welds in this detail, both a qualitative evaluation and a long history of good performance support that this detail is not subject to an elevated susceptibility to CIF. See Figure 37 and Figure 38.

A similar, related detail involves the intersection of flange-to-web fillet welds with web shop splices accomplished using CJP groove welds in butt joints. This case of intersecting welds is also, for all practical purposes, unavoidable in many bridge designs. The web shop splice is generally accomplished prior to attaching the web to the flange. See Figure 38 and Figure 39.

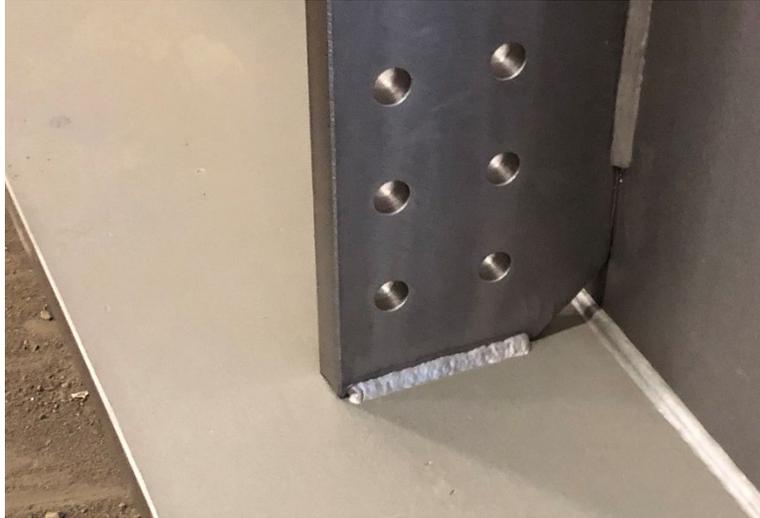
Figure 41 shows the typical detailing currently used when welding a transverse stiffener to a steel plate girder. Similar details are used to attach transverse connection plates and bearing stiffeners to a steel plate girder. Figure 58 shows a photo of a transverse connection plate with similar detailing. A cope is provided in the corner of the connection plate to clear the girder flange-to-web fillet welds. The fillet welds attaching the transverse connection plate to the girder web and flanges are stopped short of the cope; the dimension from the end of the weld to the edge of the stiffener is called the “hold-back” dimension. This type of detailing leaves the faying surfaces between the transverse connection plate and the girder web and flanges unsealed in the unwelded areas. In addition, some fabricators have noted that the practice of various owner-agencies specifying different hold-back dimensions sometimes leads to confusion and fabrication errors.

Figure 58. Photo. Transverse stiffener to a steel plate girder.

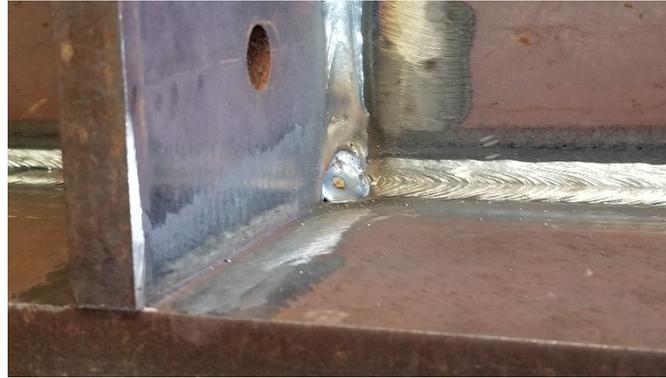
questions are mostly related to trying to avoid discontinuities in the welds, which might represent crack-like or notch-like planes of discontinuity and might contribute to an elevated susceptibility to CIF. Figure 60 shows such a detail partially completed, with the stiffener-to-web weld completed but the stiffener-to-flange weld not yet completed. Figure 61 shows the fully completed detail. Both the stiffener-to-web and the stiffener-to-flange weld stop in the corner; at that location there are greater chances for introducing weld discontinuities.

Figure 60. Photo. Transverse stiffener-to-web weld continuous into the corner at the intersection of the stiffener, web, and flange.

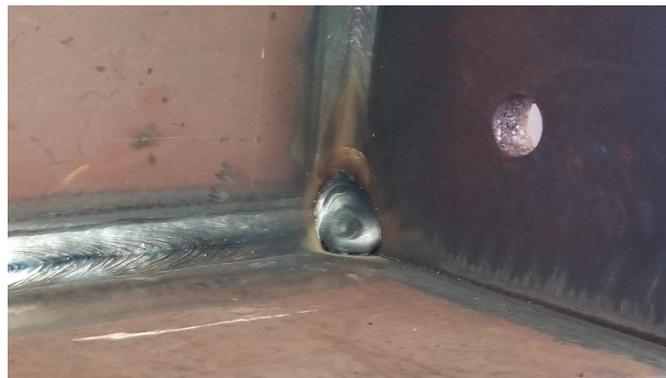
Figure 61. Photo. Transverse stiffener-to-flange weld continuous into the corner at the intersection of the stiffener, web, and flange.

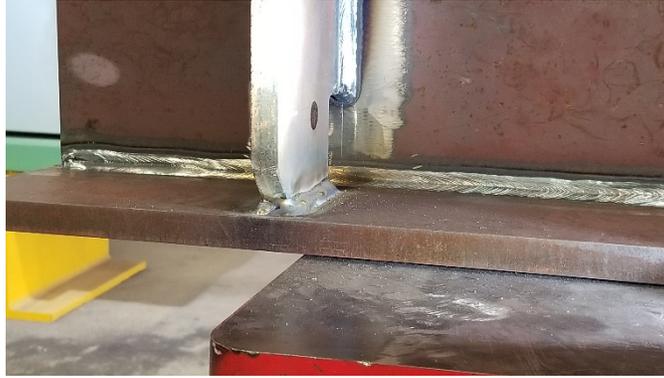
Another type of detailing would be to retain the cope and wrap the welds completely around the transverse stiffener or connection plate. See Figure 62, Figure 63, and Figure 64. This type of detailing might be preferable for hot dip galvanized steel structures; when dipped in the galvanizing bath the molten zinc can flow around the stiffener base and coat the inside surface of the cope. See also Article C6.13.3.7 of the AASHTO BDS (AASHTO, 2017a) (23 CFR 625.4(d)(1)(v) for additional information related to sealing of faying surfaces in galvanized structures.

Figure 62. Photo. Transverse stiffener-to-flange weld completely wrapped around the base of a coped stiffener for sealing.

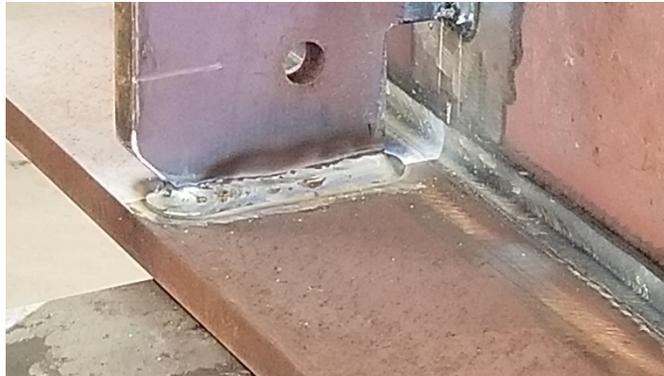
Figure 63. Photo. Transverse stiffener-to-flange weld completely wrapped around the base of a coped stiffener for sealing.

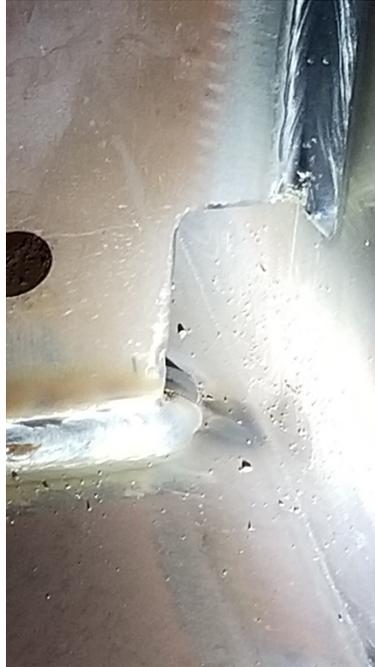
Figure 64. Photo. Transverse stiffener-to-flange weld completely wrapped around the base of a coped stiffener for sealing.
