# CULVERT INSPECTION MANUAL

## SUPPLEMENT TO THE BRIDGE INSPECTOR'S TRAINING MANUAL

**Report No.  
FHWA-IP-86-2**

**Final Report  
July 1986**

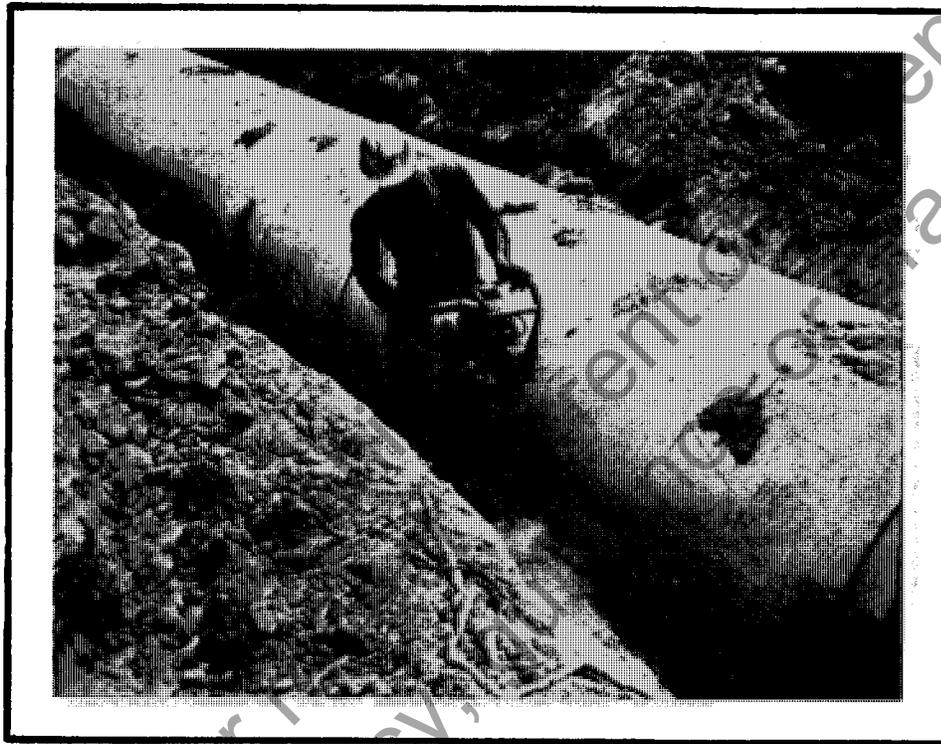
Exhibit 2. Attention to construction details such as compaction, bedding, and trench width is critical to proper culvert performance.

- Construction--Careful attention to construction details such as bedding, compaction, as shown in exhibit 2, and trench width during installation is important to the structural integrity of the culvert. Poor compaction or poor quality backfill around culverts may result in uneven settlement over the culvert and possibly structural distress of the culvert.

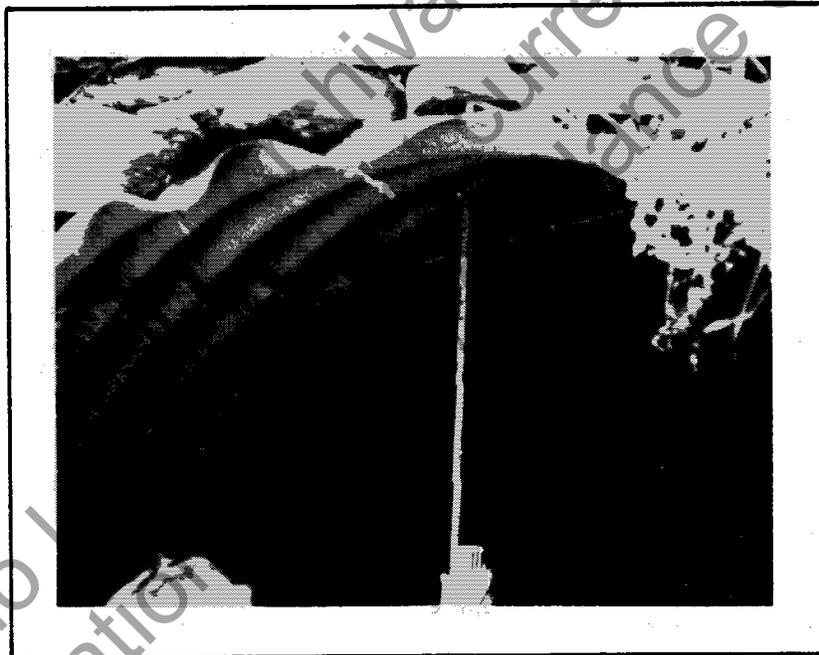
Exhibit 6. Stringline and rule being used to check middle ordinate of top plate of structural plate culvert.

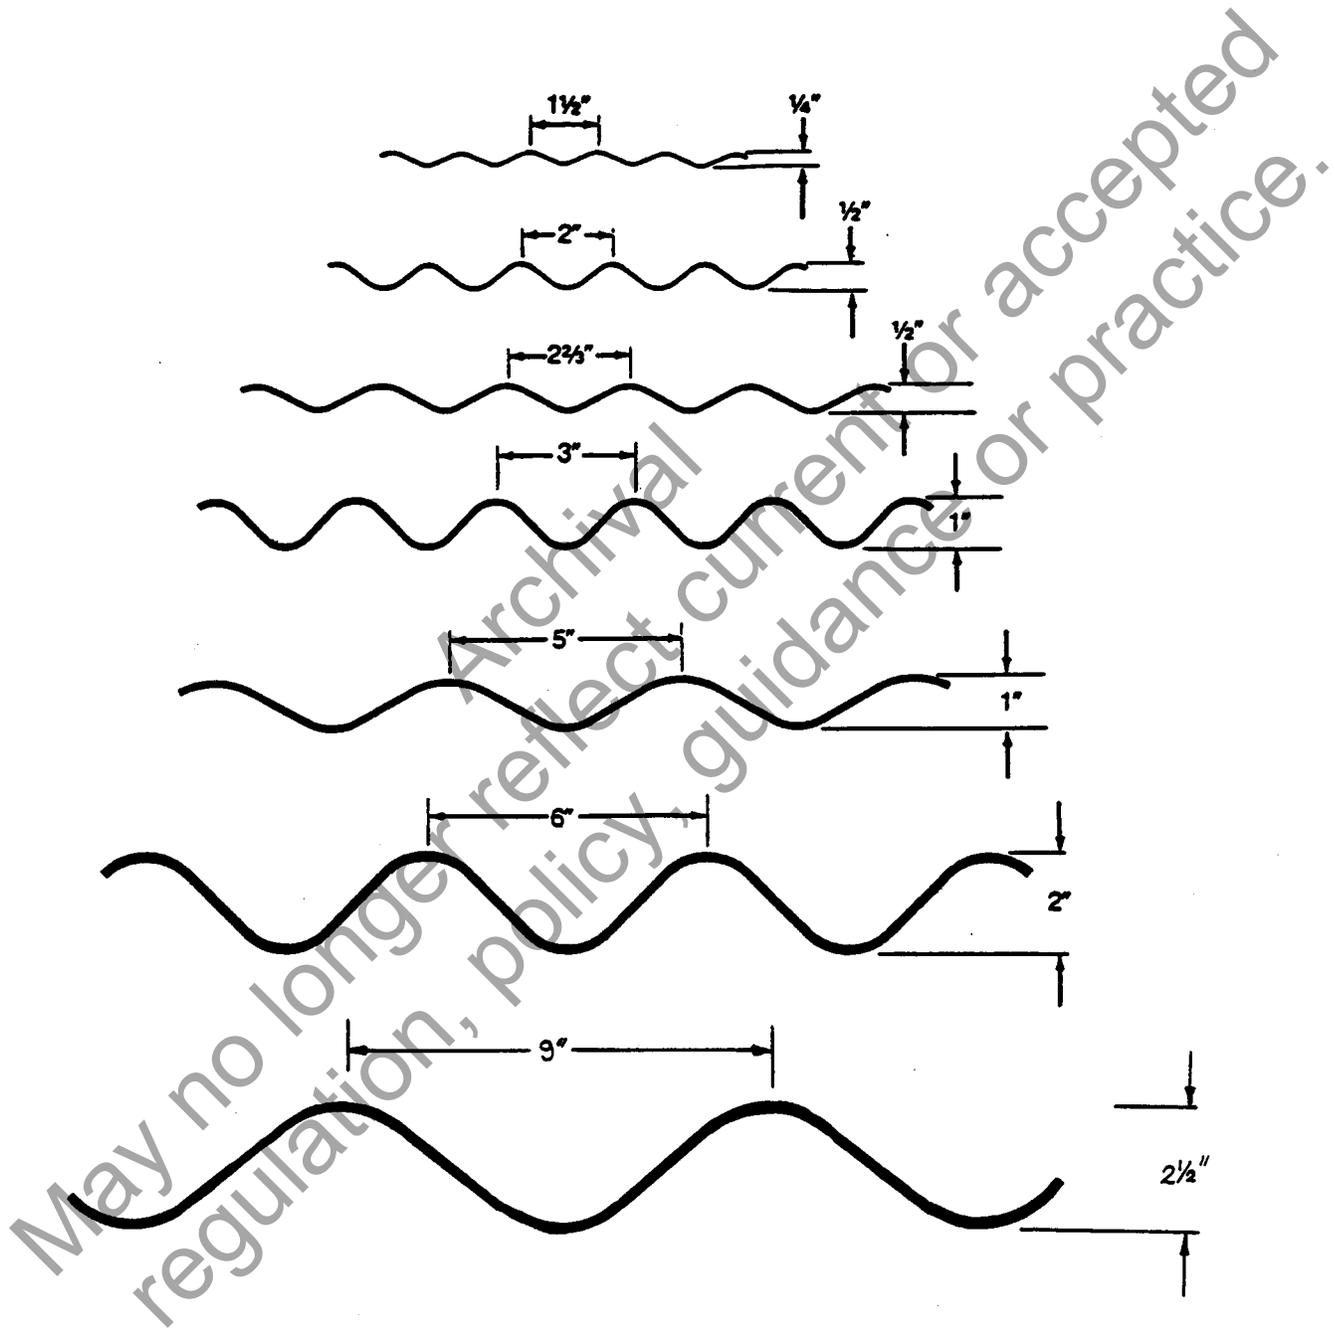
Exhibit 12. Common corrugation patterns (not to scale).

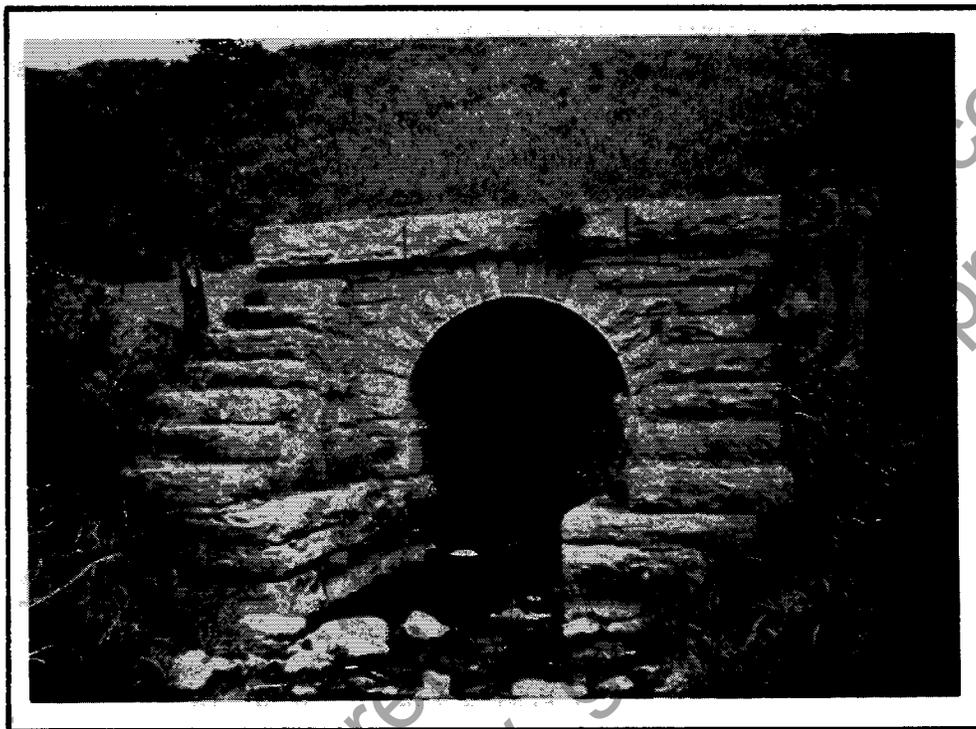
Exhibit 13. Masonry arch culvert. In some areas masonry arches and masonry box culverts are common. With good foundations these culverts have long service lives.

but the most common use of stone is for headwalls where a rustic or scenic appearance is desired. A stone arch culvert is shown in exhibit 13. While brick is rarely used for culvert barrels, it is frequently used in the construction of manholes and inlets in storm drainage systems.

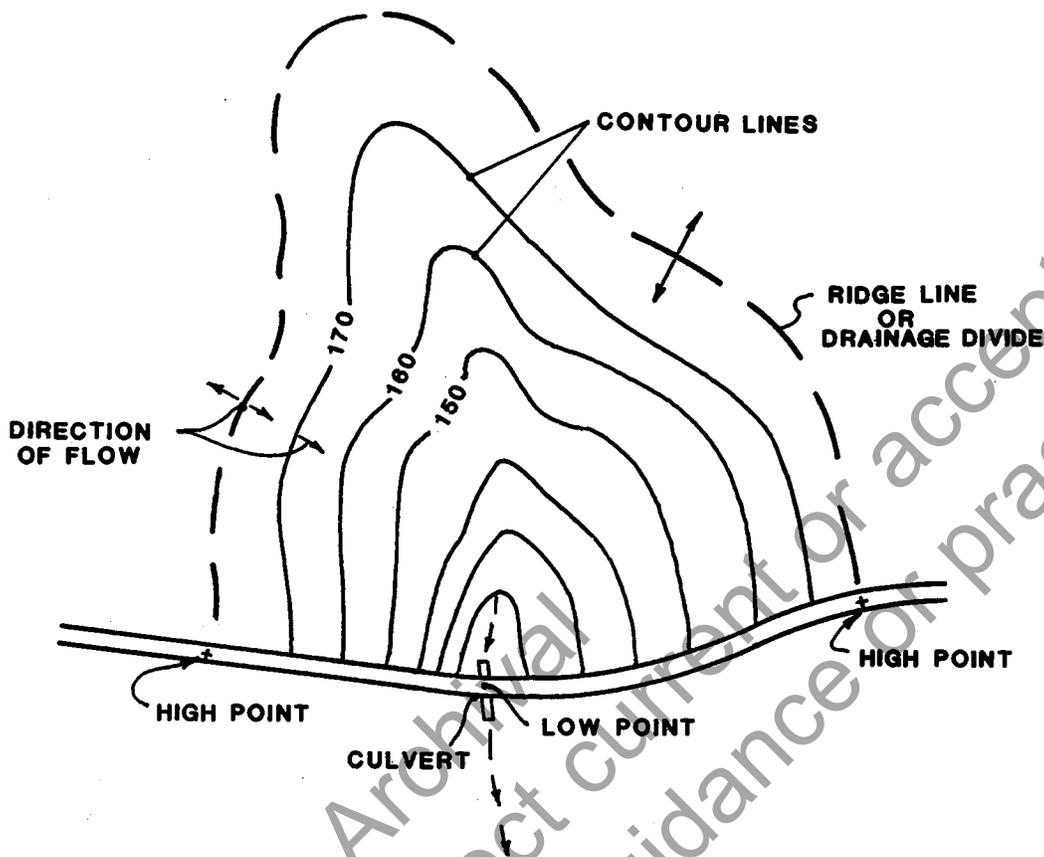
Exhibit 16. A drainage area is defined by drainage divides or lines that connect the high points or follow the ridge lines around the area served by the culvert.

Most culverts are designed to carry the surface runoff from a specific drainage area, as illustrated in exhibit 16. While the selection and use of appropriate methods of estimating runoff requires a person experienced in hydrologic analysis and would usually not be performed by the inspector, the inspector should understand how changes in the topography of the drainage area can cause major changes in runoff. Climatic and topographic factors are briefly discussed in the following sections.

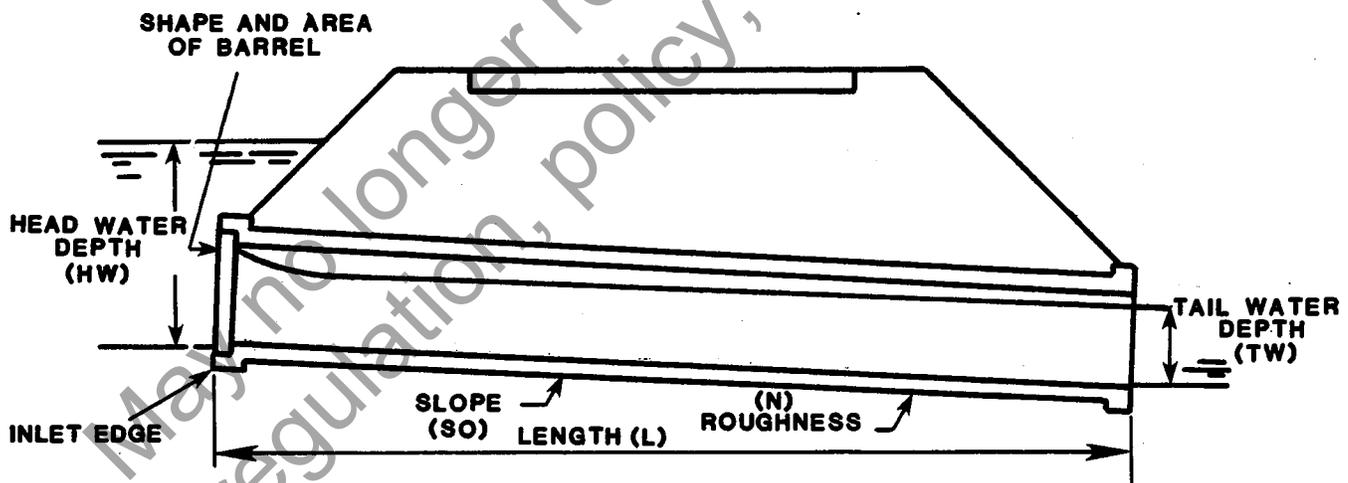
Exhibit 17. Factors affecting culvert discharge.

The factors affecting capacity may include headwater depth, tailwater depth, inlet geometry, the slope of the culvert barrel, and the roughness of the culvert barrel. These factors are illustrated in exhibit 17. The various combinations of the factors affecting flow can be grouped into two types of conditions in culverts: inlet control and outlet control.

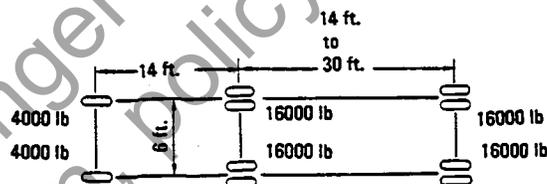
AASHTO HS20 LOAD

Exhibit 18. AASHTO live load spacing for highway structures.

b. Live Loads--The live loads on a culvert include the loads and forces which act upon the culvert due to vehicular or pedestrian traffic plus an impact factor. The highway wheel loads generally used for analysis are shown in exhibit 18. The effect of live loads decreases as the height of cover over the culvert increases. When the cover is more than two feet, concentrated loads may be considered as being spread uniformly over a square with sides 1.75 times the depth of cover. This concept is illustrated in exhibits 19 and 20.

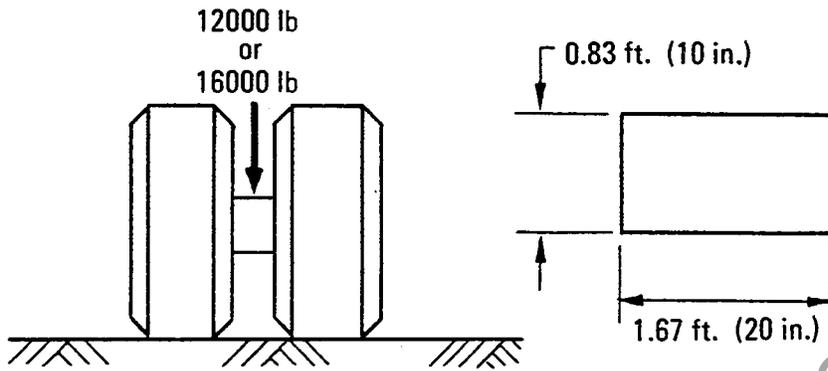
Exhibit 19. Surface contact area for single dual wheel.

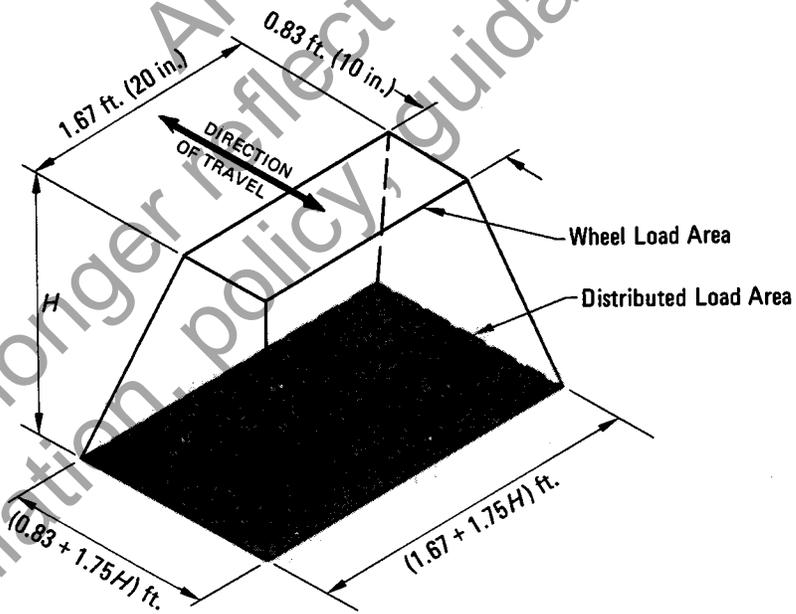
Exhibit 20. Distribution of live load (single dual wheel) for depth of cover H.

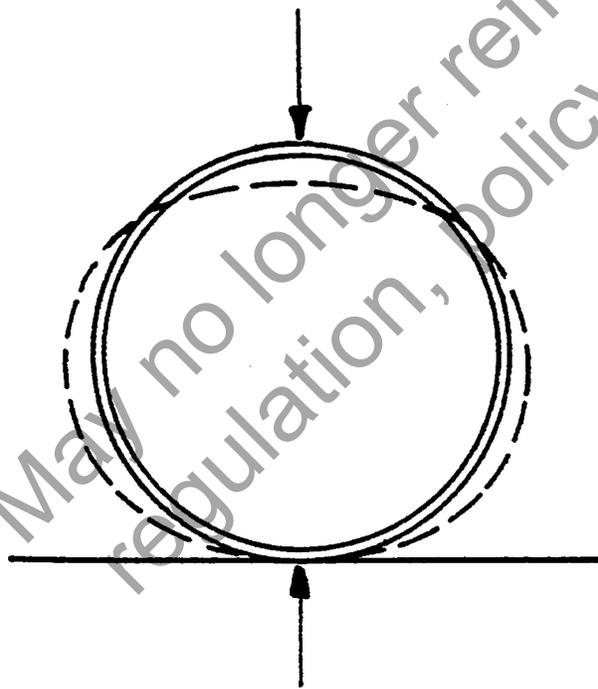
**AS VERTICAL LOADS ARE APPLIED A FLEXIBLE CULVERT ATTEMPTS TO DEFLECT. THE VERTICAL DIAMETER DECREASES WHILE THE HORIZONTAL DIAMETER INCREASES. SOIL PRESSURES RESIST THE INCREASE IN HORIZONTAL DIAMETER.**

Exhibit 21. Deflection of flexible culverts.

Flexible pipe has relatively little bending stiffness or bending strength on its own. As loads are applied to the culvert, it attempts to deflect. In the case of a round pipe, the vertical diameter decreases and the horizontal diameter increases, as shown in exhibit 21. When good embankment material is well compacted around the culvert, the increase in horizontal diameter of the culvert is resisted by the lateral soil pressure. With round pipe the result is a relatively uniform radial pressure around the pipe which creates a compressive thrust in the pipe walls. As illustrated in exhibit 22, the compressive thrust is approximately equal to vertical pressure times one-half the span length ( $C = P \times \frac{S}{2}$  or  $C = P \times R$ ).

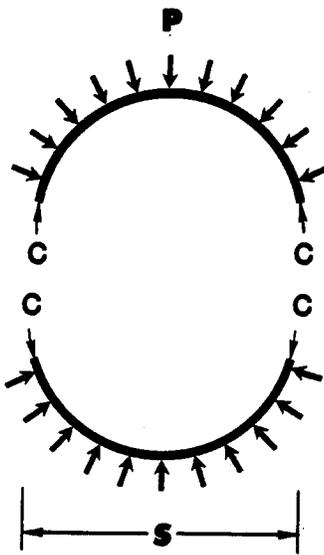
SUMMING THE VERTICAL FORCES ON HALF OF THE PIPE AT A TIME SHOWS THAT

$$C = P \times \frac{S}{2}$$

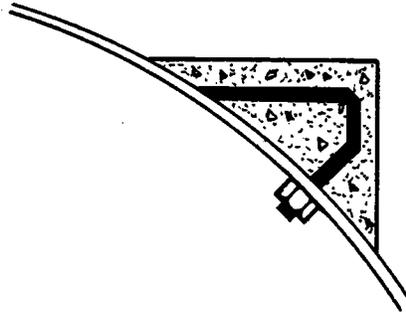
Exhibit 23. Concrete thrust beams may be used as longitudinal stiffeners.

In long span culverts the radius (R) is usually large. To prevent excessive deflection due to dead and/or live loads, longitudinal or circumferential stiffeners are sometimes added. The circumferential stiffeners are usually metal ribs bolted to the outside of the culvert. Longitudinal stiffeners may be metal or reinforced concrete, as shown in exhibit 23. The thrust beams are added to the structure prior to backfill. Concrete thrust beams provide some circumferential stiffening as well as longitudinal stiffening. They also provide a solid vertical surface for soil pressures to act on and a surface which is easier to backfill against. The use of concrete stress relieving slabs is another method used to achieve longer spans or reduce minimum cover. A stress relieving slab is cast over the top of the backfill above the structure to distribute live loads to the adjacent soil.

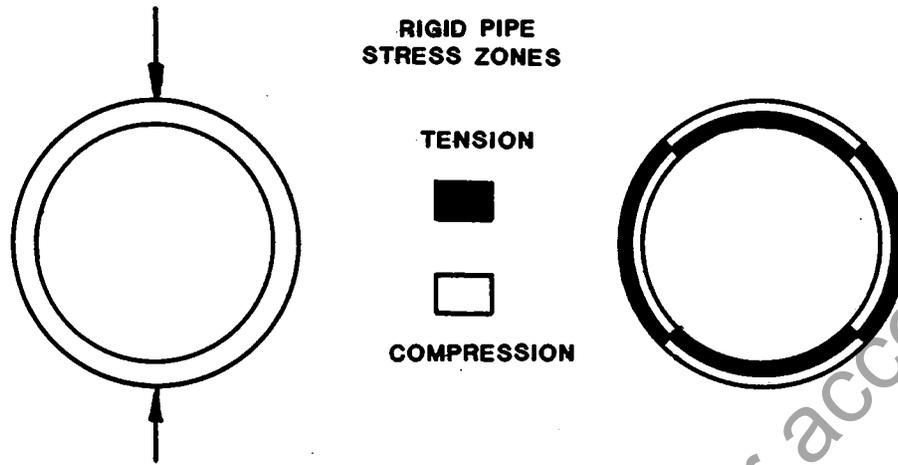
Exhibit 24. Zones of tension and compression in rigid pipes develop to resist vertical loads.

The load carrying capability of rigid culverts is essentially provided by the structural strength of the pipe itself and little benefit from the surrounding soil is required. When vertical loads are applied to a rigid pipe, zones of tension and compression are created as illustrated in exhibit 24. With the exception of non-reinforced circular pipe, reinforcing steel is added to the tension zones to increase the tensile strength of the pipe. Shear stress in the haunch area can be critical for heavily loaded rigid pipe on hard foundations, especially if the haunch support is inadequate. Because rigid pipe is stiffer than the surrounding soil, it carries a substantial portion of the load.

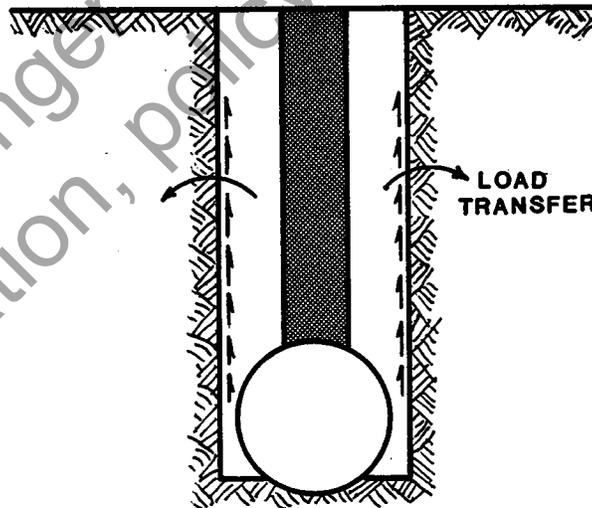
Exhibit 25. Trench installation. Friction on trench sides reduces the size of the column of fill carried by the pipe.

In narrow trench installations, the pipe is placed in a relatively narrow trench and covered with backfill material. The backfill tends to settle more than the undisturbed soil beside the trench. Friction between the backfill material and the sides of the trench tends to help support the backfill material reducing the load on the pipe. In effect the width of the soil column over the pipe is decreased. This concept is illustrated in exhibit 25.

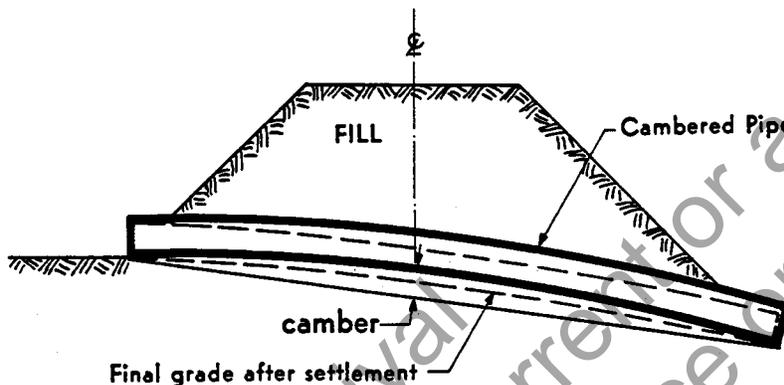
Exhibit 26. Camber allows for settlement of a culvert under a high fill.

e. Camber--In high fills the center of the embankment tends to settle more than the areas under the embankment side slopes. In such cases it may be necessary to camber the foundation slightly, as shown in exhibit 26. This should be accomplished by using a flat grade on the upstream half of the culvert and a steeper grade on the downstream half of the culvert. The initial grades should not cause water to pond or pocket.

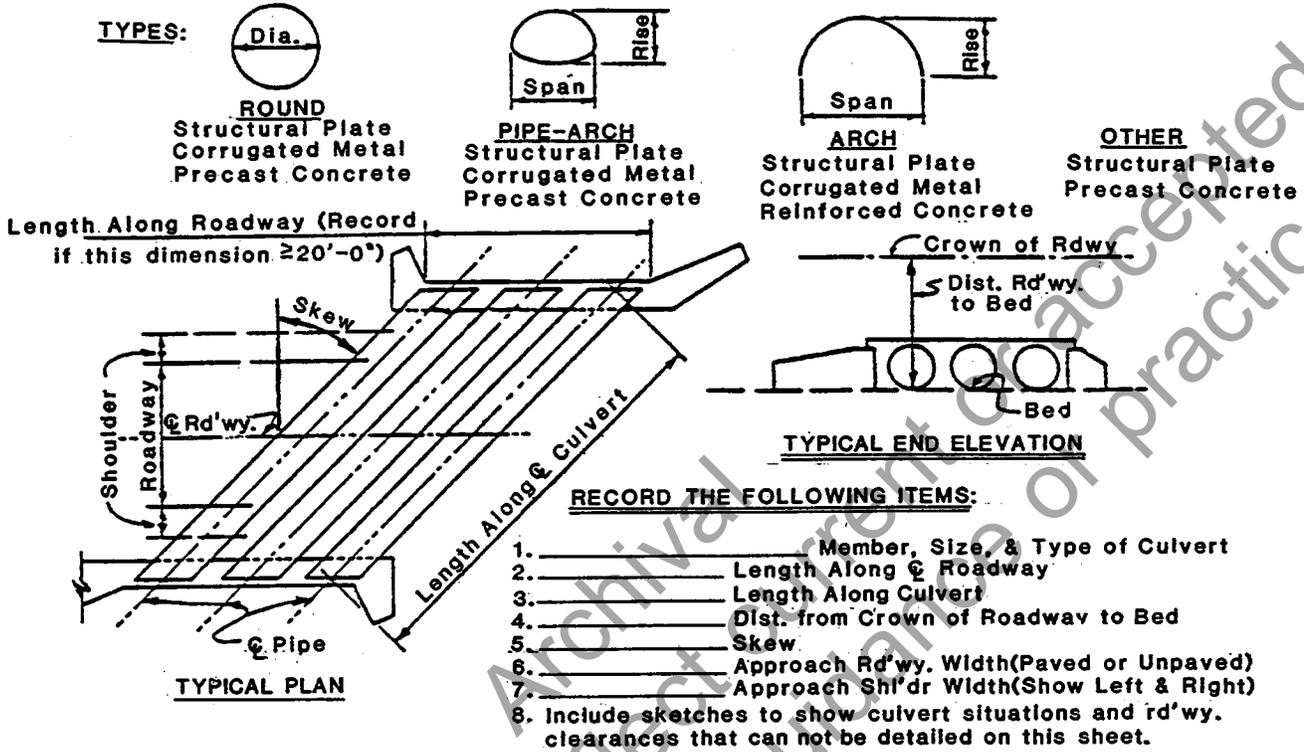
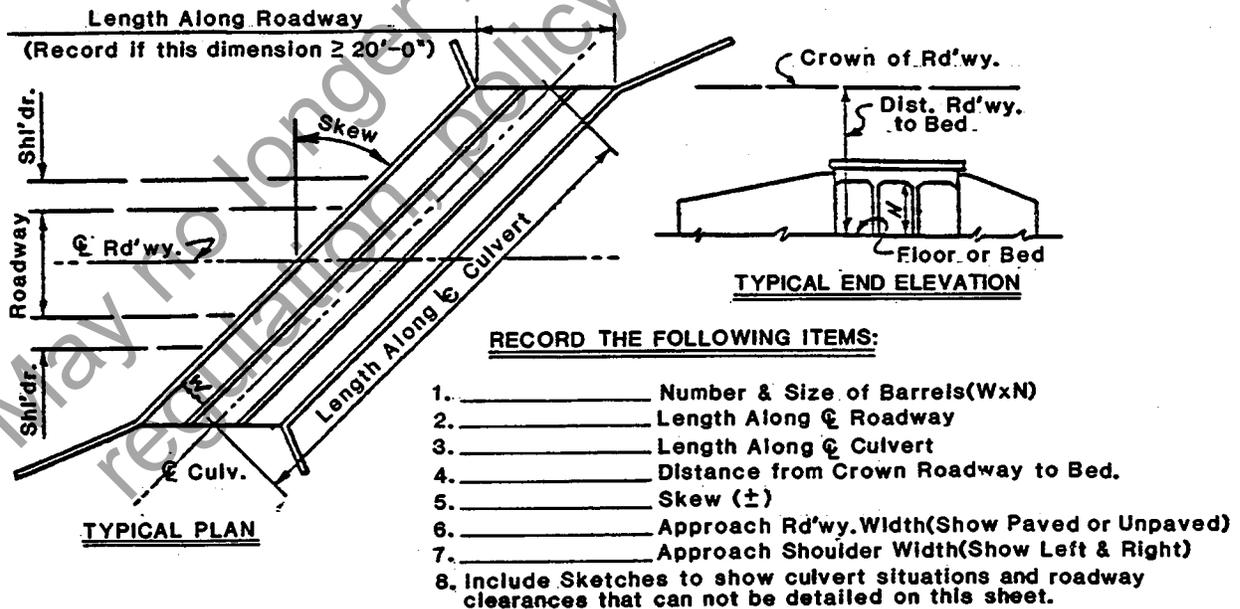
Exhibit 34. Standard prepared sketches (adapted from North Carolina inspection forms).

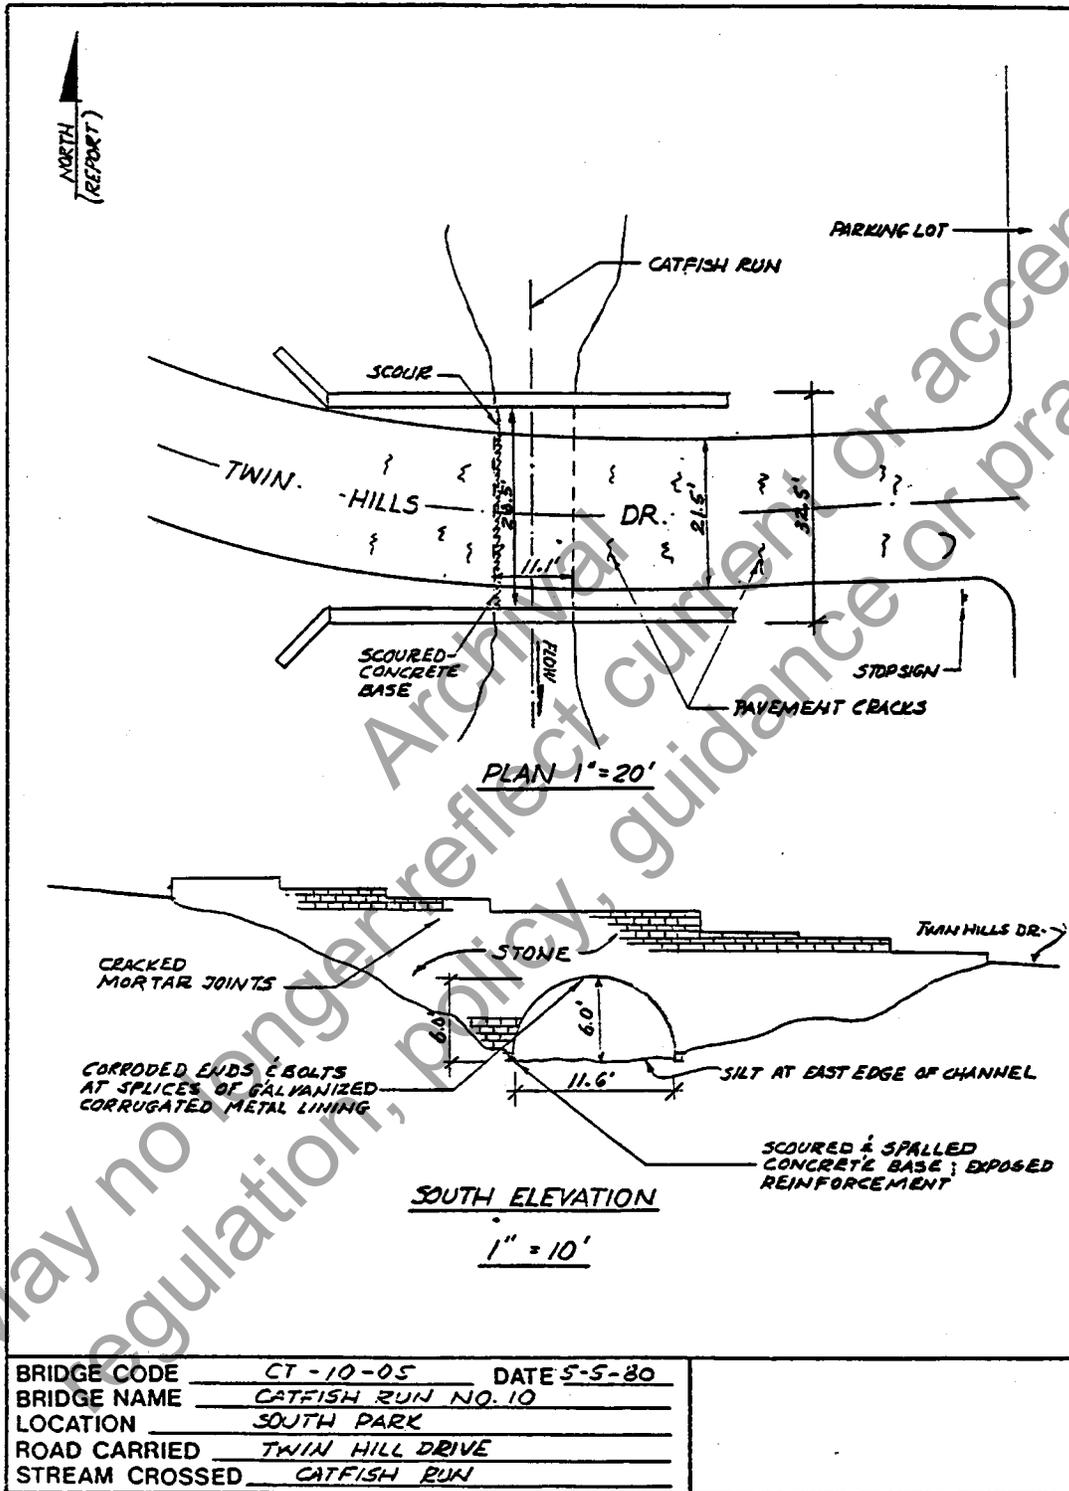
Exhibit 35. Sample sketch.

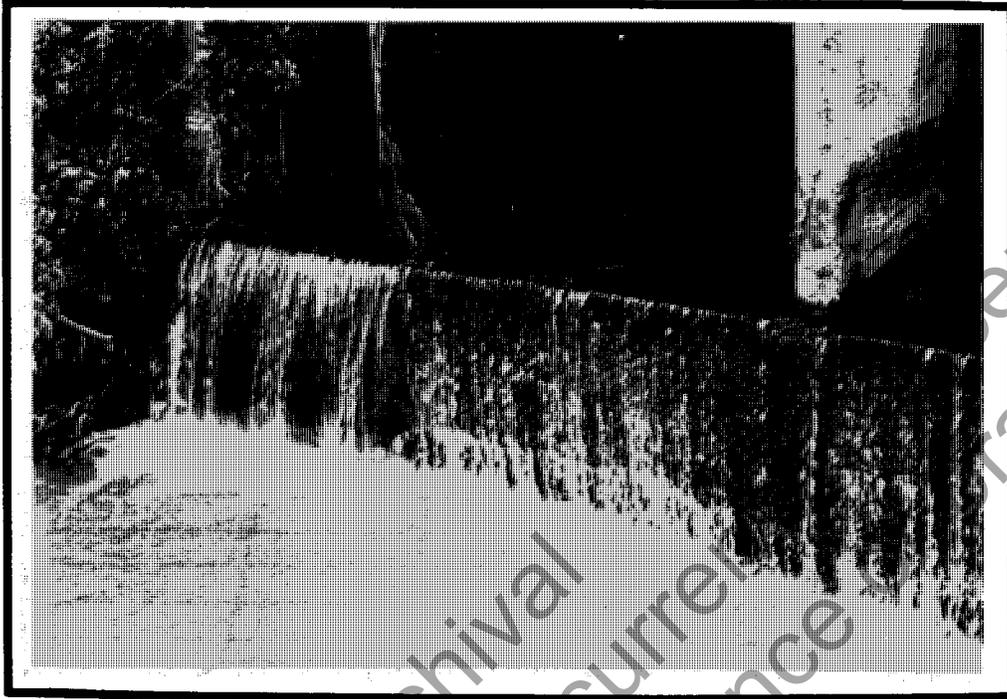
Exhibit 37. Undermined toe-wall.

Exhibits 37, 38, and 39 provide comparisons of toe-wall scour as shown in photographs and as shown in a sketch.

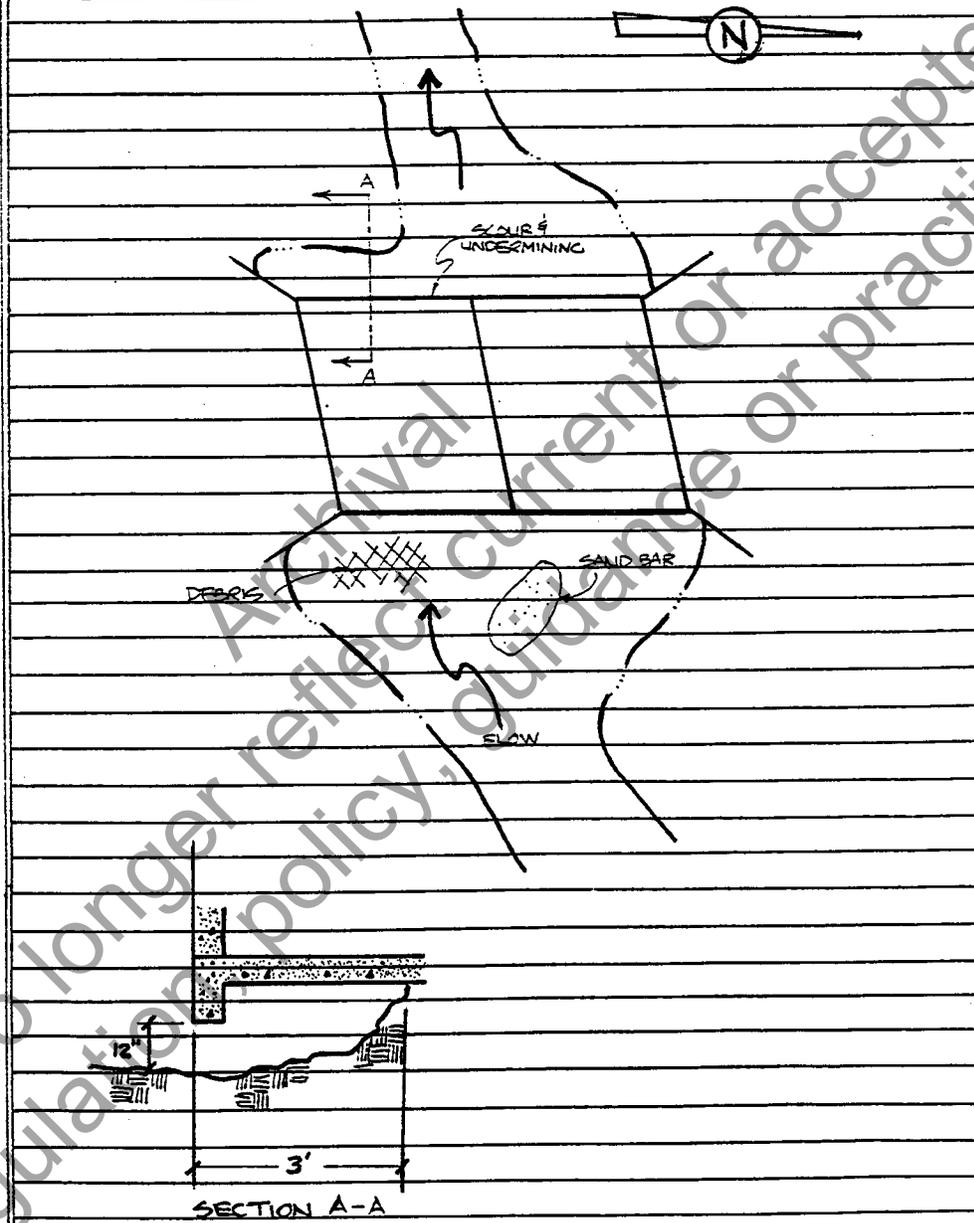
SKETCH NO. 1

Exhibit 39. Sketch of undermined toe-wall.

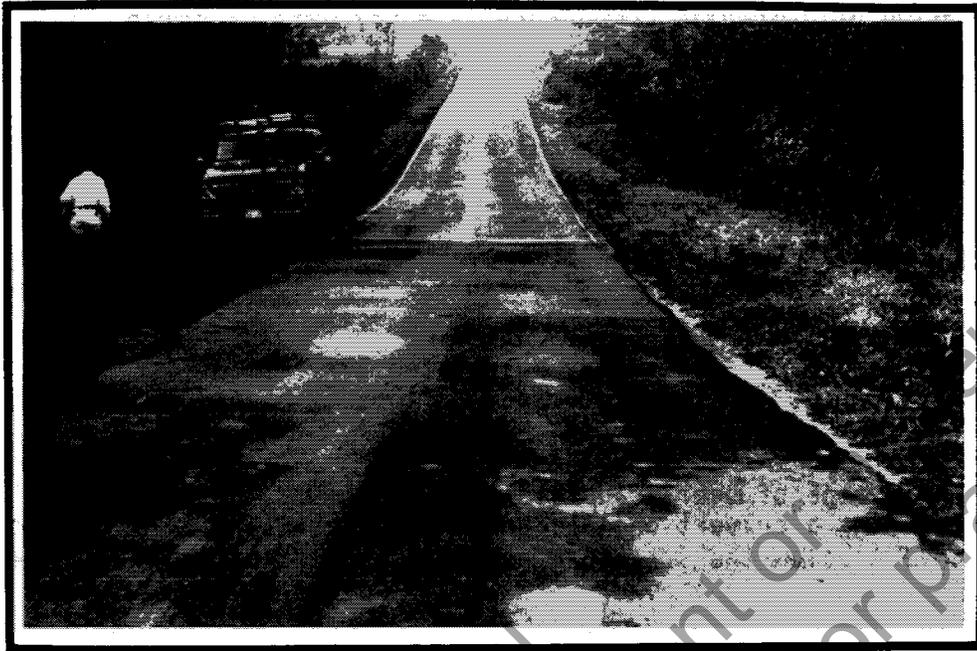
Extensive roadway patching due to settlement of the embankment.

Exhibit 41. Roadway defect may be an indication of distress in the culvert.

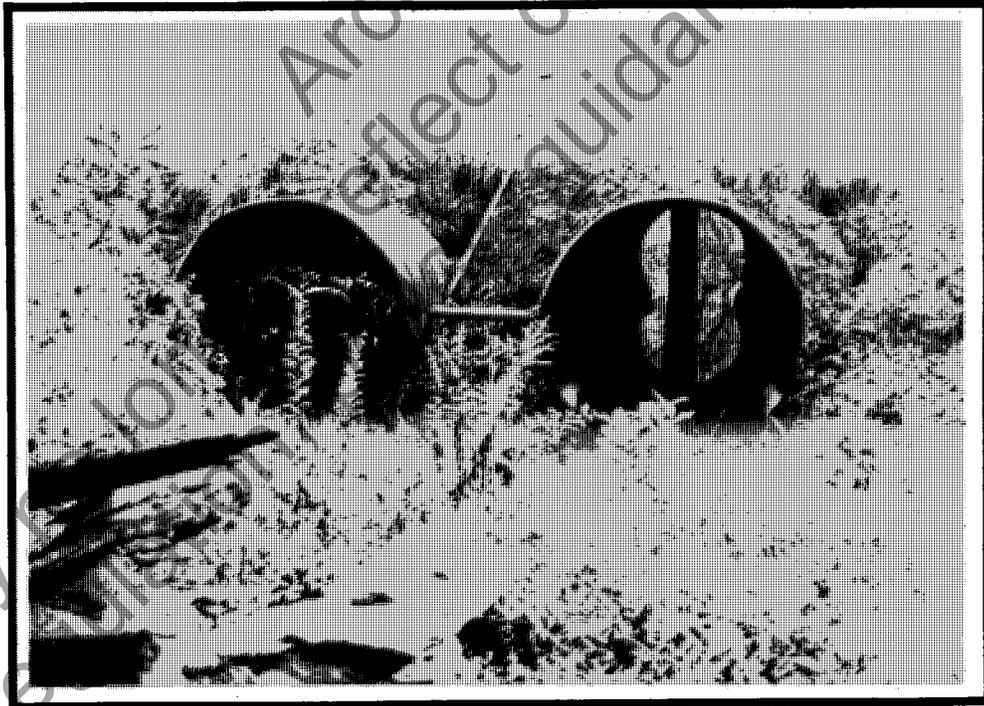
Pipes at same location as top photo require bracing to prevent excessive deflection. Bracing is a temporary measure until permanent repairs can be made.

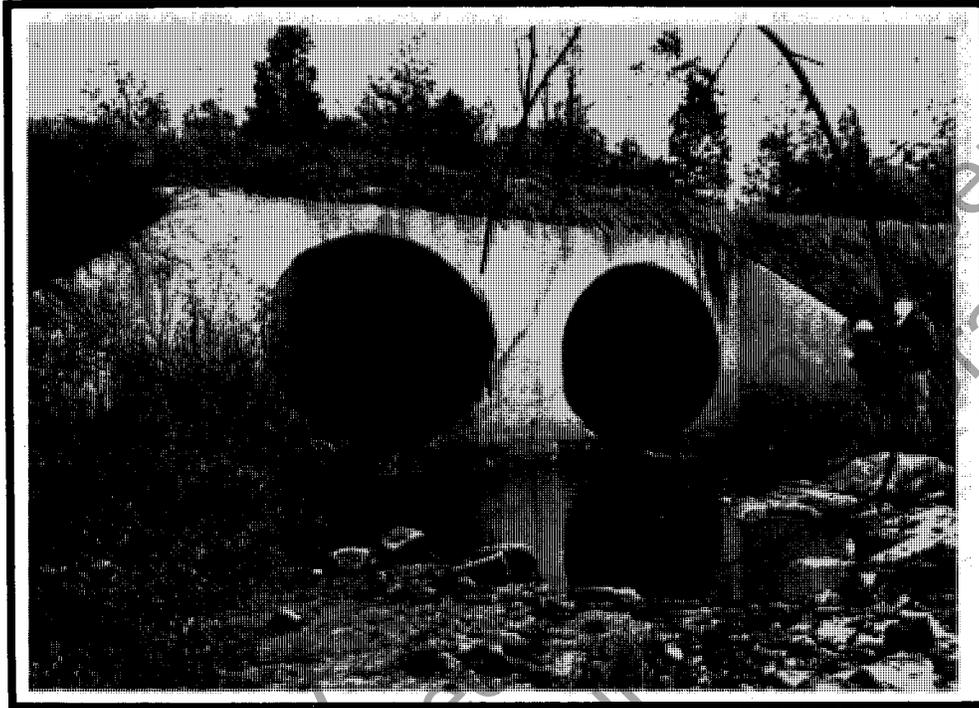
Exhibit 42. Headwall and wingwall end treatment.

End treatments such as headwalls, wingwalls, slope protections, and energy dissipators are used to protect the culvert barrel from hydraulic forces, retain the embankment, and improve hydraulic efficiency. Headwall and wingwall end treatments are shown in exhibit 42. The SI&A inspection form

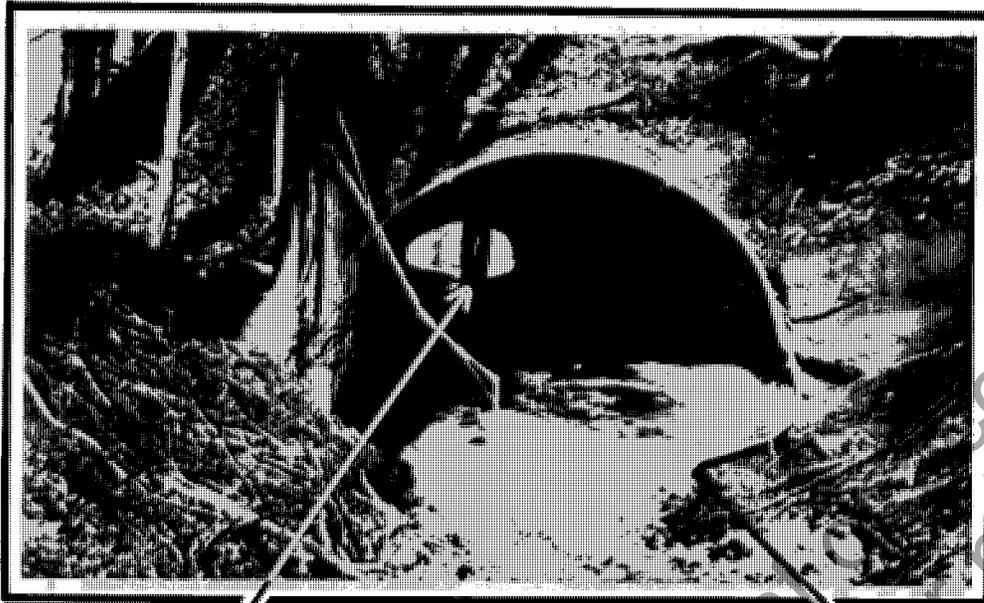
**EMERGENCY BRACING NEEDED  
DUE TO LOSS OF SUPPORT**

**VOID UNDER PIPE**

Inspections of end treatments primarily involve visual inspection although hand tools should be used such as a plumb bob to check for misalignment, a hammer to sound for defects, and a probing bar to check for scour and undermining. The inspection should be documented by a narrative description of the type and condition of end treatment used, and photographs or sketches of any significant problems found. The defects to look for during an inspection will depend upon the type of end treatment being inspected. In general, headwalls should be inspected for movement or settlement, cracks, deterioration, and traffic safety. All ends should be checked for undermining, scour, and evidence of piping. Piping is the removal of soil by water seeping along the outside of the pipe. This process is called piping because a pipe-shaped tube is often formed in the soil. Exhibit 43 illustrates a culvert with undermining at the outlet and evidence of piping.

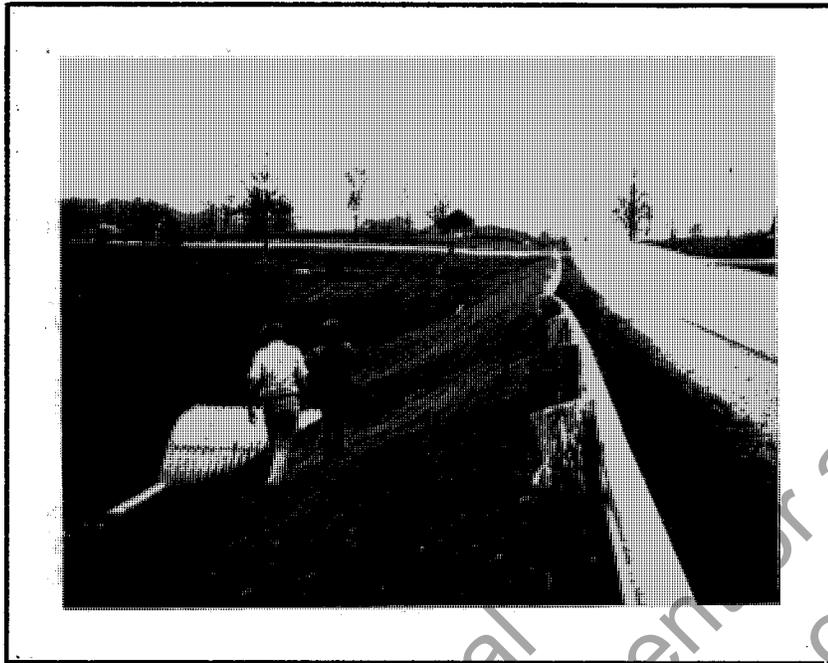
Exhibit 44. A dip in the guardrail or approach roadway may be due to excessive deflection in culvert.

Approach conditions may be inspected visually for sudden dips or sags, cracks, pavement patches, and other indications of settlement. Cracks in pavements will usually be parallel to the culvert barrel. Shoulders and embankments should also be inspected for dips, sags and other depressions, erosion, and slope slippage. Sags can often be detected by sighting along guardrails, as illustrated in exhibit 44. Sighting along the edge of pavement, or along pavement markings can also reveal sags and depressions.

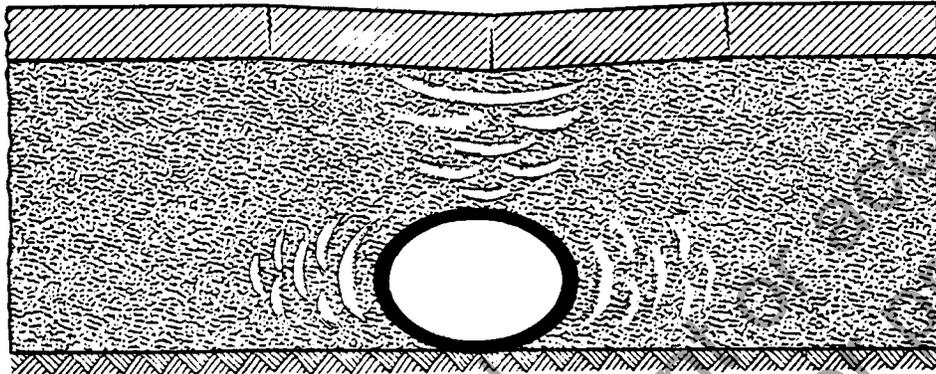
Exhibit 45. Pavement failure due to inadequate compaction or material quality adjacent to flexible pipe.

a. Pavement Type--Rigid pavements (concrete) bridge over minor subsurface voids while flexible pavements (asphalt) have little bridging capability. Settlement of material beneath the pavement can lead to cracking in rigid and irregular settlement in flexible pavements as illustrated in exhibit 45.

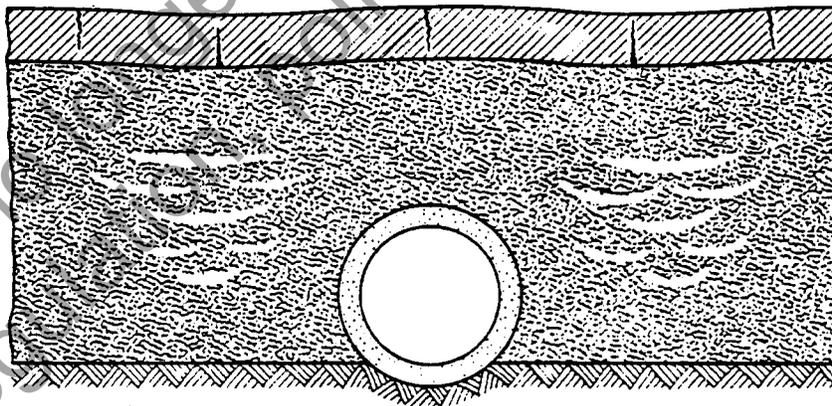
Exhibit 46. Pavement failure due to inadequate compaction or material quality adjacent to rigid pipe.

b. Structure Type--Flexible culverts will deflect if adequate lateral support is not provided by the surrounding soil. This may result in a loss of support for the approach pavement and usually results in settlement over the culvert. Inadequate compaction of backfill for rigid culverts usually results in settlement beside the culvert as shown in exhibit 46.

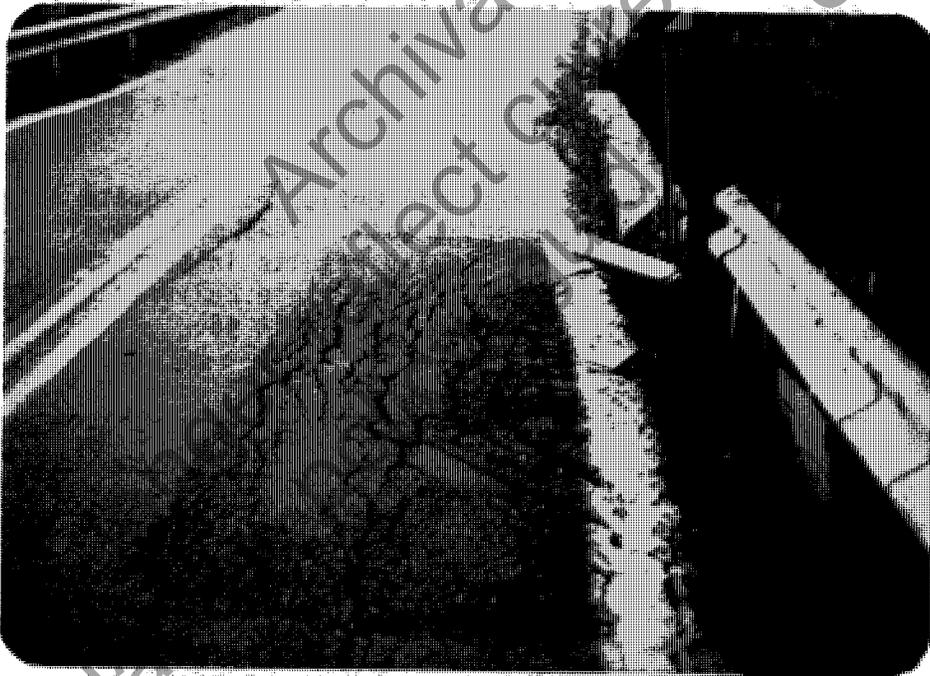
Exhibit 47. Pavement patches and pavement distress beside culvert. Distress is being caused by embankment spilling over wingwall.

e. Other Factors--Several other factors in addition to embankment settlement can cause distress in the culvert and the approach roadway, such as saturated embankment material, poor backfill quality, piping, erosion, and slope failures as shown in exhibits 47 and 48.

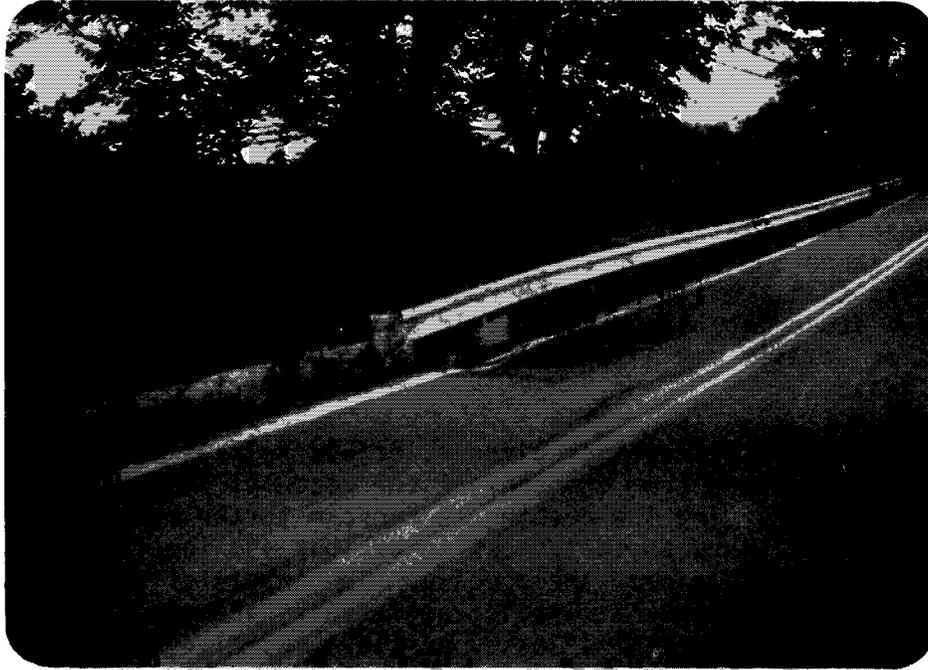
Exhibit 48. Pavement patches and distress same location as exhibit 47.

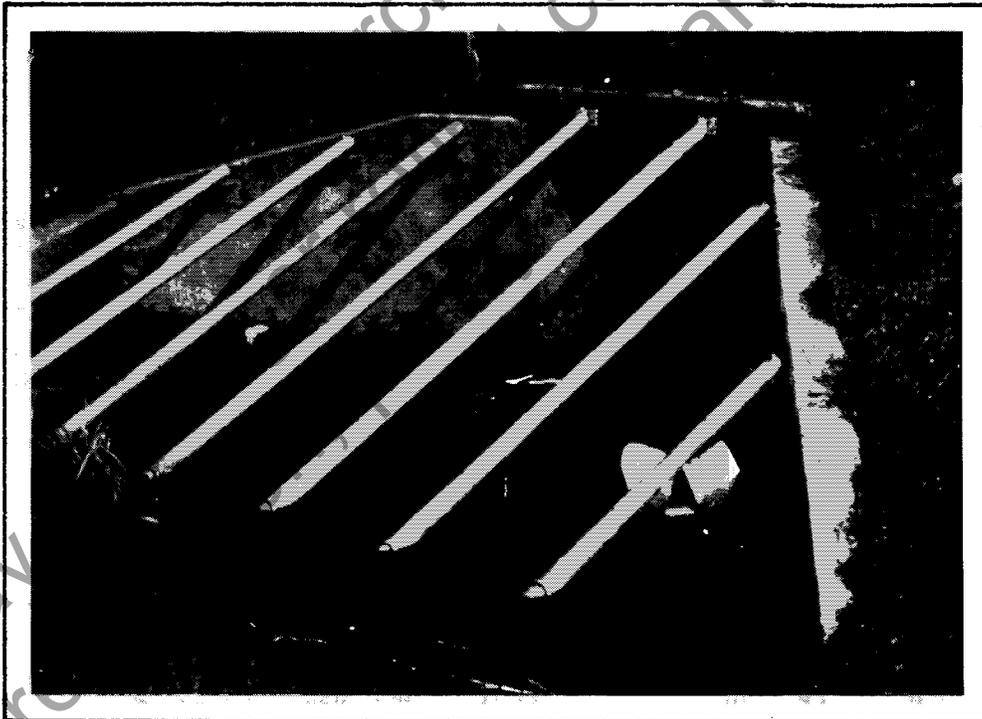
Exhibit 49. Example of vehicle safe grate on safety treated headwall.

Common methods for safety treating culverts include relocating the ends so that they are farther away from the edge of the roadway, installing guardrails or other barriers, modifying the opening to conform to the face of the slope, and installing grates (such as that shown in exhibit 49) that are structurally adequate to carry a vehicle over the opening. The inspector should be aware that grates may require frequent cleaning and repair, and may increase upstream flooding. Guardrails and Jersey barriers may also increase upstream hazards.

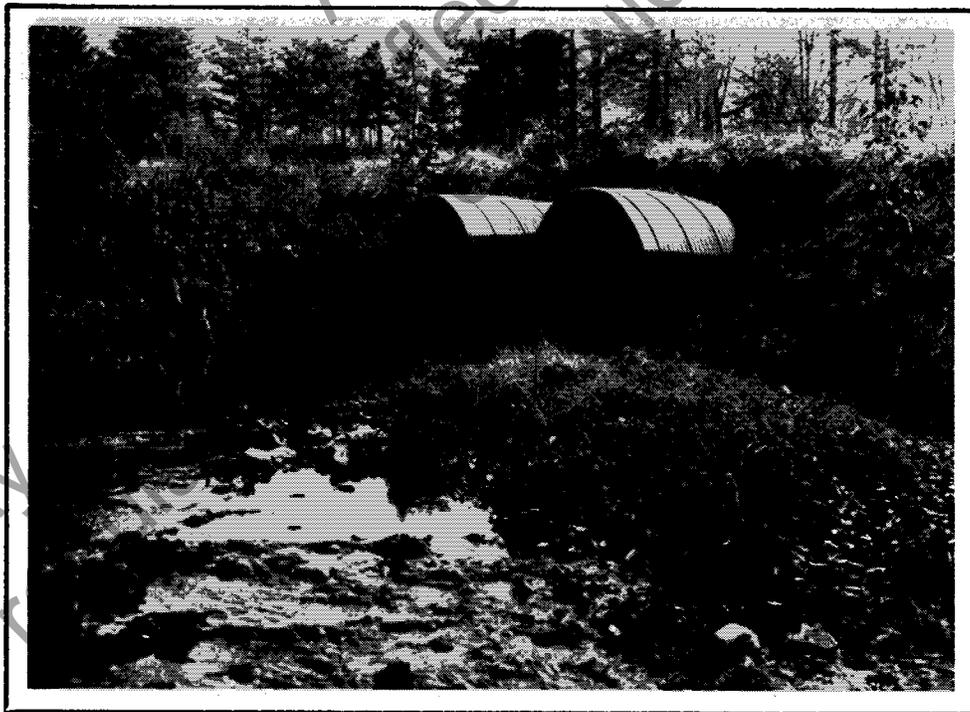
Exhibit 50. Projecting end treatment on corrugated metal pipe culvert.

a. Projecting--This type of end treatment has no end structure attached to the ends of the culvert barrel. The barrel simply extends beyond the face of the embankment, as shown in exhibit 50.
