# CULVERT INSPECTION MANUAL

## SUPPLEMENT TO THE BRIDGE INSPECTOR'S TRAINING MANUAL

**Report No.  
FHWA-IP-86-2**

**Final Report  
July 1986**

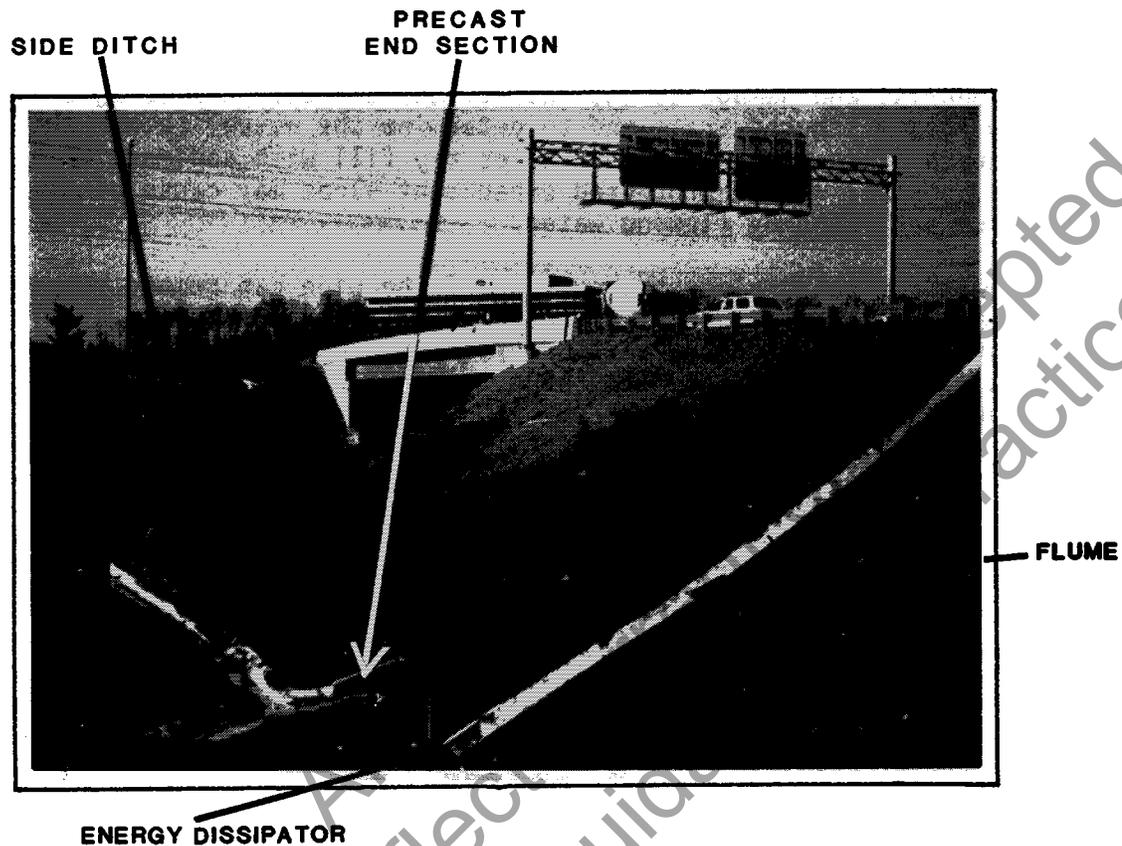
Exhibit 52. Culvert appurtenant structures.

Appurtenant structures are used with end treatments to improve drainage or reduce erosion. Typical items are listed below and shown in exhibit 52.

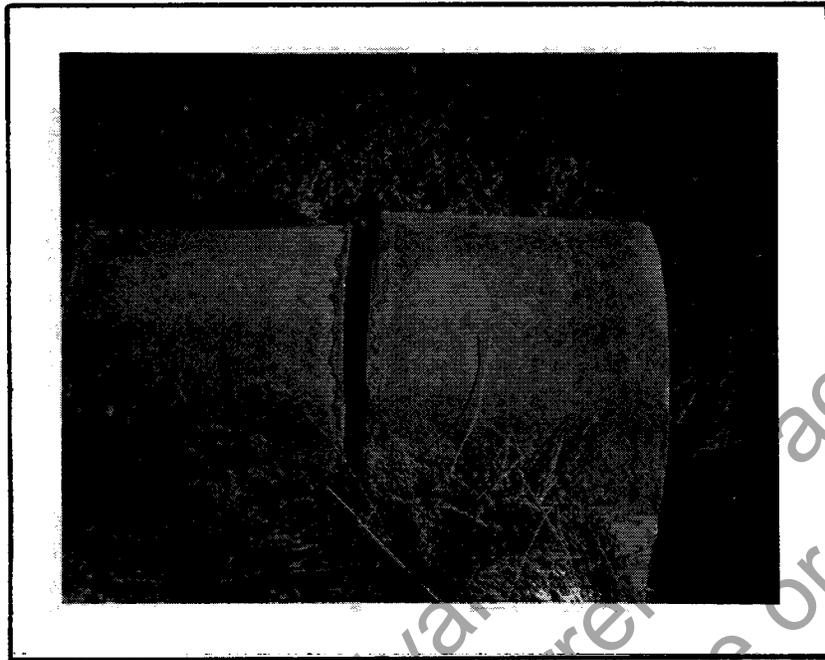
Exhibit 54. End section drop off.

Piping or water flowing along the outside of the pipe can remove supporting material, as shown in exhibit 53. Erosion can cause end-section displacement and drop off in rigid pipe culverts, particularly at the outlet ends, as shown in exhibit 54. In corrugated metal pipe culverts, the pipe may be subject to buoyant forces if the material surrounding the culvert is saturated or eroded. Examples of buoyant damage are illustrated in exhibits 55 and 56. Damage due to buoyant forces usually occurs at the inlet end but may occur at submerged outlets. The capacity of culverts may be reduced by accumulations of drift and debris at the inlet end or by slope failure. Inlet ends may also be damaged by impact from floating debris, and either end can be damaged by mowing equipment and other maintenance vehicles, as shown in exhibit 57.

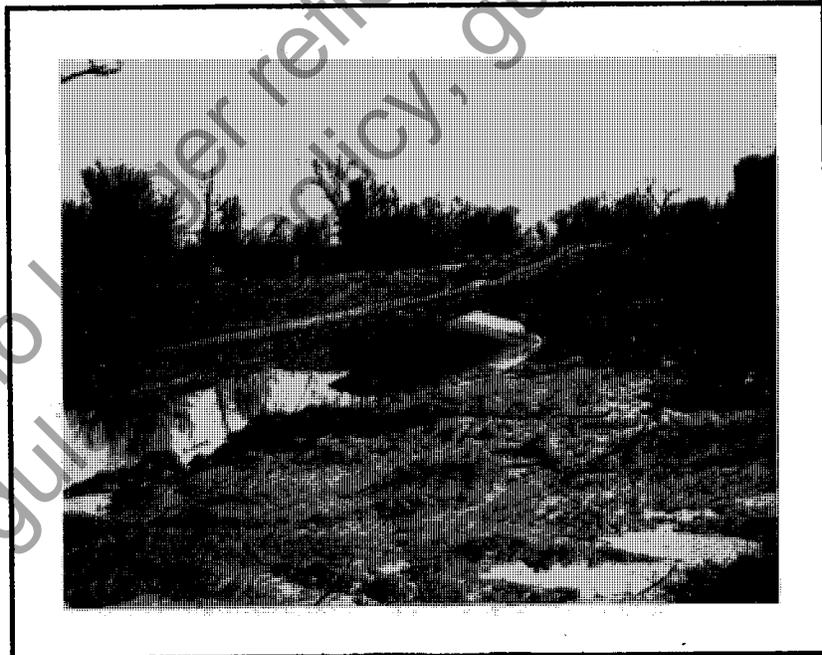
Exhibit 55. Mitered end of culvert turned up due to buoyant forces.

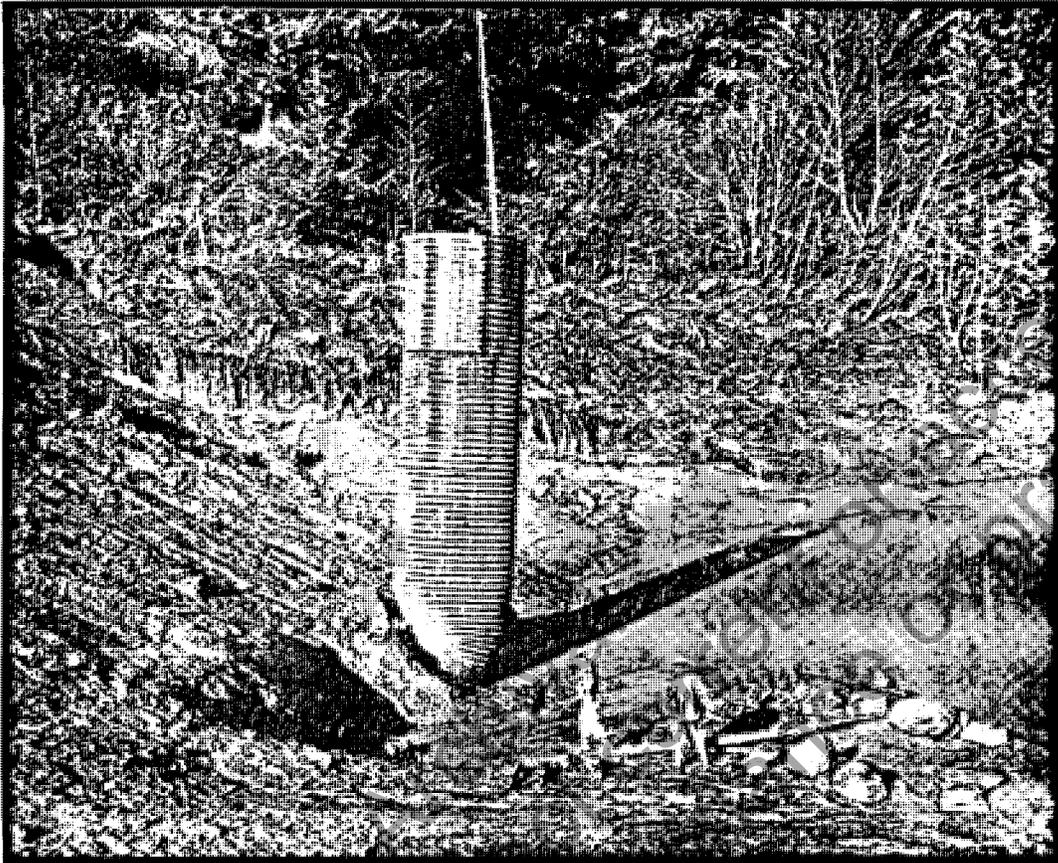
Exhibit 56. Damage due to bouyant forces.

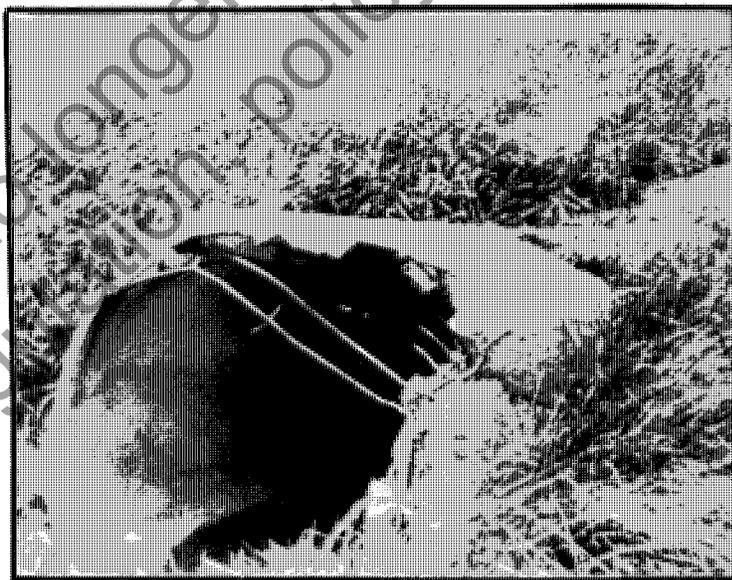
Exhibit 57. Impact damage to end of concrete pipe.

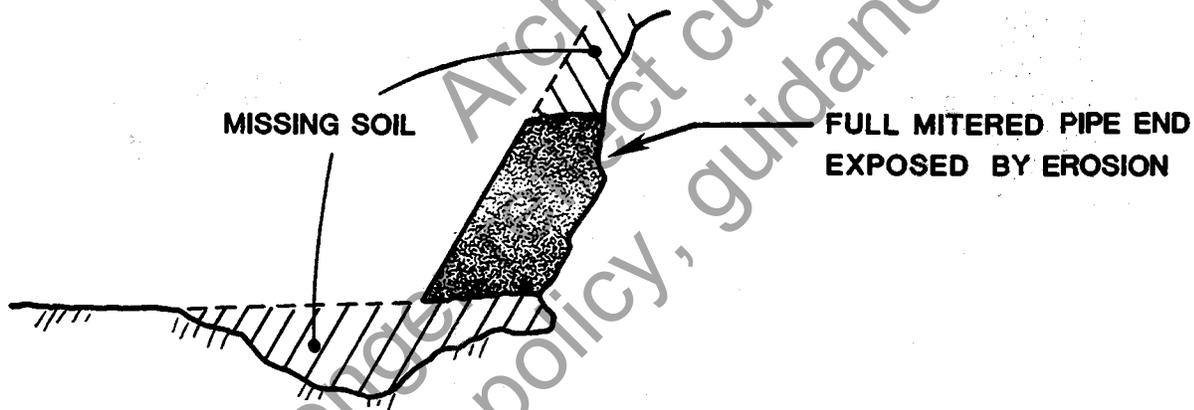
Exhibit 58. Erosion around mitered end.

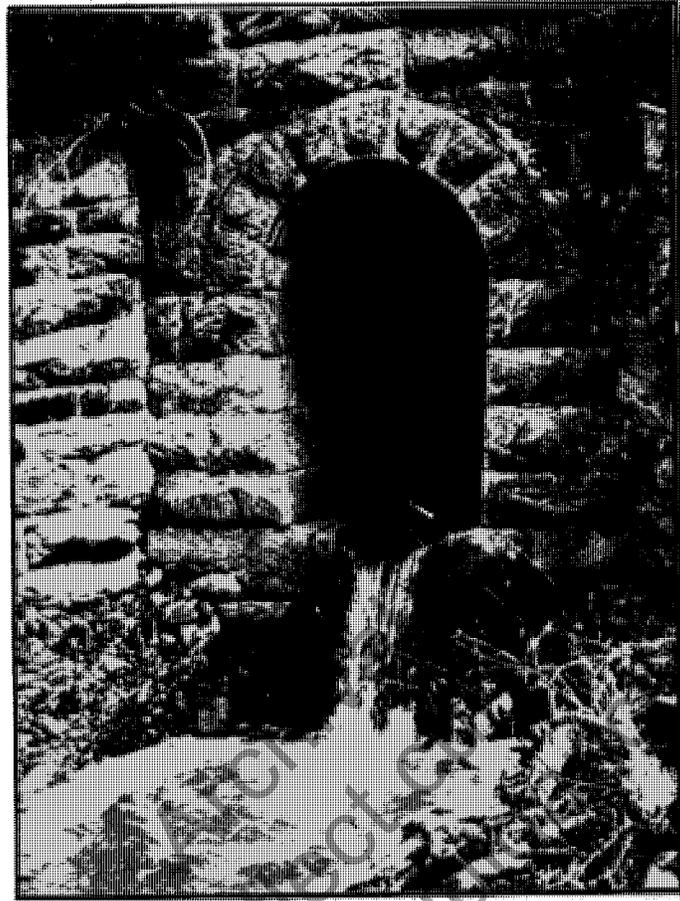
Exhibit 60. Scour at outlet of masonry culvert.

The upstream channel should be checked for scour that may undermine the culvert or erode the embankment as shown in exhibit 60. Scour that is undermining trees or producing sediment that could block or reduce the culvert opening should also be noted. The stream channel below the culvert should be checked for local scour caused by the culvert's discharge and for general scour that could eventually threaten the culvert as shown in exhibit 61.

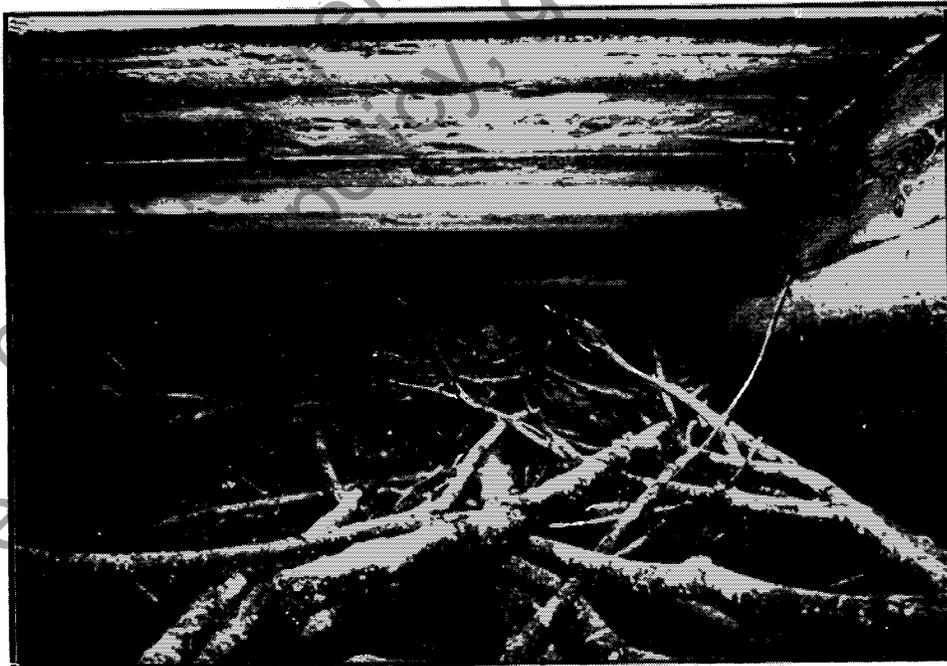
Exhibit 65. Drift and debris inside timber box culvert.

d. Sedimentation and Debris--Accumulation of debris and sediment at the inlet or within the culvert barrel reduces both the size of the opening and the culvert's capability to handle peak flows. Severe drift and sediment accumulations are illustrated in exhibits 64 and 65. However, culverts are occasionally designed with fill in the bottom to create a more natural stream bed for fish.

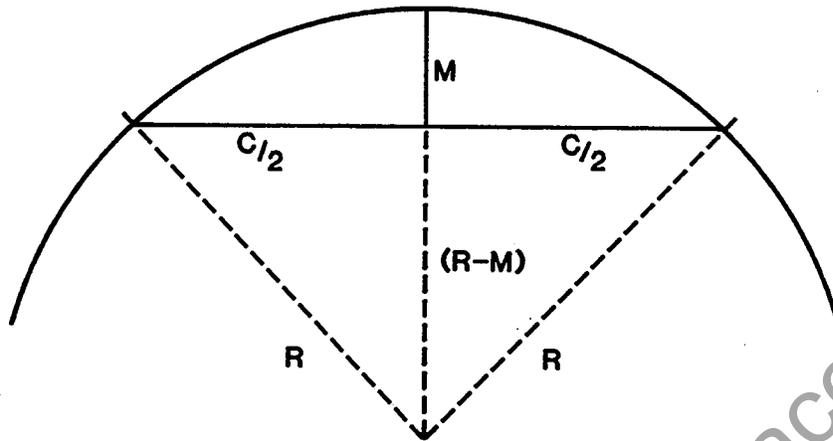
**C = MEASURED CHORD**

**M = MEASURED MIDDLE ORDINATE**

When distortion or curve flattening is apparent, the extent of the flattened area, in terms of arc length, length of culvert affected, and the location of the flattened area should be described in the inspection report. The length of the chord across the flattened area and the middle ordinate of the chord should be measured and recorded. The chord and middle ordinate measurements can be used to calculate the curvature of the flattened area using the formula shown in exhibit 66.

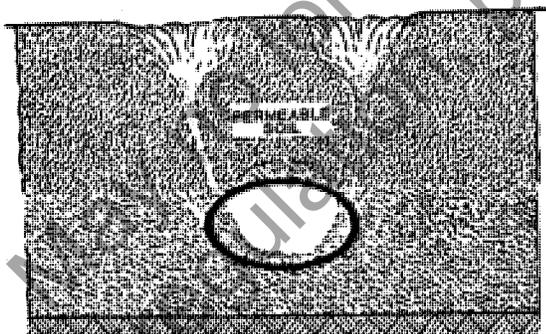
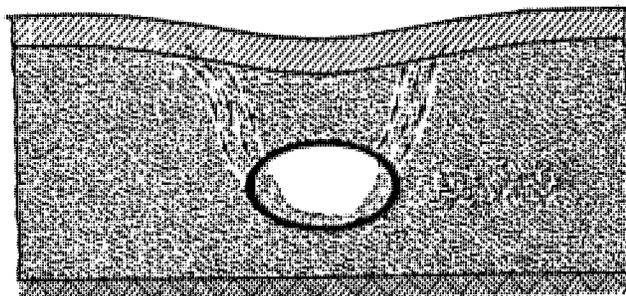
EFFECT ON UNPAVED AREAS

EFFECT ON PAVEMENT

Exhibit 67. Surface indications of infiltration.

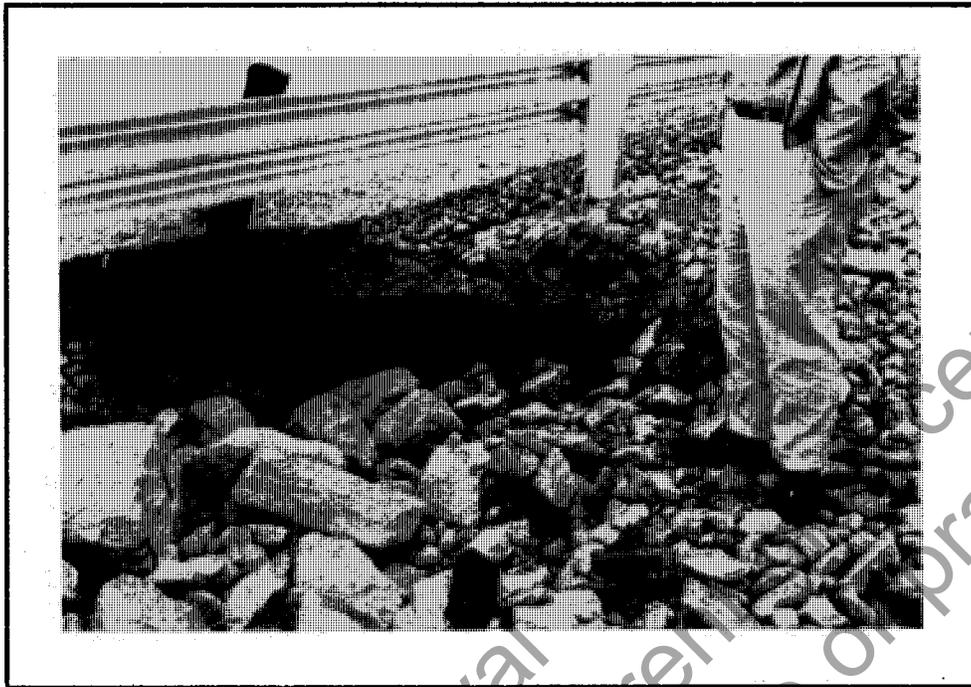
Exhibit 68. Surface hole above open joint.

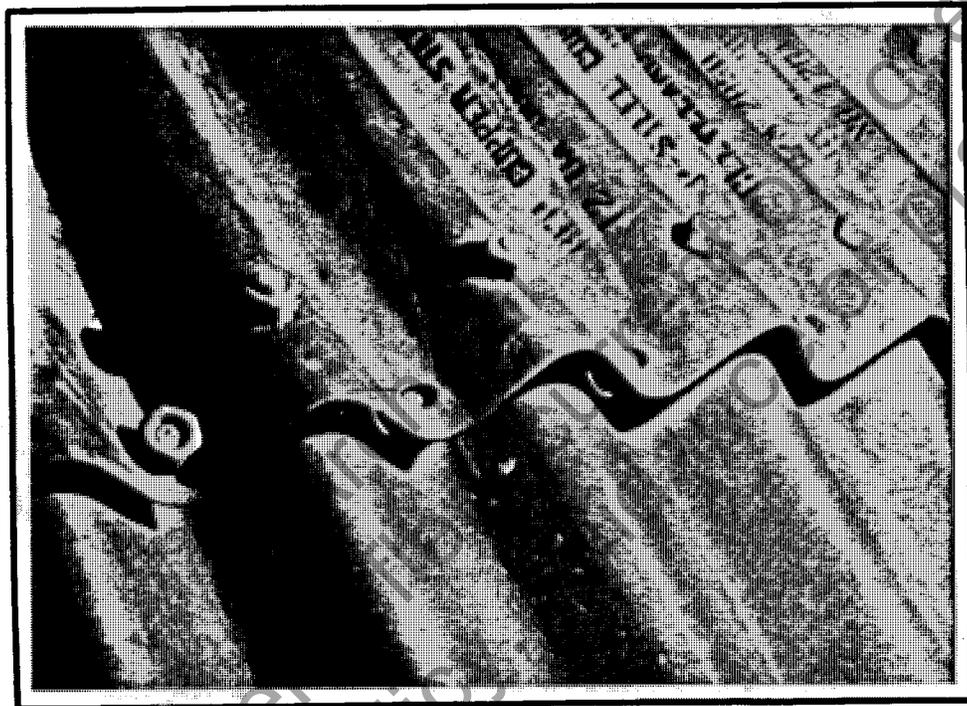
Exhibit 69. Close-up of loose and missing bolts at a cusped seam. Loose fasteners are usually detected by tapping the nuts with a hammer.

- (1) Loose Fasteners--Seams should be checked for loose or missing fasteners as shown in exhibit 69. For steel structures the longitudinal seams are bolted together with high-strength bolts in two rows; one row in the crests and one row in the valleys of the corrugations. These are bearing type connections and are not dependent on a minimum clamping force of bolt tension to develop interface friction between the plates. Fasteners in steel structural plate may be checked for tightness by tapping lightly with a hammer and checking for movement.

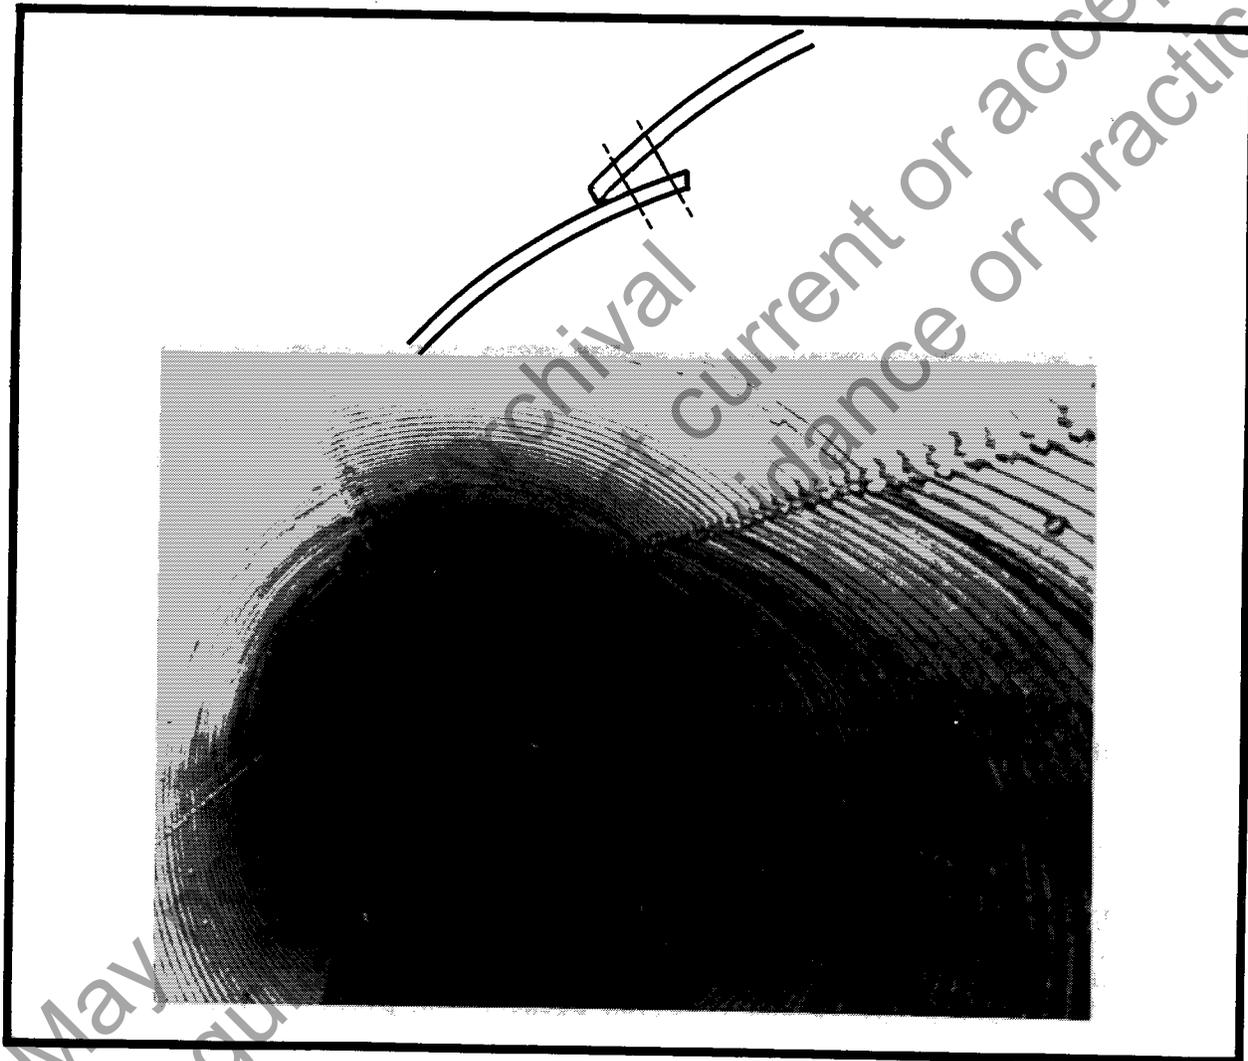
Exhibit 70. Cocked seam with cusp effect.

- (2) Cocked and Cusped Seams--The longitudinal seams of structural plate are the principal difference from factory pipe. The shape and curvature of the structure is affected by the lapped, bolted longitudinal seam. Improper erection or fabrication can result in cocked seams or cusped effects in the structure at the seam, as

illustrated in exhibit 70. Slight cases of these conditions are fairly common and frequently not significant. However, severe cases can result in failure of the seam or structure. When a cusped seam is significant the structure's shape appearance and key dimensions will differ significantly from the design shape and dimensions. The cusp effect should cause the structure to receive very low ratings on the shape inspection if it is a serious problem. A cocked seam can result in loss of backfill and may reduce the ultimate ring compression strength of the seam.

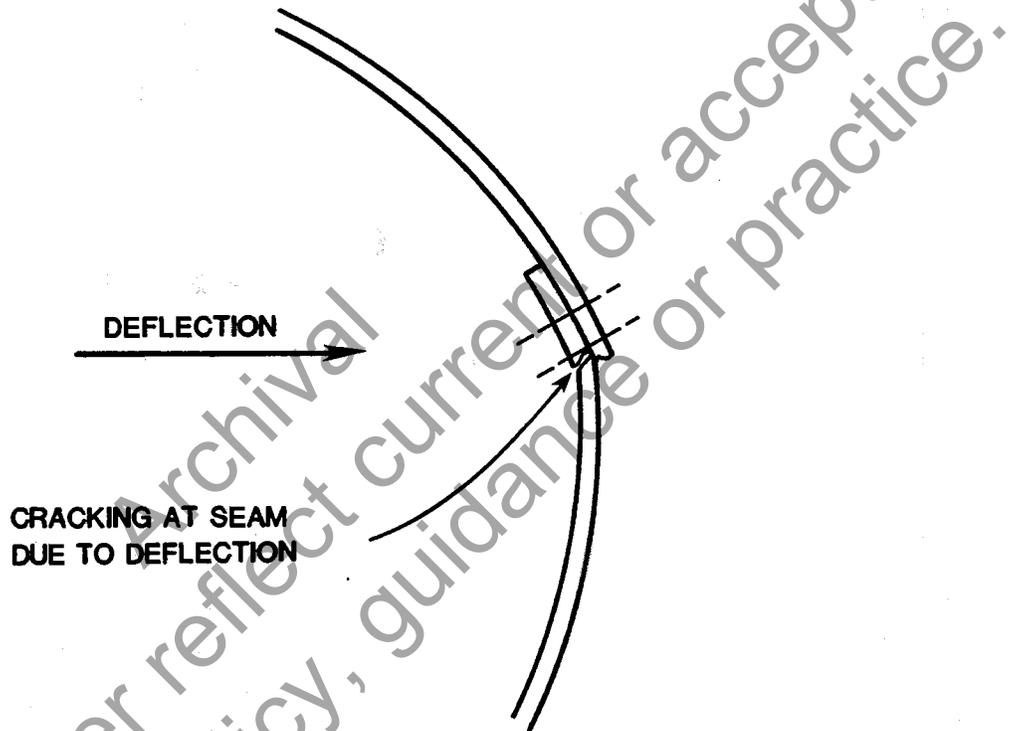
Exhibit 71. Cracking due to deflection.

failure of the structure. Longitudinal cracks are most serious when accompanied by significant deflection, distortion, and other conditions indicative of backfill or soil problems. Longitudinal cracks are caused by excessive bending strain, usually the result of deflection, exhibit 71. Cracking may occasionally be caused by improper erection practices such as using bolting force to "lay down" a badly cocked seam.

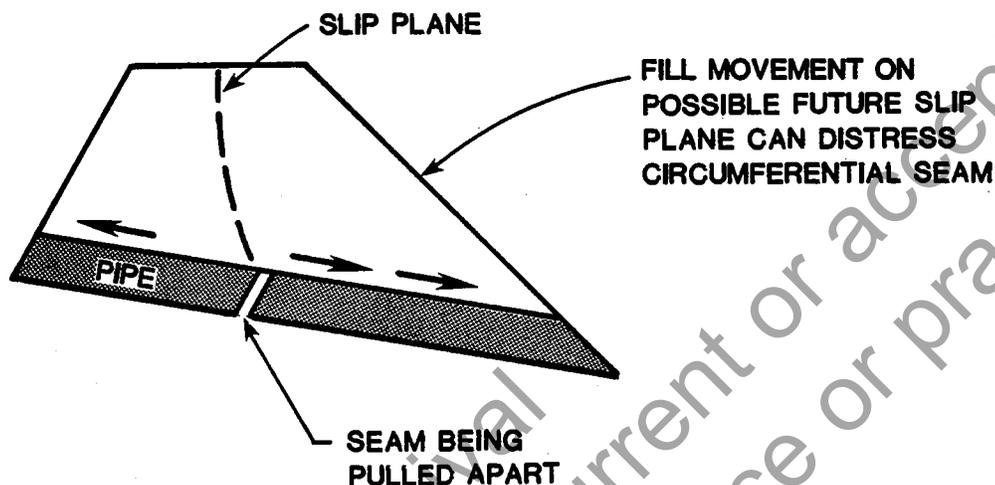
Exhibit 72. Circumferential seam failure due to embankment slippage.

other manifestation of soil failure. For example, a steep sloping structure through an embankment may be pulled apart longitudinally if the embankment moves down as shown in exhibit 72. Plates should be installed with the upstream plate overlapping the downstream plate to provide a "shingle" effect in the direction of flow.

The circumferential seam at one or more locations would be distressed by the movement of the fill. Such distress is important to note during inspections since it would indicate a basic problem of stability in the fill. Circumferential seam distress can also be a result of foundation failure, but in such cases should be clearly evident by the vertical alignment.

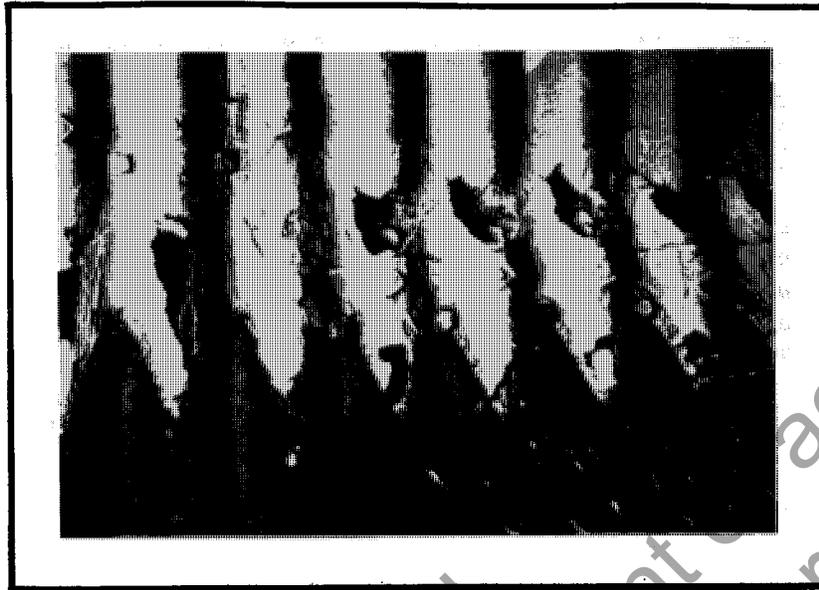
Exhibit 74. Perforation of the invert due to corrosion.

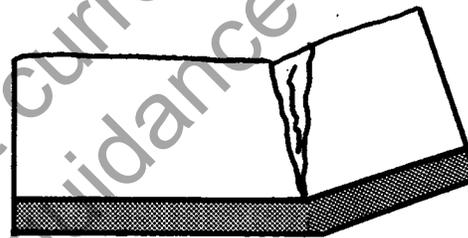
**DIFFERENTIAL FOOTING  
SETTLEMENT -  
NO DISTRESS IN ARCH**

**DIFFERENTIAL FOOTING  
SETTLEMENT -  
DISTRESS IN ARCH**

Exhibit 76. Differential footing settlement.

The most probable structural defect in the footing is differential settlement. One section of a footing settling more than the rest of the footing can cause wrinkling or other distortion in the arch. Flexible corrugated metal culverts can tolerate some differential settlement but will be damaged by excessive differential settlement. Uniform settlement will not ordinarily affect a metal arch but can affect the clearances in a grade separation structure if the footings settle and the road does not. The significance of differential footing settlement increases as the amount of the difference in settlement increases, the length it is spread over decreases, and the height of the arch decreases. This concept is illustrated in exhibit 76.

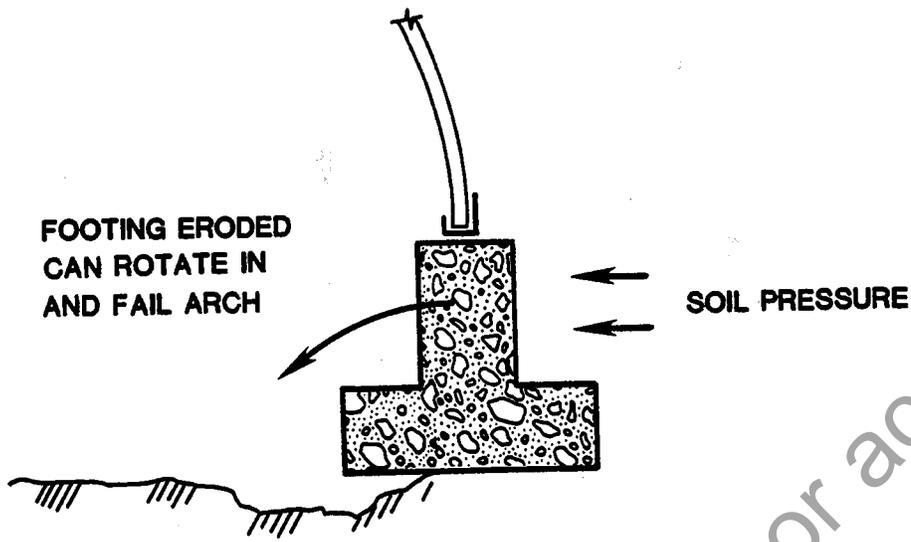
Exhibit 77. Footing rotation due to undermining.

The inspection of footings in structural plate and long-span arches should include a check for differential settlement along the length of a footing. This might show up in severe cracking, spalling, or crushing across the footing at the critical spot. If severe enough, it might be evidenced by a compression or stretching of the corrugations in the culvert barrel. Deterioration may occur in concrete and masonry footings which is not related to settlement but is caused by the concrete or mortar. In arches with no invert slab, the inspector should check for erosion and undermining of the footings and look for any indication of rotation of the footing as illustrated in exhibits 77 and 78.

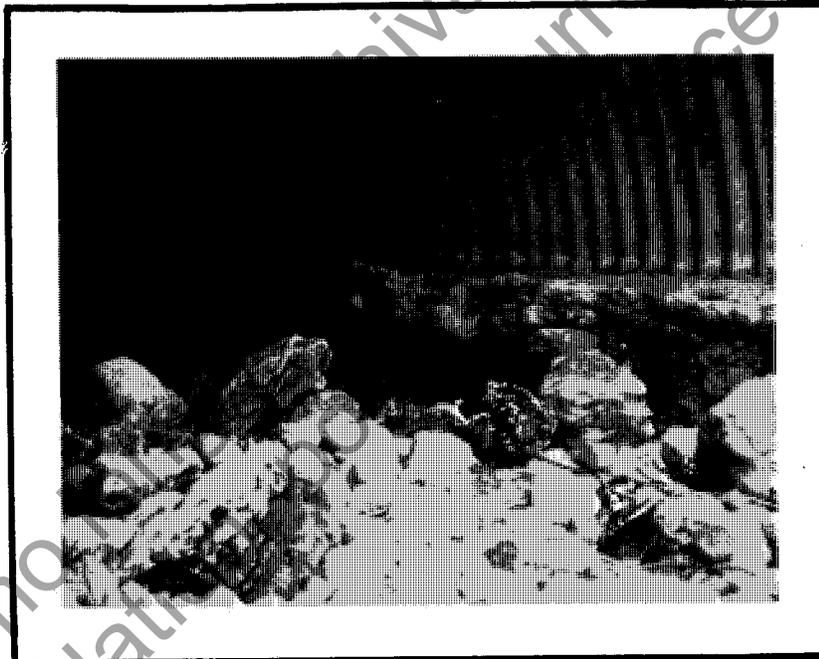
Exhibit 78. Erosion of invert undermining footing of arch.

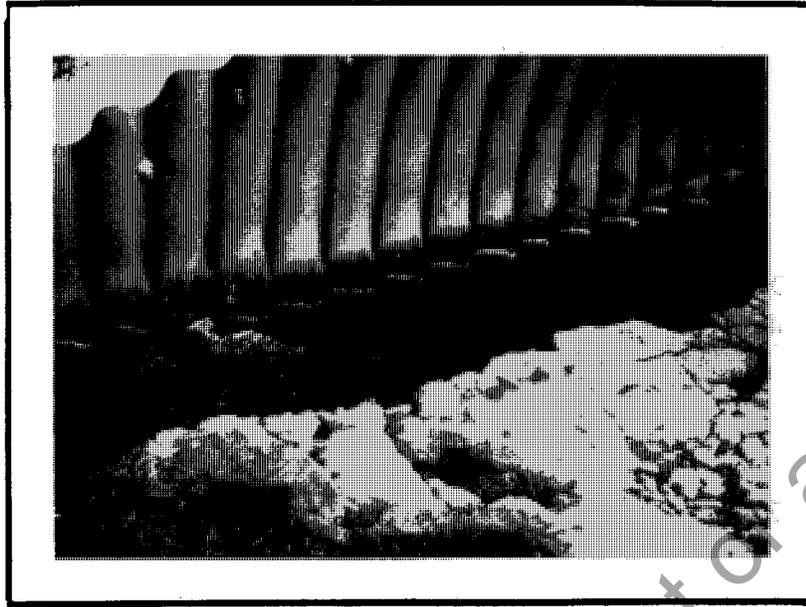
Exhibit 79. Erosion damage to concrete invert.

Culverts rated in good condition may have minor footing damage. Poor to critical condition would be indicated by severe footing undermining, damage, or rotation, or by differential settlement causing distortion and circumferential kinking in the corrugated metal as shown in exhibit 79.

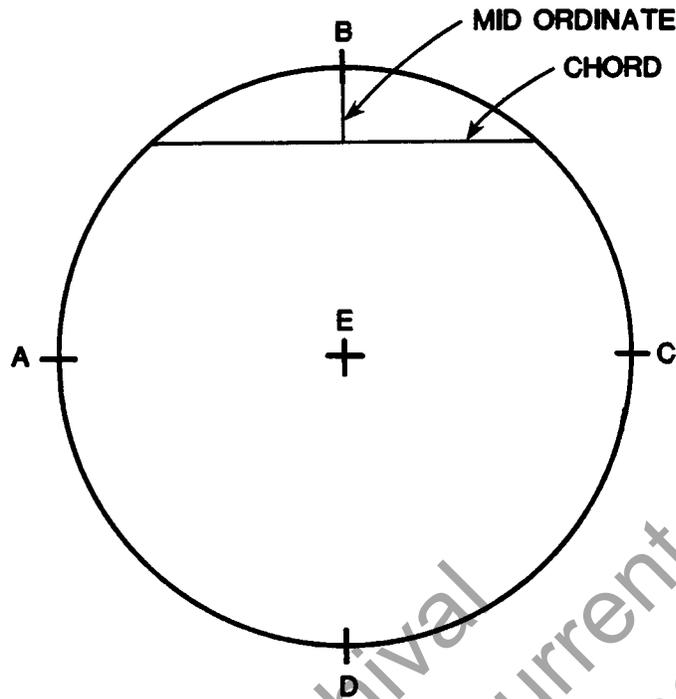
1. MINIMUM MEASUREMENTS REQUIRED:
  - HORIZONTAL DIAMETER = AC
2. IF FLATTENING OBSERVED MEASURE:
  - CHORD AND MID ORDINATE OF FLATTENED AREA
3. IF HORIZONTAL DIAMETER EXCEEDS DESIGN BY MORE THAN 10% MEASURE:
  - VERTICAL DIAMETER = BD

Exhibit 81. Shape inspection circular and vertical elongated pipe.

The inspector should note the visual appearance of the culvert's shape and measure the horizontal span as shown in exhibit 81. Almost all round or vertical elongated pipe can be directly measured and will not require elevations. Exceptions are large vertical elongated grade separation structures. On such structures, elevations should be obtained similar to those recommended for the long-span pear shape.

If the visual appearance or measured horizontal diameter differ significantly from the design specifications, additional measurement, such as vertical diameter, should be taken. Flattened areas should be checked by measuring a chord and the mid ordinate of the chord. The chord length and ordinate measurement should be noted in the report with a description of the location and extent of the flattened area.

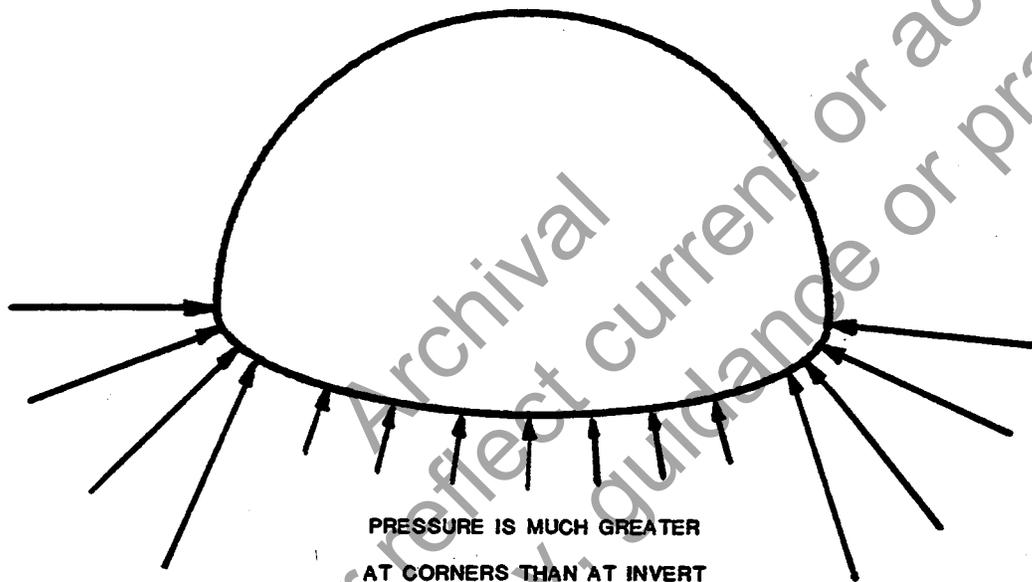
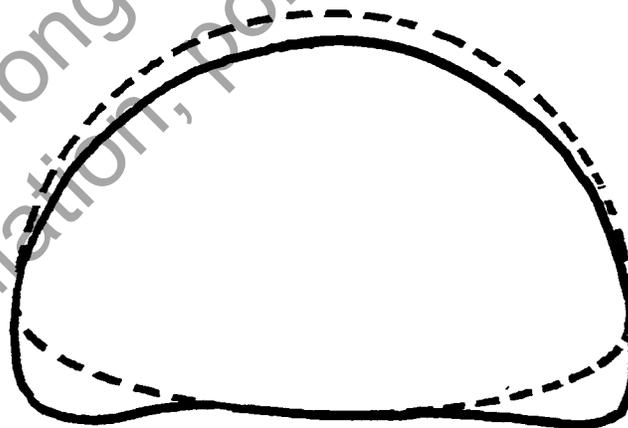
Exhibit 83. Bottom distortion in pipe arches.

The pipe arch is a completely closed structure but is essentially an arch. The load is transmitted to the foundation principally at the corners. The corners are much like footings of an arch. There is relatively little force or pressure on the large radius bottom plate. The principal type of distress in a pipe arch is a result of inadequate soil support at the corners where the pressure is relatively high. The corner may push down or out into the soil while the bottom stays in place. The effect will appear as if the bottom pushed up. This problem is illustrated in exhibits 83 and 84.

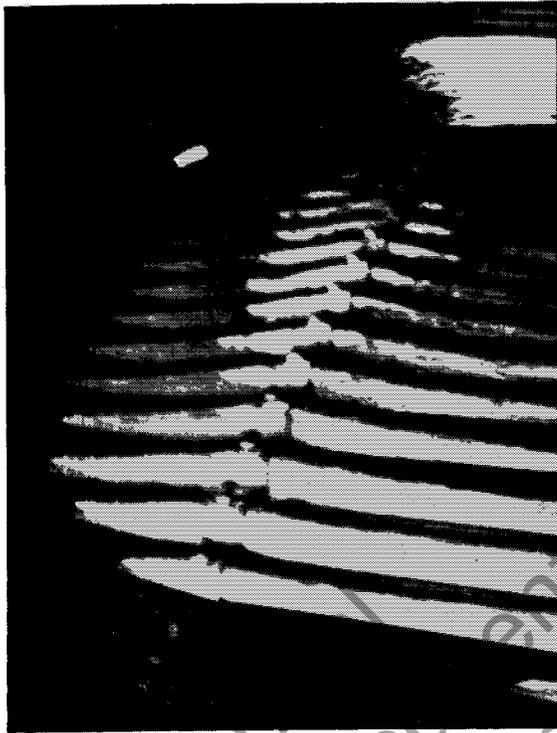
Exhibit 84. Bottom and corners of this pipe arch have settled.

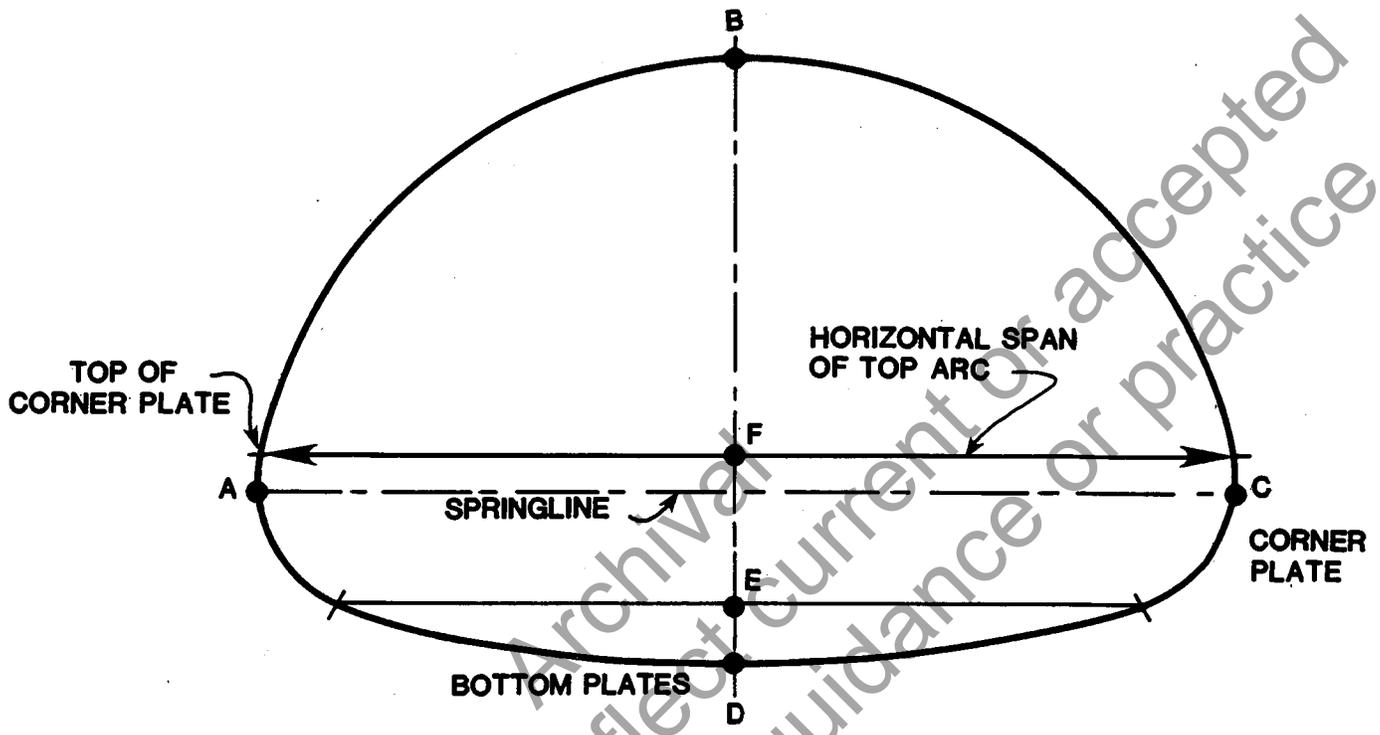
**1. MINIMUM REQUIRED MEASUREMENTS - AC, BD**

- SPAN = AC
- RISE = BD

The inspector should record the visual appearance of the shape and measure both the span and the rise. If the span exceeds the design span by more than 3 percent, the span of the top arc, the mid ordinate of the top arc, and the mid ordinate of the bottom arc should also be measured. Recommended measurements are shown in exhibit 85.

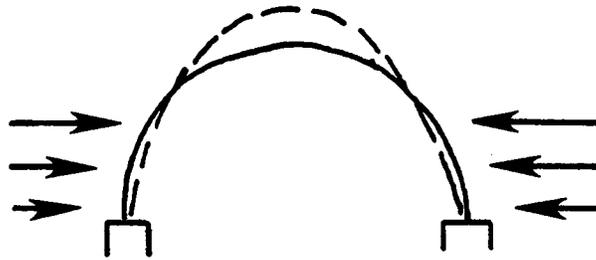
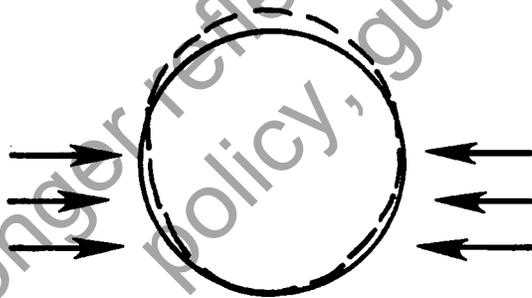
**BACKFILL TENDS TO PEAK  
ARCHES (DOTTED LINE)**

**ROUND PIPES CAN DEFLECT  
MORE UNIFORMLY**

Exhibit 87. Arch deflection during installation.

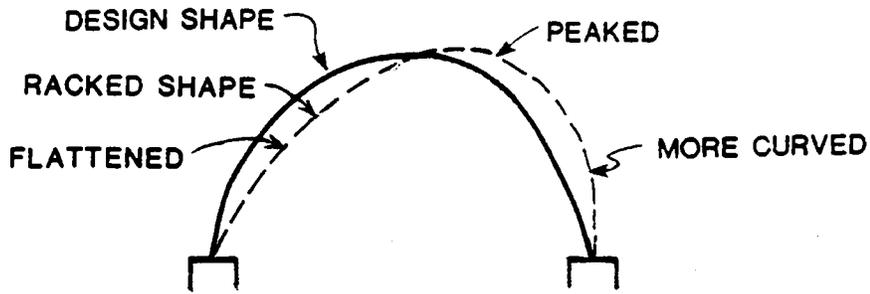
Exhibit 88. Raked and peaked arch.

Another important shape factor in arches is symmetrical shape. If the arch was erected with the base channels not square to the centerline, it causes a racking of the cross section. A racked cross-section is one that is not symmetrical about the centerline of the culvert. One side tends to flatten, the other side tends to curve more while the crown moves laterally and possibly upward. If these distortions are not corrected before backfilling the arch, they usually get worse during backfill. Exhibit 88 illustrates racked or peaked arches.

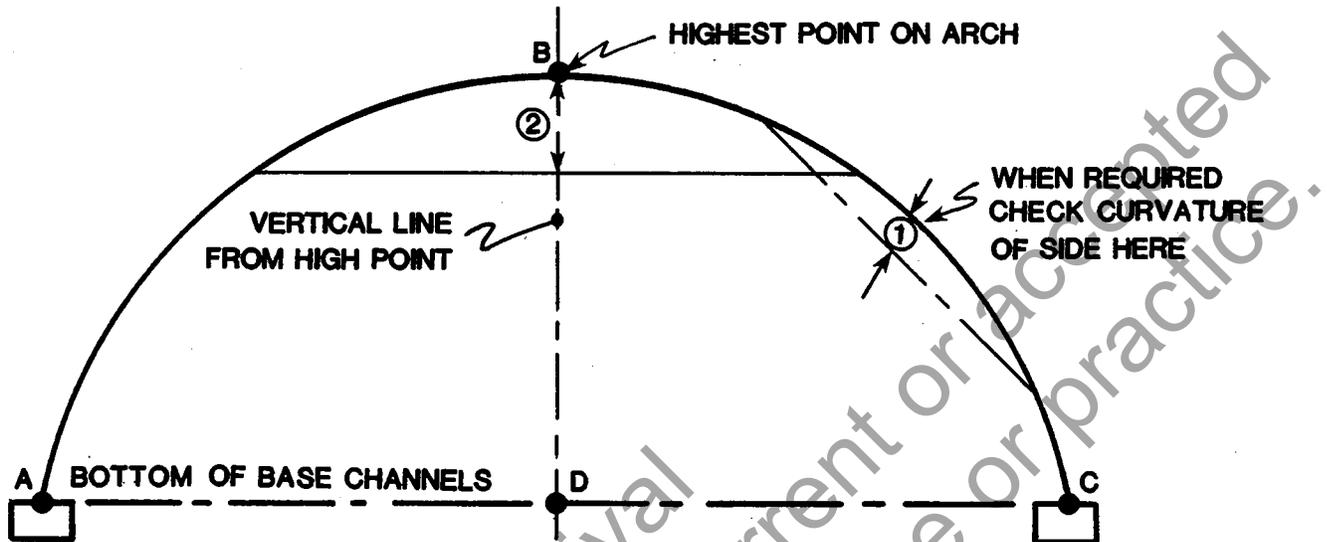
**1. MINIMUM REQUIRED MEASUREMENTS**

- SPAN = AD + DC
- RISE = BD

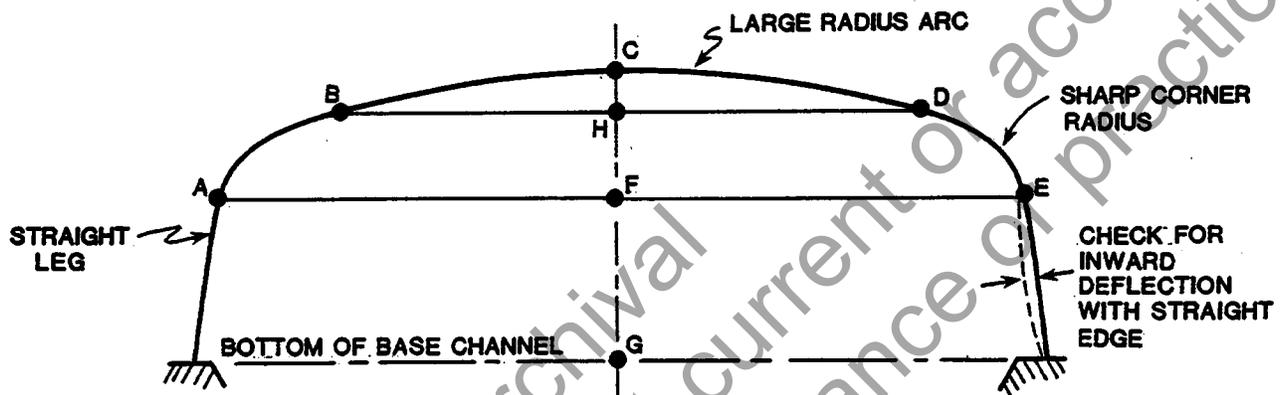
1. MINIMUM REQUIRED MEASUREMENTS

- RISE = CG
- SPAN = AE

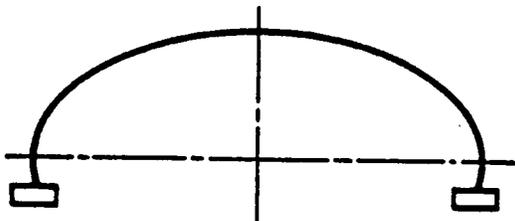
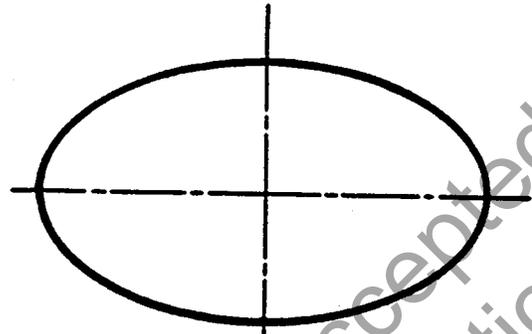
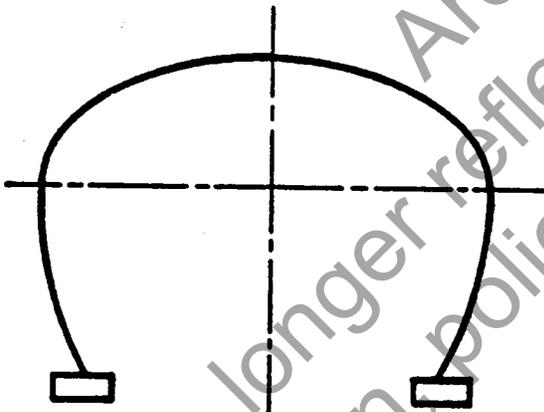
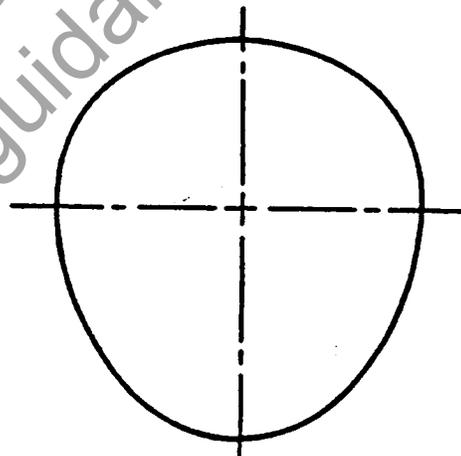
Low Profile Arch

Horizontal Ellipse

High Profile Arch

Pear

Exhibit 93. Typical long-span shapes.

As previously mentioned, the section above the springline is essentially the same for most long-span shapes. With the exception of pear shapes, the standard top geometry uses a large radius top arc of approximately 80 degrees with a radius of 15 to 25 feet. The adjacent corner or side plates are from one-half to one-fifth the top arc radius. The most important part of a long-span shape is the standard top arch geometry. Adequate curvature of the large radius top arc is critical. Inspection of the crown section should consist of a visual inspection of the general shape for smooth curvature (no distortion, flattening, peaks, or cusps) and symmetrical shape (no racking).

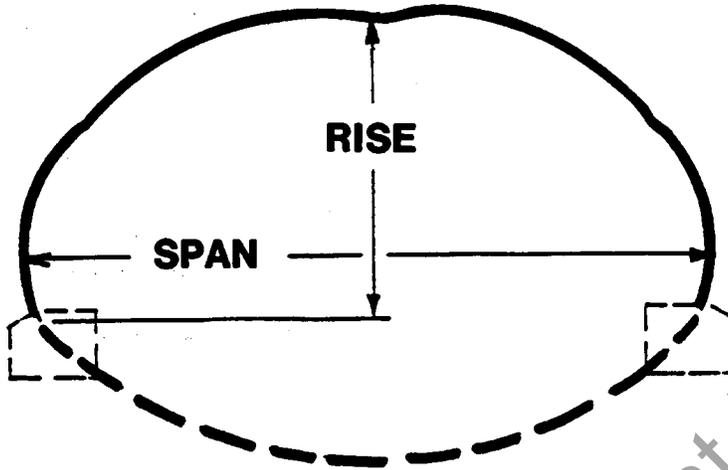
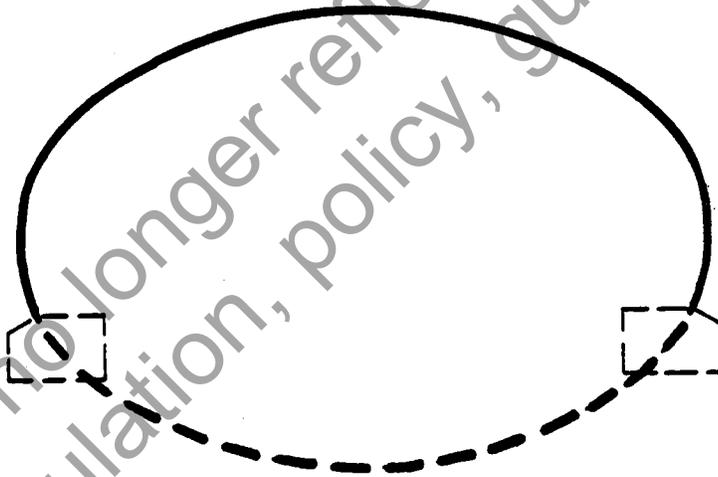
THE RISE AND SPAN ON THIS STRUCTURE ARE EQUAL TO THE DESIGN RISE AND SPAN, YET IT IS A VERY POOR SHAPE

THE RISE AND SPAN ON THIS STRUCTURE ARE CONSIDERABLY DIFFERENT FROM THE DESIGN RISE AND SPAN, YET IT IS IN EXCELLENT SHAPE

Exhibit 94. Simple linear measurements may not describe the structural shape.

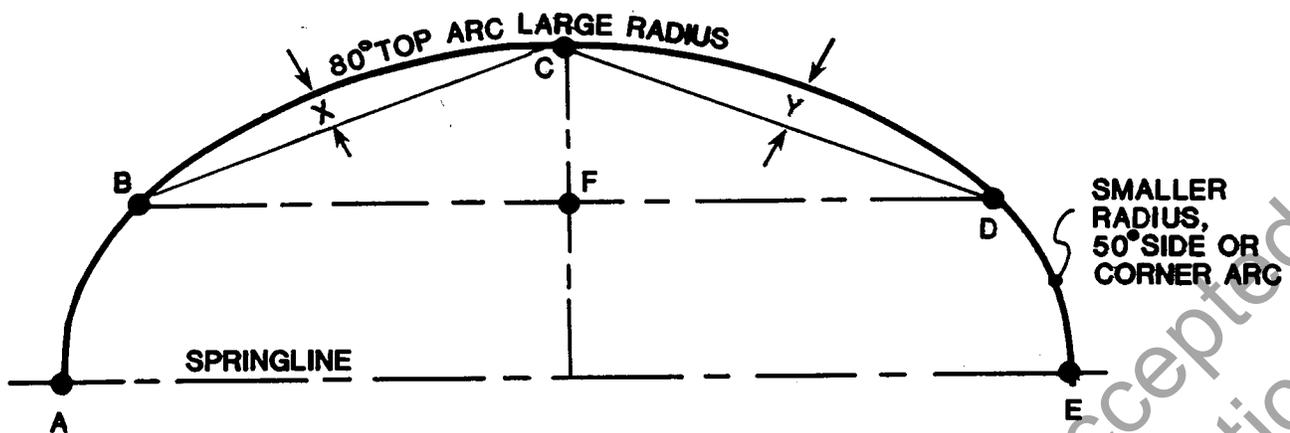
1. MINIMUM REQUIRED ELEVATIONS - B, C, D

MINIMUM REQUIRED MEASUREMENTS -

Note: These measurements and elevations should be obtained on all long span inspections (see exhibits 96, 98, 100 and 103).

Exhibit 95. Shape inspection crown section of long span structures.

An inspection should also include key measurements such as the middle ordinate of the top arc. Recommended measurements and elevations are shown in exhibit 95.

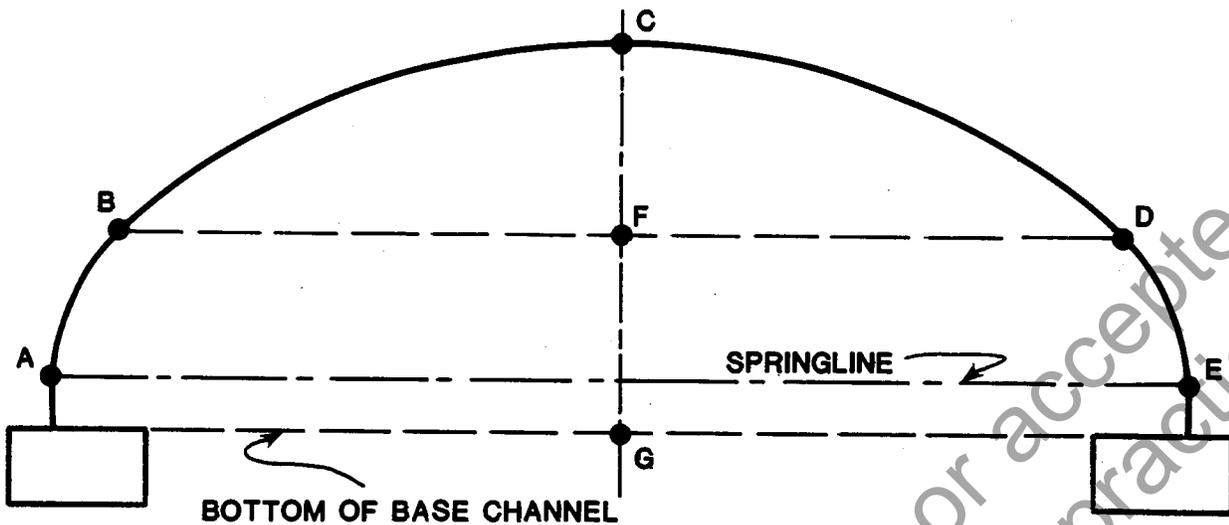
AE = SPAN, CG = RISE OR HEIGHT

1. MINIMUM REQUIRED MEASUREMENTS -

The low profile arch is essentially the same as the crown section except that the sides are carried about 10 degrees below the springline to the footing. These structures are low and can be measured more easily than other long-span shapes. Recommended measurements and elevations are shown in exhibit 96. Rating guidelines are listed in exhibit 97.
