# CULVERT INSPECTION MANUAL

## SUPPLEMENT TO THE BRIDGE INSPECTOR'S TRAINING MANUAL

**Report No.  
FHWA-IP-86-2**

**Final Report  
July 1986**

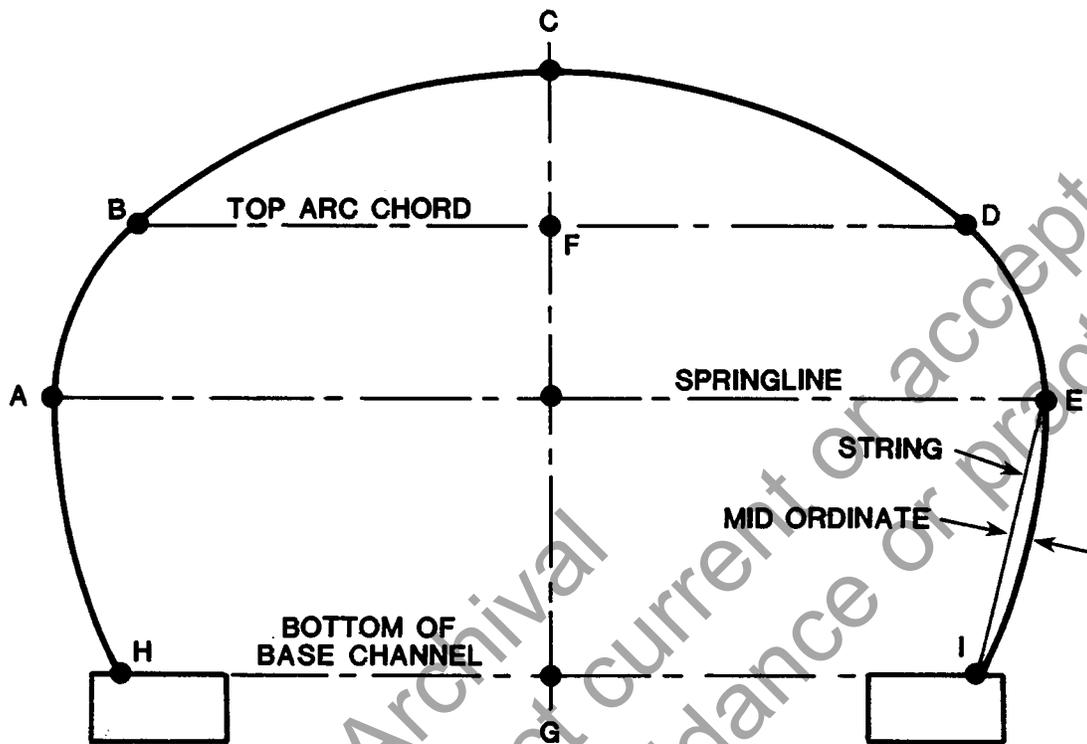
$AE = \text{SPAN}, CG = \text{RISE}$

**1. MINIMUM REQUIRED MEASUREMENTS**

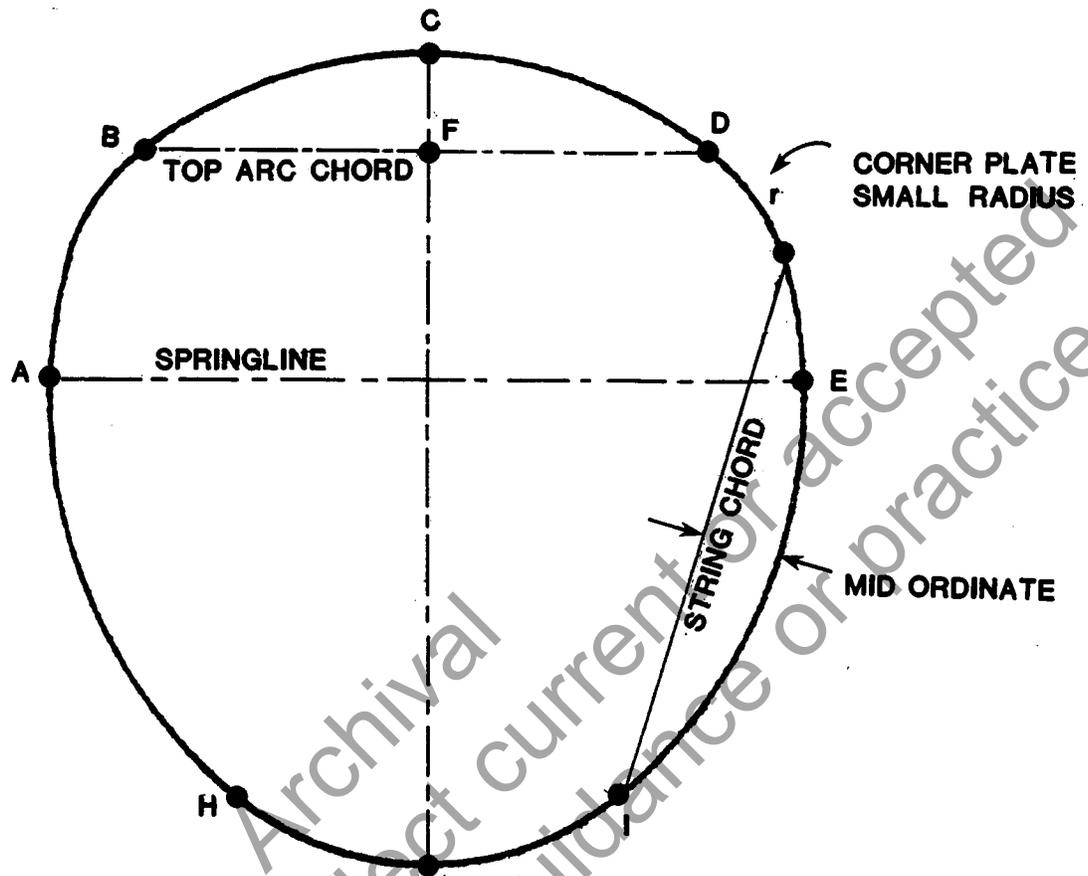
**AE = SPAN, CG = RISE**

**1. MINIMUM REQUIRED MEASUREMENT - AE**

The pear shape behaves similarly to the high profile arch. It is essentially a high profile with a metal bottom instead of concrete footings. Pears may be inspected using the criteria for a high profile arch. The recommended measurements and elevations are shown in exhibit 100. Rating guidelines are provided in exhibit 101.

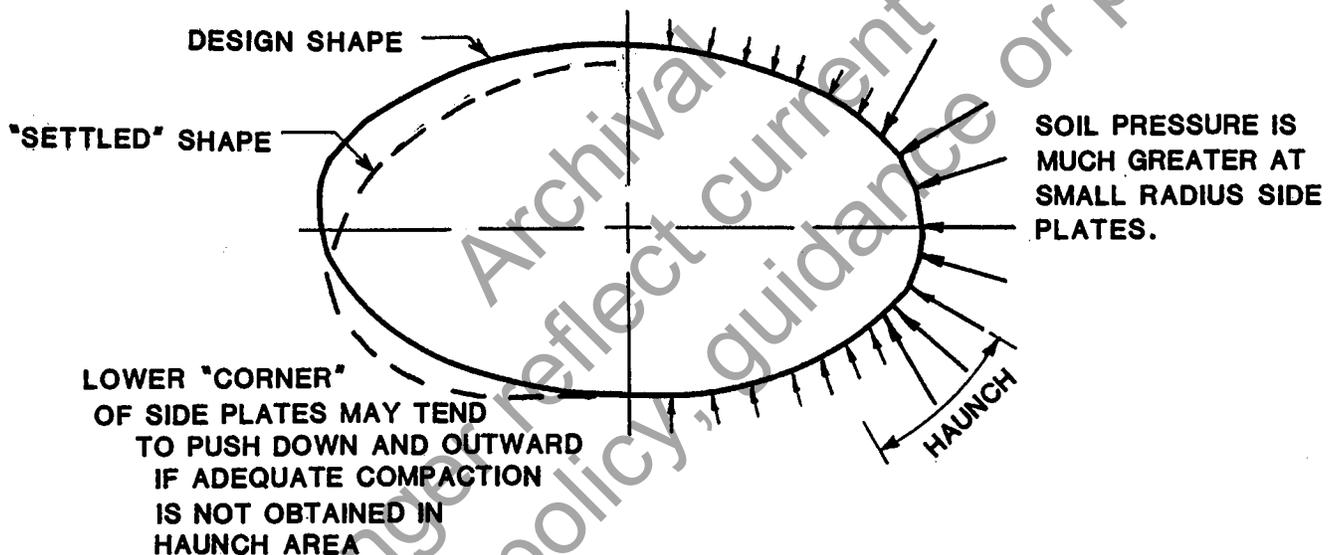
Exhibit 102. Potential for differential settlement in horizontal ellipse.

For horizontal ellipses the most important shape factor is adequate curvature in the crown section. The crown section uses the standard long-span crown geometry. The sides and bottom behave similar to the corners and bottom of pipe arches. The invert has relatively minor pressure when compared with the sides, which may have several times the bearing pressure of the invert. As a result the corners and sides have the tendency to push down into the soil while the bottom does not move. The effect is as if the bottom pushed up. Inspectors should look for indications of bottom flattening and differential settlement between the side and bottom sections, as illustrated in exhibit 102.

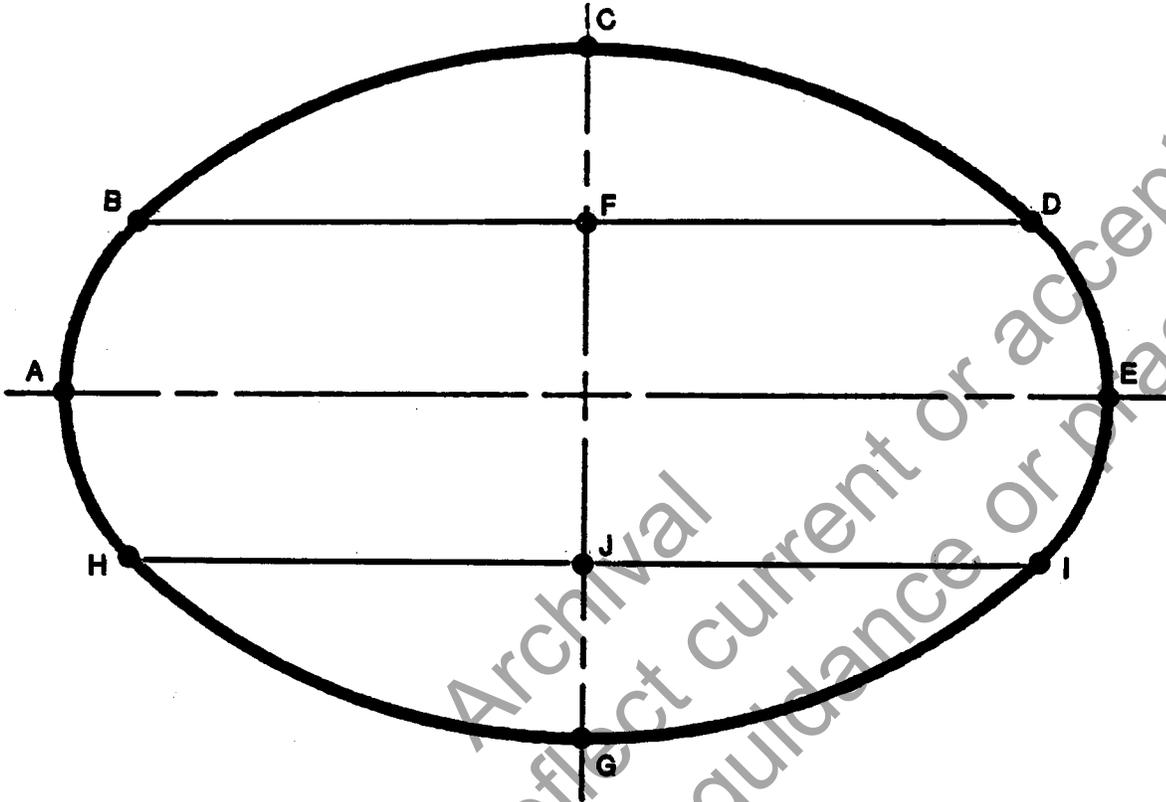
**1. MINIMUM REQUIRED MEASUREMENTS**

■ SPAN = AE

The recommended measurements and evaluations for a shape inspection of horizontal ellipse are shown in exhibit 103. The measurements are essentially the same as those recommended for a standard crown section. Shape evaluation of an ellipse is also essentially the same as the evaluation of a standard crown section except that the curvature of the bottom should also be evaluated. Marginal shape would be indicated when the bottom is flat in the center and corners are beginning to deflect downward or outward. Critical shape conditions would be indicated by reverse curvature in the bottom arc. Guidelines for rating horizontal ellipse shape culverts are provided in exhibit 104.

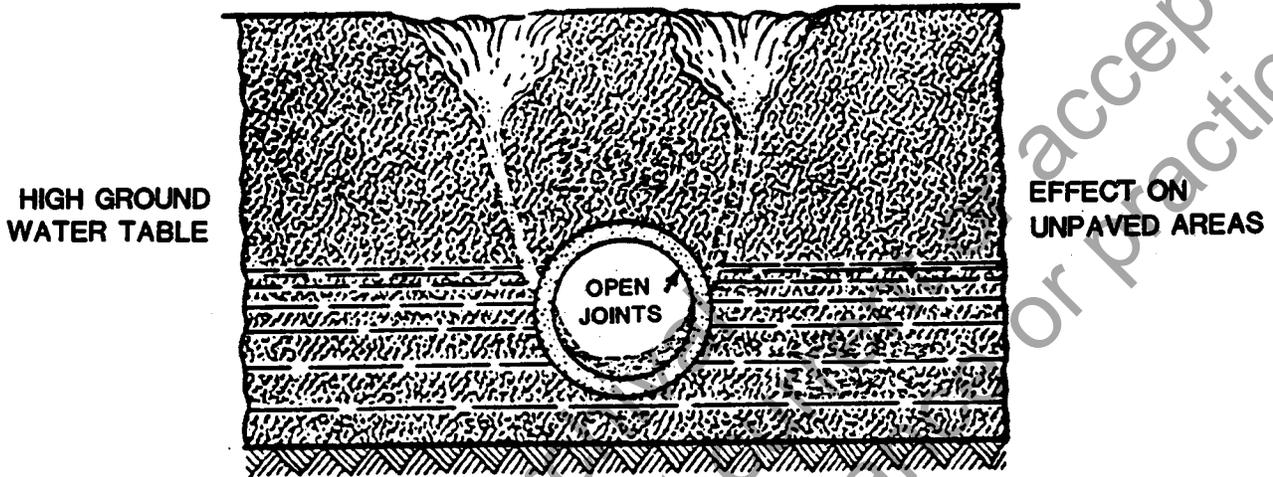
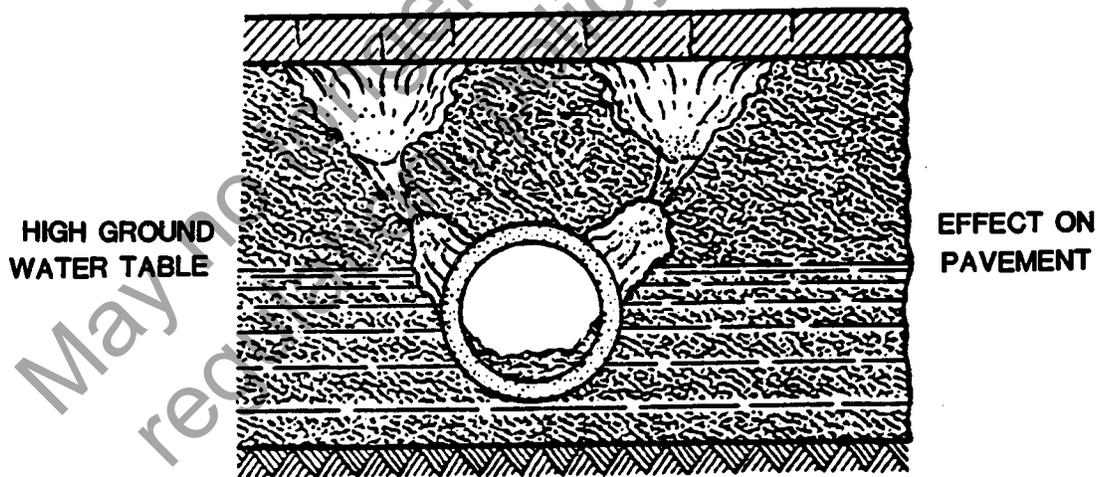
Exhibit 105. Surface indications of infiltration.

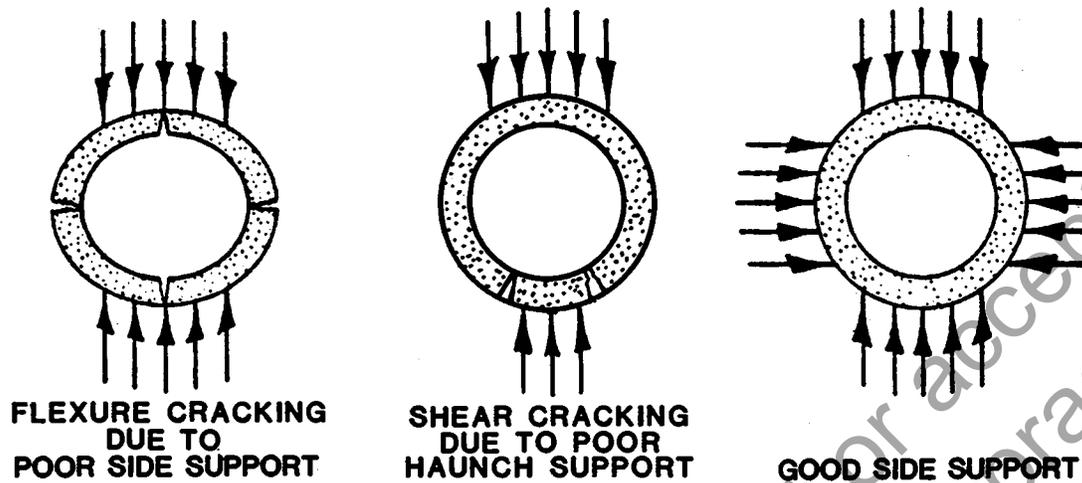
Exhibit 108. Results of poor and good side support, rigid pipe.

c. Longitudinal Cracks—Concrete is strong in compression but weak in tension. Reinforcing steel is provided to handle the tensile stresses. Hairline longitudinal cracks in the crown or invert indicate that the steel has accepted part of the load. Cracks less than 0.01 inches in width are minor and only need to be noted in the inspection report. Cracks greater than hairline cracks, or those more than 0.01 inch in width but less than 0.1 inches, should be described in the inspection report and noted as possible candidates for maintenance. Longitudinal cracking in excess of 0.1 inch in width may indicate overloading or poor bedding. If the pipe is placed on hard material and backfill is not adequately compacted around the pipe or under the haunches of the pipe, loads will be concentrated along the bottom of the pipe and may result in flexure or shear cracking, as illustrated in exhibit 108.

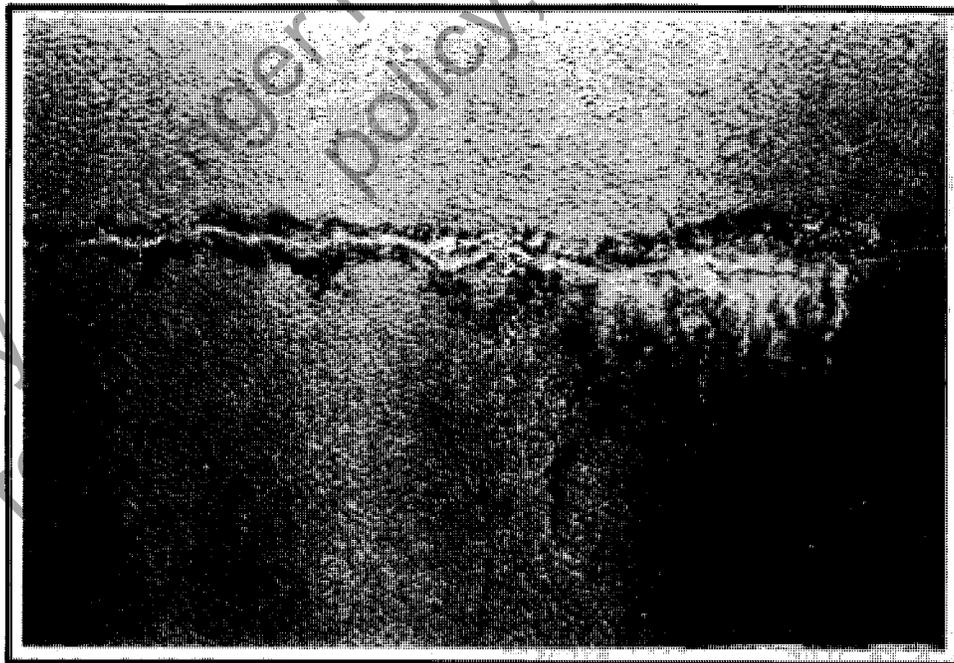
Exhibit 109. Minor longitudinal crack with efflorescence.

Other signs of distress such as differential movement, efflorescence, spalling, or rust stains should also be noted. Examples of longitudinal cracking are shown in exhibits 109 and 110. When cracks are wider than 0.1 inch measurements should be taken of fill height and the diameter of the pipe both horizontally and vertically to permit analysis of the original design. Crack measurements and photographs may be useful for monitoring conditions during subsequent inspections.

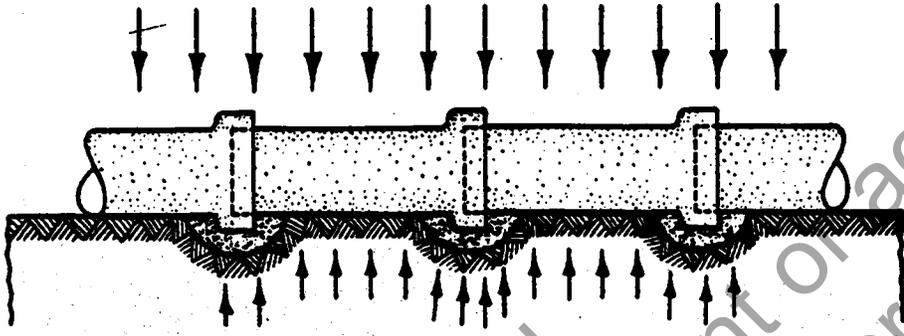
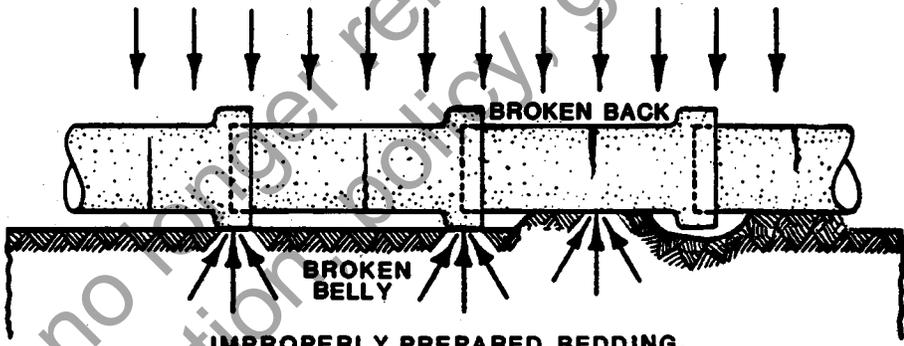
PROPERLY PREPARED BEDDING EVENLY DISTRIBUTES LOADS.  
IMPROPERLY PREPARED BEDDING MAY RESULT IN STRESS CONCENTRATIONS.

IMPROPERLY PREPARED BEDDING.

Exhibit 111. Transverse or circumferential cracks.

d. Transverse Cracks--Transverse or circumferential cracks may also be caused by poor bedding. Cracks can occur across the bottom of the pipe (broken bell) when the pipe is only supported at the ends of each section. This is generally the result of poor installation practices such as not providing indentions (bell holes) in hard foundation material for the ends of bell and spigot-type pipe or not providing a sufficient depth of suitable bedding material. Cracks may occur across the top of pipe (broken back) when settlement occurs and rocks or other areas of hard foundation material near the midpoint of a pipe section are not adequately covered with suitable bedding material. Transverse cracking is illustrated in exhibit 111.

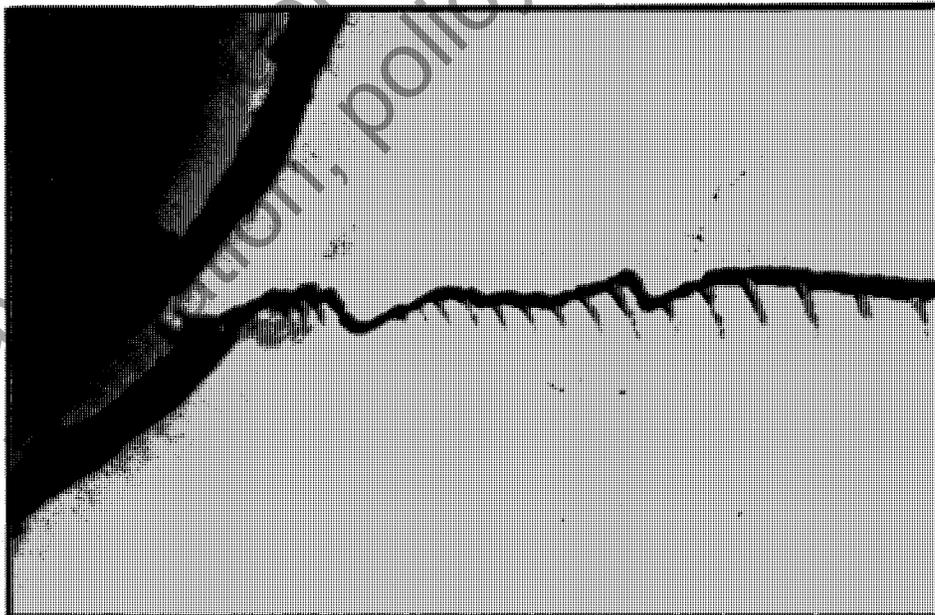
Exhibit 113. Shear slabbing.

f. Slabbing--The terms slabbing, shear slabbing, or slab shear refer to a radial failure of the concrete which occurs from straightening of the reinforcement cage due to excessive deflection. It is characterized by large slabs of concrete "peeling" away from the sides of the pipe and a straightening of the reinforcing steel as shown in exhibit 113. Slabbing is a serious problem that may occur under high fills.

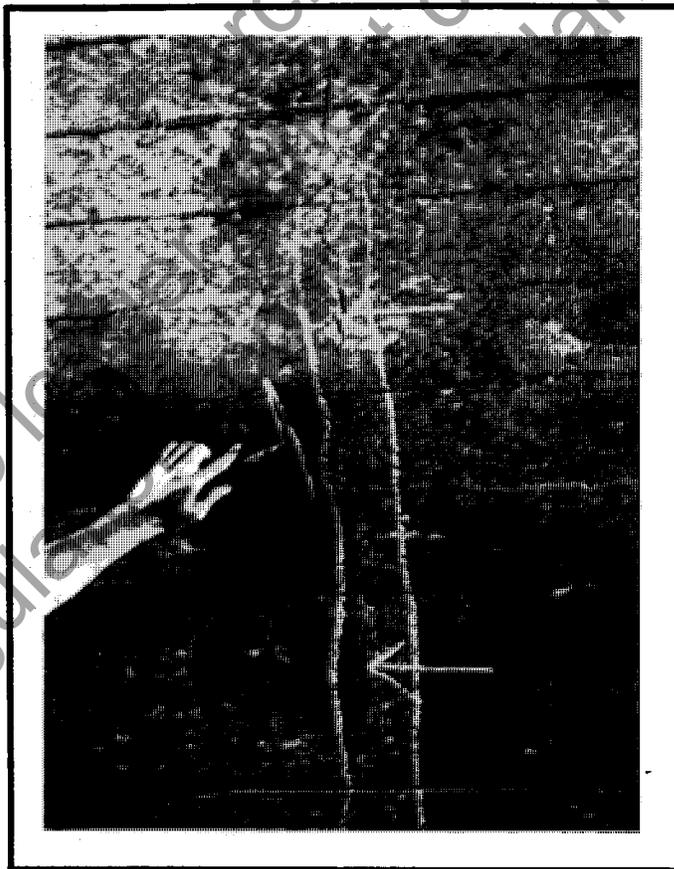
Exhibit 115. Transverse crack in wall of reinforced concrete box culvert.

c. Cracks and Spalls--The top slab and walls should be inspected visually for cracks and spalls. When either is observed, the area around the defect should be tapped with a hammer to detect incipient spalls. A ladder may be needed for inspecting the top slab. Longitudinal cracks in the top slab of box culverts may indicate either flexure or shear problems. Transverse cracks may indicate differential settlement. Spalls may occur along the edges of cracks or in the concrete covering corroded reinforcing steel. Cracks in the sides may be caused by settlement or earth pressure. The location, size, and length or area of all cracks and spalls should be noted in the inspection report. Photographs, such as those shown in exhibits 115 and 116.

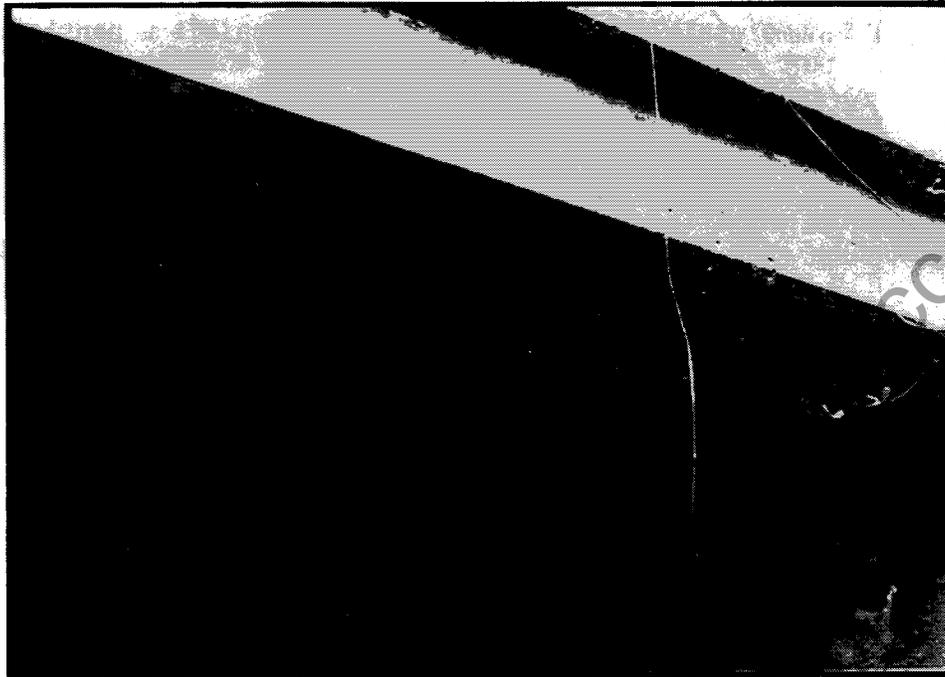
Exhibit 116. Spalls and delaminations in bottom of top slab of box culvert.

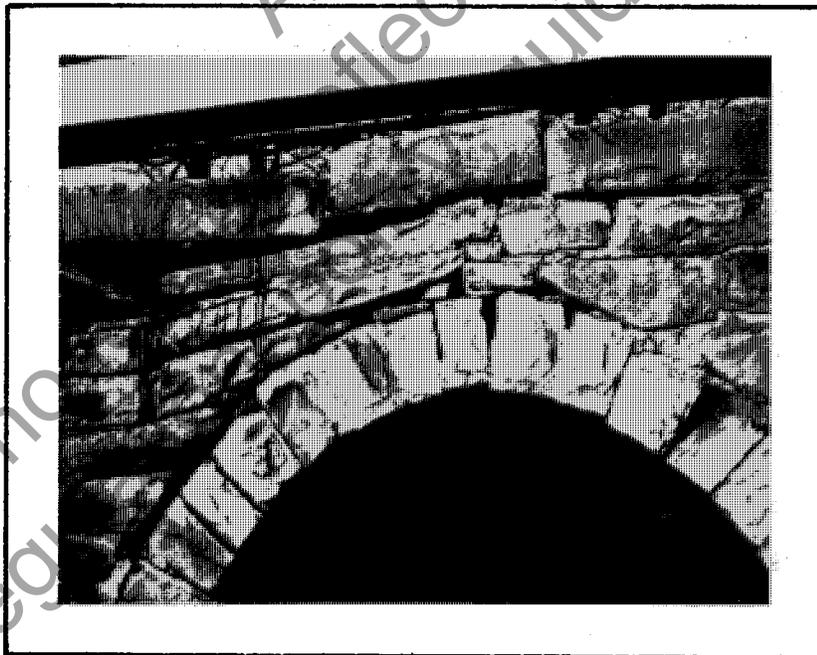
Exhibit 118. Masonry arch mortar deterioration and displaced stones in arch and headwall.

a. Masonry Units--The individual stones, bricks or blocks should be checked for displaced, cracked, broken, crushed, or missing units as illustrated in exhibits 118 and 119. For some types of masonry surface deterioration or weathering can also be a problem.

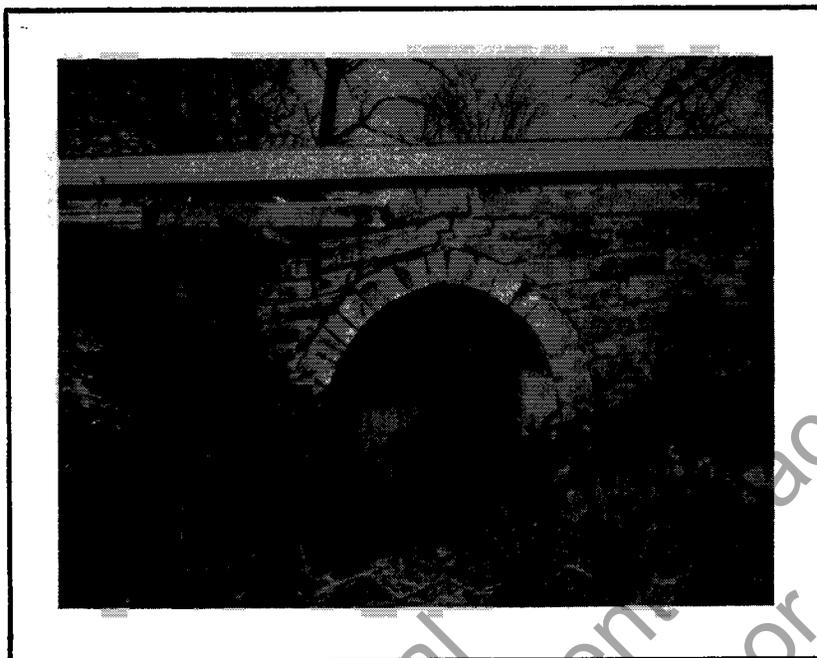
Note: Curvature of left side of arch is flatter than right side.

Exhibit 119. Masonry arch mortar deterioration and displaced stones.

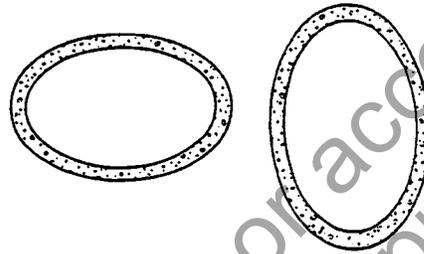
HORIZONTAL  
AND  
VERTICAL  
ELLIPSE  
PIPE

### DIMENSIONS AND APPROXIMATE WEIGHTS OF ELLIPTICAL CONCRETE PIPE

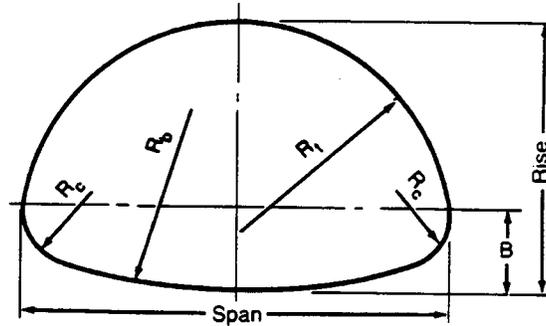
**Sizes and Layout Details—CSP Pipe Arches  
2½ × ½ in. Corrugation**

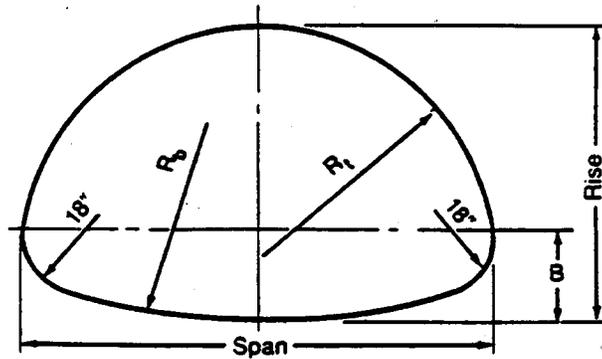
**Sizes and Layout Details—Structural Plate Steel Pipe-Arches  
6 × 2 in. Corrugations—Bolted Seams  
18-inch Corner Radius  $R_c$**

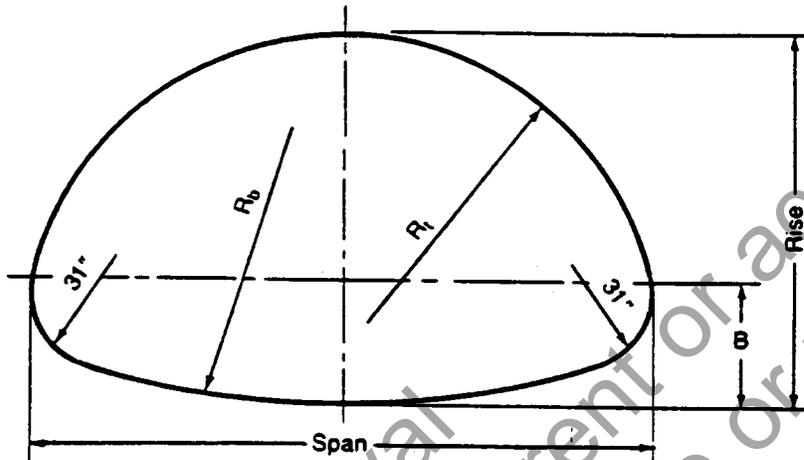
**Sizes and Layout Details—Structural Plate Steel Pipe-Arches<sup>11</sup>**  
**6 × 2 in. Corrugations—Bolted Seams**  
**31-in Corner Radius,  $R_c$**

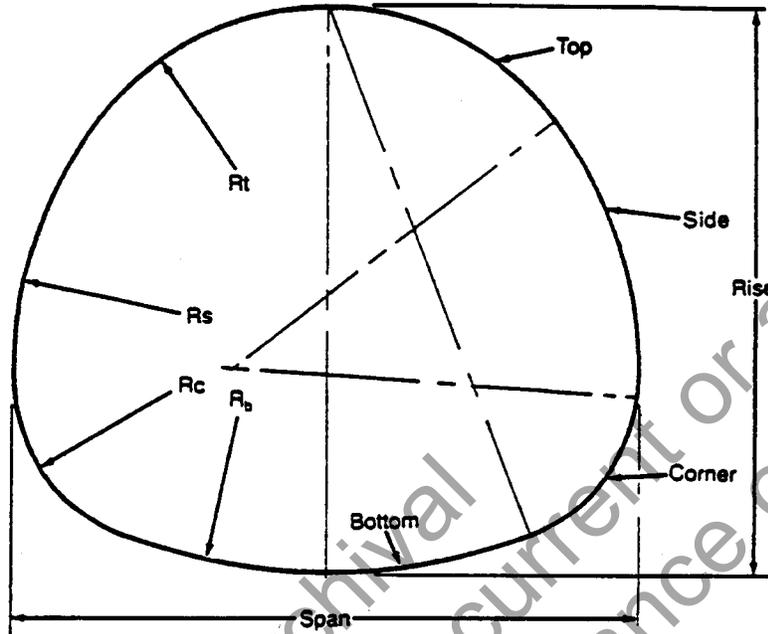
**Structural Plate Steel Underpasses  
Sizes and Layout Details**

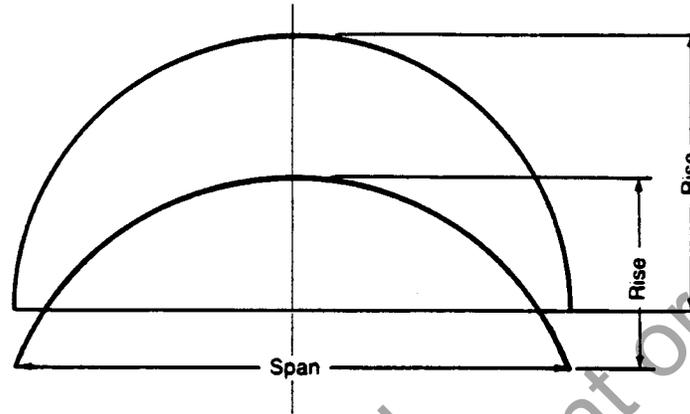
**Representative Sizes of Structural Plate Steel Arches**

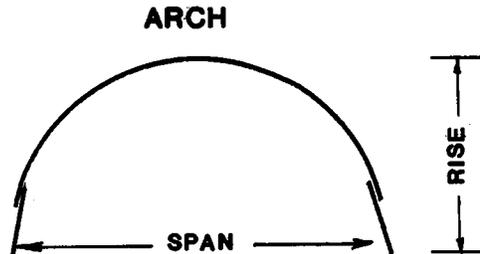
Continued. Representative Sizes of Structural Plate Steel Arches

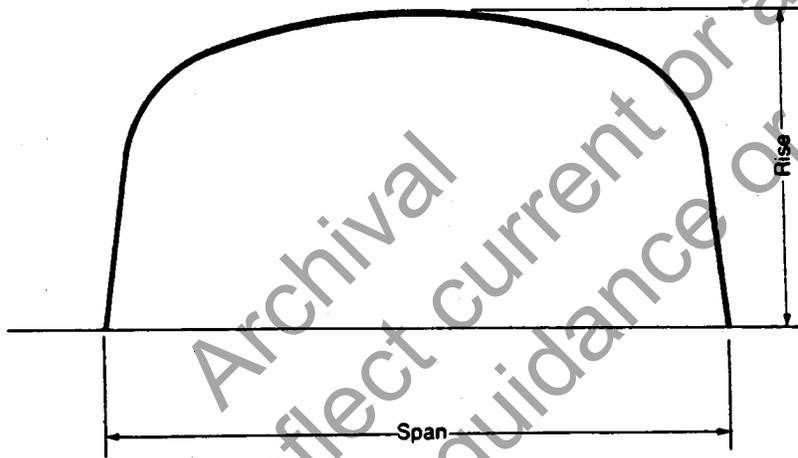
**Layout Details  
Corrugated Steel Box Culverts**

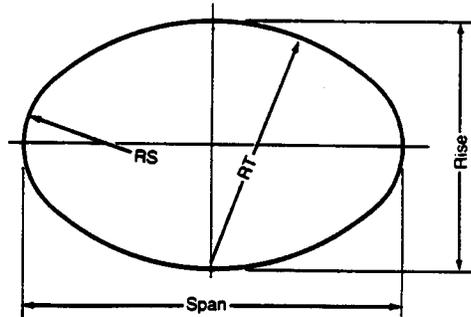
**Long Span Horizontal Ellipse Sizes and Layout Details**

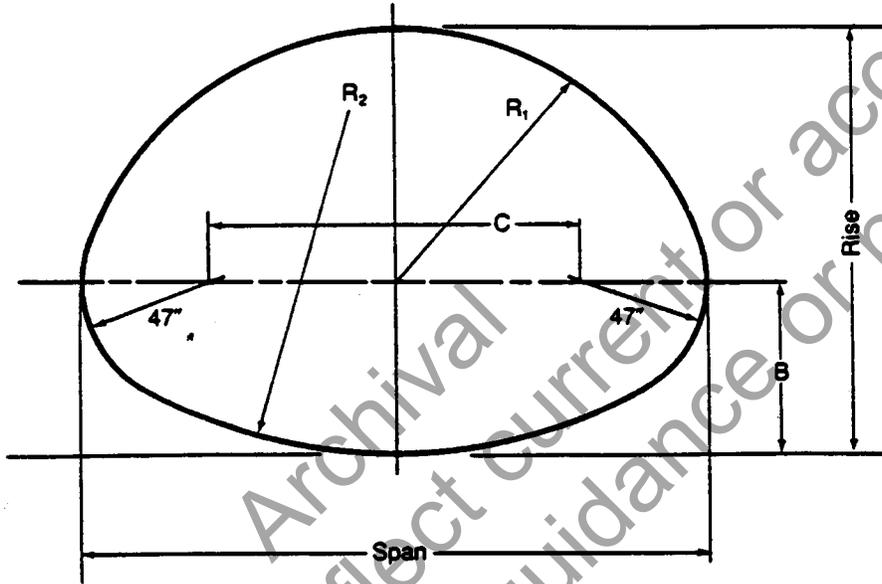
**Long Span Pipe Arch Sizes and Layout Details.**

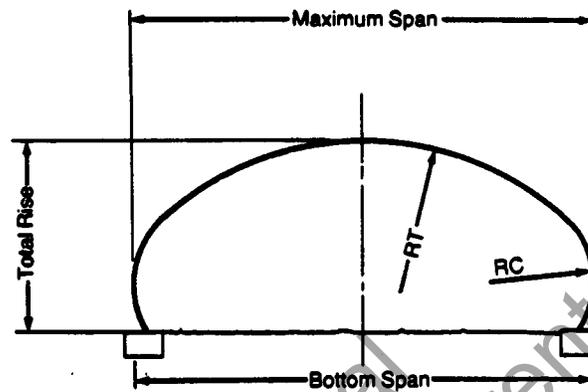
**Long Span Low Profile Arch Sizes and Layout Details**

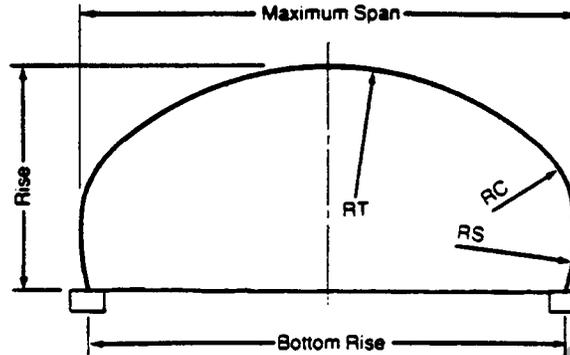
**Long Span High Profile Arch Sizes and Layout Details**

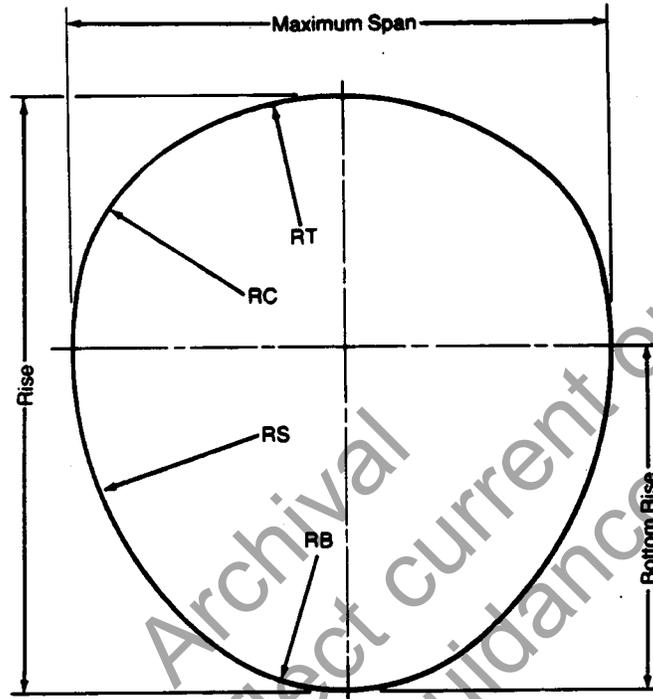
**Long Span Pear Shape Sizes and Layout Details**

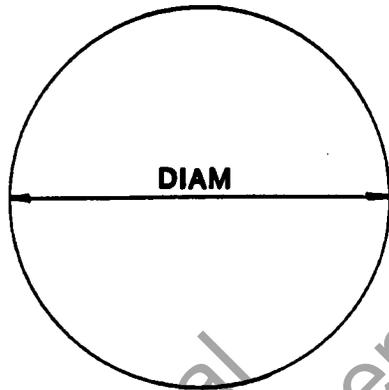
**Geometric Data — Structural Plate Pipe**

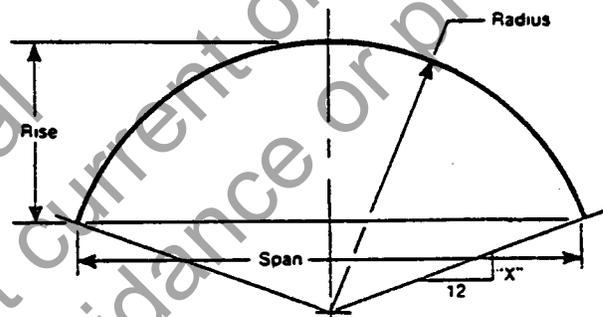
**Typical Section**

## GEOMETRIC DATA - ARCH

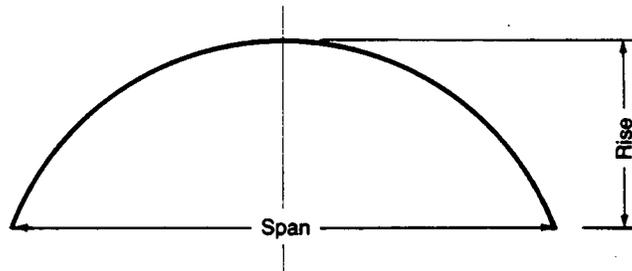
**ARCH  
(CONT'D)**

Geometric Data—Arch (Continued)

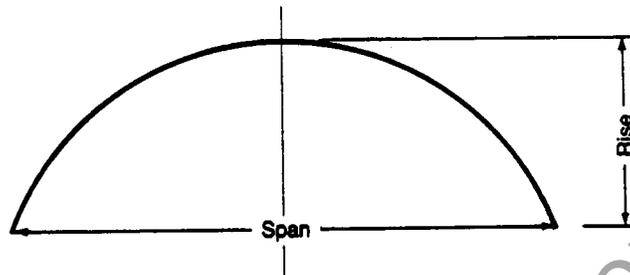
Geometric Data—Arch (Continued)

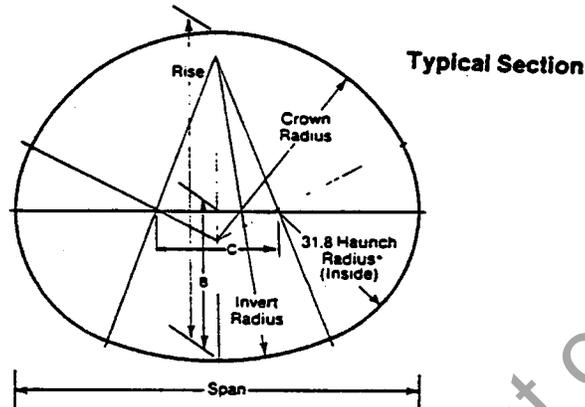
Geometric Data—Pipe Arch

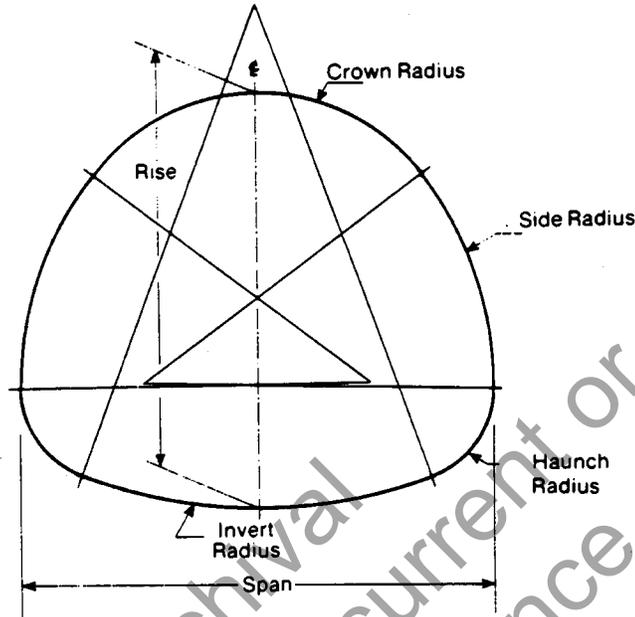
**Typical Section**

### Geometric Data—Vehicular Underpass

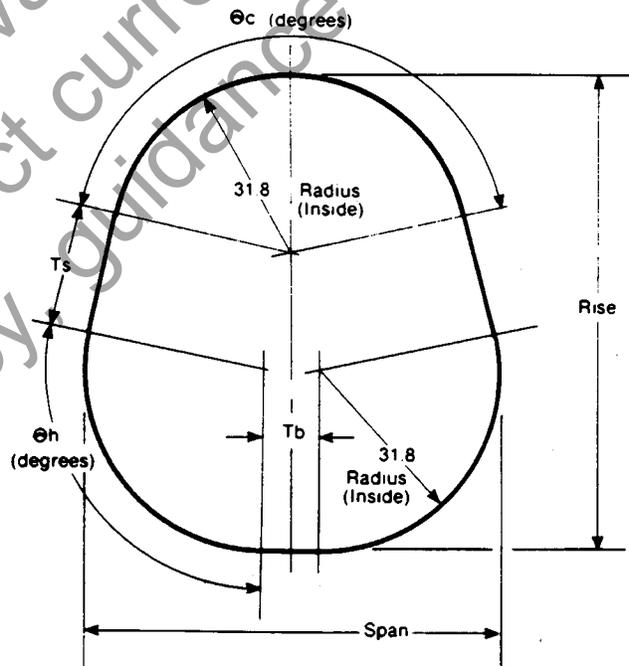
Typical Section

Geometric Data—Pedestrian/Animal Underpass

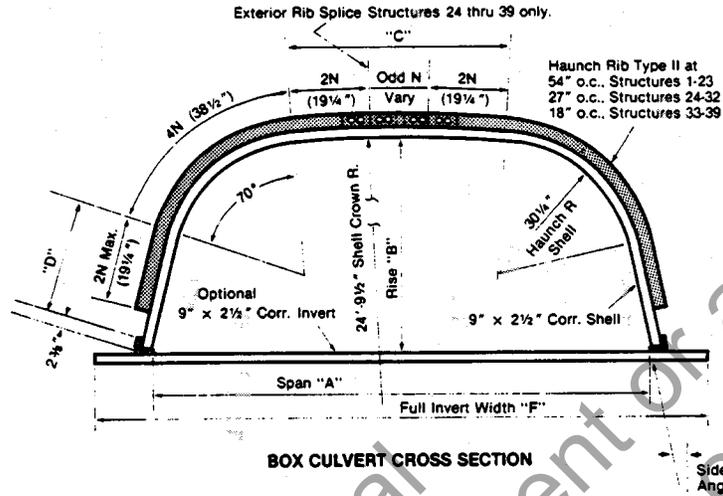
## Box Culvert Geometric Data

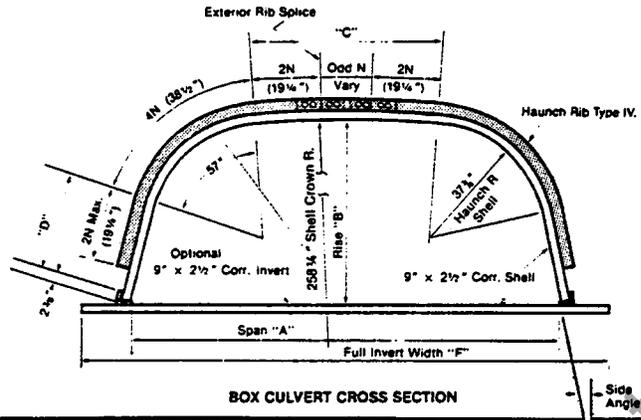
BOX CULVERT CROSS SECTION

## Box Culvert Geometric Data

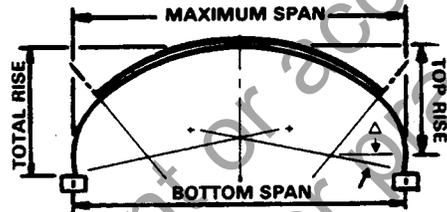
Geometric Data—Low Profile Arch

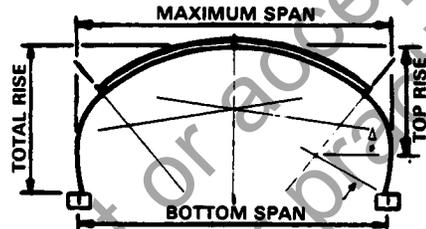
Geometric Data—High Profile Arch
