BINATIONAL BORDER TRANSPORTATION PLANNING AND PROGRAMMING STUDY

Task 9: Port of Entry Case Studies

***Barton-Aschman
La Empresa***

FINAL REPORT

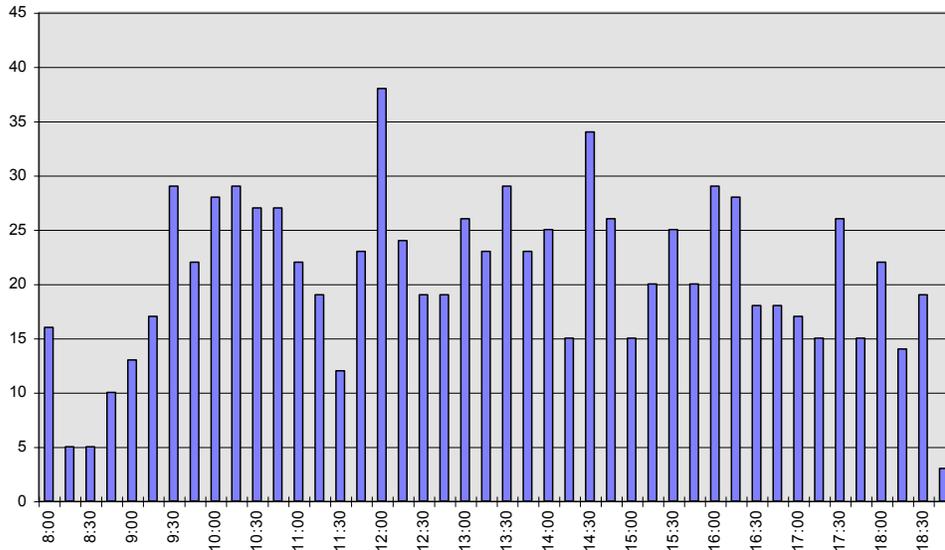
Figure 9.3 - 15-Minute Arrivals in Nogales, Mexico - January 16, 1997

Arrival Time 15-minute Intervals - Surveyed Vehicles (88%)
 Nogales, AZ - Mariposa Border Crossing Survey
 January 16, 1997

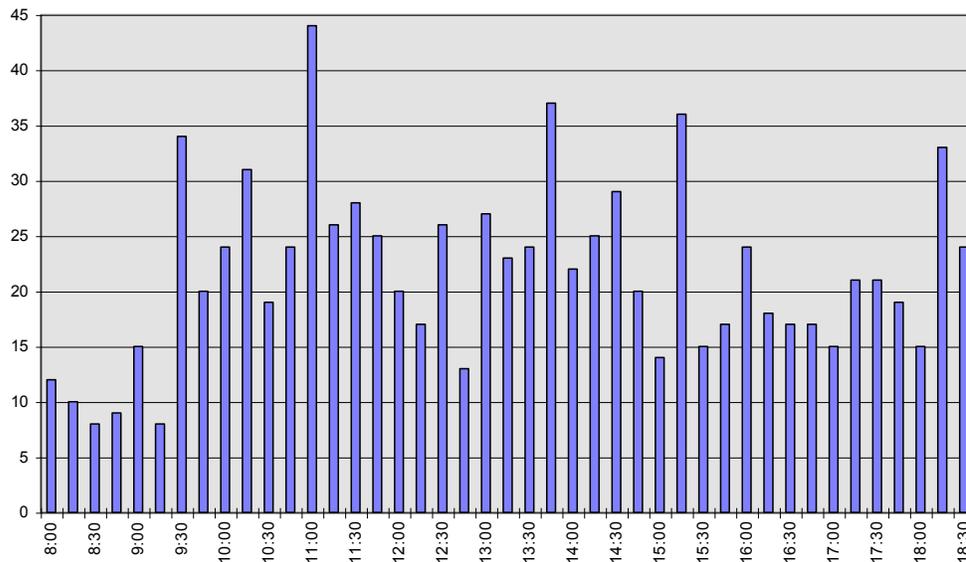
Figure 9.4 - 15-Minute Arrivals in Nogales, Mexico - January 17, 1997

Arrival Time 15-minute Intervals - Surveyed Vehicles (91%)
 Nogales, AZ - Mariposa Border Crossing Survey
 January 17, 1997
