Corrosion Monitoring Research for City of New York Bridges

PUBLICATION NO. FHWA-HRT-14-023

MAY 2014

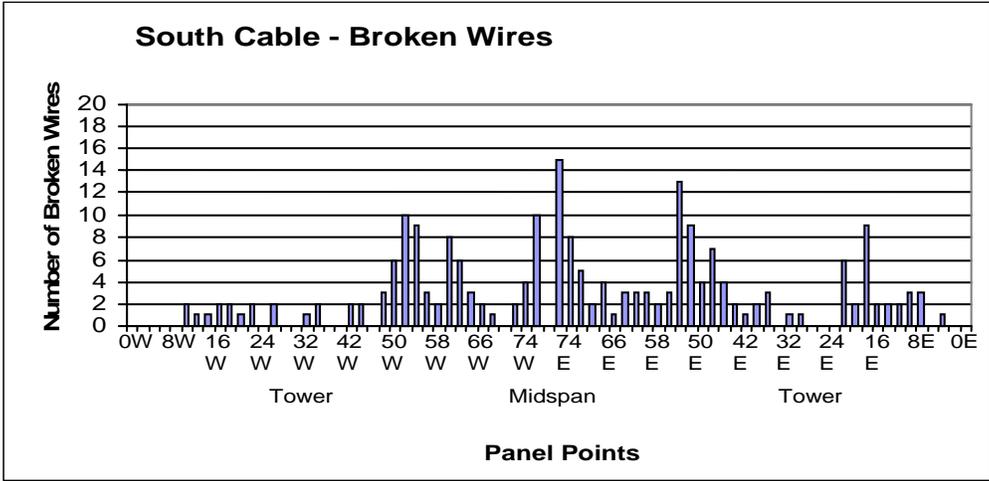
In figure 1 and figure 2, the number of broken wires along the south and north cables of an 80-year-old bridge is plotted as a function of the location along the cable length. For each panel, the length of the cable between two consecutive cable bands was defined. Each cable was divided into two segments indicated by “W” or “E,” where “W” indicates the part of the cable west of the central point, and “E” indicates the east part of the cable. Two panels (77E-78E and 76E-77E) on the north cable have a number of broken wires (307 and 119 out of 18,666 wires, respectively) that are off the charts. It is clear that locations of breaks within the main cable and the number of broken wires cannot be characterized with any specific pattern, and such data cannot be accurately predicted by inspecting some selected locations along the cable. Even when the cable is wedged open, the total number of visible wires that are exposed is limited to about 2 percent of the total number of wires in a cable cross section.

Figure 1. Graph. Number of broken wires along the south cable of an 80-year-old bridge during rehabilitation.

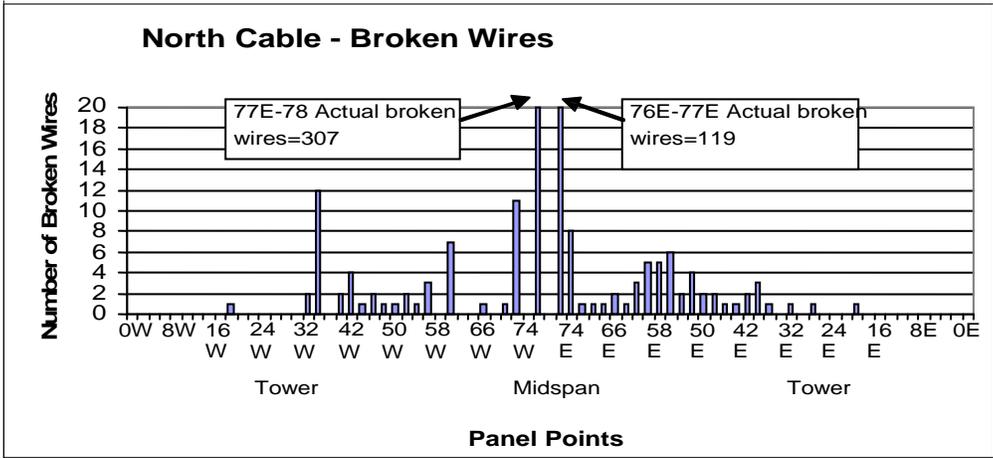
Figure 2. Graph. Number of broken wires along the north cable of an 80-year-old bridge during rehabilitation.

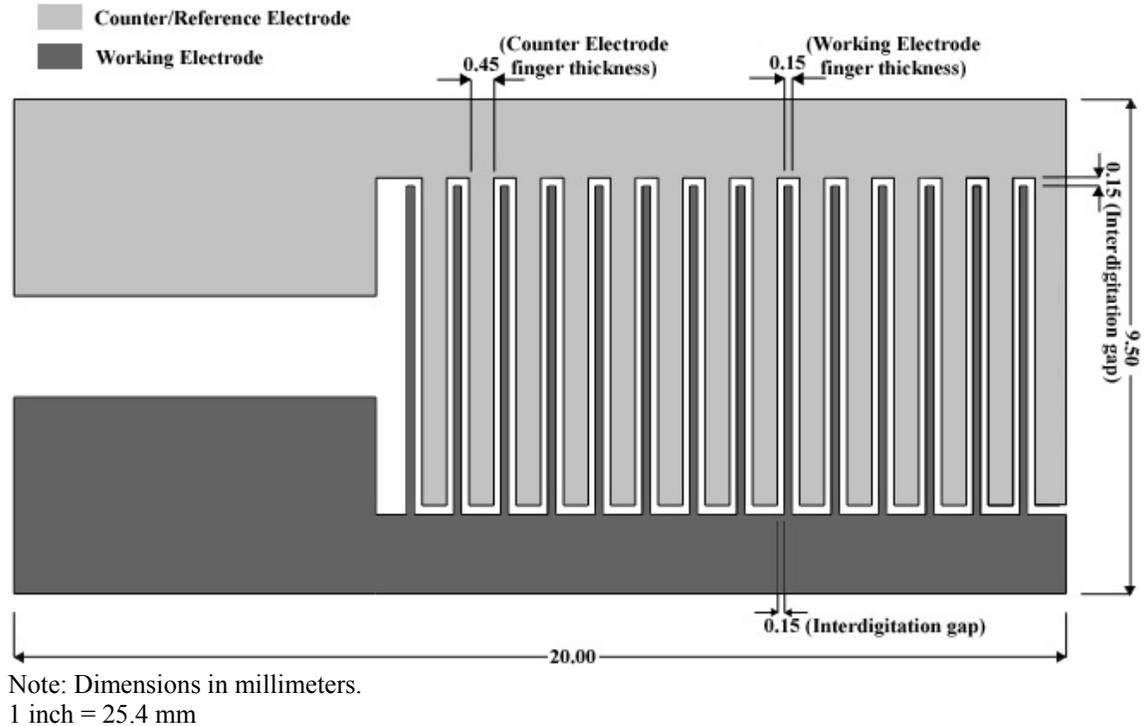
Linear polarization is an electrochemical technique where a potential scan is applied to a freely corroding sensor element, and the resulting current response is measured. This small perturbation is applied step-wise, starting below the free corrosion potential (the open circuit potential) and terminating above the free corrosion potential. The LPR sensor used in this study has two electrodes: a working electrode and a counter/reference electrode (see figure 3). The potential between the two electrodes is measured directly, eliminating the need for a third reference electrode typical of three electrode procedures. In the sensor in figure 3, the 0.006-inch (150- μm)-wide fingers of the working electrode are aligned with the 0.017-inch (450- μm)-wide fingers of the counter/reference electrode in an interlocking configuration, leaving an interdigitation gap between the two electrodes. The interdigitation distance, indicating the distance between the electrode fingers, determines the sensitivity of the sensors. A narrower gap allows an easier charge exchange and leads to more sensitive readings. In this study, three kinds of sensors with different interdigitation distances were tested. They will be referred to as 0.006-, 0.012-, and 0.048-inch (150-, 300-, and 1,200- μm) sensors, indicating the interdigitation gap between the electrodes. A smaller interdigitation gap results in a larger number of electrodes. The electrodes are 0.78 inch (20 mm) long and 0.37 inch (9.5 mm) wide and are made from standard shim stock of American Iron and Steel Institute (AISI) 1080 steel, which has a chemical composition similar to that of the bridge wires (see table 2). In this manner, the effect of sensor sensitivity stemming from material property fluctuation could be minimized. The electrodes are mounted on a Kapton[®] film, a non-conducting polymer not susceptible to corrosion.

Figure 3. Illustration. Layout of the LPR sensor.

Eight LPR sensors (labeled “LP” in figure 80) were distributed in the upper half of the mockup cable specimen’s cross section. Four sensors were placed along the upper vertical radius, while two were placed on each of the radii oriented at $\pm 60^\circ$ (see figure 3). A complete cross sectional distribution of corrosion rate sensors was desirable; however, laboratory construction operation forced the placement of LPR sensors to the upper half of the cable’s cross section. LPR sensors collected corrosion rate data every 60 s.

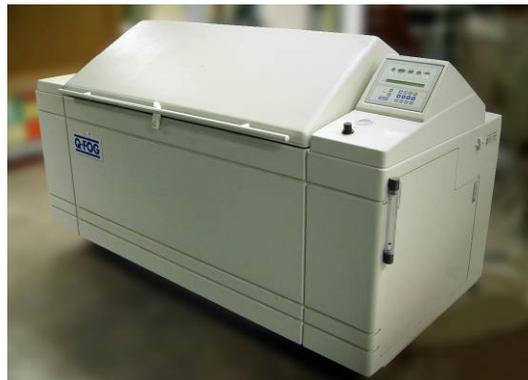
The 290.4-gal (1,100-L) capacity Q-fog cyclic corrosion tester shown in figure 4 was used to run the cyclic tests. The corrosion tester is capable of running different cycles (fog, dry-off, and humidity) repetitively to reproduce outdoor cyclic conditions.

Figure 4. Photo. Q-fog cyclic corrosion tester.

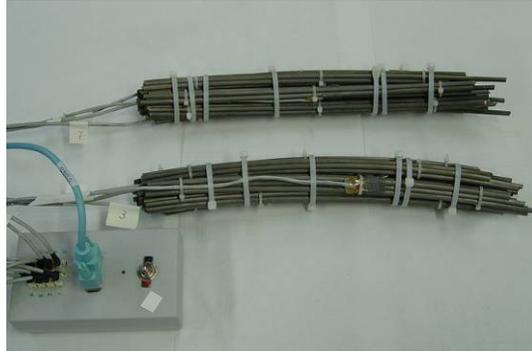
Figure 5 shows 2 of the 49-wire bundles used in this test. LPR sensors were placed in various locations on the surface and inside the bundles. The sensors showed high sensitivity to humid environments and were successful in capturing the start of corrosion reactions. Figure 6 illustrates an LPR sensor showing the onset of corrosion.

Figure 5. Photo. Wire bundles to be placed in corrosion chamber.

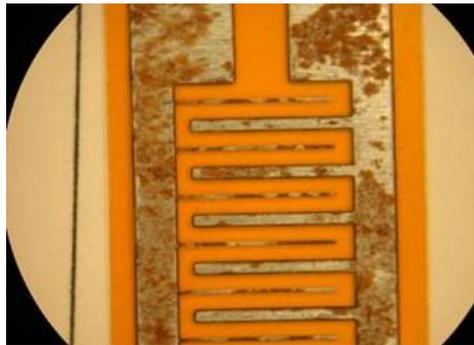
Figure 6. Photo. Onset of corrosion in an LPR sensor.

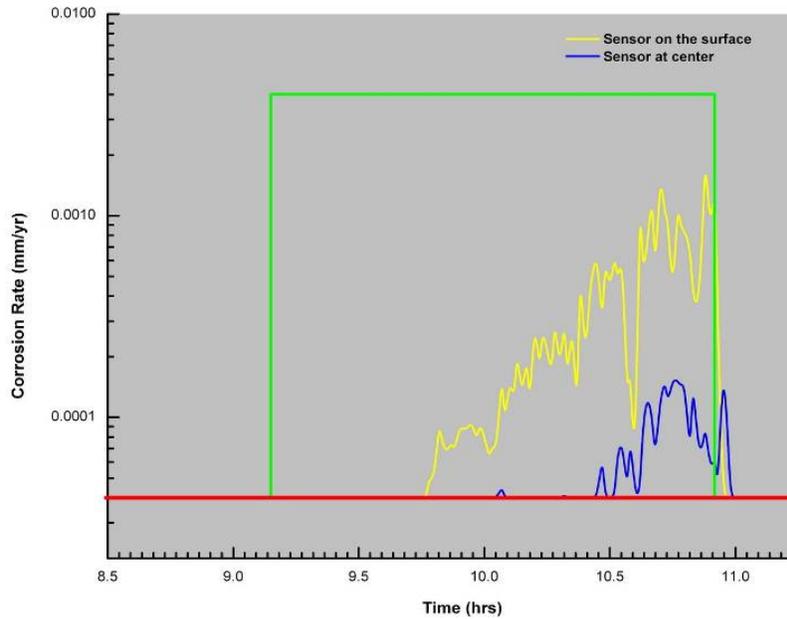
Figure 7 shows corrosion rate readings from two LPR sensors, one located on the surface (yellow line) and the other located at the center of a bundle (blue line) during a single high humidity step. The green ramp function indicates the start and the end of this humidity step. With the start of the humidity phase, relative humidity inside the chamber increased gradually and reached 100 percent. From the figure, it can be observed that the sensor mounted on the surface of the bundle detected corrosive activity earlier and at a higher rate than the sensor inside the bundle. This was expected since the wire bundle acts as a barrier against moisture.

Figure 7. Graph. Close-up of a humidity step.

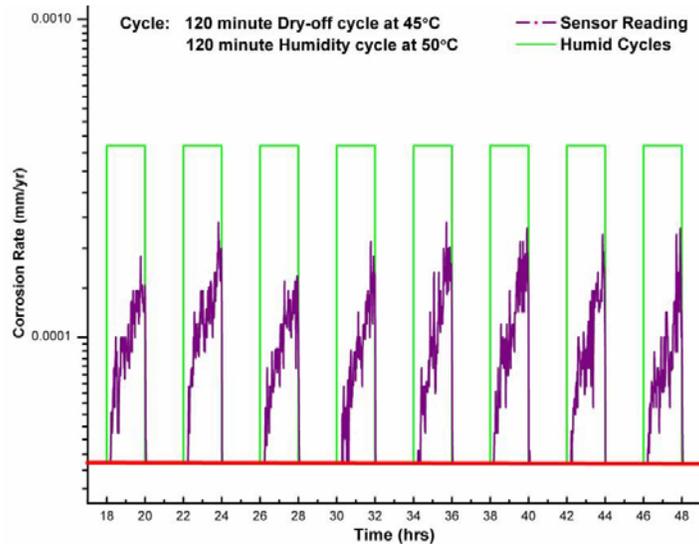
The next step of the testing was aimed at examining the consistency of the sensors when subjected to the same humidity cycle for an extended duration of time. Figure 8 shows corrosion rate readings from an LPR sensor subject to repetitive cycles. Each cycle lasted 4 h and consisted of 120 min of humid environment at 122 °F (50 °C) and 120 min of dry cycle at 842 °F (450 °C). Since the goal of this testing program was to calibrate the sensor readings to the wire corrosion rate, it was important to keep the sensor away from saturation, which is why the corrosion rate readings were low. In addition, this was the actual corrosion rate of the sensor and not that of the bridge wire. To determine this correlation, it is important to prevent saturation in the sensor. Corrosion rate readings obtained from sets of sensors with the same interdigitation distance and in the same environmental conditions were found to be consistent over time and in agreement with each other.

Figure 8. Graph. Corrosion rate versus time in cyclic humidity testing of a sensor.

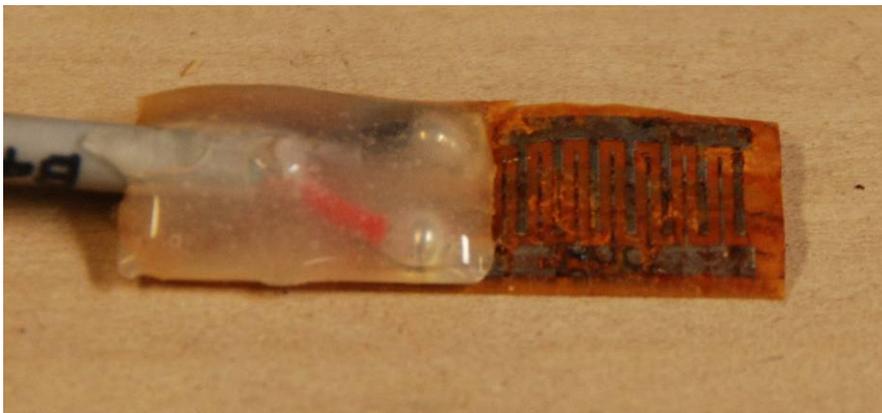
Several tests consisting of humidity, dry-off, and fog cycles were run to test the survival of sensors in harsh environments. During the fog cycles, aggressive solutions of low pH and high chloride content were sprayed on the sensors in fine mist form. Figure 9 shows an LPR sensor after a week of testing with a solution of pH = 2.5 and 3.5 percent sodium chloride in weight. Most of the sensors ceased to function after a week of cyclic testing under these severe conditions. The LPR sensors performed better in milder tests of humid dry cycles in the 77 to 140 °F (25 to 60 °C) range and fog sprays of pH = 3.5 and higher. Almost all of the sensors were functional after a month of cyclic testing with only a few sensor failures.

Figure 9. Photo. Corroded LPR sensor after 1 week test.

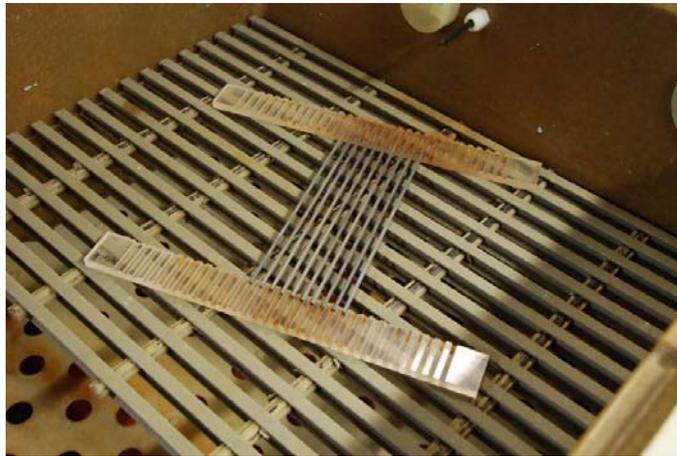
The 10 samples were placed in the corrosion chamber as shown in figure 10. Wires were held in place using two racks made out of acrylic. The only points of contact between the wires and the acrylic racks were at the wire ends where the wires were supported. These contact points were confined to thin strips of less than $\frac{1}{8}$ inch (3.18 mm). Wires were hanging freely in between the support racks. This setup ensured that the corrosion reactions were only between the wires and the atmosphere within the chamber. At the end of each test, samples were hot air dried in a desiccator for 24 h. To measure the corrosion loss for each specimen, corrosion products were removed from the surface of each wire. First, extraneous deposits and bulky corrosion products were removed by brushing. Special care was given to the cleaning so that the uncorroded metal was not removed along with the corrosion products. A chemical cleaning procedure given in ASTM G1-03 was followed to remove the remaining corrosion products.⁽²⁰⁾ The following solution was prepared at room temperature:

Figure 10. Photo. Specimens placed in the Q-fog cyclic corrosion tester.

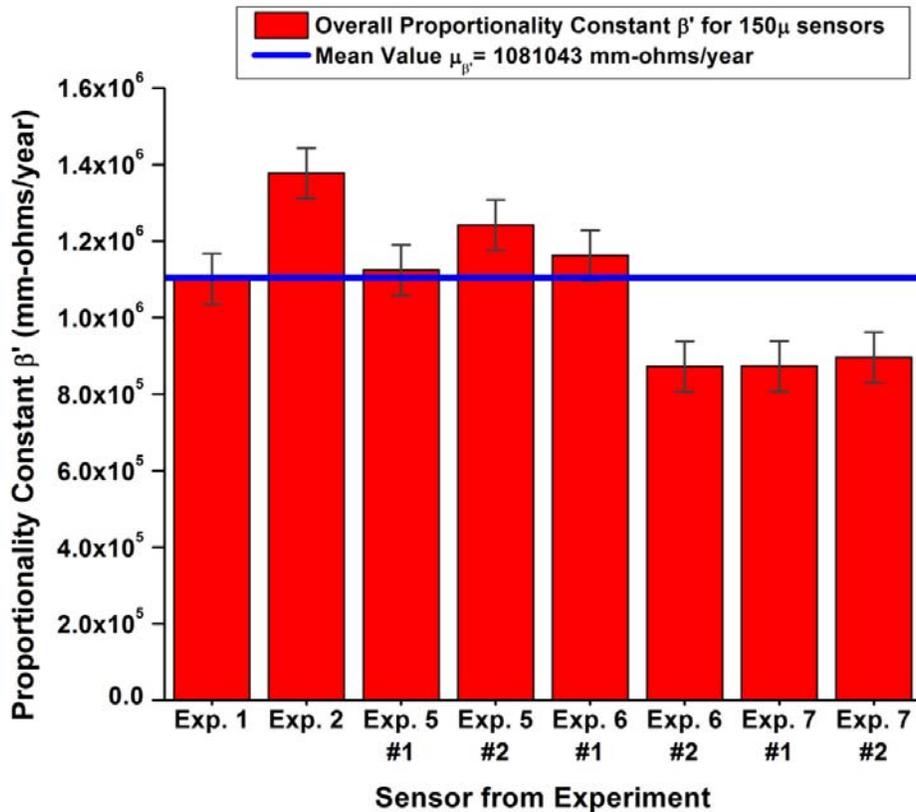
In order to obtain the bridge wire corrosion rate from the measurements of the LPR sensors, a relationship between corrosion rate of the wire and the R_p readings from the sensors was needed. The corrosion rate was calculated from measured R_p and from mass loss measurements on the corroding metal using the concept of equivalent weight and Faraday's Law (see appendix A for details on how to obtain the proportionality constant to convert the corrosion rate measurements from the sensor reading to the corrosion rate of the bridge wires). Figure 11 through figure 13 show the calculated overall proportionality constants from the experiments for 0.006-, 0.012-, and 0.048-inch (150-, 300-, and 1,200- μm) sensors, respectively. The mean values of the constants are also displayed. The constants for the 0.006- and 0.012-inch (150- and 300- μm) sensors are virtually identical. However, the constant calculated for the 0.048-inch (1,200- μm) sensor is two orders of magnitude smaller. This cannot be explained by the decreased sensitivity due to the larger interdigtation gaps of the 0.048-inch (1,200- μm) sensor. Stemming from this, higher R_p values would be expected for the 0.048-inch (1,200- μm) sensor compared to the 0.006- and 0.012-inch (150- and 300- μm) sensors. Consequently, the 0.048-inch (1,200- μm) sensor should have had higher constants than the rest of the sensors. Apart from this peculiarity with the order of magnitude of the constants calculated for the 0.048-inch (1,200- μm) sensor, the variance in constants calculated for the three sensor types are all reasonably low, suggesting a consistency of the results. This suggests that the proportionality constants obtained for LPR sensors were accurate, and so these LPR sensors could be considered as a valuable means for measuring corrosion rate of bridge wires.

Figure 11. Graph. Proportionality constant for 0.006-inch (150- μm) sensors.

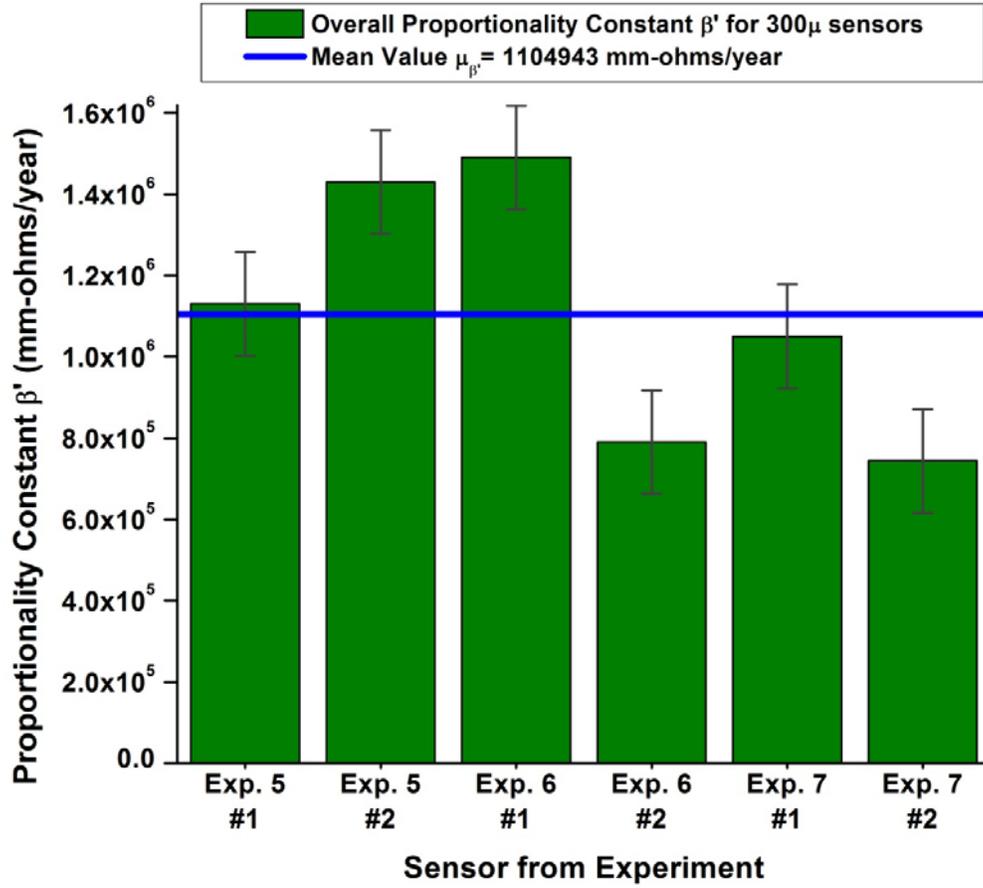
Figure 12. Graph. Proportionality constant for 0.012-inch (300- μ m) sensors.

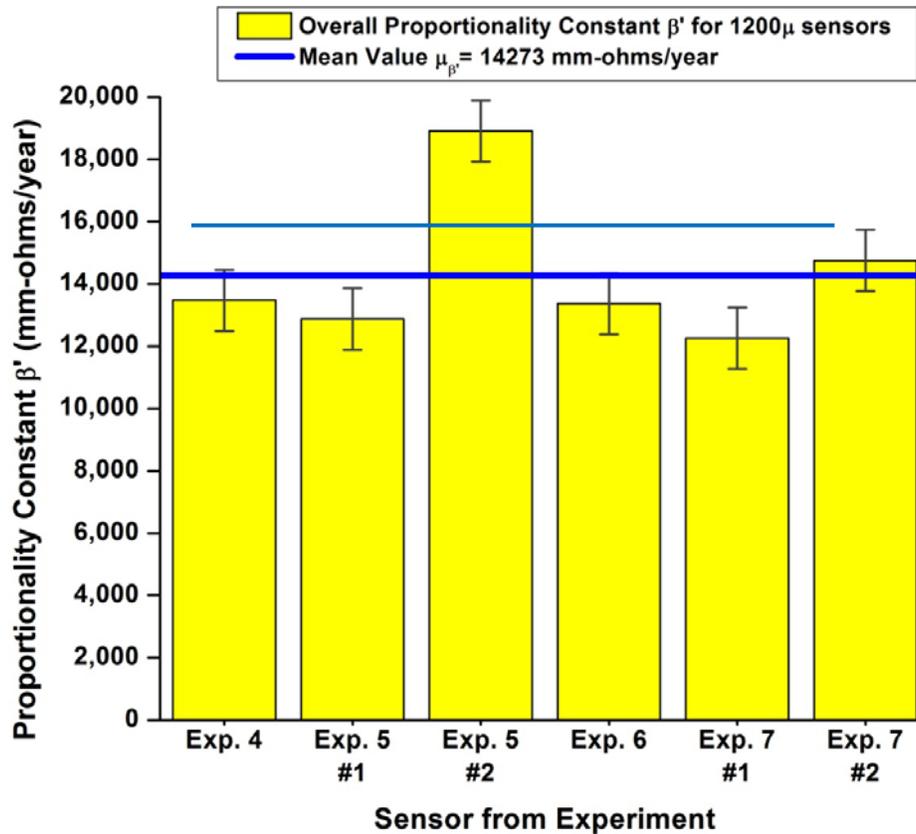
Figure 13. Graph. Proportionality constant for 0.048-inch (1,200- μm) sensors.

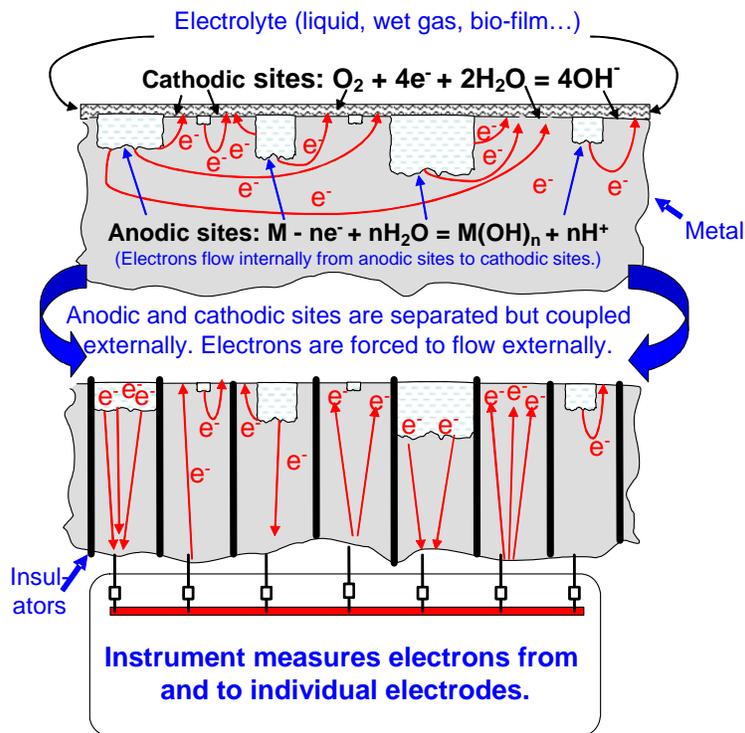
Figure 14 and figure 15 show the principle of a coupled multi-electrode corrosion sensor (CMAS). When a metal is covered by a corrosive electrolyte such as seawater or a thin film of brine formed by the deliquescence of salt deposits on the metal, corrosion may take place.⁽²¹⁾ The corrosion may be localized or nonuniform even in most cases of general corrosion. Some areas of the metal corrode more, while other areas corrode less. The areas that corrode more are considered as the anodic areas, and the areas that corrode less are referred as the less anodic or the cathodic areas. Electrons released at the anodic areas flow to the cathodic areas (see top section of figure 15). Such electron flows represent the unevenness of the corrosion taking place on the metal surface. If the metal is divided into many small pieces, with some of them mainly covered by the anodic areas and other areas mainly covered by the less corroded or not corroded areas, and these small pieces are electrically connected together through an instrument externally, the electrons produced at the anodic areas would flow through the instrument.

Thus, the electron flows can be measured by the instrument and converted to nonuniform corrosion rate using Faraday's Law. This is the principle on which the multiple array sensor is based on, with the anodic pieces being called the anodic electrodes and the cathodic pieces the cathodic electrodes.

Figure 15. Illustration. Electrons flow from anodic areas to cathodic areas inside a metal (top) and through a CMAS probe (bottom).

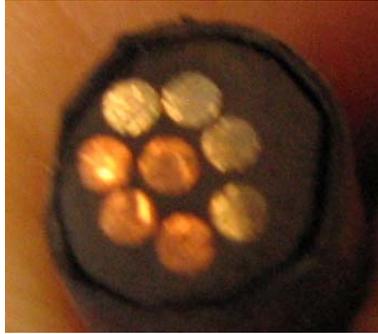
For this study, two types of CMAS were provided. One type was developed using a probe approximately 0.19 inch (5 mm) in diameter with eight high-strength steel filaments isolated with rubber (figure 16). The other type of CMAS sensors had the steel filaments replaced by zinc filaments in order to obtain measurements of the corrosion rates both of the steel core of the wire (once the wire coating has been depleted) and of the zinc coating itself.

Figure 16. Photo. Close-up of a CMAS.

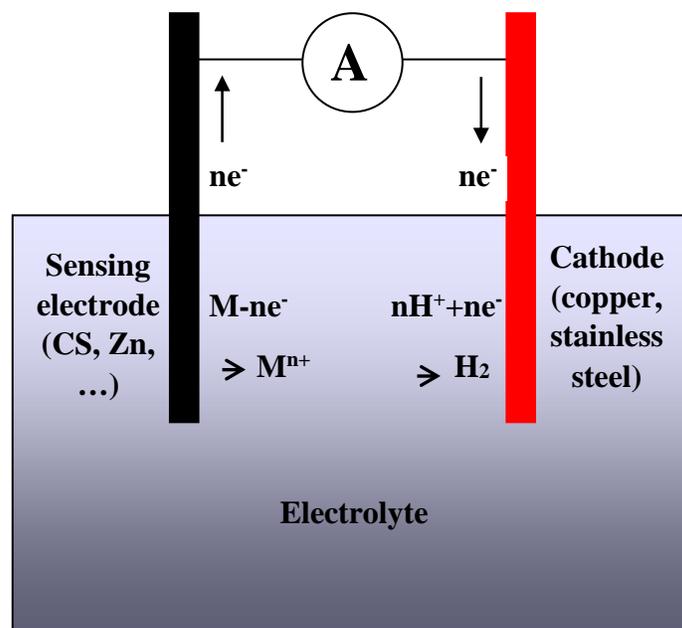
Figure 17 shows the schematic diagram of a galvanic probe for corrosion monitoring.⁽²²⁾ A sensing electrode made of a material whose corrosion rate is of interest is connected to a cathodic electrode via an ammeter, usually a zero-resistance ammeter. The cathodic electrode is made of a metal that has a higher corrosion potential than the sensing electrode. For instance, if the sensing electrode is made of CS and has a corrosion potential (open circuit potential) around -0.6 versus silver/silver chloride in seawater, the cathodic electrode is usually made of copper or stainless steel which has a corrosion potential near zero in seawater. The current from the ammeter is an indication of how much the sensing electrode is corroding under the polarized condition.

Figure 17. Illustration. Schematic diagram of a galvanic probe.

Because the sensing electrode is at a potential that is higher than the normal natural corrosion potential, such current is not the corrosion current under natural conditions and is usually higher than the true corrosion current. However, if many such identical galvanic probes are used and installed at different places, these may provide good indications for the relative corrosivity of the environment at the different places. If the corrosion rate at certain locations is measured using a quantitative probe (such as a CMAS probe), the corrosion rate at the different locations may be estimated using the results from the galvanic probes.

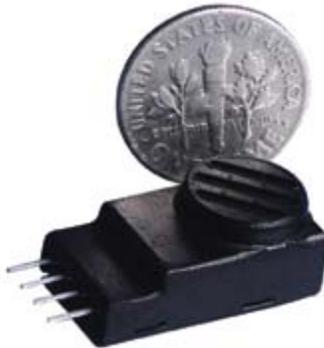
The dimensions of the sensor are 0.89 inch (22.61 mm) long, 0.47 inch (11.94 mm) wide, and 0.365 inch (9.27 mm) tall (see figure 18). Since the goal was to install these sensors inside the cable, special protection was needed to protect the sensor from crushing because of the surrounding wire pressure. The performance of this sensor was tested through a series of laboratory tests.

Figure 18. Photo. Precon HS2000V temperature/relative humidity sensor.

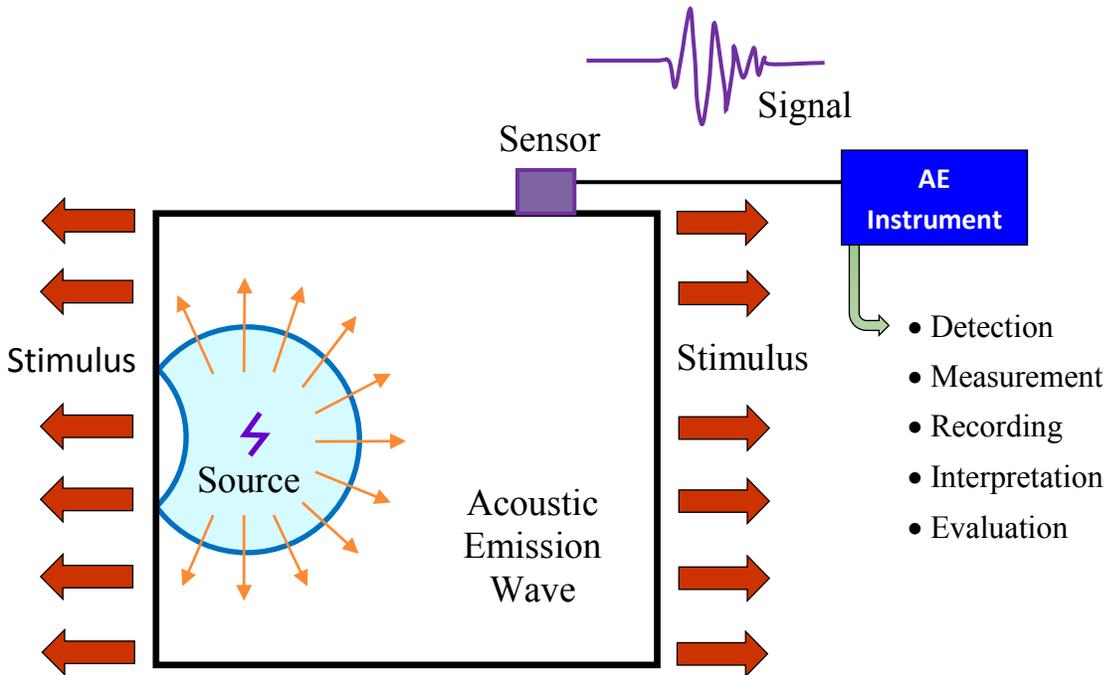
AE testing is a powerful method for examining the behavior of materials deforming under stress. AE may be defined as a transient elastic wave generated by the rapid release of energy within a material, as shown in figure 19. Materials produce AE when the local stresses around a discontinuity reach levels close to yielding. The high level of stresses can result in growing cracks and breaking fibers as well as many other modes of active damage in the stressed material.

Figure 19. Illustration. AE technology principle.

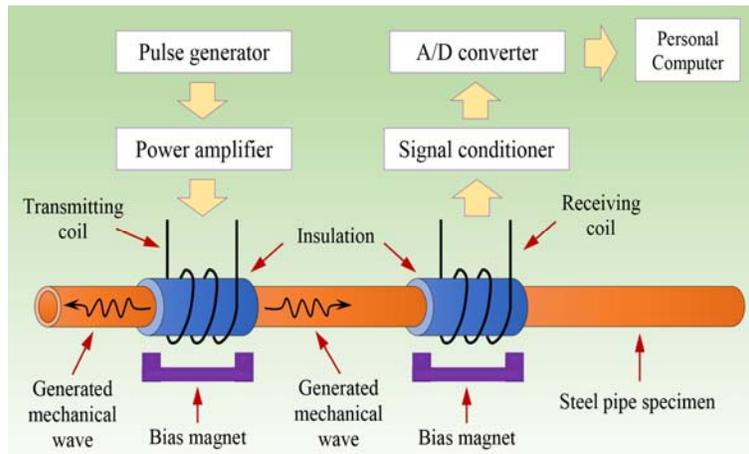
Figure 20 shows the arrangement and instrumentation used for active inspection of structures using MS technology. The MS system consists of two parts: a means for applying a time varying magnetic field or detecting a magnetization change in the material (this is most conveniently

achieved by using an inductive coil that encircles a component under inspection) and a means for providing direct current (DC) bias magnetic fields to the component (this is achieved by using a permanent magnet). The DC bias magnetic fields are used to enhance the efficiency of the energy transduction between electric and mechanical energies and to make the frequency of the elastic wave follow that of the electrical signals and vice versa. When a pulse of electrical current is applied to the coil in the transmitting MS, a time-varying magnetic field is applied to the component under inspection. This field in turn generates a pulse of elastic waves in the component which propagate in both directions along the length of the component. When the propagating elastic pulse reaches the coil in the receiving MS, it causes a change in the magnetic induction of the material via the inverse-MS effect. This change induces an electric voltage in the receiving coil that is subsequently amplified, conditioned, and processed.

Figure 20. Illustration. MS instrument.

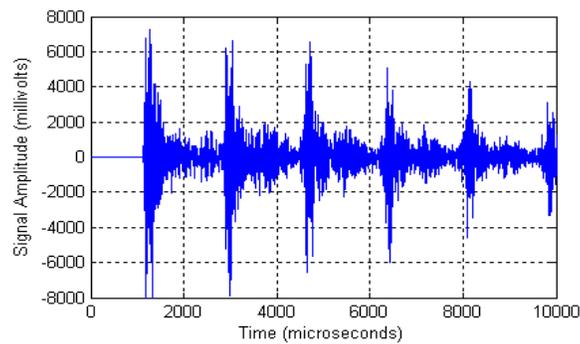
As an example of how the signals propagating in the wire change as the simulated corrosion area increased, figure 21 through figure 24 show the waveforms recorded with the R3I sensor at different stages of damage on the wire. These waveforms represent a total of six times the signal traveling back and forth along the wire. Each one of the echoes represents a reflection of the signals from the back end of the wire. In figure 21, the time elapsed between each of the echoes

Figure 21. Graph. Acoustic signals recorded on a single wire by the R3I sensor—baseline.

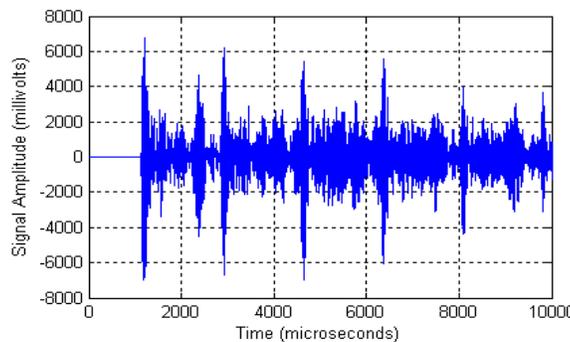
The waveform in figure 22 shows that as soon as the cross section of the wire was reduced by the introduction of damage, additional echoes appeared between the signals corresponding to the full wire length. These new echoes correspond to reflections produced by the damaged area.

Figure 22. Graph. Acoustic signals recorded on a single wire by the R3I sensor—stage 1.

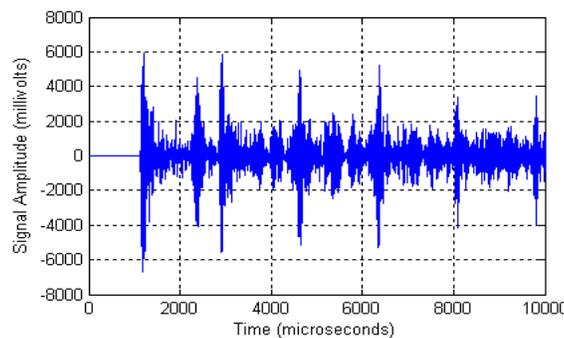
As seen in figure 23, as the cross section area of the wire is further reduced in stage 2, the amplitude of the echoes corresponding to the damaged area decreased significantly. Finally, in stage 3, the whole signal was severely affected by a notorious loss in amplitude and by a widening of the echoes corresponding to the edge of the wire and to the corrosion area (see figure 24).

Figure 23. Graph. Acoustic signals recorded on a single wire by the R3I sensor—stage 2.

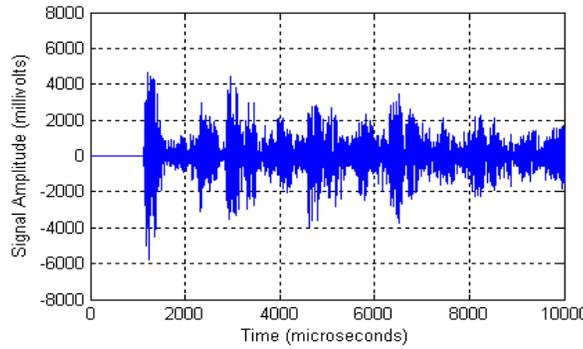
Figure 24. Graph. Acoustic signals recorded on a single wire by the R3I sensor—stage 3.

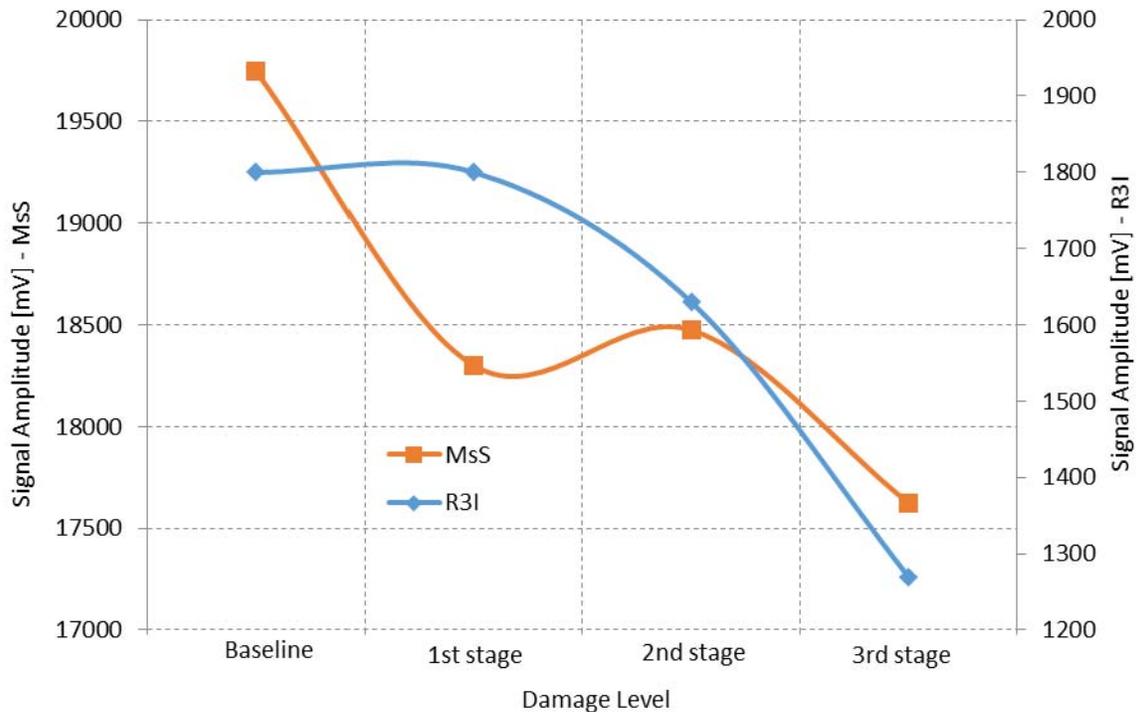
A plot of the change in maximum amplitude detected in the wire as a function of the reduction in cross section area as indicated in table 6 for the R3I and MS sensors is shown in figure 25. The results for sensor R1.5I were very inconsistent and are thus not included in this report.

The curves in figure 25 show that there is a clear reduction on the maximum amplitude of the signals traveling along the wire as the damaged area increases for both the R3I and the MS sensors. The amplitude drop for the R3I is approximately 11 percent and approximately 31 percent for the MS sensor. The drop is monotonic for the R3I with incremental drops as the damage increases, while the MS sensor dropped quickly for stage 1, increased slightly for stage 2, and dropped again for the last stage. Most likely this is a result of constructive and destructive interference in the wire, since the wavelength is approximately six times larger than the wire diameter.

Figure 25. Graph. Maximum amplitude of the acoustic signals propagating along a single wire as function of the reduction in cross sectional area for the R3I AE and MS sensors.

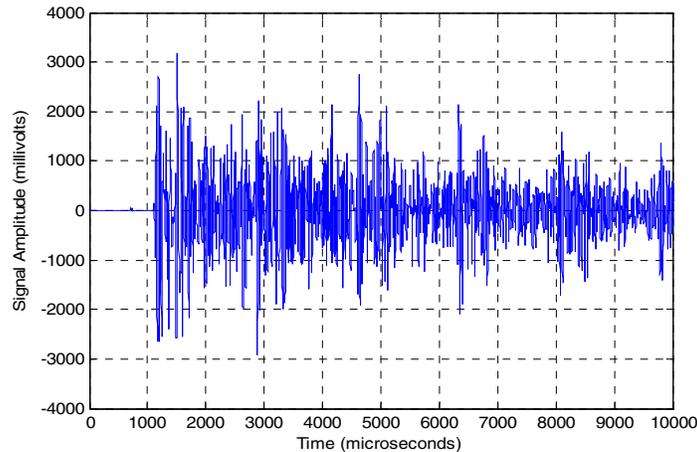
Signals with a frequency of 32 kHz were coupled into the strand, and a baseline measurement was performed. Next, an area of damage was introduced in one of the wires by mechanically removing part of the cross section. It was progressively enlarged in three stages until the wire was broken. The reduction in the wire cross section was similar as in the previous experiment (see table 6). As an example of the change in the acoustic signals propagating in the five wire strand, figure 26 through figure 31 show the waveforms detected by the three different sensors before and after the wire was broken.

Figure 26. Graph. Acoustic signals recorded on the strand of five wires by the R1.5I sensor—baseline.

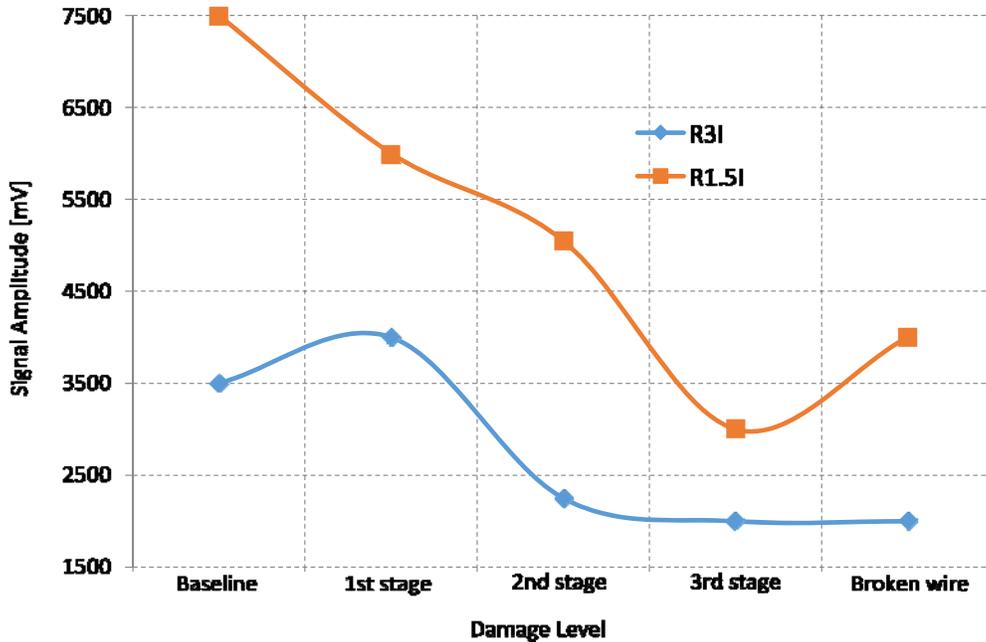
Figure 32. Graph. Maximum amplitude of the acoustic signals propagating along the five-wire strand as function of the reduction in cross section area in a single wire for R1.5I and R3I sensors.

Using the same type of analysis discussed in the previous section, the signal’s maximum amplitude was measured for each of the sensors at every stage during the damage simulation. The results of this analysis are presented in figure 32 and figure 33.

The R1.5I sensor detected a steady drop in signal amplitude, down to 50 percent of the baseline value at the transition third stage of damage, and then increased after the wire was broken. This increase could be related to constructive interference caused by signals reflected from the damaged area and the edge of the broken wire. Taking into account this increase, the total drop in amplitude between the baseline and the broken wire was approximately 34 percent. The R3I sensor showed a small increase in amplitude at the first stage of damage and then decreased steadily to 43 percent of the baseline value.

Finally, the data from figure 32 and figure 33 show that the total drop in amplitude between the baseline and the broken wire is almost 50 percent for the MS mounted in the outside wire and almost 90 percent for the inside wire.

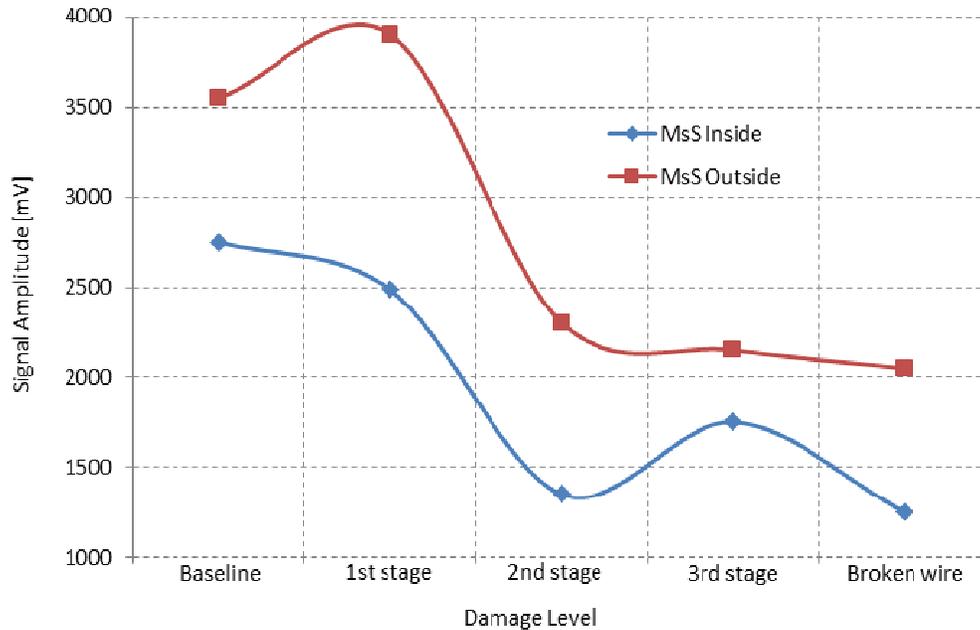
Figure 33. Graph. Maximum amplitude of the acoustic signals propagating along the five-wire strand as function of the reduction in cross section area in a single wire for MS located in one of the outside wires and in the center wire.

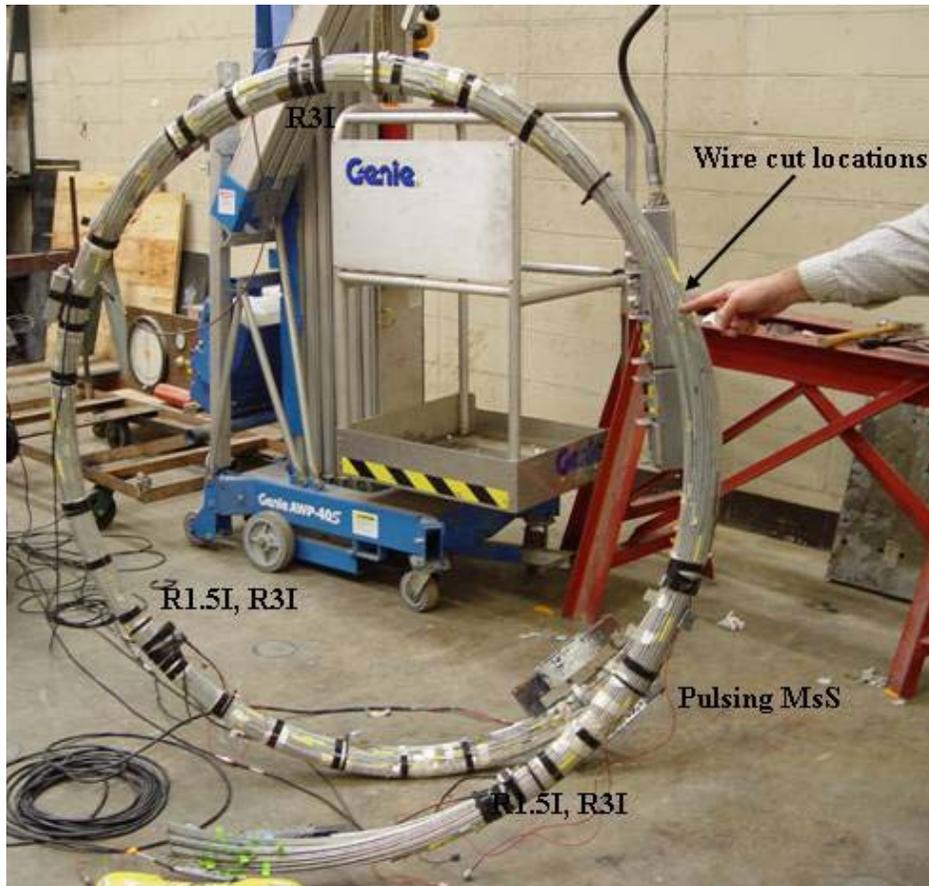
Figure 34. Photo. Location of the wire cuts and sensors on the strand.

In this series of tests, a strand consisting of 127 wires 0.196 inch (4.98 mm) in diameter and arranged in a hexagonal pattern was monitored as 5 wires in the strand were cut. The length of the strand was 19 ft (5.78 m). For this test, the R1.5I and R3I sensors were used as receivers, and the MS sensor was used as a pulser. The strand was monitored before any of the wires were cut to create a baseline as well as every time after a wire was cut. The R1.5I sensors were located 5 and 17 ft (1.53 and 5.16 m) from the MS, while the R3I sensors were located at 5, 10, and 17 ft (1.53, 3.05, and 5.16 m) from the MS system. The wire cuts were located 13 ft (3.97 m) from the MS position. Figure 34 shows the location of the sensors and the wire cuts.

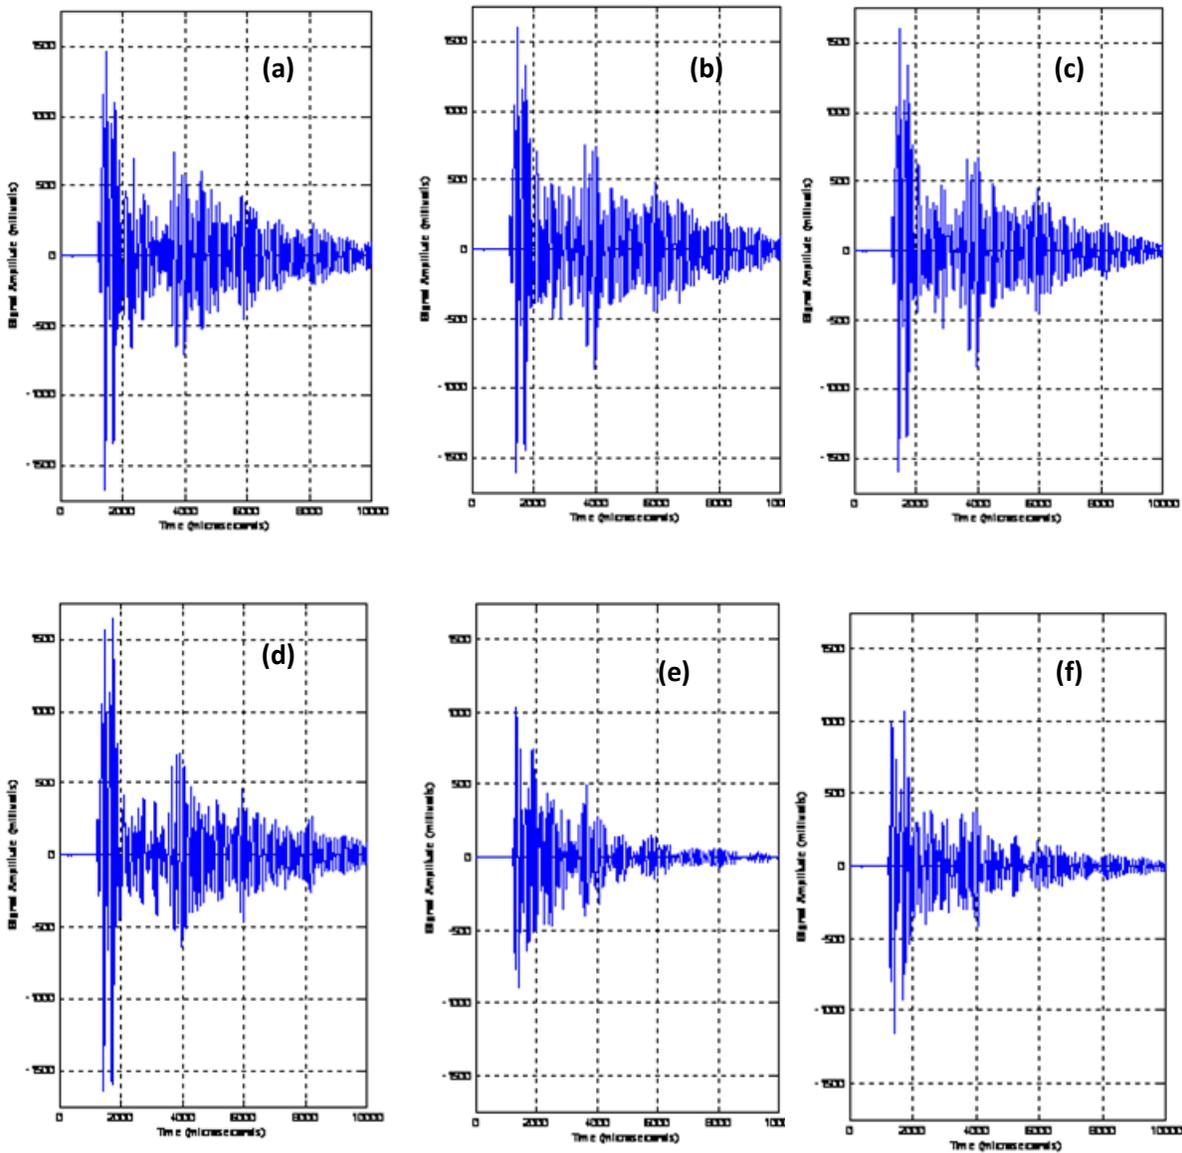
Figure 35. Graph. Acoustic signals recorded on the strand with the R1.5I sensor— (a) no damage, (b) 1 wire cut, (c) 2 wires cut, (d) 3 wires cut, (e) 4 wires cut, and (f) 5 wires cut.

As an example of changes in the waveforms observed in this test, figure 35 shows the signals recorded with the R1.5I sensor at the 17-ft (5.16-m) location beyond the point of the wire cuts. There was no drop in amplitude from the baseline value (see figure 35a) as well as for the first three wire cuts (figure 35b, c, and d). There was a clear drop for the last two wire cuts (see figure 35e and f). Results for the R3I sensors in the same position showed similar results.

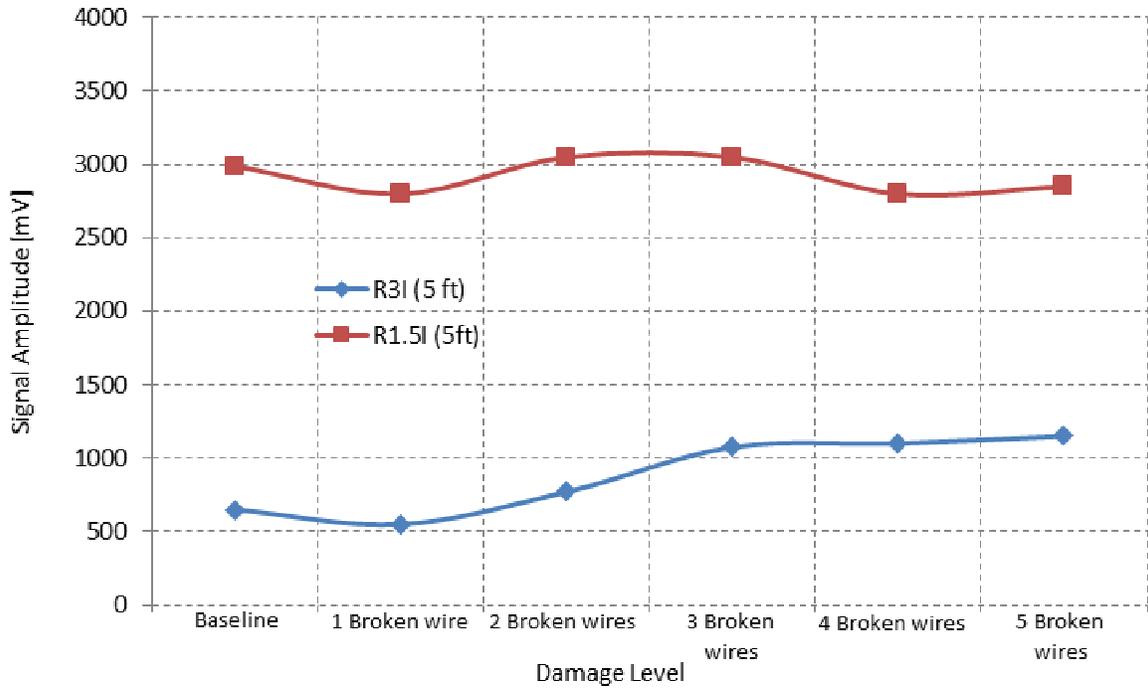
Figure 36. Graph. Maximum amplitude of the signals detected by the MS-AE technique—sensors located before the wire cut location.

Figure 36 and figure 37 show the maximum amplitude detected by the sensors located before and beyond the wire cut locations (see figure 34). It is clear that the sensors located closer to the MS were affected in a different way by the wire cuts, as shown in figure 36. Either the amplitude values fluctuated around the baseline as for the R1.5I sensor or increased as for the R3I sensor. For the sensors beyond the wire cut location, the signal dropped suddenly after the fourth wire was cut. The drop in amplitude is approximately 30 percent of the baseline value for both the R1.5I and the R3I sensors. In terms of the cross section area of the strand, this means that the MS-AE technique is sensitive to losses in the cross section area larger than 3 percent.

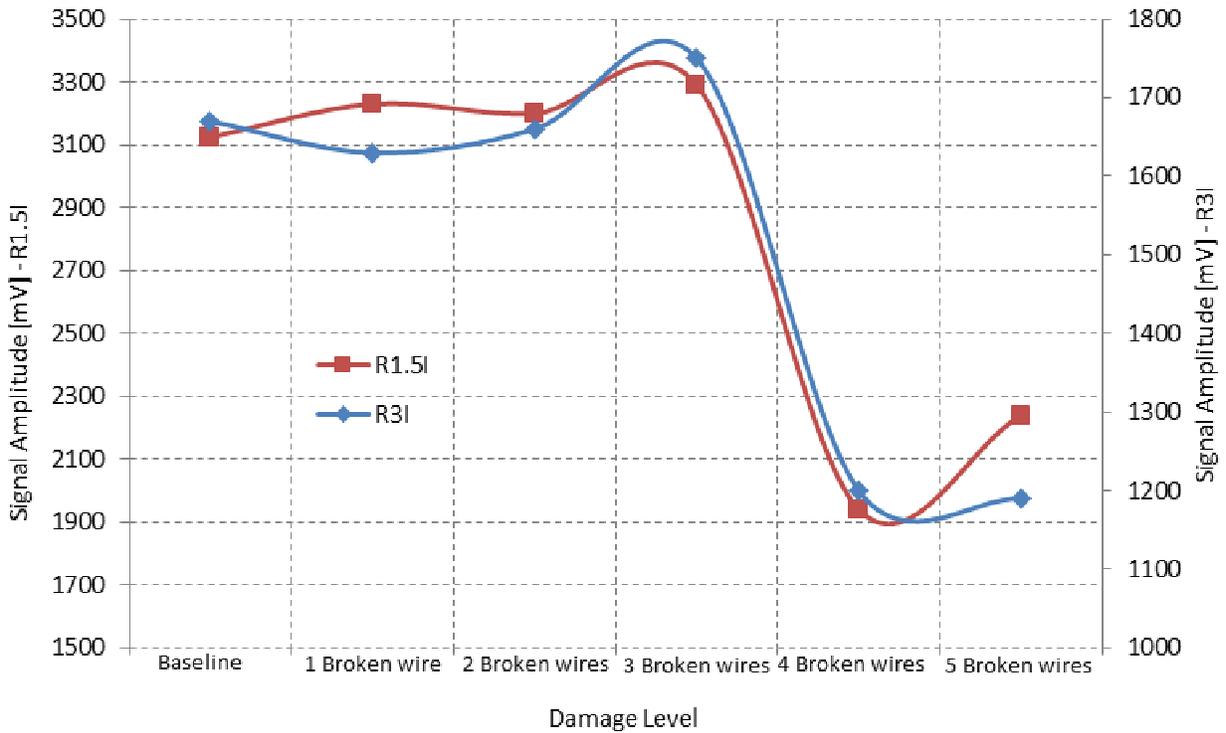
Figure 37. Graph. Maximum amplitude of the signals detected by the MS-AE technique—sensors located after the wire cut location.
