Corrosion Monitoring Research for City of New York Bridges

PUBLICATION NO. FHWA-HRT-14-023

MAY 2014

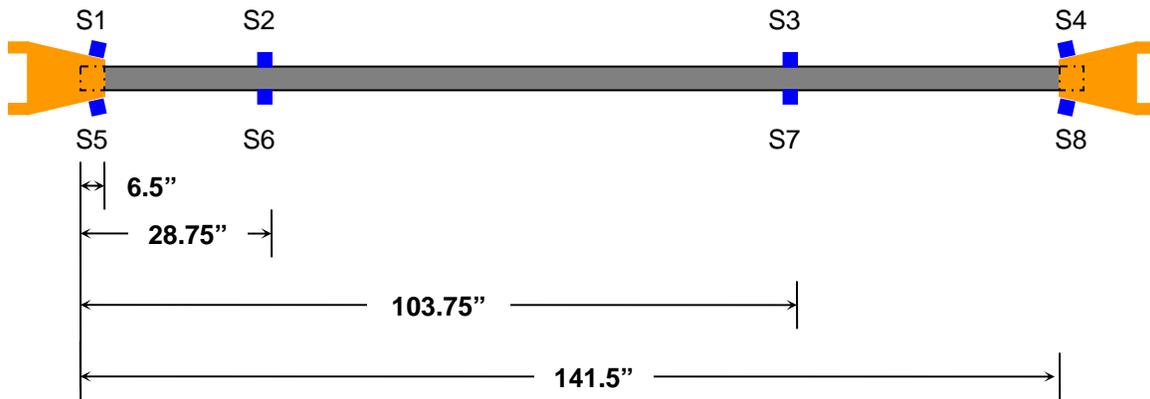
S = Sensor.
1 inch = 25.4 mm

Figure 38. Illustration. Position of the AE sensors along the strand.

The steel wire strand used in these experiments had a length of 148 inches (3,759.2 mm) and was made of 61 wires with a diameter of 0.196 inch (4.98 mm) arranged in a hexagonal pattern and mounted on two steel sockets. The strand was instrumented with eight R3I PAC AE sensors distributed on the sockets and at two locations along the strand. The position of the sensors is shown in figure 38.

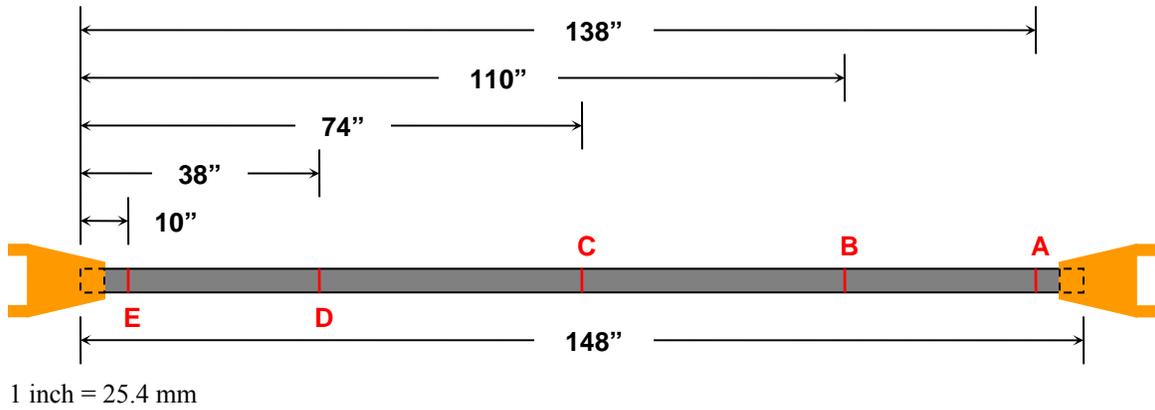
Figure 39. Illustration. Notch locations along the wire strand.

Out of the 61 wires in the strand, 54 were notched, with the notches distributed along the cable at 5 different positions. The positions of the notches, labeled A to E, are shown in figure 39. A schematic of the strand cross section showing the 54 notched wires and the position and depth of each notch is shown in figure 40.

According to figure 39 and figure 40, there were only 10 wires at notch A and 8 at notch E, so the massive amount of activity observed could not be the result of potential wire breaks alone. This event accumulation was most likely produced not only by wire breaks, but also by potential pullout of wires from the epoxy filler and by cracking of the epoxy inside the sockets. An example of this type of failure in the lower socket is shown in figure 48.

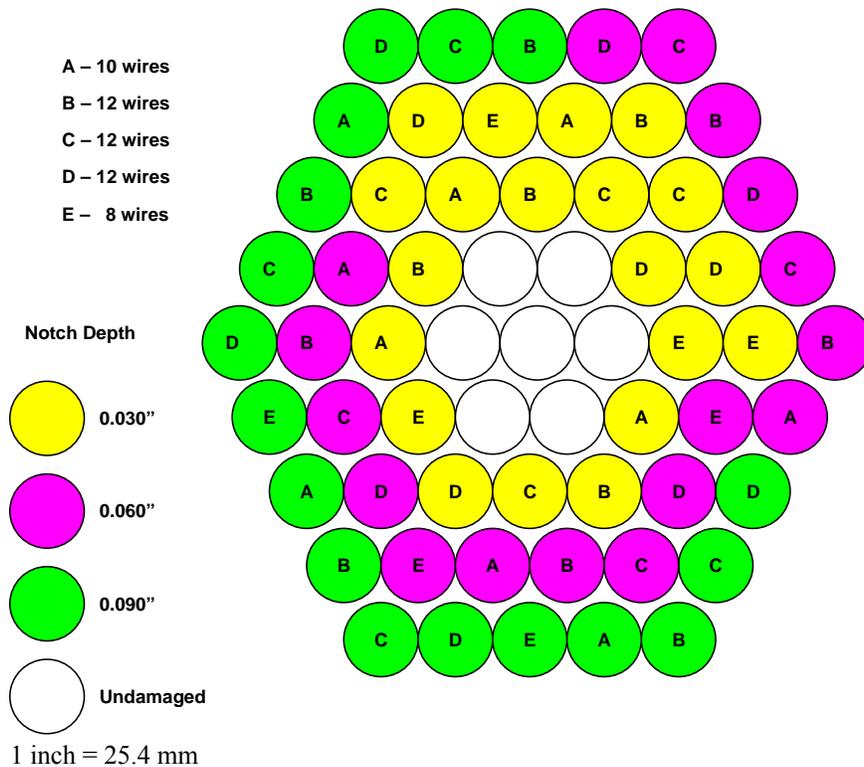
Figure 40. Illustration. Cross section of the wire strand showing position and depth of the notches along the strand length.

According to figure 44, figure 45, and table 9, there were a total of 25 events: 8 at notch B, 9 at notch C, and 8 at notch D. Figure 45 shows that 12 wires were notched at each one of these sites. If it is assumed that each one of the events corresponds to a notch wired breaking, then four, three, and four notched wires must have remained unbroken at the notch sites, respectively. A postmortem analysis of the failed strand corroborated that four unbroken notched wires remained at notches B and D and three remained at notch C. All these 11 notched unbroken wires have shallow notches 0.03 inch (0.76 mm) deep marked in yellow in figure 40. The events located by the AE sensors in notches B, C, and D were confirmed as wire breaks.

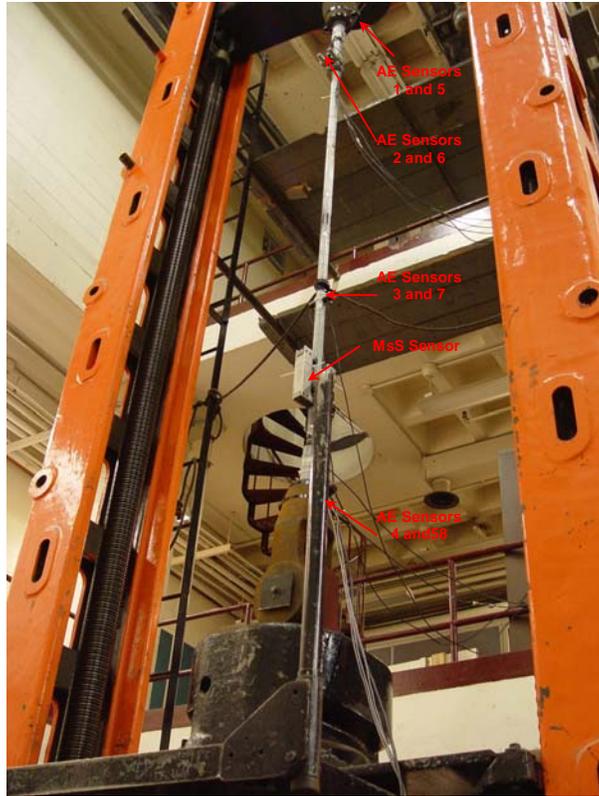
Figure 41. Photo. Wire strand mounted on the tensile machine and instrumented with AE and MS sensors.

The instrumented strand was mounted on the tensile machine. The top end of the strand corresponds to the end where sensor 1 was mounted, according to figure 36 and figure 37. Once the strand was mounted in the tensile machine, the MS sensor was installed 116 inches (2,946.4 mm) from the top end of the strand. The AE sensors were connected to a PAC AE eight-channel Samos system, and the MS was connected to a computer controlled system. Figure 41 shows the strand mounted in the tensile machine as well as the position of the AE and MS sensors.

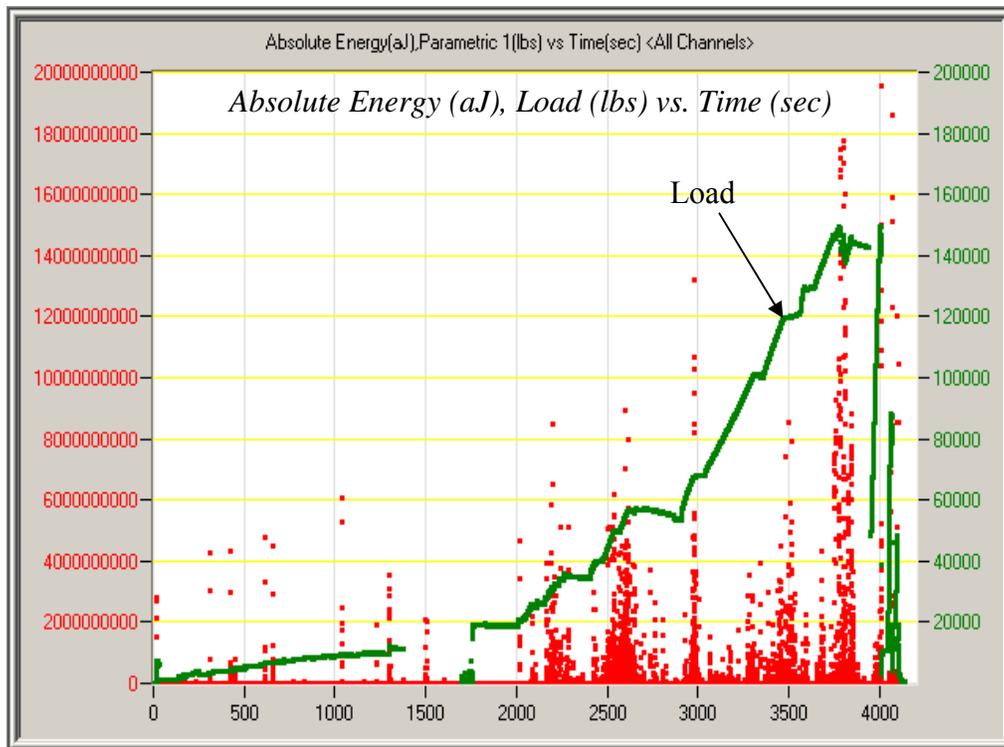
Figure 42. Graph. AE activity as a function of time during the tensile test of the wire strand.

Figure 42 shows the AE activity detected during the active load periods of the test in terms of the absolute energy released in the form of acoustic waves as a function of time. Superimposed with this AE data (red dots), the green trace represents the actual load being applied to the strand and read directly from the load cell. The load was monitored by the AE system at a rate of 10 times/s (10Hz) regardless of the amount of AE activity being detected by the AE sensors.

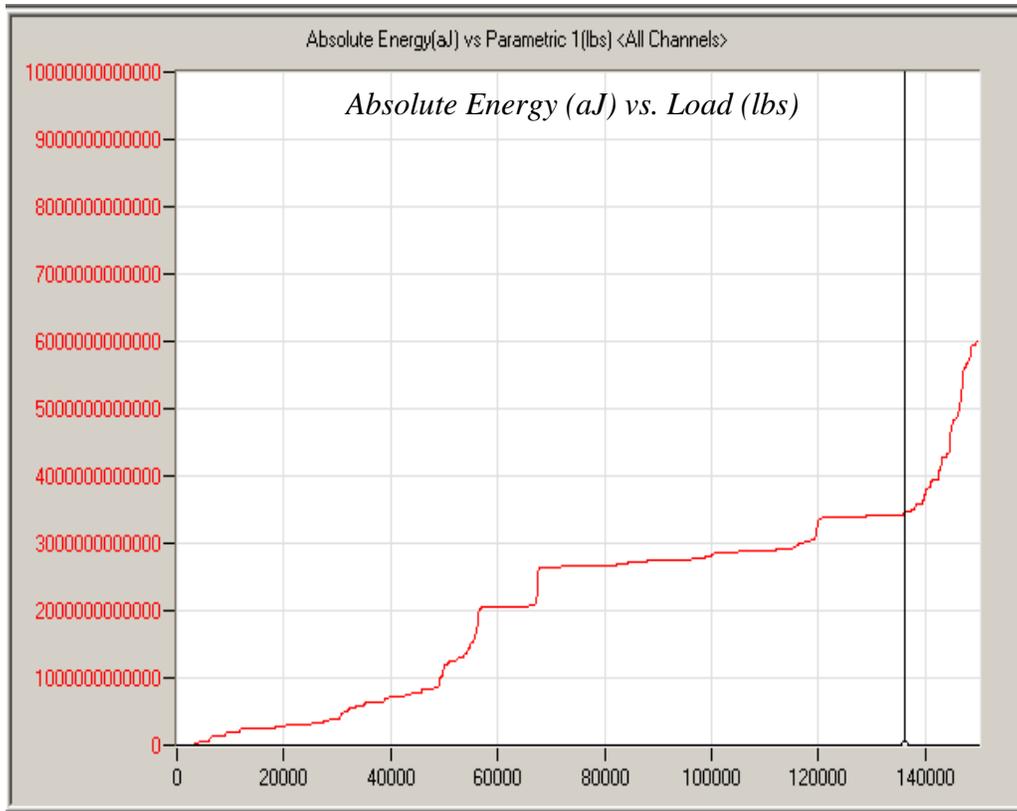
Figure 43. Graph. Cumulative AE absolute energy as a function of load.

As it is observed in figure 43 in which the cumulative AE absolute energy is displayed as function of the load, there is very little AE activity below 30,000 lb (13,620 kg), and it increases steadily up to 136,000 lb (61,744 kg). At this point, the AE activity began to increase exponentially, an indication of impending catastrophic failure, which occurs at 150,000 lb (68,100 kg).

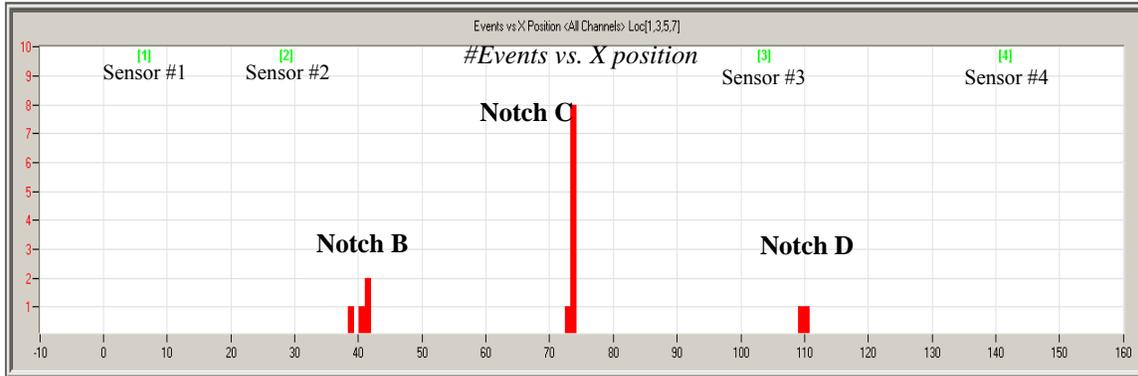
Figure 44. Graph. Events located around notches B, C, and D located by sensor groups 1, 3, 5, and 7.

Figure 44 and figure 45 show histogram plots of the AE events located by these sensor groups. For reference, the positions of the sensors are indicated on top of the plots. The y-axis shows the number of AE events, and the x-axis shows the location along the length of the strand. Figure 44

shows the event located by sensor groups 1, 3, 5, and 7, and figure 45 shows the events located by sensor groups 2, 4, 6, and 8. The events observed at the locations of the notches B, C, and D, which were 38, 74, and 110 inches (965.2, 1,879.6, and 2794 mm), respectively. These events all happened at loads higher than 30,000 lb (13,620 kg) and within ± 2 inches (50.4 mm) of the nominal position of the notch site, as indicated in table 9.

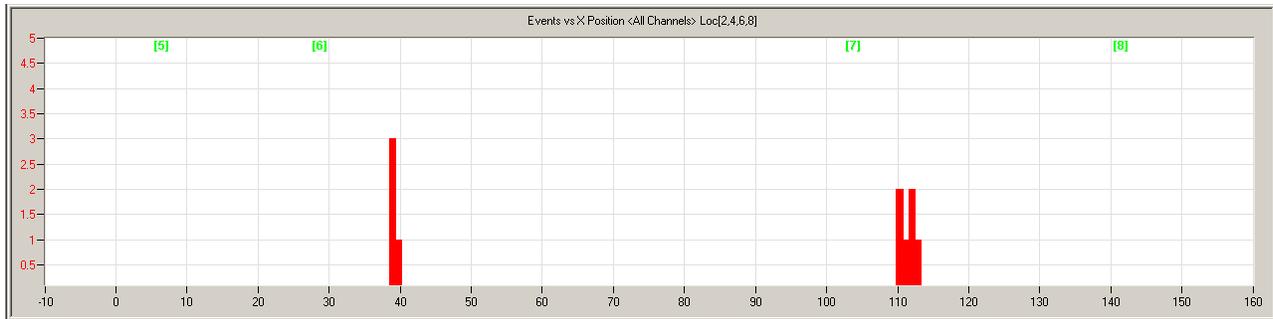
Figure 45. Graph. Events located around notches B and D located by sensor groups 2, 4, 6, and 8.

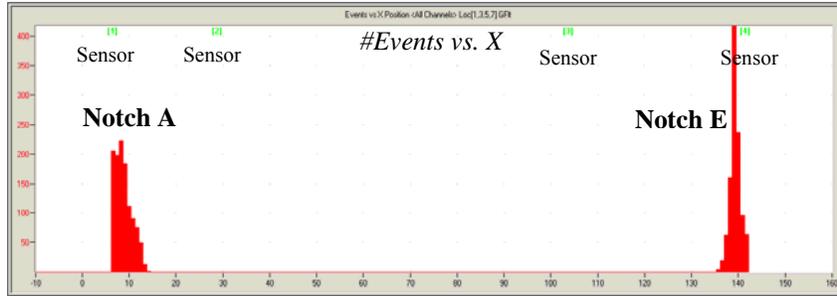
Figure 46. Graph. Events located around notches A and E located by sensor groups 1, 3, 5, and 7 (unfiltered data).

The AE system detected hundreds of events around notches A and E at 10 and 138 inches (254 and 3,505.2 mm) respectively, from the reference end of the strand, as shown in figure 46 and figure 47. In the figures, the y-axis shows the number of AE events, while the x-axis shows the location along the length of the strand.

In order to better discriminate the potential wire breaks from the epoxy failure and wire pullouts, a series of filters were applied to the data in figure 46 and figure 47. It was expected that the wire breaks would happen at relatively high loads, and since the sensors were in close proximity to

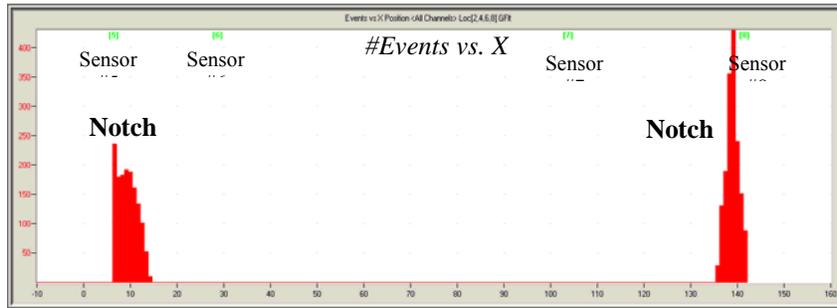
Figure 47. Graph. Events located around notches A and E located by sensor groups 2, 4, 6, and 8 (unfiltered data).

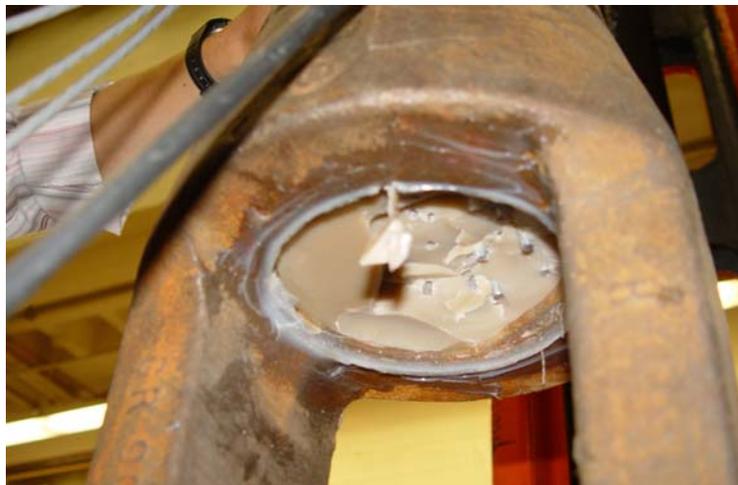
Figure 48. Photo. Failure of the epoxy filler inside the sockets.

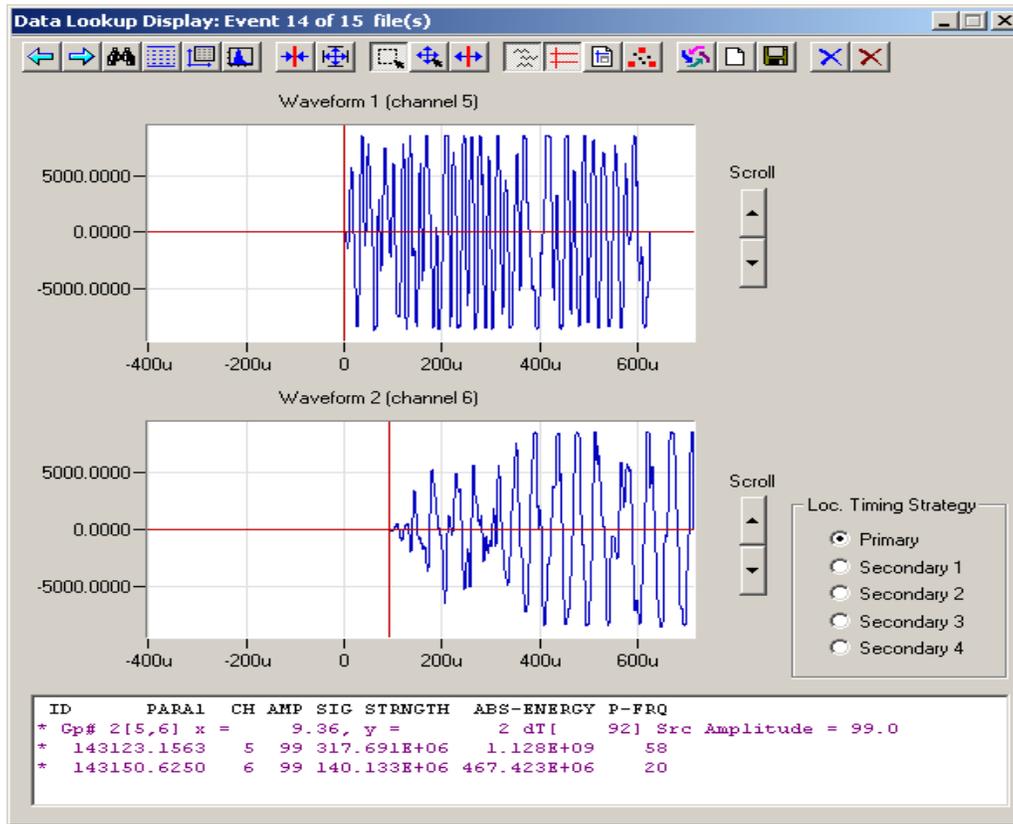
Figure 49. Illustration. AE signals from a potential wire break at notch A.

the potential wire break site, it was also expected that a signal from an actual wire break would have in fact saturated the AE channel, as shown in figure 49.

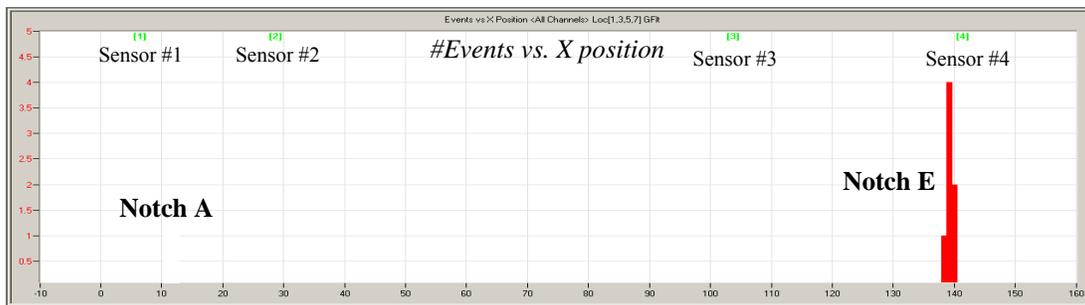
Figure 50. Graph. Events located around notches A and E by sensor groups 1, 3, 5, and 7 (filtered data).

A simple analysis of this type in conjunction with the requirement that the event was detected at a load 30,000 lb (13,620 kg) or higher led to the elimination of a massive number of events, leaving only 7 events for the notch A and 19 for notch E. Figure 50 and figure 51 show the location plot for these 26 events. In the figures, the y-axis shows the number of AE events, and the x-axis shows the location along the length of the strand.

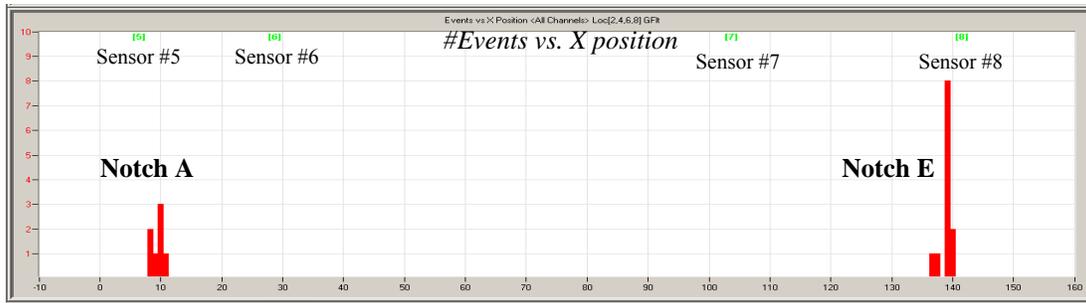
Figure 51. Graph. Events located around notches A and E located by sensor groups 2, 4, 6, and 8 (filtered data).

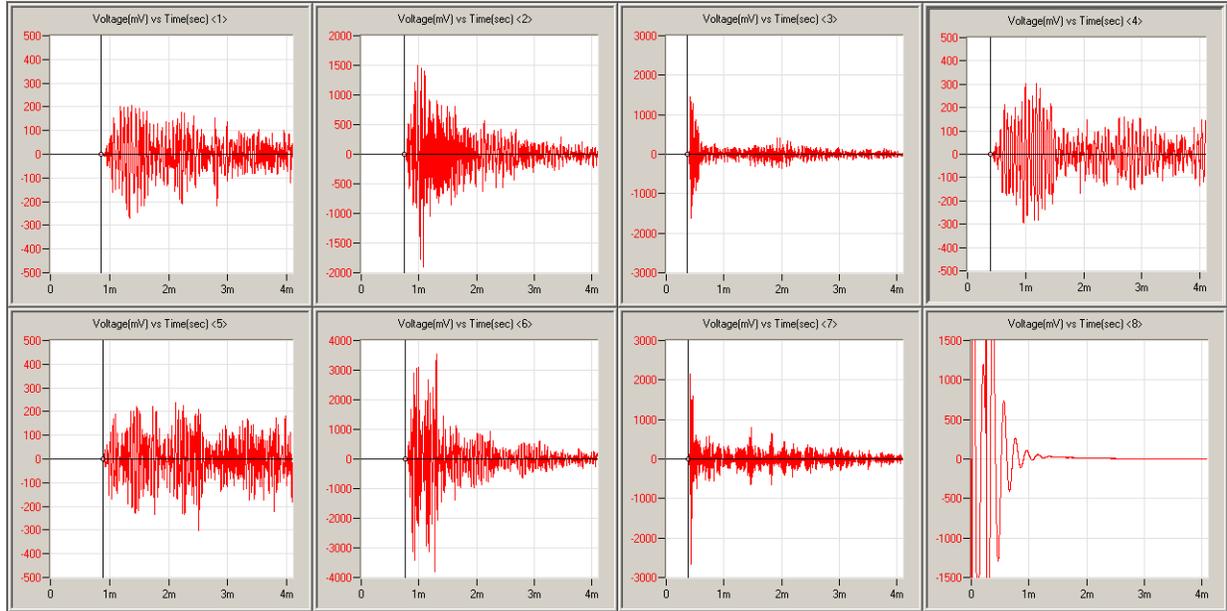
Figure 52. Graph. Baseline acoustic signals detected by the AE sensors along the strand.

In order to establish a common reference point for measurements with no load applied to the strand, the MS was pulsed using a tone burst signal with central frequency of 64 kHz at a rate of 10 Hz. This acoustic wave propagated along the strand and was detected by the AE sensors located at different positions. Figure 52 shows the baseline recorded waveforms detected by sensors 1 to 7, whose locations are provided figure 38. Only seven sensors were used in this operation because channel 8 was used to synchronize the AE system with the MS system, as can be seen in the waveform corresponding to channel 8 in figure 52.

The increasing delay in the arrival of the signals corresponds to the increasing distance between the MS and the position of the AE sensor along the strand. This delay was used to calculate the average propagation velocity of the elastic wave along the wires, which resulted in an average value of 193,800 inches/s (4.92 mm/ μ s). The waveforms can also provide valuable information about the loss of different frequency components as the signal travels along the strand. For this purpose, the power spectra of the signals from figure 52 were extracted and analyzed. The results indicate that the peak frequency of the signals shifts to lower frequencies as the acoustic wave propagates along the strand away from the MS (see table 11).

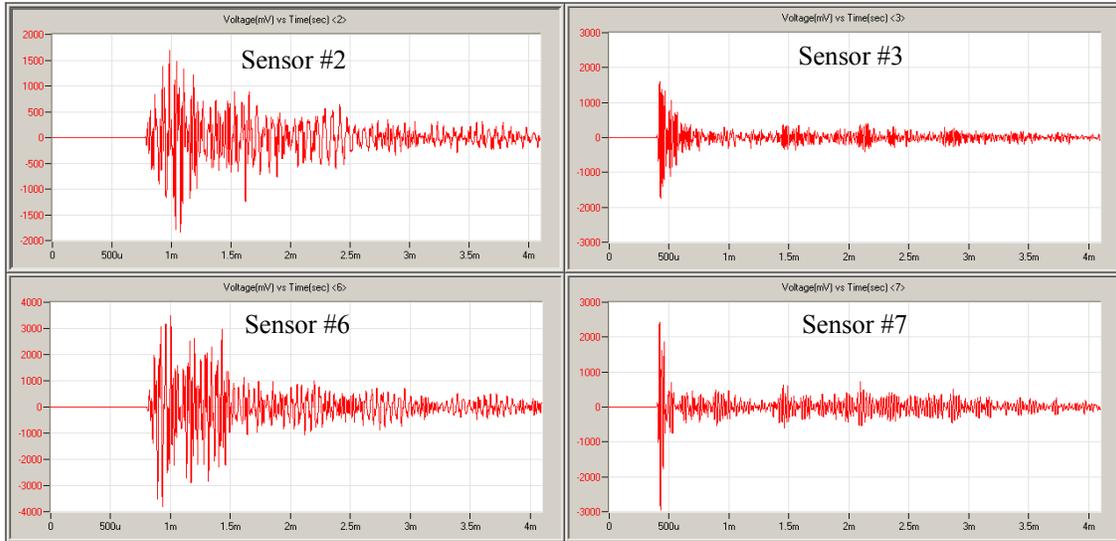
Figure 53. Graph. Acoustic signals detected by the AE sensors 2, 3, 6, and 7 during the hold at 34,000 lb (15,436 kg) (no damage).

The data in table 10 indicate that no wire break had occurred at 34,000 lb (15,436 kg) in notches B, C, or D. Thus, the signals in figure 53 can be considered representative of the strand with full cross section. The signals detected by the same sensors during the hold at 142,000 lb (64,468 kg) are shown in figure 54. According to the previous results, at the tensile load of 142,000 lb (64,468 kg), 13 wire breaks had occurred at this point in the test, which is reflected in the clear reduction in amplitude of the signals in all the sensors. This reduction in amplitude is approximately 50 percent across the four sensors. Ideally, these changes in signal characteristics could be related to a known damage level, in this case a known reduction in the strand’s cross section. An extensive analysis was performed in the different features of the signals detected at different levels of damage produced in the strand during the tensile test.

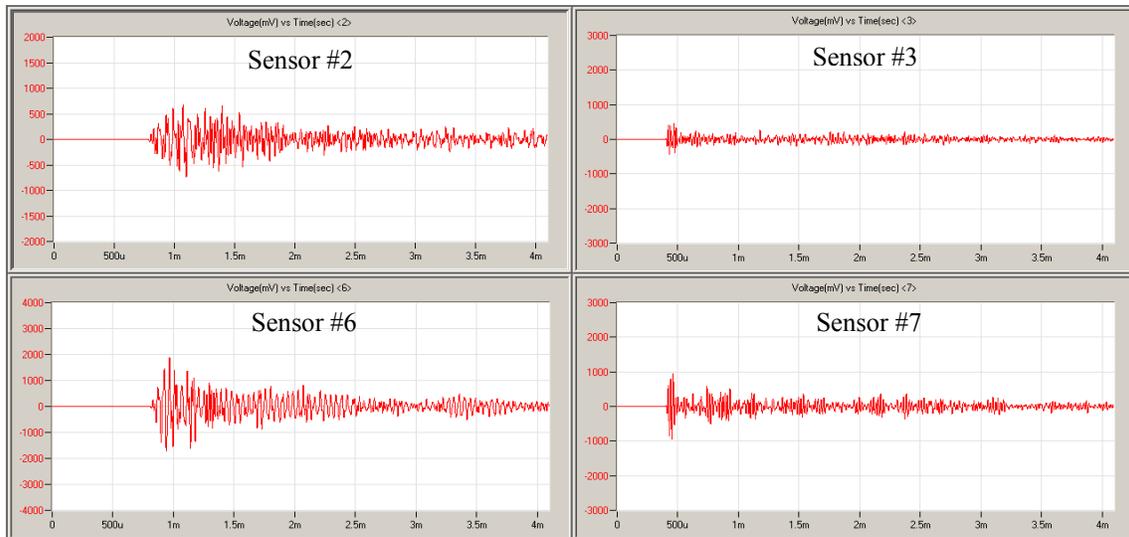
Figure 54. Graph. Acoustic signals detected by the AE sensors 2, 3, 6, and 7 during the hold at 142,000 lb (64,468 kg) (severe damage).

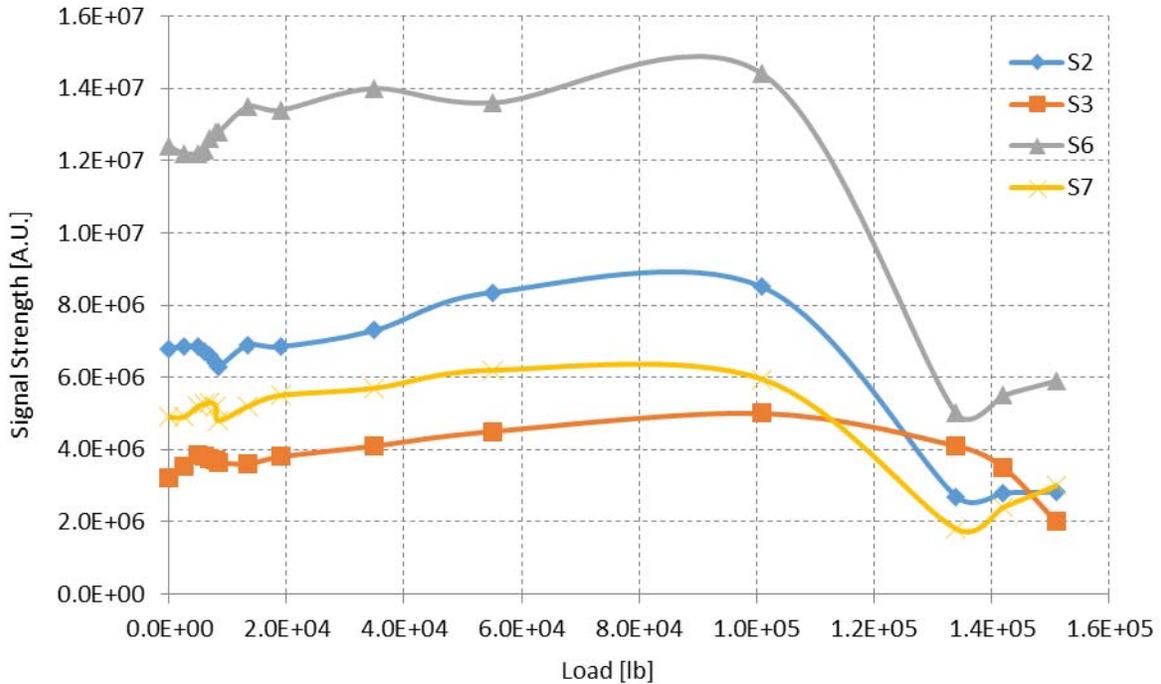
Figure 55. Graph. Signal strength as function of load for sensors 2, 3, 6, and 7.

This analysis revealed that the signal feature that correlated better with the progression of damage in the strand is the signal strength. Figure 55 shows a plot of signal strength versus load on the strand for sensors 2, 3, 6, and 7. It is clear from these plots that there is an increase in the signal strength with load on the strand up to approximately 100,000 lb (45,400 kg). This increase is caused by changes in the strand as the wires get tensioned and by the fact that the attenuation of the signal in the strand decreases due to a better consolidation of the wires. However, according to figure 42 and figure 43, at 100,000 lb (45,400 kg), there is significant damage in the strand. It is at this point where the signal strength starts to drop substantially, with increasing load and more damage being produced in the strand.

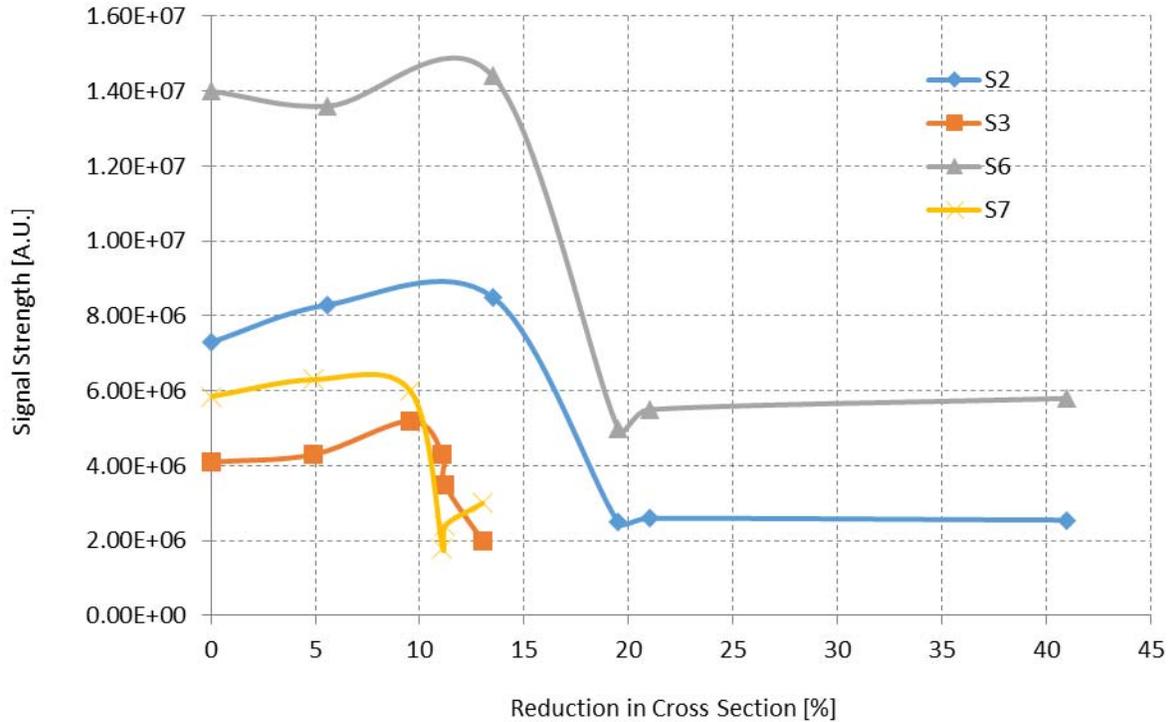
Figure 56. Graph. Signal strength versus cross section reduction for sensors 2, 3, 6, and 7.

In order to decouple the effect of load and correlate the change in signal strength directly to damage, the changes measured by sensors 2, 3, 6, and 7 were plotted against the actual loss in strand cross section according to the sequence of wire breaks shown in table 10. The results are shown in figure 56.

Sensors 3 and 7 covered the area between the MS sensor and notch D. The results indicate that the signal strength decreases sharply after the damage accumulation reached 10 percent. The plots for sensors 2 and 6 showed a decrease in the signal strength after the damage accumulation reached 13 percent. This slight decrease in sensitivity may be the result of sensors 2 and 6 being mounted in a clamp, which causes the loss of high frequency components, as previously discussed in this section.

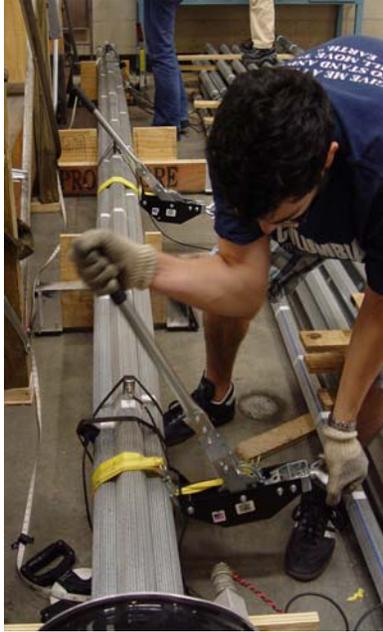
Figure 63. Photo. Compaction of strand bundle.

In the first test, the strand with cut wires was moved to the center of the bundle, and then the seven strands were strapped together at three locations, as shown by the yellow straps in figure 63, to enhance their contact and the transmissibility of the traveling elastic waves. The MS coil was then placed around the entire bundle of strands to generate a magnetic field within the bundle. The AE sensors were placed on the outer surfaces of the strands (see figure 64). For this test, as well as for tests 5-2 and 5-3, the excitation of the pulse was performed at 8, 16, 32, and 64 kHz.

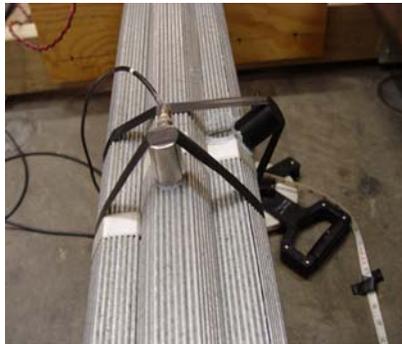
Figure 64. Photo. Mounted AE sensors.

With the coil wrapped around the entire bundle, the MS pulse could not detect the cut wires located in the center strand at all four excitation levels. However, the AE sensors located along the outer strand (see figure 64) were able to detect the MS pulse. To understand why the MS pulse could not detect the broken wires, sensor A (the 15-kHz R1.5I sensor) was moved and mounted to the center strand where the cut wires were. This is the low frequency sensor, and it is more sensitive to the lower frequency guided waves generated by the MS system. After moving this sensor to the center strand, it was determined that the MS pulse was not reaching the center strand. It was found that while the MS pulse could reach the opposite end of the strand setup, it could only be detected along the portion of the strand that was in contact with the MS coil. Two possible reasons for such lack of signal in the central strands were identified: lack of penetration of the magnetic field and lack of contact force between the strands. To better understand the effect of the compaction force on the signal transmission through the strands in test 5-2, the strands were tightened further to increase contact force between all the wires, and the coil was then moved to the center strand.

For test 5-2, the MS coil was moved to the center strand, while the AE sensors were left mounted on the outer circumference of the entire setup. In this configuration, the MS sensor was now able to detect the cut wires within the strand, while the AE sensors, still placed on the outer strands, were not able to detect the MS signal from the center strand despite the increase in compaction force. Again, the R1.5 low-frequency sensor was moved to various positions along the length and circumference of the cable. As previously observed in test 5-1, the AE sensor could only detect the MS pulse when it was mounted to the center strand that was in contact with the coil.

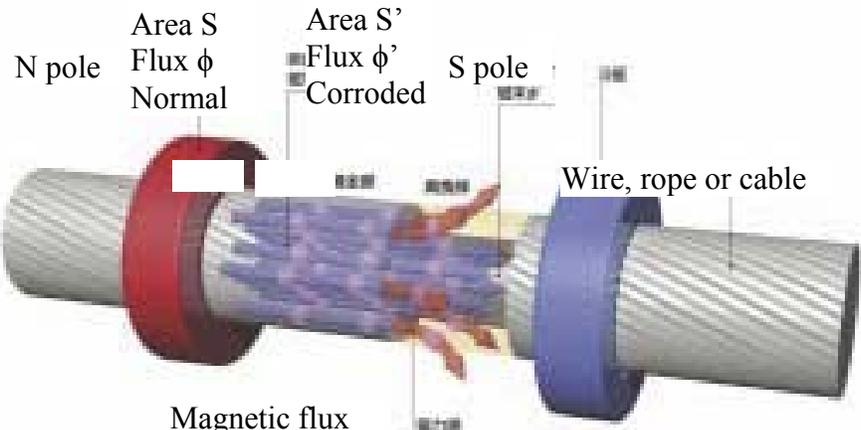
Figure 65. Illustration. Flow of magnetic flux in a wire rope.

The fundamental principle of this technology is that when a steel wire, rope, or cable is longitudinally saturated by a strong magnetic field, the magnetic flux in the wire, rope, or cable is proportional to the wire's, rope's, or cable's cross sectional area, as shown in figure 65. When a magnetic field moves along the length of the cable, then the measured variation of the magnetic flux at a given location may be correlated to the change in cross sectional area at that location.

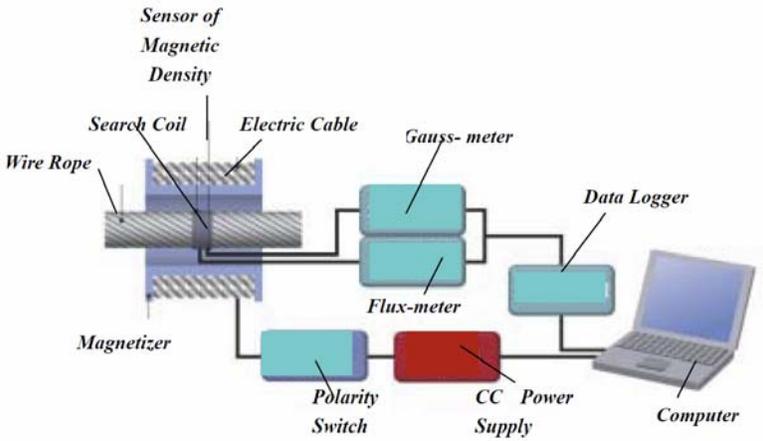
Figure 66. Illustration. MMFM measurement system.

The MMFM system consists of a magnetizing unit, sensor units, and a computer (see figure 66). The magnetizing units consist of an electromagnet, a variable DC power supply, and a switch of polarity. The sensor units are comprised of the search coil, flux meter, Hall-sensors, and Gauss-meter. A computer controls the magnetizing current and records and analyses the measurement data. Figure 67 and figure 68 show the electromagnet, mounted on the cable mockup, and the MMFM system developed for this specific test.

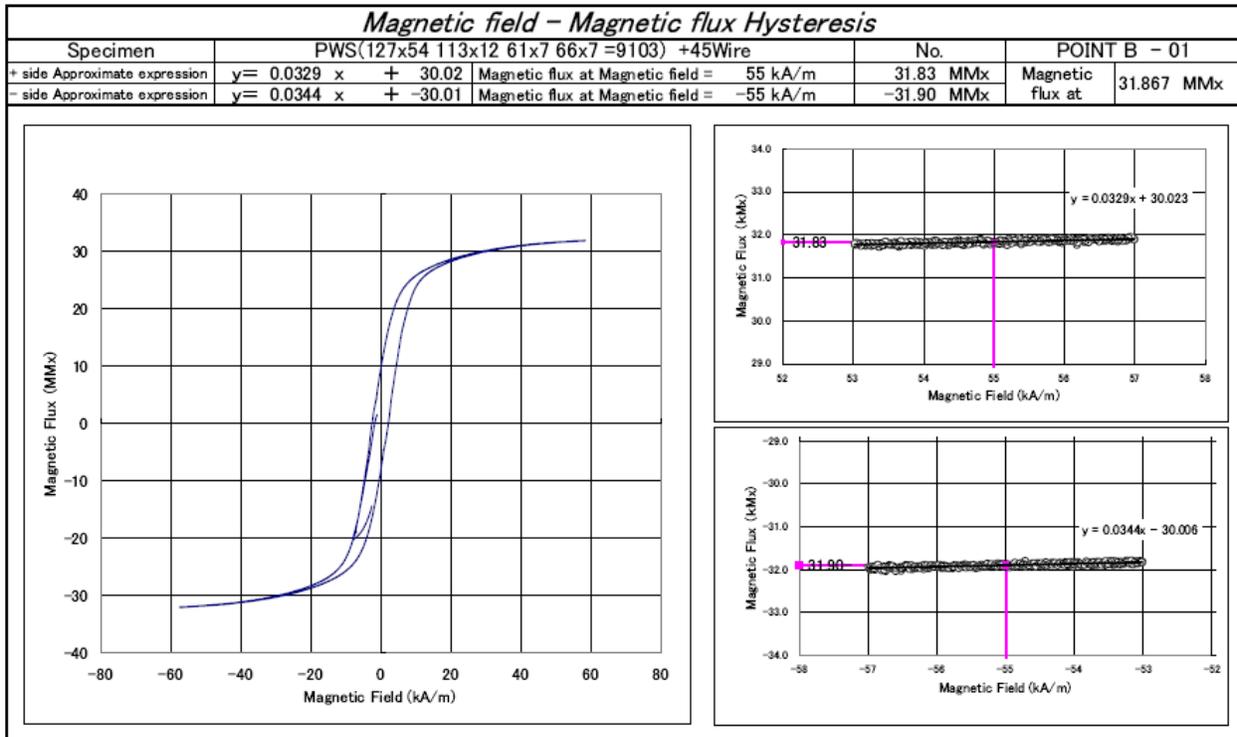
Figure 69. Illustration. Magnetic flux versus magnetic field plot for an MMFM test.

During each test, the cable mockup was saturated with a magnetic field of 55 kA/m, and measurements of the maximum magnetic flux were recorded. In figure 69, the results from a single test (location B, 45 additional wires added to the cable) are presented.

The baseline (no wires added) showed a magnetic flux value of 31.842 and 31.688 MMx for locations A and B, respectively. This small difference (0.5 percent) between the magnetic fluxes at the two locations is within the measurement error range of the method (1 percent).

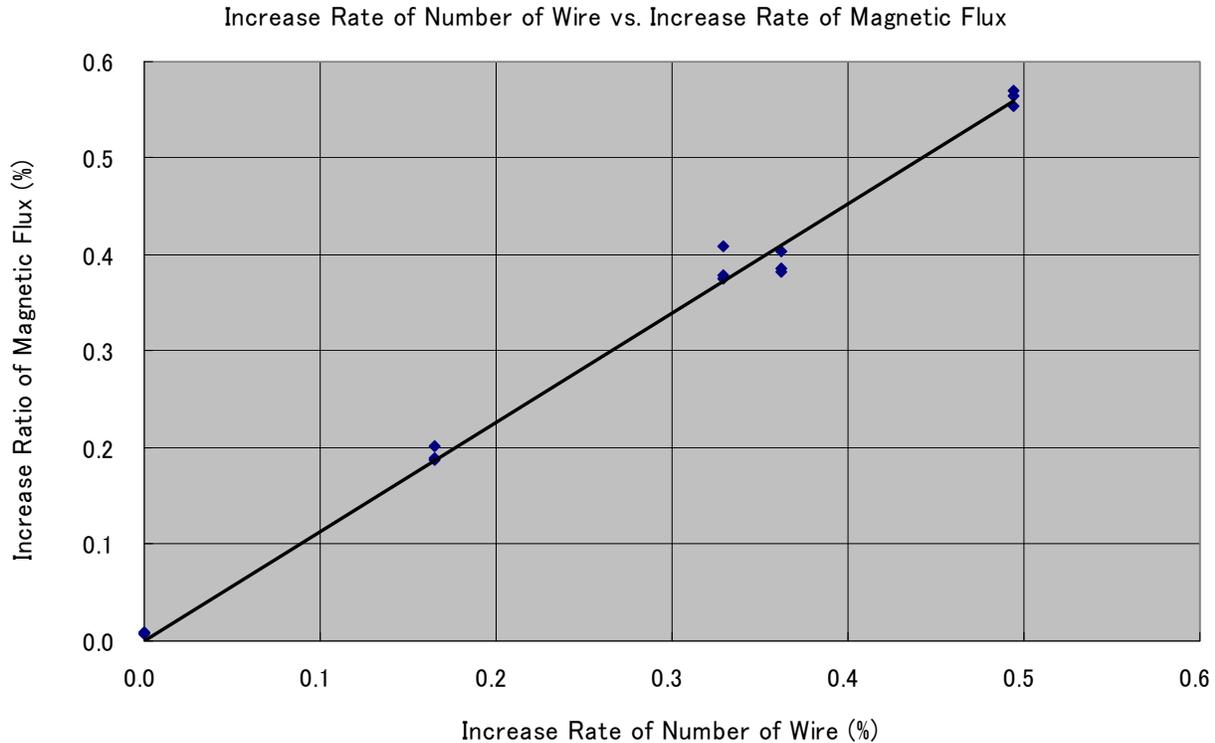
Figure 70. Graph. Increase in magnetic flux versus increase in the number of wires.

When wires were added to the surface of the cable, then the magnetic flux corresponding to a magnetic field of 55k A/m increased, reaching values up to 31.970 MMx at location A and 31.868 MMx at location B. Plotting the changes in magnetic flux with the increased number of wires, it is possible to see a linear relation between these two quantities (see figure 70).

This graph presents a very interesting result. In real-life applications, this graph should be read from right to left, considering that the number of “good” wires decreases. In any case, the results show that there is a linear relation between the number of wires that deteriorate and the reduction of magnetic flux. This could be quite useful in real bridge applications for an accurate estimate of the number of broken wires.

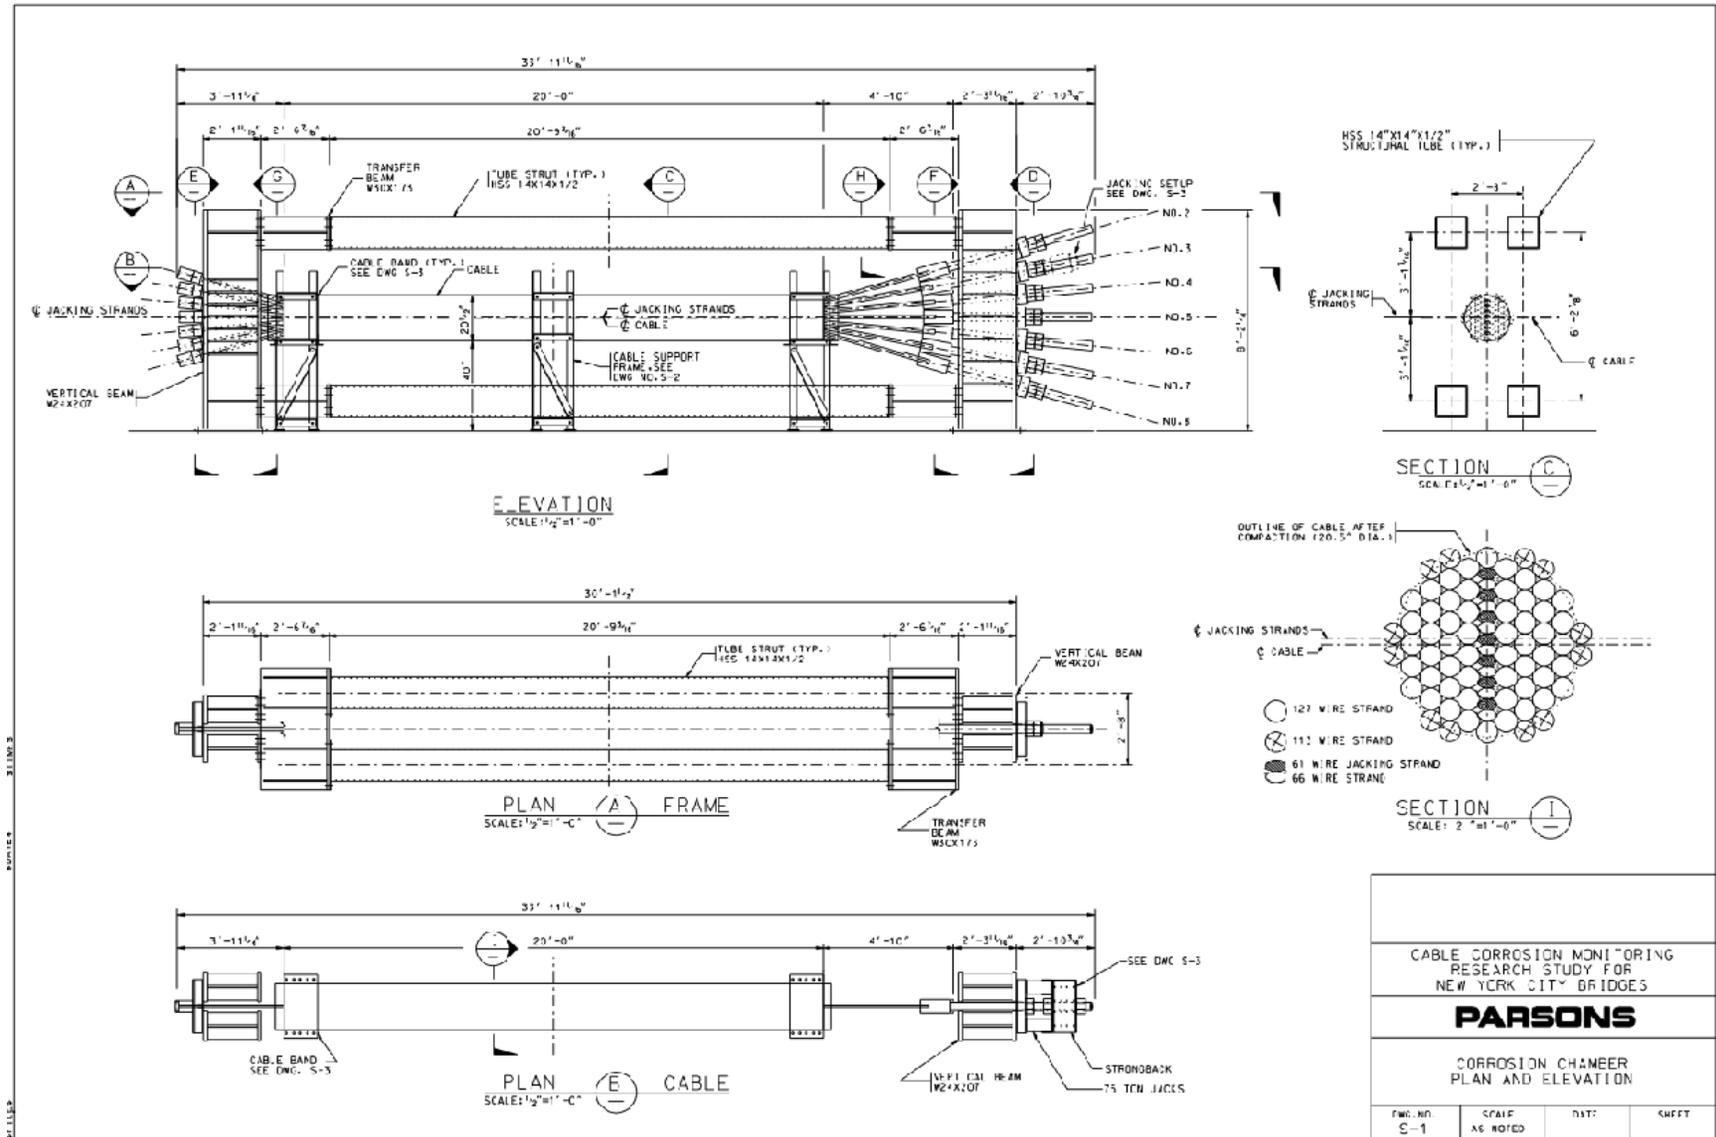
Figure 71. Illustration. Drawing of the cable mockup and corrosion chamber—plan and elevation.

The construction of such a cable was a challenging task because this is the longest cable of such diameter ever built in the world subjected to some external loading. Additionally, original bridge wires were used in the construction of the cable so to simulate as closely as possible the real conditions and to improve the fidelity of the experiment. Its design and construction presented many difficulties that required a lot of trial and error attempts. Figure 71 shows the side and plan views of the cable mockup and the cable cross section.

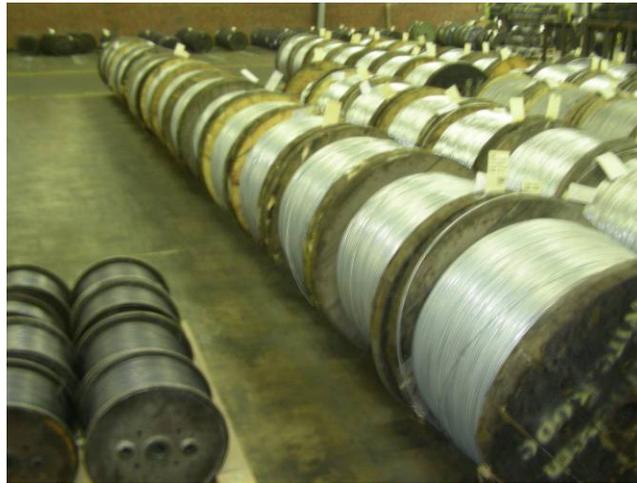
Figure 72. Photo. Wire coils to be used for the construction of the cable mockup (first row of coils).

The typical manufacturing process of a bridge wire involves the wires being sent through a set of dices made of tungsten carbide steel in order to reach the final diameter of the desired cross section. This process is driven by a set of power-activated drums, each one 36 inches (91.44 cm) in diameter. Cold working alters the wire microstructure. The grains are squashed, and their dislocation density is raised dramatically, producing tangles and residual stresses. Because of the small diameter of the pulling drum, the wires are subjected to large plastic strains, which induce a plastic distribution of stresses inside the wires. The effect of cold drawing increases the strength of the metal but also reduces its ductility. After being removed from the pulling drum, the wire coil experiences an increase in diameter (up to 50 to 60 inches (1,270 to 1,524 mm)) due to the fact that no pulling action is applied to the wire. This change in curvature induces an additional distribution of internal stresses which are then added to the original plastic stress distribution (currently unknown). The final wire coil is then chemically and thermally processed before being dipped in a hot zinc bath for galvanizing. Heating the cold-worked metal (annealing) reverses the effects produced by the cold drawing process. With the supplied thermal energy, dislocations will move to accommodate the stored residual stresses, forming a polygonized subgrain structure that concentrates the lattice disruption in just a small part of the grain volume. Recrystallization of the steel will begin with nucleation and growth of new grains, improving the ductility but reducing the wire strength. The galvanized wire is then wrapped on a reel of 60 inches (152.4 cm) in diameter and taken to the construction site. Figure 84 shows the entire amount of bridge wires used for the construction of the cable mockup.

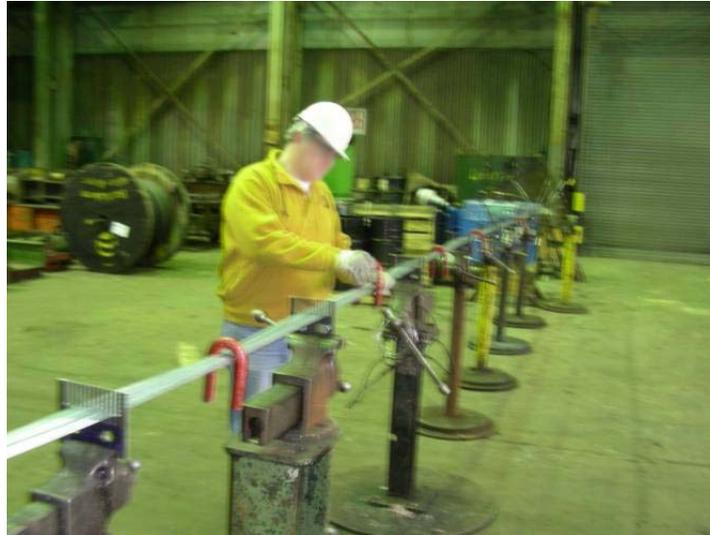
Figure 73. Photo. Strand under construction.

One of the major challenges has been the study of a procedure to build by hand straight strands from coiled steel wires. This has never been attempted before and requires a lot of trial and error. A complex procedure was finally developed that allowed researchers to build a straight strand out of coiled wires, as shown in figure 73. This required passing the wire in a series of combs and distributing the ends in a proper order of directions so that the curvature effects were minimized.

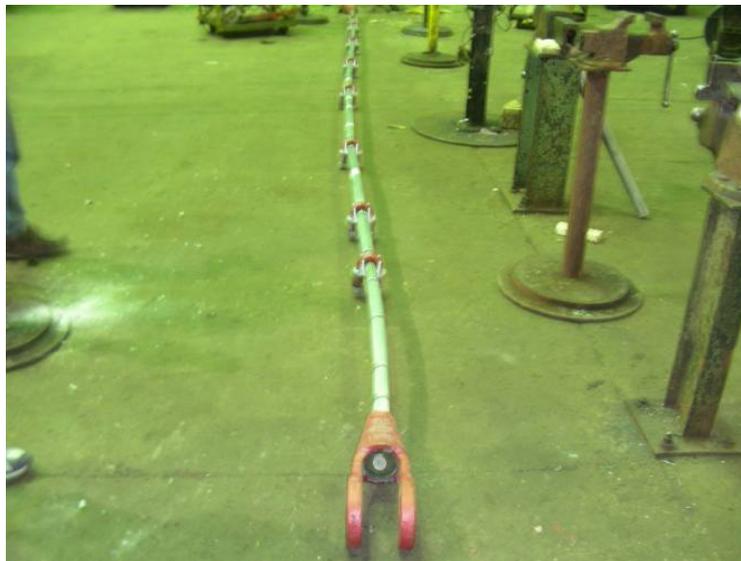
Figure 74. Photo. Final straight strand from coiled wire.

This methodology was used for the construction of the 7 35-ft (10.68-m) strands that were subjected to loading. The other 66 strands, all 20 ft (6.1 m) in length, were built using the same methodology and the same steel wires from the initial coils but straightened (see figure 74). The straightening of the wires was necessary; otherwise, it would have not been possible to build such short strands. In fact, these strands were not socketed, and this would have made it impossible to build them from the original wires. The arrangement and details of the various strands are presented in figure 75.
