Corrosion Monitoring Research for City of New York Bridges

PUBLICATION NO. FHWA-HRT-14-023

MAY 2014

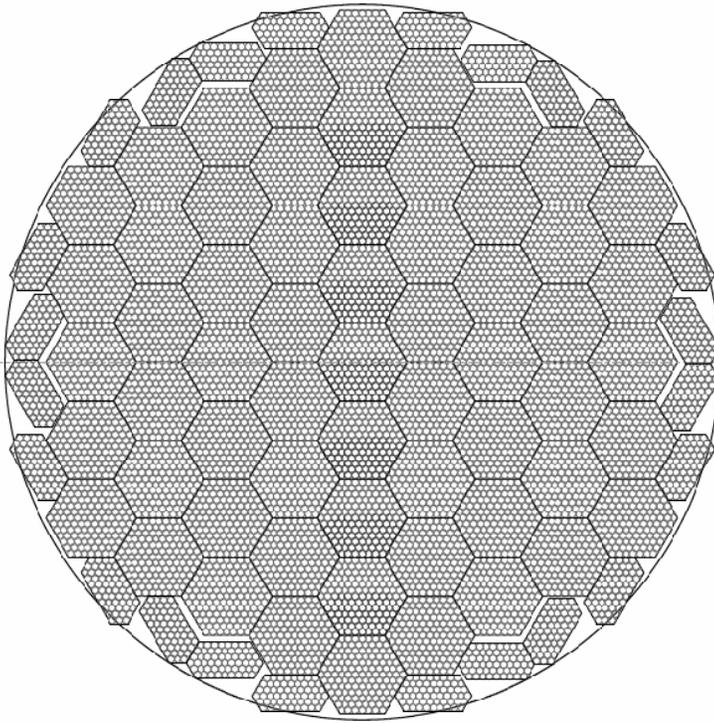
Figure 75. Illustration. Cable cross section and strand details.

CABLE CORROSION MONITORING RESEARCH STUDY FOR NEW YORK CITY BRIDGES			
PARSONS			
CORROSION CHAMBER CABLE SUPPORT FRAME			
DWG. NO. 5-4	SCALE	DATE	SHEET 2 of 2

Once all the strands were completed, they were assembled following the arrangement presented in figure 75. Stacking of the strands started from the bottom of the cable moving upward, first placing the long strands and then the surrounding straight strands. Because of their tendency to curl as a result of the initial state of stress in the wires, the long strands needed to be pretensioned. First, a long strand was placed within the form and pretensioned, and then the surrounding straight strands were positioned so to restrain the long one. This procedure is shown in figure 76 through figure 78.

This methodology was used for the construction of the 7 35-ft (10.68-m) strands that were subjected to loading. The other 66 strands, all 20 ft (6.1 m) in length, were built using the same methodology and the same steel wires from the initial coils but straightened (see figure 74). The straightening of the wires was necessary; otherwise, it would have not been possible to build such short strands. In fact, these strands were not socketed, and this would have made it impossible to build them from the original wires. The arrangement and details of the various strands are presented in figure 75.

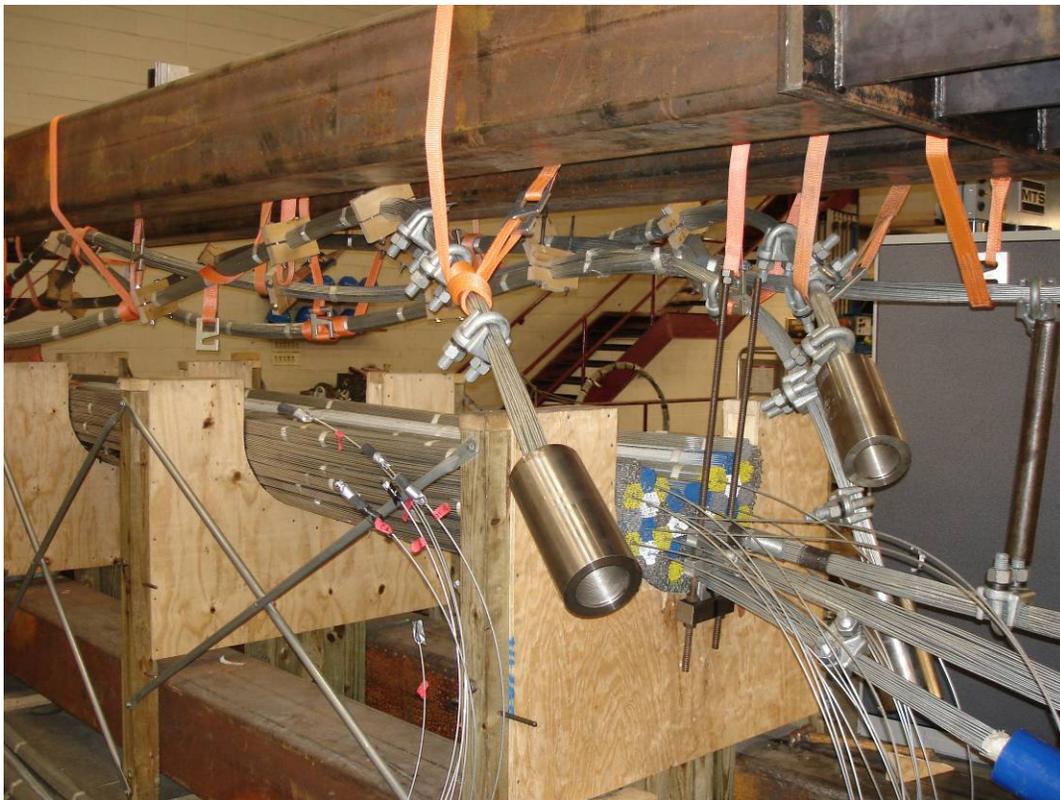
Figure 79. Photo. Intermediate cable construction phase.

Figure 79 shows an intermediate phase of the construction of the cable mockup.

It is interesting to see the long strands with the end sockets hanging from the top beams of the loading frame. These strands were socketed at both ends and placed in tension through tensioning rods.

In figure 79, long wires are visible coming out of the shorter strands. Twenty-five long wires were prenotched at three locations along their length and inserted into various strands. Three of these wires were pulled to failure, and the results were used to test the AE system in detecting wire breaks occurring in the interior of a cable. The knowledge of the breaking locations allowed researchers to record and study different wire breaking signatures based on the breaking location along the cable length and along its diameter and on the sensor location relative to the breaking.

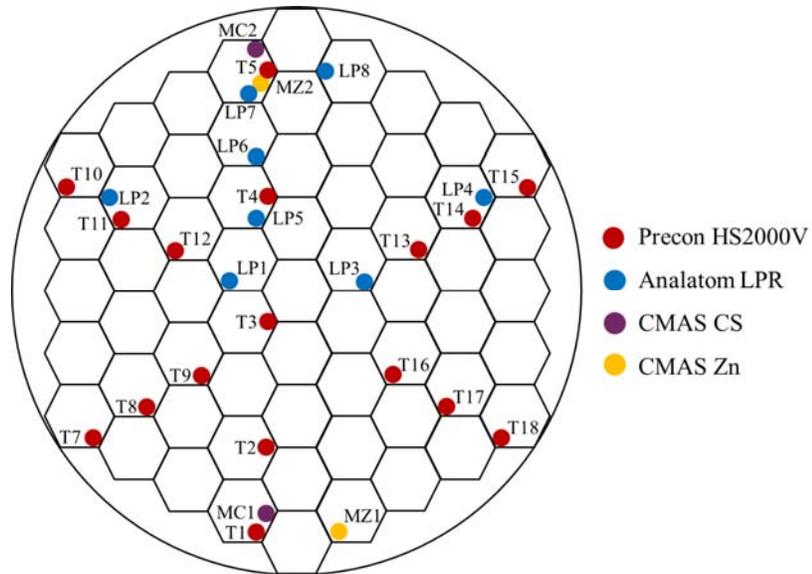
Figure 80. Illustration. Schematic locations of sensors in cable mockup cross section.

In total, 72 sensors were installed in the cross section of the cable. Figure 80 provides a schematic representation of the locations where sensors that successfully performed during the tests were placed. Sensors were placed along three diameters, inclined at 60° with respect to each other. Such distributions allows for measurements that are distributed along the radial direction in order to have a three-dimensional distribution of the various parameters (e.g., temperature, humidity, etc.). The 16 temperature/relative humidity sensors were evenly spaced along the three diameters in order to have measurements for the temperature and humidity variations inside the entire cross section. Figure 81 shows a phase of the sensor placement inside the cable mockup. Special attention had to be made in protecting the sensors from being squished during the cable compaction. As shown in figure 81, sensors were protected using stainless steel pipes that were 3 inches (76.2 mm) long and covered with heat shrinking moisture-resistant coating. The heat shrink coating was used to prevent stainless steel pipes to act as cathode (since the chemical composition of the stainless steel pipe was unknown) and thus induce accelerating corrosion on the wires. The sensors were hard wired, and the electrical wires were run out of the center of the cable at two vertical locations.

Of the total 72 sensors initially installed in the cable, only 50 sensors provided data worthy of analysis (see figure 80). Those sensors measured temperature, relative humidity, and corrosion rate. Being distributed across the cross section of the cable, they provided an experimental image of the distributions of temperature, relative humidity, and corrosion activity within the cable. The sensors were hard wired, and the electrical wires were run out of the cable center and connected to a DAQ.

The sensor numbering displayed corresponded to the numbering used during data collection. A total of 17 Precon HS2000V temperature/relative humidity sensors (labeled “T” in figure 80 to represent temperature; referred to as “RH” to represent relative humidity) were evenly distributed according to depth and angle of incline. Sensor T6 was discarded from use (not referenced in figure 80) because of early installation malfunctions, while sensors T7 and T18 had some malfunctioning problems during the early tests. Both temperature and relative humidity data was collected at 300-s intervals for the duration of each test.

Eight LPR sensors (labeled “LP” in figure 80) were distributed in the upper half of the mockup cable specimen’s cross section. Four sensors were placed along the upper vertical radius, while two were placed on each of the radii oriented at $\pm 60^\circ$ (see figure 3). A complete cross sectional distribution of corrosion rate sensors was desirable; however, laboratory construction operation forced the placement of LPR sensors to the upper half of the cable’s cross section. LPR sensors collected corrosion rate data every 60 s.

The remaining 22 sensors (not displayed in figure 80) measured pH and corrosion rate levels (using different methods). However, their measurements were erratic and considered unreliable and consequently discarded.

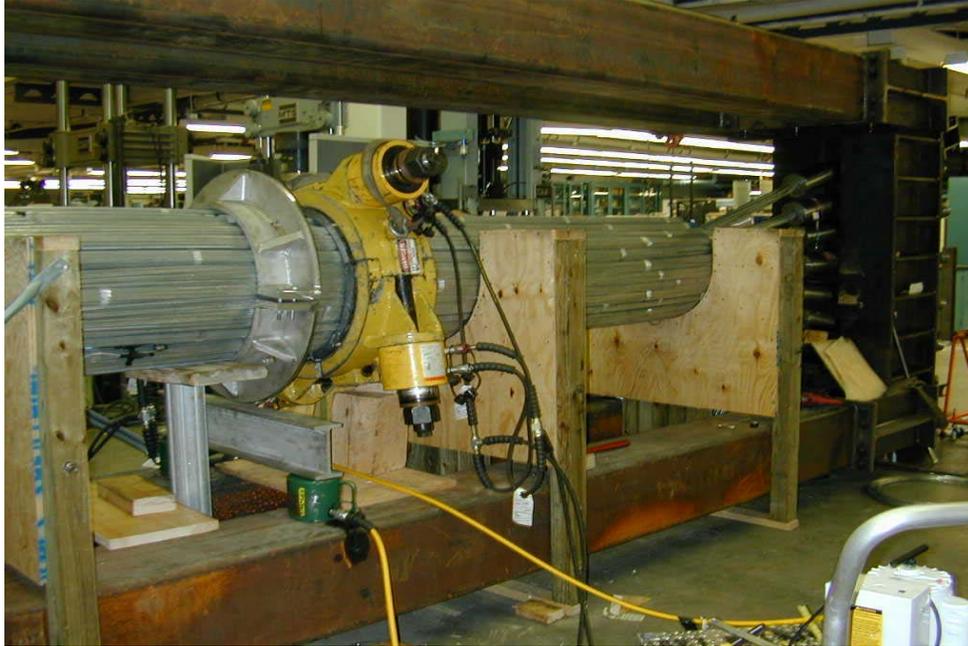
Figure 82. Photo. Cable compaction.

Once all the strands had been placed in the right position, the cable was compacted using a 20.75-inch (527.05-mm)-diameter compactor (see figure 82). It is estimated that the compaction force produced inside the cable a pressure of approximately 2,000 psi (13,780 kPa). After the cable was compacted, the temporary wood forms were removed, and the cable was pulled to approximately 1,100 kip (4,893.04 kN) of tension. This cable tensioning was obtained by pulling each strand in increments of 25 kip (111.21 kN) each up to the maximum load of 145 kip (644.99 kN) for the central and lower three strands and 175 kip (778.44 kN) for the upper three strands. The tensioning of each strand was done using two 100-kip (444.82-kN) hydraulic jacks, as shown in (see figure 83).

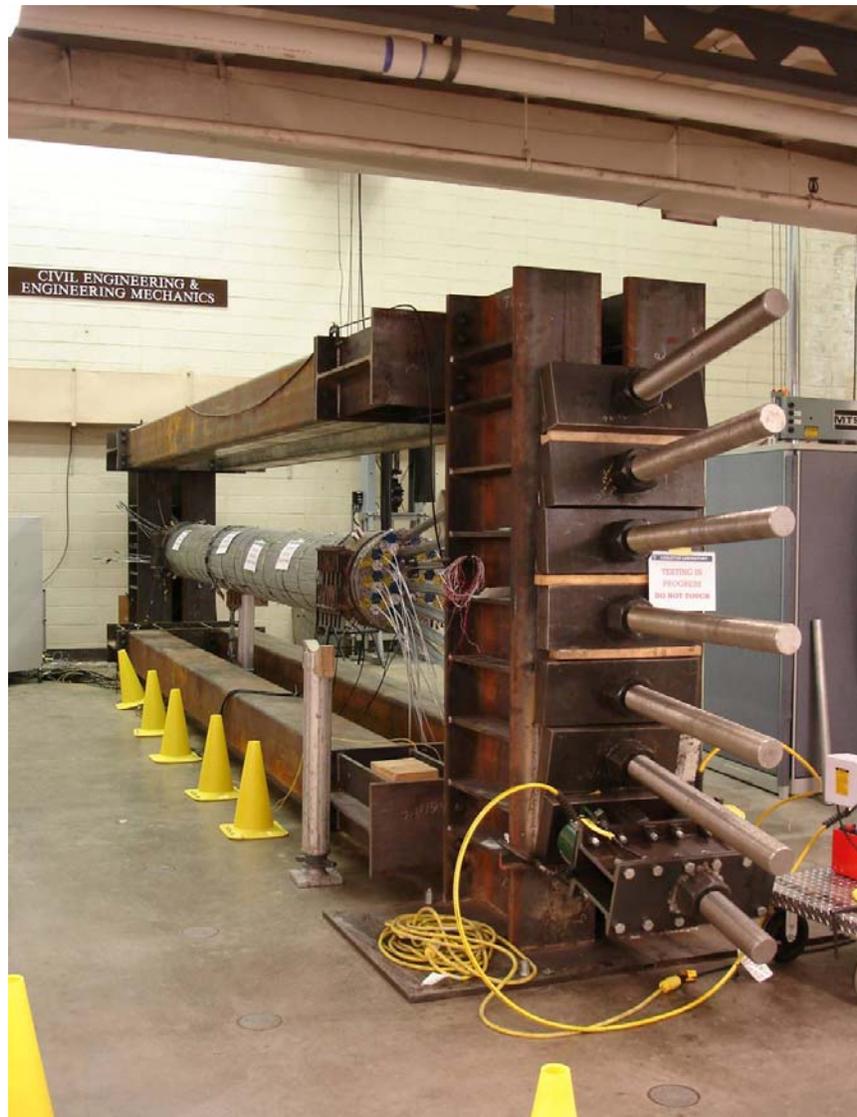
Figure 84. Photo. Cable mockup representative of a full-scale section of a suspension bridge cable.

The cable mockup in its final configuration prior to wrapping and to the construction of the environmental chamber is shown in figure 84.

The exterior protective wrapping of the cable mockup was performed by wrapping the cable with aluminum tape. It is important to observe that in these tests, the function of the wrapping was different from in a real bridge. In this test, since the sensor network had to be tested, the function of the wrapping coating was to keep as much humidity as possible inside the specimen so that the humidity sensors could be successfully tested. In real cables, instead, the function of the external wrapping is exactly the opposite (to prevent water to enter the cable). A neoprene strap

was placed under the aluminum wrapping in correspondence of the exit location of the electric wires from the interior of the cable. This strap was needed to protect the electric wires from the intense heat of the heating lamps.

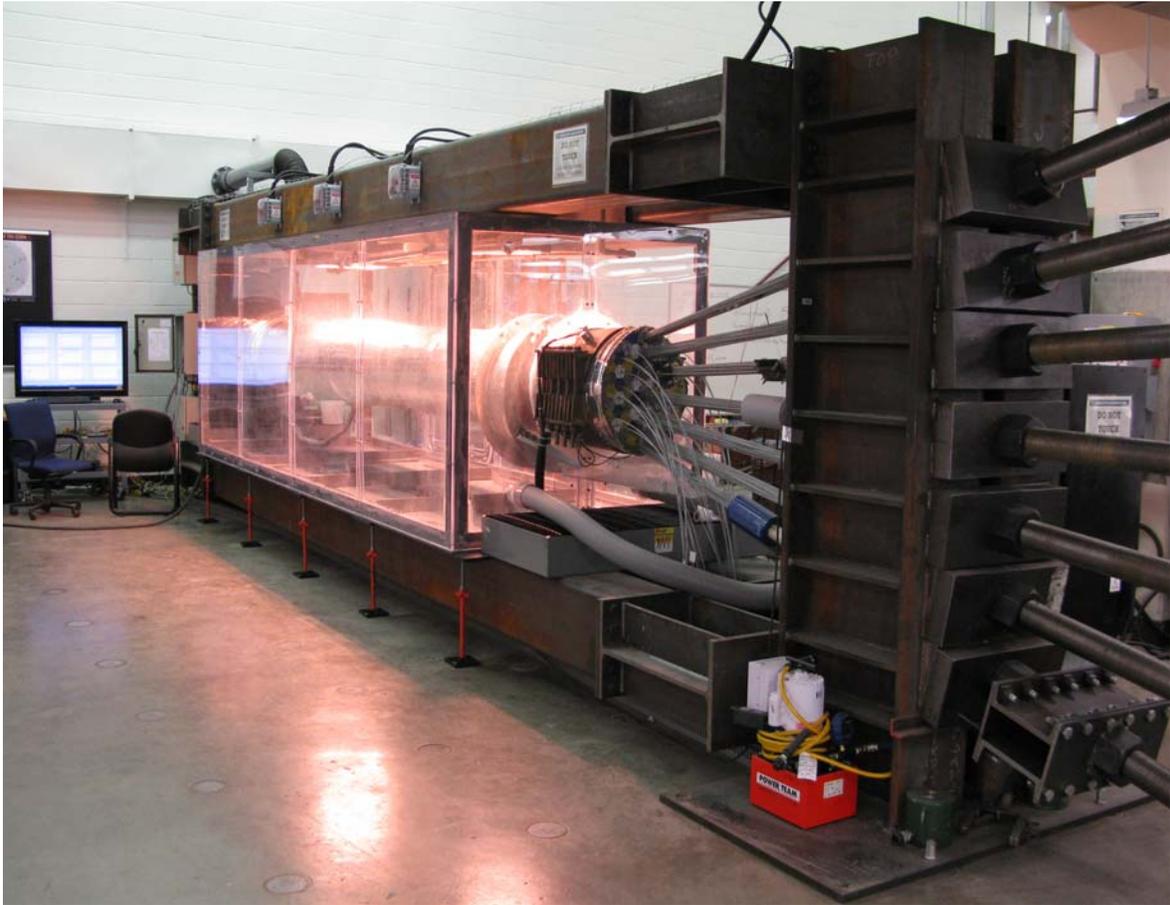
Figure 85. Photo. Cable specimen with environmental chamber.

An environmental chamber was built around the mockup cable specimen. The chamber was designed to expose the cable to controlled environmental conditions (i.e., simulated rain, heating, and cooling) to accelerate corrosion of the cable specimen, thereby assessing the functionality of the sensor network. Moisture was introduced into the system via water pumps and elevated punctured polyvinyl chloride (PVC) piping to simulate rainfall. Midway through the test program, openings were made in the cable wrapping coating to facilitate the influx of moisture to the inside of the cable mockup. Temperature increases were controlled with heat lamps located at the top of the chamber with a cut-off temperature of 125 °F (51.67 °C), while an air conditioning unit promoted temperature stabilization and rapid chamber/cable cooling. A ventilation system

allowed for increased control of the relative humidity levels within the chamber environment. The final cable mockup with the environmental chamber ready for testing is shown in figure 85.

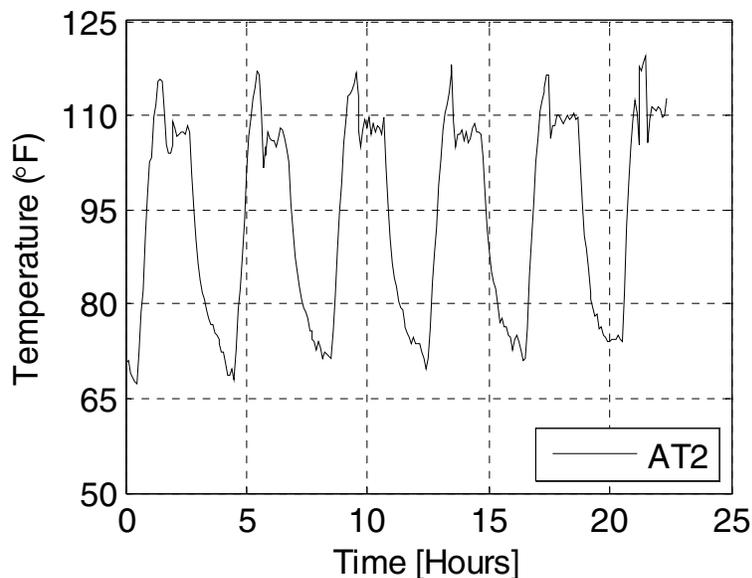
Figure 86. Graph. Test 1 AT2 chamber temperature recordings.

Figure 86 clearly shows the temperature pattern inside the chamber. After an initial drop associated with the 30 min of rain, there was a constant increase of temperature in correspondence to the heat phase of the cycle, after which the temperature stabilized around a value of approximately 105 to 110 °F (40.56 to 43.33 °C). Such a temperature remains approximately constant until the heating lamps are shut off and the air conditioning only phase starts. This induces a cooling of the air inside the chamber and a corresponding decrease in temperature. In general, only minor increases of chamber temperature minima were recorded with each cycle in the tests progression.

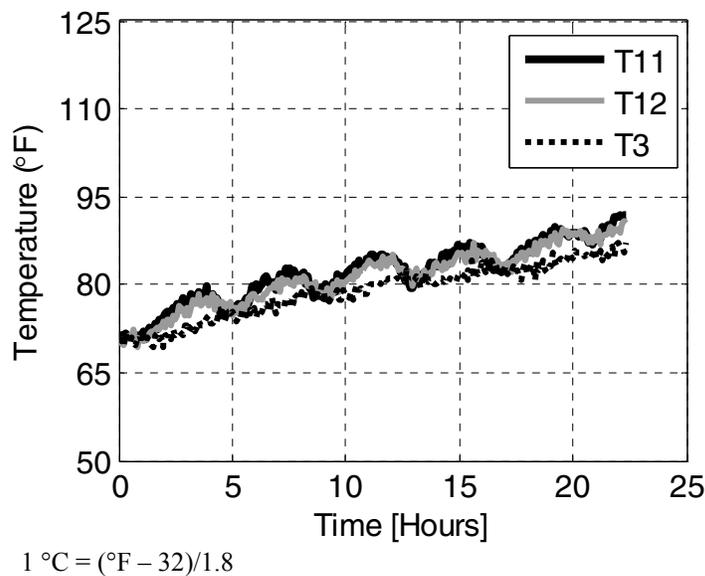
Figure 87. Graph. Test 1 upper cable temperature distributions along diameter at -60° .

As far as the temperature distribution inside the cable, sensor T3, which was centrally located within the cable's cross section, was taken as the baseline, and its recordings are shown in figure 87 through figure 89 for comparative purposes. It recorded temperature values between 72 and 85 °F (22.22 and 29.44 °C), showing no distinct cyclic minima and maxima. Although

slight fluctuations appear, a linear regression analysis provided an R^2 value of 0.9606 for the temperature increases recorded by T3 (see figure 87), stating that the temperature at the cable center appears to monotonically increase with a rate of approximately $1^\circ\text{F}/\text{h}$ ($0.56^\circ\text{C}/\text{h}$).

As in the temperature analysis, the relative humidity recordings of Precon sensor 3 (RH3), referring to the center of the cable, was used for comparative purposes. The sensor recorded initial relative humidity levels of 40 percent, while the reading within the chamber was at 55 percent. Over the course of testing, despite the external fluctuations in relative humidity levels, the center of the mockup cable experienced an approximate cyclic decline in relative humidity of 2 percent. A linear regression analysis returned an R^2 value of 0.9701, suggesting a nearly linear decline of the relative humidity in the cable center. This is consistent with the linear increase of the temperature at the center, as shown in figure 87 through figure 89.

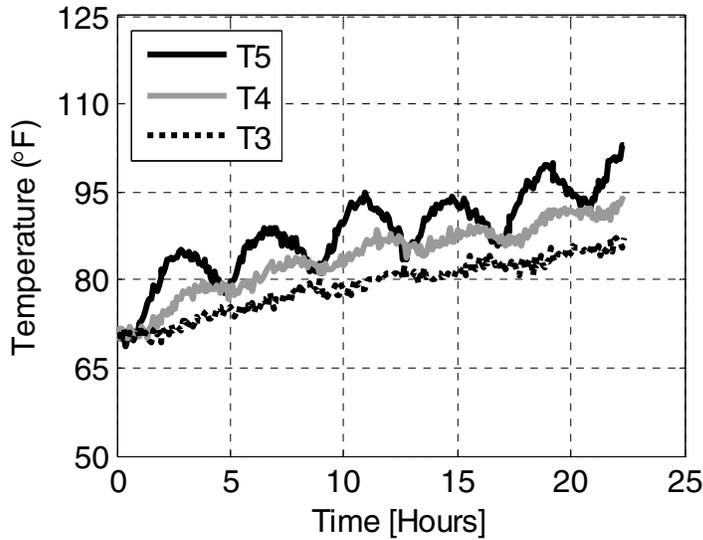
Figure 88. Graph. Test 1 upper cable temperature distributions along diameter at 0°.

As expected, the greatest temperature increases and fluctuations were recorded in the outer level of the cable's upper section (T5 and T15 (see figure 88 and figure 89)) because of the proximity of the sensors to the heat sources. Sensor T5, which was the closest to the heat lamp, shows sharper cycles than T15. Similar temperature cyclic variations were recorded by the middle and inner layer sensors (T11, T14, T12, T4, and T13 in figure 87 through figure 89) even though the range of such fluctuations decreased when moving toward the center of the cable. The measurements confirm that the left part of the cable shows a temperature distribution that is the mirror image of the temperature distribution in the right half, as expected because of the position of the heat lamps. At the inner level, temperature minima were recorded approximately 20 min after those recorded in the chamber. The time interval between minimum and maximum temperature at the inner level is the same as those recorded at both the middle and outer levels; however, there is a time lag of 10 to 15 min between these minimum and maximum temperatures and the corresponding temperatures at the other outer levels. This lag is a result of the thermal diffusivity properties of the cable.

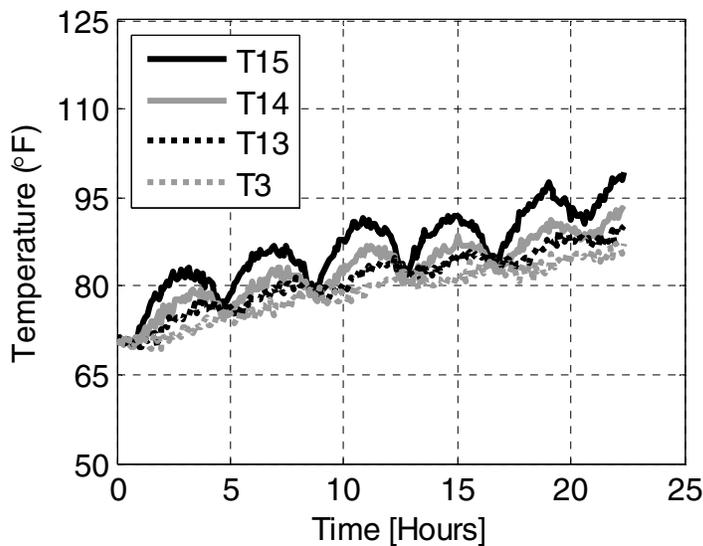
Figure 89. Graph. Test 1 upper cable temperature distributions along diameter at 60°.

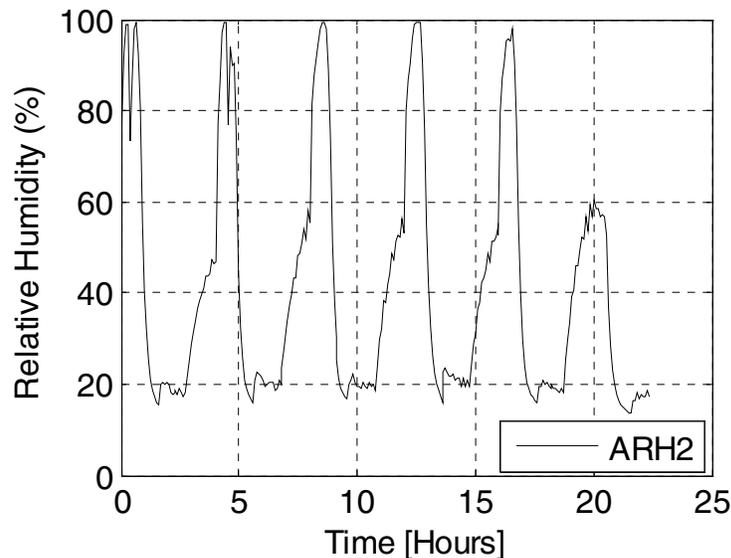
Figure 90. Graph. Test 1 Precon HS2000V ARH2 chamber relative humidity recordings.

The interpretation of the relative humidity data is much more complex because while the temperature data lend itself to a collective analysis, general trends are not as identifiable in the relative humidity data. This is because water can penetrate inside the cable from many different locations and can find many different paths to spread in between the many wires and reach the sensors at different times. However, some general trends can still be found and provide useful information on the functioning of certain sensors. In figure 90, the recordings of the Precon sensor labeled “ARH2” are presented and display the effects of the various phases of the cycle on the relative humidity levels within the testing chamber. Starting from an average level of 55 percent relative humidity in the chamber, the onset of the rain phase caused the chamber relative humidity to increase from 55 to 99 percent. After the rain phase was over, ARH2 recorded relative humidity values of approximately 15 to 20 percent during the heat and heat plus air conditioning phases and increased to the initial 55 percent value at the end of the cycle. This type of fluctuation was as expected and showed the good functioning of the sensor placed in the environmental chamber.

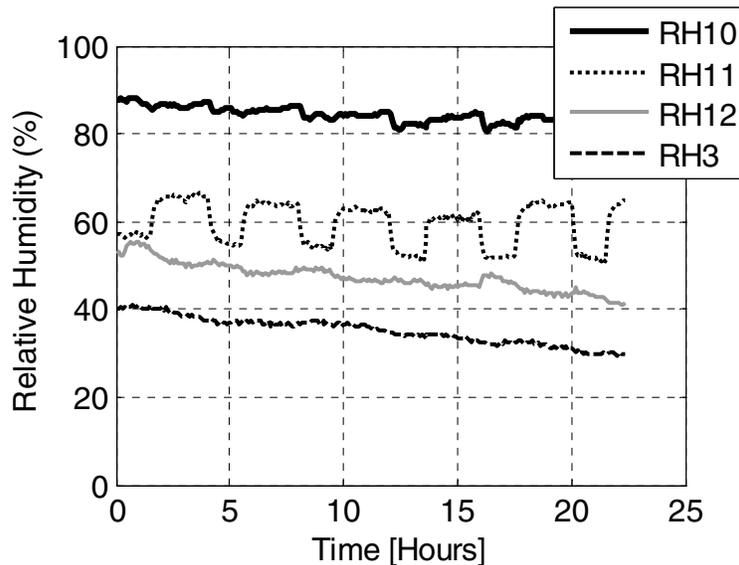
Figure 91. Graph. Test 1 upper cable relative humidity distributions along diameter at -60°.

Sensors within the outer level (RH10, RH5, and RH15) of the upper portion of the cable mockup specimen recorded substantial variations in relative humidity levels (see figure 91 through figure 93). RH10 recorded the highest initial relative humidity levels at 88 percent (see figure 91). This occurred due to three possibilities: some local trapped water, the sensor was near complete saturation, and/or a possible sensor malfunction (the temperature component

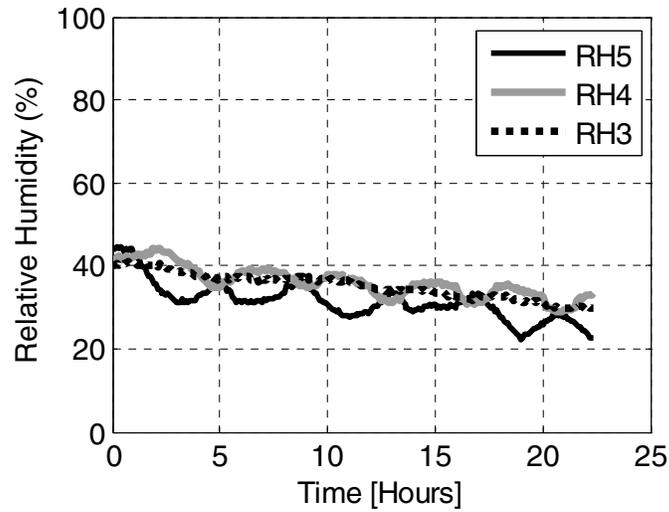
Figure 92. Graph. Test 1 upper cable relative humidity distributions along diameter at 0°.

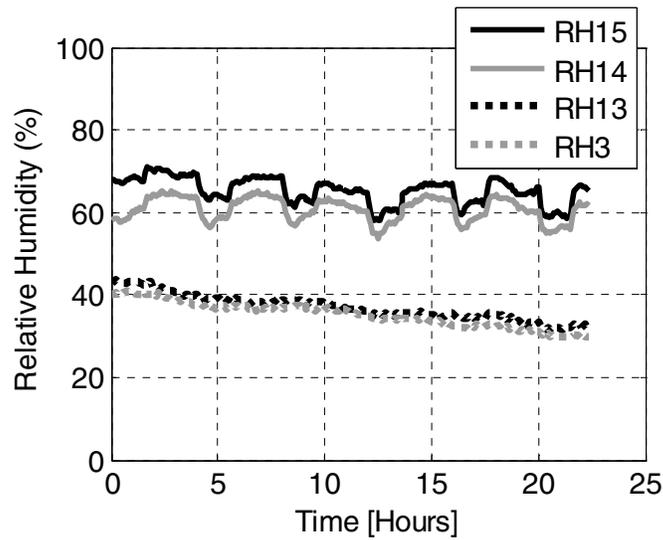
Figure 93. Graph. Test 1 upper cable relative humidity distributions along diameter at 60°.

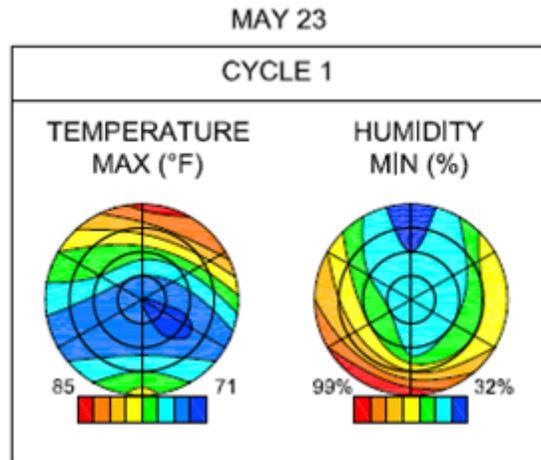
Figure 94. Illustration. Mapping of maximum and minimum temperature and relative humidity distribution during cycle 1 over the entire cable’s cross section.

Figure 94 and figure 95 provide a visual mapping of the variation of the maximum and minimum temperatures and relative humidity over the entire cable's cross section.

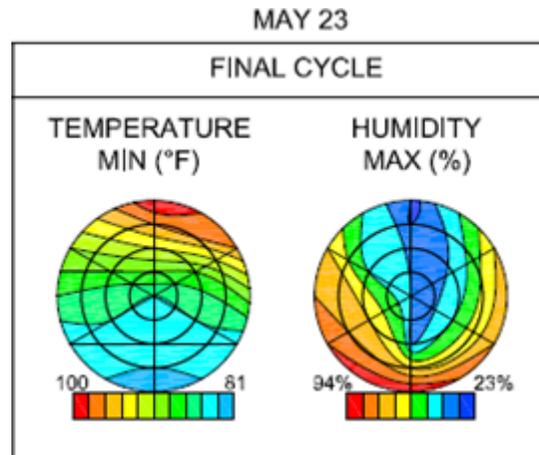
Figure 95. Illustration. Mapping of maximum and minimum temperature and relative humidity distribution during the final cycle over the entire cable’s cross section.

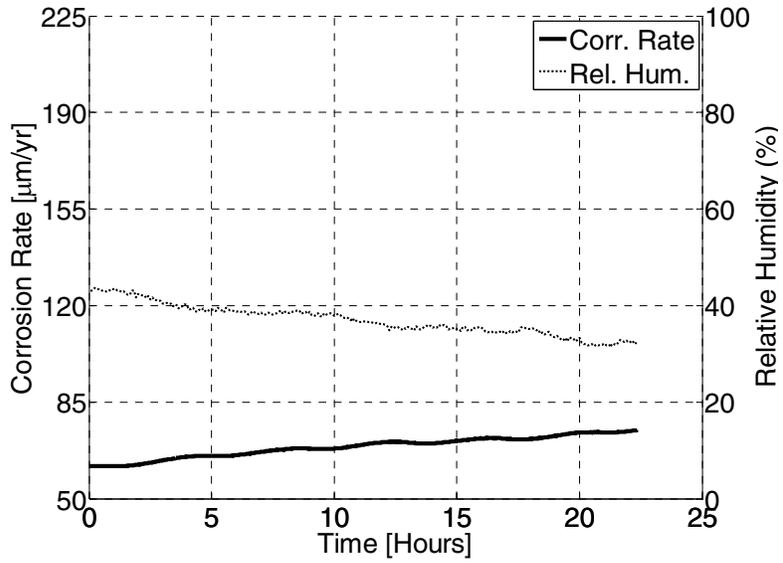
Figure 96. Graph. Test 1 LPR3 versus RH13.

A statistical analysis of the data presented in figure 96 and figure 97 revealed that in test 1, the LPR3 recordings had strong linear (positive and negative) relationships with temperature and relative humidity levels, respectively. A correlation coefficient of 0.9855 existed between the data recorded for LPR3 and T13, while a correlation coefficient of -0.9844 existed between the recordings for LPR3 and RH13.

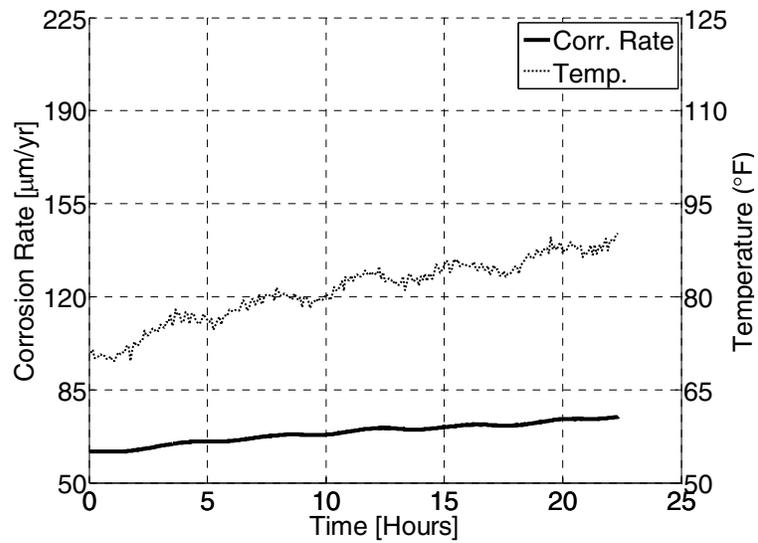
Figure 97. Graph. Test 1 LPR3 versus T13.

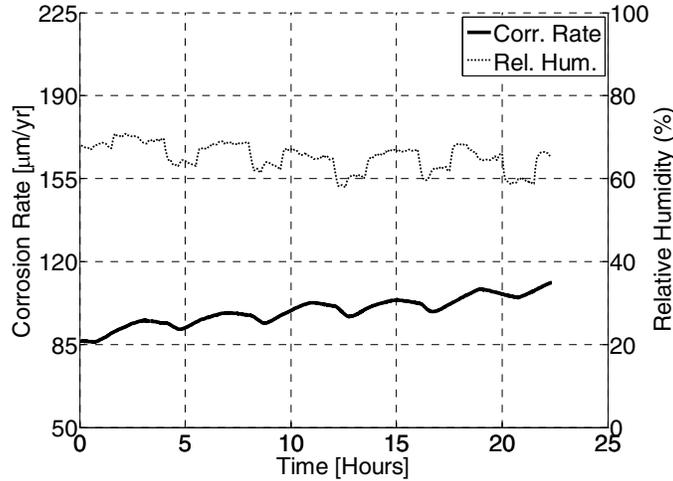
Figure 98. Graph. Test 1 LPR4 versus RH15.

Conversely, for the correlation between LPR4 and RH15, it was found that the correlation coefficient dropped to -0.3192, losing the inverse proportionality seen in LPR3 and RH13. With regard to the T15 temperatures, the correlation coefficient for the LPR4 data was 0.9841, thus confirming the strong linear relationship between corrosion rate and temperature readings. For each ± 1.5 °F (0.83 °C) increase in temperature, there was a $\pm 3.93 \times 10^{-5}$ inch/year (1 µm/year) increase in corrosion rate. Comparing the measurements from RH13 and RH15, a difference in relative humidity levels of 25 percent appears to have induced an increase in baseline corrosion

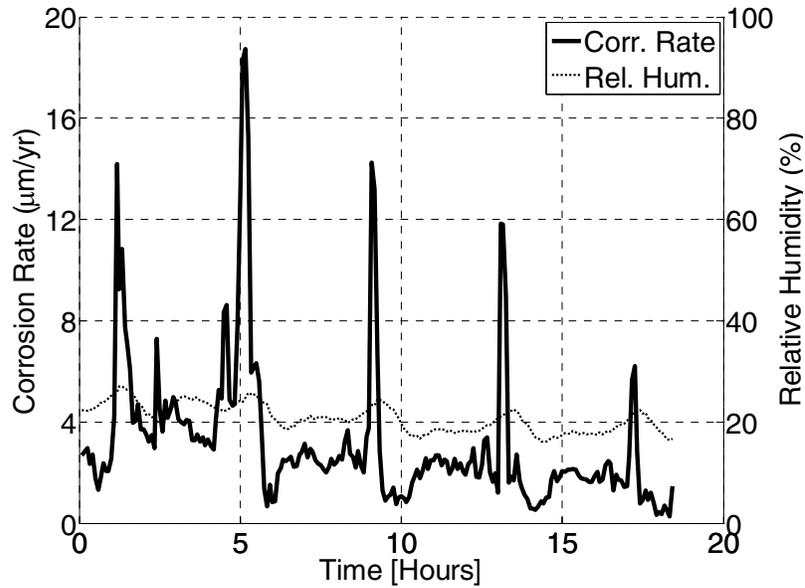
Figure 100. Graph. Test 4 CMAS CS with sensor 5 readings for relative humidity.

Corrosion rate readings from the CMAS CS sensors were analyzed in conjunction with temperature and relative humidity levels as recorded by T5. In similar fashion to the LPR analysis, the CMAS sensor analysis identified cyclic fluctuations in corrosion rate readings as well as the fluctuations of the surrounding environmental variables. The sensors being considered were located at the top of the cable cross section 0° from the vertical axis (MC2 and T5 in figure 80). Because of different characteristics, measured corrosion rates are presented for two different conditions: for relative humidity below 50 percent (test 4 in figure 100 and figure 101) and between 80 and 90 percent (test 2 in figure 102 and figure 103).

When humidity levels were consistently below 50 percent (see figure 100) and the temperature varied between 70 and 110 °F (21.11 and 43.33 °C) (see figure 101), the CMAS CS sensors recorded low yet viable corrosion rates. However, the overall level of relative humidity within the cable was sufficiently low so as to not induce much corrosion activity. Only at times when the relative humidity showed some non-negligible gradients did the CMAS CS sensor record slight activity.

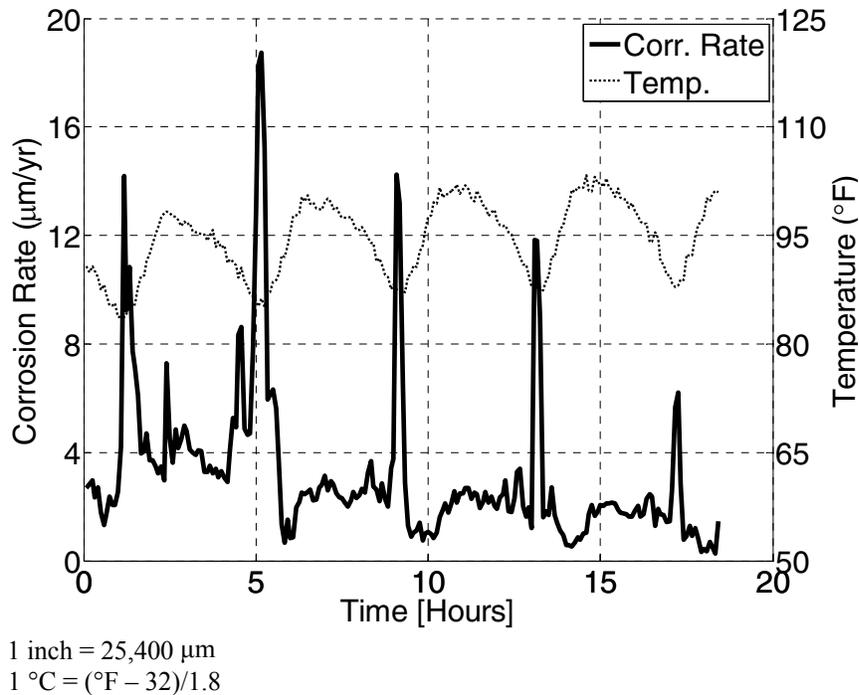
Figure 101. Graph. Test 4 CMAS CS with sensor 5 readings for temperature.

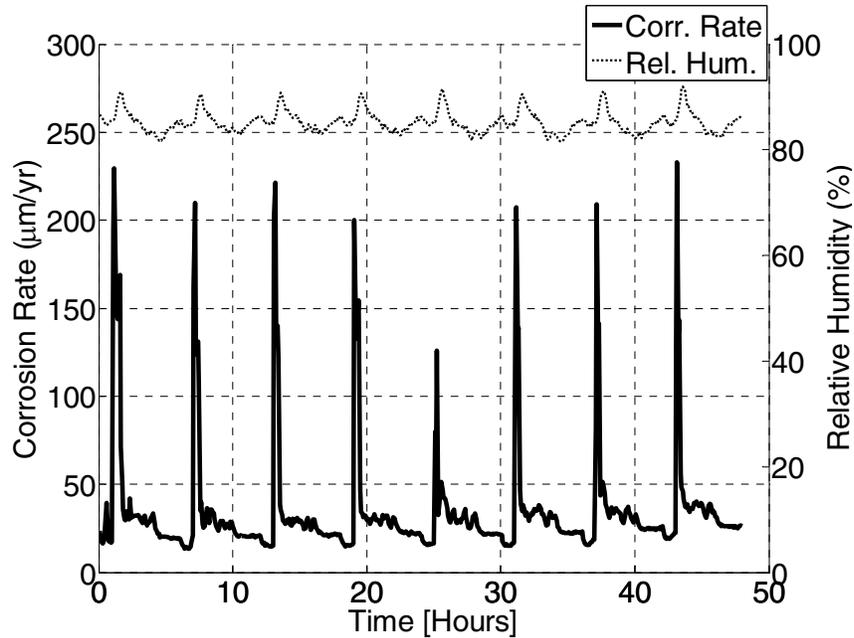
Figure 102. Graph. Test 2 CMAS CS with sensor 5 readings for relative humidity.

With relative humidity levels of 80 to 90 percent, both CS corrosion rate peaks and baseline values increased by approximately 15 to 20 times those recorded at low levels of relative humidity (< 50 percent). At high levels of relative humidity (> 80 percent), temperature effects were more pronounced and identifiable. Increases in corrosion rate minimum values from

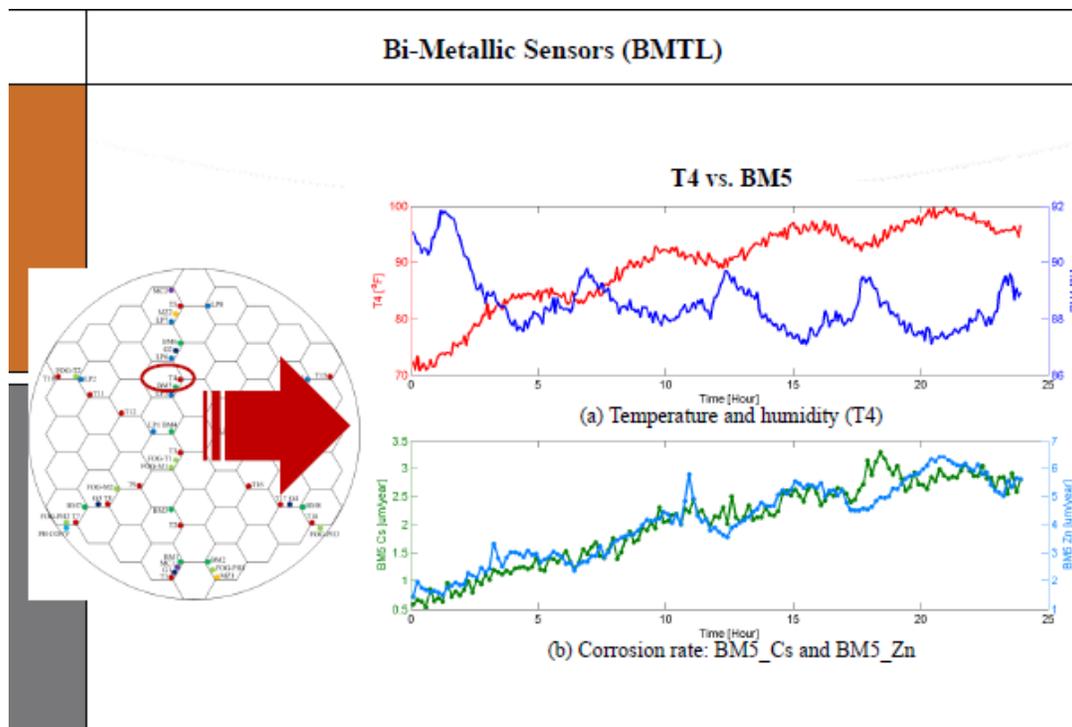
Figure 104. Illustration. Test 2 corrosion rate for CS and zinc obtained by sensor BM5 in test 2.

As an example, the BM corrosion sensors recorded some activity, but the levels of the measured corrosion rate were well below those recorded by other corrosion rate sensors. Figure 104 shows the measurements of the corrosion rate recorded by sensor BM5, which is in the proximity of the T4 and RH4. Even with high temperature levels (between 70 and 100 °F (21.11 and 37.78 °C)) and relative humidity (between 86 and 92 percent), the recorded corrosion rates for CS and zinc were low (1.97×10^{-5} to 0.00014 inch/year (0.5 to 3.5 $\mu\text{m}/\text{year}$) for steel and 3.93×10^{-5} to 0.00027 inch/year (1 to 7 $\mu\text{m}/\text{year}$) for the zinc). Also these BM sensors showed a clear dependence of the corrosion rate with the temperature; at high relative humidity levels (between 87 and 92 percent), the corrosion rate measurements for both the CS and zinc presents a strong correlation with the temperature (see figure 104).

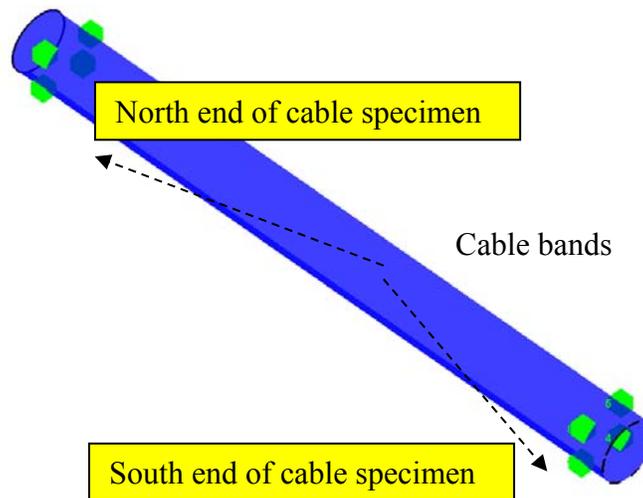
Figure 105. Illustration. Sensor locations.

In order to accomplish this objective, two different types of AE sensors were mounted on the mockup cable: eight AE sensors R0.45I (4.5 kHz) and eight AE sensors R1.5I (15 kHz) were installed on the two cable bands at the ends of the cable specimen (see table 14). Data were collected using the PAC 16-channel sensor highway II installed as part of the permanent equipment designed for monitoring and control of the environmental chamber of the cable mockup. The sensor locations on the cable bands of the mockup are shown in figure 105.

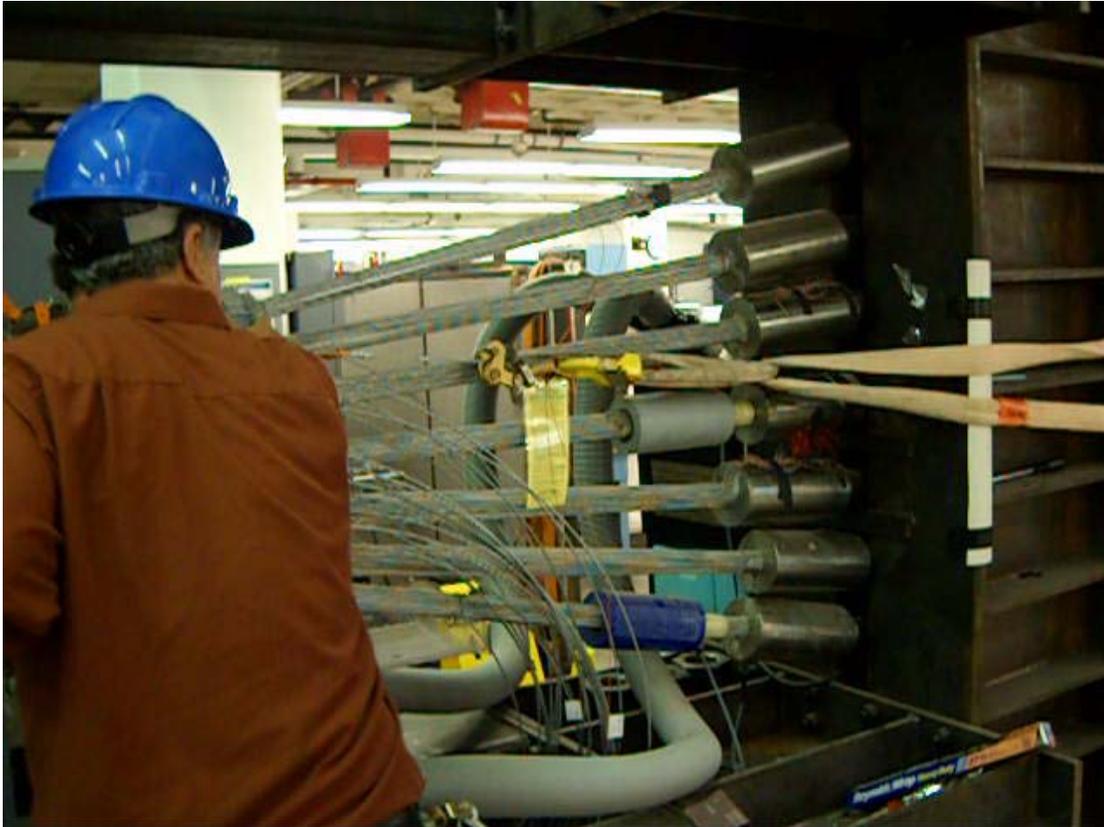
Figure 106. Photo. Mechanism to apply load to the prenotched wires.

The objective of the test was to attempt to break three prenotched wires. The difficulties in pulling wires until they failed were created by the presence of the massive steel frame supporting the cable specimen (see figure 106), and this limited the number of pulled wires to three. Figure 106 shows the setup used to load the prenotched wires. In the first two wires, the prenotched wires broke at the junction with the grip used to applied load, so the results were not considered.

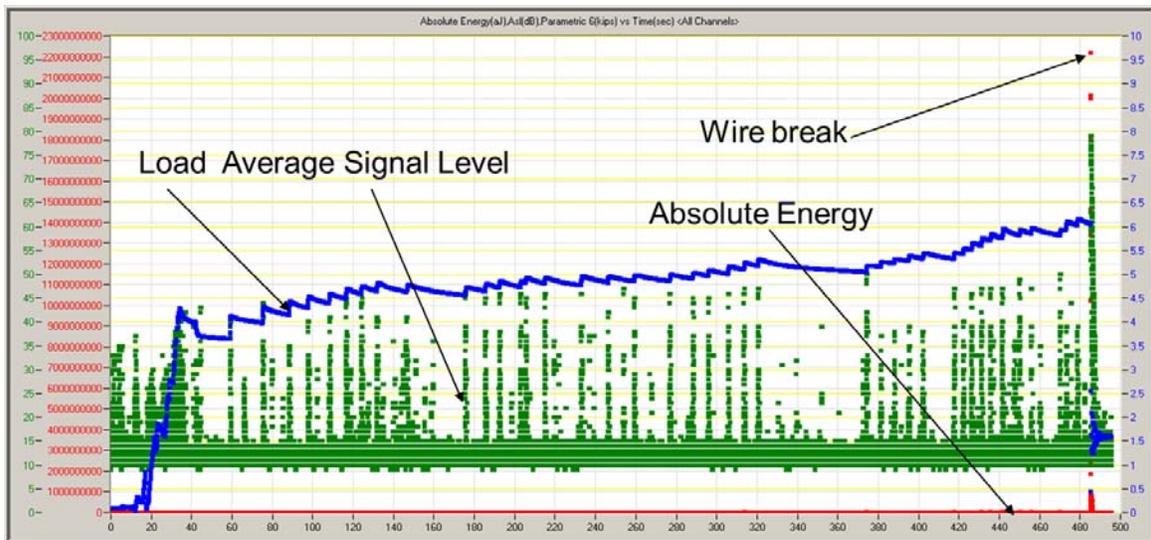
Figure 107. Graph. ASL (green), absolute energy (red), and load (blue) versus time during the third wire break attempt.

The green line represents the average signal level (a measurement of the AE signals over time that reach a channel) and is measured in dB units. The red line indicates the absolute energy, representing the area under the curve of the rectified waveform, and is measured in aJ, while the blue line indicates the load applied to the wire in kips. Figure 107 indicates that bursts of AE produced by friction were detected every time the load was increased.

In the third attempt, the wire broke as expected. Figure 107 shows plots of acoustic ASL, absolute energy ($\text{Joules} \times 10^{-18}$), and load (kips) versus time during the third wire break attempt. In the figure, ASL is depicted in green, absolute energy is depicted in red, and load is depicted in blue.

However, the absolute energy of these AE bursts was insignificant compared to the absolute energy generated by the wire break. This means that a wire break could be clearly set apart from regular AE caused by movement or load changes in the cable.

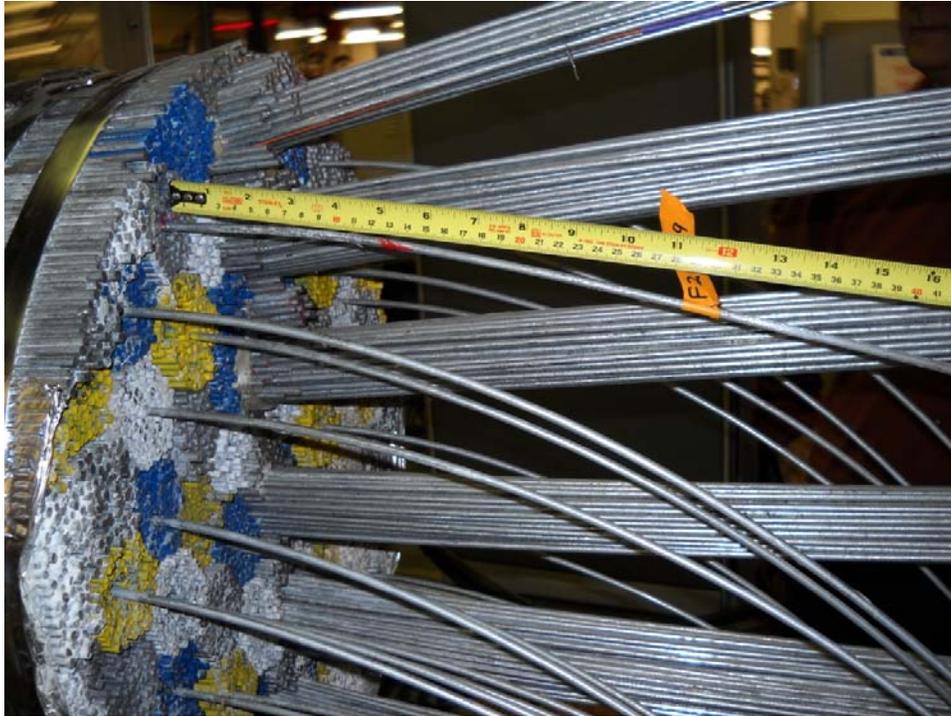
Figure 108. Photo. Broken wire pulled out from the edge of the cable before breaking.

After the wire was broken, the wire was pulled out about 5 inches (127 mm) from the edge of the cable before it broke, as can be seen in figure 108.

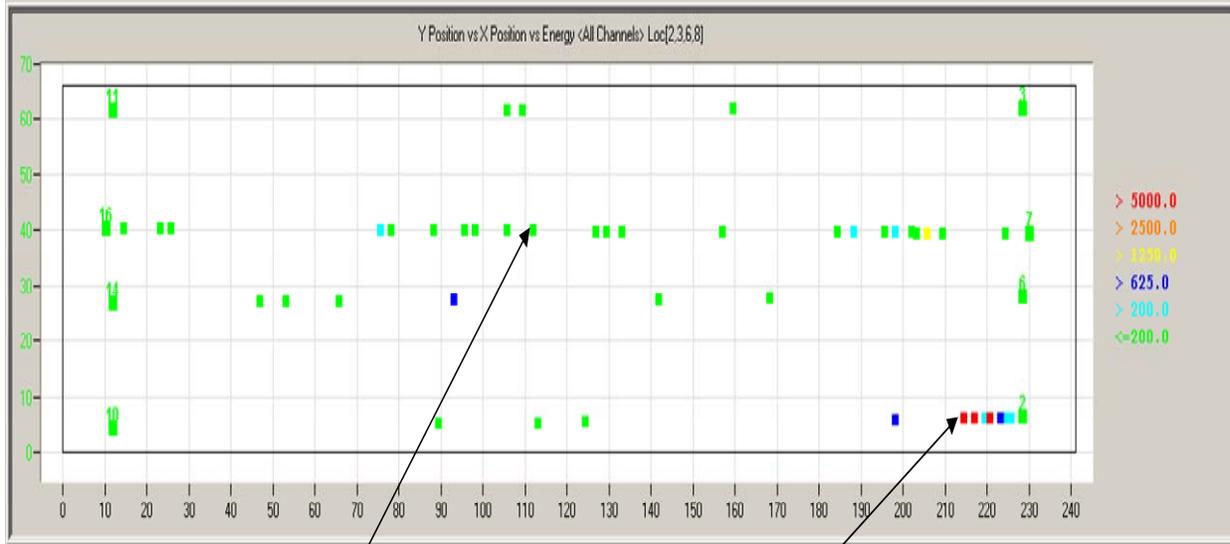
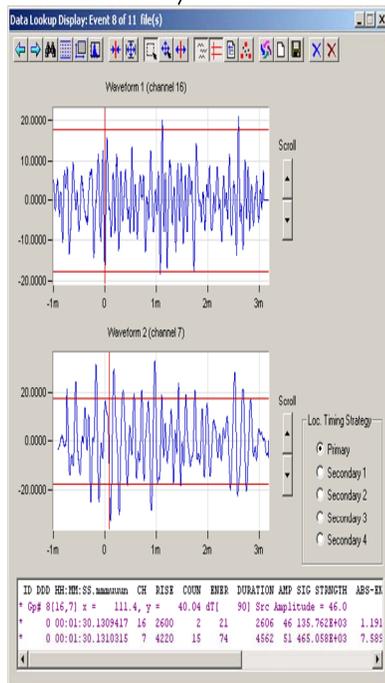
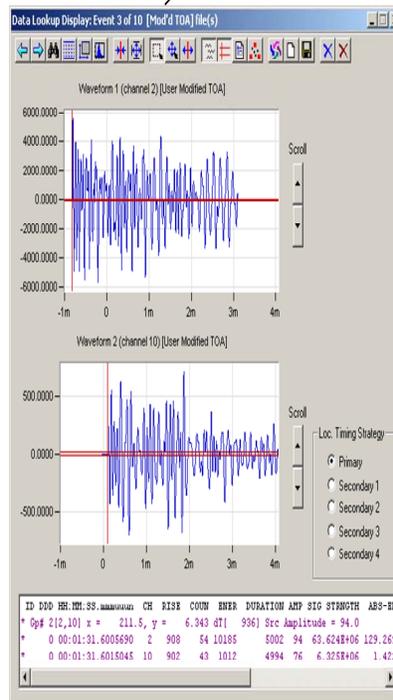
Figure 109. Illustration. Low- and high-energy events during the wire break from R0.45I sensors.

During the wire break, the R0.45I array sensors located many low energy events during the loading process, in addition to the actual high energy wire break, as shown in figure 109. In this figure, the cylindrical surface of the mockup cable is shown open, with the horizontal axis (in inches) representing the length of the mockup, and the vertical axis representing the perimetral distance. In addition, the locations, with related channel number corresponding to the sensors, are presented on their actual locations on the cable bands.

The low-energy events generated by friction and movement of the cable, shown in green, are located all along and around the cable, while the high-energy data, generated by the wire failure, are shown in blue, yellow, and red. A quick review of the waveforms corresponding to the low- and high-energy events show a clear difference when comparing the amplitude of the signals with the threshold values represented by the red horizontal lines. The wire break signals show a large amplitude and sharp rise time, while the noise signals are barely above the threshold. The difference in energy between these two types of signals is of two orders of magnitude or about 40 dB.
