Corrosion Monitoring Research for City of New York Bridges

PUBLICATION NO. FHWA-HRT-14-023

MAY 2014

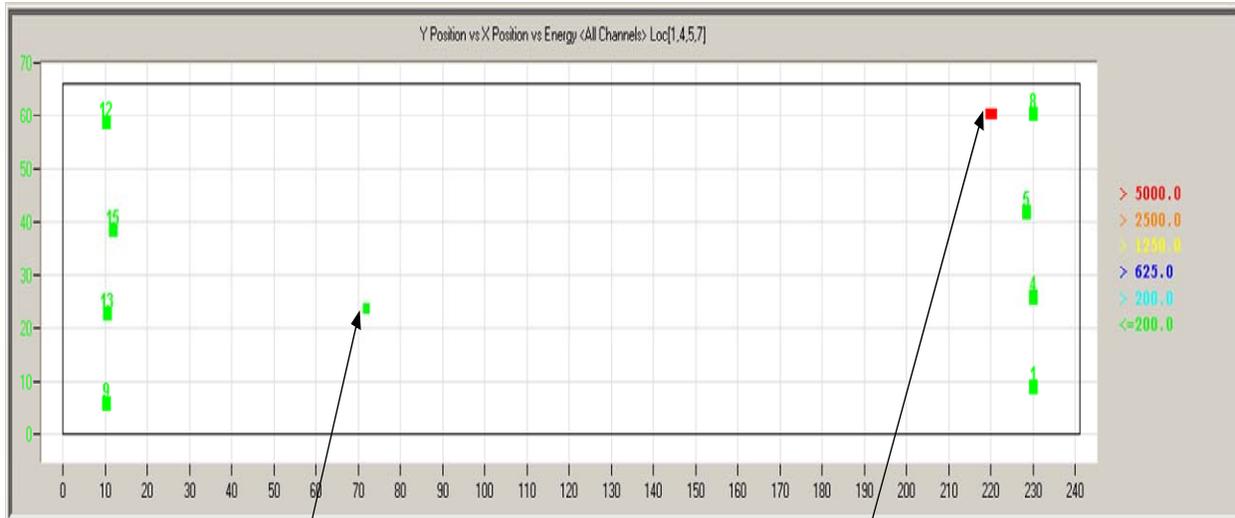
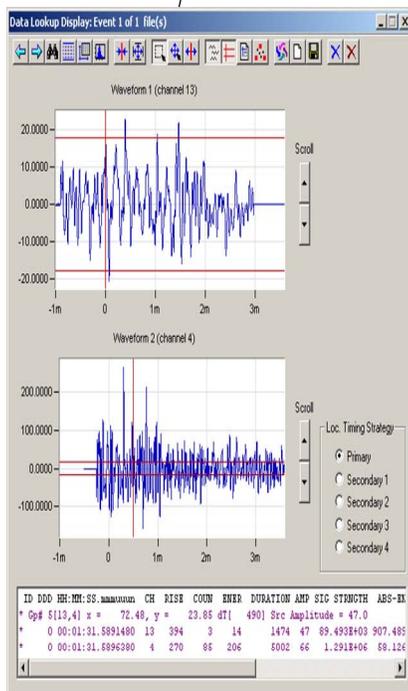
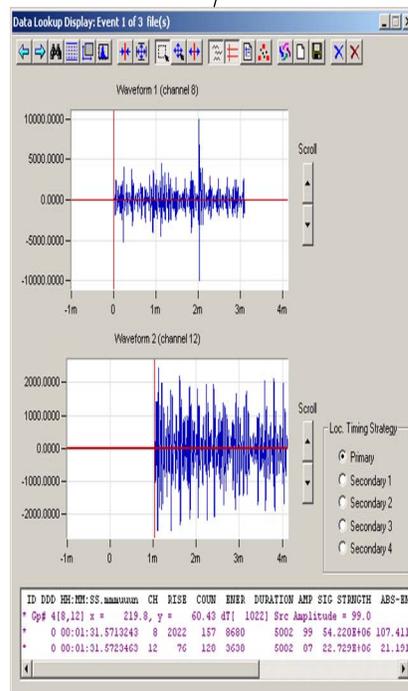
Figure 110. Illustration. Low- and high-energy events during the wire break from R1.5I sensors.

By comparison, the results obtaining with the R1.5I sensors shown in figure 110 present only one event with low energy and two events related to the wire break. This indicates that the R1.5I sensor is less susceptible to detect the noise signals, traditionally containing lower frequency. It is important to mention that the two set of sensors correctly located the position of the wire break.

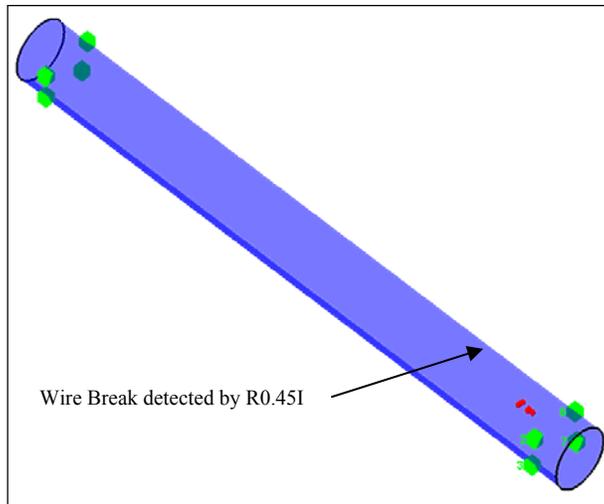
Figure 111. Illustration. Location of the wire break with the R0.45I sensor on the surface of the cable mockup.

The array of R0.45I sensors detected and located the wire break longitudinal position with good accuracy—217.9 inches (5,534.66 mm) from the edge of the cable versus 223 inches (5,664.2 mm) of the actual wire break. The circumferential position calculated was 18 inches (457.2 mm) away from the actual position at 61 inches (1,549.4 mm) along the circumference of the cable. The R1.5I sensors detected and located the wire break longitudinal position with excellent accuracy—222.9 inches (5,661.66 mm) from the edge of the cable versus 223 inches (5,664.2 mm) of the actual wire break. The circumferential position calculated was 57.9 inches (1,470.66 mm) versus 61 inches (1,549.4 mm) for the actual position. The position of the wire break on the cylindrical surface of the cable is shown in figure 111 and figure 112.

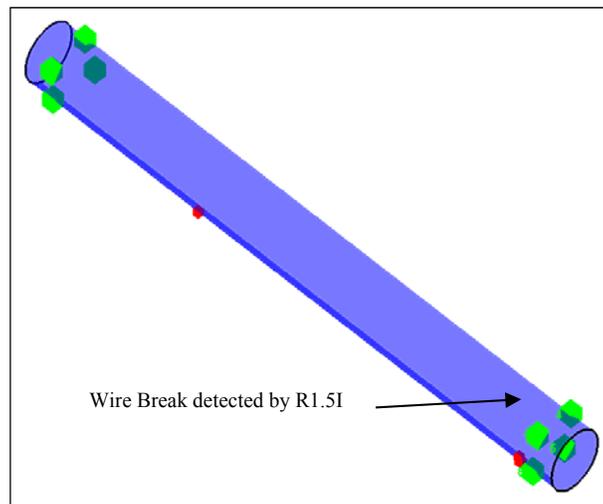
Figure 112. Illustration. Location of the wire break with the R1.5I sensor on the surface of the cable mockup.

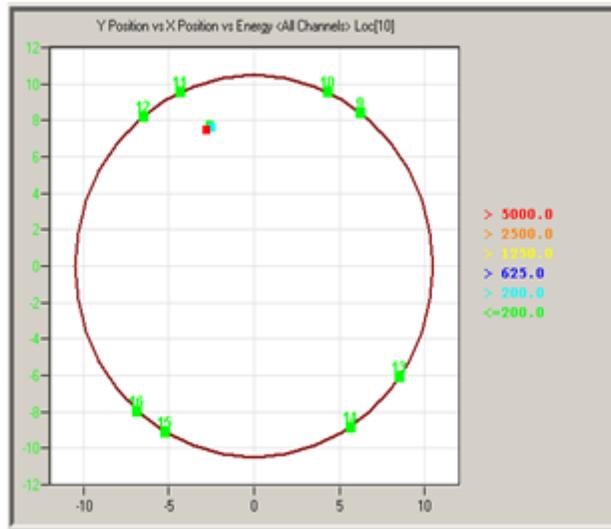
Fixed End Cable Band

Figure 113. Graph. Planar localization of the wire break using the R0.45I sensor.

Looking at the localization of the wire break in the cable cross section, both sets of AE sensors, R0.45I and 4 R1.5I, provided accurate estimation of the wire break position. The calculated position of the wire break was approximately 2.5 inches (63.5 mm) from the surface of the cable (figure 113 and figure 114), which was very close to the position of the broken prenotched wire. In the figures, the x- and y-axes represent the Cartesian coordinates that indicate the wire locations. The circle represents the cable cross section with the corresponding sensor locations. The recorded AEE vents are indicated by colored dots.

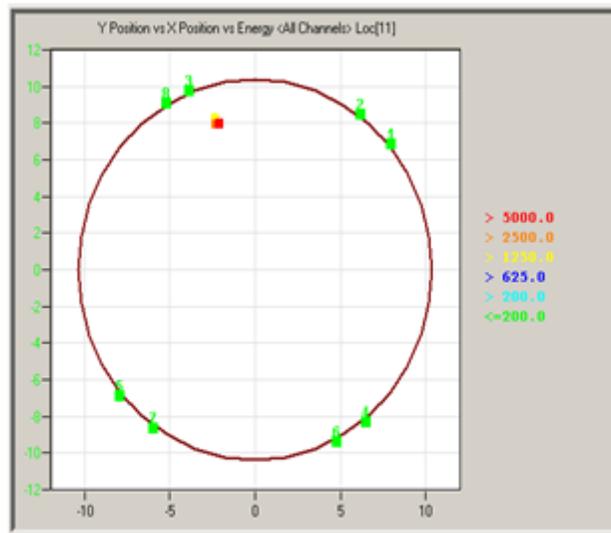
Loaded End Cable Band

Figure 114. Graph. Planar localization of the wire break using the R1.5I sensor.

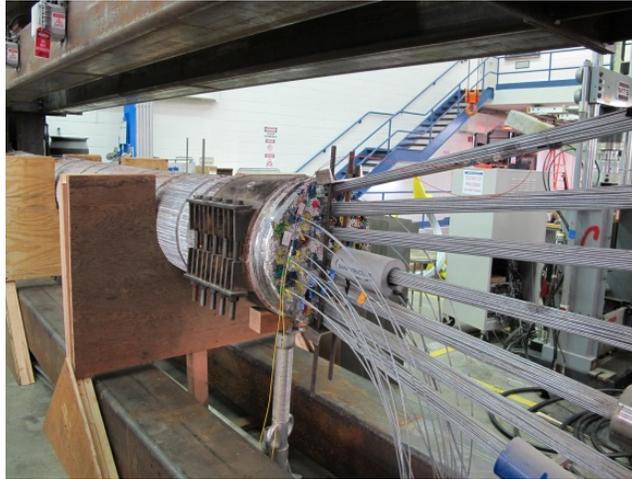
Figure 115. Photo. Disassembled environmental chamber with cable mockup specimen.

In an effort to directly determine the effects of cyclic corrosion testing, the cable mockup specimen was deconstructed. Following the completion of cyclic testing, both the aluminum wrapping and centrally located neoprene strap were removed from the cable, the environmental chamber was disassembled, and form work was placed around the cable (see figure 115).

Prior to dissection, the ends of the individual strands were color coded. Both the color-coded left side and the numbering system cable mockup's cross section are shown in figure 115 and figure 116. The wire strands on the surface of the cable (not marked in figure 116) were shaped so as to fill in any voids thereby ensuring a compact circular cross section.

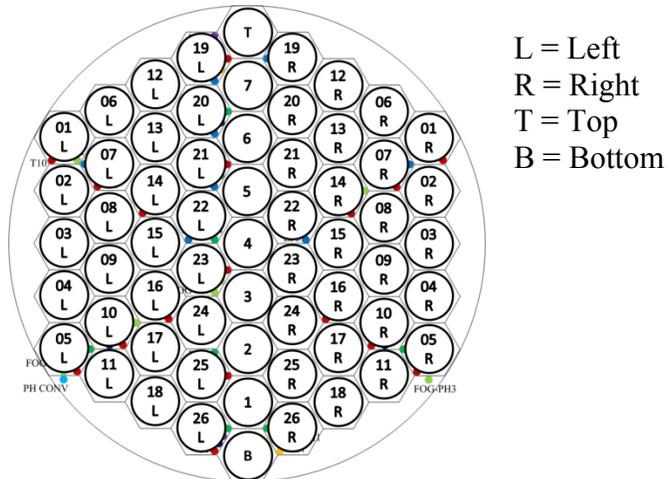
In figure 116, the 20-ft (6.1-m) straightened strands were labeled with a number and a letter indicating the placement and side of the mockup cable when viewed from the jacking end (e.g., 09L). The 35-ft (10.68-m)-long tensioned strands were labeled from bottom to top with numbers 1 through 7. The top and bottom centrally located strands were 20 ft (6.1 m) long and were labeled "T" and "B," respectively.

Figure 116. Illustration. Strand labeling.

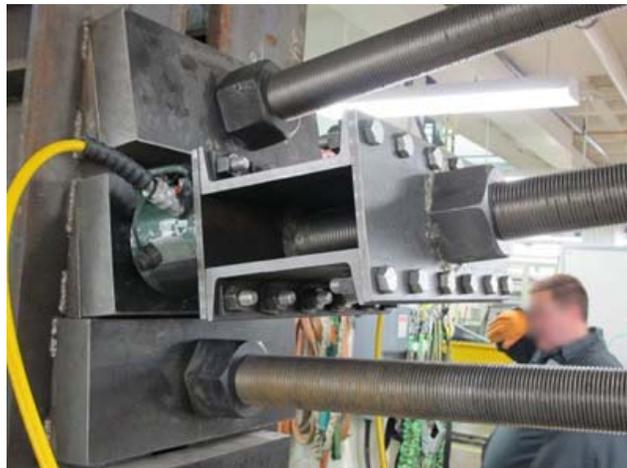
Once all strands were identified and labeled, the stresses in the tensioned strands were determined and released. In order to de-tension a strand, a jacking beam and two hydraulic jacks that were 6.5 inches (165.1 mm) long and 100,000 lb (45,400 kg) were used (see figure 117). The stress required to completely separate the nut from the framework was recorded by considering the tensile force in the strands using the hydraulic jack's conversion factor of 39 lb/psi (0.689 N/cm²).

Figure 117. Photo. Jacking beam with hydraulic jacks secured into position.

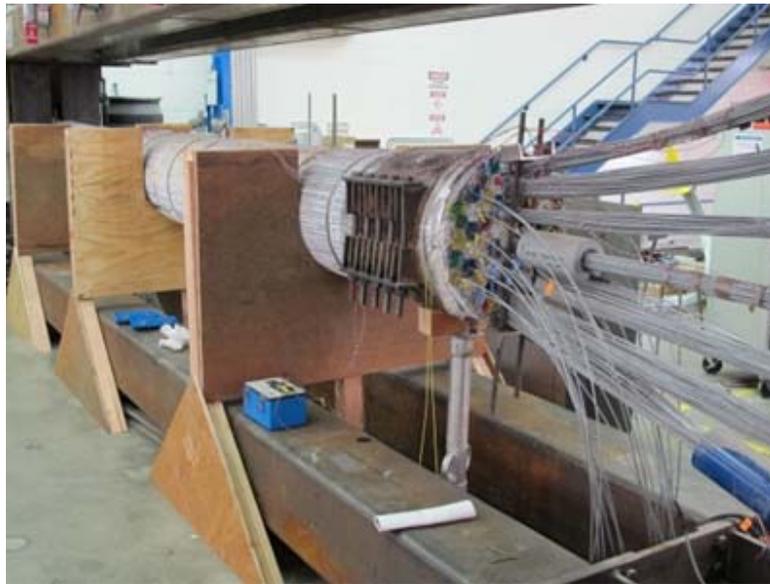
During the de-tensioning process, strain levels in two wires of strands 4 and 7, and visual observations of the cable reactions were recorded. Figure 118 shows an image of the setup of the strain gauges attached to the cable on strands 4 and 7.

Figure 118. Photo. Strain gauge setup on strands 4 and 7.

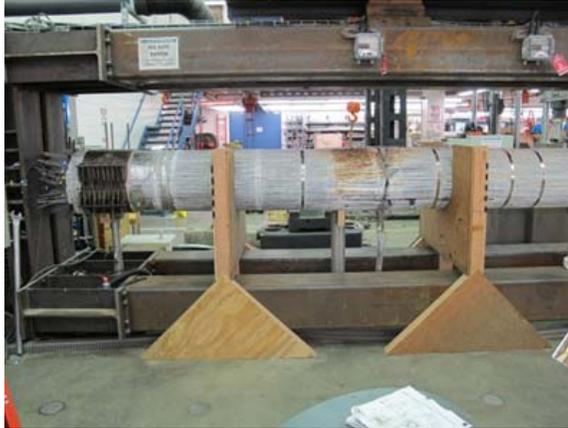
As stated earlier, the neoprene wrapping used to cover the area at which the wires connected to the sensors exit the cable's cross section was removed prior to the unloading process. Following the unloading, the stainless steel straps (see figure 119) were removed from the cable. The straps were removed from the outside to the inside. The first stainless steel strap was removed at the south end of the cable near the threaded rods. The clamps were unhooked using a screwdriver and then loosened with a hammer until the strap released. This process (see figure 120) was subsequently performed on the north side of the cable and then repeated until all the straps were removed.

Figure 119. Photo. North end of cable mockup with stainless steel straps.

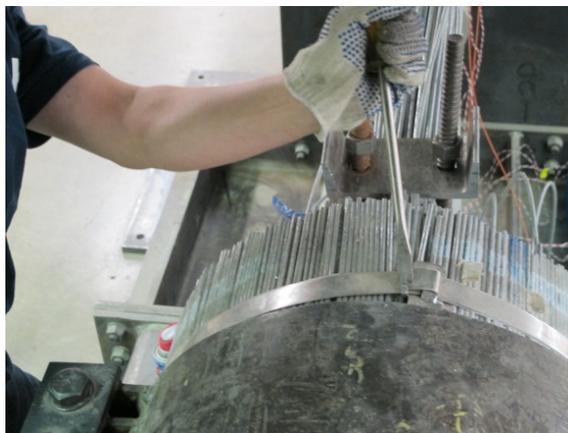
Figure 120. Photo. Removal of south-side strap.

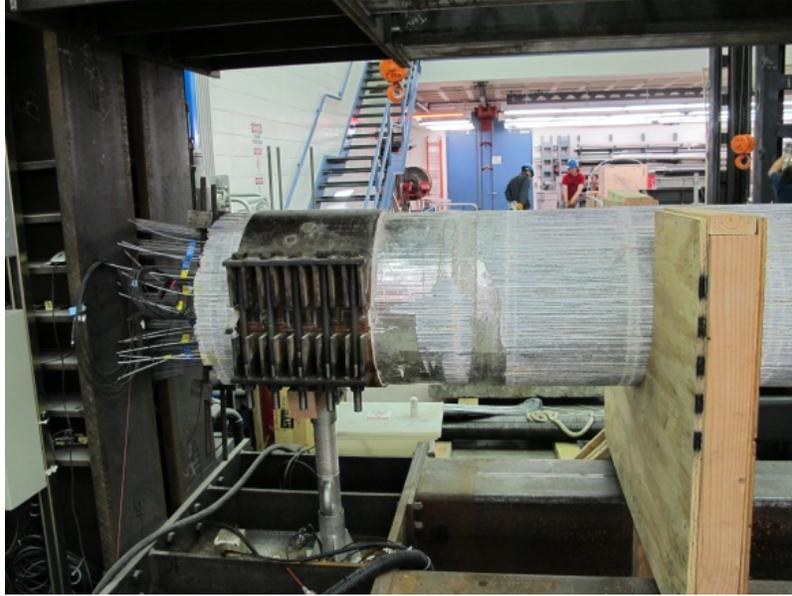
Areas of high ferrous corrosion occurring underneath the stainless steel straps were easily identifiable in the south central location shown in figure 123, whereas the north side of the cable experienced little to no ferrous corrosion under the stainless steel straps (see figure 121). This observation can be related to the fact that the cable specimen was slightly inclined toward the south end. The water that penetrated into the inside of the wrapping was able to move toward the south end, favoring the accumulation of water, and consequently the beginning of corrosion, at this end.

Figure 121. Photo. Stainless steel straps removed from north side of cable mockup specimen.

Once the wrapping was removed, a general inspection of the cable was performed. It appeared that the cable was heavily covered by a white powder, which was a mix of salt residue and zinc oxide. In a couple of spots along the length of the cable, small pockets of water were found on the side portion of the cable cross section. Heavy corrosion appeared at the location where the sensors' wires exited the cable. Apparently, the neoprene strap that served as a protection for the electric wires functioned as a moisture trap and kept the wires in a wet environment for a long time. In addition, areas of high ferrous corrosion occurring underneath the stainless steel straps were easily identifiable in the south part of the cable, as shown figure 123, whereas the north side of the cable seemed to have experienced little to no ferrous corrosion (see figure 121).

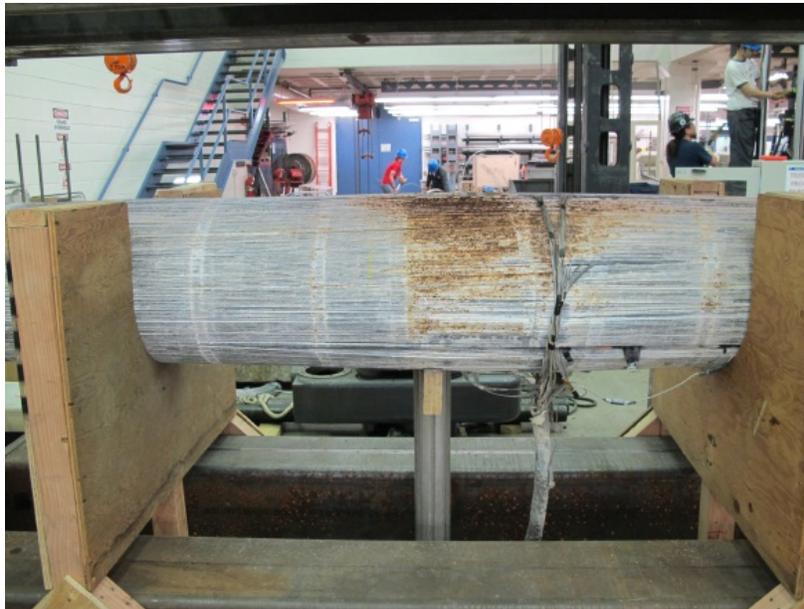
Figure 122. Photo. Stainless steel straps removed from north central side of cable mockup specimen.

Galvanic as well as crevice and pitting corrosion in areas of moisture build-up occurred in this cable. The build-up of salt and/or zinc oxide as well as ferrous oxide below the stainless straps was easily identifiable, as shown in figure 122 and figure 123. These straps were made of unknown chemical composition, so they may have facilitated the onset of corrosion at their location. In addition, the small gaps between the strap and the outer wires ended up trapping rain water and moisture for a long time, initiating crevice and pitting corrosion. The corrosion of the wires under the stainless steel straps tended to increase toward the south side of the cable. As previously mentioned, the cable was constructed on a slight angle for drainage purposes, thus the increase of ferrous oxide was directly a result of the increased moisture content at the south side of the cable. Mild salt build-up, zinc oxide, and ferrous oxide may be seen under the stainless steel straps, as shown in figure 134.

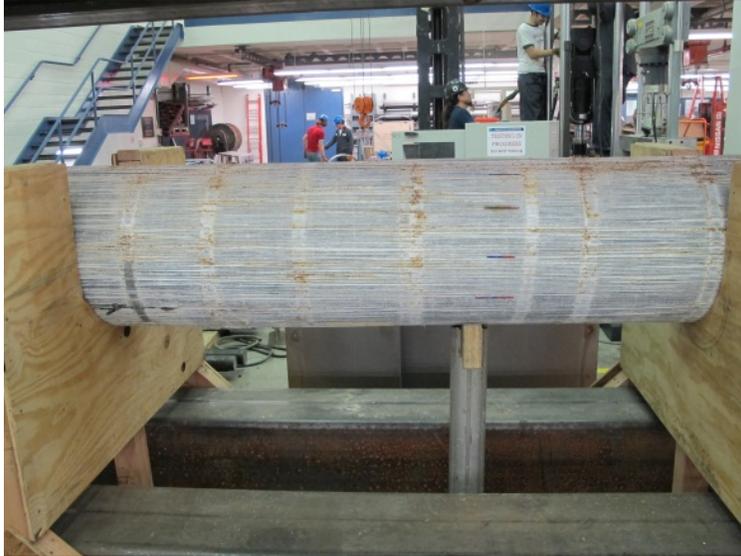
Figure 123. Photo. Stainless steel straps removed from south central side of cable mockup specimen.

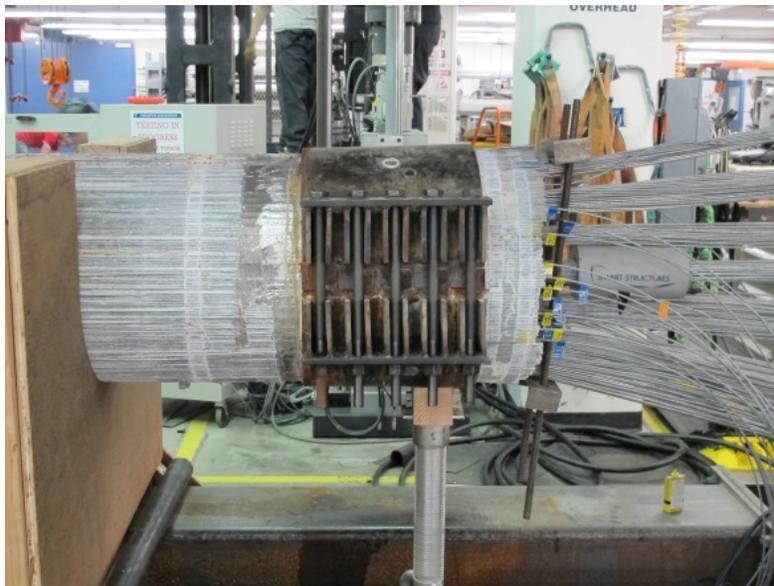
Figure 124. Photo. Stainless steel straps removed from south side of cable mockup specimen.

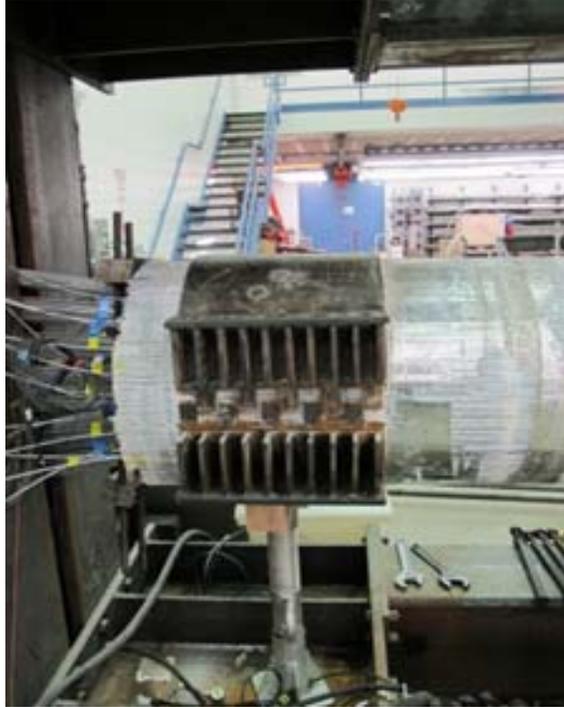
Next, both the south and north side cable bands were removed. The bolts and exterior of the cable bands experienced large amounts of corrosion. Wires underneath the cable band remained intact and experienced various amounts of corrosion (addressed in the subsequent section). A before and after image of the area under the north side cable band is shown in figure 125 and figure 126.

Figure 125. Photo. North side prior to cable band removal.

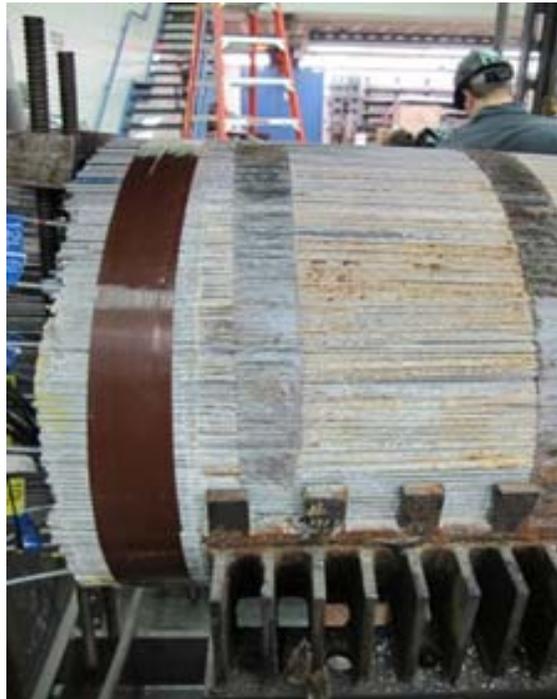
Figure 126. Photo. North side cable end following cable band removal.

Upon removal of the neoprene strap, it was found that large amounts of what appeared to be uniform corrosion occurred under the neoprene wrapping. Furthermore, the strap was still moist when removed from the cable surface. The area where the neoprene strap was is shown in figure 126. Figure 130 and figure 131 show progressively closer views of the corroded area. It is interesting to note that the highest density of corrosion appears to have occurred on the top side of the cable directly in line with the water and heat sources.

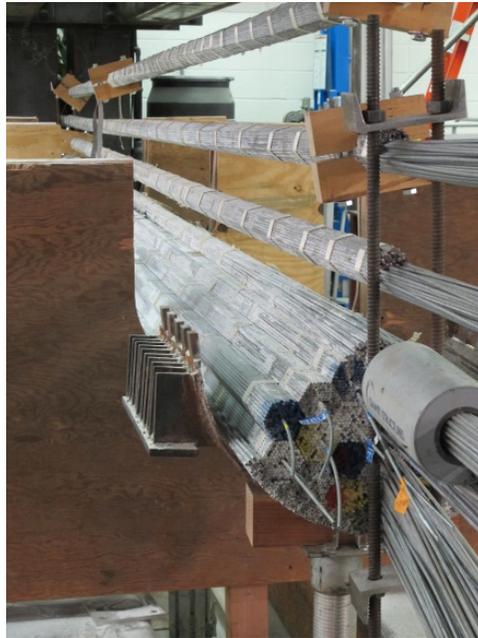
Removal of the strands started with the removal of the top strands and proceeded toward the bottom of the cable mockup. Because of the difficulties in mounting the long central strands, it was decided to keep the long strands in the loading frame with no tension in them. Upon removal, each strand was first labeled and photographed. Then, a careful visual inspection was carried out for each strand, and pertinent details were reported. Figure 127 and figure 128 show some stage of the cable disassembly. Figure 129 shows the long strands in the loading frame.

Figure 127. Photo. Cable specimen during disassembly.

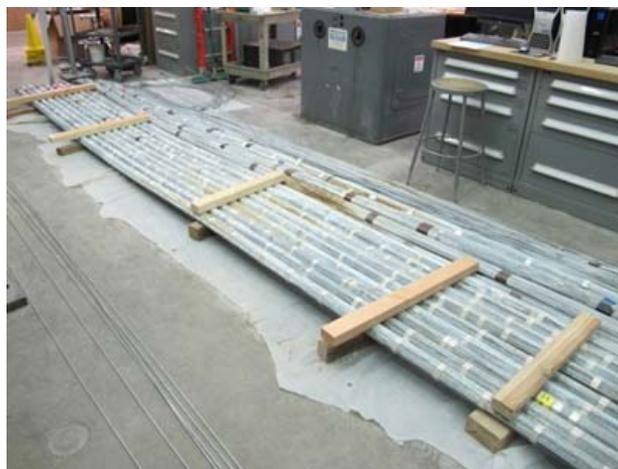
Figure 128. Photo. Removed strands.

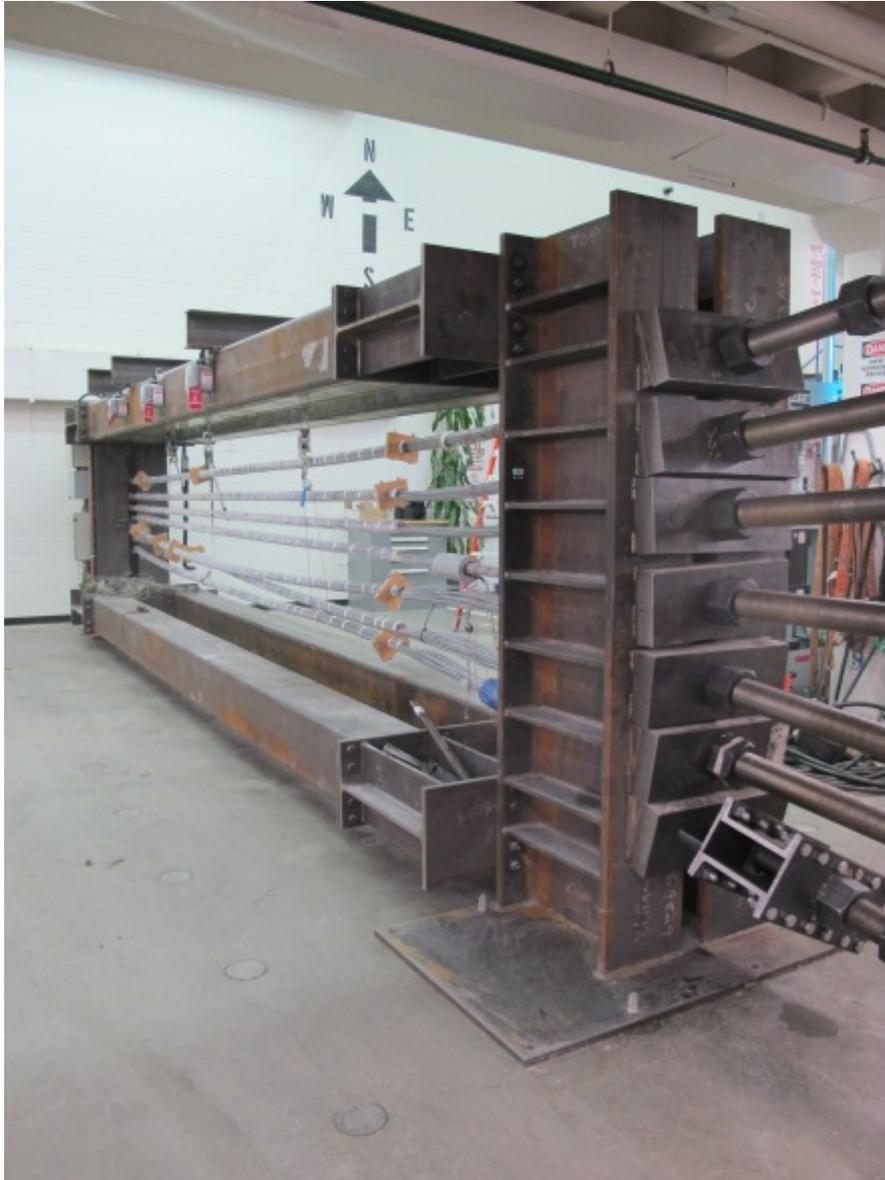
Figure 129. Photo. Completed cable deconstruction.

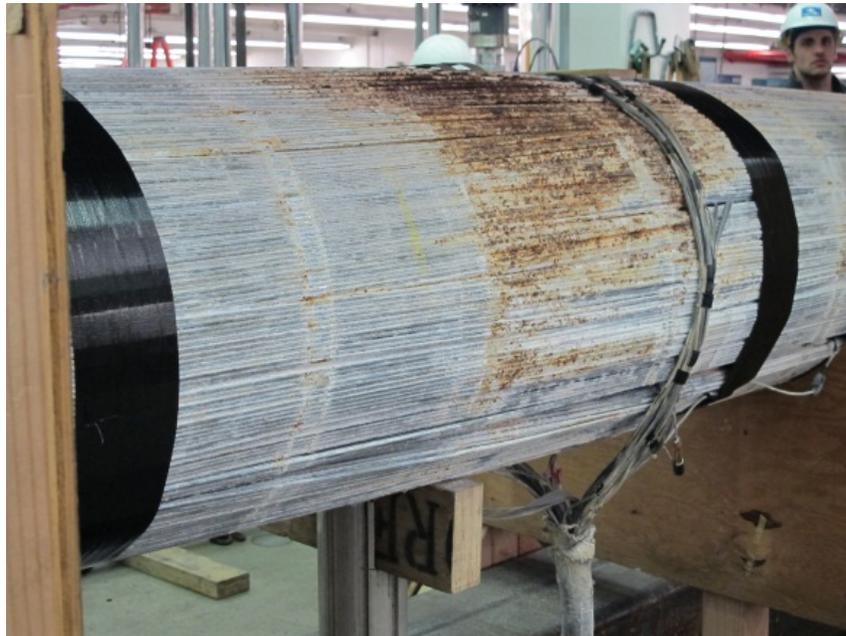
Figure 130. Photo. Corroded area under neoprene wrapping.

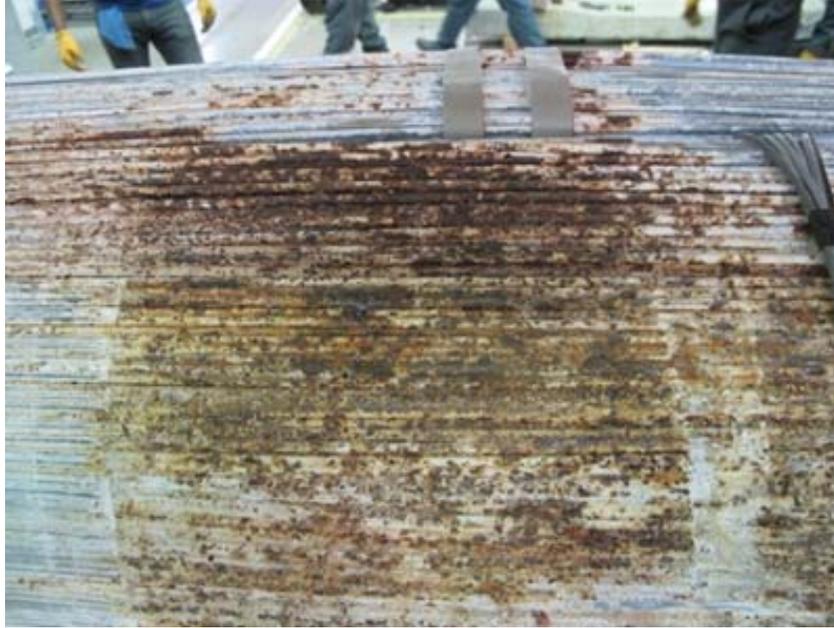
Figure 131. Photo. Close-up view of corroded area under neoprene wrapping.

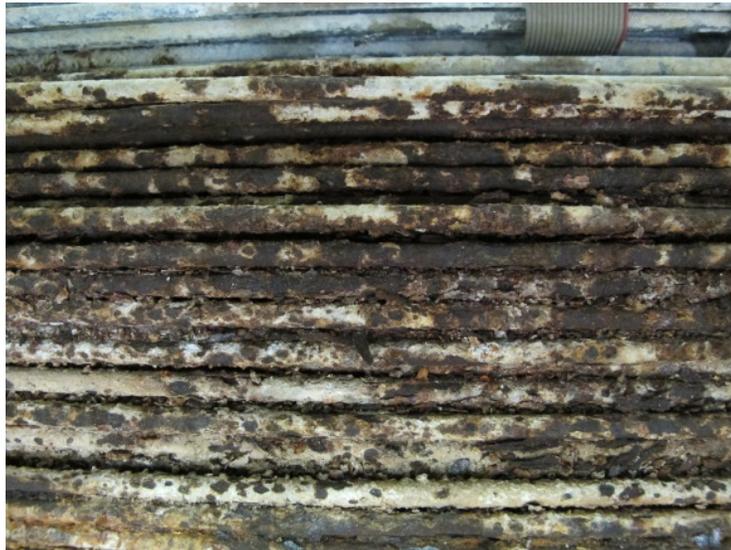
A close-up investigation of the top of the cable revealed stage 4 uniform corrosion for the wires on the outer layers in which close to 90 percent of the high-strength steel wires had undergone ferrous corrosion (see figure 132 and figure 133). This area was the one most exposed to higher temperatures (directly below the central heating lamp) and rain. The presence of the neoprene strap helped maintain high levels of humidity that, with high temperature levels, created ideal conditions for the progress of corrosion.

Figure 132. Photo. Wires with stage 4 corrosion on the top of the cable surface.

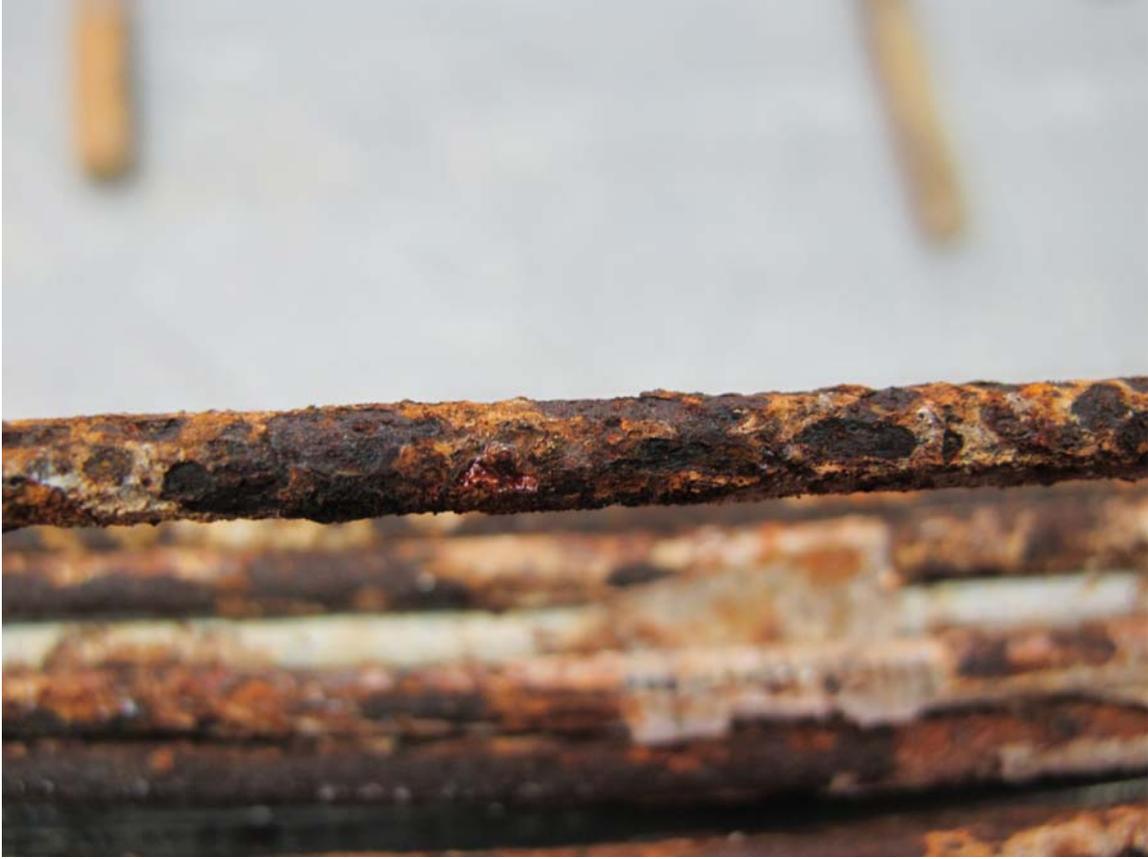
Figure 133. Photo. Close-up view of corroded wire.

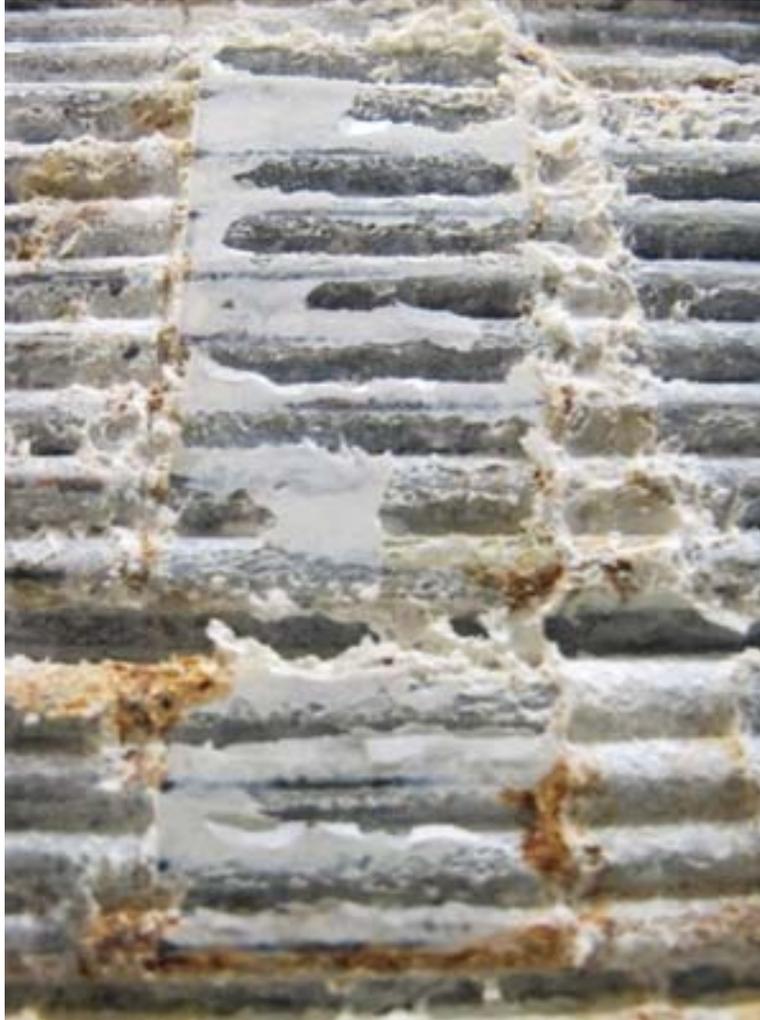
Figure 134. Photo. Salt build-up and zinc/ferrous corrosion product.

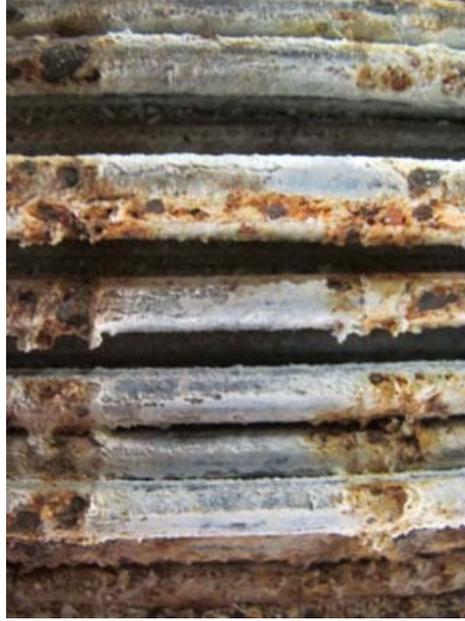
At points closer to the south side of the cable, more critical forms of corrosion formed. The presence of high moisture, the potential difference between the stainless steel of the strap and the zinc-coated high-strength steel wires, and the presence of crevices created by the voids between the straps and the wires initiated heavy pitting corrosion (see figure 135 and figure 136). From this result, it is noteworthy that the use of stainless steel straps, which are commonly used in practice, should be carefully considered in environments with aggressive conditions.

Figure 135. Photo. Pitting corrosion under stainless steel strap.

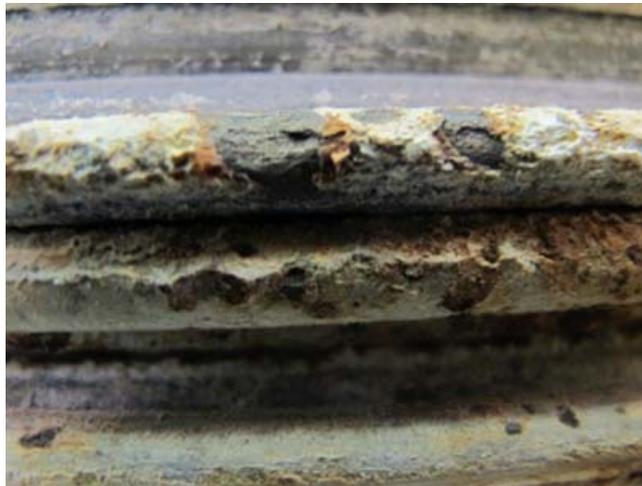
Figure 136. Photo. Close-up view of pit.

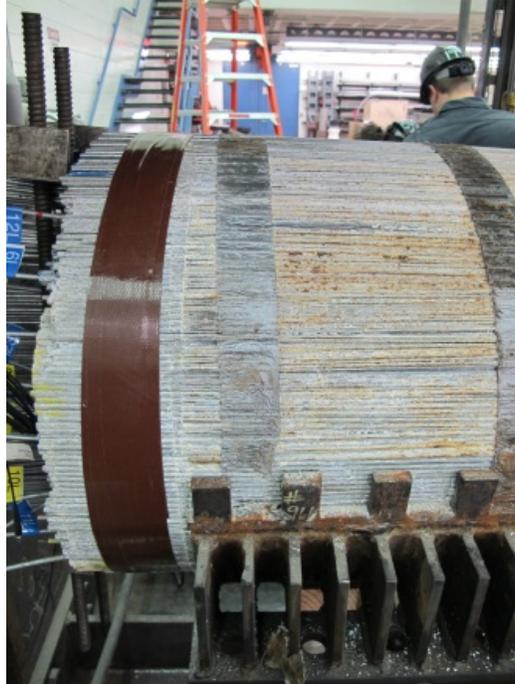
The cable bands on either end of the cable mockup specimen presented another place for moisture entrapment. Similar to the stainless steel straps, the corrosion of the high-strength steel wires was greater at the south side of the cable. Looking eastward at the north side of the cable, it is possible to identify what may be assumed to be stage 2 corrosion (near complete zinc oxidation) and definite signs of stage 3 corrosion (ferrous corrosion is identifiable at approximately 20 to 30 percent coverage) (see figure 137 and figure 138).

Figure 137. Photo. North end of cable with band removed.

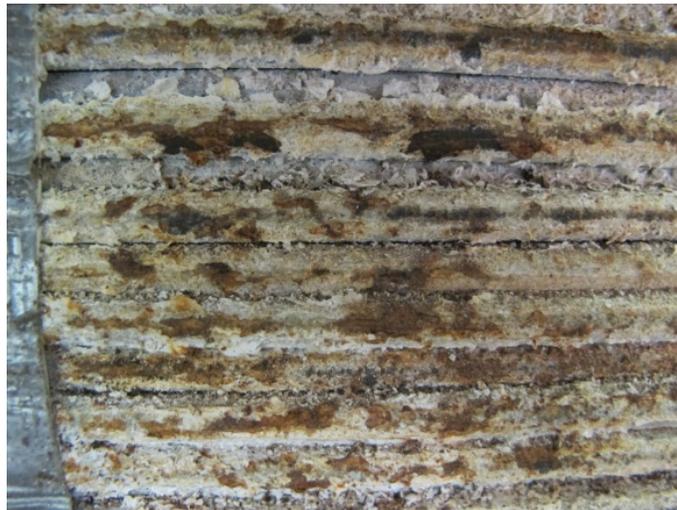
Figure 138. Photo. Wires at north end of cable with stage 3 corrosion.

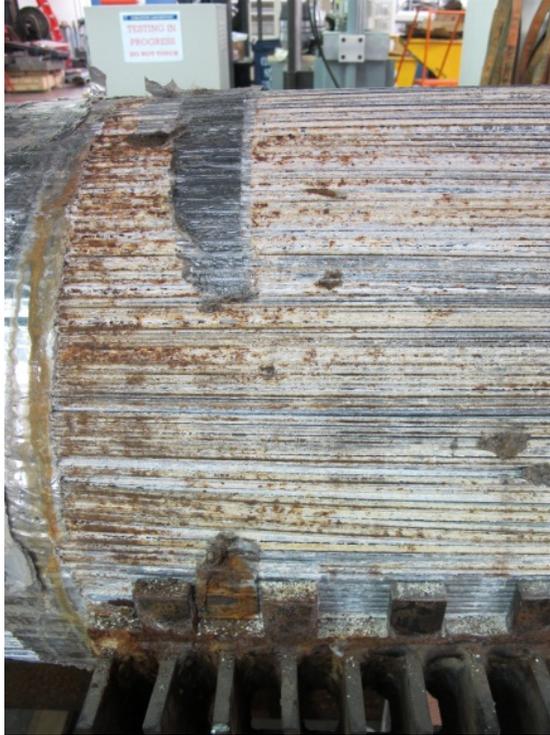
The corrosion under the cable band at the south end of the cable was more severe than that at the north end, as both the percentage of area covered by stage 3 corrosion (see figure 139), and the degree/depth of corrosion was greater at the south end (see figure 140).

Figure 139. Photo. South end of cable with band removed.

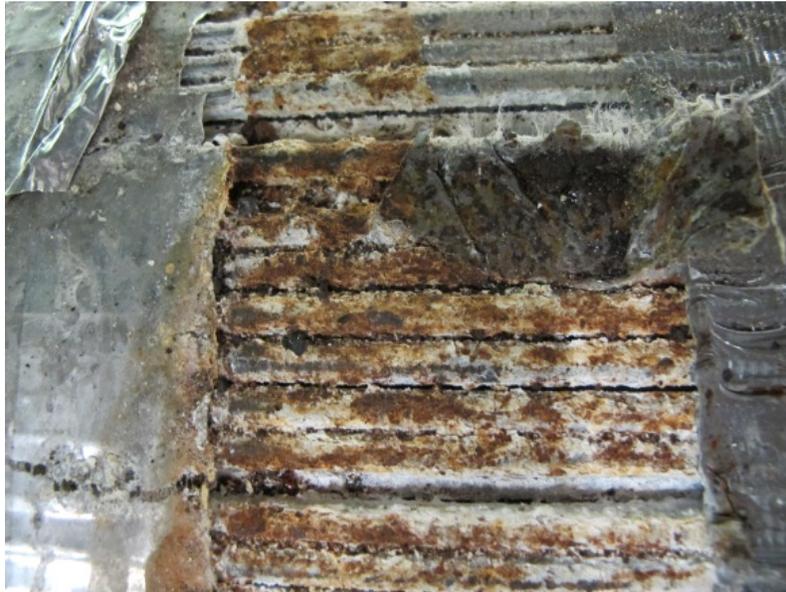
Figure 140. Photo. Wires at south end of cable with large percentage of stage 3 corrosion.

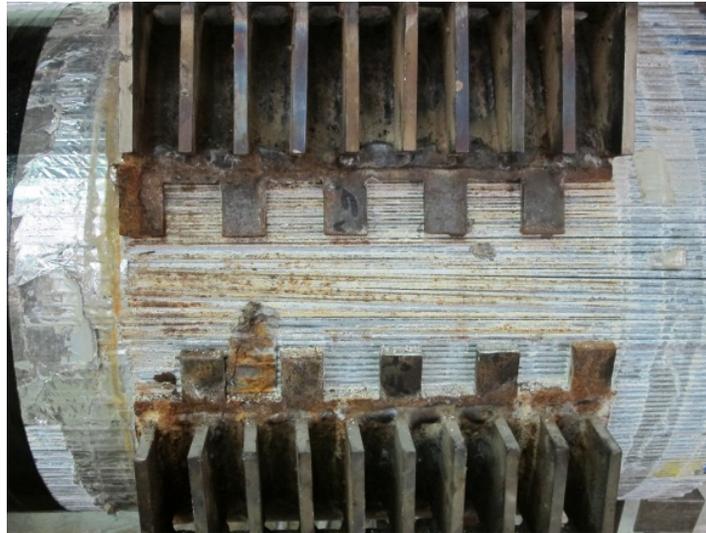
The cable bands themselves also experienced significant amounts of corrosion. A high concentration of ferrous corrosion product was found on the cable band at the location where the cable band began on the south side of the cable. On the surface, the greatest amount of corrosion was seen on the teeth where the top and bottom cable bands met, which is an area directly in contact with air (see figure 141).

Figure 141. Photo. South end of cable highlighting teeth of cable band.

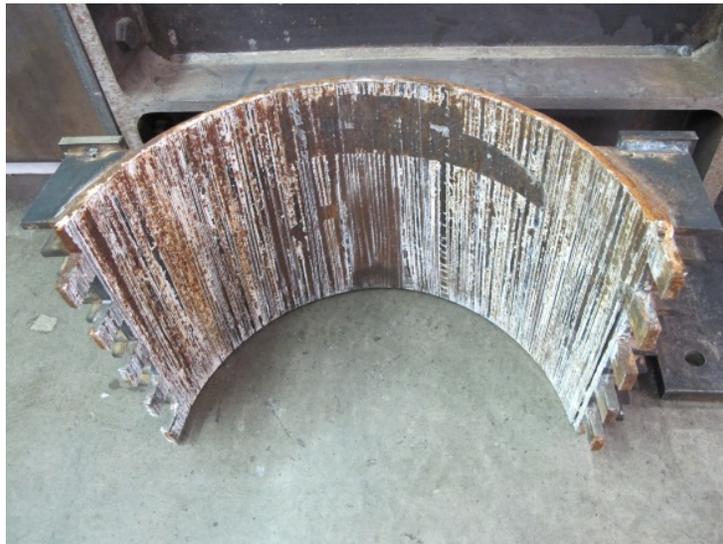
On the underside of the cable band, a substantial amount of salt and/or zinc oxide and ferrous oxide was found (see figure 142). The concentration of ferrous corrosion was observed on the left side of the cable band.

Figure 142. Photo. Interior of top of south side of cable band.

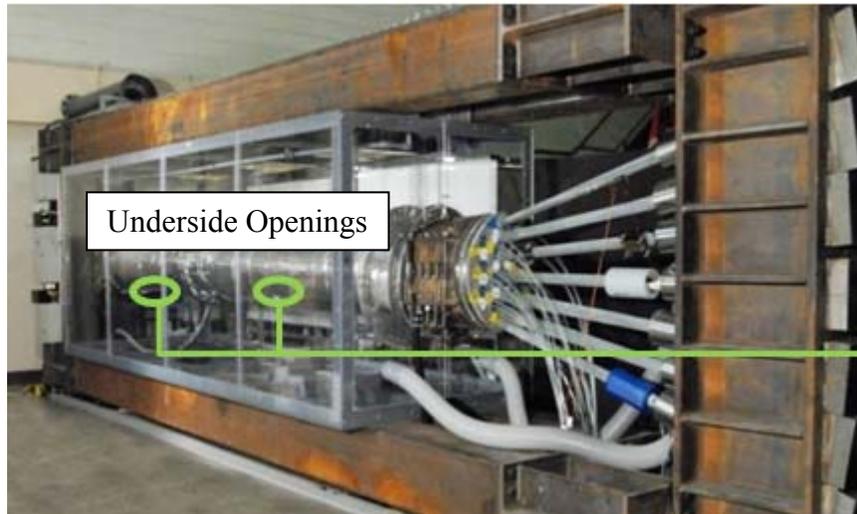
Midway through the test program at points approximately 3.94 ft (1.2 m) from either end of the cable mockup, four holes were placed in the cable wrapping (see figure 143). Two 11.89-by-11.89-inch (30.5-by-30.5-cm) openings were made in the underside of the wrapping and at a location on the topside of the cable, and two 0.99-by-0.99-inch (2.54-by-2.54-cm) openings were made 3.94 ft (1.2 m) from the jacking end to facilitate the influx of moisture to the inside of the cable mockup and accelerate corrosion of the wires (see figure 144).

Figure 143. Photo. Mockup cable specimen within environmental chamber and location of both holes.

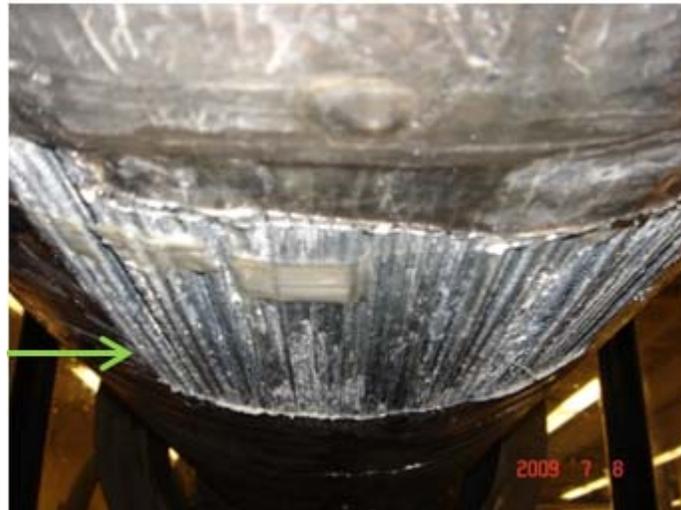
Figure 144. Photo. Image of one of the 11.89-by-11.89-inch (30.5-by-30.5-cm) holes placed in the aluminum cable cover.

During cable disassembly, the area highlighted in figure 144 was analyzed and documented. A solid white coating developed and enveloped the exposed wires (see figure 145 and figure 146). It is evident that ferrous corrosion was not present; the wires were covered by a thick layer of a white substance mainly composed of salt but also with the presence of zinc oxide (see

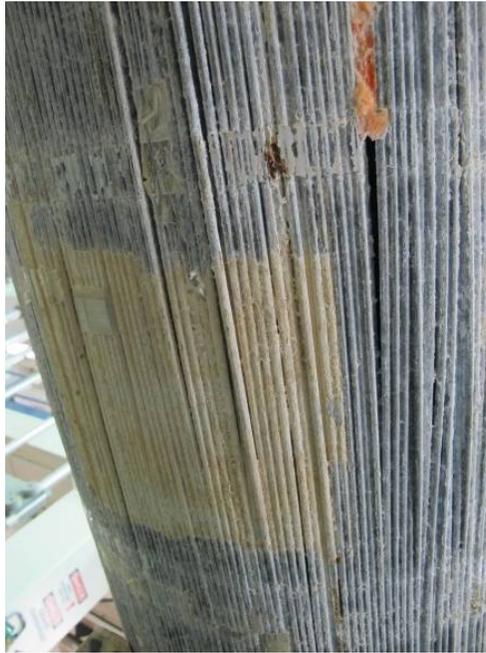
Figure 145. Photo. Product that formed where the 11.89-by-11.89-inch (30.5-by-30.5-cm) hole was placed in the aluminum cable cover.

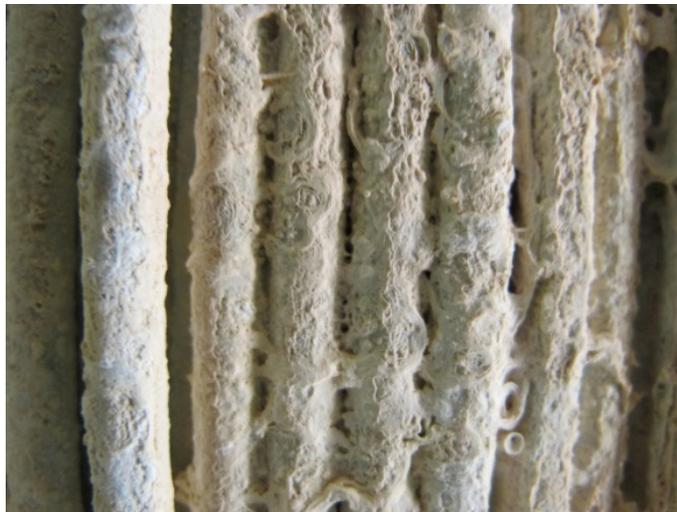
figure 146). The presence of such a high concentration of salt in the test solution was justified by the fact that test conditions were supposed to create harsh conditions for the sensor system.

Figure 146. Photo. Close-up view of the product formed on the high-strength steel wires.

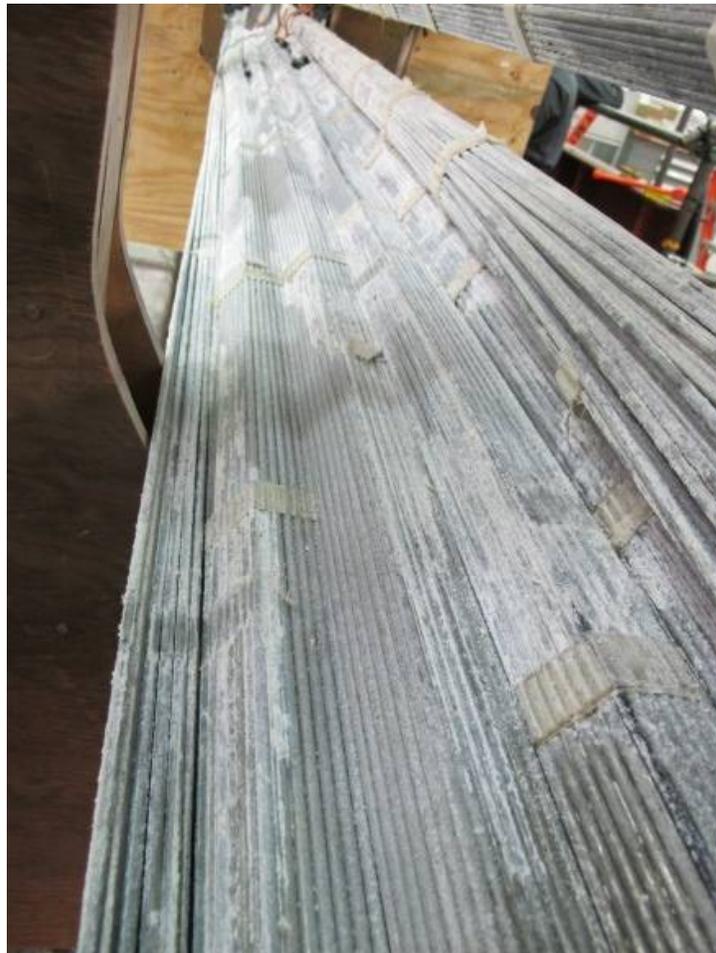
The interior of the cable showed areas where heavy salt deposition occurred. These areas showed no particular pattern, following more the potential path of the water that penetrated inside the wrapping. Such areas were more frequent in the south end of the cable because of the specimen inclination. In addition to these areas of salt deposition, it appeared that extensive zinc coating corrosion occurred. Almost the totality of the inside wires were coated with a white dust, and once this dust was removed, the wires had a non-shiny zinc surface. Figure 147 shows the inner core of the specimen.

Figure 147. Photo. Inner core of the specimen during disassembly.

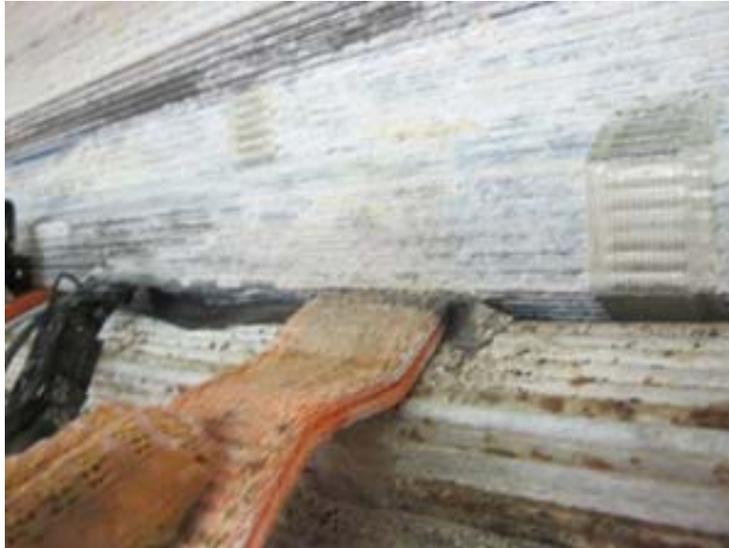
Areas that were highly subjected to corrosion activity were those located adjacent to the nylon straps embedded within the cable (see figure 148). These straps were placed only at one location along the length of the cable to protect the electrical wires from the sensors during compaction operations. The gaps next to the straps were not sealed before the wrapping, with the intention that water could easily penetrate the interior of the cable to activate the sensors. In real-life applications, it is strongly recommended to seal these openings to avoid water penetration inside the cable.

Figure 148. Photo. Orange nylon strap embedded within cable.

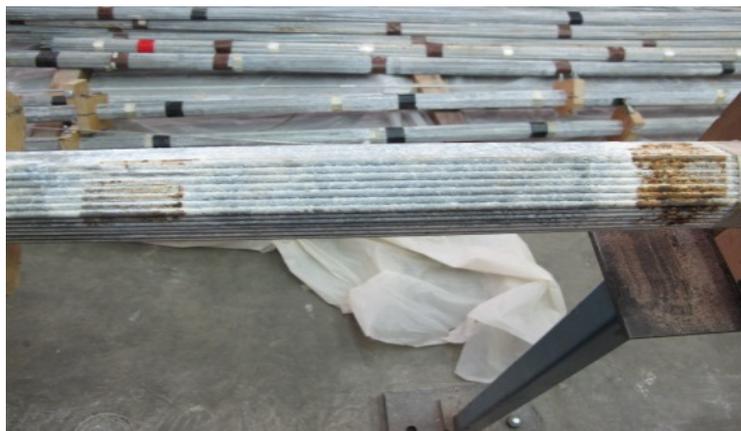
Basically, these straps acted similarly to the neoprene wrapping. That is to say, the nylon straps held any moisture present within the cable for extended periods of time, keeping the solution necessary for the electrochemical corrosion reaction. The corrosion product formed in the distinct shape of the overlapping strap (see figure 149).

Figure 149. Photo. Corrosion formation at nylon strip location.

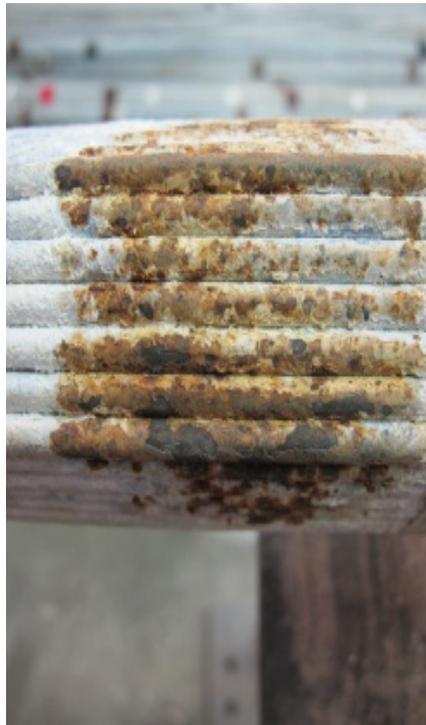
As was seen with the corrosion associated with the neoprene wrapping, the corrosion around the nylon straps was fairly uniform. Heavy stage 4 corrosion was seen on the bottom of a strand in contact with a nylon strap (see figure 150).

Figure 150. Photo. Close-up view of the wires with stage 4 corrosion.
