Corrosion Monitoring Research for City of New York Bridges

PUBLICATION NO. FHWA-HRT-14-023

MAY 2014

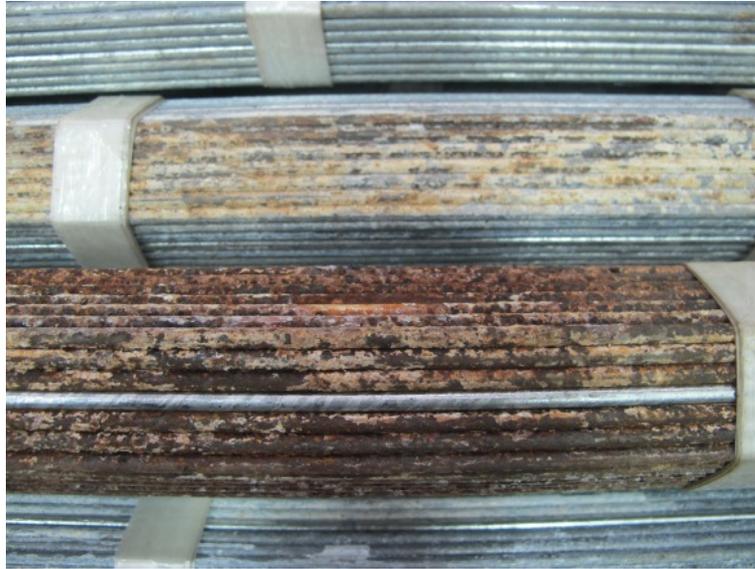
Figure 151. Photo. North end of cable—pre-corroded strand 9R (bottom) and adjacent side of strand 16R.

New strands within the cable mockup specimen that were adjacent to the two pre-corroded strands also experienced heavy amounts of corrosion on the contact surface between the strands. As was commonplace with the other corrosion documented, corrosion of strands adjacent to pre-corroded strands was heaviest in the central and southern sections of the cable due to the slight inclination of the cable specimen toward the jacking end. Following the nomenclature introduced in figure 116, strands 8R and 9R were pre-corroded with the intent of generating some hidden corrosion damage for the direct sensing technologies. Looking at the surface of strand 16R in contact with strand 9R, it was evident the presence of ferrous corrosion in stage 3, approaching stage 4, was seen in the area adjacent to strand 9R even on the north side of strand 16R (see figure 151). In fact, several sections displayed stage 4 corrosion and black oxides (see figure 152).

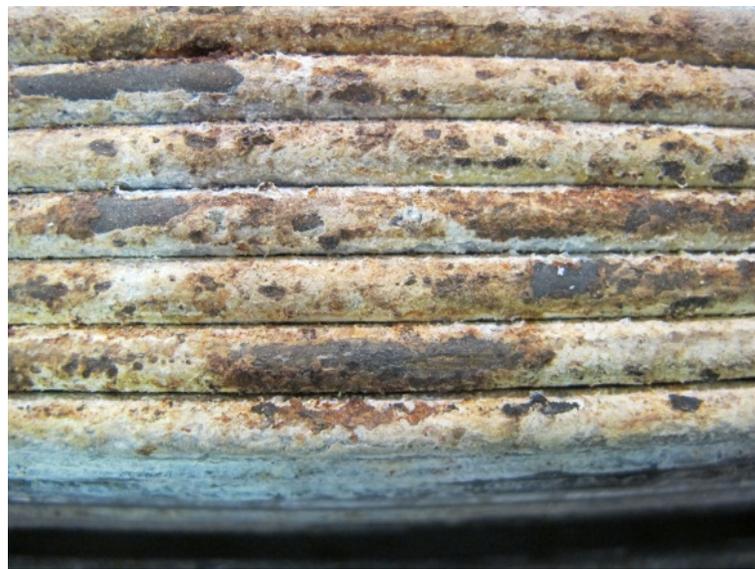
Figure 152. Photo. North end of cable close-up of 16R showing stage 3 corrosion.

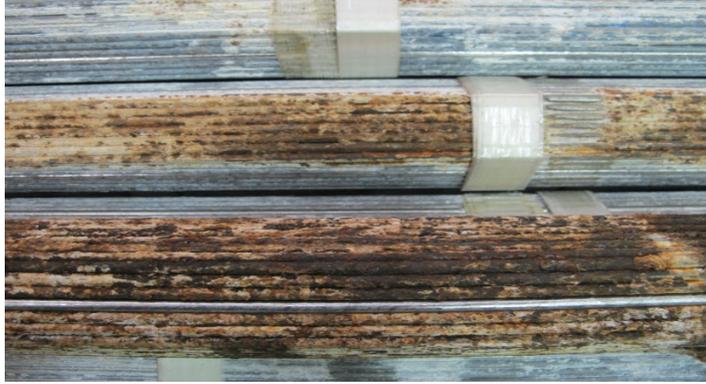
Figure 153. Photo. South end of cable pre-corroded strand 9R (bottom).

The effect of the contact between the corroded strand and the initially uncorroded strand was evident. Even greater amounts of ferrous corrosion were seen on the southern end of strand 16R (see figure 153). At the southern end, nearly the entire adjacent face had undergone stage 4 corrosion (see figure 154 and figure 155). Once again, it appears that the slight angle at which the cable sat caused a greater amount of moisture build-up in the southern end of the cable; however, unlike the corrosion under the stainless steel straps, the extent of the corrosion caused by the pre-corroded strands did not differ drastically from one end to the next. The corroded surface of the pre-corroded strand provided more surface area for water particles to adhere to, thereby increasing the time of wetness of the material, the time of wetness on the adjacent strand face, and the length of the corrosive electrochemical reaction.

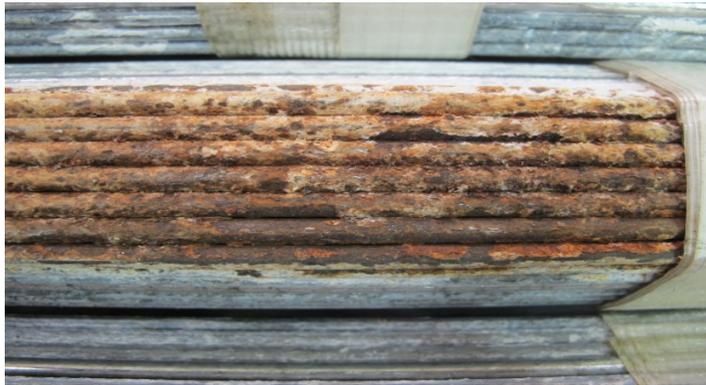
Figure 154. Photo. South end of cable adjacent side of strand 16R.

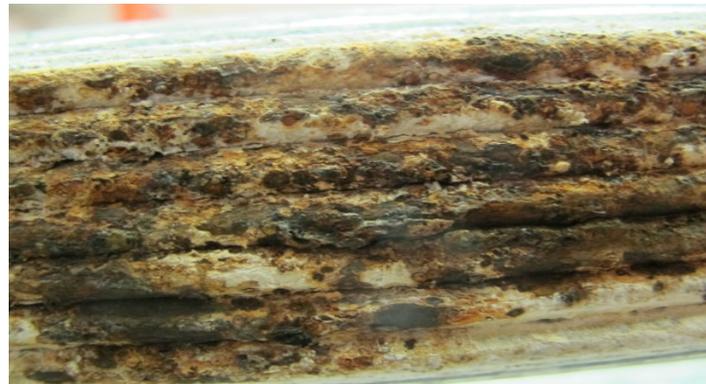
Figure 155. Photo. South end of cable close-up of 16R showing stage 4 corrosion.

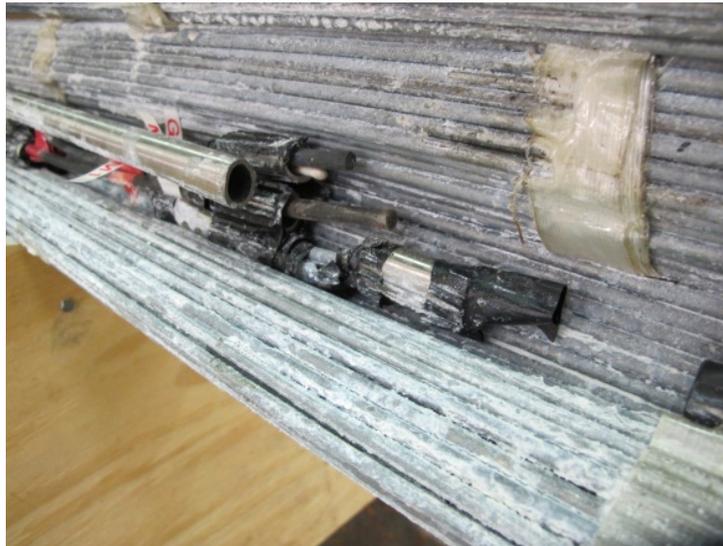
Figure 156. Photo. Sensors T1, BM1, and CMAS CS1.

On the surface, mostly all of the sensors appeared to not have been crushed by the cable compactions. Figure 156 shows the conditions of the exterior of the Precon sensor 1, BM sensor 1, and CMAS CS 1. They were placed in the lowest point of the cable cross section. The surrounding wires were not damaged by galvanic corrosion resulting from the potential difference between the wires and the stainless steel protective piping. The general state of the sensors and the surrounding wires shown in figure 156 is applicable to almost all the sensors throughout the cable.

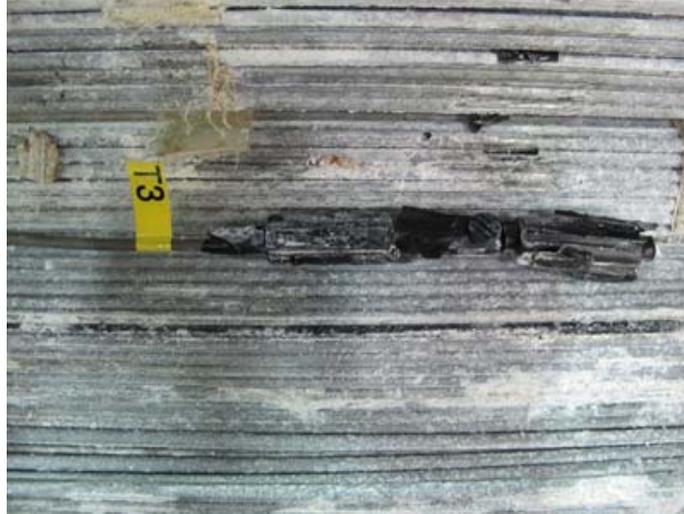
Figure 157. Photo. Precon HS2000V sensor 3 during cable disassembly.

With the exception of a few, nearly all of the Precon sensors performed satisfactorily during testing. For example, sensor 3, located at the center of the cable, recorded consistent temperature and relative humidity values. The consistency of these recordings provided a sense of reliability in the functionality of this sensor, shown in figure 157 and figure 158. Figure 157 shows that the stainless steel piping with heat shrinking coating appears to have worked in protecting the sensor from crushing. Figure 158 indicates that no visual damage could be seen on the electrode itself.

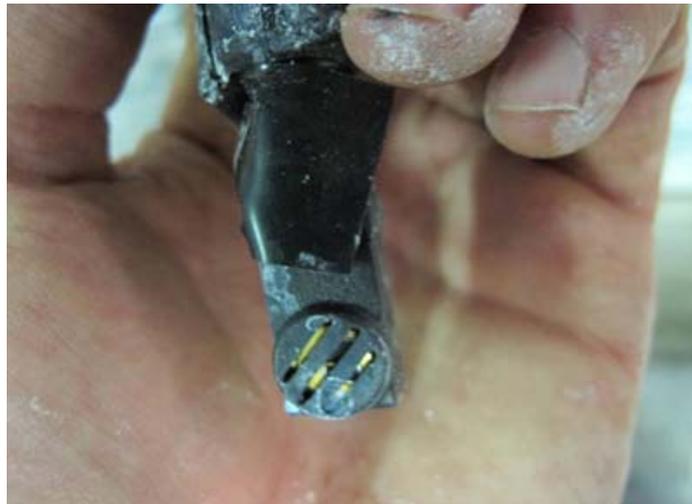
Figure 158. Photo. Close-up view of Precon HS2000V sensor 3 electrode.

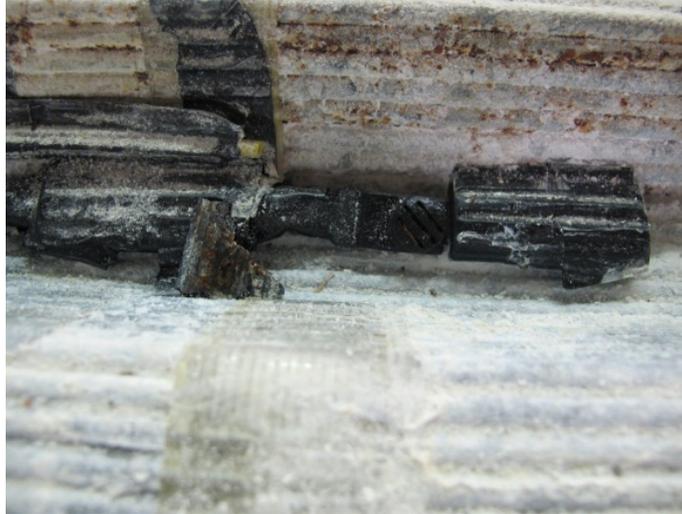
Figure 159. Photo. Precon HS2000V sensor 13 during cable dissection.

Similarly, sensor 13 provided reliable data that recorded large amounts of temperature and relative humidity fluctuations during testing. Figure 159 and figure 160 reflect the image of Precon sensor 3 with no visual damage being recognizable. Almost all the Precon temperature and relative humidity sensors look similar to sensors 3 and 13.

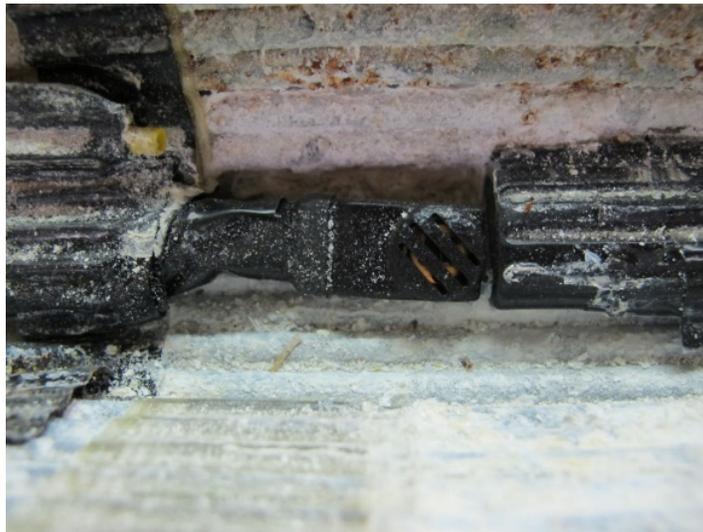
Figure 160. Photo. Close-up view of Precon HS2000V sensor 13 electrode.

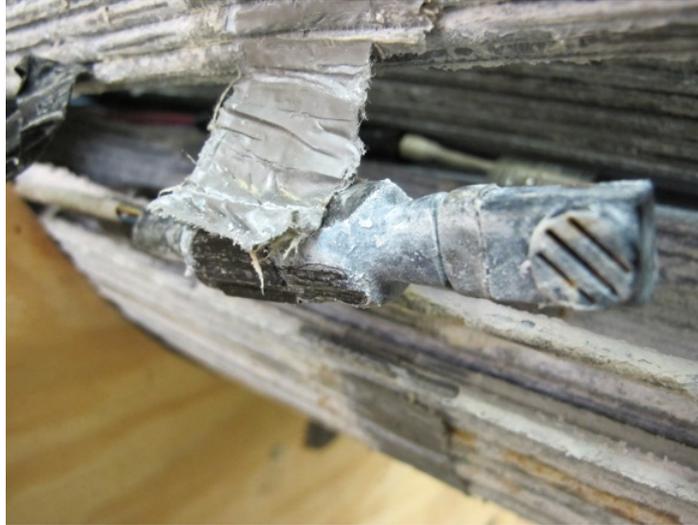
Figure 161. Photo. Precon HS2000V sensor 7 close-up of electrode during cable dissection.

On the contrary, since the beginning of testing, sensor 7, located close to the surface on one of the diagonal diameters, malfunctioned, and no significant data were ever ascertained. The opening of the cable revealed the status of the sensor (see figure 161 and figure 162). During the cable autopsy, sensor 7 was discovered hanging from a piece of masking tape, as shown in figure 161, with the internal wires exposed (see figure 162). Short circuiting of the electrode and exposure problems may have led to the sensor malfunction.

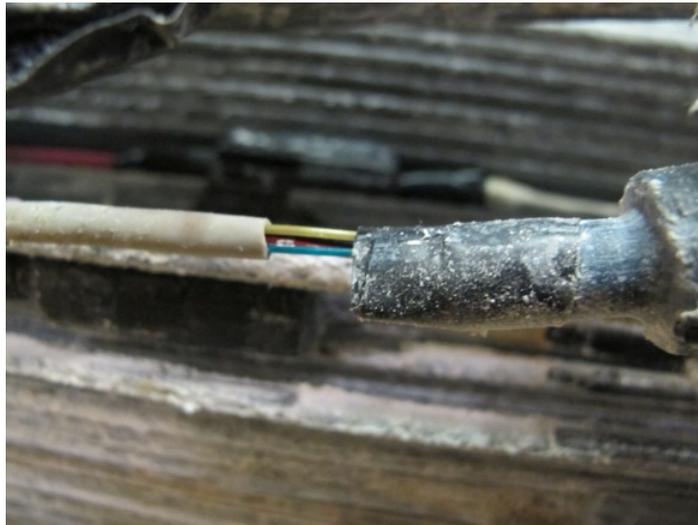
Figure 162. Photo. Precon HS2000V sensor 7 wires exposed.

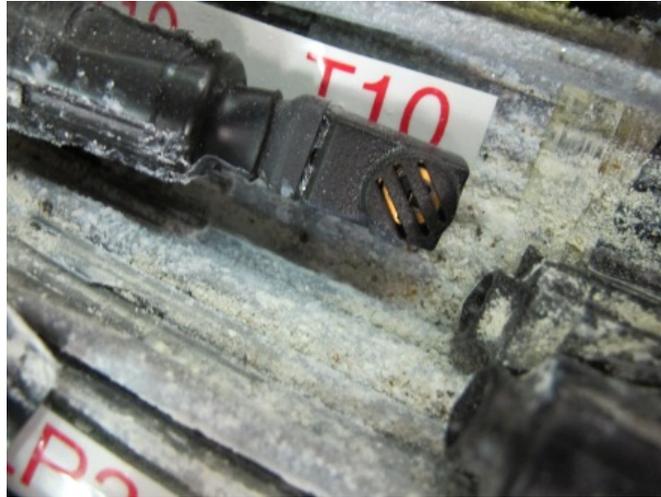
Figure 163. Photo. Precon HS2000V sensor 10 during cable dissection.

Unfortunately, not all sensors that malfunctioned showed problems that were as easily identifiable as those of sensor 7. For example, sensor 10, which was located close to the outer surface along one of the diagonal diameters, consistently recorded extremely elevated relative humidity levels. The analysis of sensor 10 (see figure 163) showed that the sensor suffered no damage, suggesting that sensor saturation during testing may have been the cause of the high levels recorded.

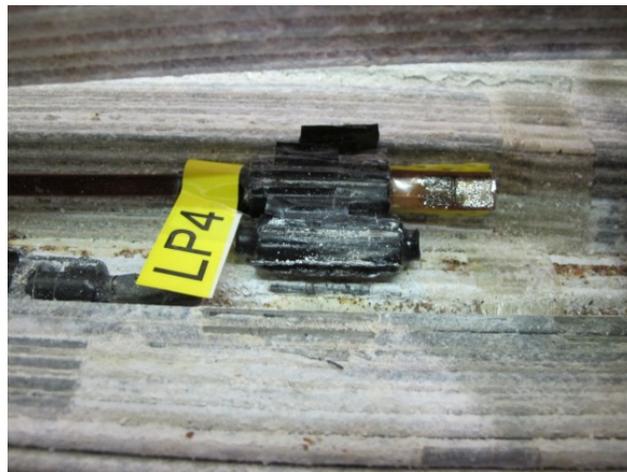
Figure 164. Photo. LPR sensor 4 during cable disassembly.

As shown in the data analysis section, eight LPR sensors were placed in the cable cross section. From data analyses, it was found that only LPR sensors 3 and 4 provided consistent data that extended beyond noise level threshold, while the remaining six did not record any significant activity, posing the question of whether or not all the sensors were functioning correctly. Upon disassembly of the specimen, LPR sensor 4 was found to be in good condition. The protective casing had remained intact, leaving the sensor unscathed (see figure 164), and the sensor probe itself had not corroded nor did it appear to have been damaged in any other way (see figure 165). LPR sensor 3 was found to be in similar condition as LPR sensor 4. These two sensors were placed along the upper part of the inclined diameter in the right half of the cable cross section.

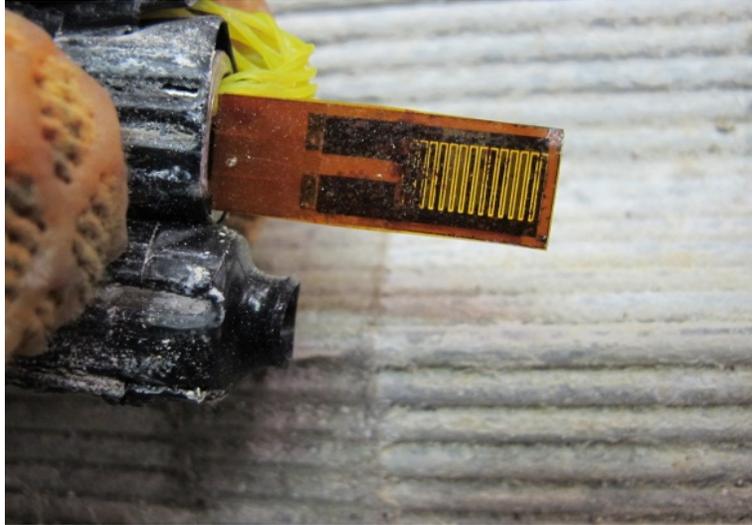
Figure 165. Photo. Close-up view of LPR sensor 4.

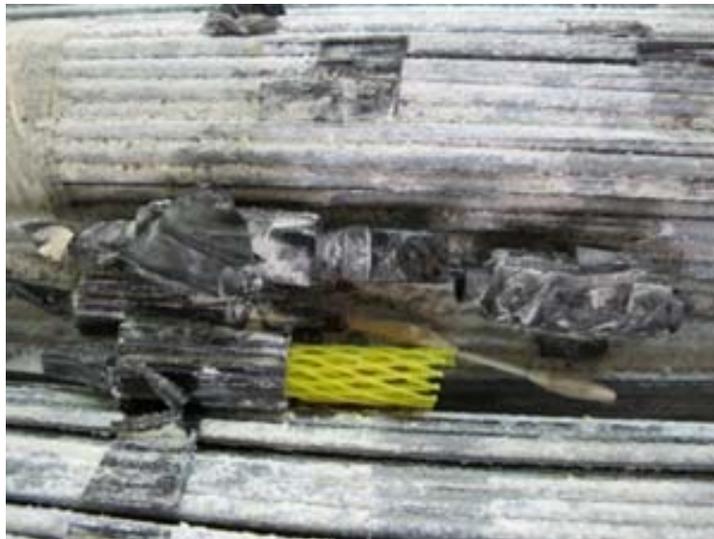
Figure 166. Photo. LPR sensor 6 during cable disassembly.

Some of the remaining LPR sensors suffered extensive corrosion damage that, most probably, compromised their functioning. For example, LPR sensor 6 recorded fluctuations beyond noise at times; however, the data were too erratic and inconsistent to be deemed usable. LPR sensor 6 was located in its original place on the vertical diameter halfway from the center and the surface of the cable. This sensor was placed together with other corrosion rate sensors (see figure 166), and it appeared to have been severely corroded (see figure 167). The corrosion of the sensor electrodes of LPR sensor 6 provides an explanation for the erratic data recordings.

As shown figure 166 and figure 167, LPR sensor 6 appeared to be in an area of heavy salt deposit, indicating that the area must have been subjected to aggressive corrosive action and justifying the presence of extensive corrosion products on the sensor.

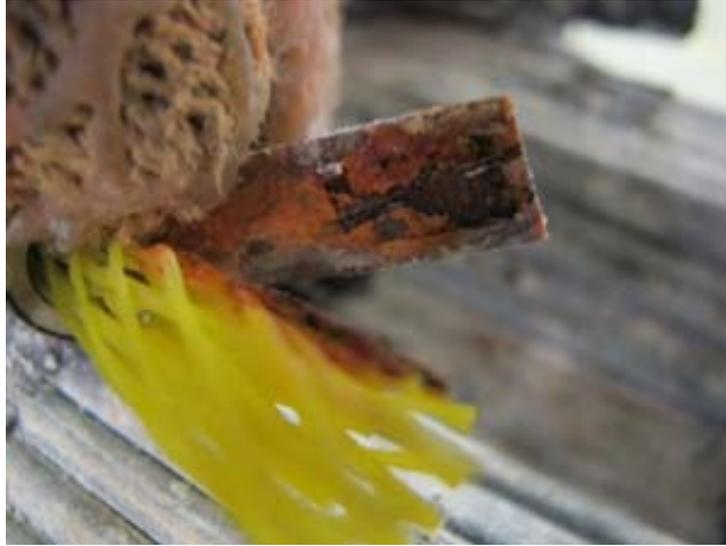
Figure 167. Photo. Close-up view of LPR sensor 6.

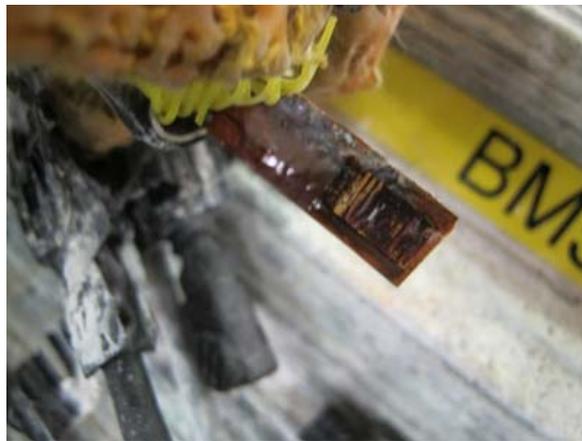
Figure 168. Photo. Corroded LPR sensor 5.

Upon further inspection, however, all of the sensors were either corroded or the electrodes were disfigured. LPR sensor 5 was found to be corroded (see figure 168), while LPR sensor 7 was found to be both crushed and corroded (see figure 169).

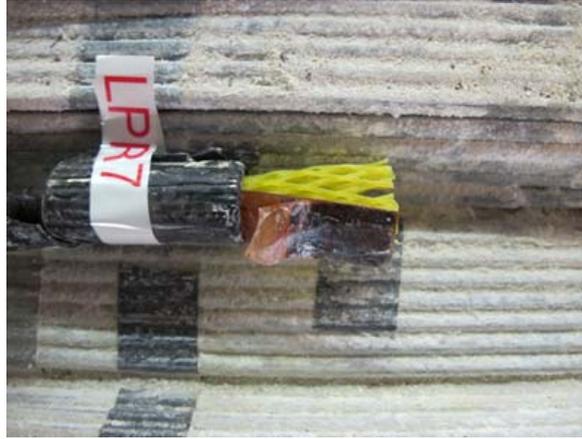
Figure 169. Photo. Corroded and disfigured LPR sensor 7.

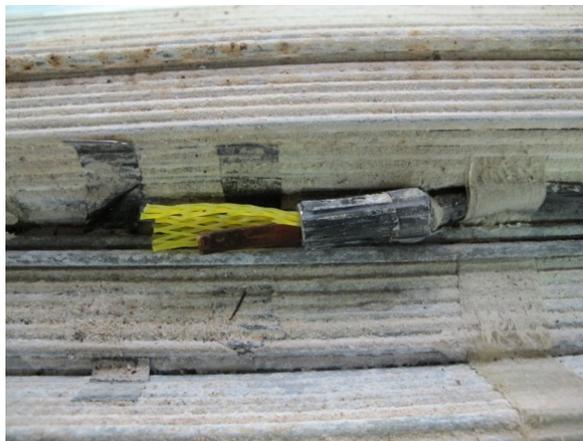
Figure 170. Photo. LPR sensor 8 during cable dissection.

At first glance, it appeared that the sensors closer to the surface (e.g., LPR 7) were more likely to fail due to crushing; however, LPR sensor 8, which was located in a position analogous to LPR 7, did not get crushed from compaction forces (see figure 170). Rather, it seemed to have malfunctioned due to corrosion (see figure 171).

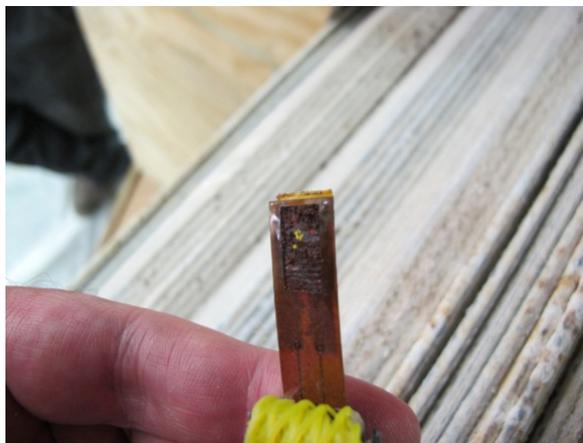
Figure 171. Photo. LPR sensor 8 close-up of corroded sensor electrodes.

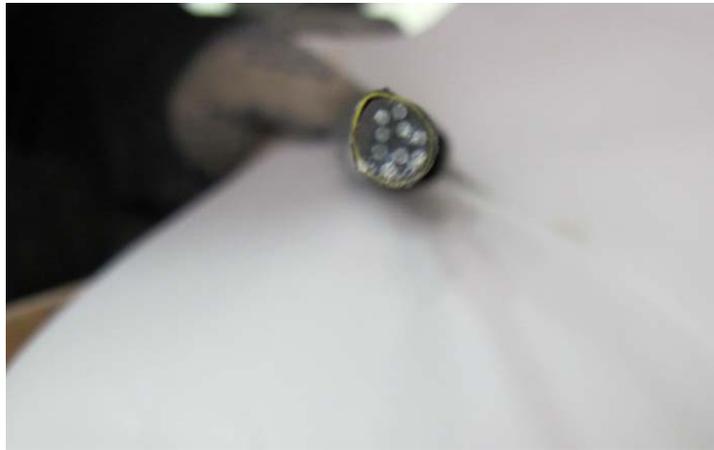
Figure 172. Photo. CMAS CS 2 intact.

Looking at the data collected during the experimental analyses, the measurement of the corrosion rate obtained from the CMAS CS sensor appeared to be promising, while the recorded data for zinc corrosion rates (CMAS Zn 2) did not. During the cable autopsy, it was found that the CMAS CS sensor 2 (located at the top of the cable cross section) (see figure 172) was not affected by the cable compaction and appeared to have resisted severe corrosion deterioration. Conversely, CMAS Zn sensor 2, located next to CMAS CS sensor 2, was crushed during cable compaction (see figure 173), which explained the lack of measurement data from it.

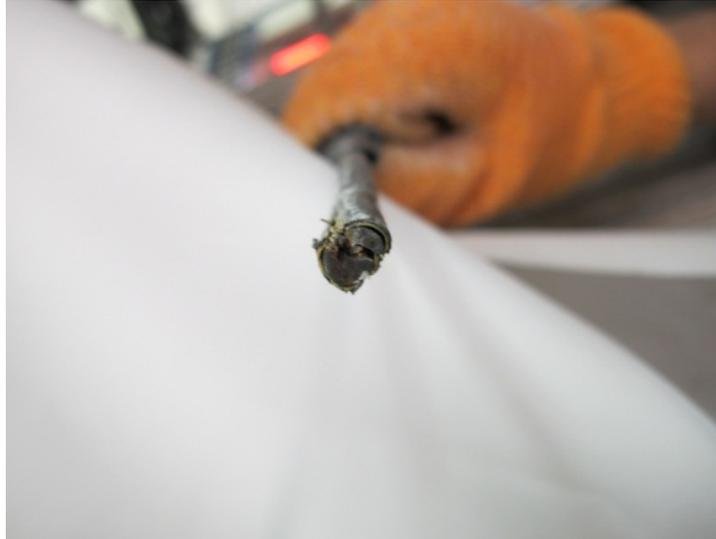
Figure 173. Photo. Crushed CMAS Zn 2 sensor.

The recordings of these sensors were analyzed and have been previously presented. The noise signal recorded by the CMAS Zn sensor 2 was a result of the sensor malfunctioning due to crushing during cable compaction.

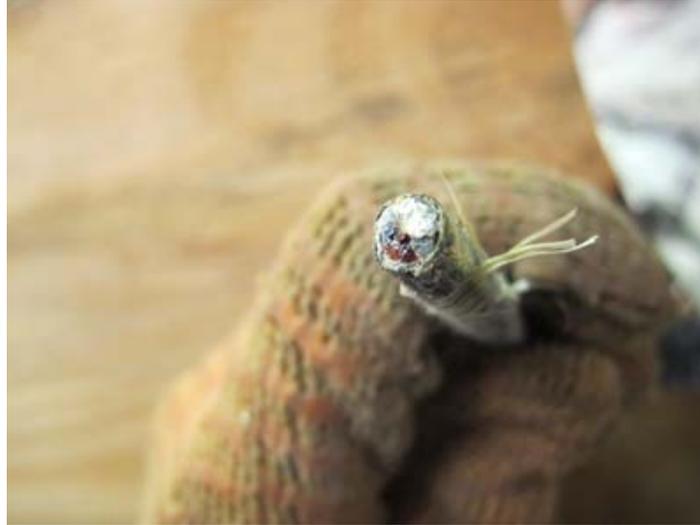
Figure 174. Photo. Heavy corrosion on BM sensor 7.

Most of the BM sensors did not record much corrosion activity beyond the noise level. During the cable autopsy, BM electrodes were found to have various amounts of corrosion, from heavy (sensor 7 in figure 174) to minimal (sensor 3 in figure 175).

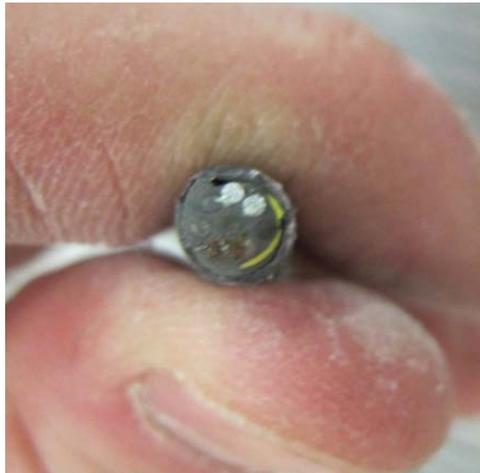
Figure 175. Photo. Minimal corrosion on BM sensor 3.

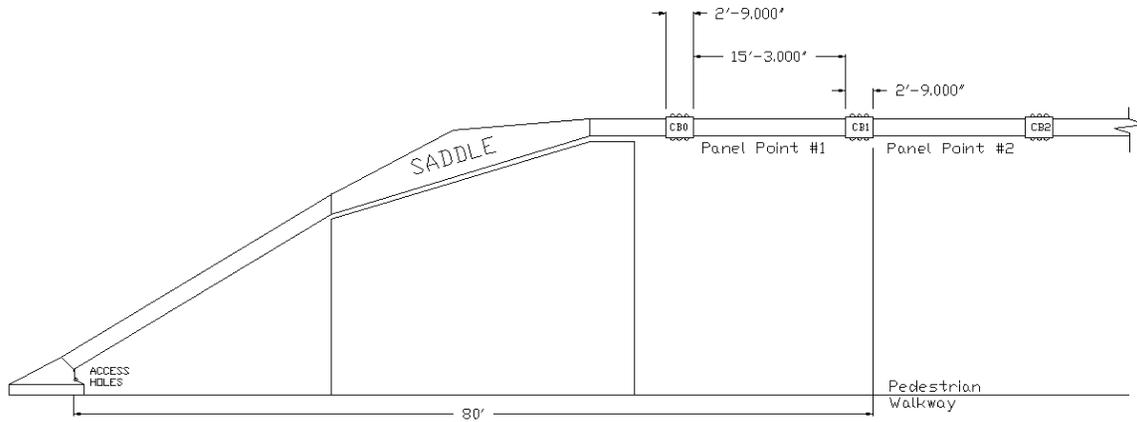
Figure 176. Illustration. Cable sketch and dimensions of field installation phase 1.

A first set of sensors (fiber-optic strain gauges) was installed between panel point 1 and panel point 2 of cable D, as shown in figure 176 and figure 177, a location that is relatively close to anchorage D and where there were no obstructions for sensors mounting. Access to the main cable was coordinated with the appropriate bridge authorities.

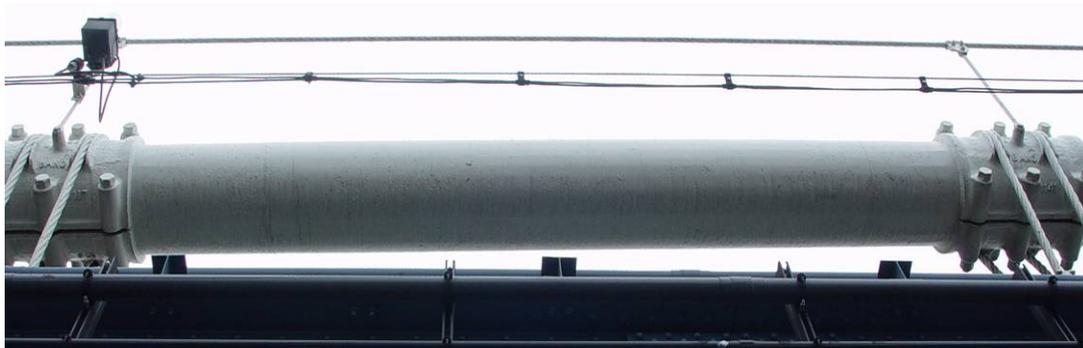
Figure 177. Photo. Panel point 2 of Manhattan Bridge.

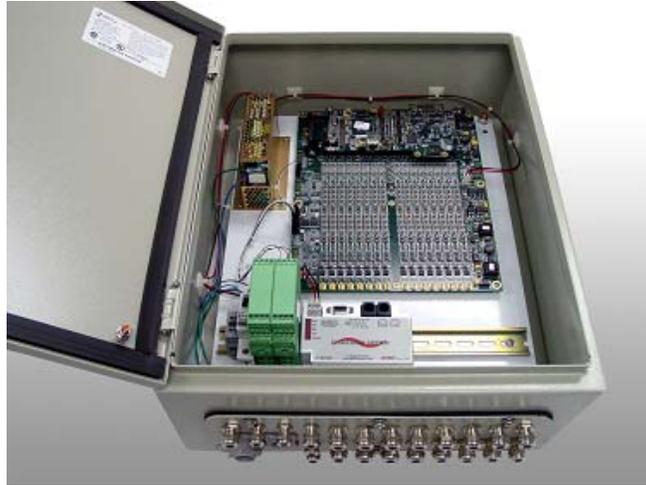
Figure 178. Photo. Sensor Highway II System.

Figure 178 shows the PAC Sensor Highway II system developed for this study. One key aspect in the final monitoring system was that all the sensors and technologies had to be integrated together into the sensor highway. A prototype of this system was developed and installed on the Manhattan Bridge, utilizing up to eight AE sensors/channels, an internal (and external) temperature sensor, two accelerometers, a weather station, and a wireless parametric adapter for monitoring suspension cable environmental parameters including temperature, humidity, and corrosion rate. The Sensor Highway II System was located inside the chamber of anchorage D (north cable on the Brooklyn side). The current block diagram for the integration of the various sensors and sensing systems that are being utilized in this project is shown in figure 179.

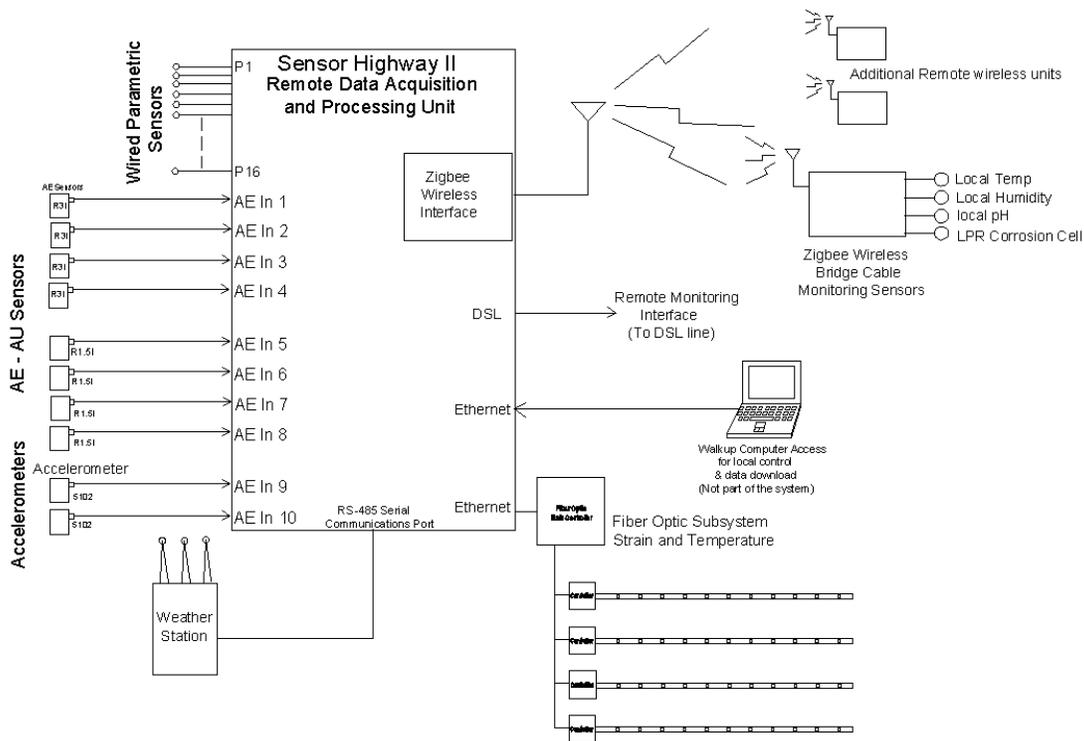
Figure 179. Illustration. Block diagram of the Sensor Highway II System.

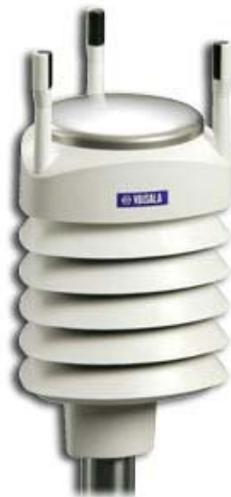
Figure 180. Photo. Vaisala WXT510 weather transmitter.

A Vaisala WXT510 weather transmitter was selected to measure external temperature, relative humidity, rainfall, wind speed and direction, barometric pressure, etc. (see figure 180 and figure 181). This model was chosen because of it is entirely solid state; it is completely electronic without any moving parts. Mounted on the parapet above the arch over the pedestrian walkway approximately 50 ft (15.25 m) from panel point 2, this weather station used the RS-485 interface and was connected to the Sensor Highway II system (via cable) in anchorage D, which also provided the required 12-V power for operation.

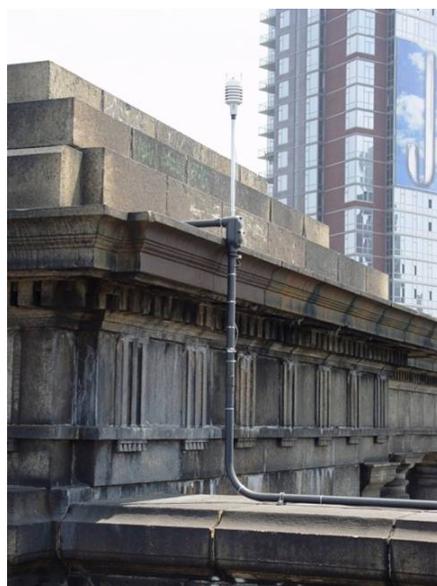
Figure 181. Photo. Weather station installed on the Manhattan Bridge.

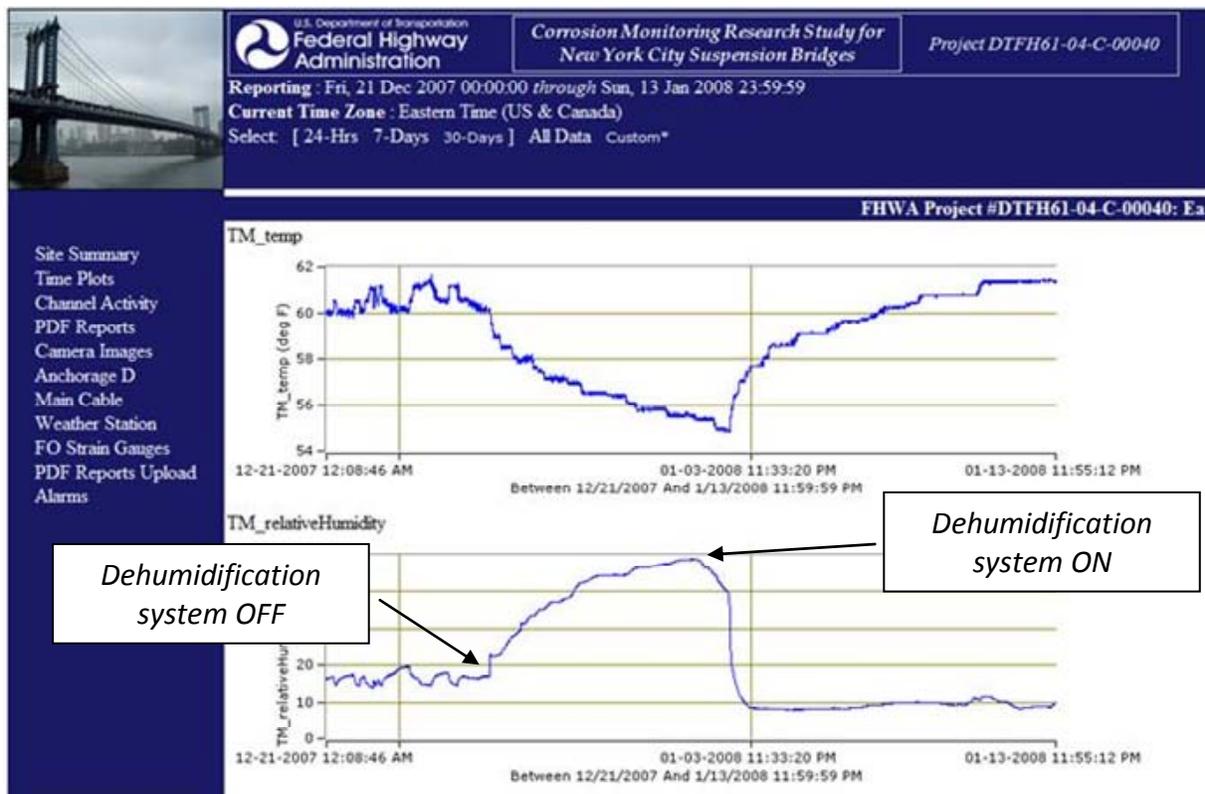
Figure 182. Screenshot. Graph of temperature and humidity inside the cable anchorage remotely reported via a secure Web portal.

A temperature/humidity sensor was connected to the wireless parametric interface box. The size of the integrated sensor was 0.9-by-0.5-by-0.365 inch (22.86-by-12.7-by-9.27 mm) and required low power and minimal external conditioning circuitry. This sensor was used to monitor any changes of the environmental conditions inside anchorage D (e.g., shut down of dehumidification system). The wireless parametric sensor interface was installed to create a wireless link between the parametric readings of temperature and humidity in the anchorage and the Sensor Highway II System installed in the same location. The initial data collection was configured for collection on an hourly basis to maximize battery life. This system was tested by shutting down the anchorage dehumidification system. As shown in figure 182, the system immediately recorded a decrease in temperature and a consequent increase in humidity. As soon as the anchorage dehumidification system was reactivated, the temperature and the humidity inside the anchorage chamber returned to normal values.

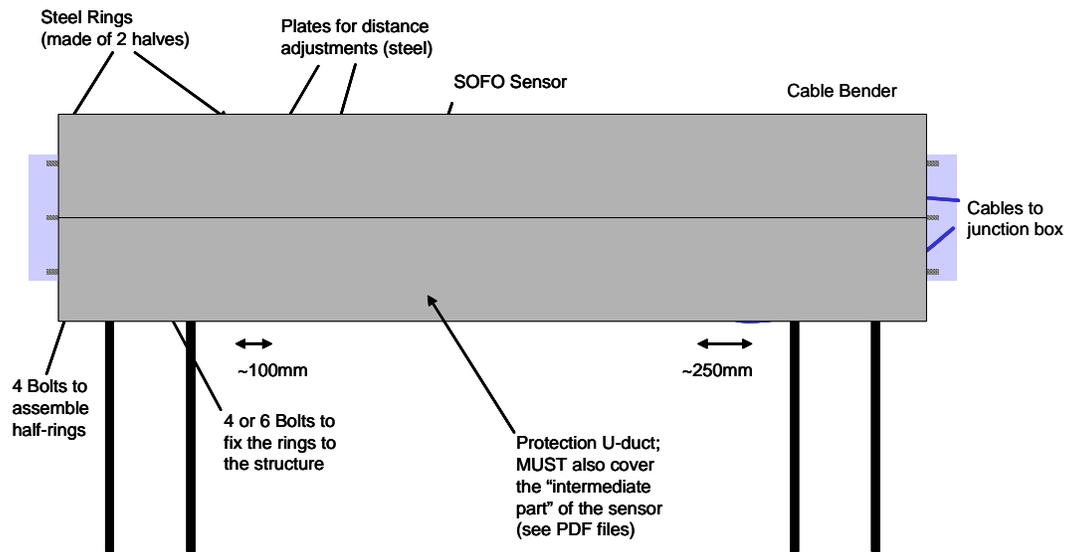
Figure 183. Illustration. Mounted SOFO sensors.

The fiber-optic strain gauge system was installed on panel point 2 as well on the eyebars at the anchorage, as shown in figure 183 through figure 186. It consisted of three Surveillance d’Ouvrages par Fiber Optiques (SOFO) sensors placed along the suspension cable and two multiplexed strain and temperature (MuST) deformation sensors mounted on the eyebars in the anchorage. Mounting of these sensors on the cable and eyebars has been coordinated with NYCDOT.

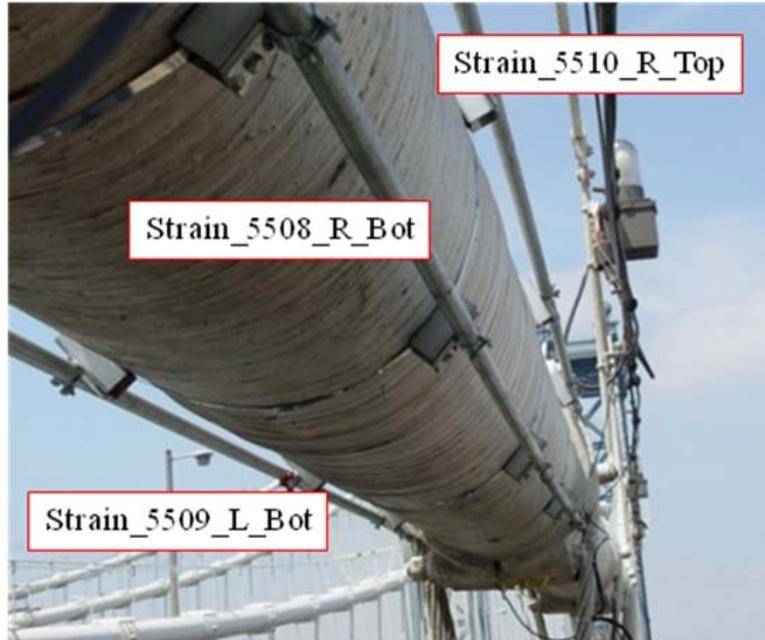
Figure 184. Photo. Actual locations of mounted SOFO and MuST fiber-optic sensors.

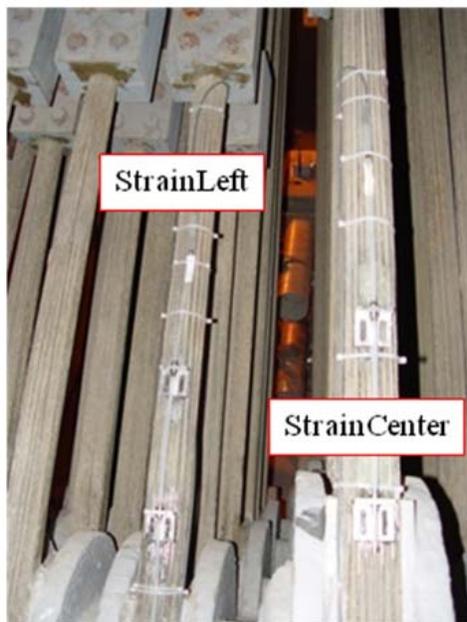
Figure 185. Photo. Strands at the anchorage with mounted fiber-optic strain sensors.

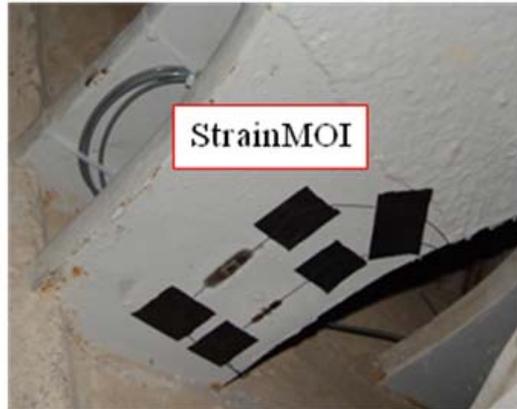
Figure 186. Photo. Strain gauges mounted on the eyebar.

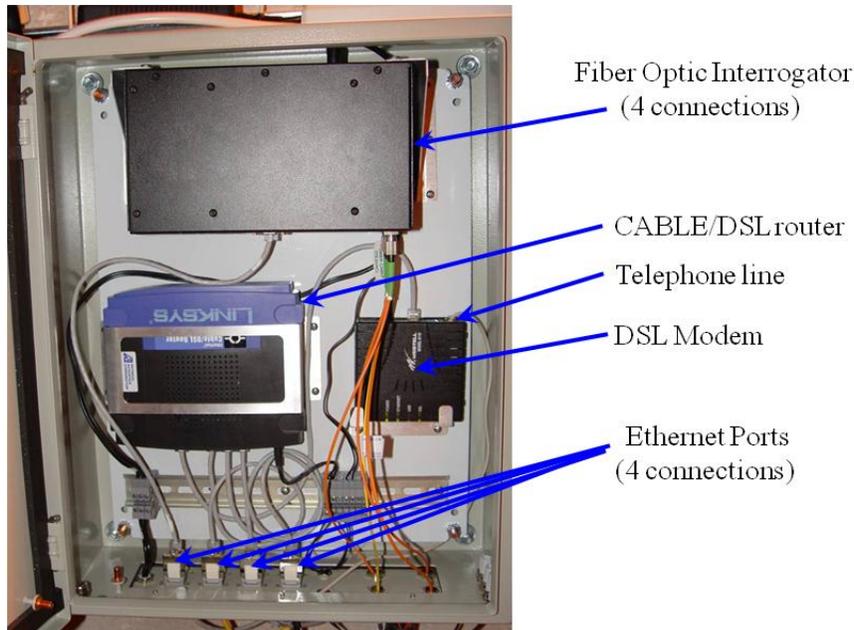
Figure 187. Photo. Typical NEMA-4 enclosure housing fiber-optic reading unit, DSL router, and modem.

All DAQs were housed in a standard National Electrical Manufacturers Association (NEMA-4) enclosure (see figure 187). The “4” rating means that the enclosure is intended for indoor or outdoor use primarily for providing a degree of protection against windblown dust, rain splashing, and hose-directed water. Communication and data collection between the Sensor Highway II system and the fiber optic system was through a digital subscriber line (DSL) connection at the bridge with a cable/DSL router connected to the DSL modem to allow the connection and remote access of the two DAQs (see figure 187). The cable/DSL router had a built-in firewall capability that was configured for security to protect the systems from unauthorized access. A Web portal (see figure 188) for secure remote data collection was created.

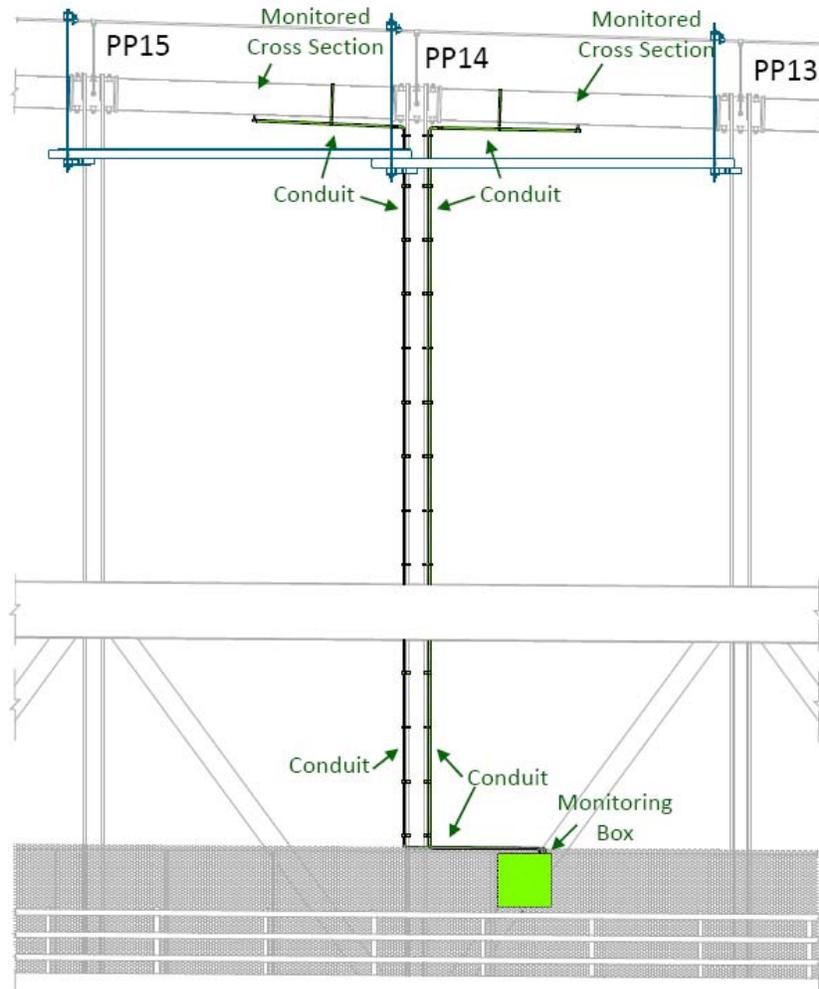
Figure 189. Illustration. Field installation location of sensor prototype on Manhattan Bridge north cable D.

Upon successful completion of the laboratory phase for testing the sensors, the selected setup of sensors, measuring temperature, relative humidity, and corrosion rate was installed on cable D of the Manhattan Bridge. Two 19.68-ft (6-m) panels on the Brooklyn side span were chosen along the cable between panel points 13 and 15 (see figure 189). In each of the two panels, the main cable was wedged at four groove positions along the circumference, and sensors were installed

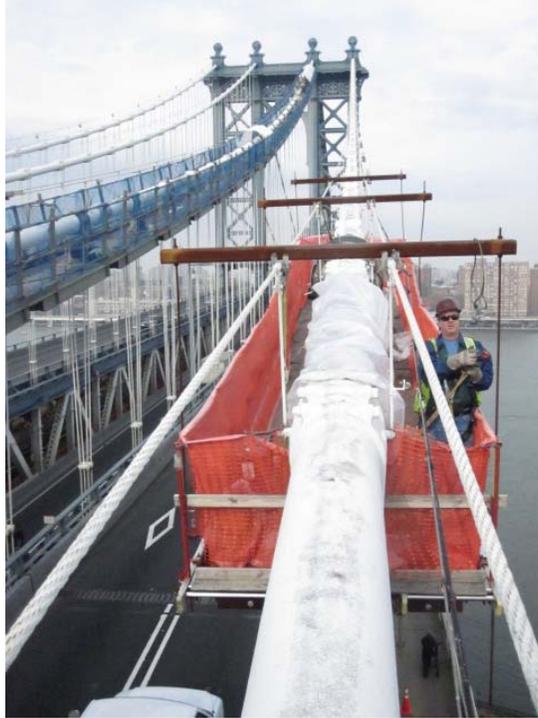
Figure 190. Photo. Suspended platform between panel points 13 and 15.

Prior to installation, access to each panel point was required. Access was facilitated through the use of a suspended platform that was installed by NYCDOT maintenance personnel. The platform was suspended from three cable bands on the north cable between panel points 13 to 15 (see figure 190 and figure 191), with the top of the platform approximately 36 inches (914.4 mm) below the bottom of the main cable.

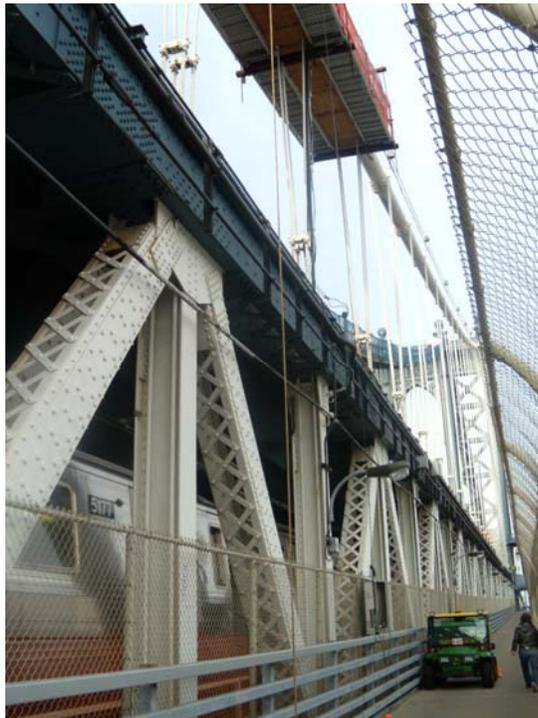
Figure 191. Photo. Walkway where the DAQ was installed.

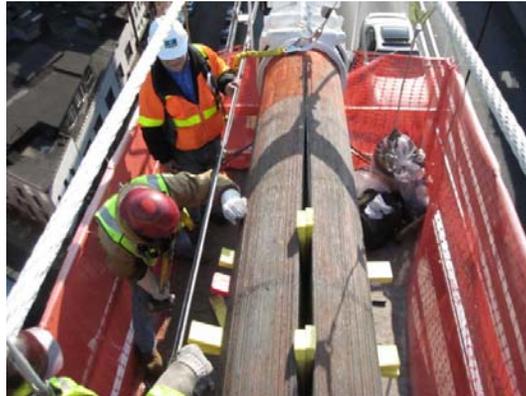
Figure 192. Photo. Cable preparation by unwrapping and wedging.

After the platform was installed, the cable was unwrapped and wedged at four groove positions along the circumference, namely at the 3, 6, 9, and 12 o'clock positions (see figure 192).

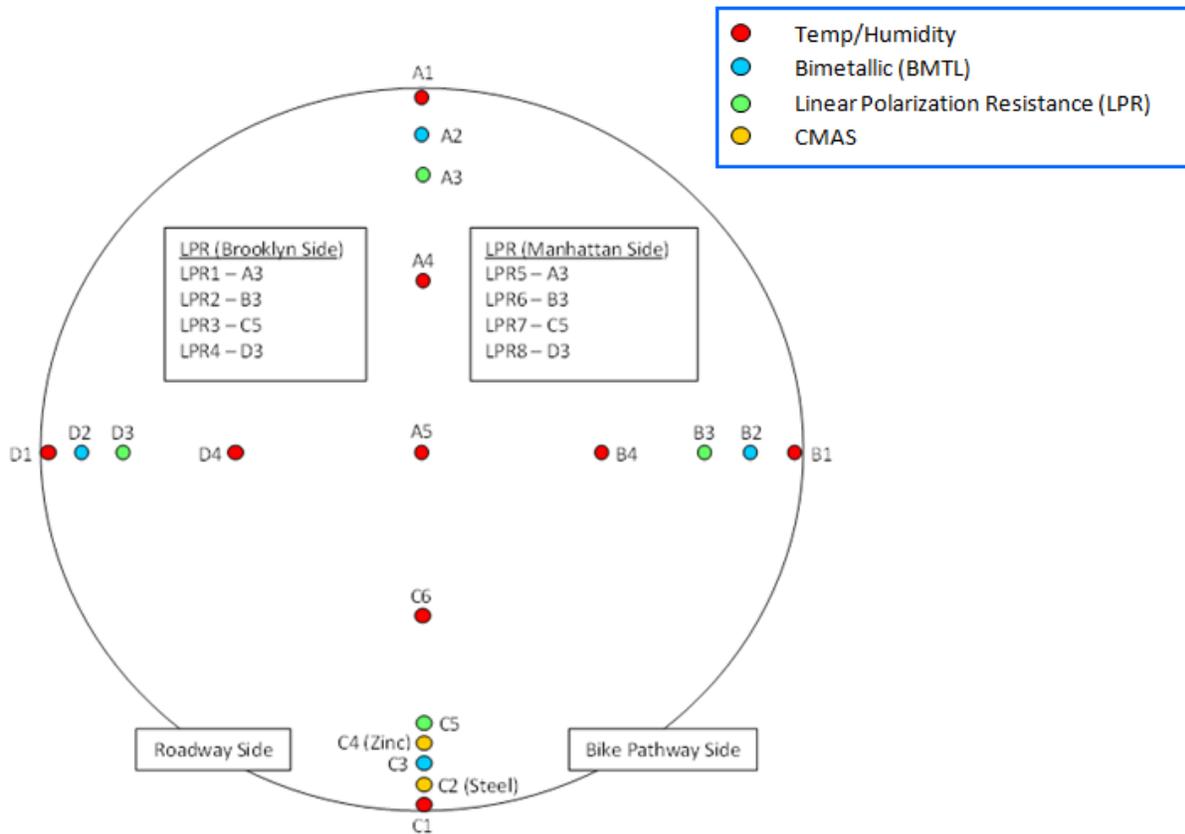
Figure 193. Illustration. Sensor distribution diagram within the cross section of the main cable (grooves A–D).

A total of 38 sensors (19 per panel) were installed within the 2 panels of the main cable on the Manhattan Bridge, as shown in figure 193. Each panel had eight temperature/humidity sensors, four LPR sensors, four BM sensors, and two CMAS.

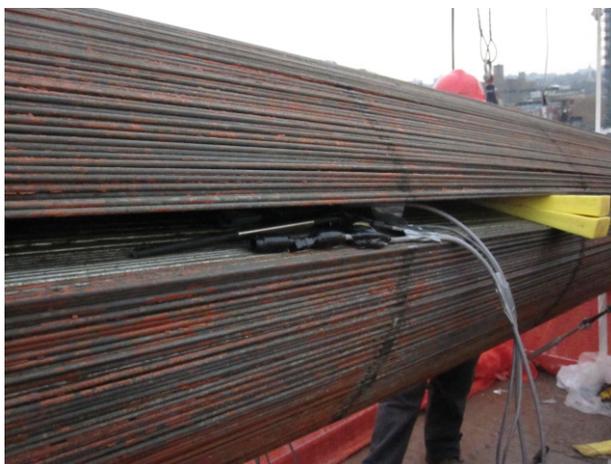
Figure 194. Photo. Sensor array used in each groove opening consisting of temperature/humidity sensors and LPR, CMAS, and BM corrosion sensors.

The sensors were assembled together (see figure 194) by placing them on a plastic strap that was then placed inside the cable (see figure 195). Each of the four locations contained at least one sensor of each type in order to look at the potential changes through the entire cross section of the cable (e.g., time of wetness, onset of corrosion, etc.). The sensors and wires for each section were protected from crushing through the use of polymer jackets and strapping. The wires from each section exited from the top, bottom, and sides of the main cable (see figure 195 and figure 196).

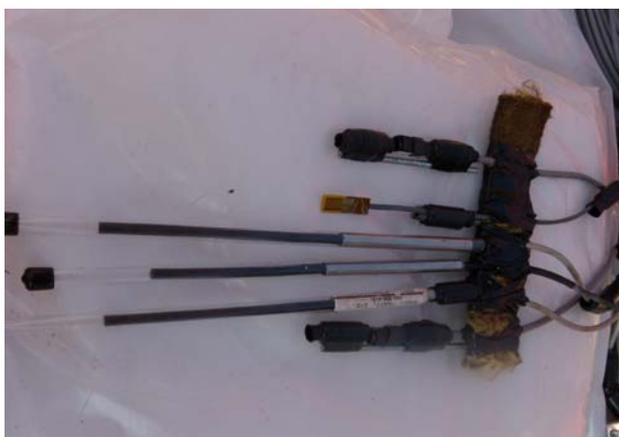
Figure 195. Photo. Set of sensors ready for installation.

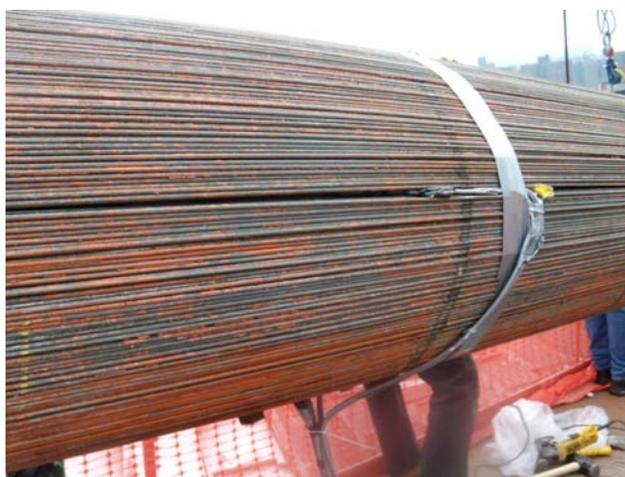
Figure 196. Photo. Sensor lead wires exiting from the cable after installation.

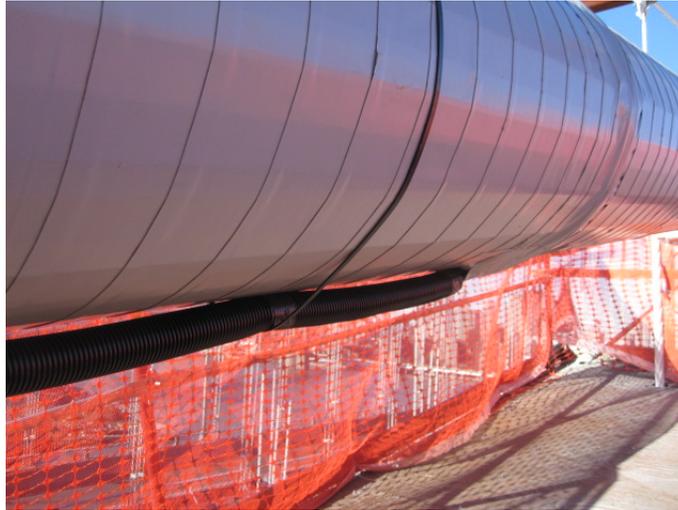
Figure 197. Photo. Cable temporary wrapping with neoprene and main conduit exiting at the bottom of cable leading to the main DAQ box at roadway level.

Once the sensors were installed, the cable grooves were closed, and the cable was rewrapped with neoprene wrapping, leaving an exit port at the bottom of cable for the wires leading to the

data acquisition box at the sidewalk level (see figure 197 and figure 198). All sensor cables exiting the main cable were bundled, placed inside a conduit for protection, and pulled through a semi-rigid conduit from the platform location, through the platform deck, down the suspender rope, and then to the DAQ on the sidewalk level. For the LPR sensors, because of the short wiring length, the data collector box was located inside an enclosure right below the cable and then connected to the data acquisition box at the sidewalk level.
