Corrosion Monitoring Research for City of New York Bridges

PUBLICATION NO. FHWA-HRT-14-023

MAY 2014

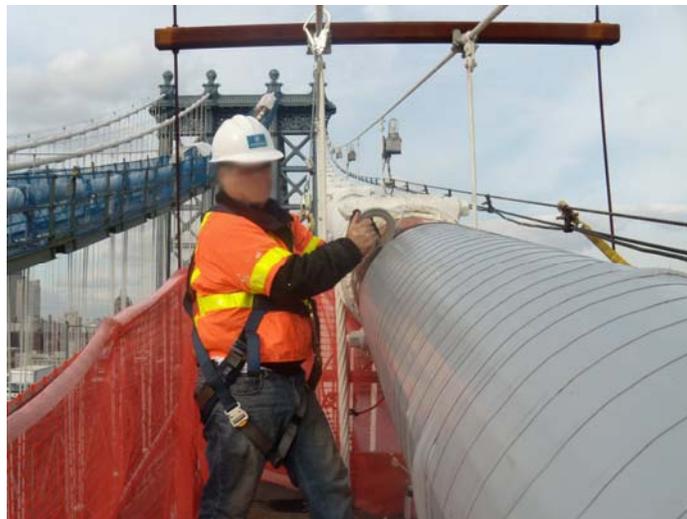
Figure 198. Photo. Final stage of the installation of the neoprene wrapping.

data acquisition box at the sidewalk level (see figure 197 and figure 198). All sensor cables exiting the main cable were bundled, placed inside a conduit for protection, and pulled through a semi-rigid conduit from the platform location, through the platform deck, down the suspender rope, and then to the DAQ on the sidewalk level. For the LPR sensors, because of the short wiring length, the data collector box was located inside an enclosure right below the cable and then connected to the data acquisition box at the sidewalk level.

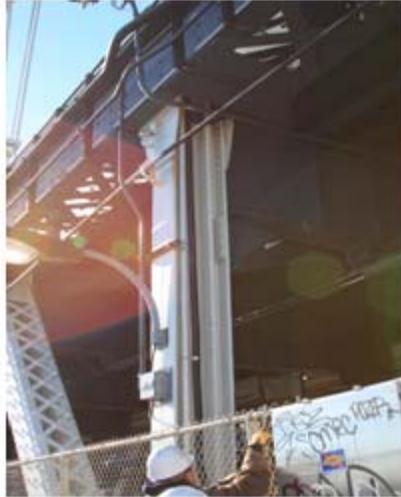
Figure 199. Photo. DAQ system/subsystem layout.

Prior to pulling the sensor cables from the platform, a NEMA-4 enclosure was installed along the sidewalk directly below the platform and panel points being monitored. Figure 199 through figure 201 show the installation of the DAQ enclosure for collection of data from all installed sensors. The DAQ was offset so that the enclosure did not extend past the vertical plane of the top railing or impede bicycle/pedestrian traffic on the pathway.

The DAQ housed all the components, subsystems, and hardware required for the collection of the data from the temperature, humidity, and corrosion sensors. The DAQ system included a main motherboard and central processing unit, subsystems for the BM and CMAS corrosion sensors (black boxes), RS485-232 converters, temperature/humidity parametric input board and converter (universal serial bus-2533), power supply, hard drive, monitor, uninterrupted power supply backup, and wireless cellular modem.

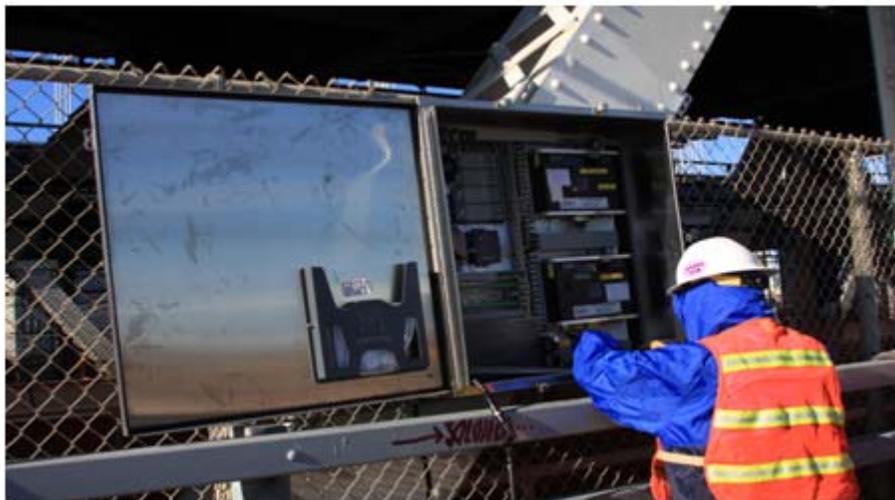
Figure 200. Photo. Installation of the central DAQ system.

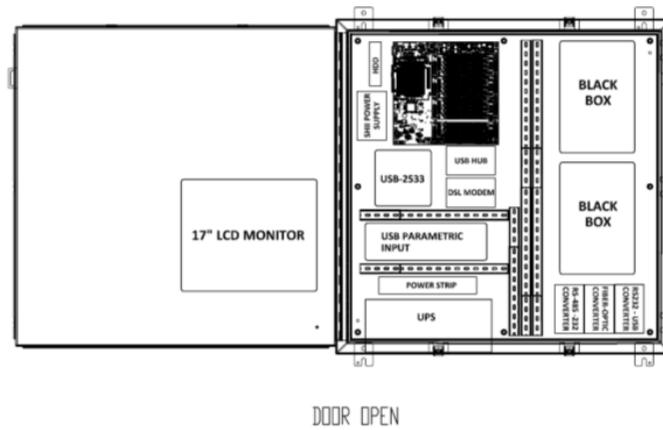
Figure 201. Illustration. Schematic representation of DAQ system.

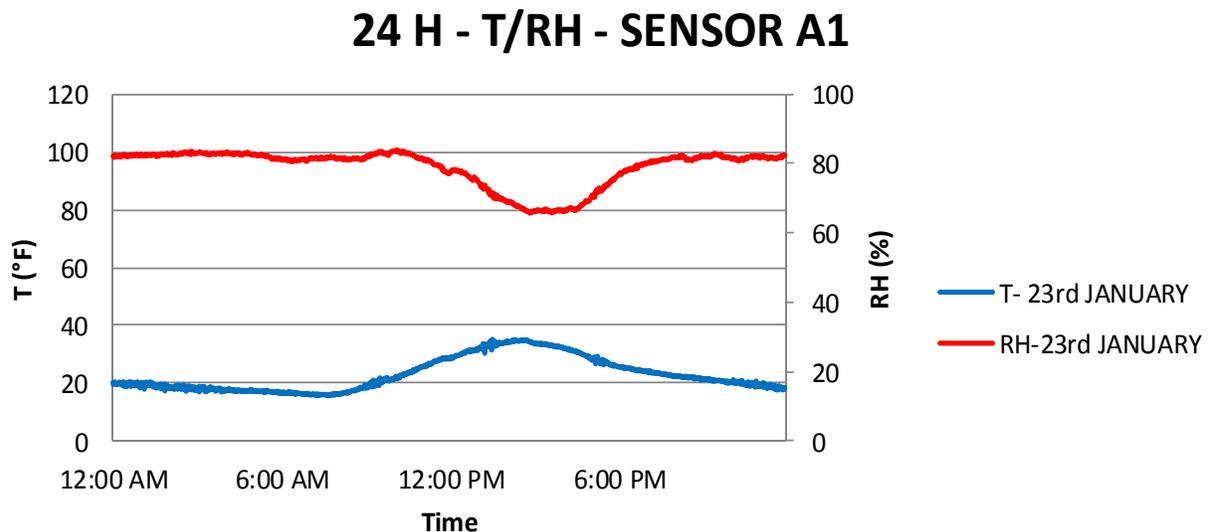
Figure 202. Graph. Temperature and relative humidity over a 24-h period.

In examining the temperature and relative humidity data inside the cable over a 24-h period, it was confirmed that there was a direct and inverse correlation between these two quantities (e.g., as the temperature rises the humidity level decreases, confirming the results from the laboratory phase). Figure 202 shows the recorded temperature and relative humidity recorded by sensor A1 located on the top portion of the cable cross section on January 23, 2011. As the temperature increased from 20 to about 38 °F (-6.67 to 3.33 °C) (around 3 p.m.), the relative humidity decreased from 100 to 80 percent.

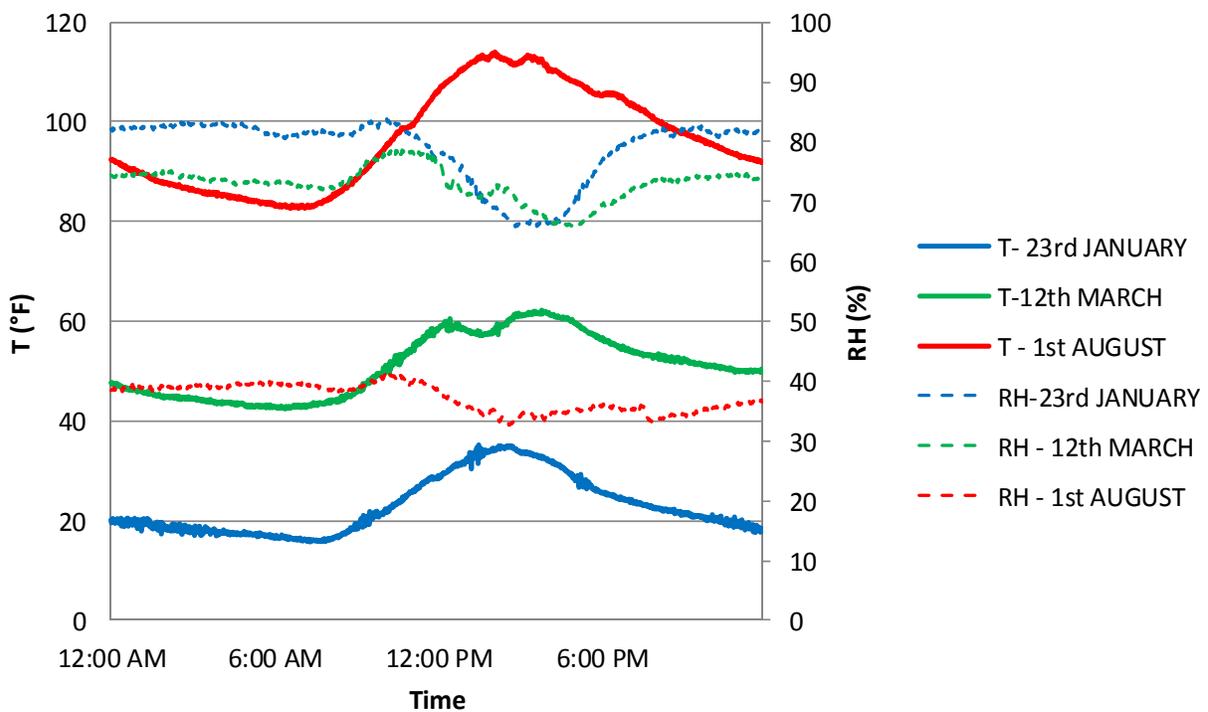
Figure 203. Graph. Temperature and relative humidity over a 24-h period showing variations from winter to summer.

A similar inverse trend is shown in figure 203 where the daily variations of the temperature and relative humidity are plotted for 3 days at different times of the year (representing winter, spring, and summer). In August, as the temperature rose from 85 to 110 °F (29.44 to 43.33 °C) and reached a peak at 3 p.m. in the afternoon, the relative humidity decreased from 40 to 30 percent. In cooler months of the year (e.g., January and March), the temperature values were much lower (between 40 and 60 °F (4.44 and 15.56 °C) in March and 20 and 35 °F (-6.67 and 1.67 °C) in January), and the relative humidity values were much higher (between 65 and 75 percent in March and 65 and 90 percent in January). As shown in the laboratory phase of the experimental testing, the relative humidity values were affected by many different environmental parameters that were not necessarily synchronized with the sensor readings (e.g., rainfall during previous rain can affect the reading of a sensor a few days later).

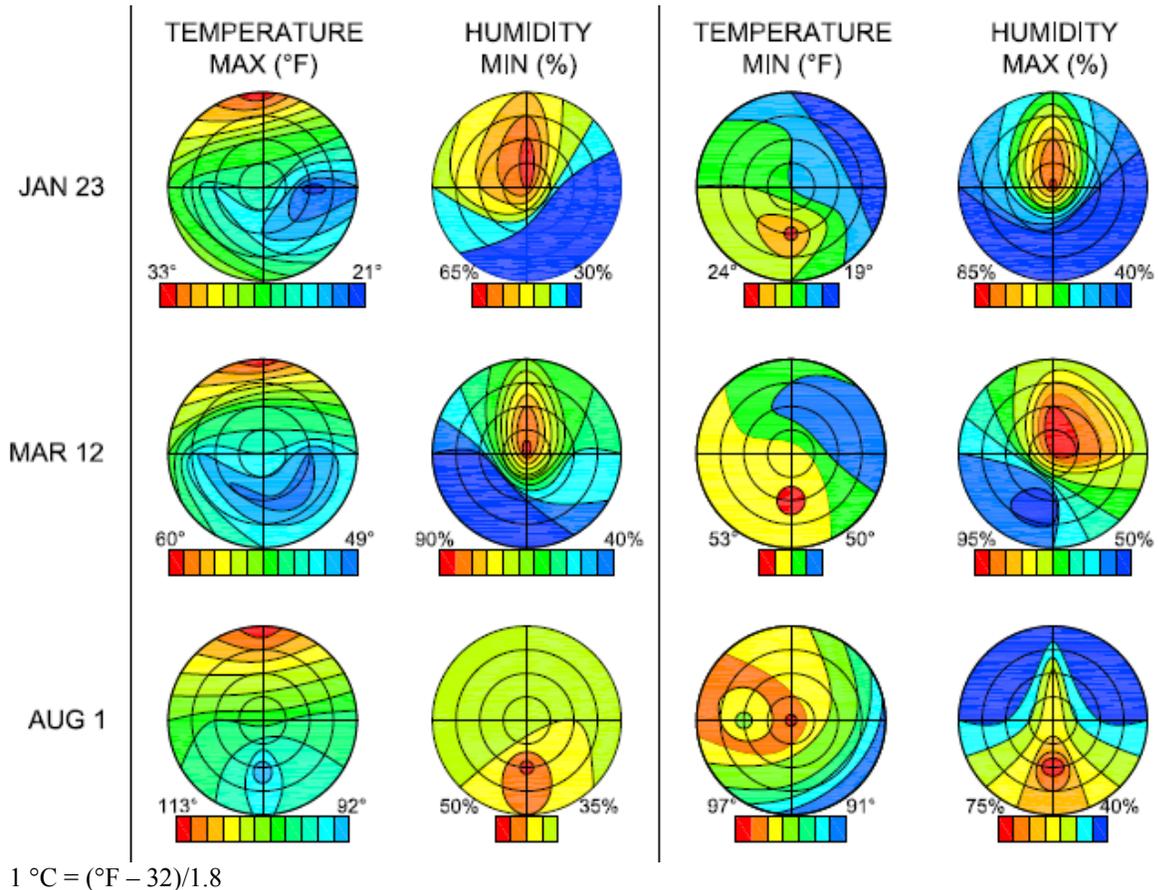
Figure 204. Illustration. Temperature and relative humidity relationship/distribution throughout the cable cross section during winter, spring, and summer.

In the figure, red represents the highest range value, while blue indicates the lowest range value. Additionally, the left column reflects daytime distribution, and the right column reflects nighttime distribution. With regard to the corrosion rate sensors (LPR, CMAS, and BM), all of the sensors provided some useful and consistent measurement of corrosion activity. For example, all sensors showed that no corrosion activity was detectable when the relative humidity was below 45 percent. The relation between relative humidity and corrosion rate is shown in figure 205 for the LPR sensor A3 and figure 206 for the BM sensor C3.

In order to analyze the temperature and humidity distribution across the cable cross section between day and night and also between winter and summer, the maximum and minimum values of the temperature and relative humidity recorded during different days were plotted. Figure 204 shows an actual mapping of the maximum and minimum temperature and humidity readings taken from the all the sensors in the cross section of cable. These maps clearly show that the distribution of temperature and humidity as not uniform across the cable cross section and that the bottom and shaded side portions of cable were likely to retain higher levels of humidity than the upper portion. Moreover, the daytime exhibited higher temperatures and lower humidity. In

addition, when comparing the humidity levels between summer (August) and winter (January), the internal relative humidity level was higher in the winter than during the summer.

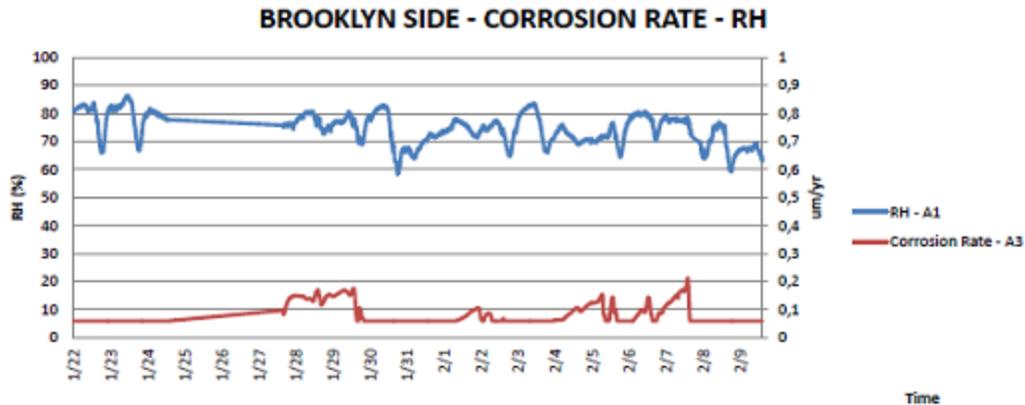
Figure 205. Graph. Relative humidity versus corrosion rate measurement for LPR sensor.

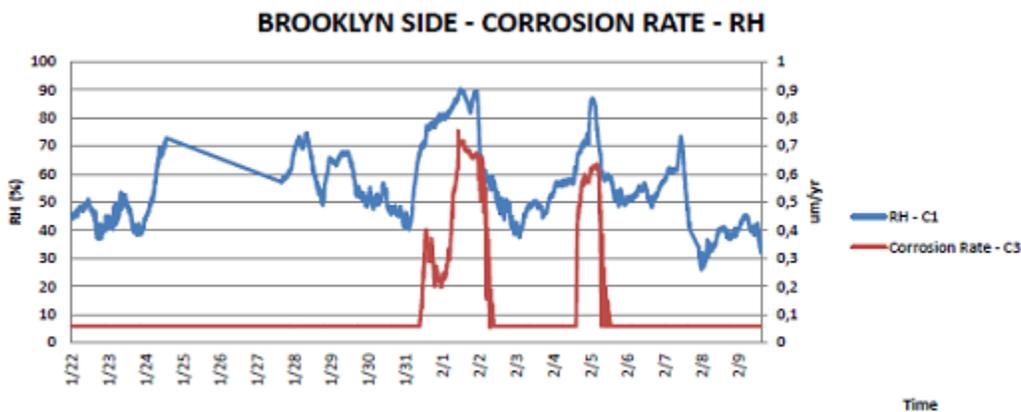
Figure 206. Graph. Relative humidity versus corrosion rate measurement for BM sensor.

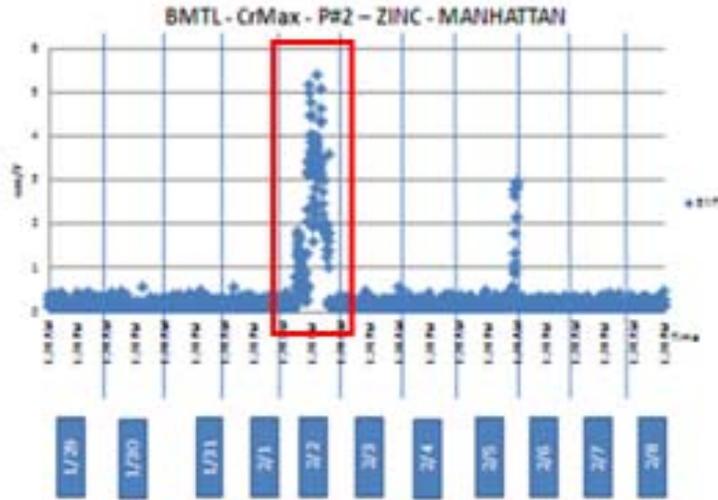
Figure 207. Graph. Increases in zinc corrosion recorded by BM sensor.

An interesting event occurred between January 31 and February 3, 2011. During these 3 days, all the corrosion rate sensors installed in the Manhattan panel (between panel points 14 and 15) recorded a potential onset of corrosion activity. During these 3 days, there was a substantial snowfall followed by heavy rain. The BM corrosion rate sensor recorded a spike in both zinc and steel corrosion rates. The zinc sensor recorded an increase in the corrosion rate of approximately 0.0002 inch/year (5 $\mu\text{m}/\text{year}$), while the corresponding steel corrosion rate reached a value of 2.16×10^{-5} inch/year (0.55 $\mu\text{m}/\text{year}$) (see figure 207 and figure 208). Similarly, the LPR sensors recorded an increase in the corrosion rate of approximately 2.76×10^{-5} inch/year (0.7 $\mu\text{m}/\text{year}$) (see figure 209). Overall, it took approximately 24 h before the corrosion rate returned to normal (i.e., no corrosion) for all sensors. As an example, temperature, relative humidity, and corrosion rate data recorded on the bridge during the months of March and April are provided in appendix B.

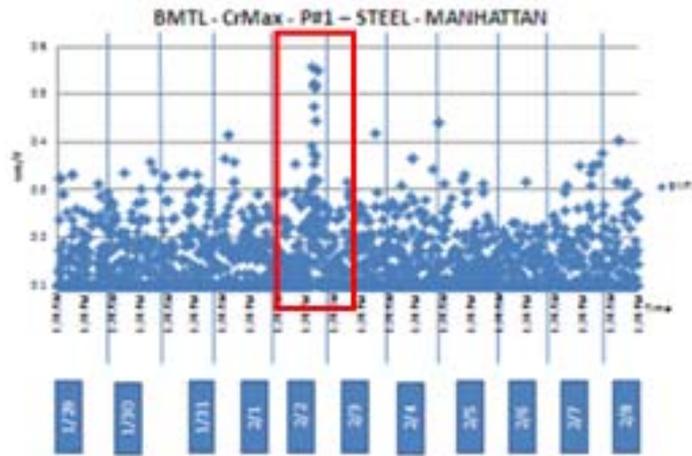
Figure 208. Graph. Increases in steel corrosion recorded by BM sensor.

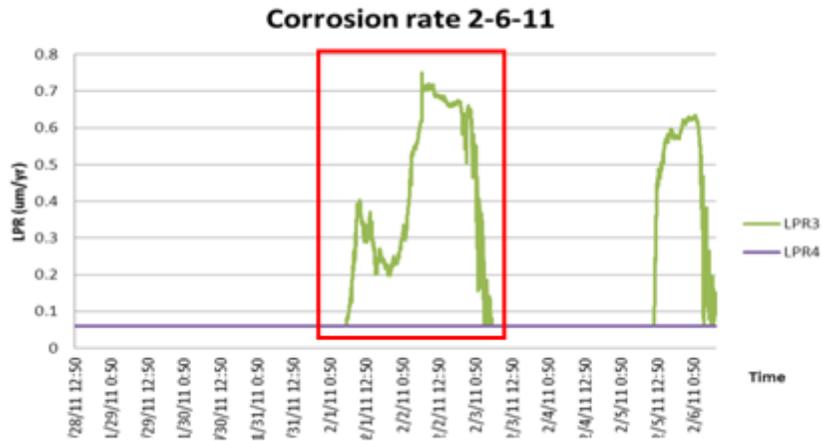
Figure 209. Graph. Increase in corrosion rate recorded by LPR sensors.

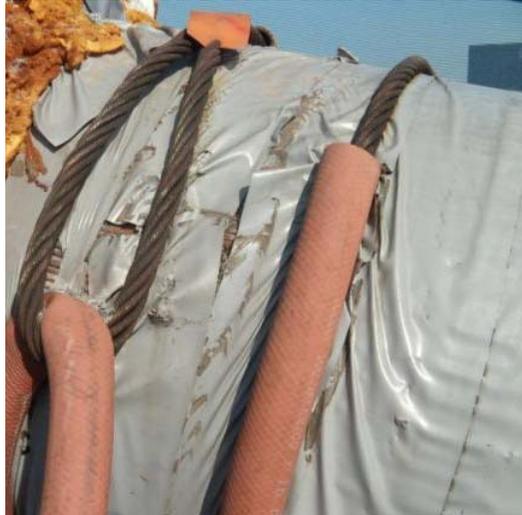
Figure 210. Photo. Damaged neoprene wrapping due to construction activity on the bridge.

Following the measurement of what could be interpreted as an onset of corrosion activity, a visual inspection of the cable panels revealed that the neoprene wrapping used in these two panels was damaged due to construction activity (see figure 210). This sizeable opening might have been responsible for the penetration of water inside the cable.

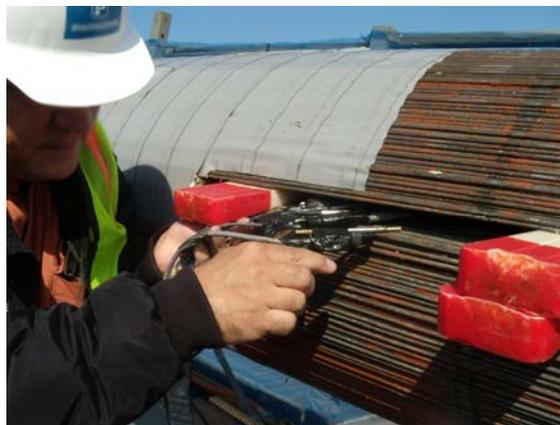
Figure 211. Photo. Decommissioning of the monitoring system by wedging the cable and pulling the sensors out.

Upon completion of the 11-month monitoring, the cable wrapping was removed, and the cable was wedged open to retrieve the sensors, as shown in figure 211 and figure 212. The cable open groove was closely inspected for any damage due to contact with the sensors, but no damage was found (see figure 213). The cable was protected with temporary wrapping until the rehabilitation contractor began the permanent wrapping operation.

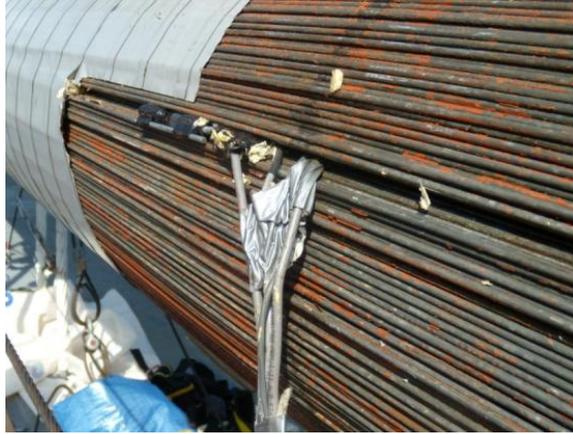
Figure 212. Photo. Wires from sensors prior to removal.

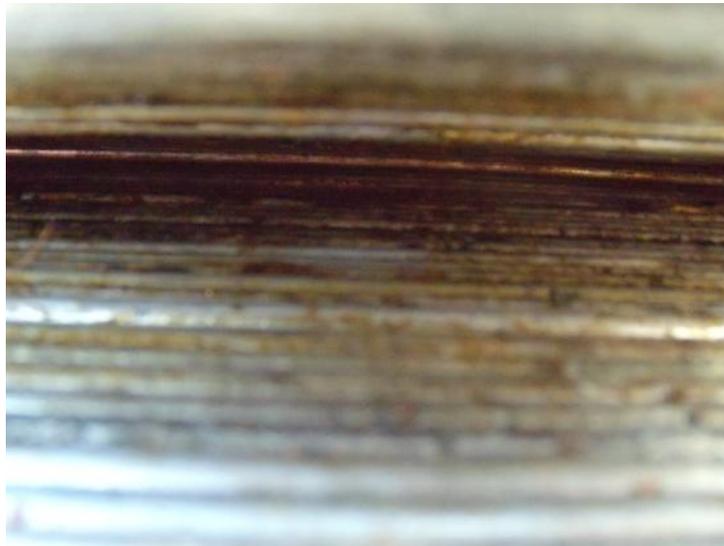
Figure 213. Photo. Close-up view of cable wires at the same location where the sensors were installed showing no damage to the main cable wire.

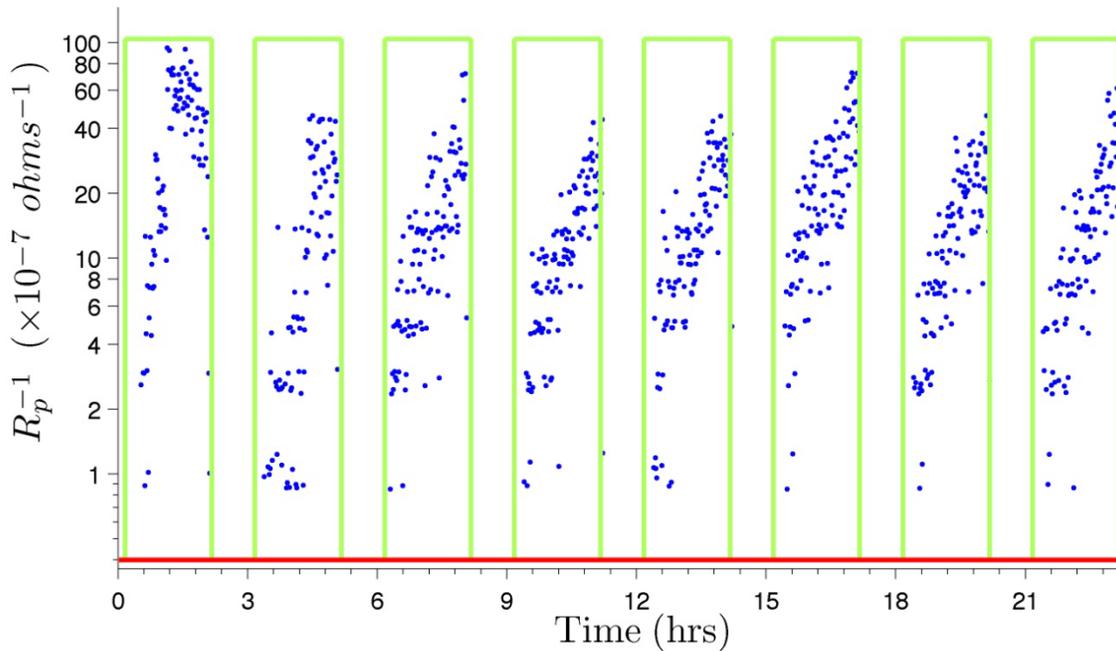
Figure 229. Graph. Inverse of R_p versus time.

As an example, the calculation of B' for the 0.006-inch (150- μm) LPR sensor used in experiment 1 is provided. In this experiment, only one 0.006-inch (150- μm) LPR sensor was placed in the chamber with the wires. Figure 229 shows the inverse of R_p readings for this sensor during the first eight cycles of experiment 1. Each data point on the plot corresponds to the inverse of R_p at a given instant in time and is proportional to the instantaneous corrosion rate value at that recording time, following the relation given by figure 226. The integration of this time series (multiplication of these values by the sampling interval (1 min) and summation of all these products) yields the denominator of figure 227.

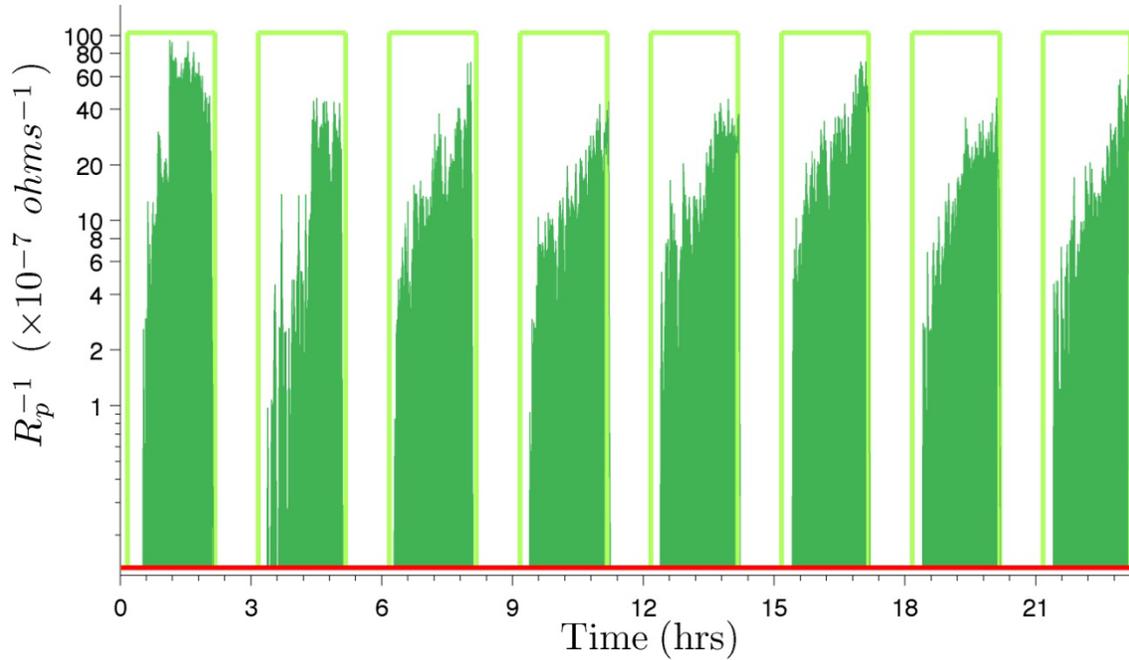
Figure 230. Graph. Integration of inverse of R_p .

The integrated area is shown for the first eight cycles of experiment 1 in figure 230. The area for the entire duration of the test (its integration) is 7.1020×10^{-3} min/ohms.

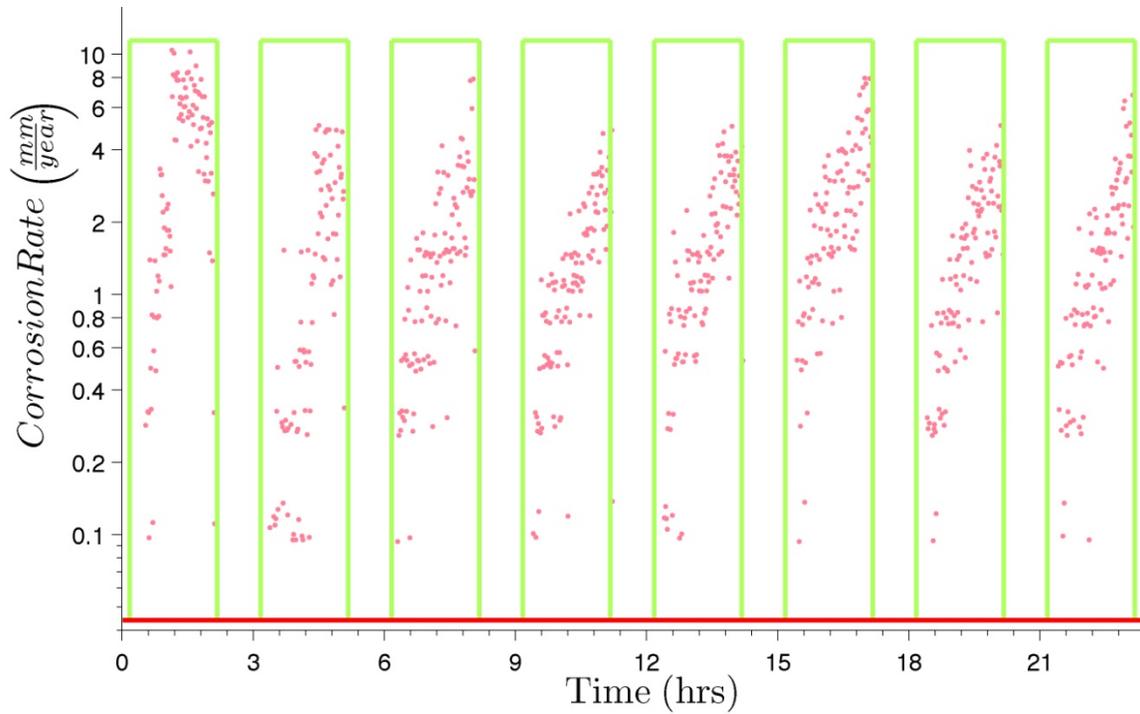
Figure 232. Graph. Instantaneous corrosion rates versus time.

Hence, when using measurements from the 0.006-inch (150- μm) LPR sensors, dividing this value of B' by R_p will provide an instantaneous measurement of the corrosion rate of the wire. Figure 232 displays the instantaneous corrosion rate values calculated using the overall proportionality constant B' .

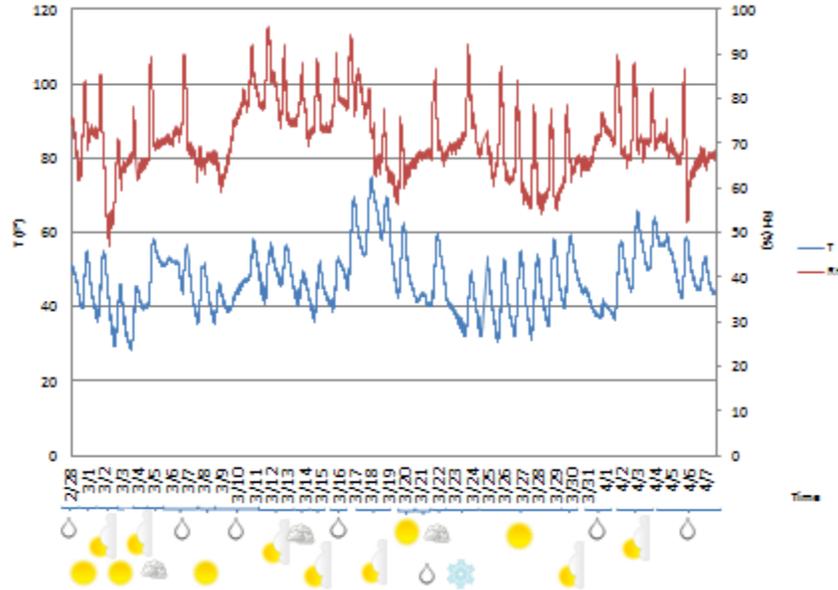
Figure 233. Graph. Temperature-relative humidity measurements for sensor A4 on Brooklyn side in March 2011.

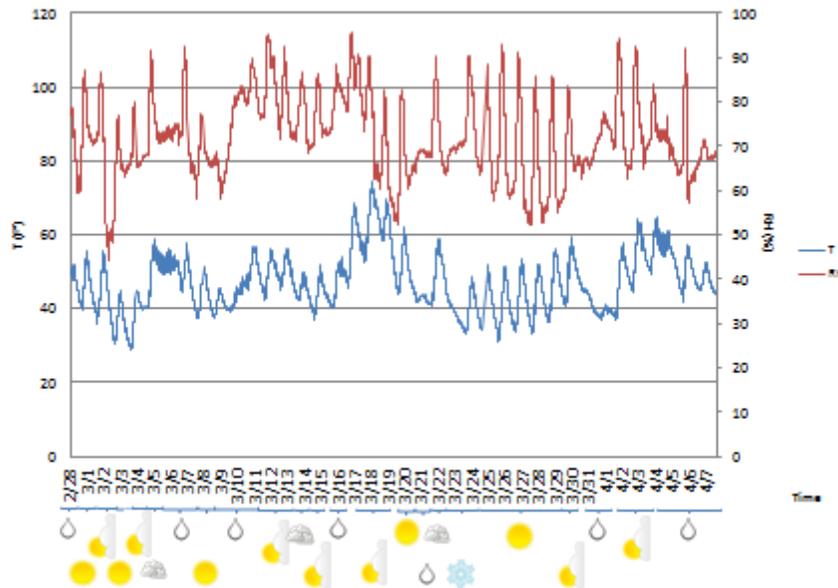
Figure 234. Graph. Temperature-relative humidity measurements for sensor A5 on Brooklyn side in March 2011.

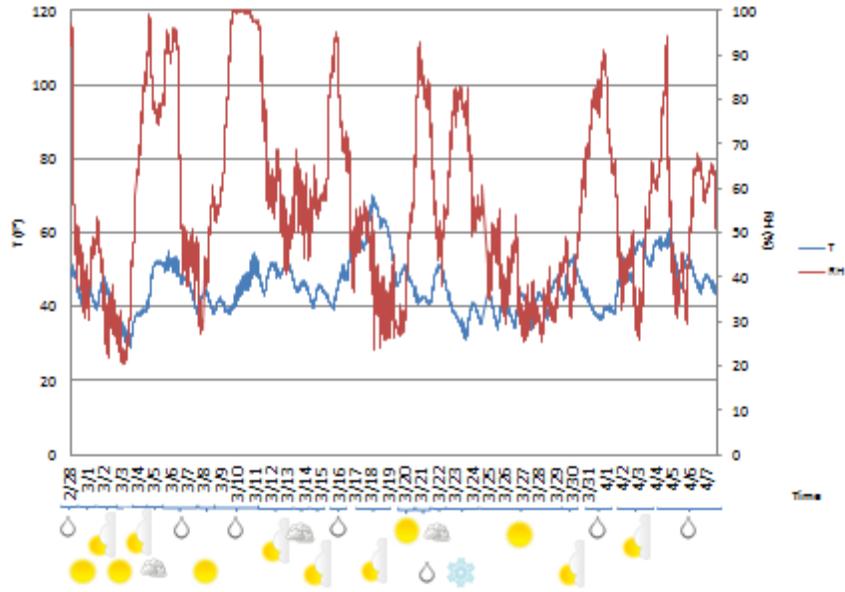
Figure 235. Graph. Temperature-relative humidity measurements for sensor B4 on Brooklyn side in March 2011.

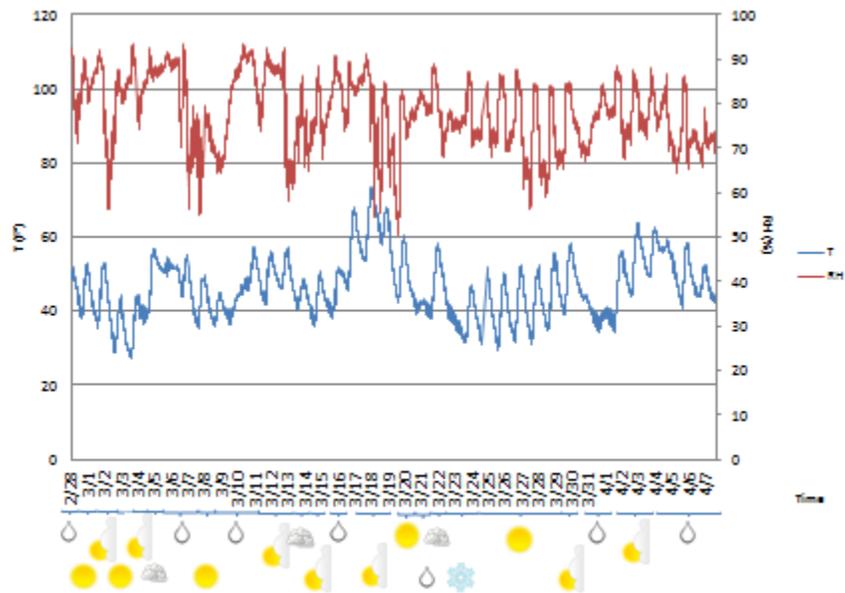
Figure 236. Graph. Temperature-relative humidity measurements for sensor A4 on Manhattan side in March 2011.

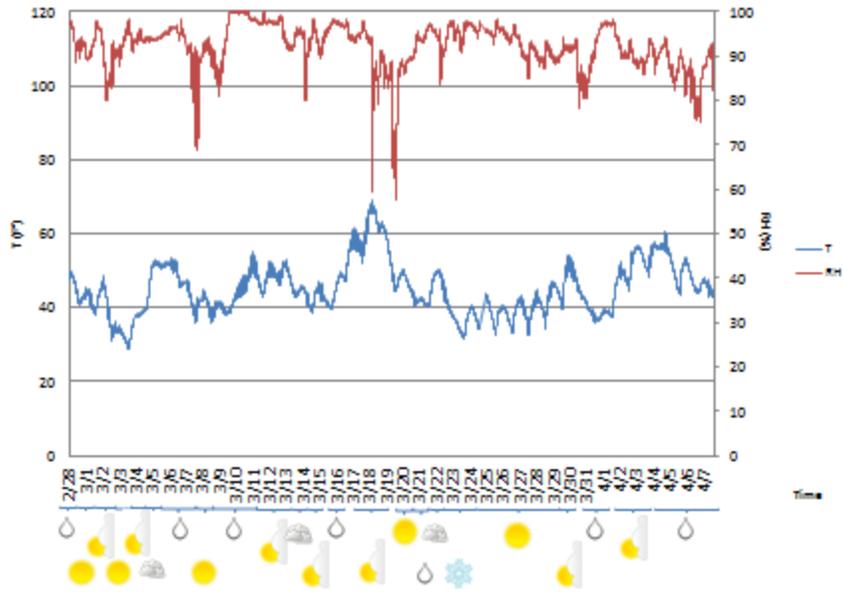
Figure 237. Graph. Temperature-relative humidity measurements for sensor B4 on Manhattan side in March 2011.

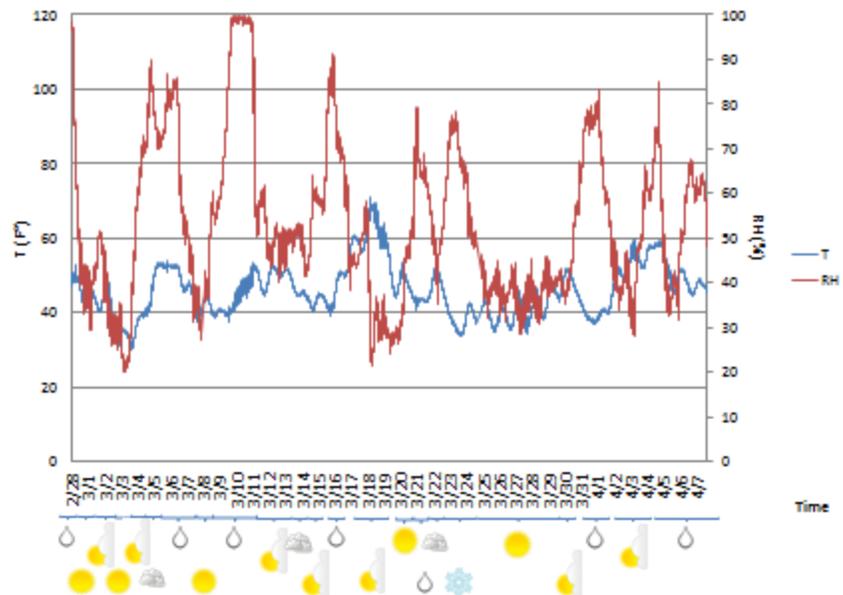
Figure 238. Graph. Temperature-relative humidity measurements for sensor C6 on Manhattan side in March 2011.

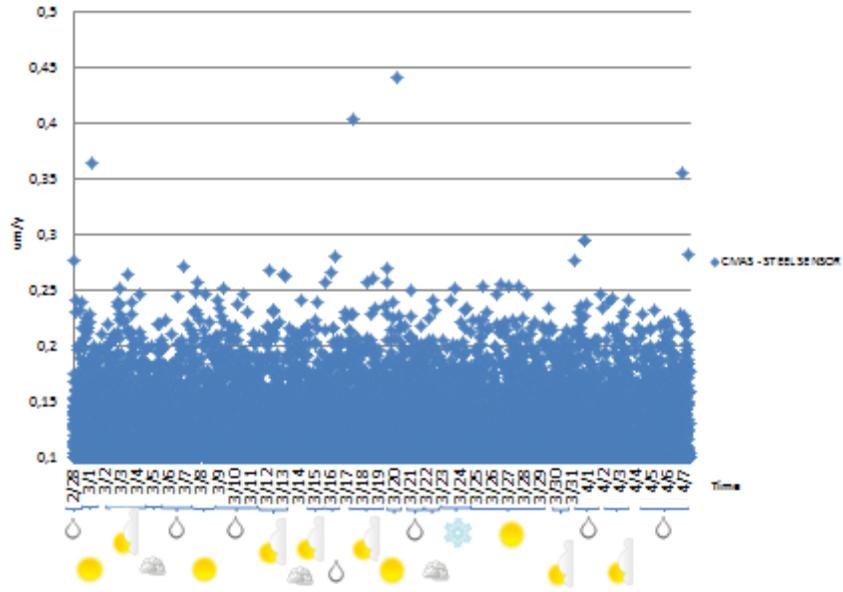
Figure 239. Graph. Corrosion rate measurements for CMAS CS sensor in March 2011.

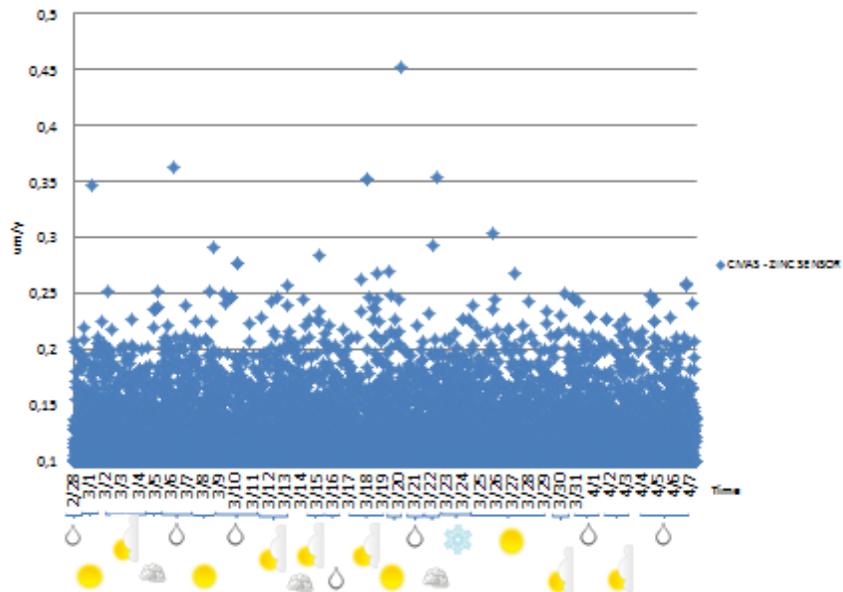
Figure 240. Graph. Corrosion rate measurements for CMAS Zn sensor in March 2011.

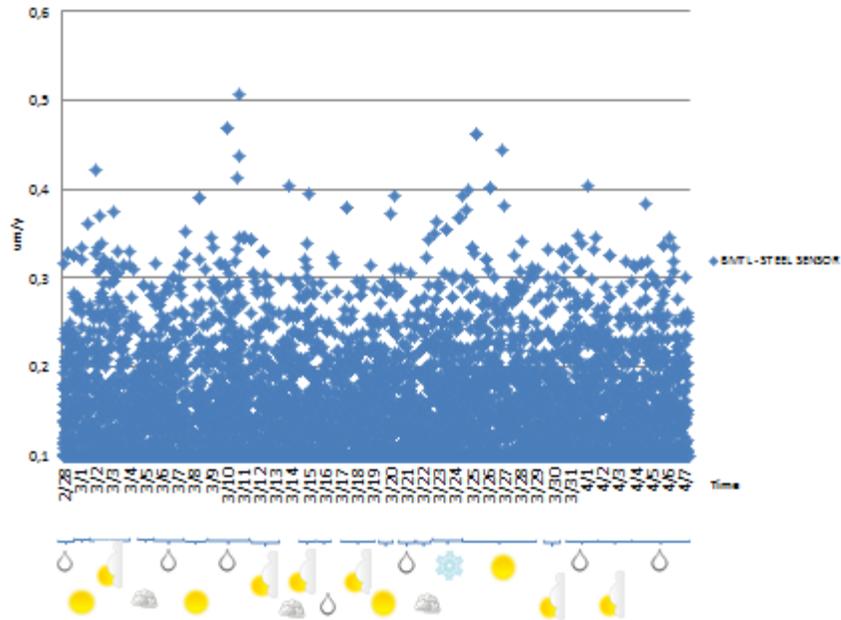
Figure 241. Graph. Corrosion rate measurements for BM CS sensor in March 2011.

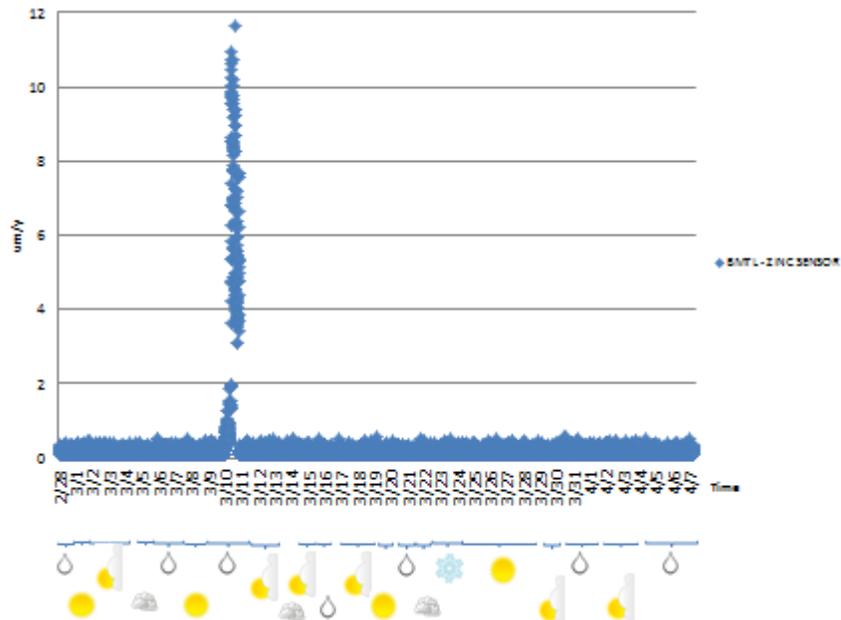
Figure 242. Graph. Corrosion rate measurements for BM Zn sensor in March 2011.

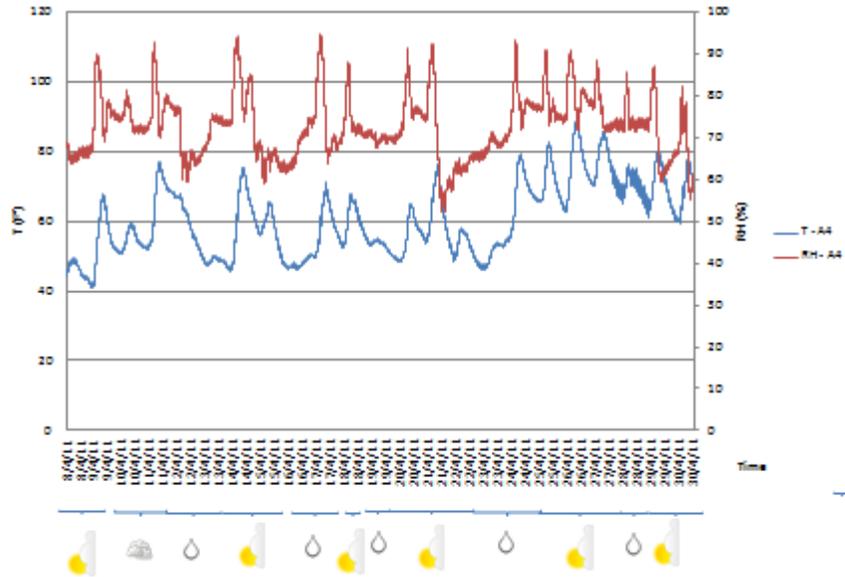
Figure 243. Graph. Temperature-relative humidity measurements for sensor A4 on Brooklyn side in April 2011.

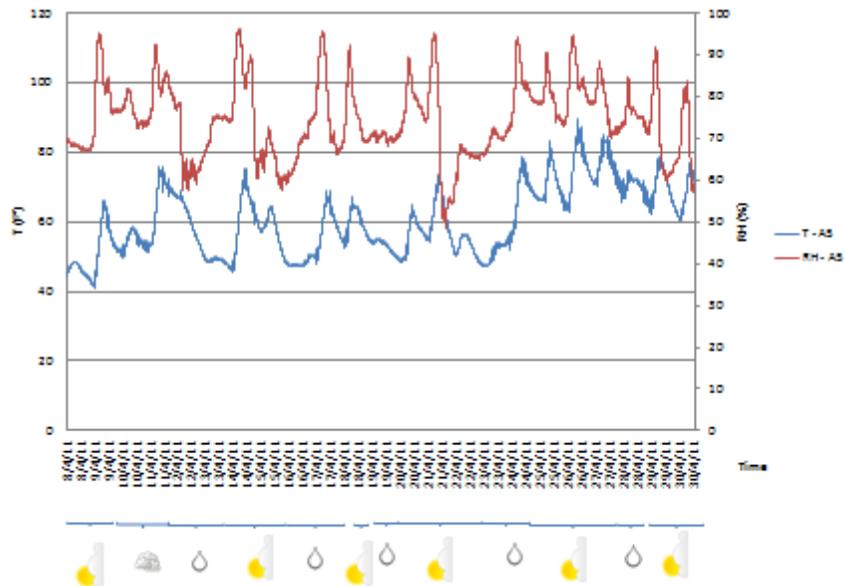
Figure 244. Graph. Temperature-relative humidity measurements for sensor A5 on Brooklyn side in April 2011.

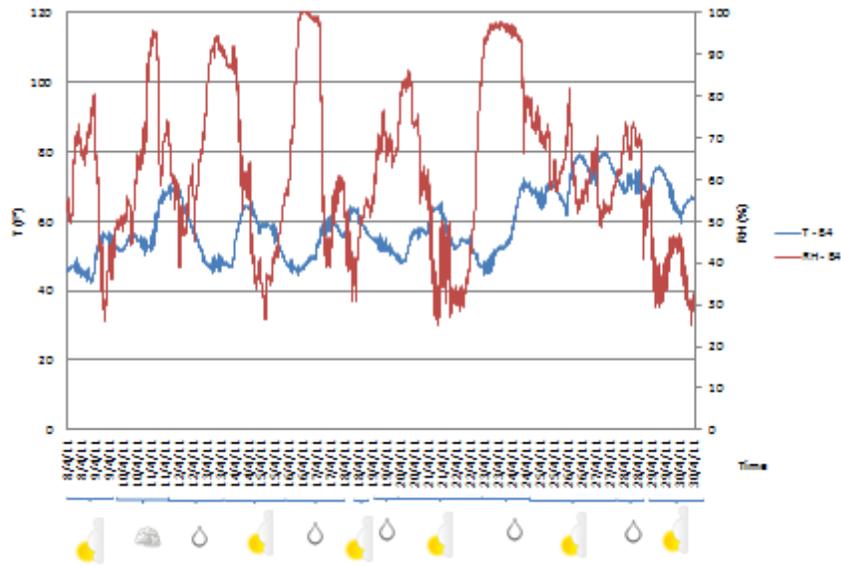
Figure 245. Graph. Temperature-relative humidity measurements for sensor B1 on Brooklyn side in April 2011.
