IMPLEMENTATION SUPPORT FOR STRATEGIC HIGHWAY RESEARCH PROGRAM II (SHRP2) RENEWAL PROJECT R21 NEW COMPOSITE PAVEMENT SYSTEMS

Tennessee DOT Two-Lift Concrete Pavement Construction Project: I-65 NB Shoulder

This report documents the construction of a two-lift concrete composite pavement by the TDOT on October 21 - 22, 2014.

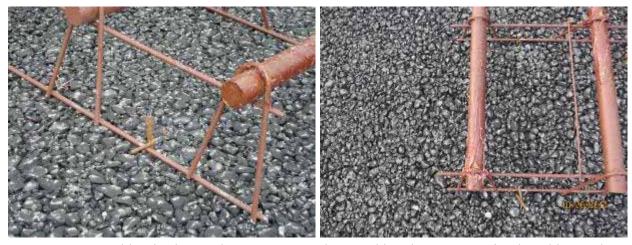
Dowel bar basket anchors.

b. Bond breaker on opposite dowel bar ends.

Dowel baskets were anchored to the base, with the first dowel being located 3 to 6 inches from the adjacent travel lane joint (see figure 4a). A bond breaker was applied on one-half of each dowel, alternating ends across the basket length (see figure 4b).

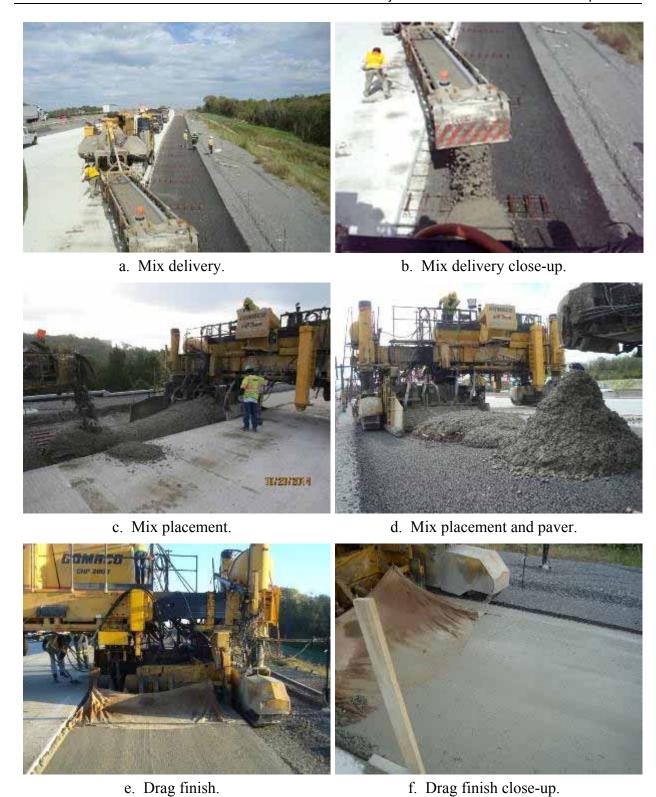
Figure 7. Placement of bottom lift.

The bottom lift concrete was placed using a Gomaco Model 9500 Belt Placer, paving was performed using a Gomaco GHP 2800, and finished using a burlap drag (see figure 7). Additional construction photos are provided in Appendix E.

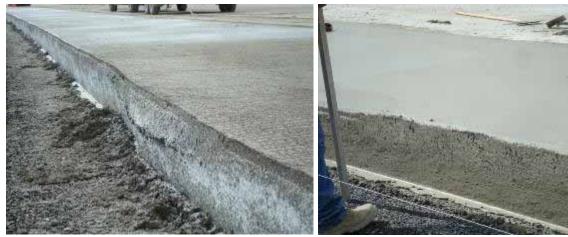
a. Significant edge slump.

b. Edge slump.

The top lift concrete mixture appeared to have a higher slump than expected, particularly on the first day of paving. Since this mixture was encapsulating the bottom lift by as much as 12 inches wide on the outside and to a depth of 13 inches, there were some areas with significant amounts of edge slump and "blowouts" (see figures 12a and 12b). The workers struggled valiantly to repair and shore up these areas (see figure 12c), but the result was a wandering shoulder edge and probably some edge depressions (although this was not verified with a straightedge) (see

figure 12d). It seems likely that these problems were caused by a combination of the higher-slump top lift material and the very wide encapsulation.

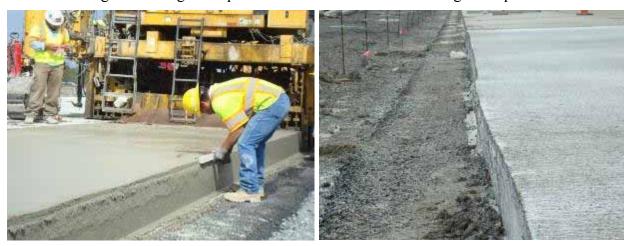
c. Workers effort to repair edge slump.

d. Wandering edge in high slump area.

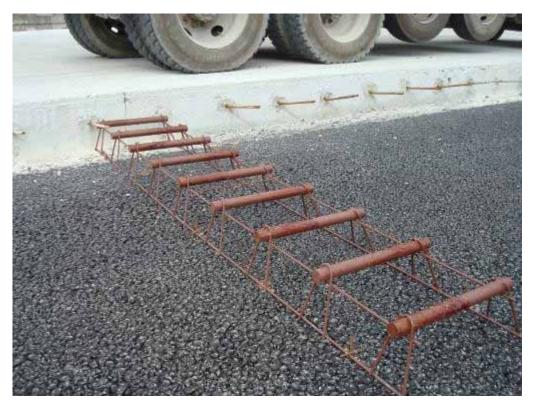
Photo E-3. Dowel basket anchored to asphalt-treated permeable base.

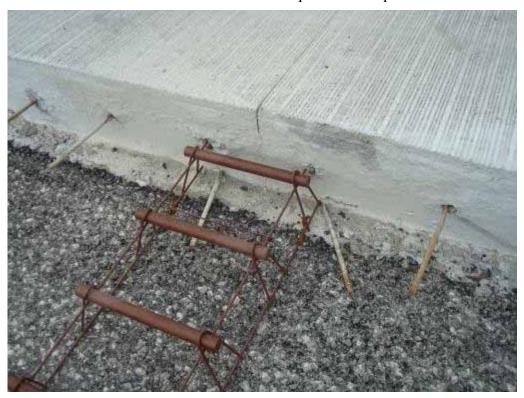
Photo E-4. Dowel basket placement showing proximity to travel lane and interfering with tie bars.

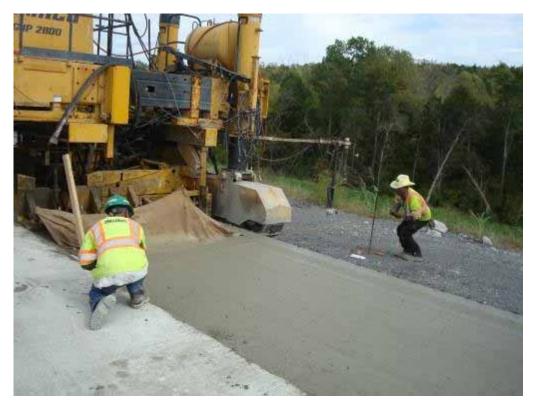
Photo E-19. Workers checking bottom lift elevation and profile using stringline.

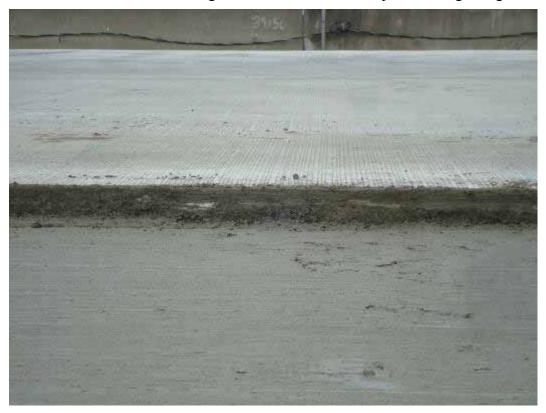
Photo E-20. Bottom lift surface behind paver (note: top lift will need to be more than 3 inches thick in this area).

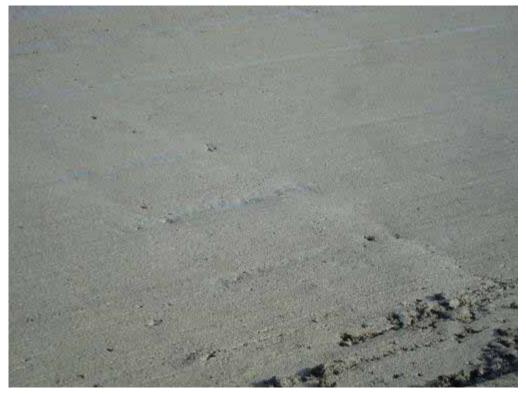
Photo E-22. Bottom lift surface "shadowing" due to proximity of dowels (thin lift).

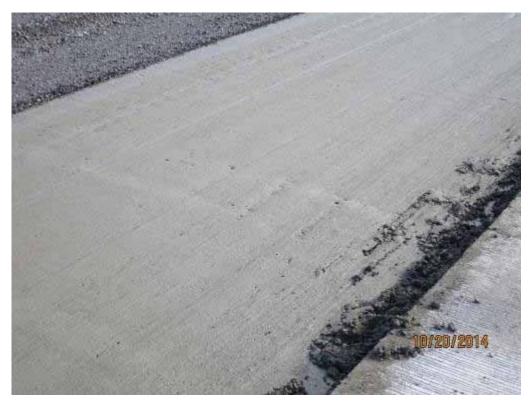
Photo E-23. Dowel "shadowing" and surface depressions and debris near end of Day 1 placement of bottom lift.

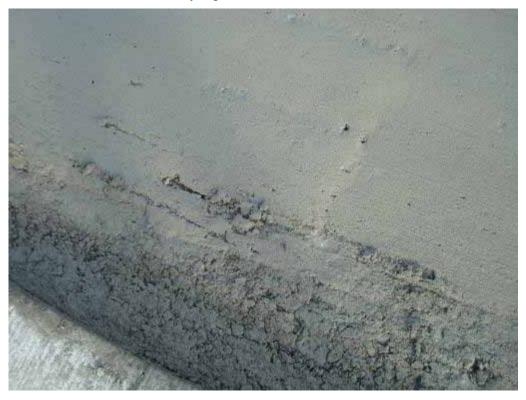
Photo E-24. Exposed dowel end in bottom lift due to thin lift.

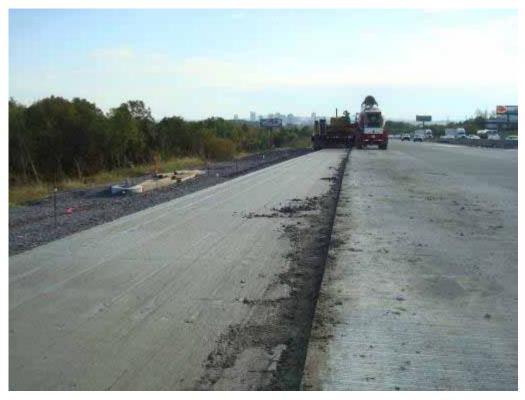
Photo E-25. Dowel "shadowing" in bottom lift surface and surface condition ahead of top lift placement at end of Day 1.

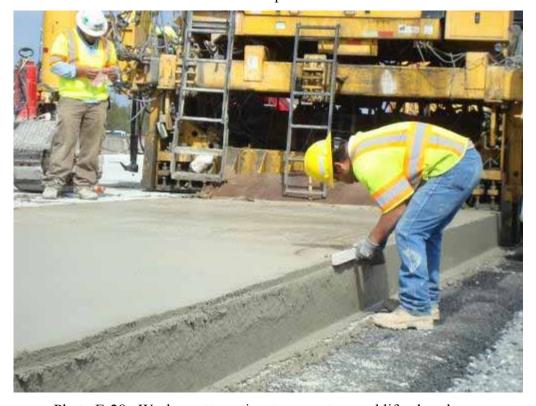
Photo E-28. Workers attempting to correct second lift edge slump.

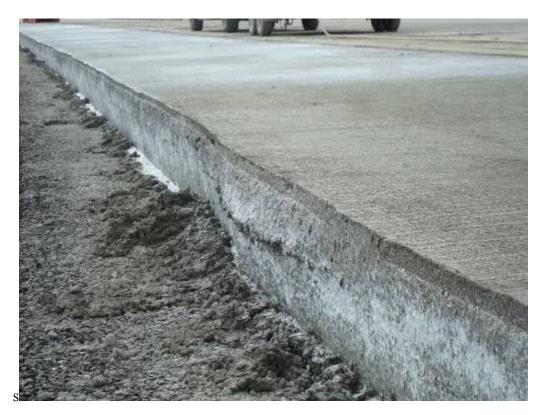
Photo E-31. Edge blowout #1.

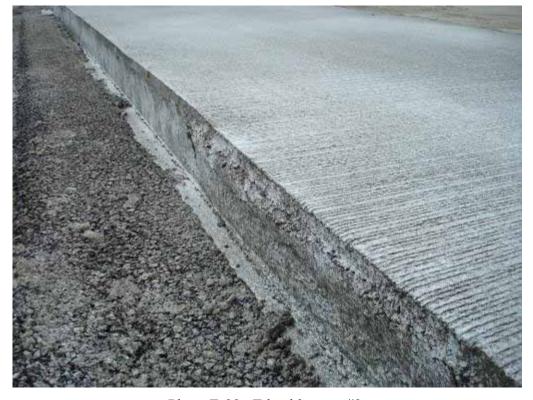
Photo E-32. Edge blowout #2.

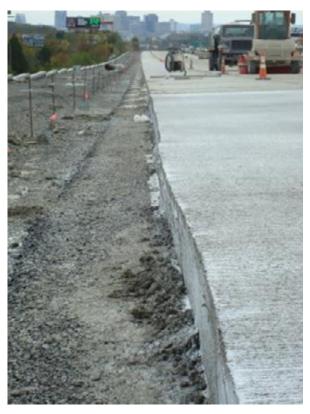
Photo E-33. Edge blowout #2 after repair.

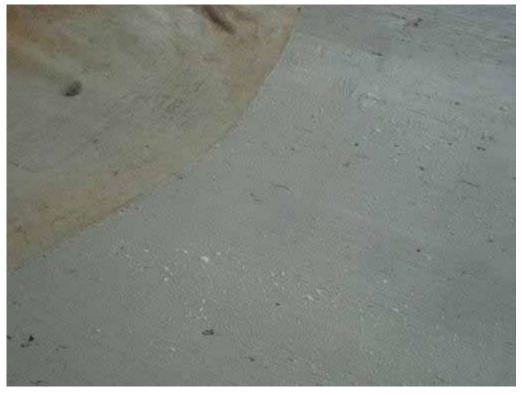
Photo E-34. Free water and bubbles on surface of bottom lift due to excessive water application to burlap drag.

The paver operators were frequently observed spraying water on the mixture in front of the paver and on the burlap and pavement behind the paver (see figure 13a). This was true for both the bottom and top lifts. In some cases, the trailing burlap for the top lift was so wet that bubbles and excess water were clearly visible on the pavement surface, and the finishers frequently pulled "waves" of mortar off of the pavement surface with bull floats (see figure 13b). Conversations with the paver operators indicated that the crews were not well-informed about the concepts and fundamentals concerning two-lift paving. The main concern with the presence of excessive surface water include reduced surface durability (scaling, poor wear resistance), as well as a higher potential for map/shrinkage cracking.

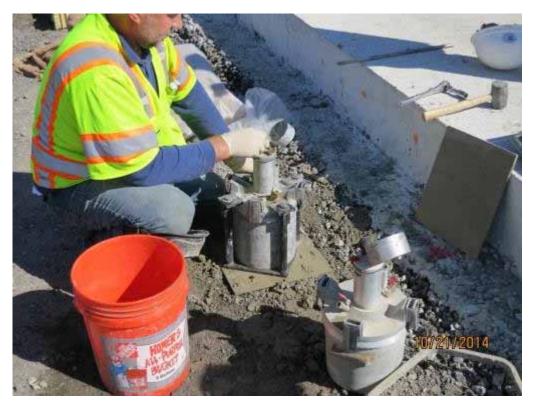
Photo E-47. Testing concrete using Super Air Meter (SAM).

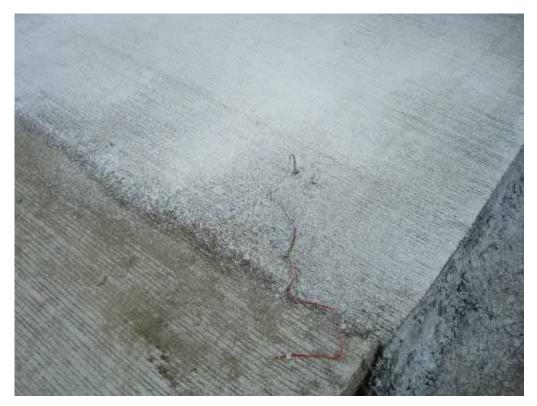
Photo E-55. Thermocouple/maturity sensor installation at south end of project.

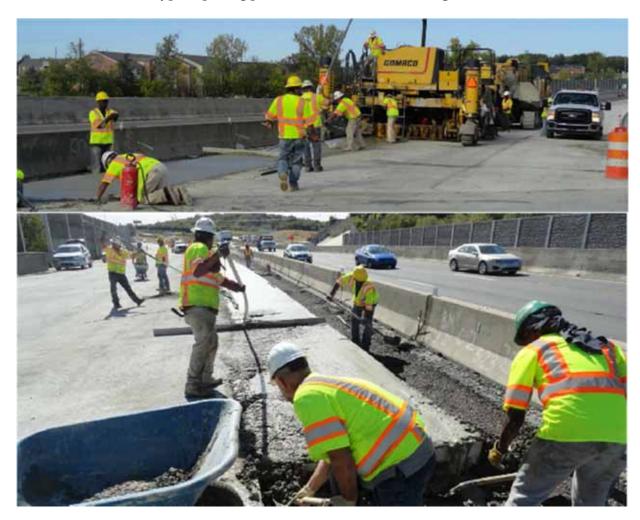
Figure 16: Construction of the shoulder using the conventional mixture

Figure 16 shows the activities during construction of the concrete shoulder using the conventional concrete. Typical paving practices were followed during this section construction.

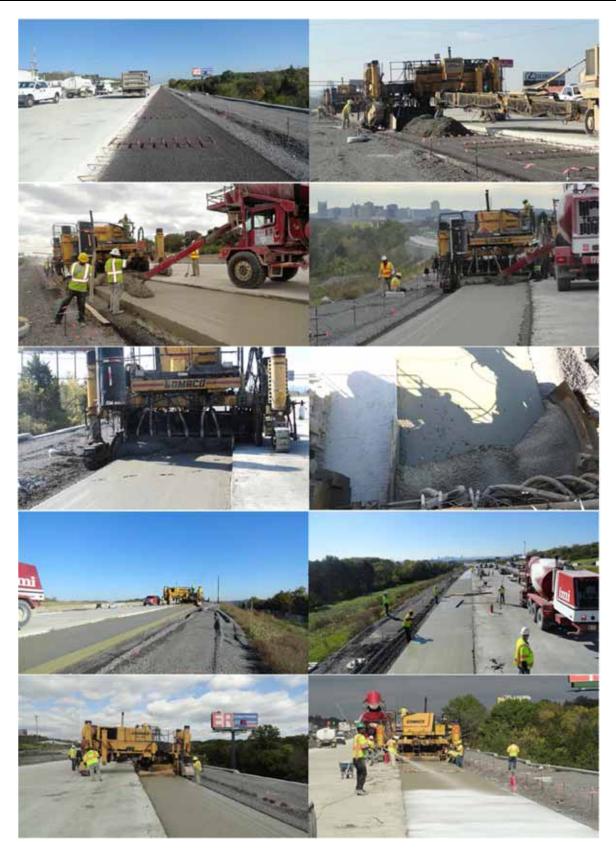
Figure 17: Composite Pavement Construction

Photos in Figure 17 show some of the activities that took place during construction of the composite pavement shoulder. The bottom lift concrete was placed on HMA base. Dowels were placed using dowel baskets and shipping wires were left uncut. The shoulder was tied to the existing concrete pavement using tie bars. The operation consisted of two pavers; one for each lift. Concrete for the bottom lift was placed using a belt placer. After the bottom lift was paved, concrete for the top lift was directly placed on top of the bottom lift from ready mixed trucks. Due to paving equipment limitation, the top lift was placed one foot wider than the bottom. The 5000' long section was completed in four days. The finished pavement was burlap dragged. Figures 18 and 19 show the overall paving train. One of the interesting features of this project is the use of maturity concept for opening pavements to construction traffic.

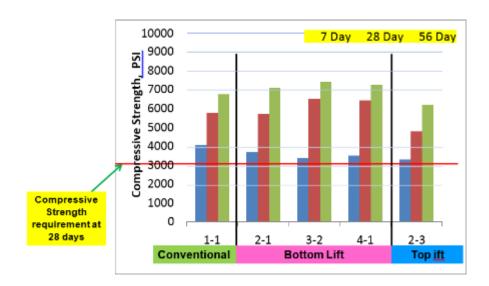
Figure 26: Compressive Strength versus Age

It is interesting to note that even though the top lift mixture had a higher cementitious content than the bottom lift mixture, the compressive strength of the top lift mixture sample was lower than that of the bottom lift samples. The gap gradation of the top lift mixture could have contributed to the difference in strength with the bottom lift. It could also be noted that for the 3-2 and 4-1 samples from the bottom mixture the rate of increase in strength from 7 to 28 days is significantly higher than the other three samples (1-1, 2-1 and 2-3).

Overall, in all three mixtures (five samples), the 28 day minimum compressive strength requirement of 3000 psi is exceed in only 7 days. Even though the three mixtures used in this project had low cementitious contents (between 526-571 lbs/yd3) and SCMs were used, it appears that there is still an opportunity to optimize the mixture design by reducing the cement content. Reducing the cement content would reduce cost as well as the potential for shrinkage (thereby reducing the risk of cracking) and would result in an environmentally "greener" concrete.

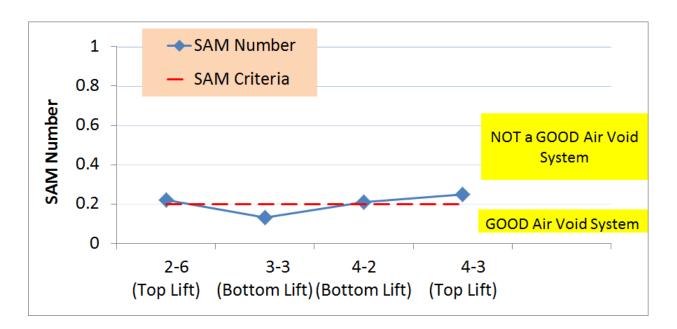
Figure 33: The Super Air Meter (SAM) Test Results

The SAM is a state of the art technology for measuring the air void system of fresh concrete. As mentioned previously, the MCL is currently evaluating the SAM by using it in several field projects and correlating SAM data with Freeze-Thaw and Hardened Air Content Test (ASTM C457) tests. The SAM has the potential to revolutionize the way air is tested in concrete. Some of the advantages of SAM are its ease of use, economical, rapid results, and field implementable.

- 7. All the four samples (two from bottom lift and two from the top lift) tested in this project using the Super Air Meter had a "SAM" number close to 0.2 which is classified as having a GOOD air void system to resist damage from freezing and thawing. The SAM is a state of the art technology for measuring the air void system of fresh concrete. It has the potential to revolutionize the way air is tested in concrete. Some of the advantages of SAM are its ease of use, economical, rapid results, and field implementable.

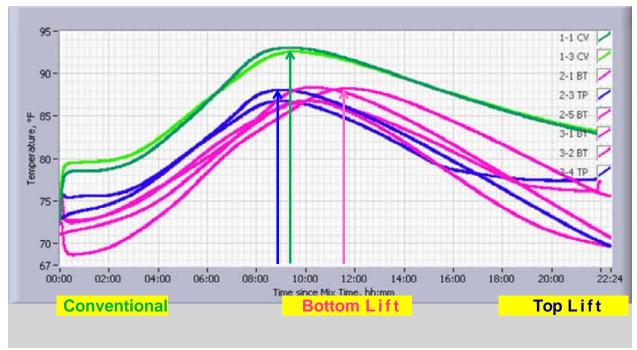
Figure 35: Heat Signature Curves from all three Mixtures

- 5. One of the bottom lift sample had a much lower starting temperature (~5°F) compared to the other bottom lift samples. This sample had delayed time of peak temperature.
- 6. The calorimeter data matches well with the 56 day strength data (Figure 30).

Measuring heat signature using a semi-adiabatic calorimeter is a very easy and relatively inexpensive test to perform. The test requires a standard cylinder to be cast from a concrete sample and put in the calorimeter. The initial temperature of the concrete and time of placing the cylinder mold in the apparatus is noted. For such a simple test, the heat signature data can be used for a variety of purposes such as identifying changes in source and quantities of cementitious materials as well as detect any incompatibilities during production. The semi-adiabatic device that was used by the MCL in this project is designed to be used in a laboratory as well as field setting.

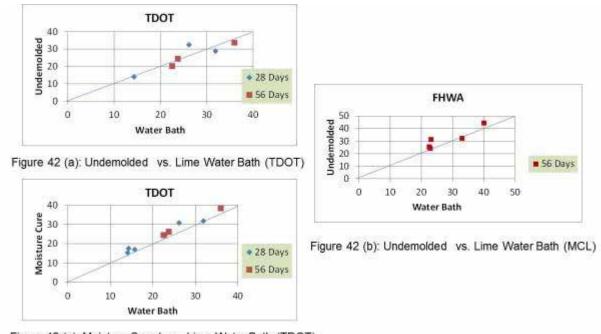
Figure 42 shows the results between various curing conditions from TDOT and the MCL. The figures show that there was not a significant difference in resistivity measurements between specimens that were demolded and cured in limewater bath and those that was non-demolded and left in lime water baths.

Interestingly, there was slight difference in resistivity measurements between moisture cured and lime water bath cured specimens. Almost all the data points in Figure 42 fell slightly above the line of equality. The SR results of the moisture cured specimen in Figure 42c were corrected per AASHTO TP95 (increased the actual measurements by 10% by multiplying the measured SR measurements with 1.1).

Figure 42 (c): Moisture Cured vs. Lime Water Bath (TDOT)

Figure 42: Comparison of various curing conditions

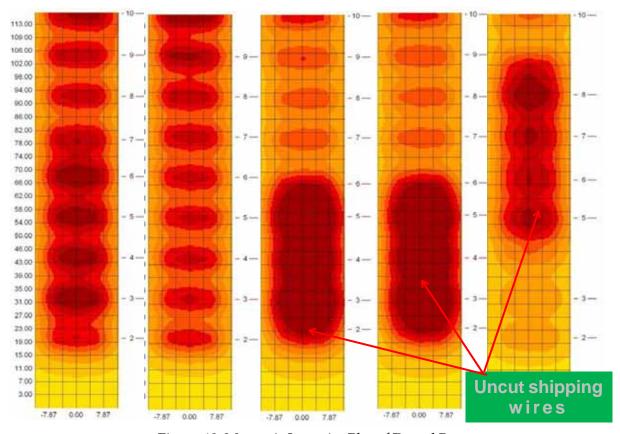
Figure 48: Magnetic Intensity Plot of Dowel Bars

For Figure 48, the individual magnetic images for the first two joints appear to be distinct. However, the magnetic images at the remaining three joints appear to coalesce together. This is because the shipping wires were not cut at these joints and due to this a magnetic loop is formed around the basket. This magnetic loop yields a large area of red instead of distinct red horizontal bars as seen at the other joints where the shipping wires were cut. Overall, however, based on all the magnetic images in Figure 47 and 48, it appears that all the dowels were well aligned without any issues at these ten joints. Appendix C shows the results for all the joints in Figure 47 and the first two joints in Figure 48 in a tabular form.

MIT Scan 2 is a very effective tool specifically designed to non-destructively identify the presence and alignment of dowel bars at a joint. The advantage with MIT Scan 2 is it can be used as soon as the pavement can be walked upon to check the presence and alignment of dowel bars and allows the contractor to take corrective action immediately. Coring is not typically resorted to unless dowel bar placement issues are suspected. Even in those cases, coring is not a good method to check the presence and alignment of dowel bars, since coring can be performed at only a limited number of joints. In addition, multiple cores have to be taken at each joint since taking one or two cores will not reveal the overall picture of dowel bar alignment at a joint. The major benefit of MIT Scan 2 is that it is nondestructive, results can be seen in a graphical display or a tabular format (Appendix C) immediately in the field for quality control and it is not too complicated to operate.

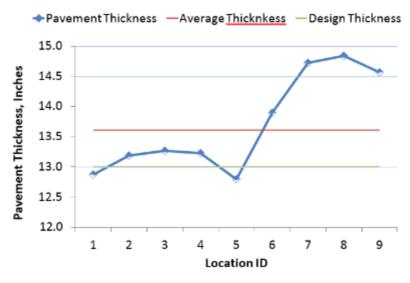
Figure 51: Pavement Thickness Measurements using the Scan T2

Even though data presented in Table 13 is only for one pavement thickness, there is published research which shows that the MIT Scan T2 works well and is accurate over a wide range of concrete pavement thicknesses and base conditions (5) and can be used in lieu of taking cores for measuring pavement thickness. MIT Scan T2 offers several benefits such as cost savings (in general, it is at least four times cheaper than taking cores in the long run), faster measurements (can take measurements as soon as the pavement can be walked upon), larger number of locations (more robust statistical analysis) and finally, it eliminates the need to cut cores on new pavements and thereby reducing the need to patch the core holes. Iowa DOT has adopted the and has started using it as part of their specifications (http://www.iowadot.gov/specifications/dev_specs/DS-09063.pdf).
