**Nondestructive Thickness of  
Distressed Concrete Pavement  
Using Impact-Echo**

**SPS-2, Interstate 10, Maricopa County, Arizona**

**FHWA MCL Project # 0207**

**SUMMARY REPORT**  
**LTPP Impact-Echo Thickness Determinations**  
**I-10, Maricopa County, Arizona**  
**December 2002**

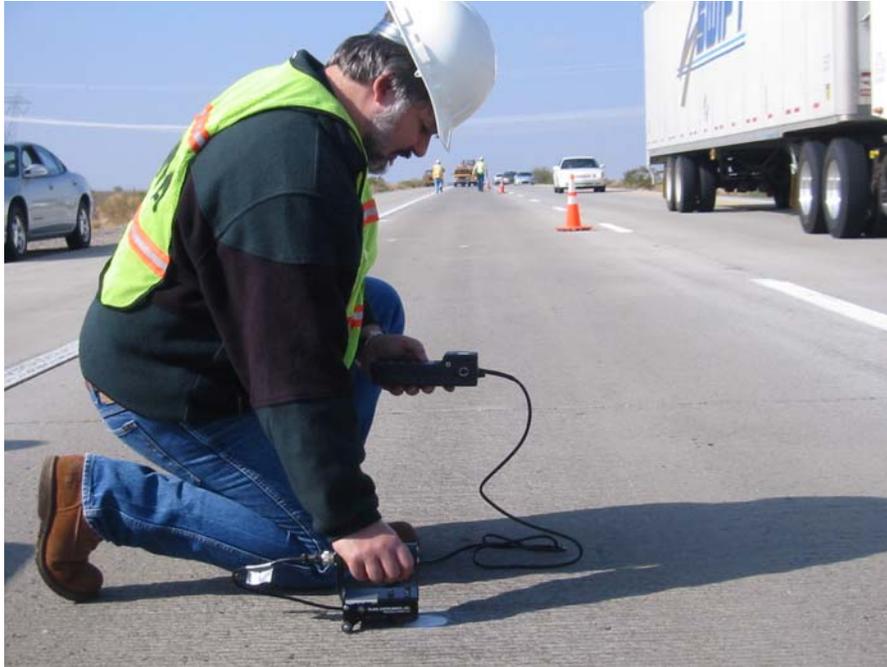
Figure 1. CTG-1 testing in progress.

**Testing:** During late November, 2002, Gary Crawford (FHWA/MCL), Gonzalo Rada (Mactec/LTPP), Jack Springer (FHWA/LTPP) and Leif Wathne (SaLUT/MCL) devised and agreed upon a test plan where each of 12 separate SPS-2 test sections would have 10 panels tested, with two IE thickness tests per slab (at mid-slab, 1.2 meters from edge and .2 meters from edge). SPS-2 sections were originally constructed to examine the effectiveness of different structural factors, such as drainage, concrete thickness, base type, concrete flexural strength, and lane width of doweled jointed plain concrete pavement (JPCP) sections, for various climatic regions, subgrade soils, and traffic rates. The test sections are located on eastbound I-10 west of Phoenix, near milepost 104. The majority of thickness testing was performed using a Concrete Thickness Gauge (Olson Instruments, CTG-1). This is an IE device tailored specifically for slab thickness testing. Wave speed "calibrations" were performed on the approach slab to each test section, where cores have already been extracted for thickness determination. Another IE device (from Physical Acoustics) was also used in some of the locations for verification, and to periodically establish surface wave speeds for comparison to through-speeds determined using the CTG-1. A total of 257 tests were performed. Each test was actually performed at least twice, using two identical CTG-1 units to verify the integrity of the signal and to check repeatability. IE testing took place on December 3, 4, and 5, 2002. The testing was documented with photographs, and test results were recorded on-site by Gonzalo Rada. Figures 1 and 2 show IE testing (using the CTG-1) in progress.

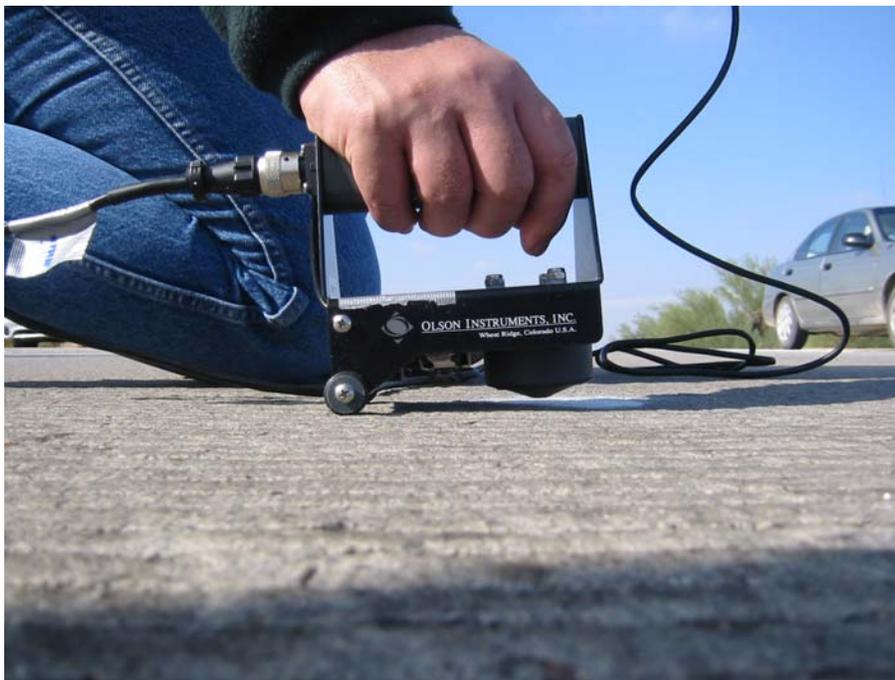
Figure 2. Closeup of impactor/transducer unit.

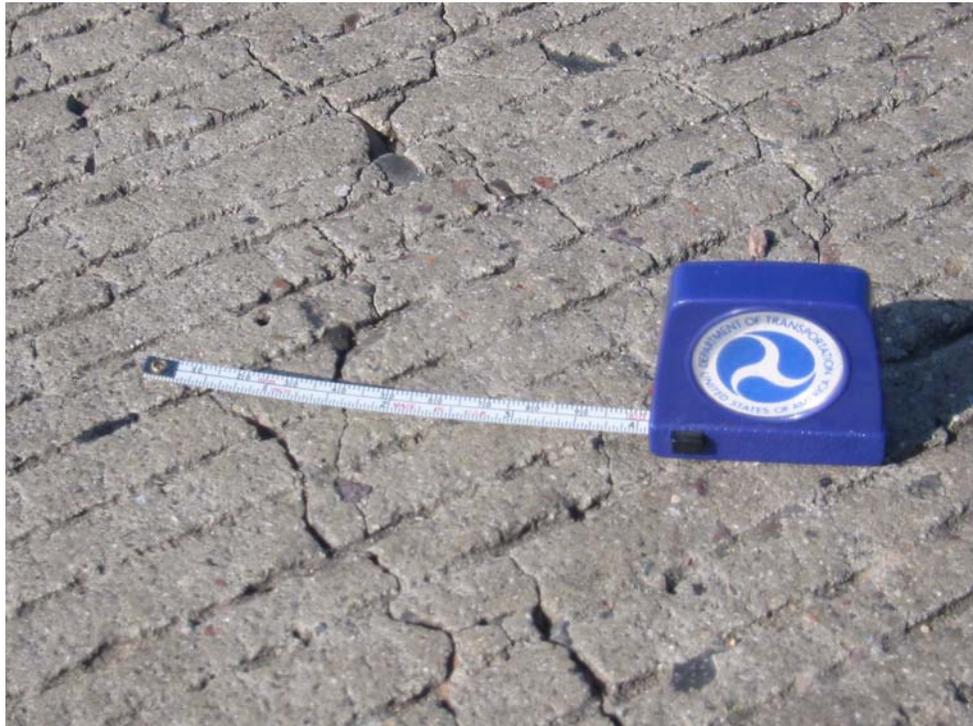
Figure 4. Example of pavement distress

**Conclusions:** Based upon the analyses of the SPS-2 data, it appears that IE is not a suitable means to estimate the pavement thickness for LTPP’s SPS sections within the 5mm desired accuracy. The primary reason for this is most likely related to the distressed condition of the subject pavement sections during testing. Although successful use of IE for pavement thickness determinations (with high degrees of accuracy) has been documented on recently constructed and sound concrete pavements, the subject tests were performed on older, distressed concrete pavements. The majority of these SPS-2 pavement sections were visually distressed with evidence of map cracking and some transverse and longitudinal cracking. Figure 4 shows an example of typical distress. As the IE method relies on an assumed “wave-speed” (previously measured on the approach-slab) to determine thickness, it is imperative that this wave-speed does not change appreciably from location to location within a section. This is a valid assumption for sound concrete with no signs of distress. However, if significant distress is present, the wave speed will vary as a consequence. If the wave speed varies by 10%, for example, the resulting thickness measurement will be off by 10% as well. Consequently, since the subject SPS-2 sections exhibit sporadic signs of

significant distress, a representative wave speed is impossible to determine, and the IE thickness measurements will be inaccurate.
