Maintenance of Highway Edgedrains

Robert H. Baumgardner

February 2002

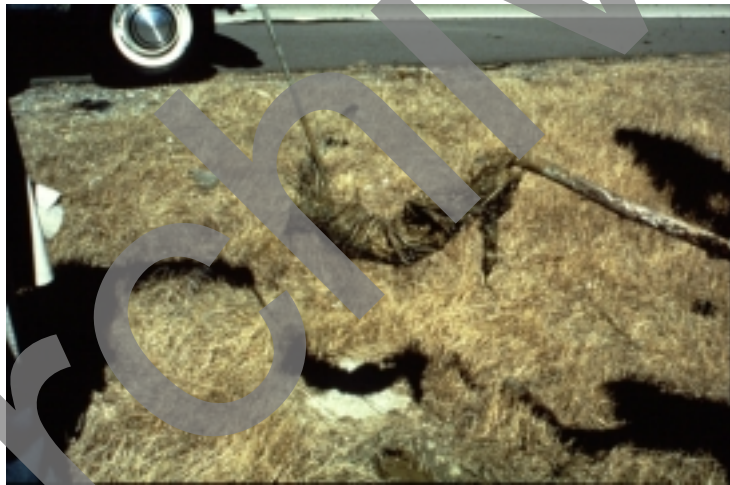
Photo No. 1 Vegetative Material Removed from an Edgedrain System

An example of vegetative material removed from an edgedrain is shown in Photo No. 1, while an edgedrain pipe blocked by a rodent's nest is shown in Photo No. 2.

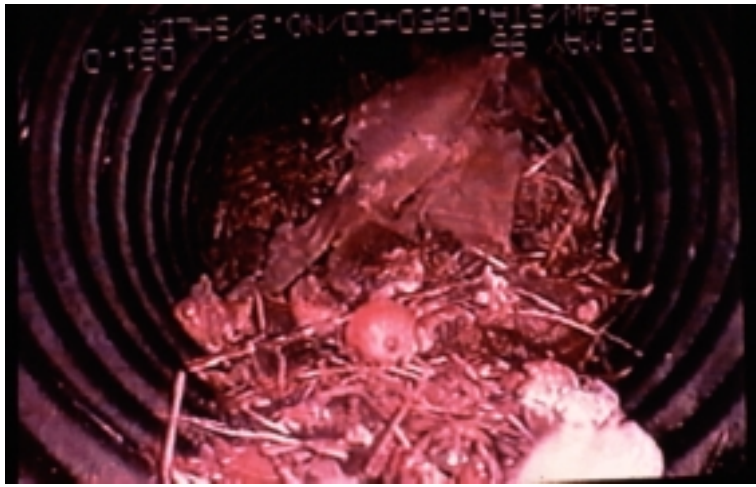
Photo No. 2 Rodent's Nest

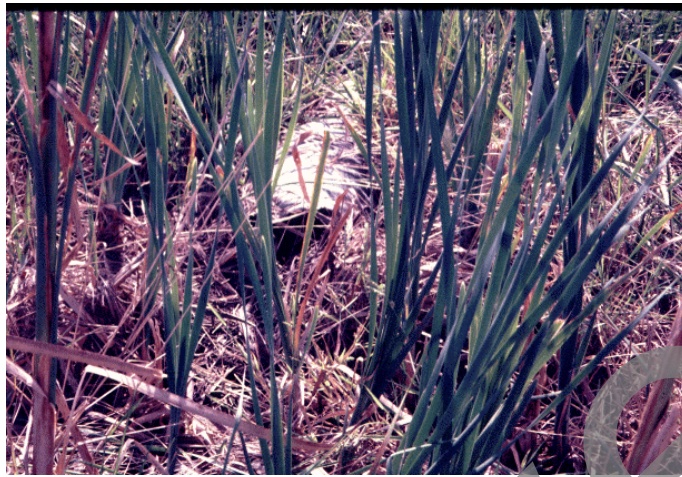
Photo No. 5 Hidden Outlet Pipe

Often outlets cannot be found because they are hidden by vegetative growth. Photo No. 5 shows a typical hidden and crushed outlet. Note that there is no headwall.

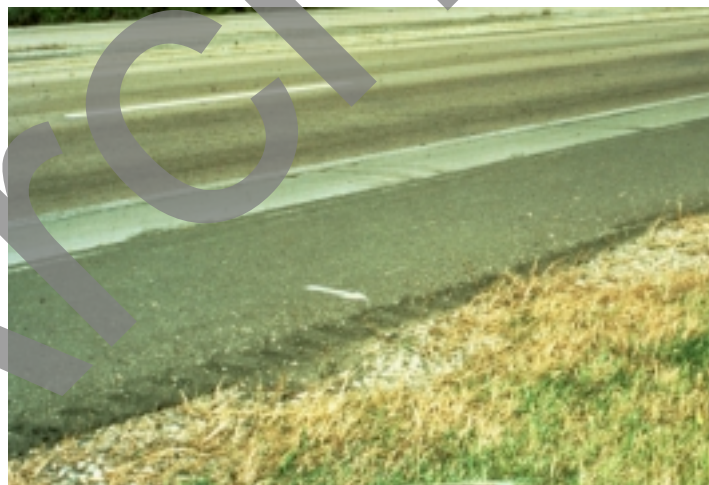
Photo No. 6 Painted Arrow as a Reference Marker

It is obvious that if maintenance personnel can not find the outlets, no maintenance can be performed. SHA's that use concrete headwalls, reference markers, signs on fences, reflector disks in the shoulder, or painted arrows on the shoulders have better success in providing maintenance. It is also important that maintenance activities not block or damage the pipe outlet. A simple arrow painted on the edge of the shoulder, as shown in Photo No. 6, is a good reference marker for maintenance personnel.

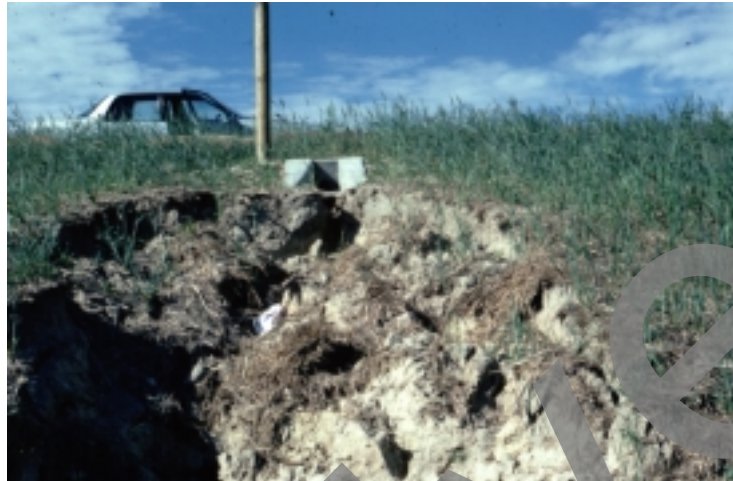
Photo No. 7 Excessive Erosion at the Outlet Pipe

One of the purposes of a headwall is to eliminate erosion at the pipe outlet. Unfortunately, excessive erosion at an edgedrain outlet is shown below in Photo No. 7.

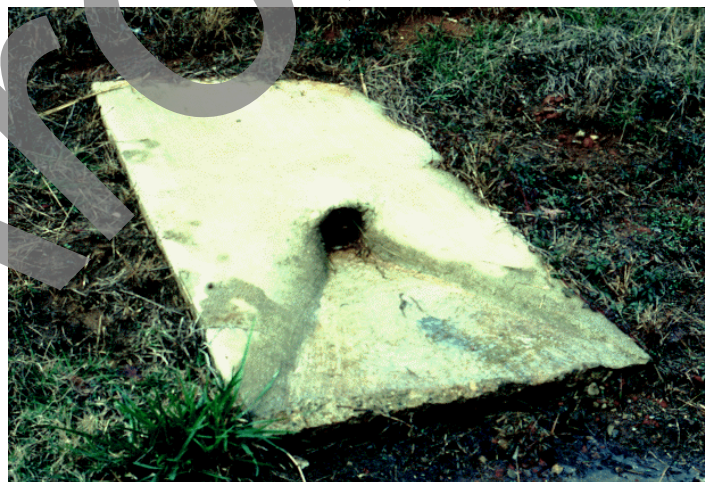
Photo No. 8 Large Outlet Pipe Headwall

Larger headwalls, as shown in Figure No.8 have the following advantages:

- \$ Easier for maintenance personnel to locate
- \$ Roadside vegetation located farther away from the outlet pipe.
- \$ Reduce erosion
- \$ Prevents crushing of the outlet pipe.

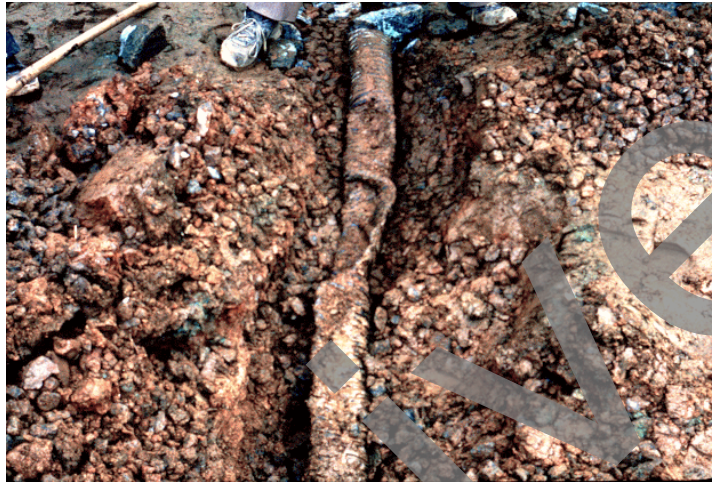
Photo No. 9 Crushed Edgedrain Pipe

Photo No. 9 shows a section of edgedrain that has collapsed. This problem was identified by video inspection.

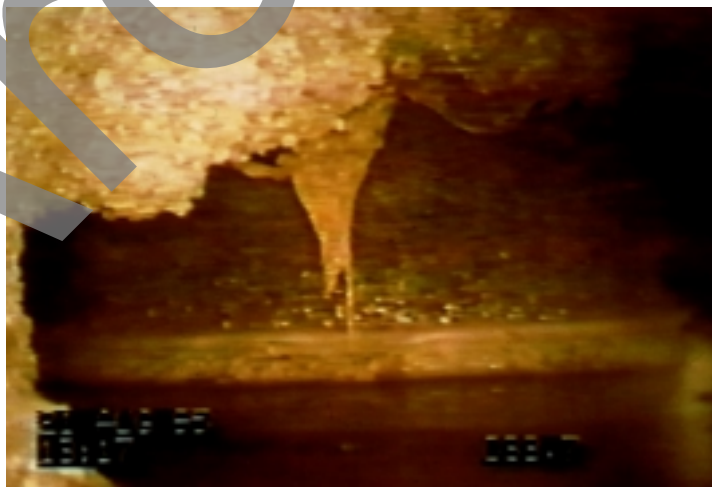
Photo No. 10 Ninety Degree Tee

In Photo No. 10, the video inspection camera is approaching the main line longitudinal edgedrain. It will be difficult for the camera to make this turn from the outlet pipe to the edgedrain. It will also be difficult for any cleaning equipment to make the turn. This is why FHWA recommends large radius pipe or a combination of bends to make the turn.

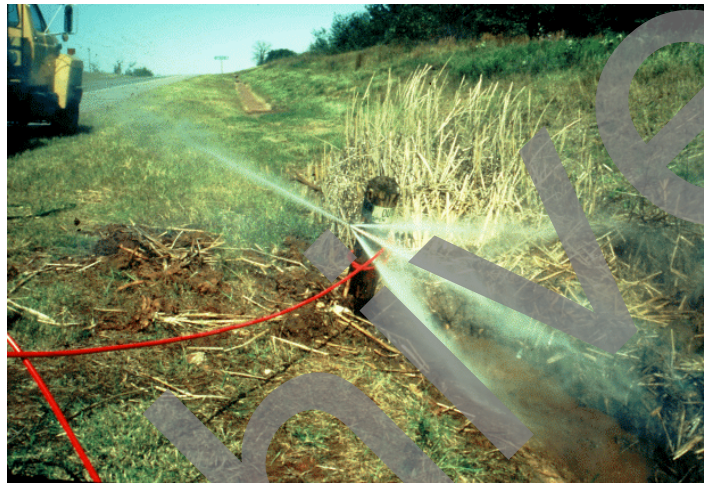
Photo No. 11 Pipe Flushing Unit

A pipe flushing unit is shown in Photo No. 11. The water jets point towards the rear of the unit so that the jetting action helps to propel the unit through the pipe.
