TECHBRIEF

Comparison of Driver Yielding for Rectangular Rapid-Flashing Beacons Used Above and Below Pedestrian Crossing Signs

FHWA Publication No.: FHWA-HRT-16-041

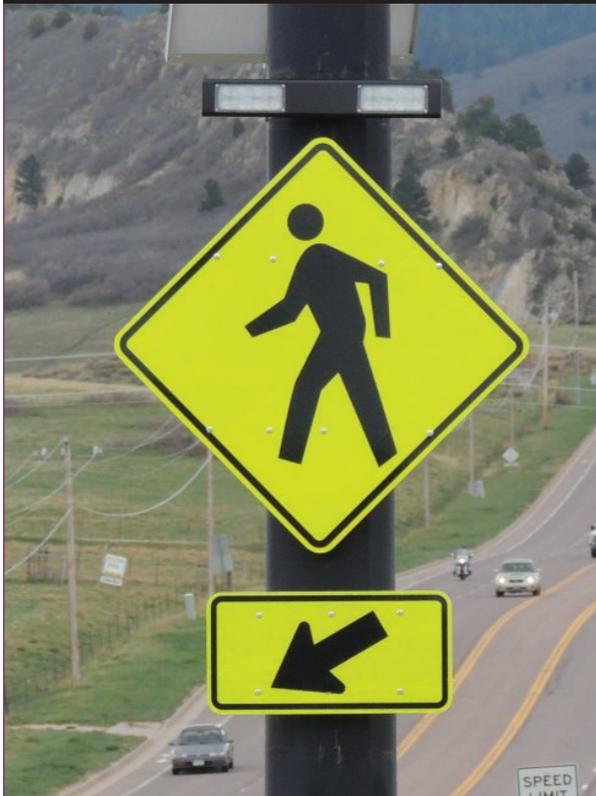
Figure 1. Example of beacons placed above sign.

Examples of study assemblies are shown in figure 1 (above position) and figure 2 (below position). The beacons were mounted on a roadside pole to supplement either a pedestrian (W11-2) or trail (W11-15) crossing warning sign with a diagonal downward arrow (W16-7p) plaque and located at or immediately adjacent to the marked crosswalk.

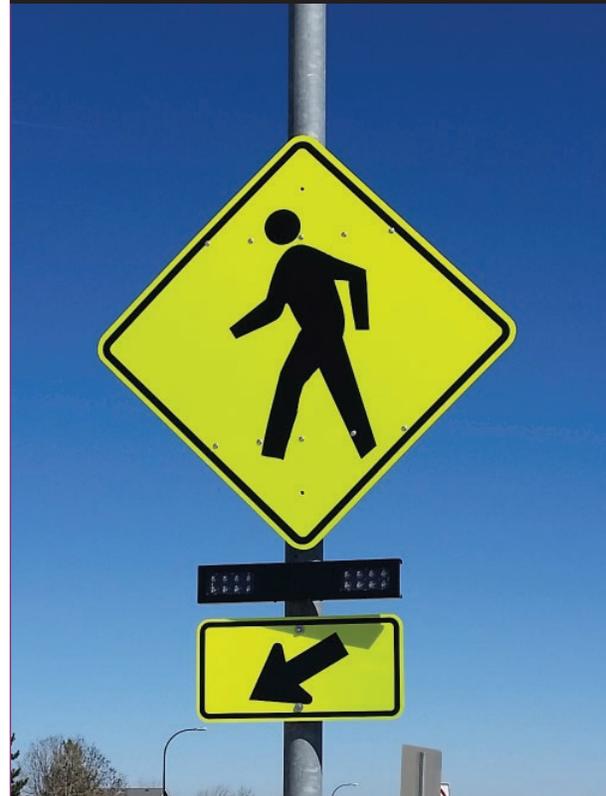
Figure 2. Example of beacons placed below sign.

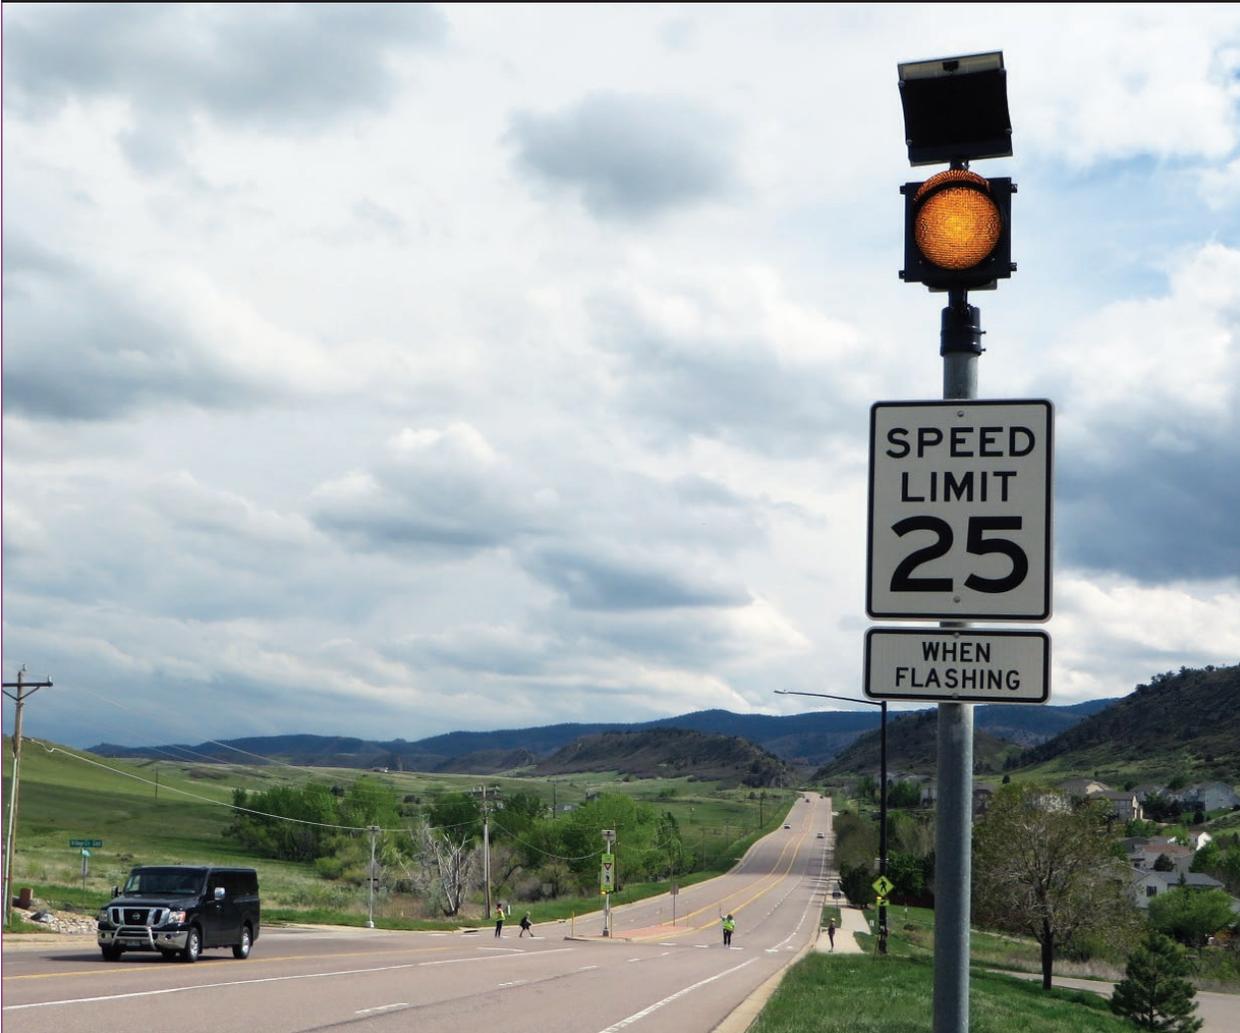
Figure 3. Example of speed limit sign assembly used at three sites in Colorado.

Three of the Colorado sites had a unique series of signs in advance of the crossing. The series started with a Pedestrian Crossing (W11-2) warning sign with AHEAD (W16-9P) plaque. Next was a SPEED LIMIT 25 (R2-1) regulatory sign with WHEN FLASHING (S4-4P) plaque and a 12-inch circular beacon. This beacon flashes when the RRFBs at the crossing are activated. (See example shown in figure 3.) At the crosswalk are RRFBs with the Pedestrian Crossing (W11-2) warning sign and diagonal downward pointing arrow (W16-7P) plaque. Also at the crossing and in the median are the STATE LAW YIELD TO (pedestrian symbol) WITHIN CROSSWALK (R1-6) sign and RRFB.
