Steel Bridge Design Handbook

Design for Fatigue

Publication No. FHWA-IF-12-052 - Vol. 12

November 2012

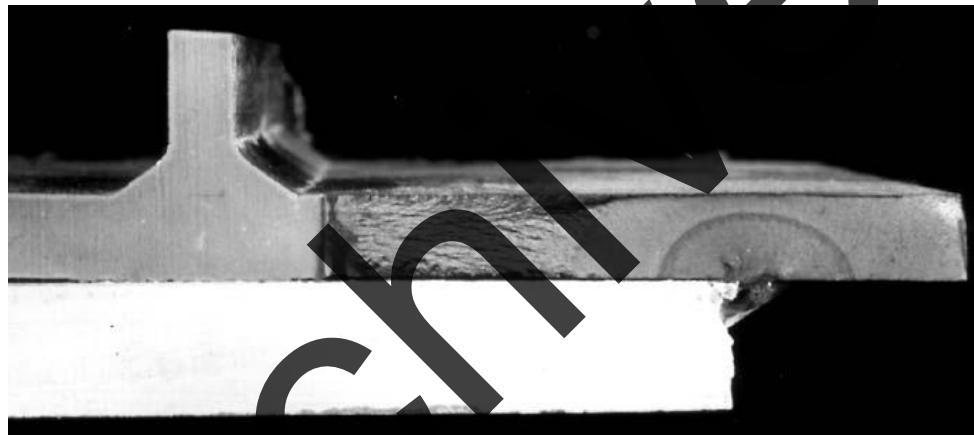
Figure 8 Crack Surface Showing Fatigue Crack Growth

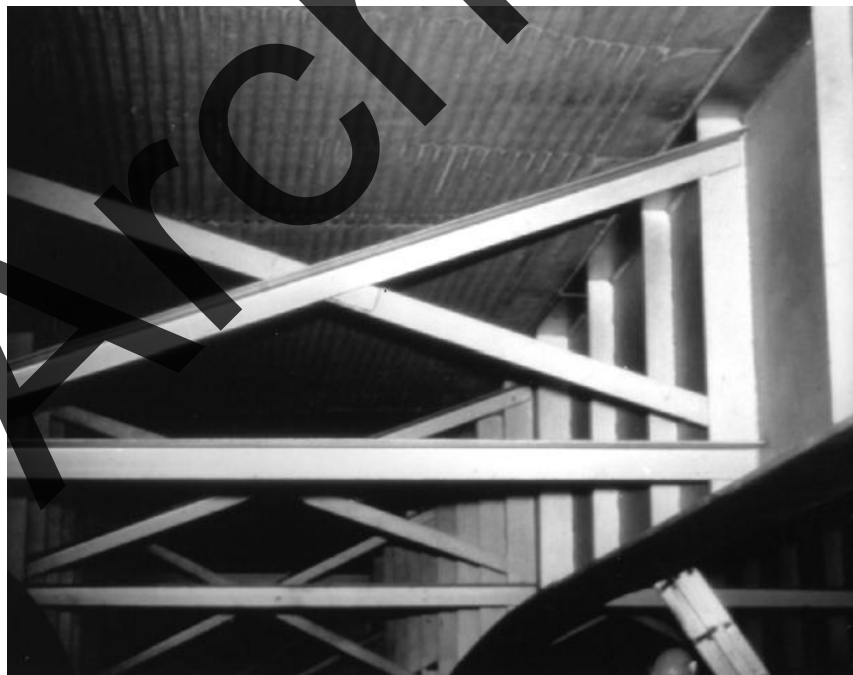
Various types of diaphragms are used, ranging from rolled sections to simple X-bracing made of angles. Figure 14 shows the underside of a multiple girder bridge that has an X-type cross-frame bracing system. In the web gap, cracking developed in the negative moment region (i.e., top flange in tension) of this continuous span structure. This cracking is illustrated in Figure 15, which is a view along the length of the bracing toward the girder and its transverse stiffener. The transverse stiffener to which the X-bracing is attached was not welded to the top (tension) flange for the reasons described earlier. This permitted out-of-plane displacement to occur in the web gap and, consequently, cracks formed along the web-to-flange fillet weld and at the top of the connection plate.

Figure 14 X-Bracing and Girders

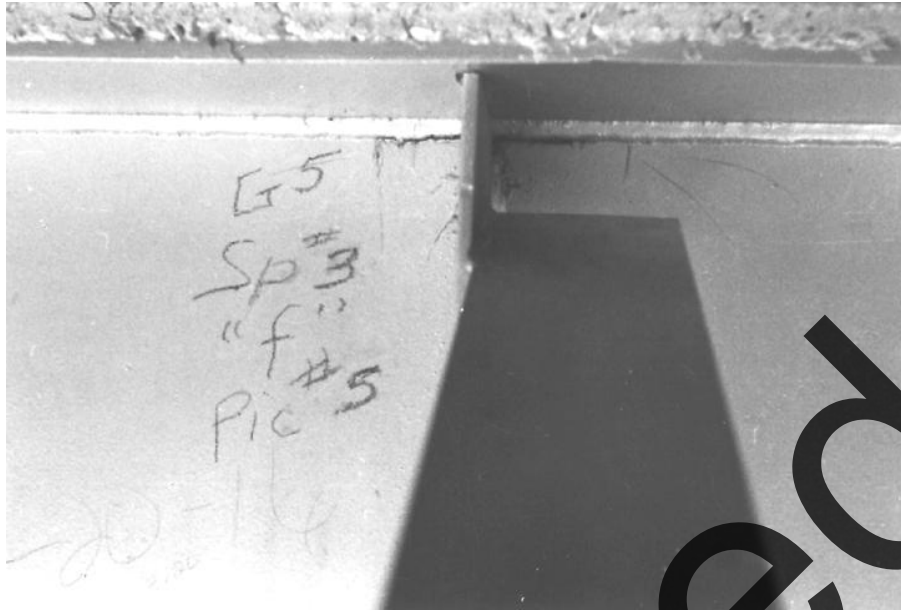
Figure 15 Fatigue Cracks in Web Gap of Diaphragm Connection Plate

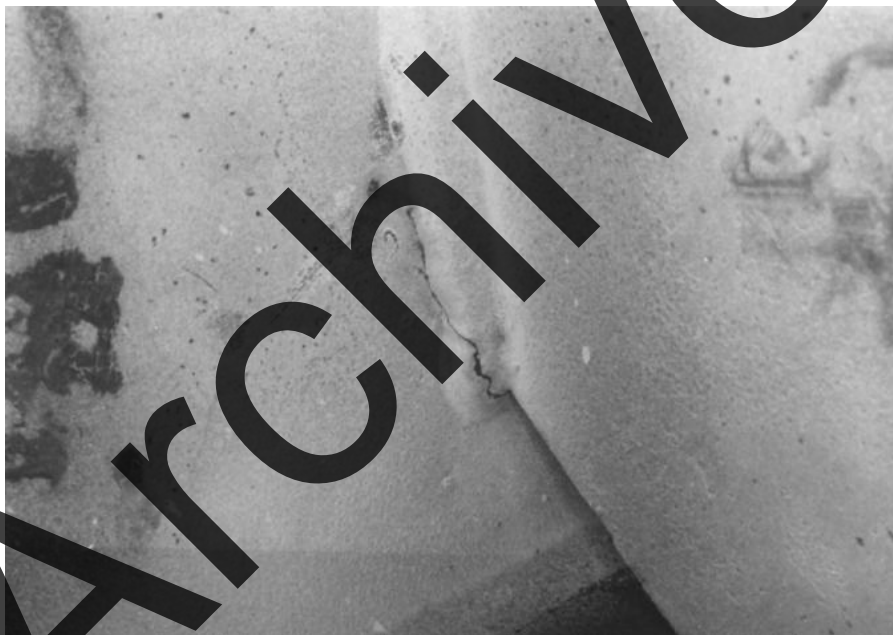
Fatigue cracking has also been observed in the bottom web gaps at the locations of internal diaphragms in simple span steel box girders. An example of this type of cracking is shown in Figure 18. These cracks are also the result of out-of-plane distortion in the web gap. The web gap displacement results primarily from torsional distortion of the box girder when eccentric loads are applied to the structure and the diaphragm is not connected to the flange. The deformation can be eliminated in new construction by welding the diaphragm connection plate to the flanges.

Figure 18 Web Gap Cracking at End of Transverse Connection Plate
