INSPECTION AND DATA COLLECTION

WINNER: Olmsted County
Public Works, Minnesota

360-Degree Camera Sled Transforms Culvert Inspections

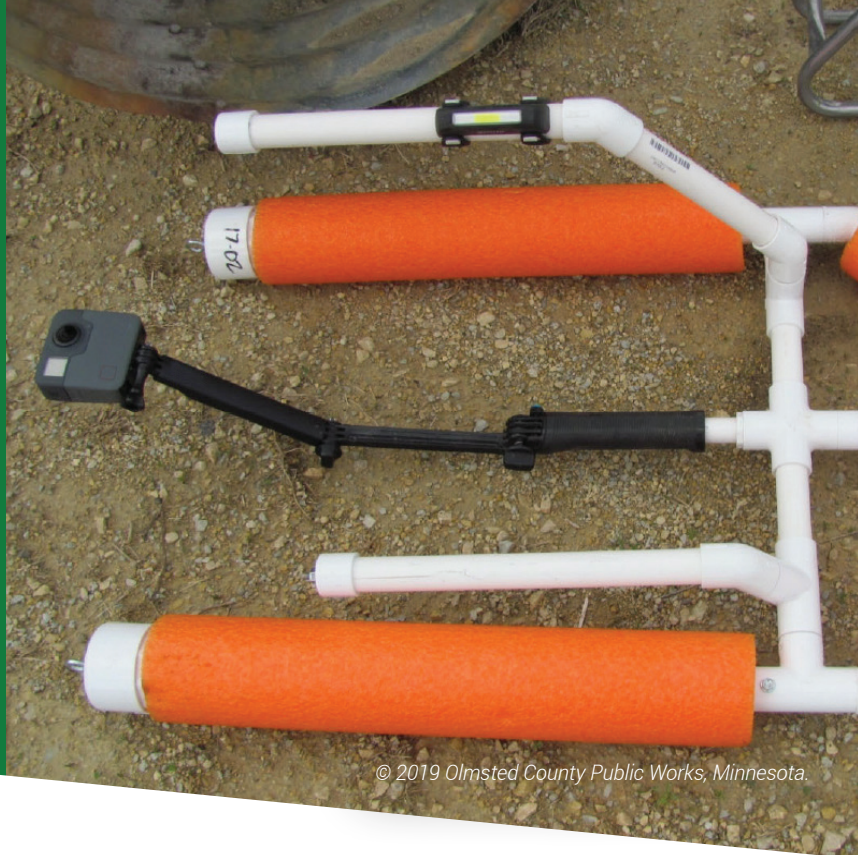
Busch has been stopped only twice after sending his sled through roughly 120 culverts. And despite pulling his sled over rocks, rusted metal, and even a deer skull, there hasn't been a single flip-over or wreck. Pretty impressive for something composed of a PVC pipe sled, pool noodle side arms for buoyancy, rechargeable bike lights to illuminate the action camera, a flashing pet collar for visual location, a toilet tank float, and a kite reel that operates as a "positioning yo-yo" or recovery line.

Next, he needed to find a way to move the camera through the culvert. The perfect ingredient came in the form of 4 mm fiberglass fish tape, typically used by electricians to route new wiring, which could be pushed through the pipe and locked into the sled when it got to the other side. A toilet tank float was ideal at the end of the fish tape to help it skip through the pipe without getting stuck.

Busch has already modified his original design and is now using a third, more compact version featuring even greater stability and flotation capabilities. He also plans to use the 360-degree action camera to get a better view of trouble spots in other areas of his work, including construction and bridge inspections. Culverts are only the beginning.

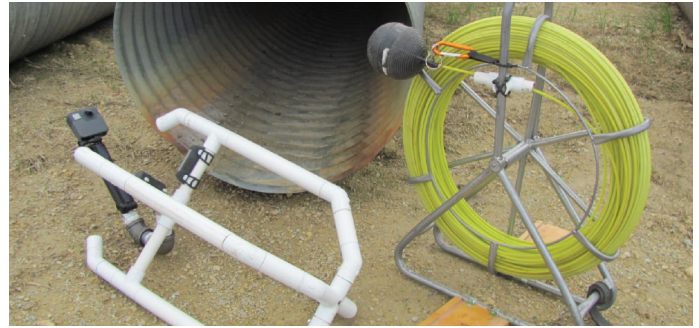
Holmes is impressed with how the 360-degree action camera on skids has transformed their work, not to mention Busch's ingenuity. "It's nice having an innovator like Jeff," he says. "You can go back and look at all these still pictures around the whole culvert—around the top, around the sides, around the bottom. You can spend a half-hour looking at it in the office, and he only ran it through there for a minute."

Before his innovation, the smallest culvert inspectors could enter was 24 inches—and they couldn't get quality visual documentation for their evaluations. Now, inspectors can obtain clear images in culverts as small as 15 inches. The new system has already provided maintenance crews with better data; in one instance, preventing a road from being torn up when Busch's video revealed that only a patch was required.

"You can look at video multiple times and get a different view every time," Busch reports. He was initially concerned about the lens being too close to the pipe for clear images, but that hasn't been an issue. He does slow videos down to half speed for better resolution, however.
