# NCHRP Report 350 Test Report Compilation

## Full-Scale Crash Evaluations of the ET Plus<sup>®</sup> End Terminal with 4-inch Wide Guide Channel Installed with a Rail Height of 27¾ Inches

Tests: ET27-33, ET27-31, ET27-32 and ET27-30

SwRI<sup>®</sup> Project No. 18.20887

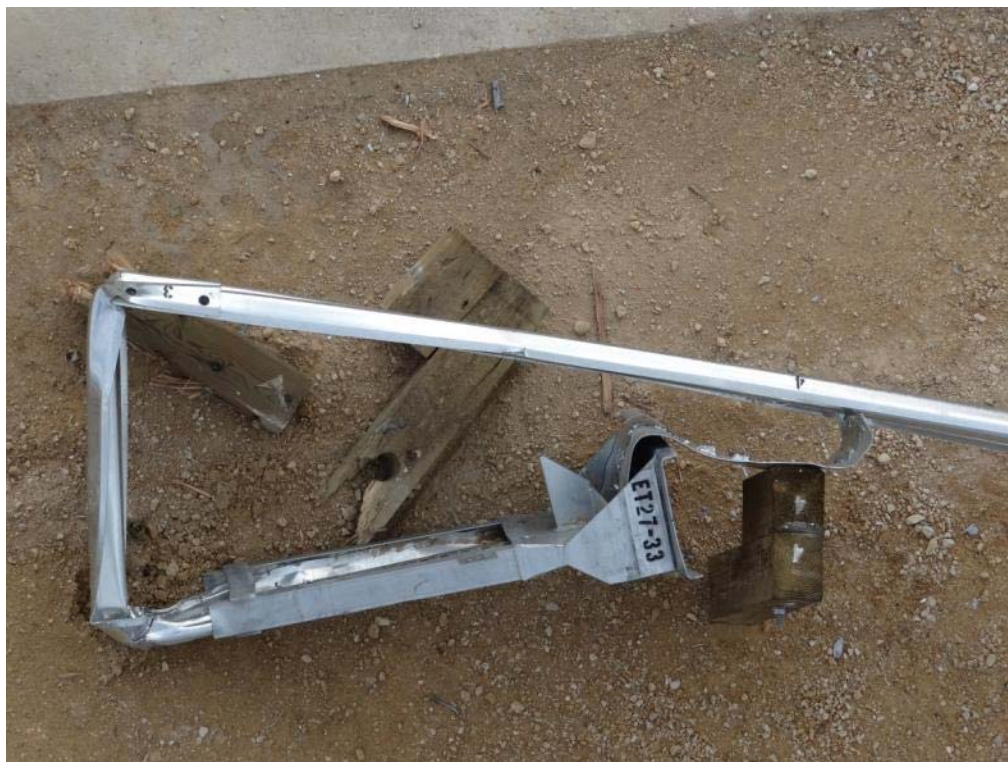
**Figure 3.7: Post Test – Overhead View Close-up**

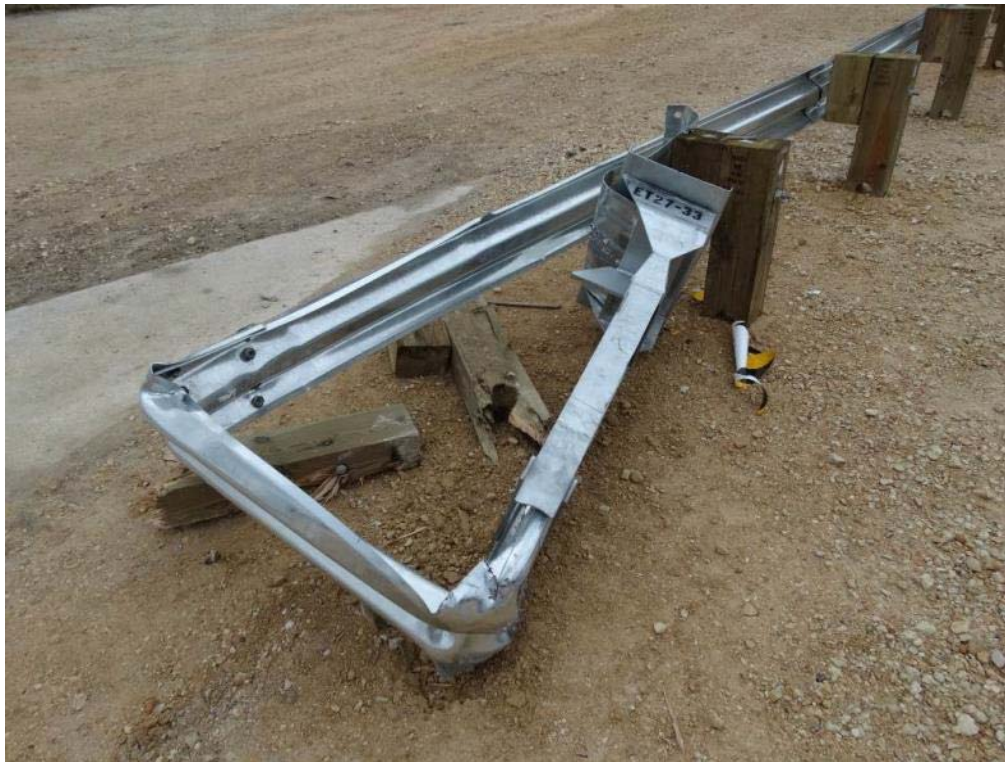
**Figure 3.8: Post Test – Side View**

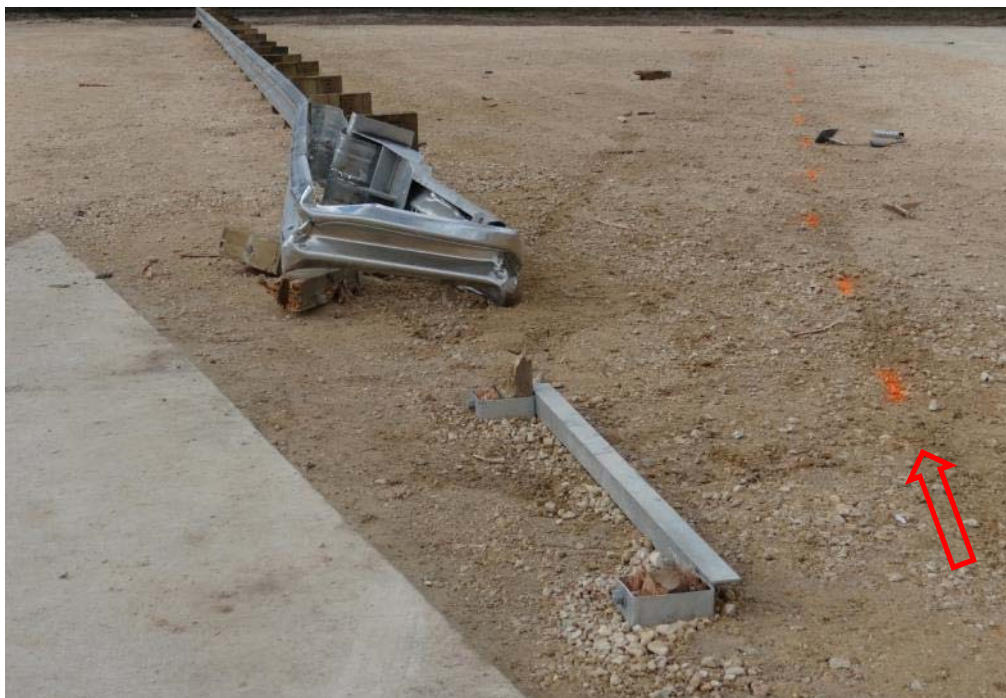
**Figure 3.9: Post Test – Right Vehicle Track (Orange Paint)**

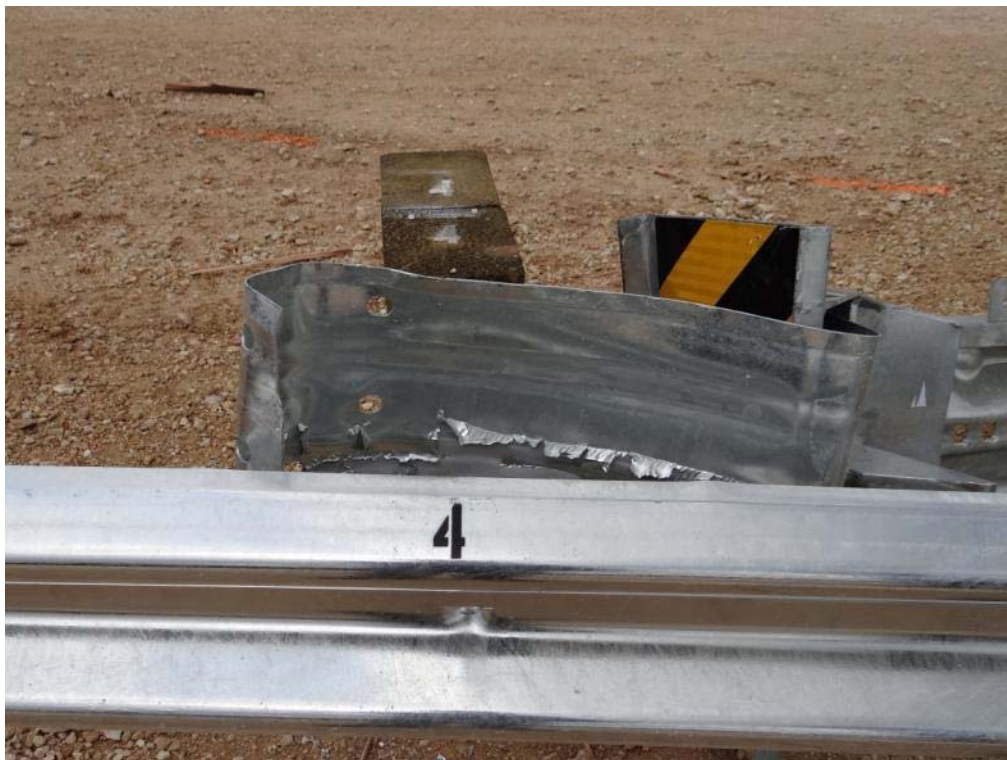
**Figure 3.14: Post Test – Post 4**

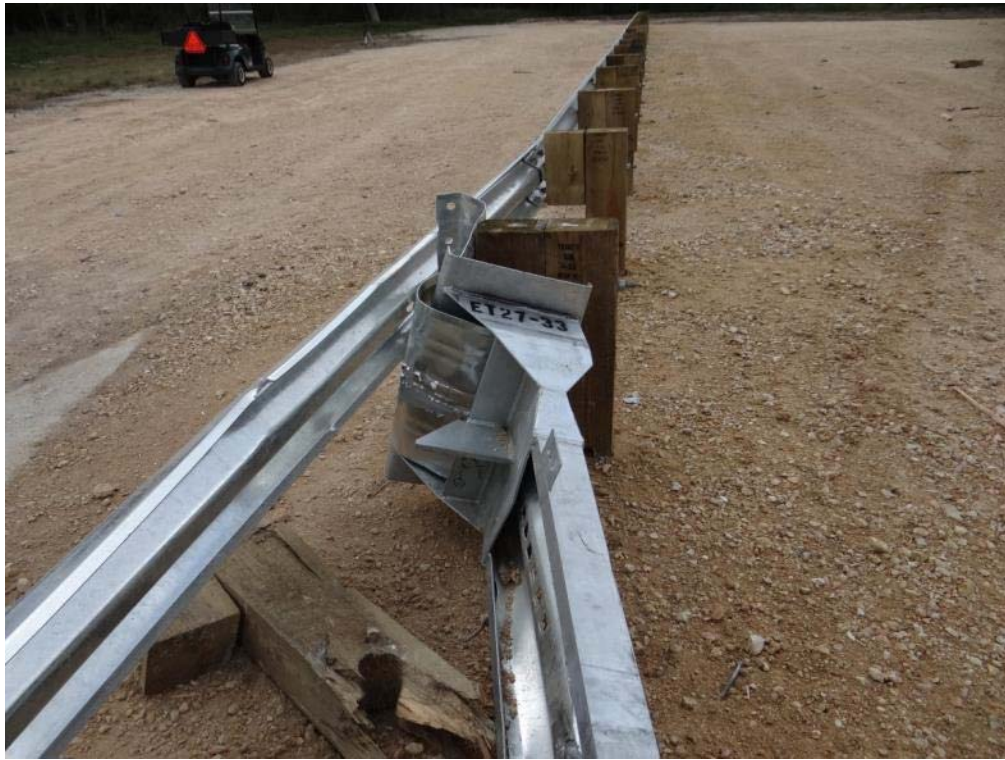
**Figure 3.21: Post Test – Gated Guardrail Extruder Head**

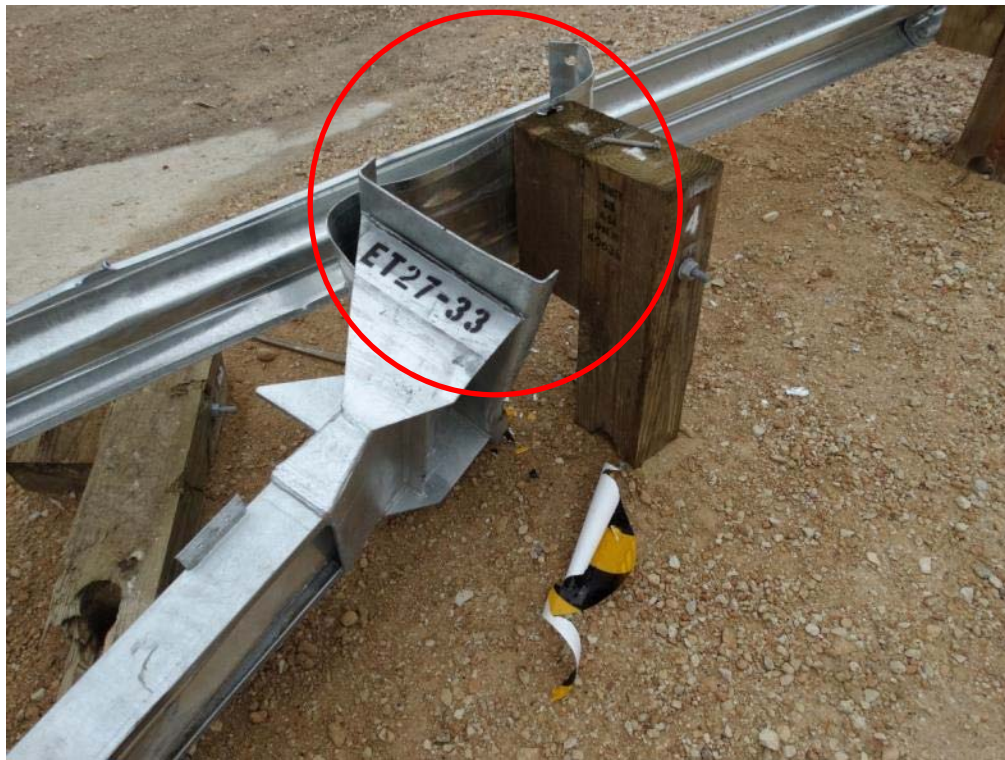
**Figure 3.23: Post Test – Extruded W beam**

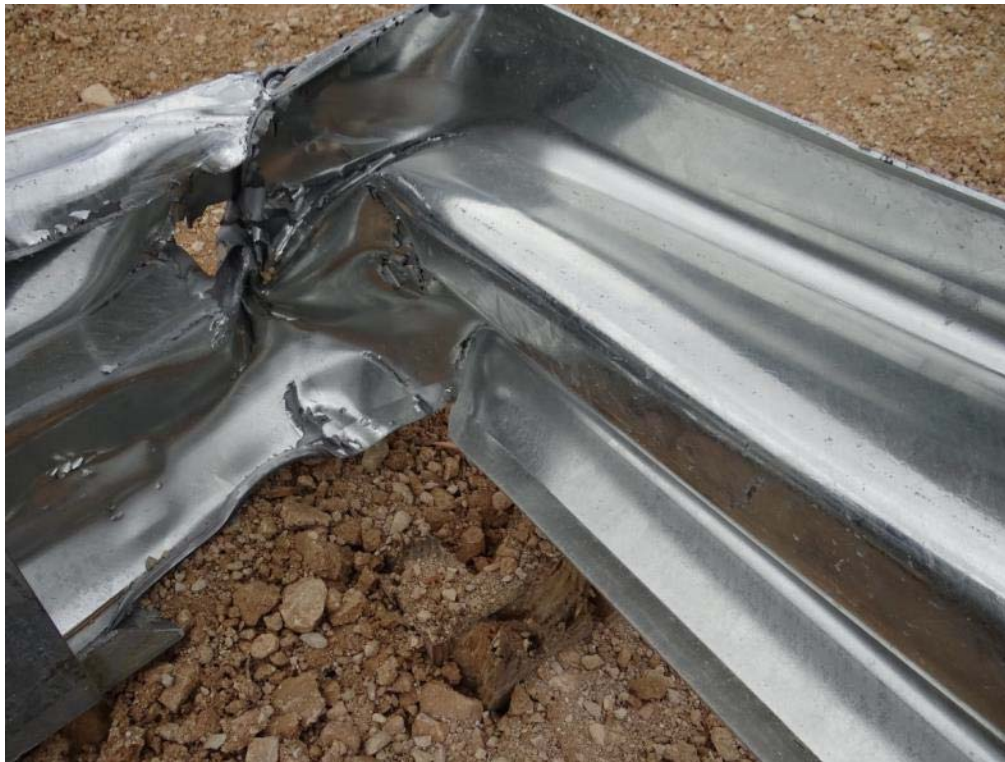
**Figure 3.25: Post Test – Gating Past Extruder Head**

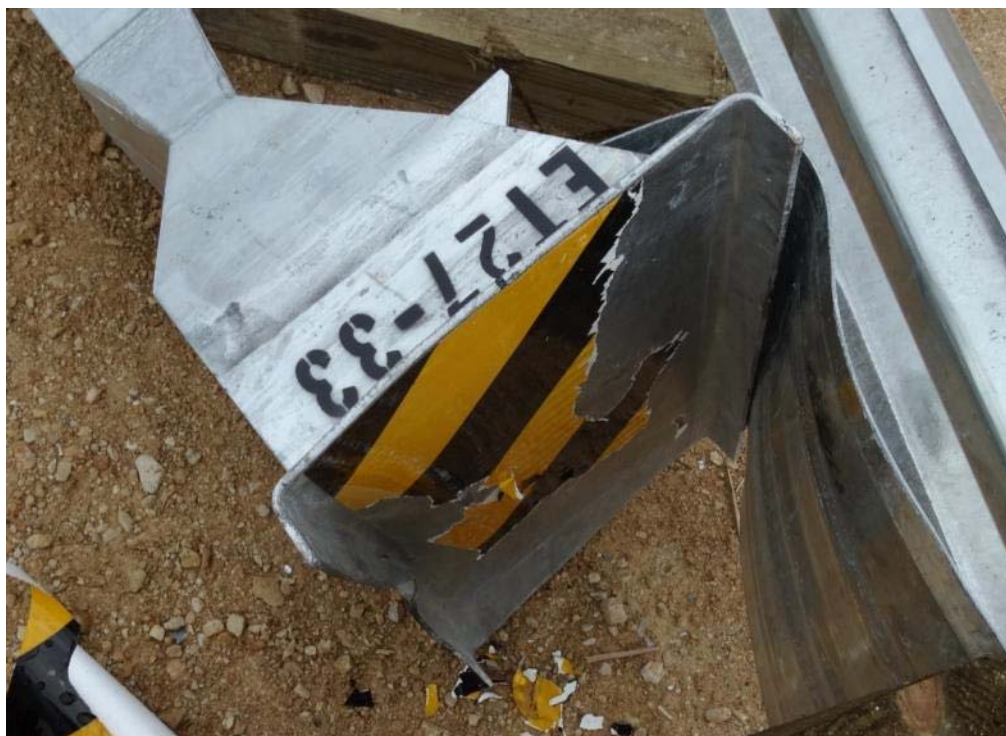
**Figure 3.30: Post Test – ET Plus Head Impact Plate**

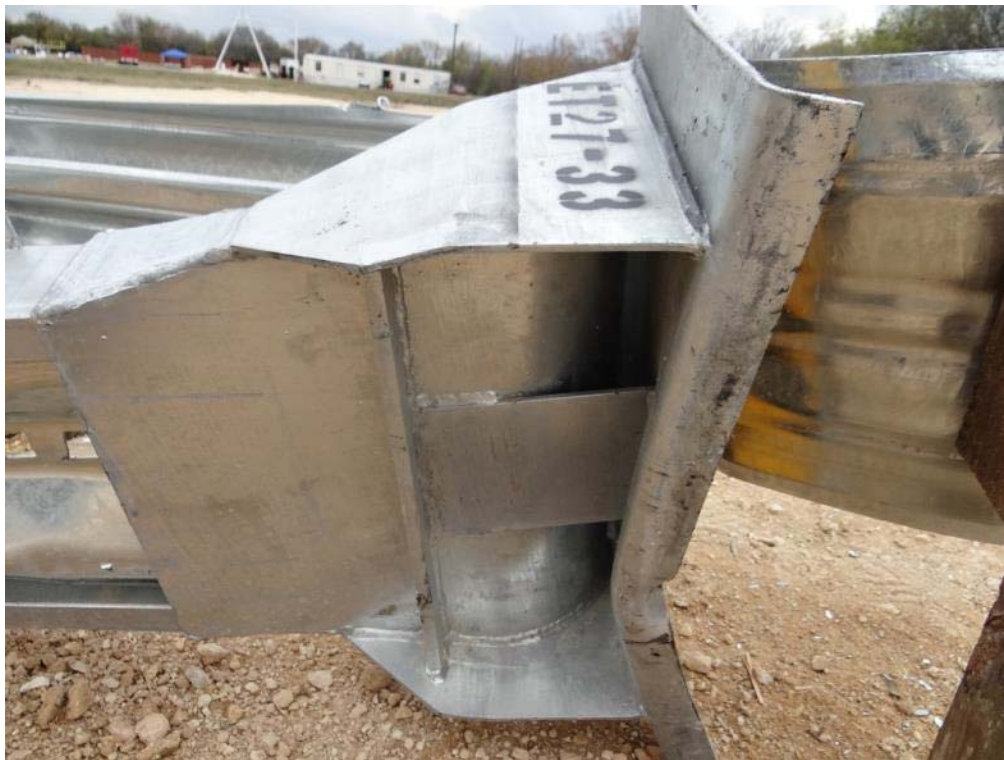
**Figure 3.31: Post Test – ET Plus Head, Traffic Side**

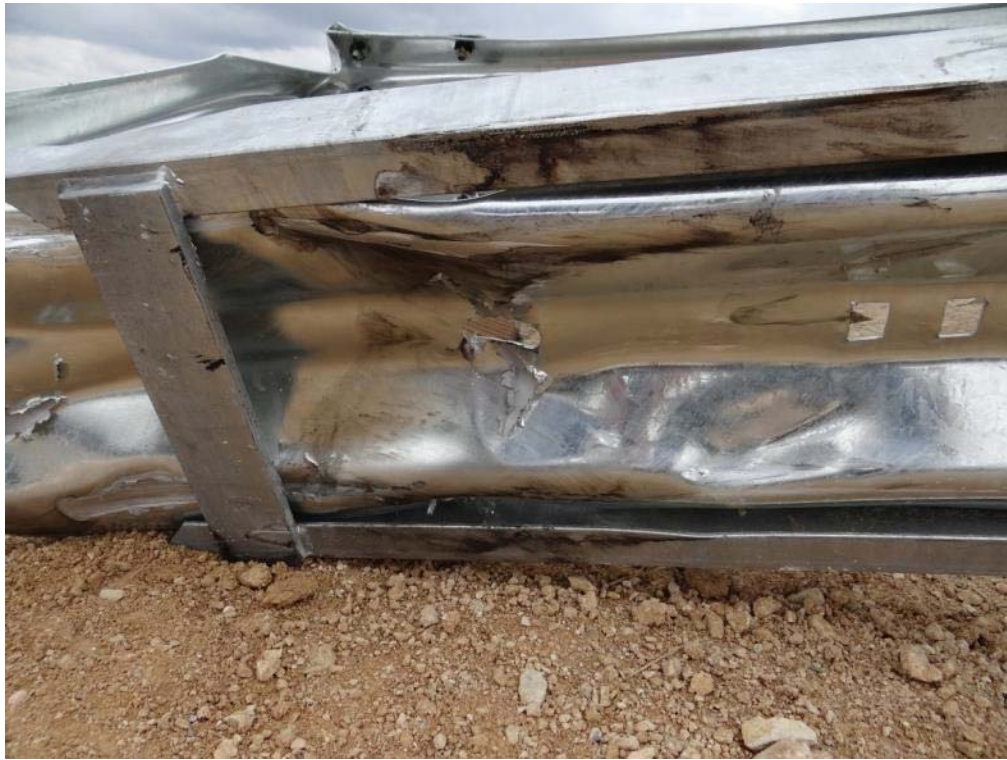
**Figure 3.33: Post Test – ET Plus Head Guide Chute Entrance, Traffic Side**

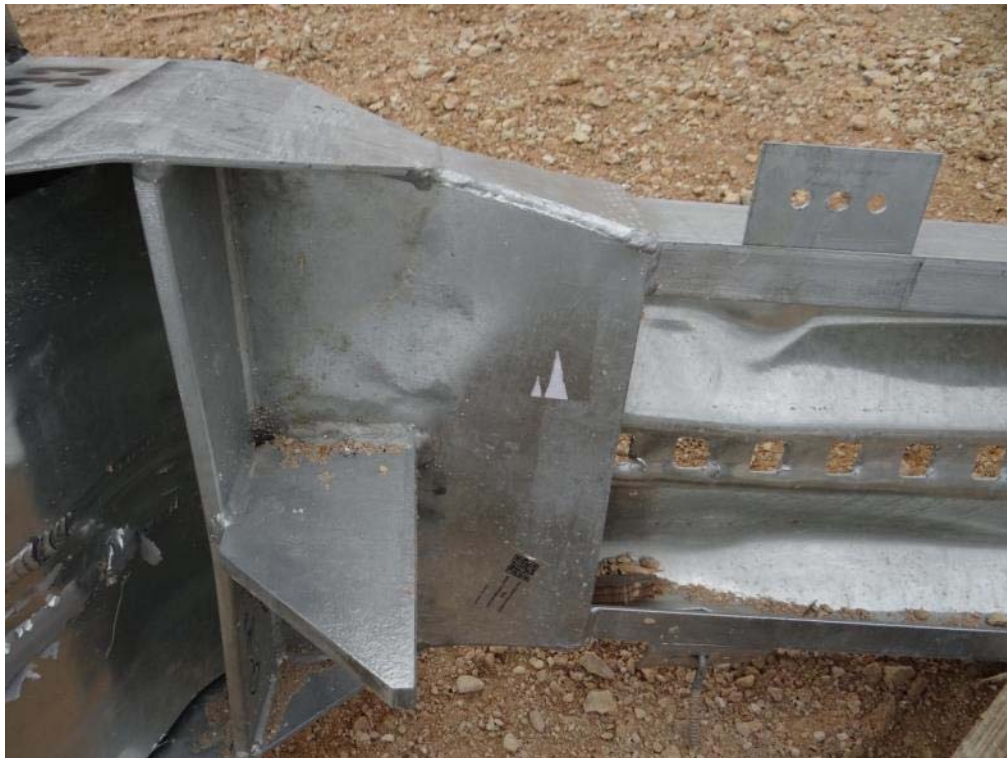
**Figure 3.34: Post Test – ET Plus Head, Non-Traffic Side**

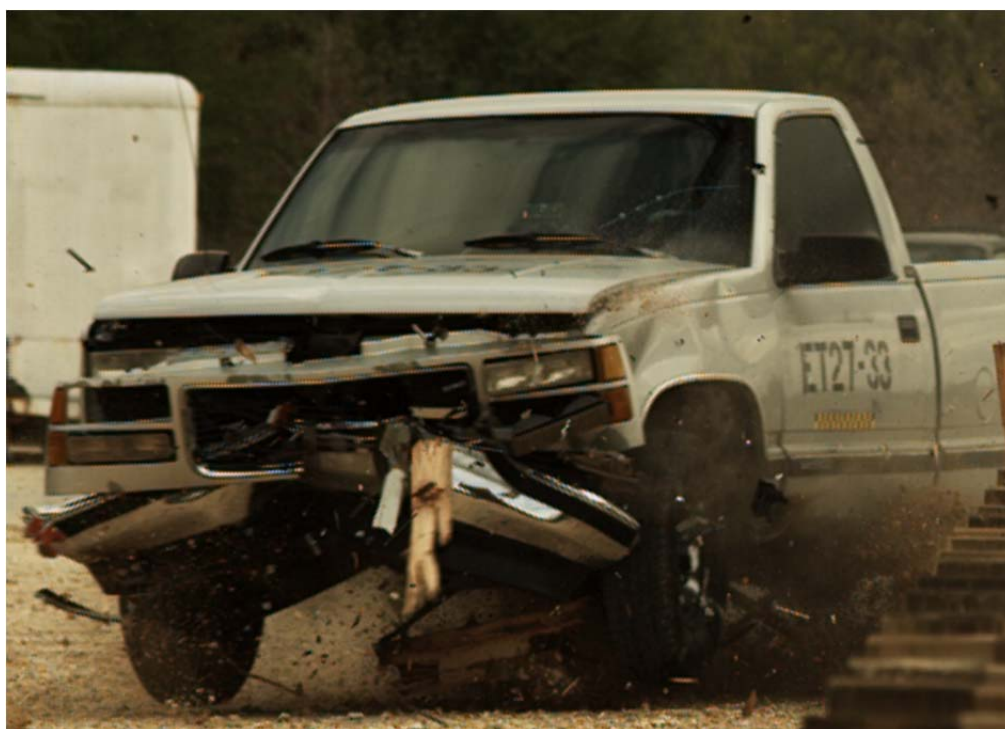
**Figure 3.44: Front End of Vehicle Following ET Plus Impact**

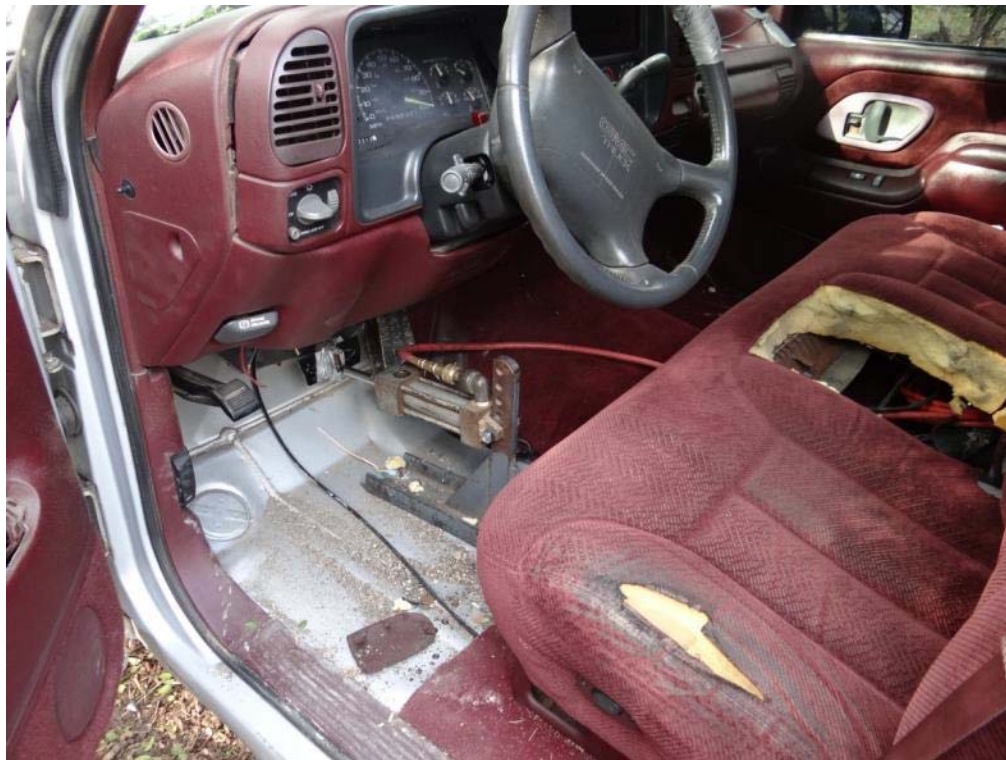
**Figure 3.53: Post-Test – Occupant Compartment**

- There was no penetration of the vehicle by the test article, and no deformation of the occupant compartment resulting from the test.
- There was no undue hazard presented by test article debris outside of the immediate impact zone; the only debris thrown from the installation included pieces of posts and blockouts, the majority of which fell to the non-traffic side of the guardrail.
- The vehicle remained upright during and following the impact.
- The test article provided for controlled deceleration with impact velocity and ridedown acceleration values within allowable limits.

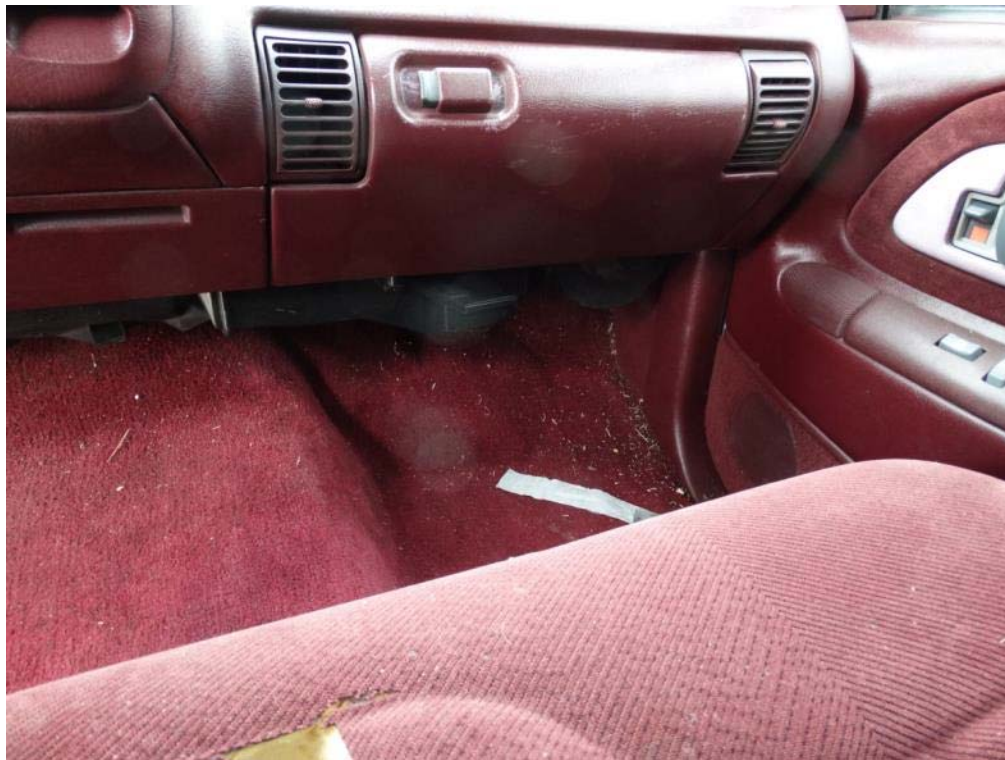
**Figure 3.55: Post-Test – Passenger Side Floorboard**

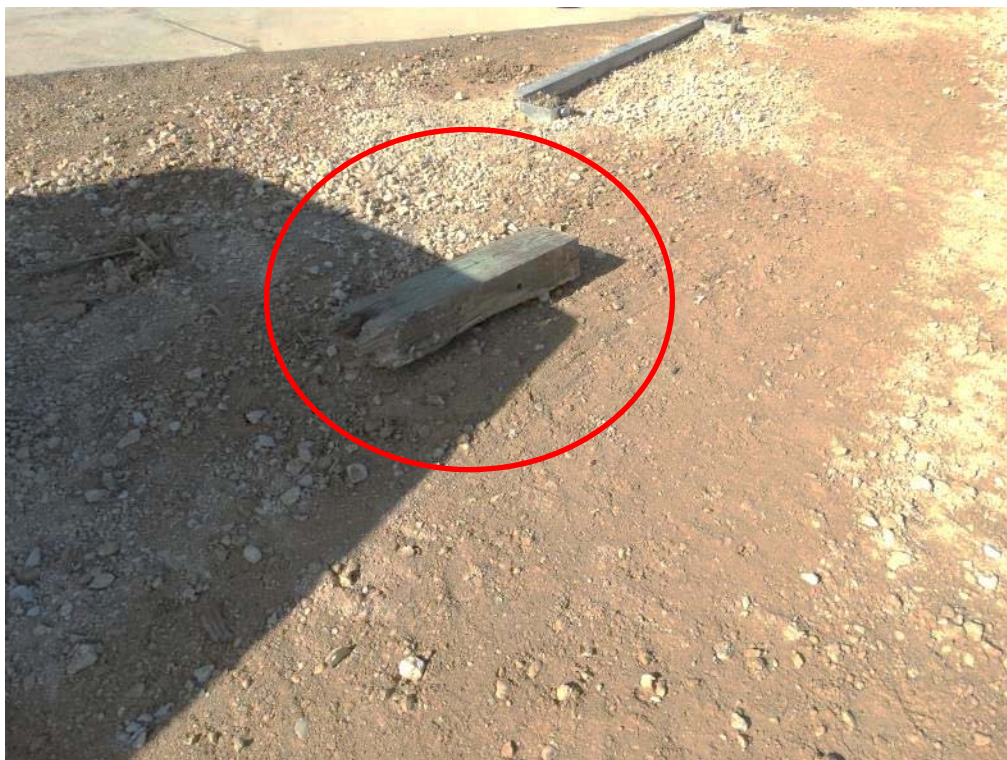
**Figure 3.11: Post Test – Post 1**

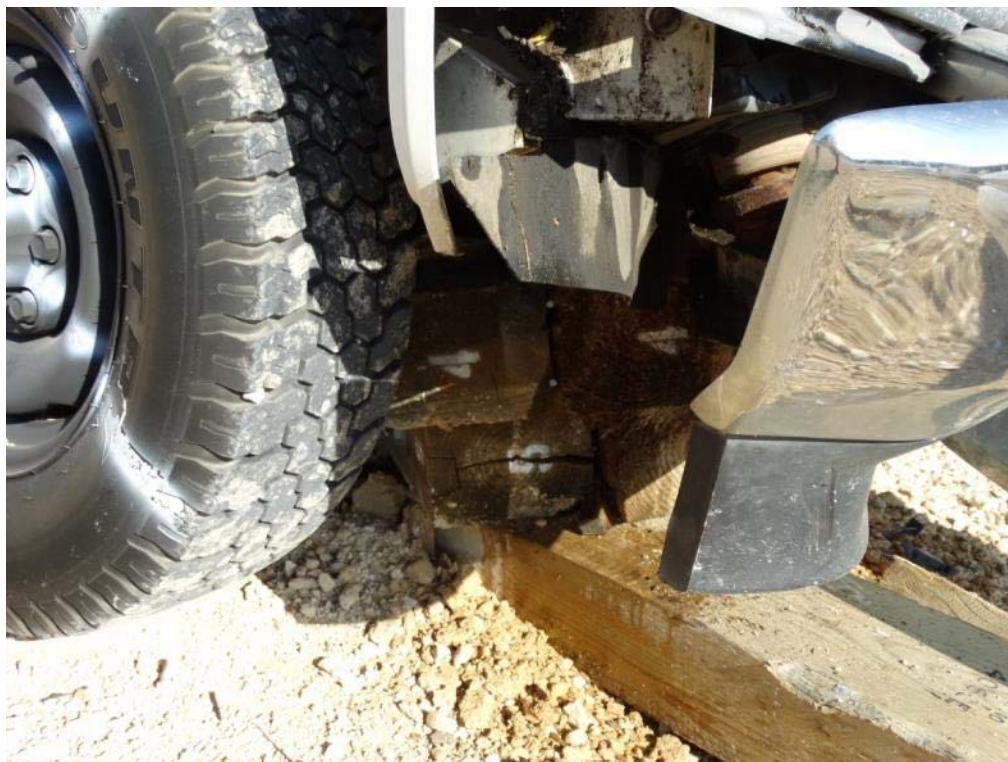
**Figure 3.13: Post Test – Posts 4, 5 and 6 Stacked Under Vehicle**

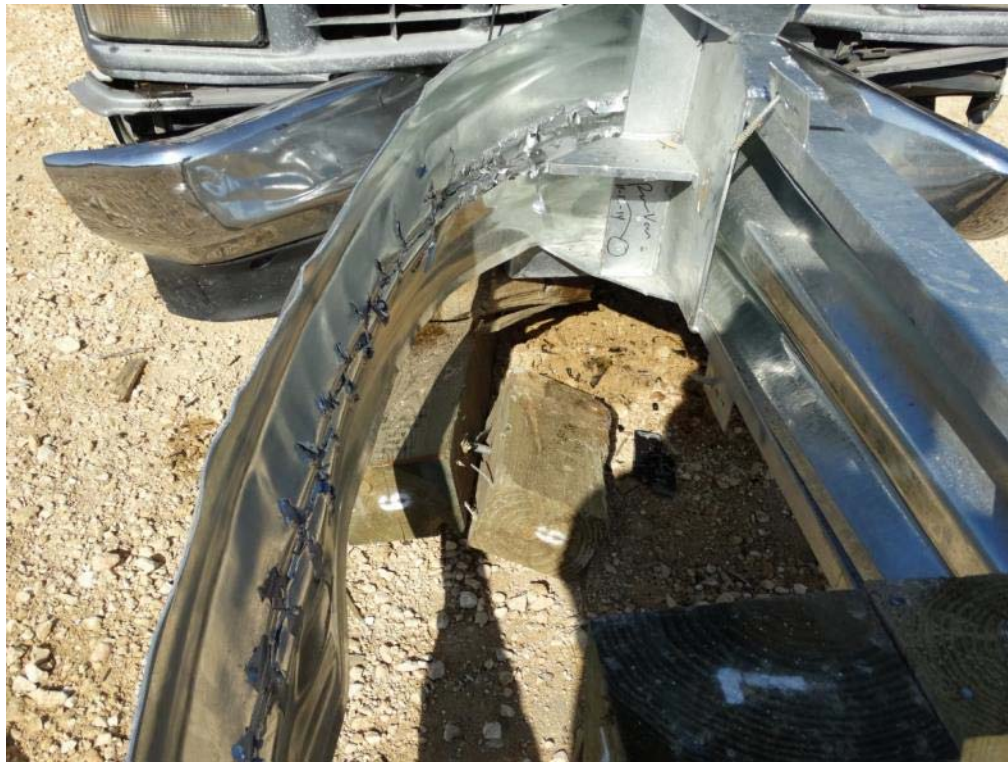
**Figure 3.16: Post Test – Back Side of Extruder Head**

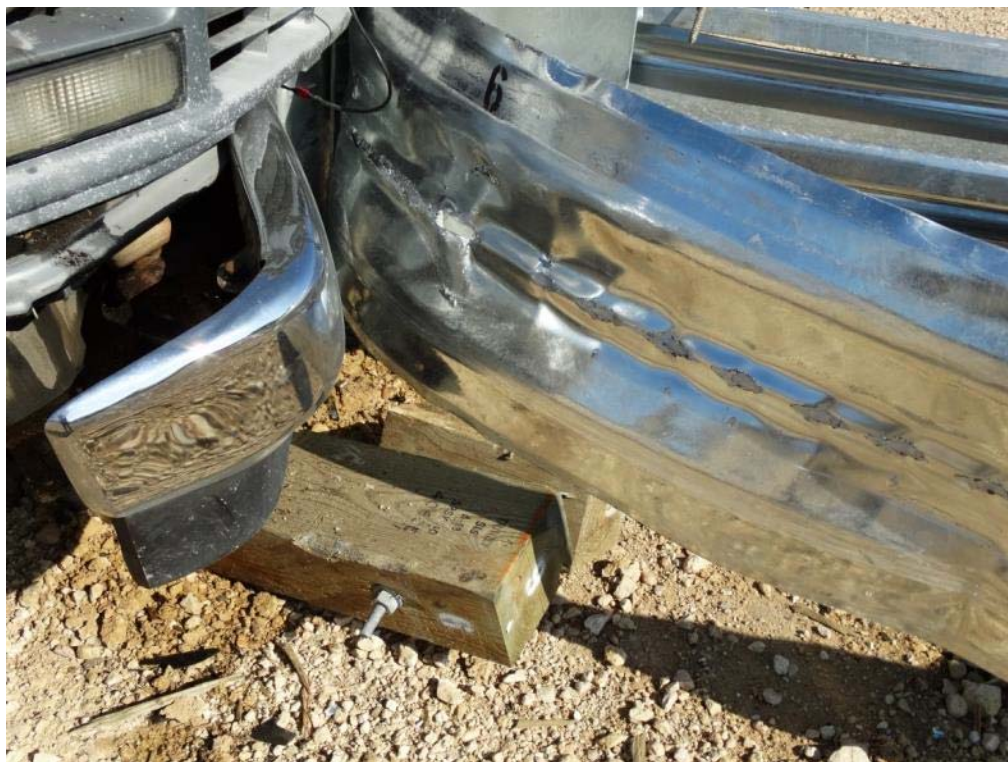
**Figure 3.17: Post Test – Side View**

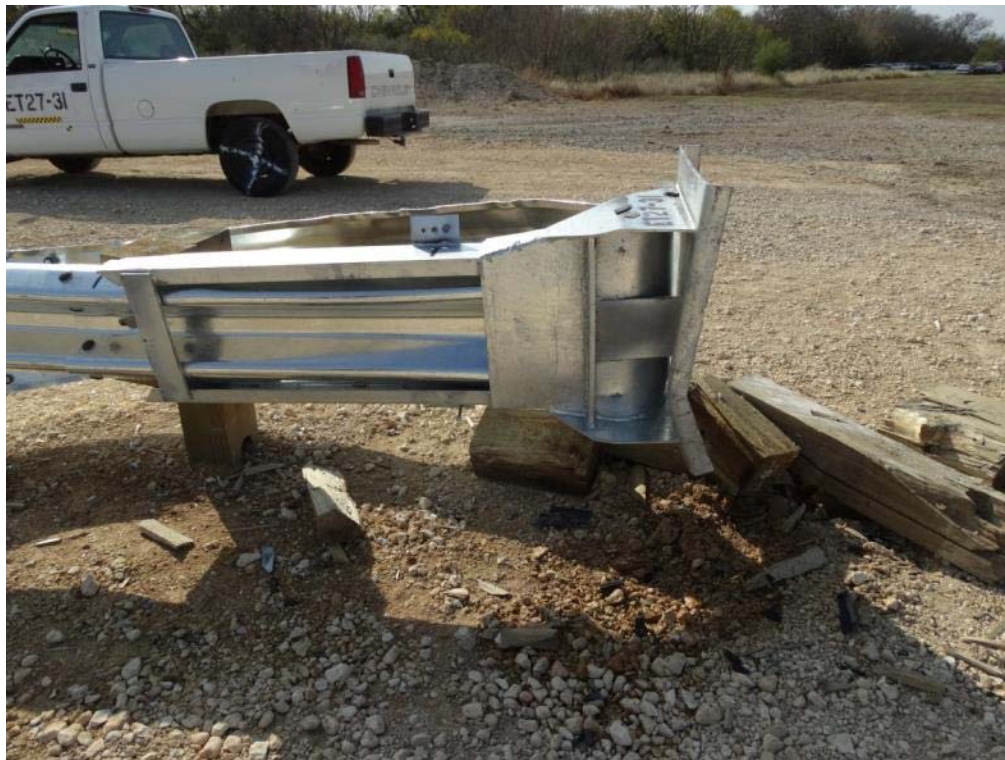
**Figure 3.34: Post-Impact Test Article after Vehicle Removed – Traffic Side View**

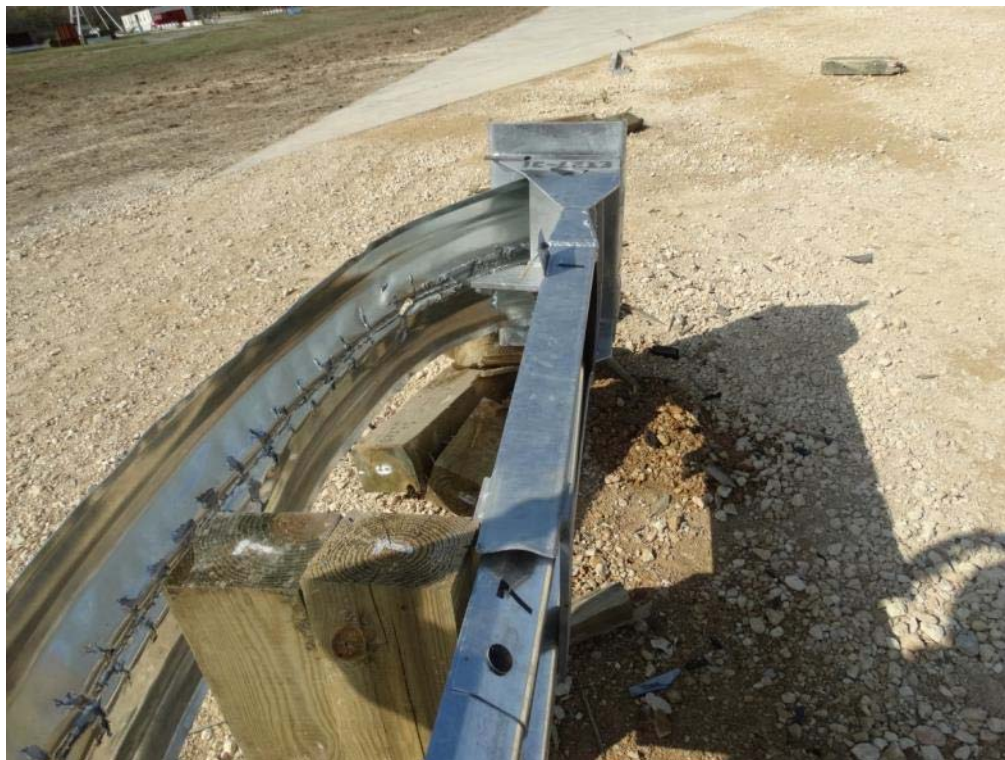
**Figure 3.35: Post-Impact Test Article after Vehicle Removed – Rear View**

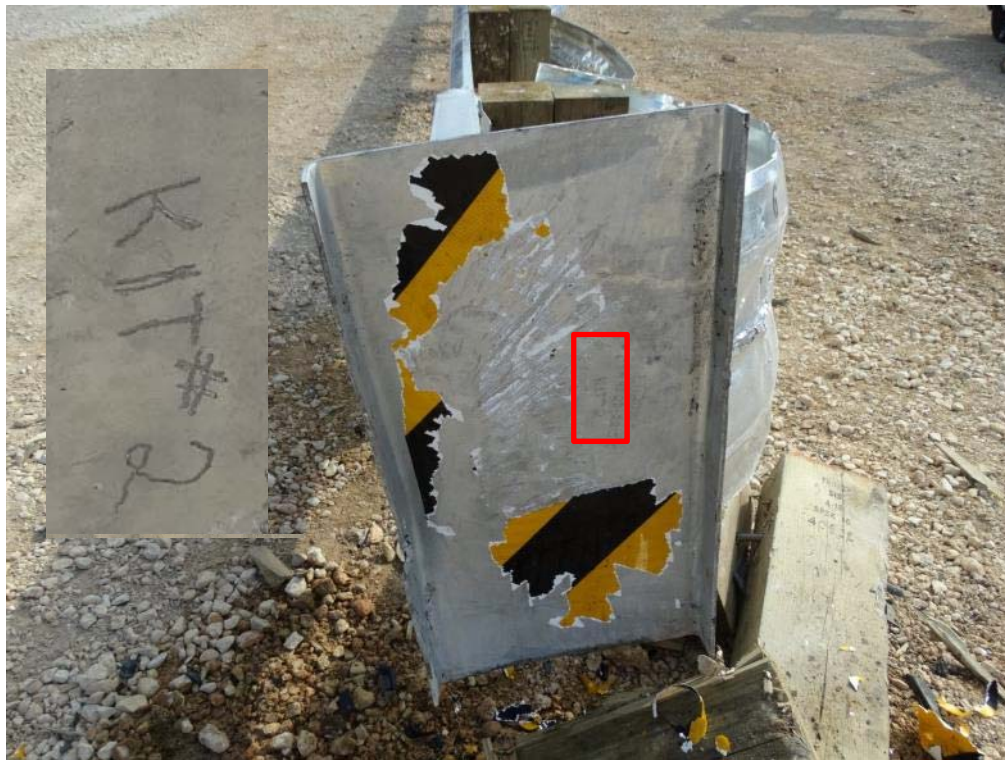
**Figure 3.38: Post Test Verification of Extruder Head 2**

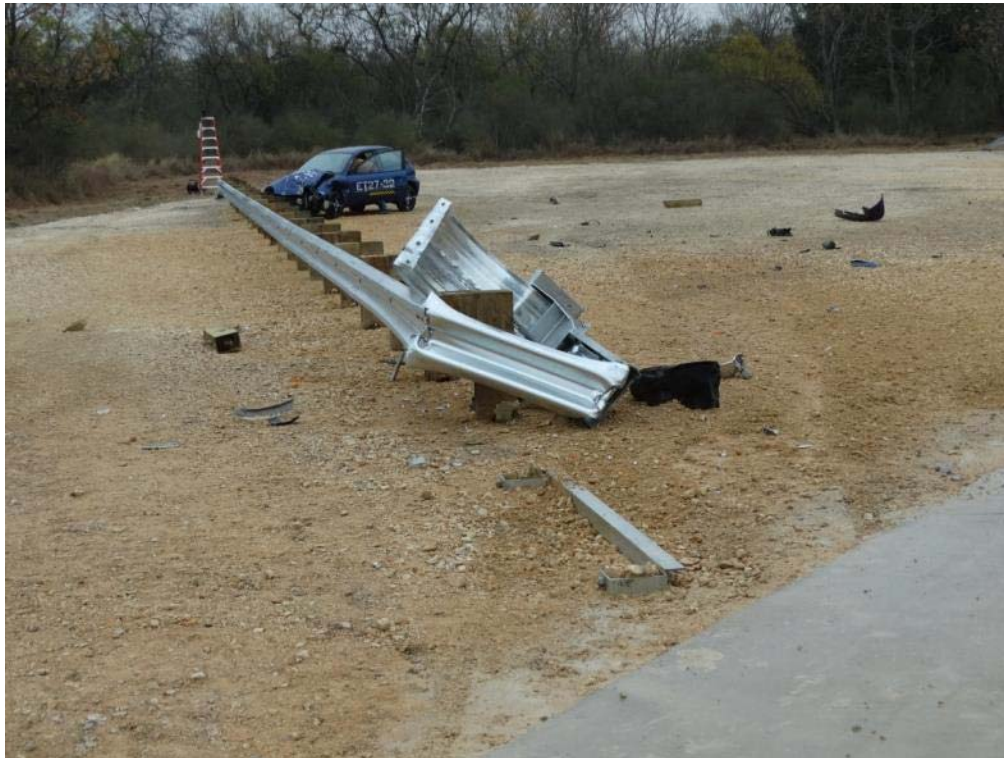
**Figure 3.6: Post-Impact Condition of the Test Article and Vehicle**

After the initial impact event, the ET Plus extruder head stroked along the guardrail, extruding approximately 3 feet of guardrail. Before the guide channel entrance end of the head reached Post 2 the head began to rotate, following the angled path of the vehicle; this rotation caused a fold to form in the W beam at Post 2. As the vehicle continued its angled trajectory, the channel guide portion of the ET Plus extruder head was pushed further downstream on the W beam over the fold that had formed at Post 2. As the vehicle continued forward the head continued to rotate, allowing the vehicle to pass (or gate) through to the non-traffic side of the system. The ET Plus extruder head ended up roughly parallel to the guardrail and facing in the downstream direction.

As the vehicle passed by the gated extruder head, the corner of the guide channel entrance scraped the driver's side door creating a tear approximately 9" long in the door surface. The tear affected the sheet metal but there was no damage caused to the interior door panel, and no intrusion or potential for intrusion of the test article into the occupant compartment based on the position of the extruder head relative to the vehicle trajectory.

The ET Plus extruder head directly contacted and sheared-off Posts 1 and 2, and damaged Post 3 at the end of the stroke. The splice at Post 3 remained intact and connected to the post. Although Post 4 appeared undamaged, there was twisting of the Post 4 blockout due to relative longitudinal motion of the guardrail panel. All posts and blockouts downstream of Post 4 appeared undamaged, and no appreciable movement of the downstream turndown anchor was observed. Additionally, the anchor cable at Post 1 broke free of the installation and came to rest near Post 4. There was no penetration of the vehicle by the test article, and there was no deformation of the occupant compartment resulting from the test. The only debris thrown from the installation as a result of the impact included pieces of posts and blockouts from the first two posts; the majority of the debris fell to the non-traffic side of the guardrail. There was no significant deformation of the 4" guide channels as a result of the impact, and they remained attached to the impact head.

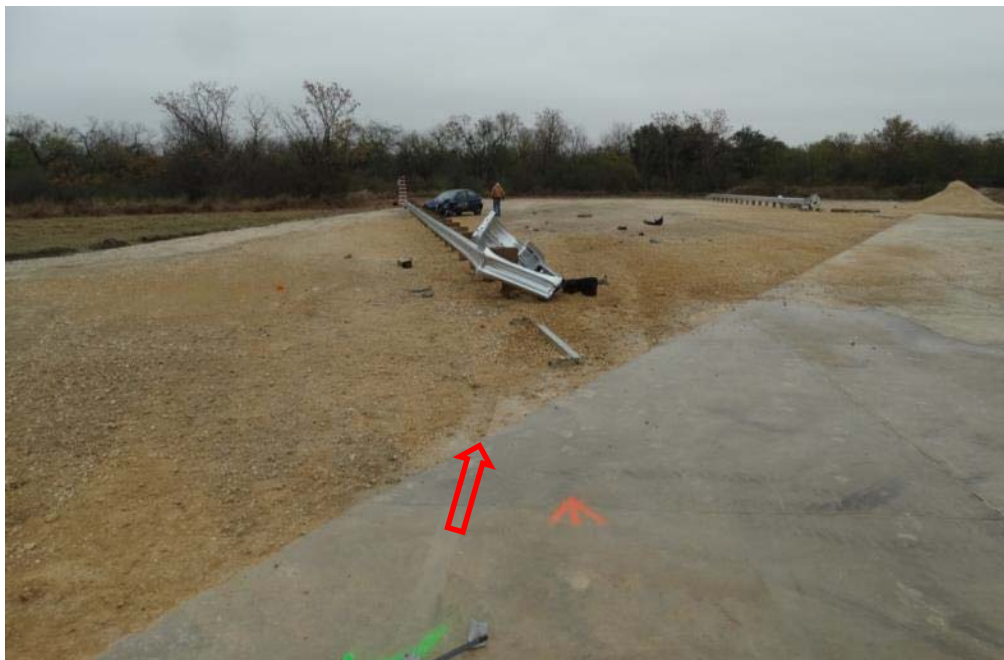
**Figure 3.7: Post Test – Left Vehicle Track**

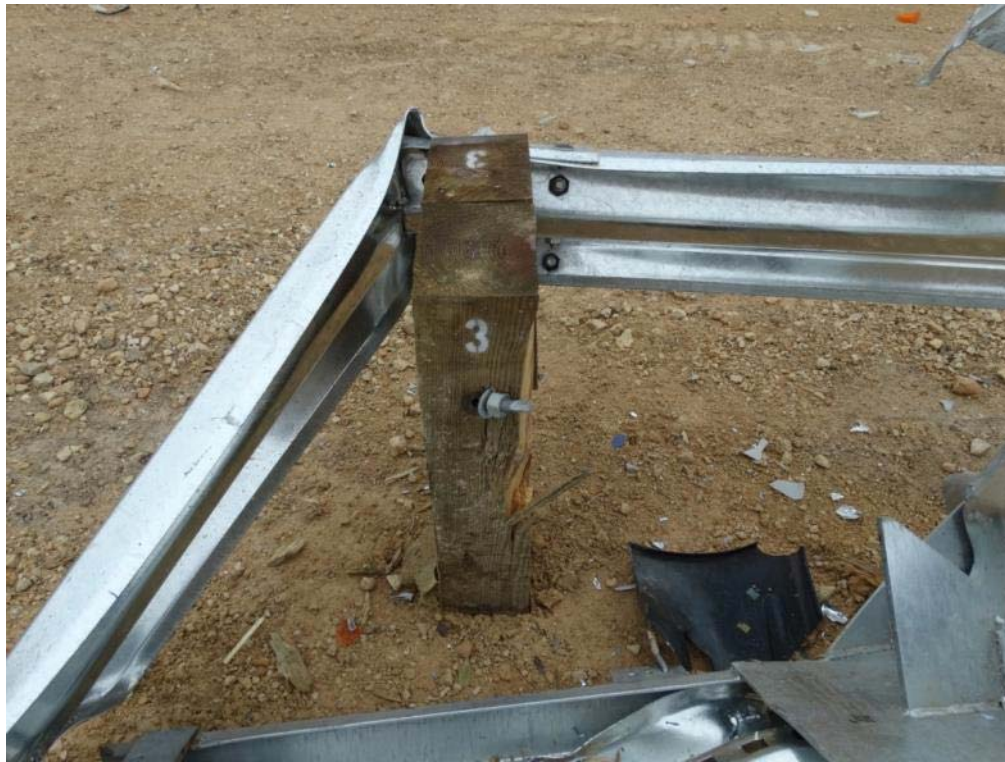
Figure 3.10: Post Test – Post 3

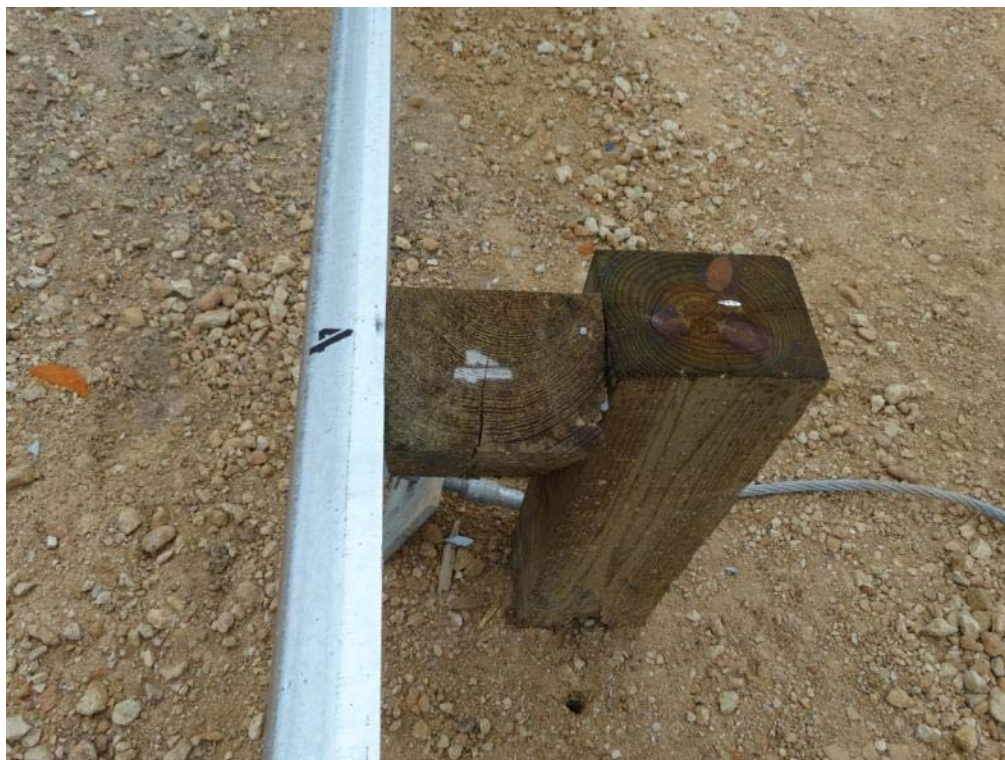
Figure 3.11: Post Test – Post 4

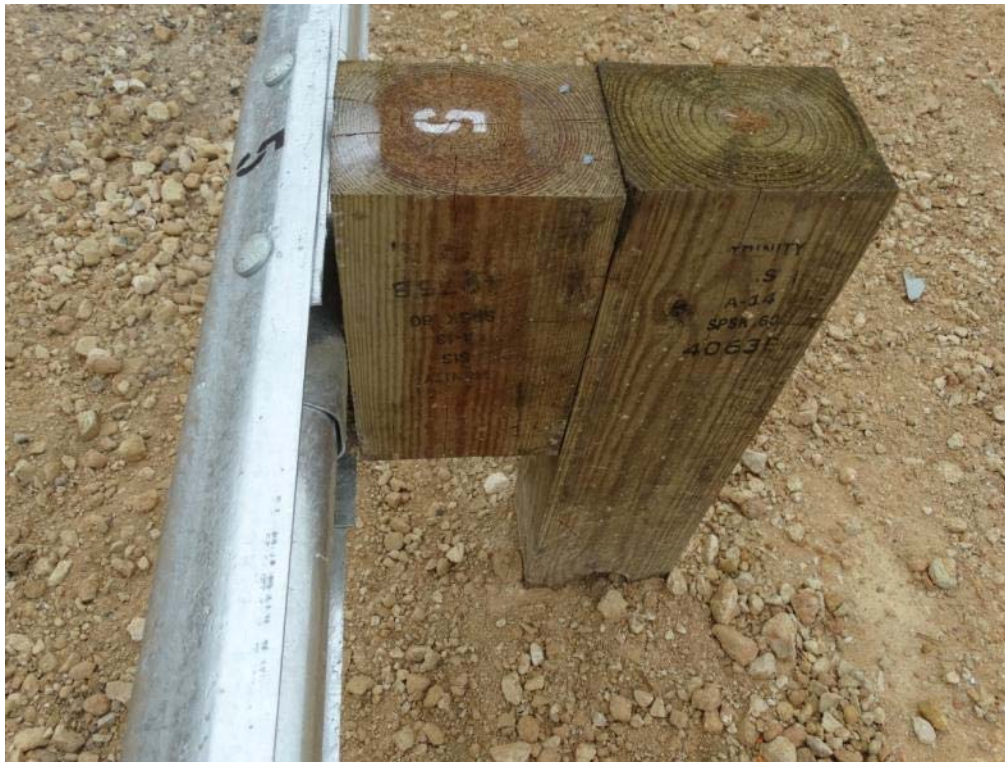
Figure 3.12: Post Test – Post 5

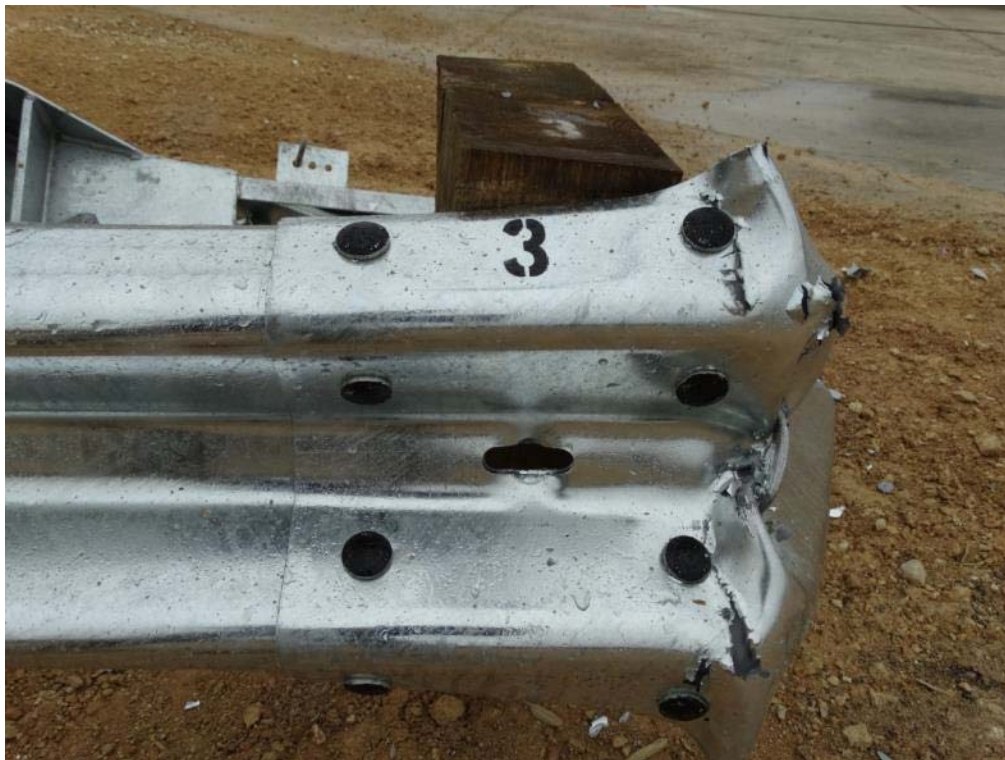
Figure 3.13: Post Test – Gated Guardrail, View from Traffic Side

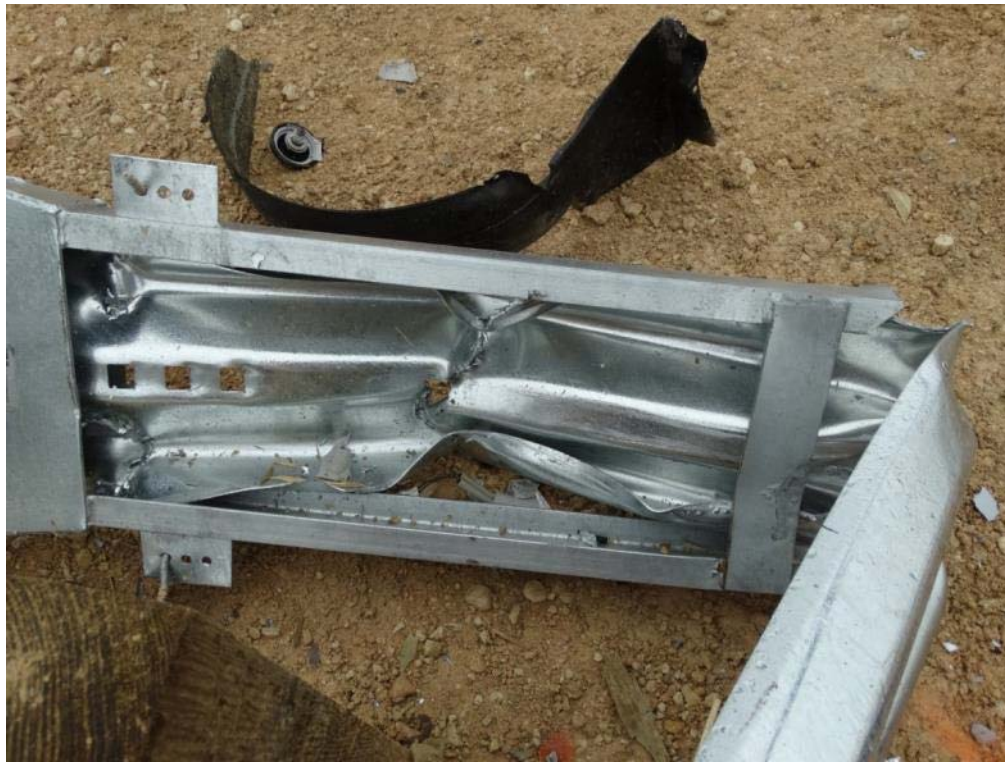
**Figure 3.20: Post Test – Non-Traffic Side of Extruder Head**

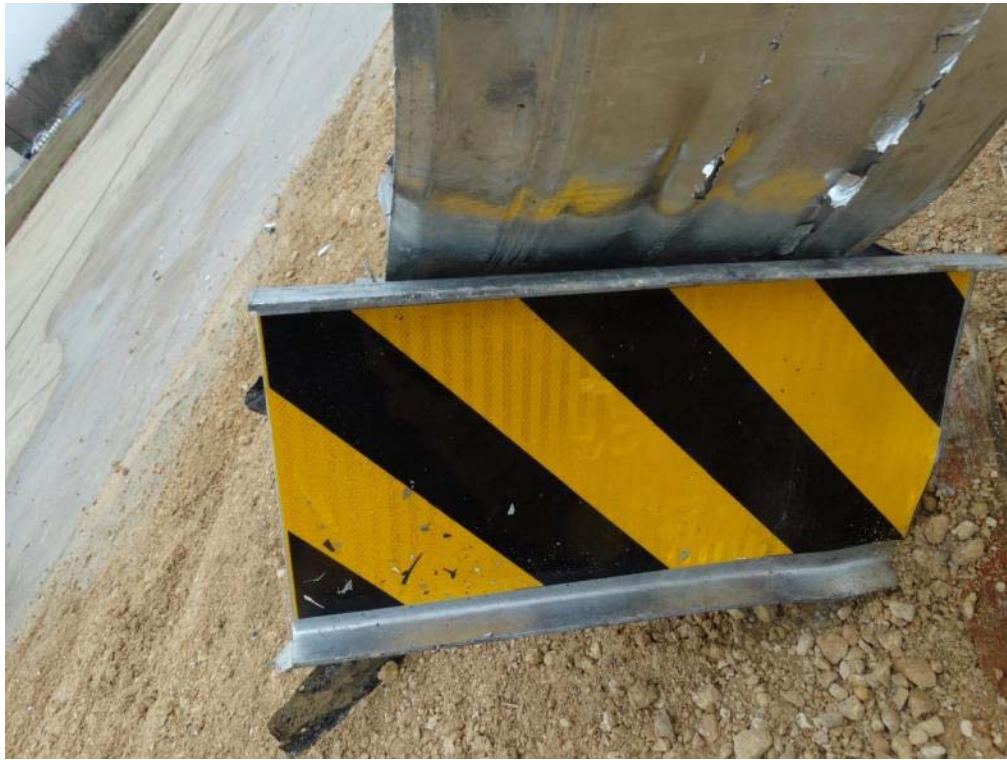
**Figure 3.27: Post Test Terminal Extruder Head Impact Plate**
