# NCHRP Report 350 Test Report Compilation

## Full-Scale Crash Evaluations of the ET Plus<sup>®</sup> End Terminal with 4-inch Wide Guide Channel Installed with a Rail Height of 27¾ Inches

Tests: ET27-33, ET27-31, ET27-32 and ET27-30

SwRI<sup>®</sup> Project No. 18.20887

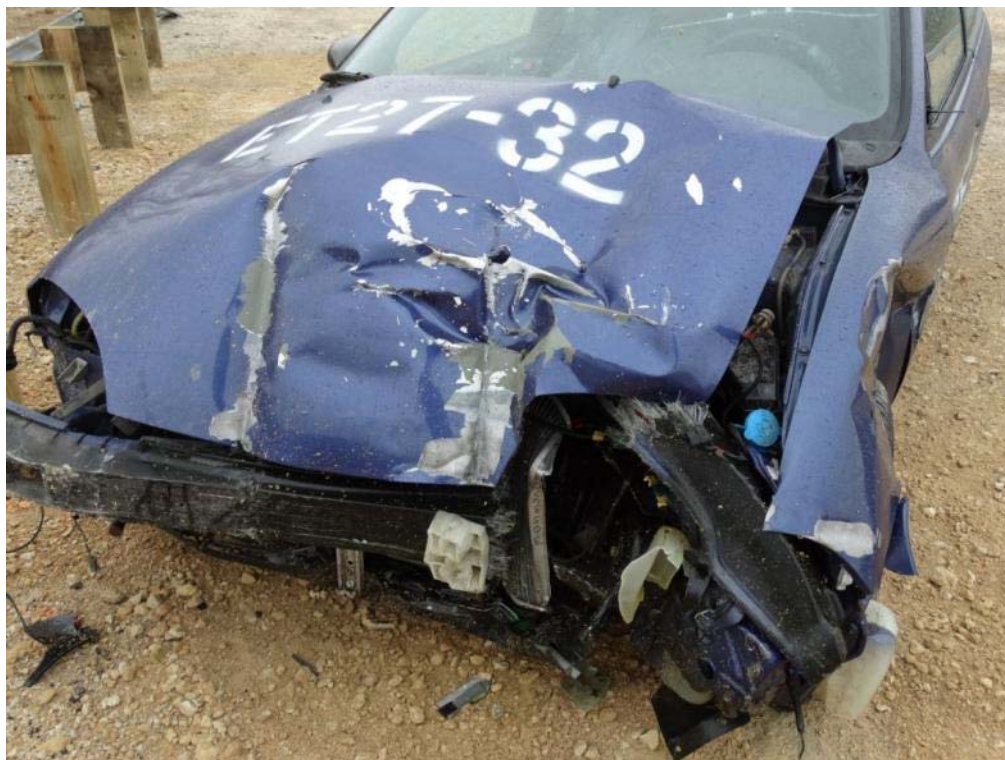
**Figure 3.34: Damaged Test Vehicle – Front View Close-up**

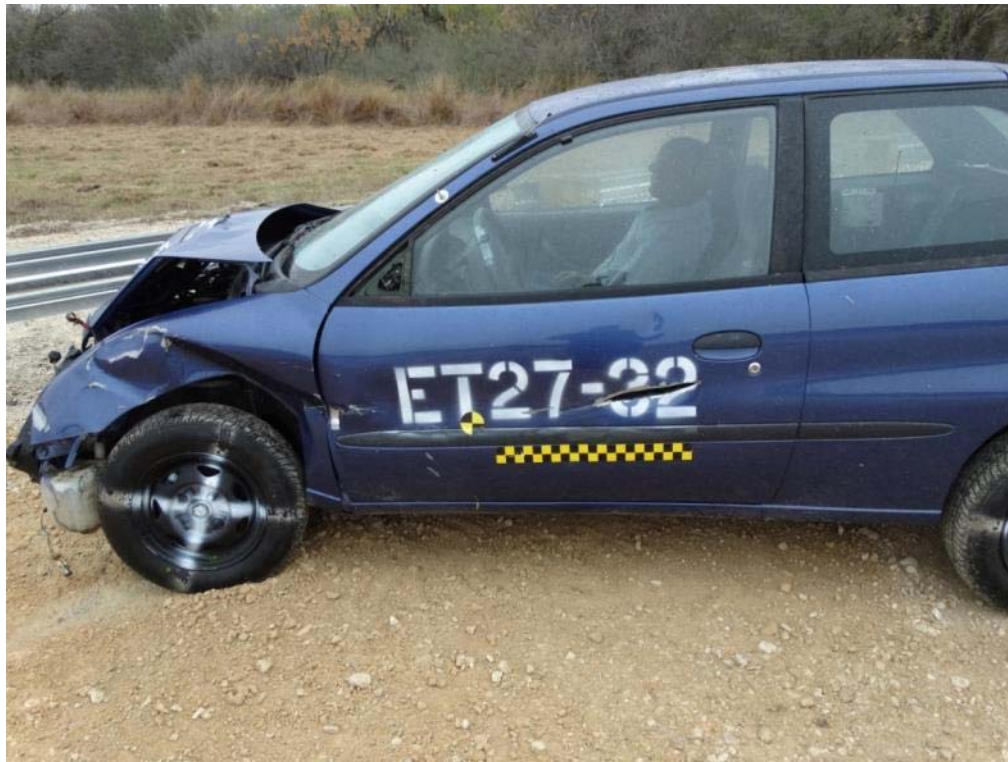
**Figure 3.35: Damaged Test Vehicle – Left Side**

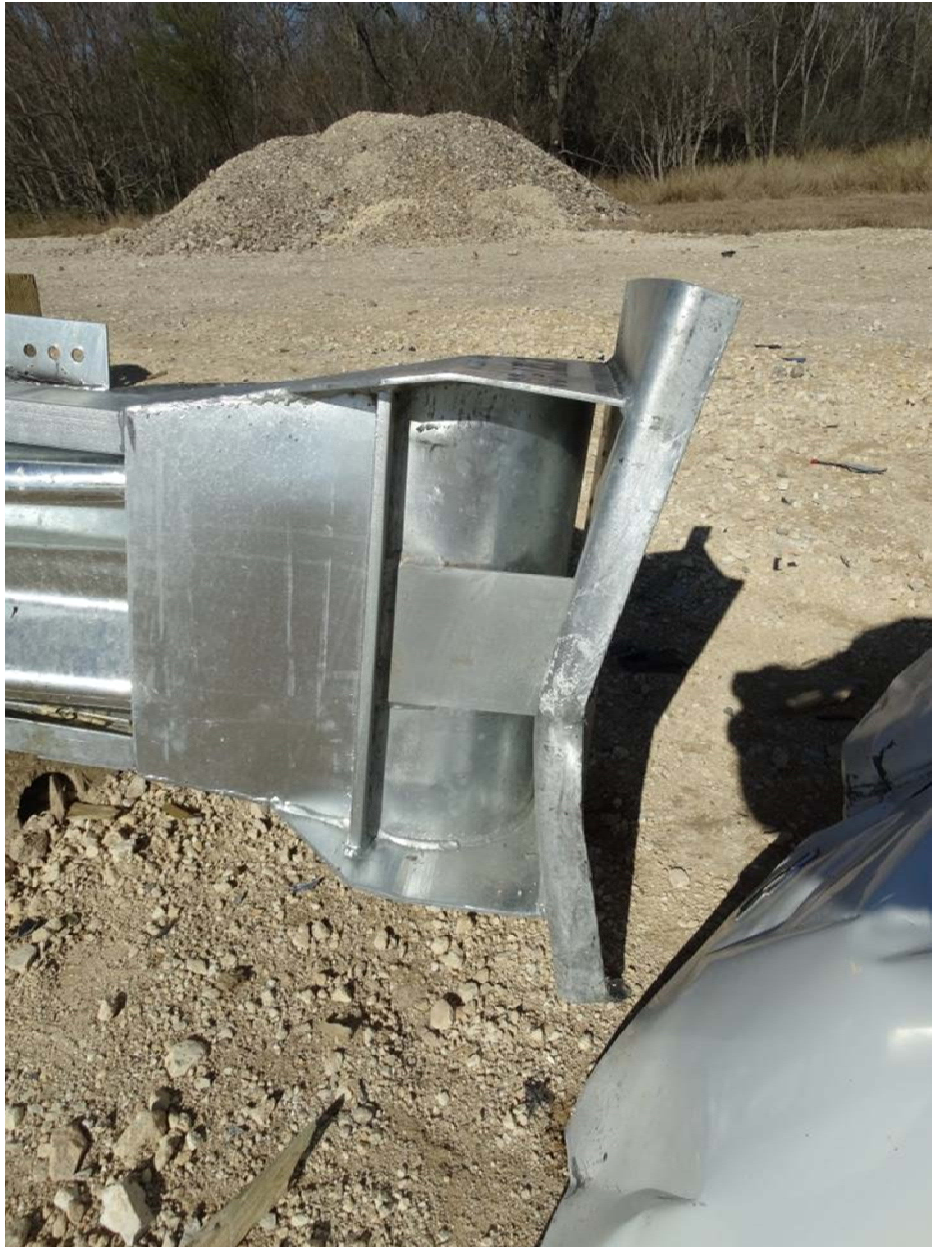
**Figure 3.6: Post Test – Side View of Extruder Head**

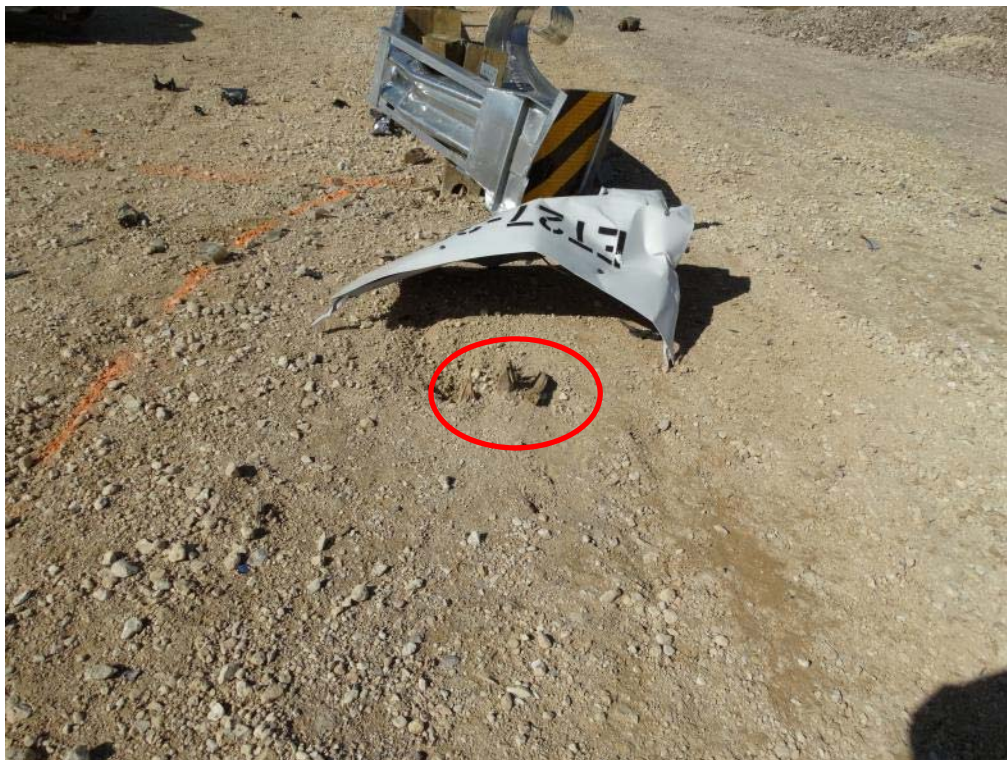
**Figure 3.10: Post Test – Post 3 and Extruder Head**

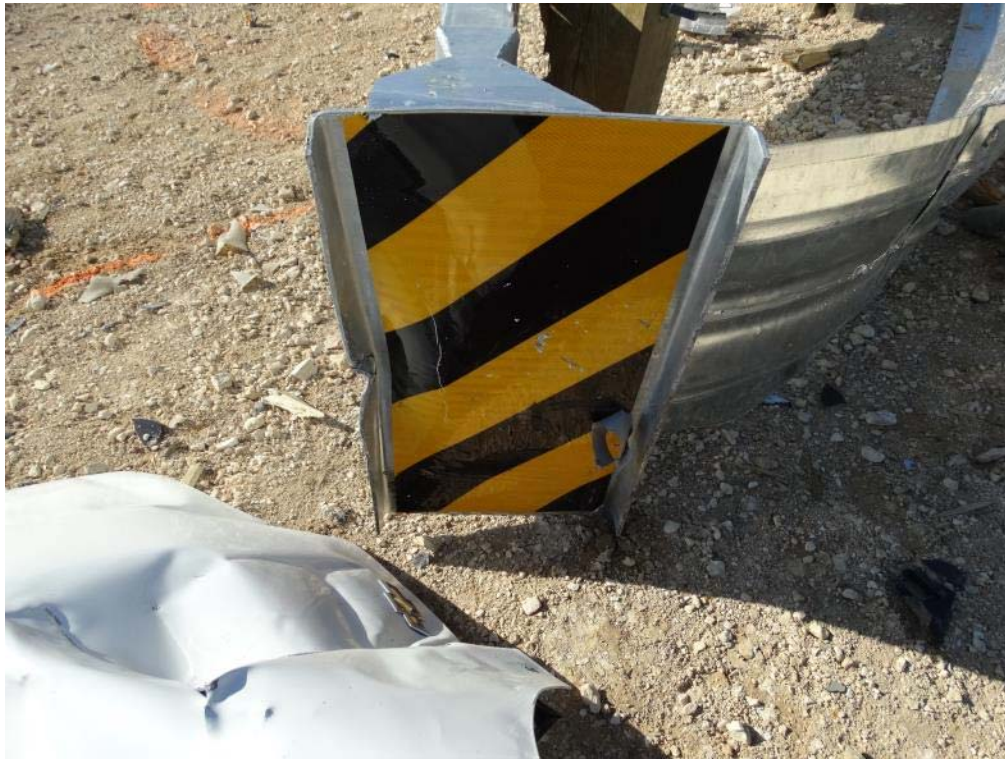
**Figure 3.11: Post Test – End View of Extruder Head Impact Plate**

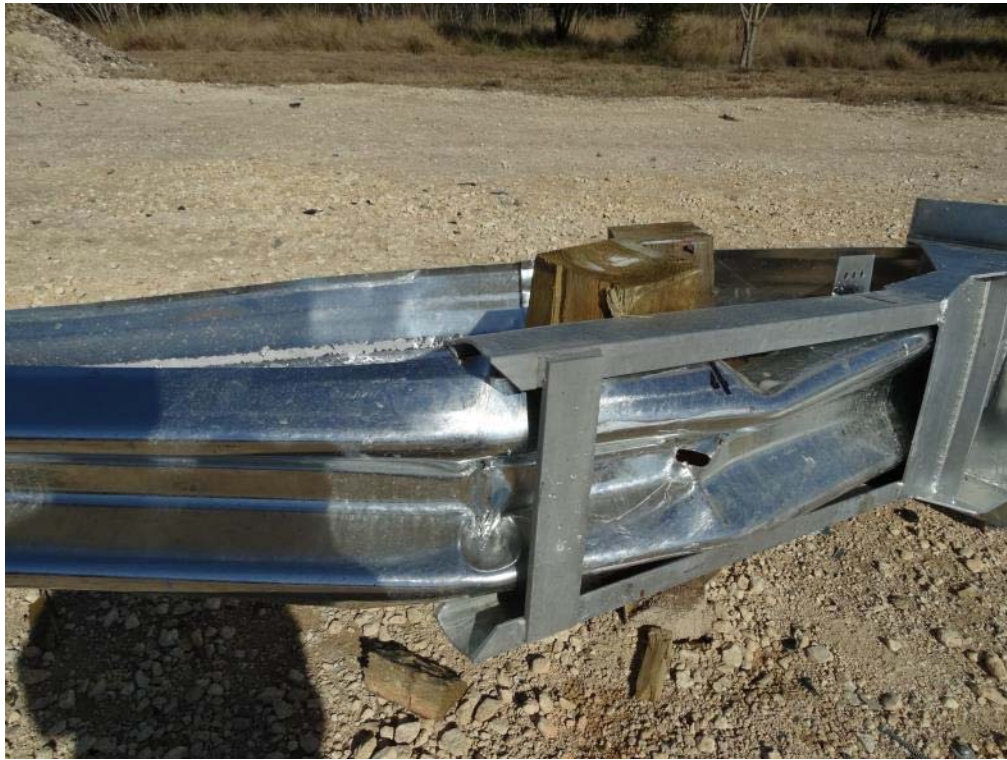
**Figure 3.13: Post Test – Traffic Side View of Extruder Head**

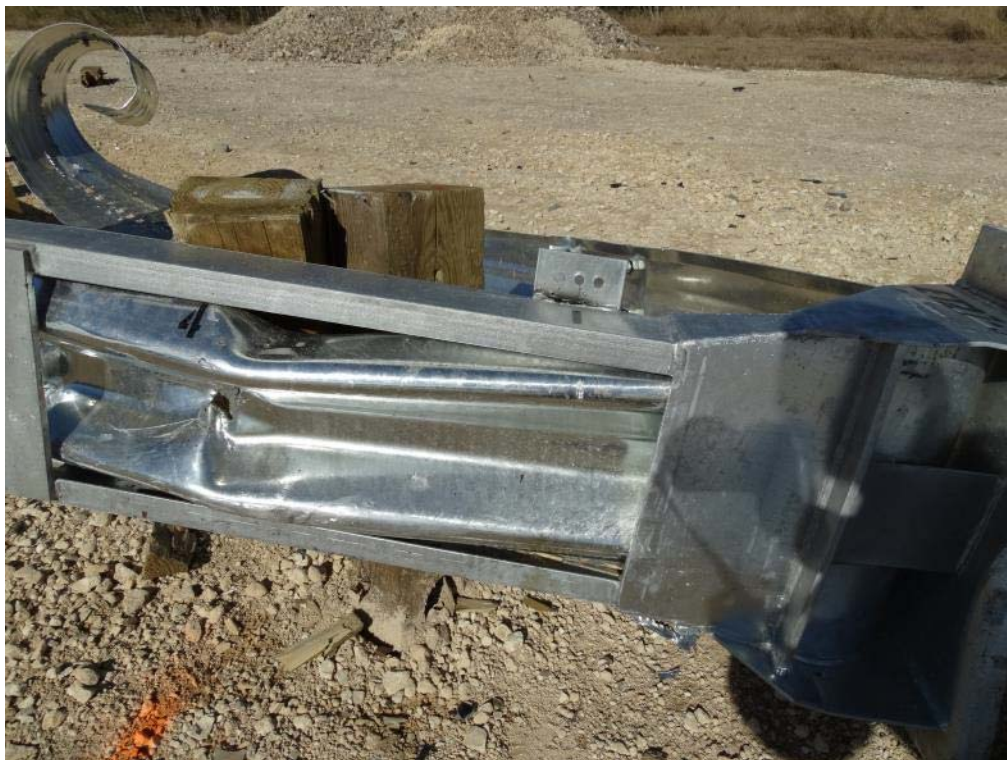
**Figure 3.14: Post Test – Side View of Extruder Head**

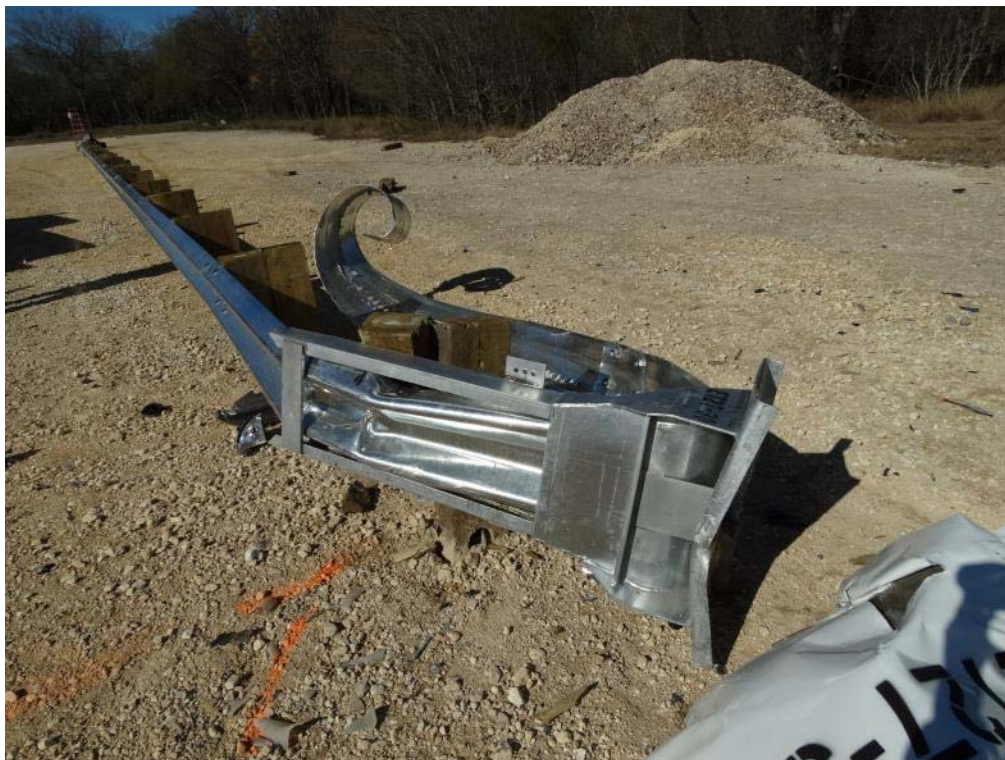
**Figure 3.24: Post Test – Traffic Side View of Extruder Head**

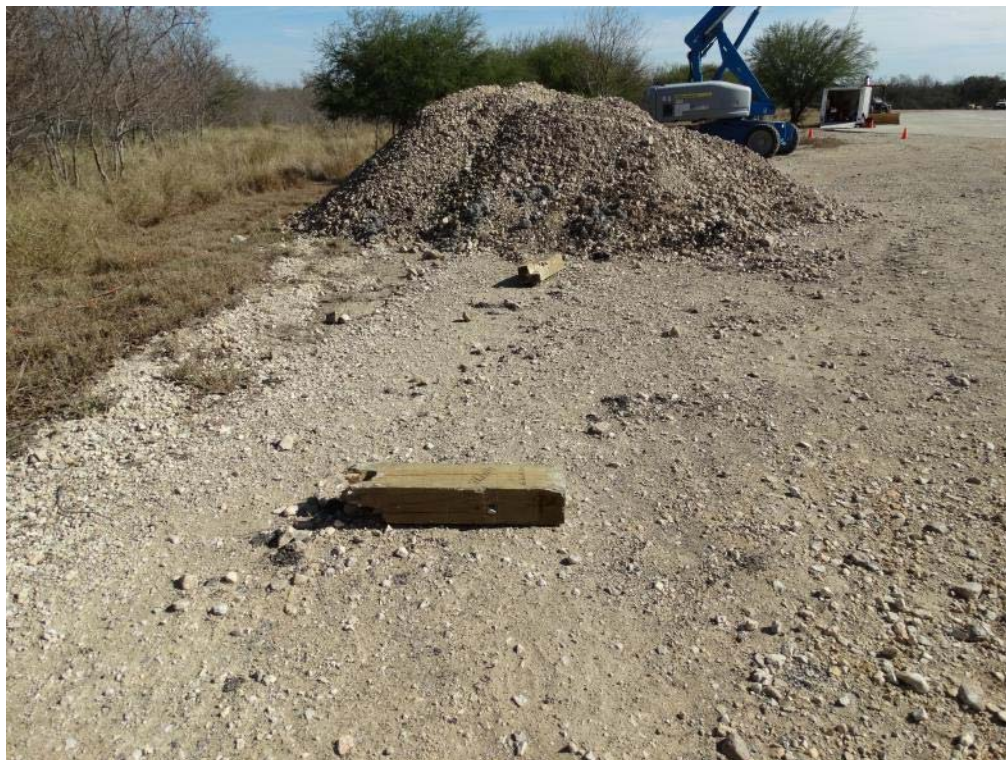
**Figure 3.26: Post Test – Breakaway Posts 1 and 2**

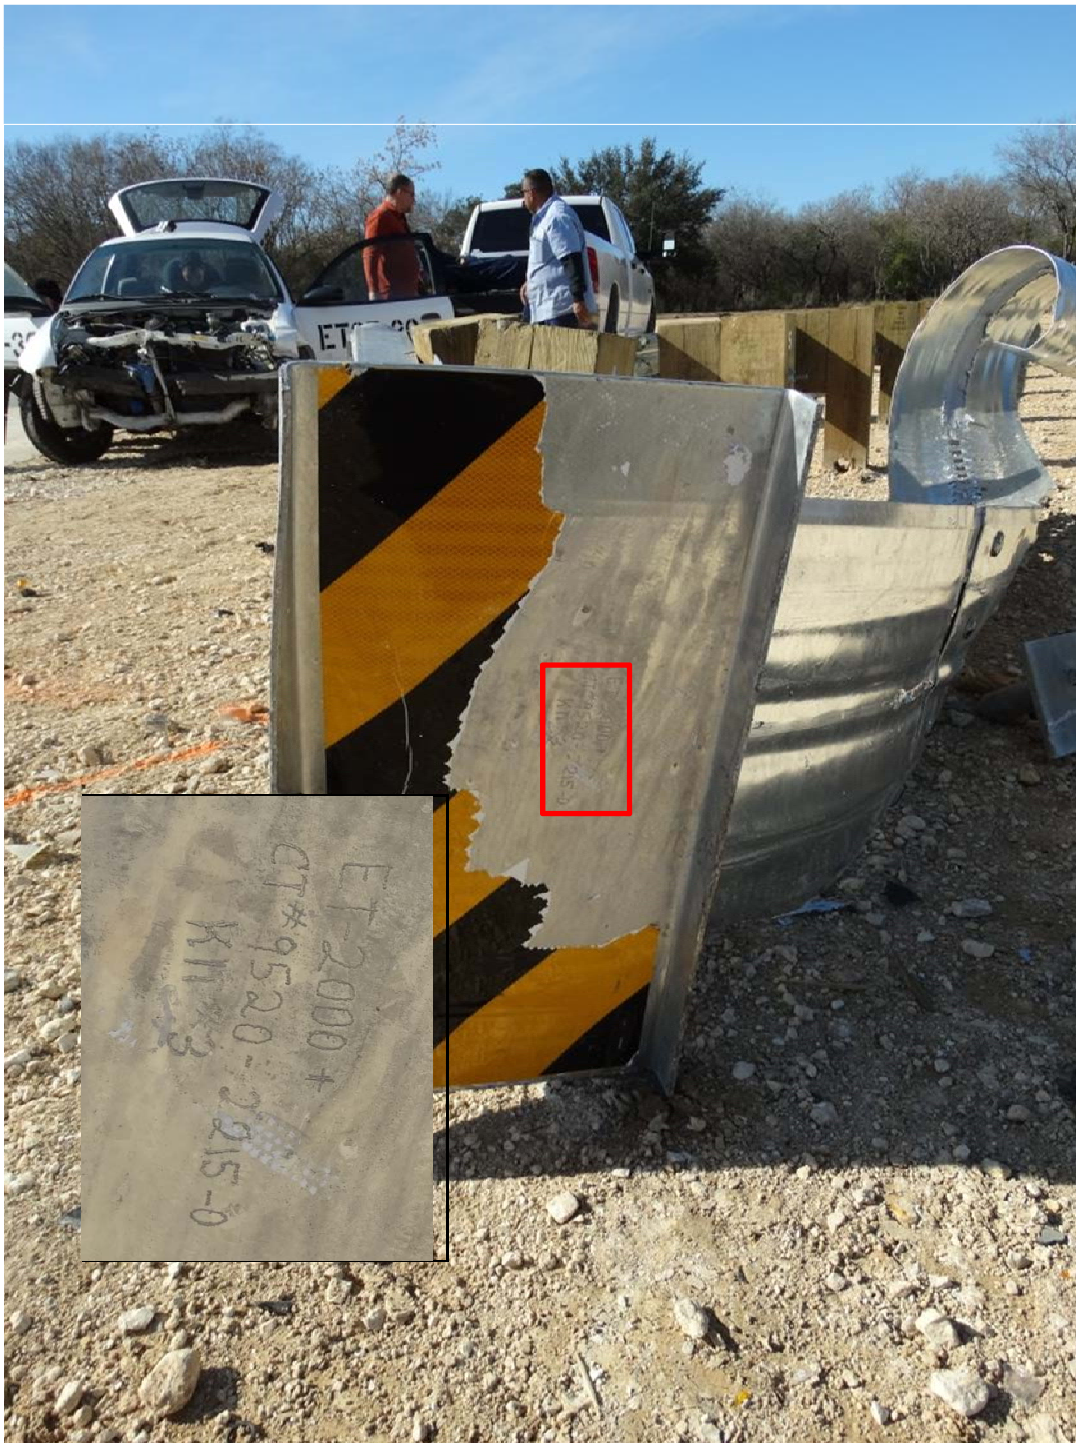
Figure 3.28: Post Test Verification of Extruder Head 3

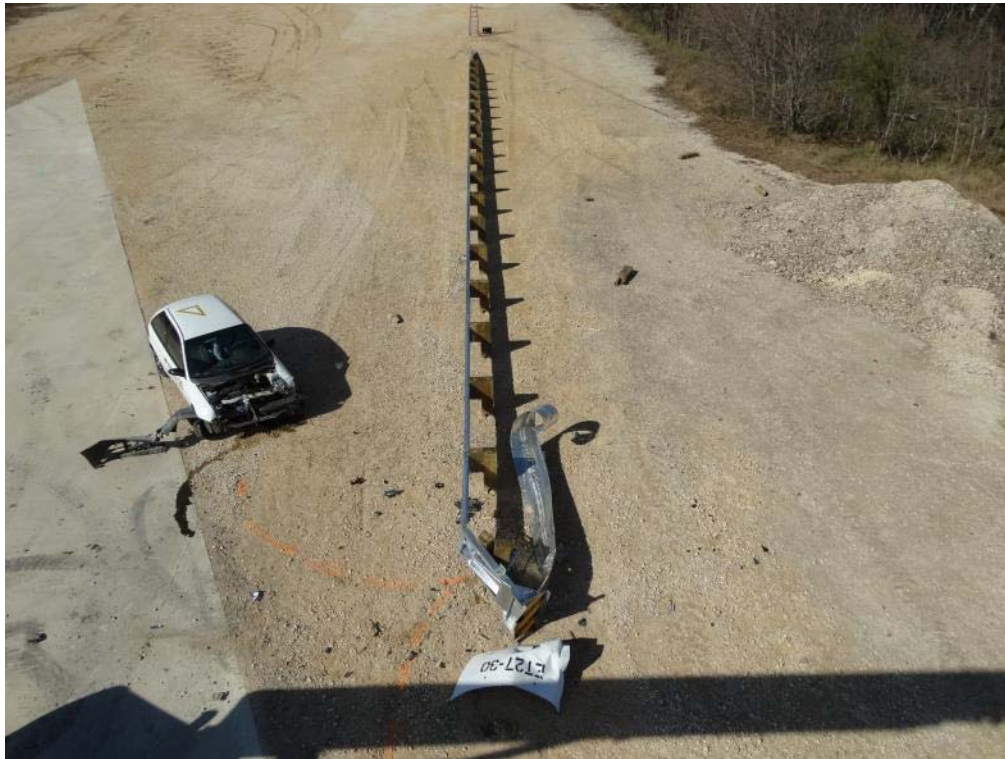
Figure 3.29: Vehicle Post Test Location

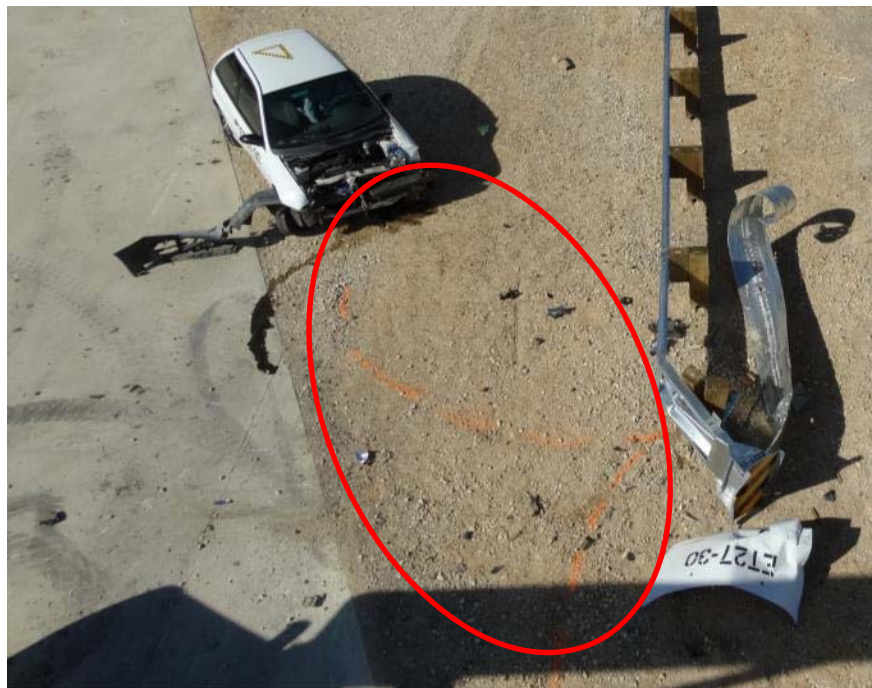
Figure 3.30: Test Vehicle Path of Left Front Tire (Orange Paint)

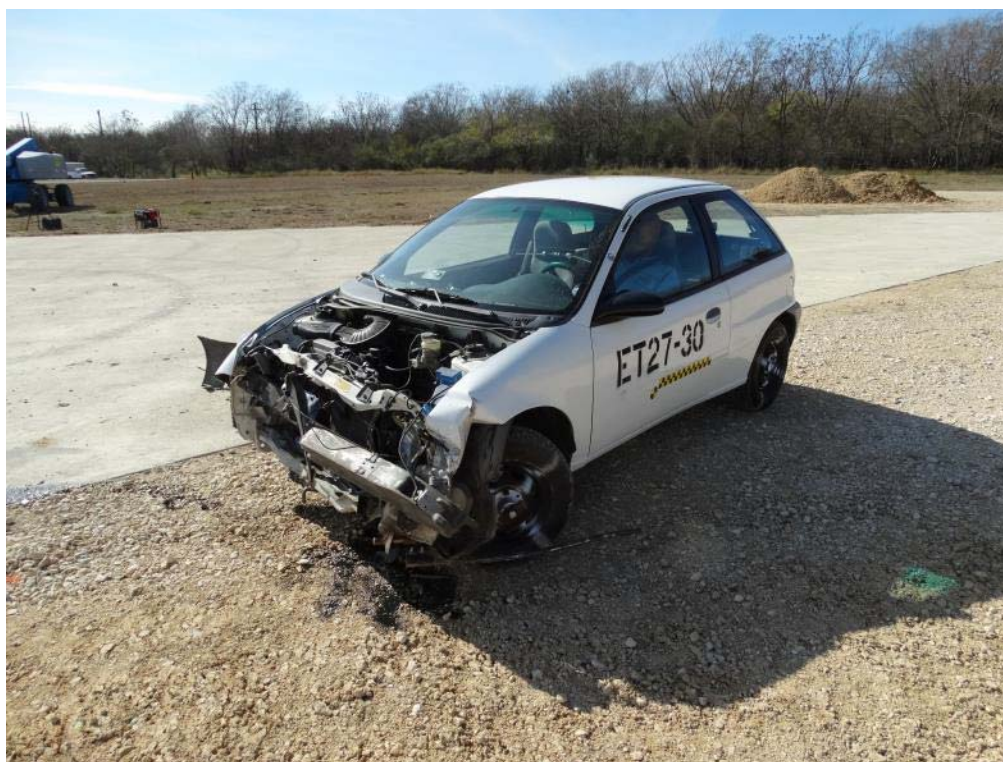
**Figure 3.33: Damaged Test Vehicle – Left Side**

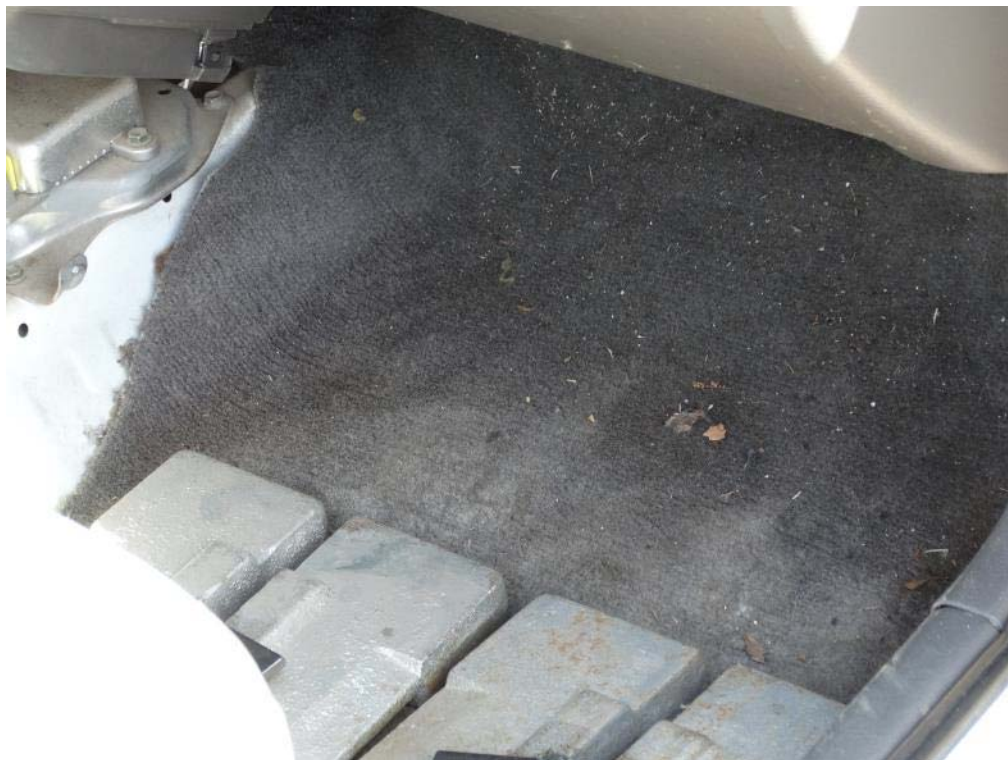
**Figure 3.38: Post-Test – Passenger Side Floorboard**
